155MM XM198 HOWITZER MUZZLE WEAR

R. G. Hasenbein

Watervliet Arsenal

May 1975

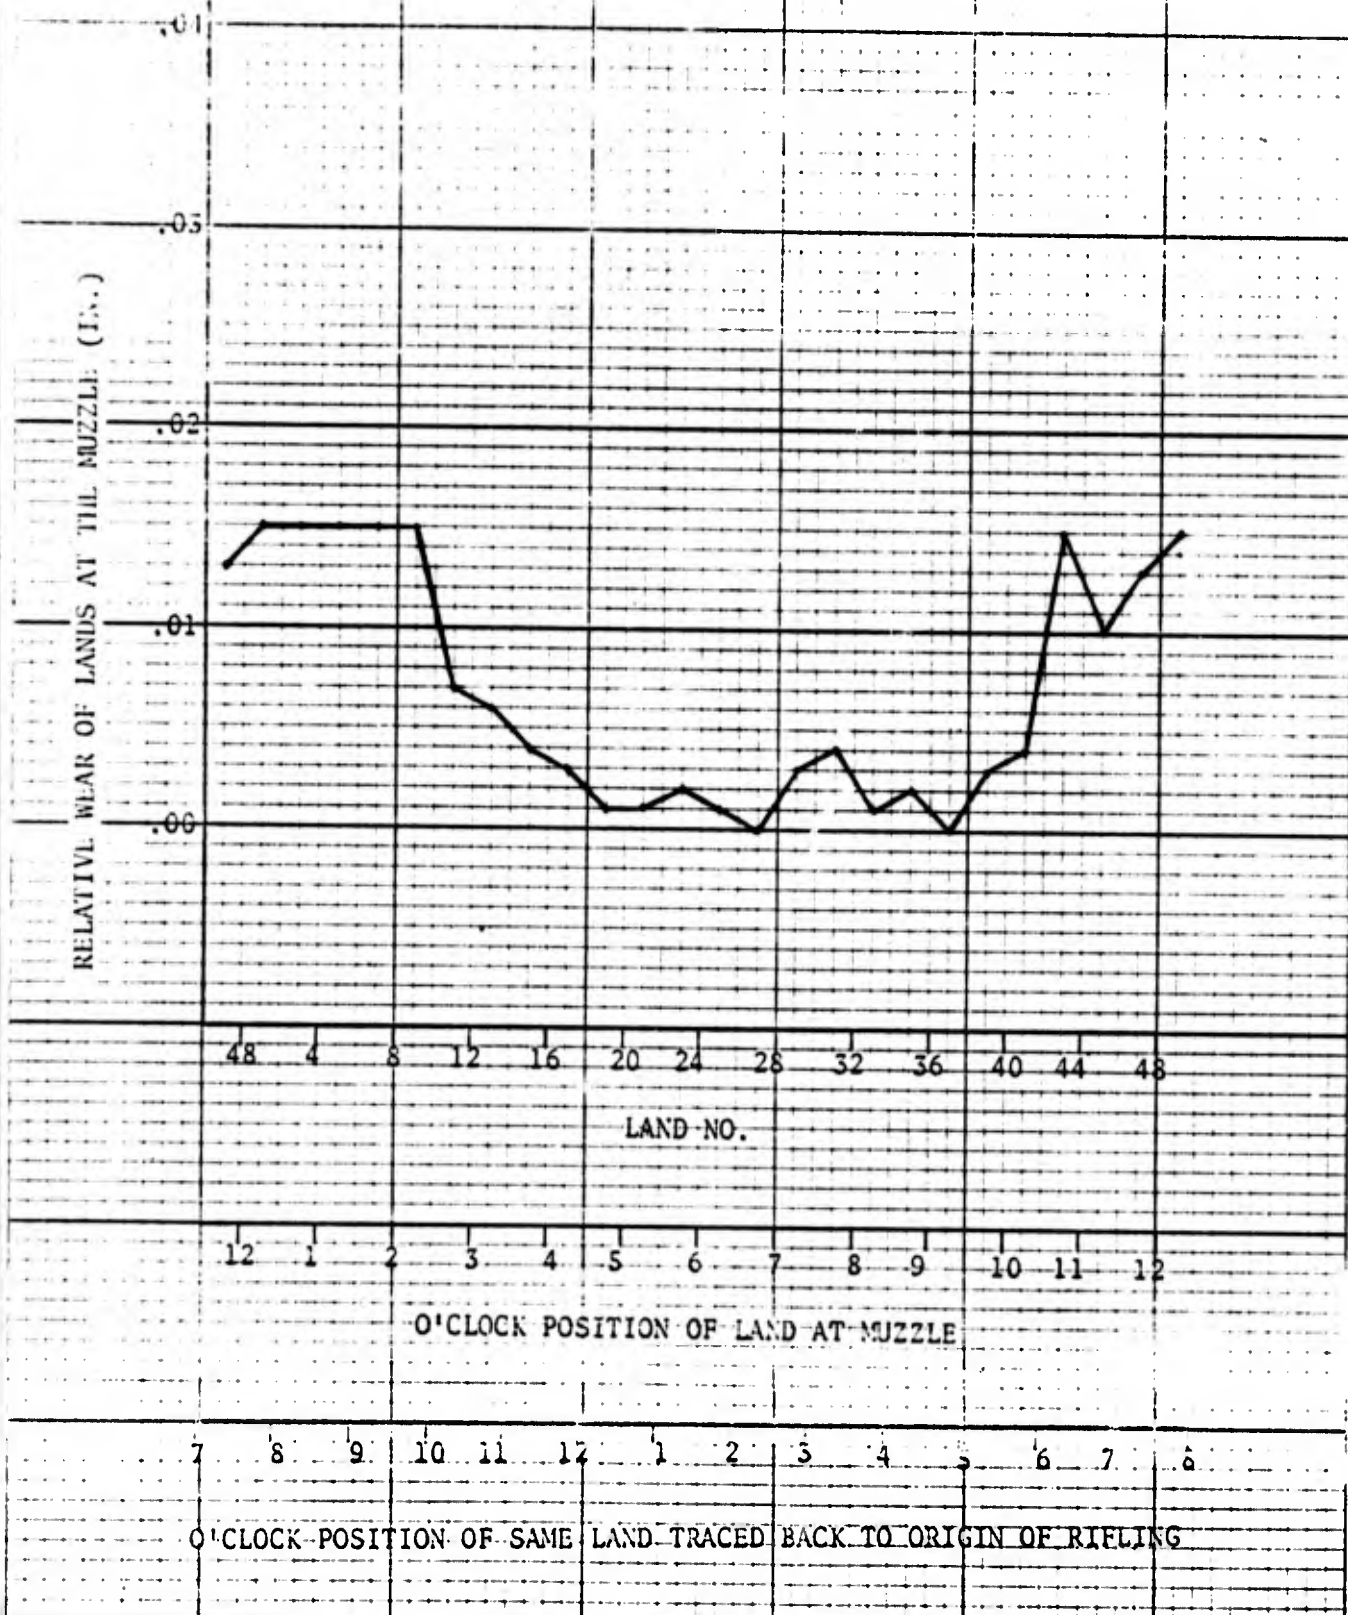
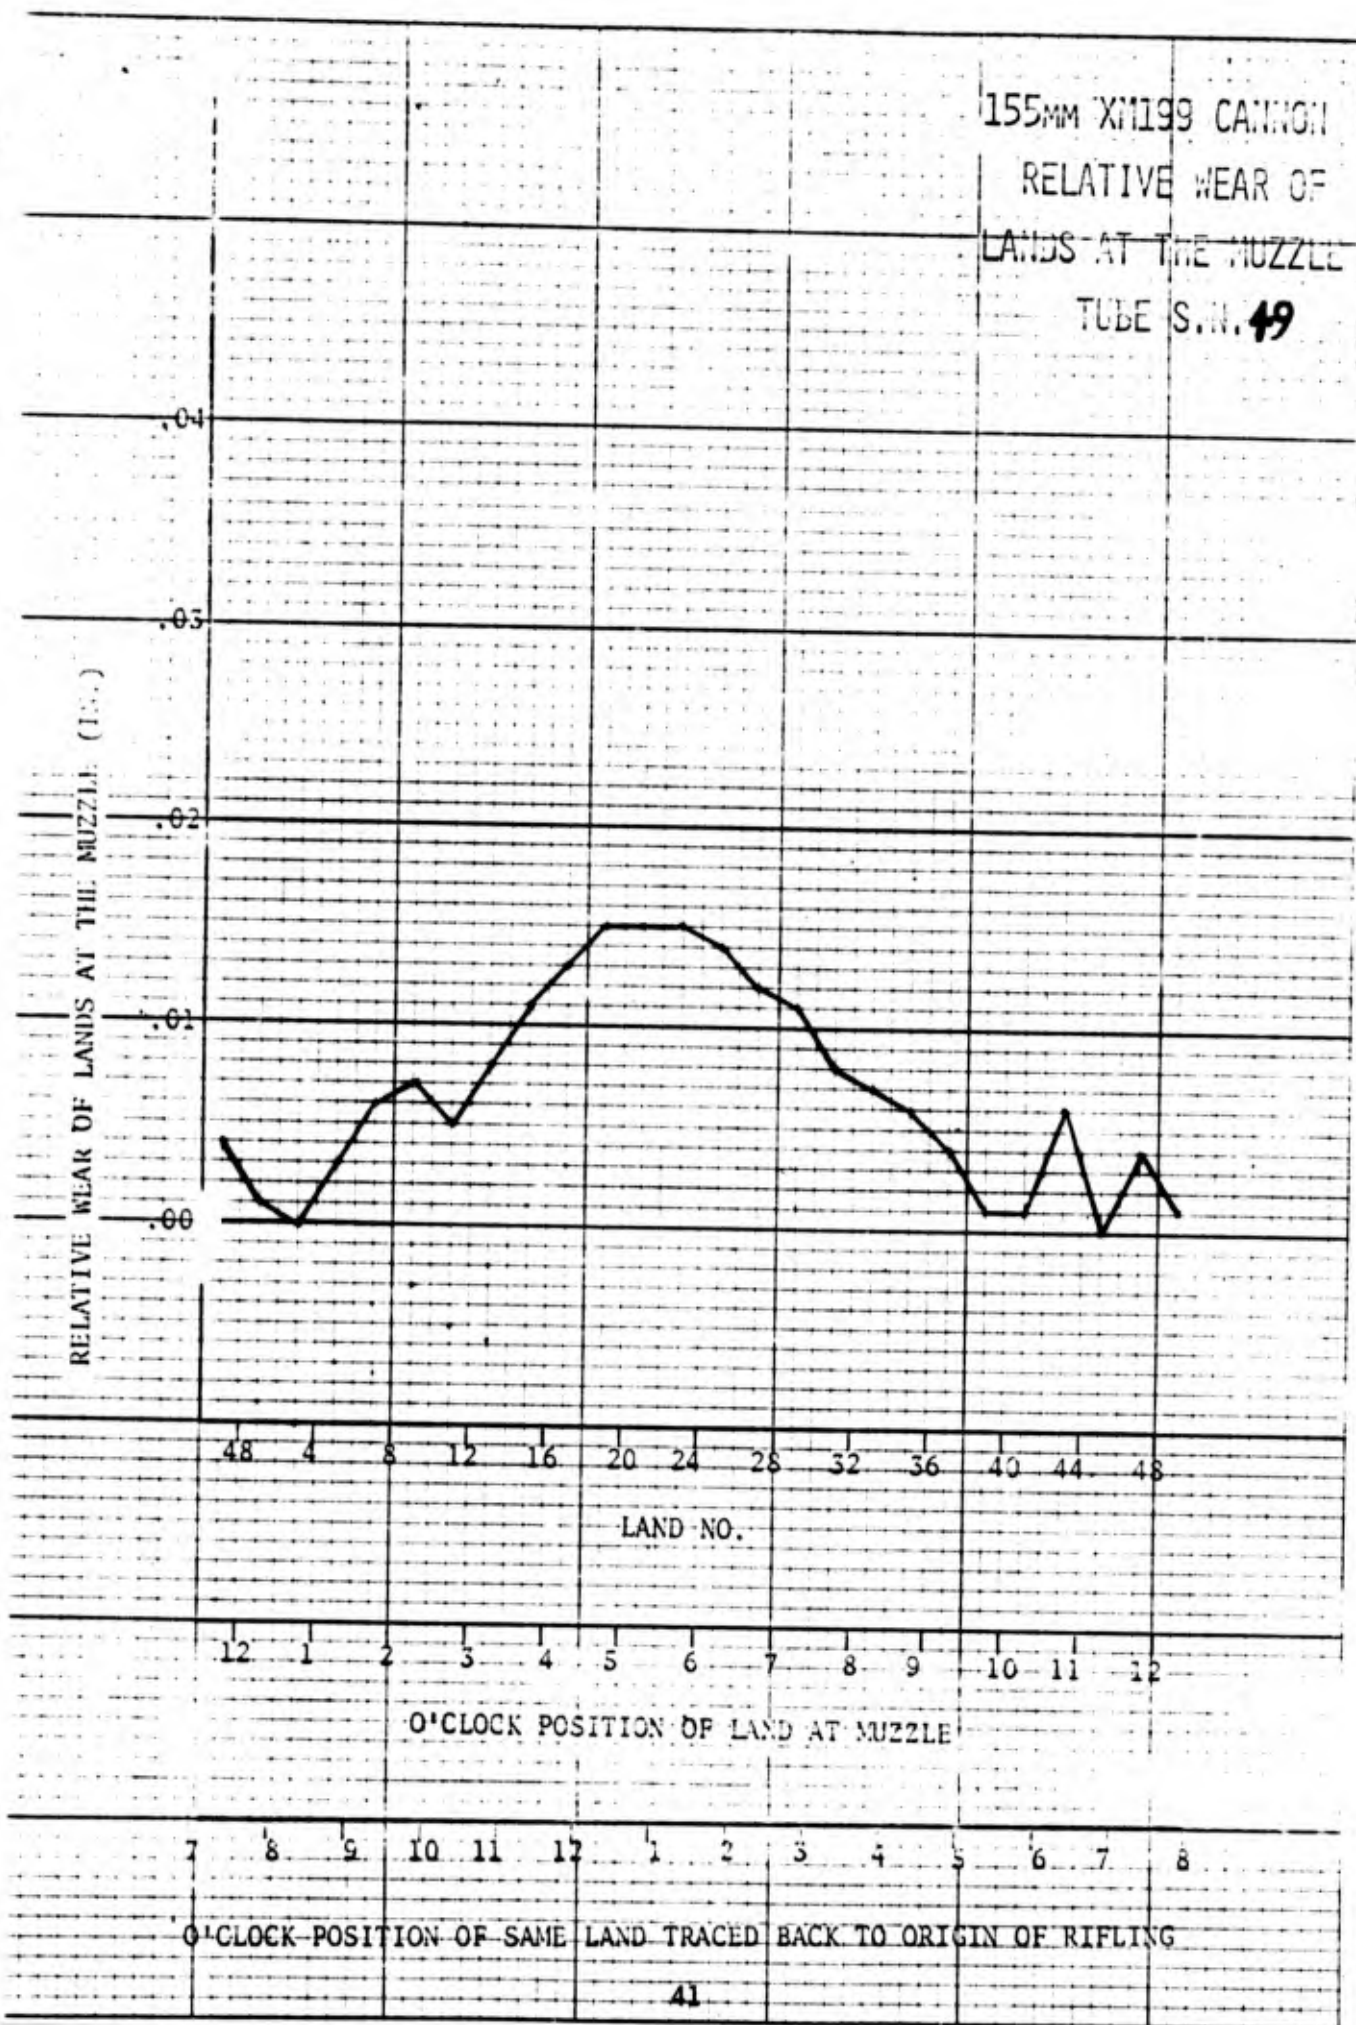
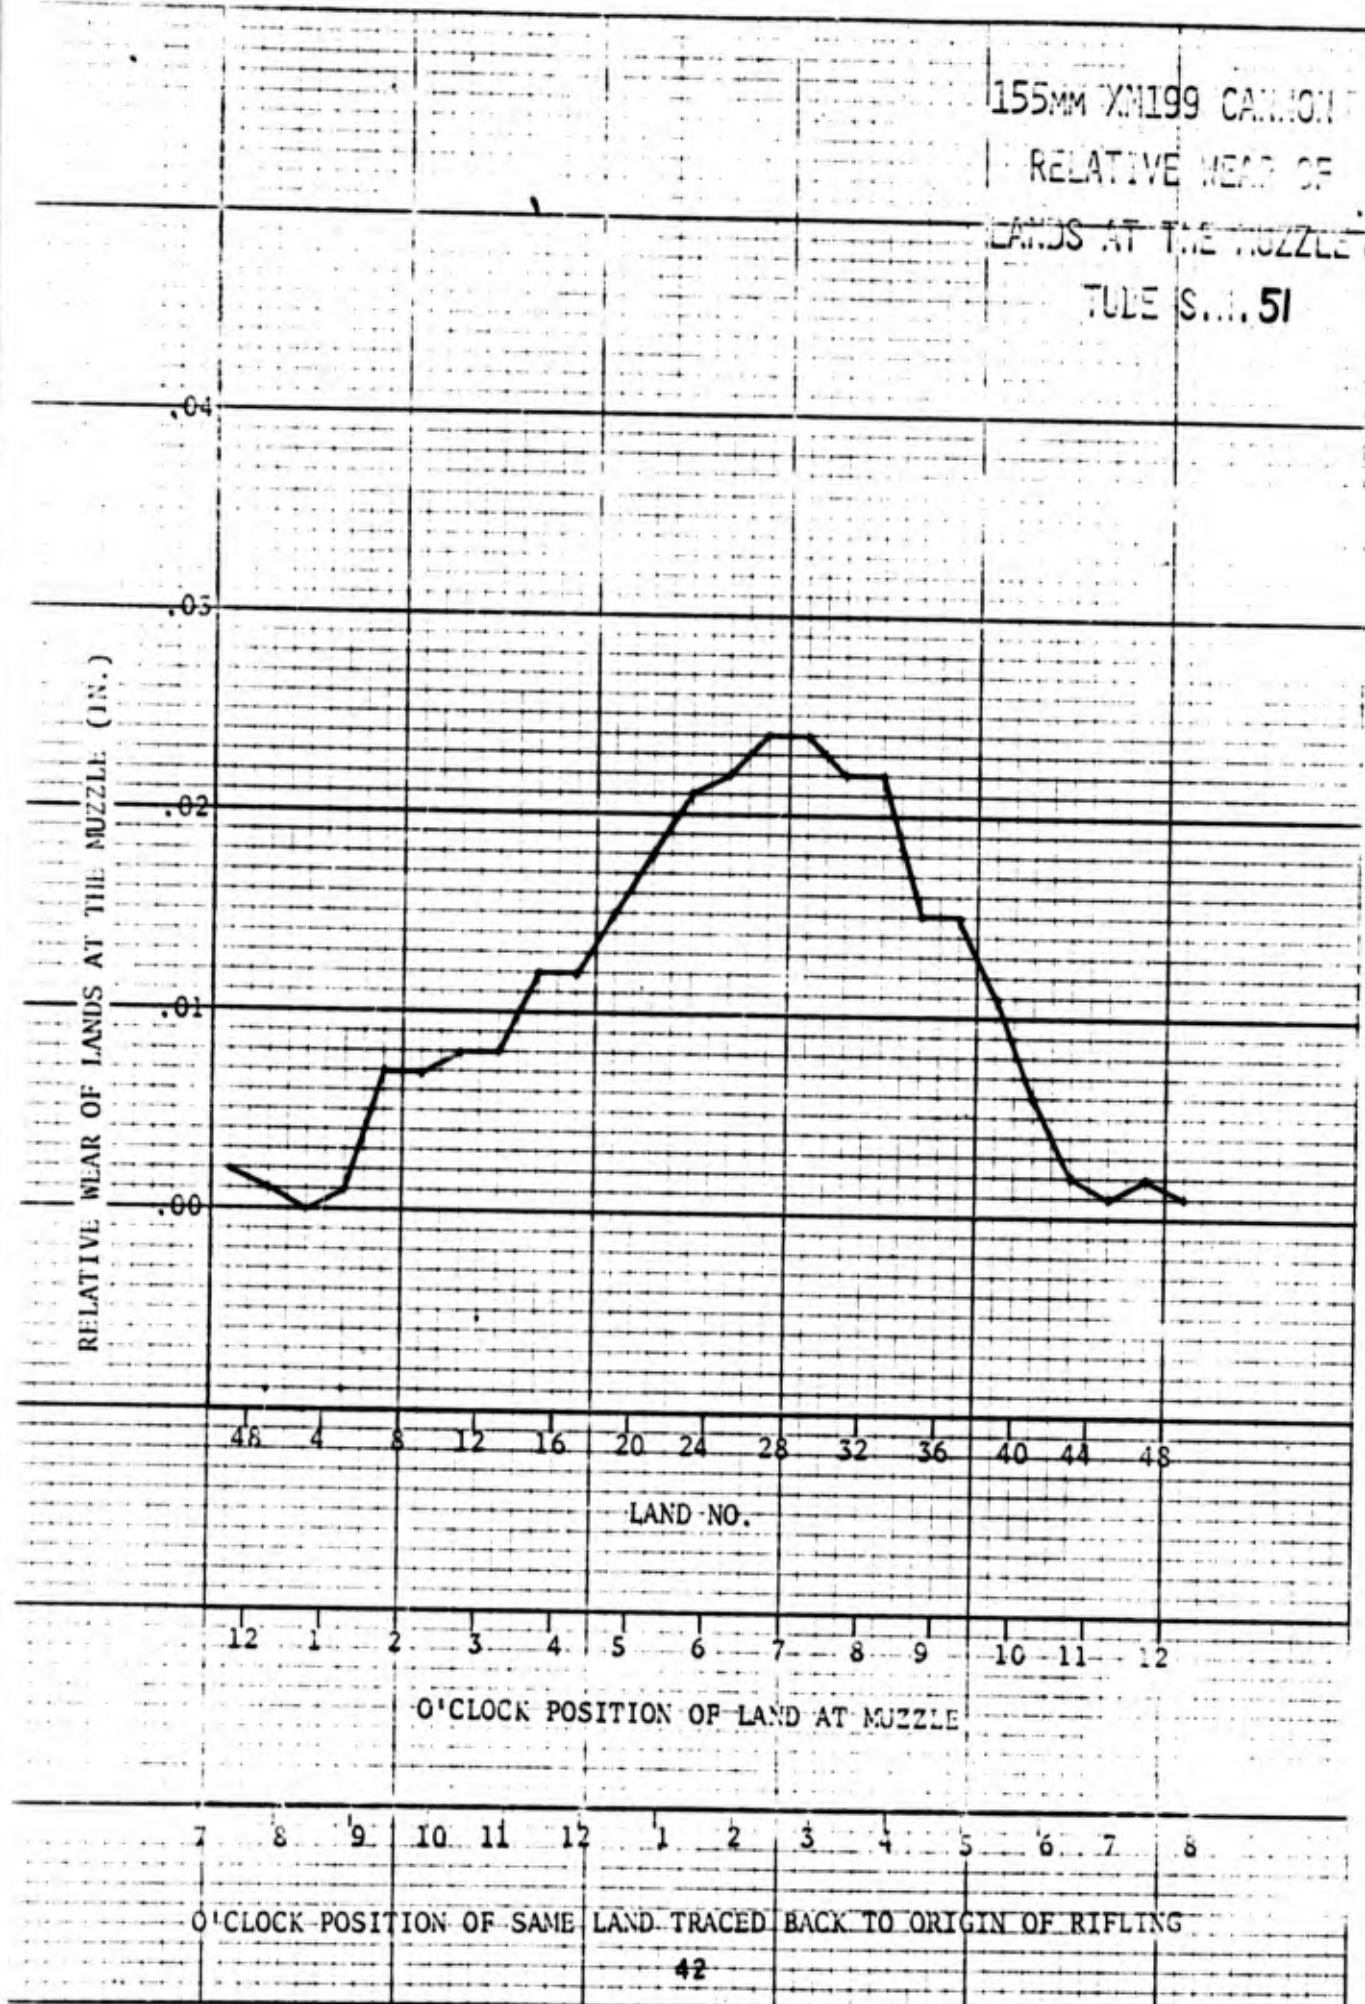
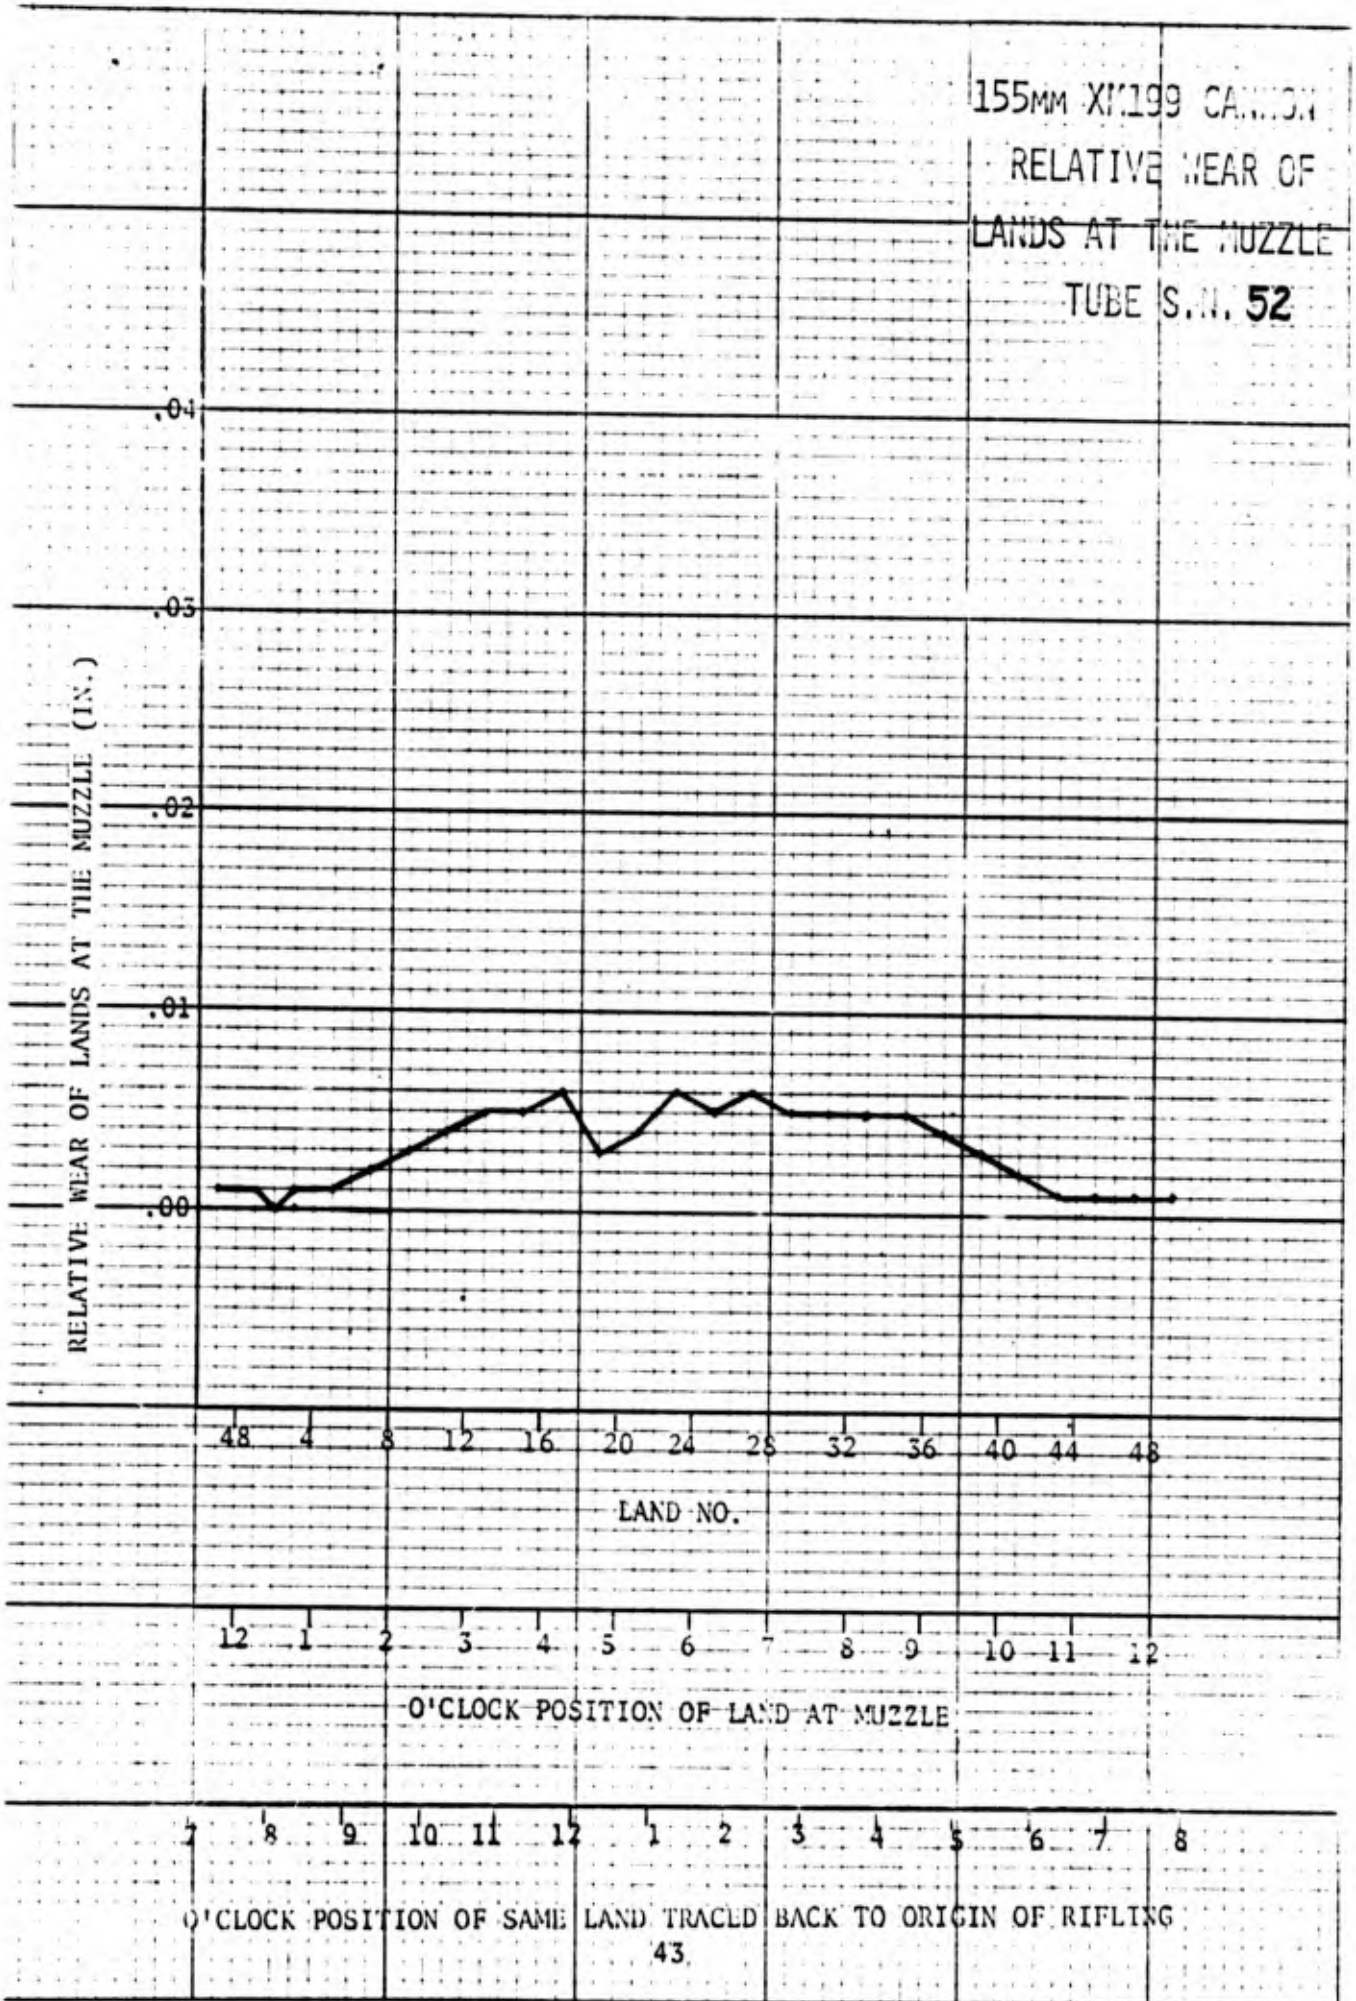
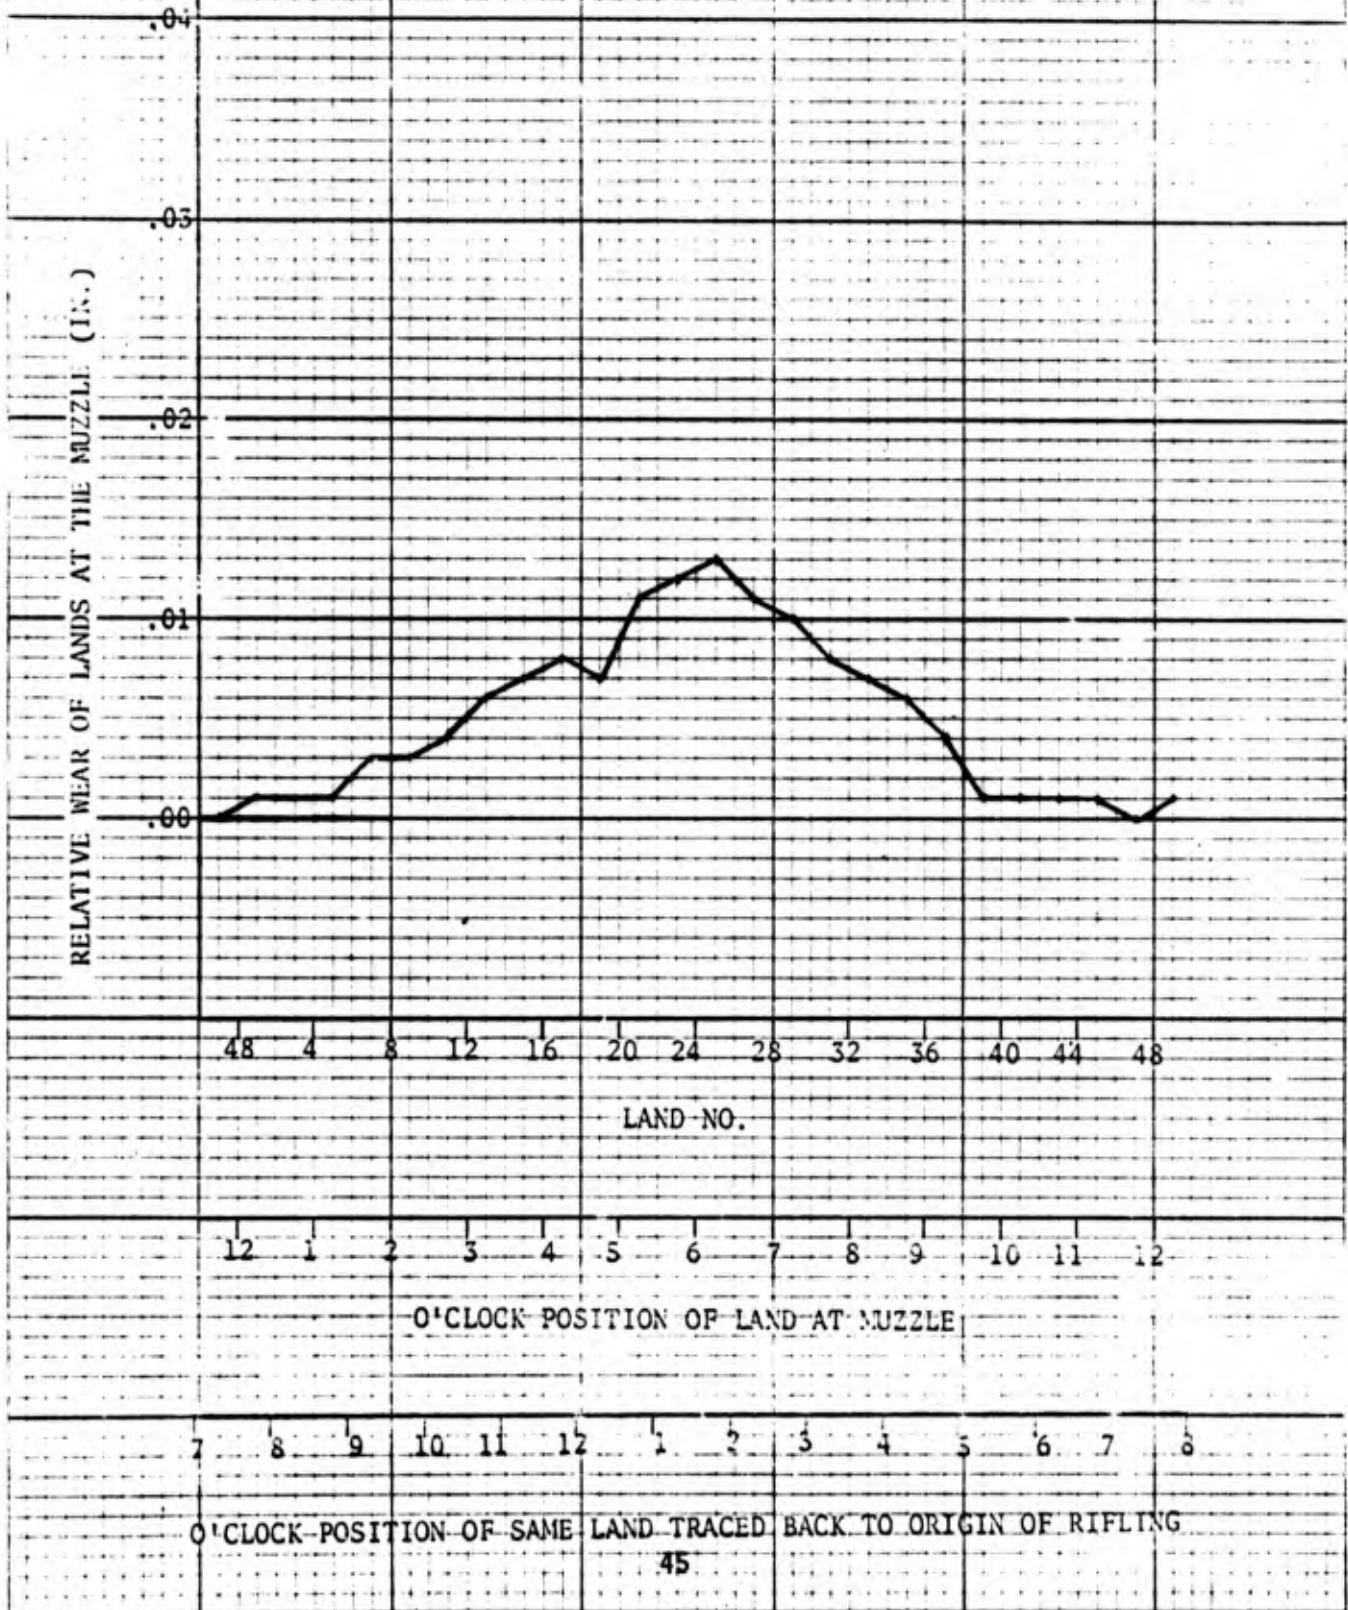
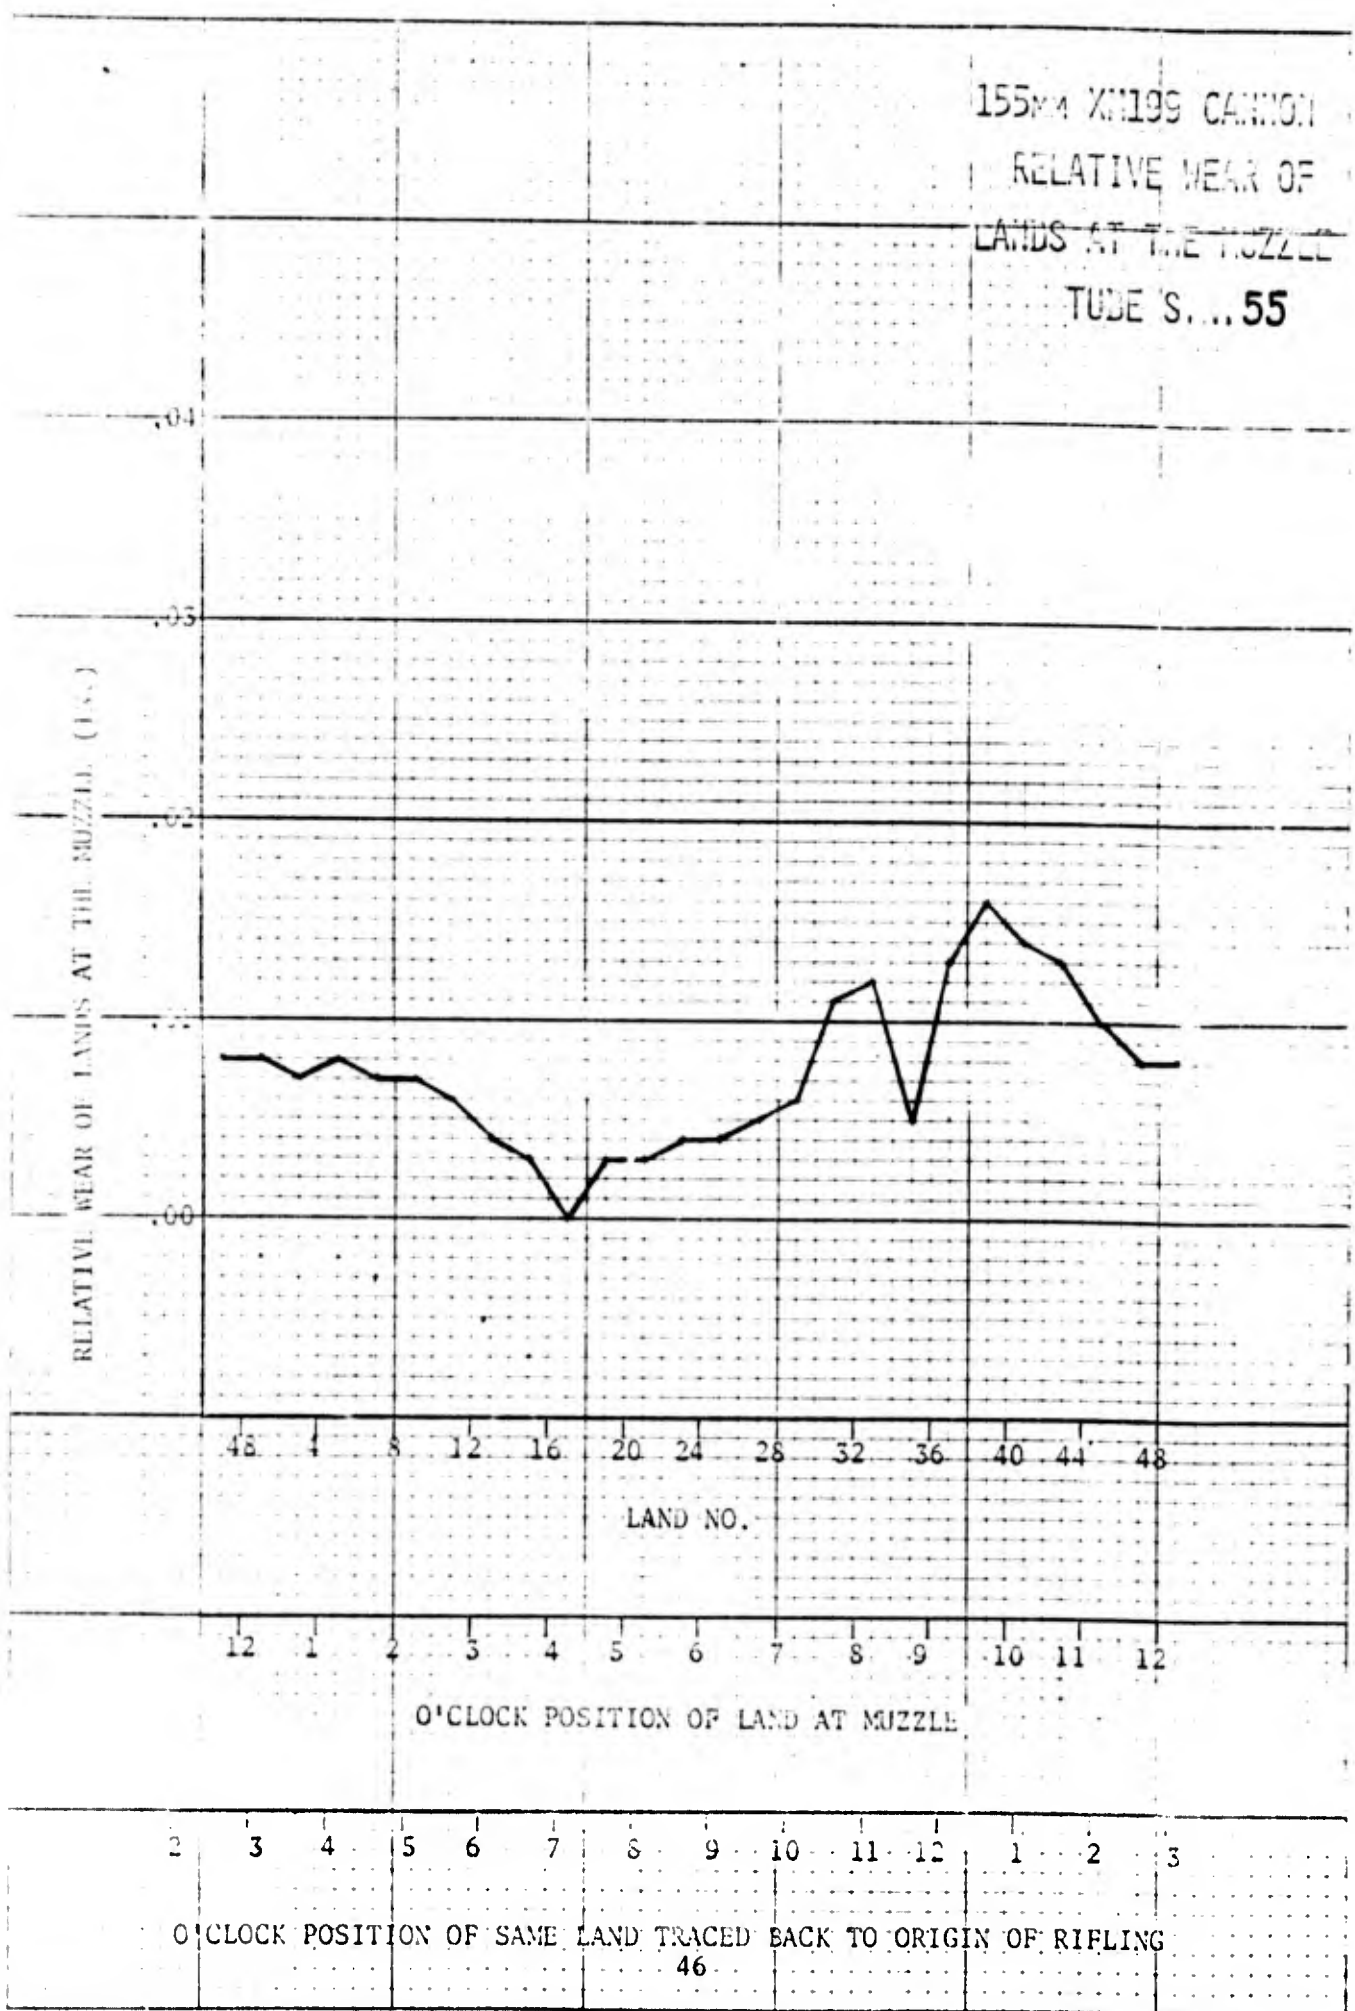
A good indication of wear location can be derived from measurements of each land's height at the muzzle. Since the grooves have been found to wear very little, comparative land heights indicate which lands are wearing most heavily. It was found that the best way to obtain land height readings was to take micrometer readings (using spherical heads) between the top of the land and the outside surface of the tube. The average of the micrometer readings between the two grooves on either side of the land and the outside surface of the tube was subtracted from this. Unfortunately, due to the lack of spherical heads required for this method of measurement, many land height readings were taken directly using a depth gage during this test. This latter method gave far less accurate absolute results. However, either method is capable of indicating relative wear at the muzzle and will show the circumferential position of maximum wear. Figures 20 thru 26 show the relative land wear readings for each tube after final use in the Durability Test (except tube S.N.48, measurements taken after round 905). The approximate o'clock positions of maximum and minimum wear are tabulated in Table 8. If all tubes are considered, maximum wear at the muzzle occurs, on the average, at 5:34 o'clock (land #22) while minimum wear occurs on the average at 11:54 o'clock (land #48). These lands are approximately diametrically opposed. If one follows the land of maximum wear clockwise for 1.64 revolutions back to the origin of rifling, the land position would be, on the average, at 12:24 o'clock (viewed from the muzzle).

Tube S.N.48 does not conform well to the above average tube model. Calculations are shown in Table 8 which exclude S.N.48 data; as can be seen, the average values shift by at most three lands.

Tube S.N.55 also appears at first glance not to conform with the average tube model above. However, it must be remembered that this tube was manufactured with gain twist rifling while all others had constant twist rifling. Although the locations of maximum and minimum wear at the muzzle are different than the average tube model, the land of maximum wear traces back to the same location at the origin of rifling: approximately 12:30 o'clock. This would tend to substantiate previous findings which correlate muzzle wear with commencement wear.

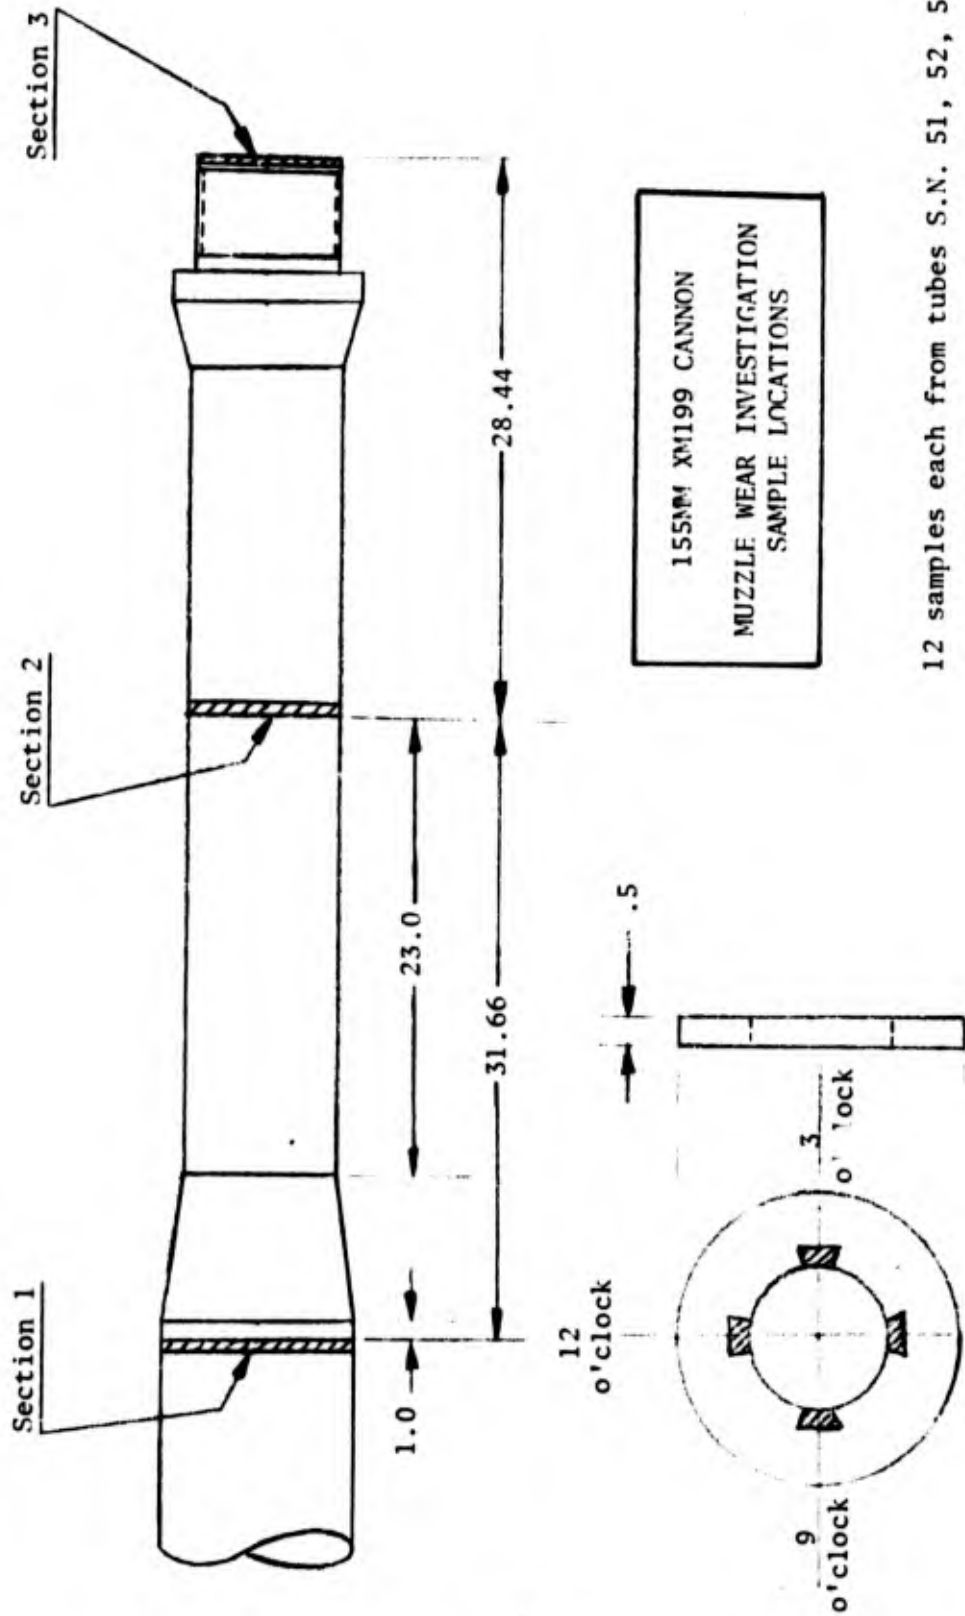
FIGURE 27

Four tubes were fired to the end of their useful lives during this Durability Test (S.N.51, 52, 53 and 54). These tubes were cut up, and twelve bore samples were machined from each as shown in Fig.27. Each specimen was mounted so that the lands could be observed in cross-section using a high power microscope.

12 samples each from tubes S.N. 51, 52, 53, 54

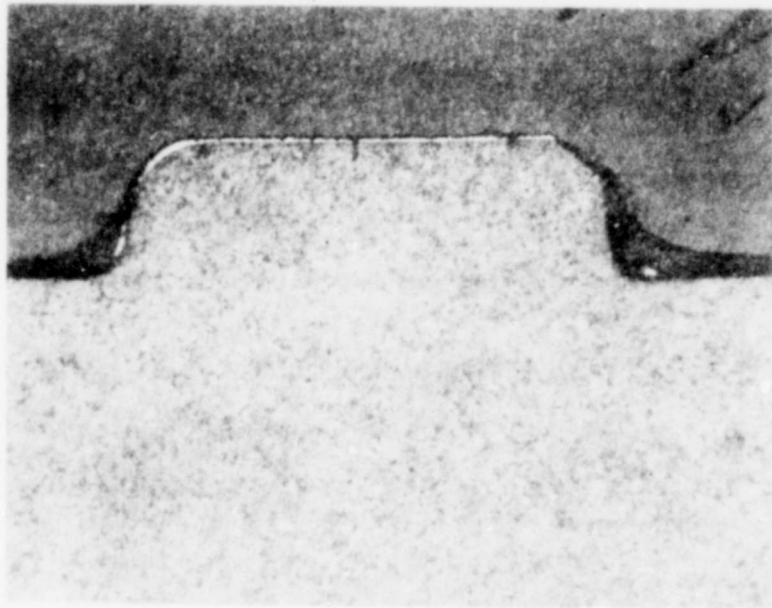
Macroscopically, the chamfer of the driving edge of the lands was generally rounded and cracked whereas the non-driving edge's chamfer was generally intact and crack-free. (See Fig. 28). The base metal of all tubes was well-structured tempered martinsite, homogeneous and free of impurities. Hardness was uniform and generally in the Rc 40 - 43 range for all tubes.*

Fig. 28 Bore sample showing cross sectional geometry of a worn land.
Tube S.N.52; Section 1; 3 o'clock position: (15 X)

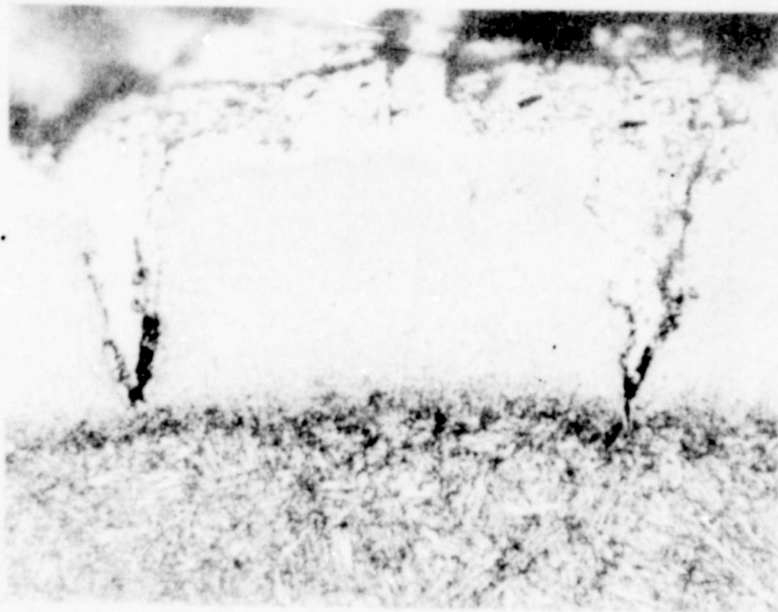
Fig. 29 Bore sample showing thermally altered layers on driving
edge of land.
Tube S.N.52; Section 1; 3 o'clock position (750 X)

Observations on a microscopic scale revealed the presence of thermally altered layers (also called "heat affected zones", HAZ) in certain areas near the bore (see Fig. 29). Two distinct types of HAZ were noted: a gray zone which had a much finer grain structure than the base metal; and a white zone which appeared to have an even finer structure. Microhardness readings indicate that the gray layer was substantially harder than the base metal; the white layer was too thin and close to the surface to measure hardnesses (see Fig. 30). These HAZ are not located uniformly on the bore's rifled surface but rather tend to form in certain areas. The non-driving edge of the land (including its chamfer and radius) and the half of the groove towards the non-driving edge show, in nearly all cases, no evidence of a HAZ. The groove surfaces towards the driving edge of the land sometimes had a HAZ, although these were normally quite thin. On the other hand, the driving edge of the land (including its chamfer and radius) normally showed an extensive HAZ. A HAZ was also noted on top of the land, and it tended to be only slightly thinner than that on the driving edge.

A thermally altered layer which was substantially harder than the base metal was found to exist on the driving edge (including radius and chamfer) and the top of the lands. On the other hand, no thermally altered layer was found to exist on the non-driving edge of the land or in the groove. The physical location of the altered layer would indicate that the source of the heat which transforms the base metal (tempered martensite) is physical abrasion rather than hot propellant gases. It is not known whether tube contact with the shell body or the copper rotating band or both is generating this heat; however, the presence of copper deposits was noticed, especially in cracks in the HAZ and in samples from Section 1.

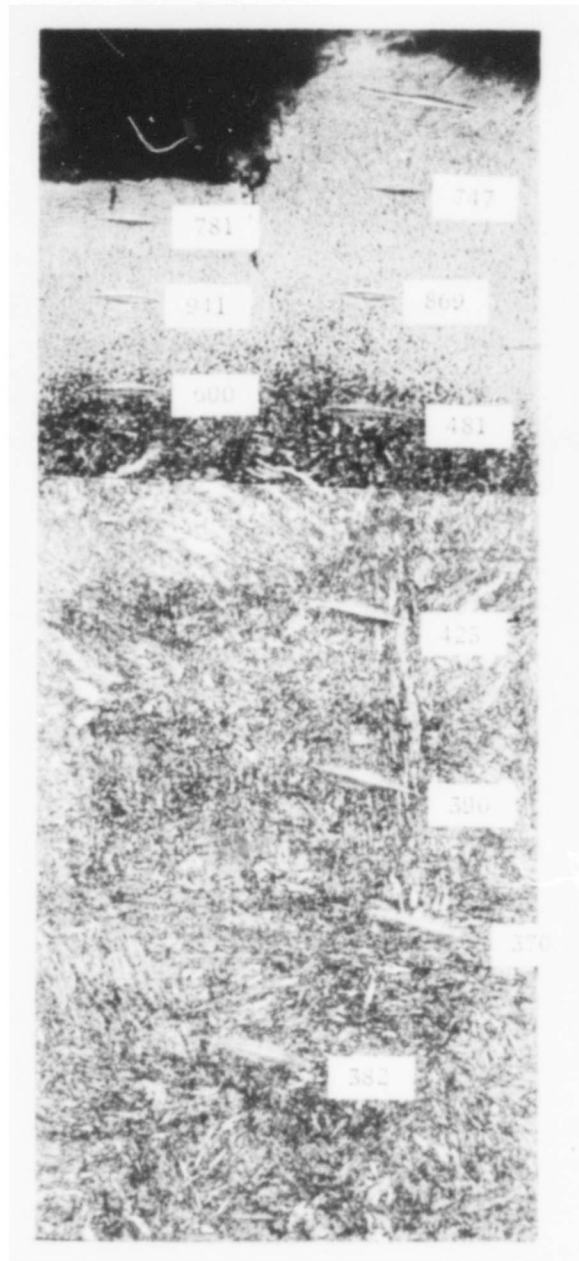
Fig. 30 Typical microhardness readings in the area of a thermally altered layer. Readings obtained using a Knoop Hardness Tester, 10 gram load. (750 X)

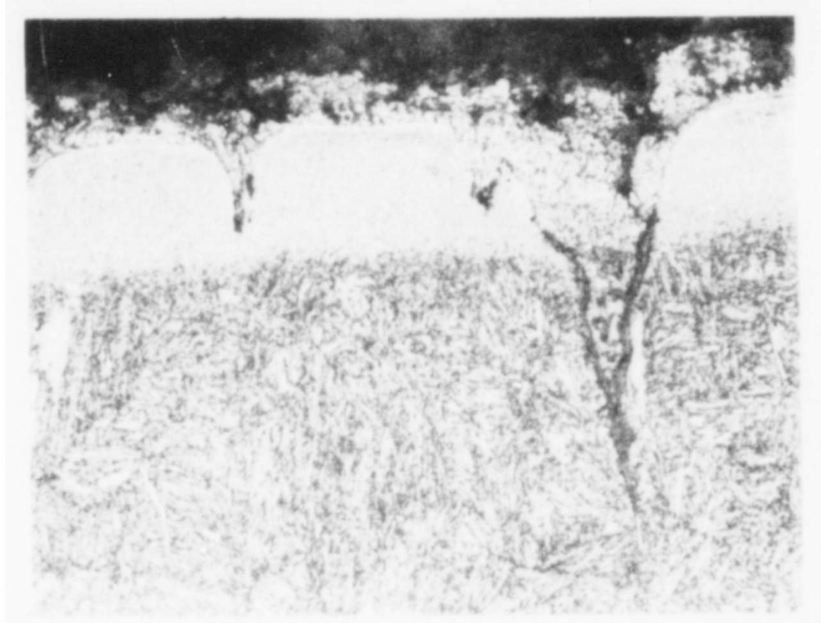
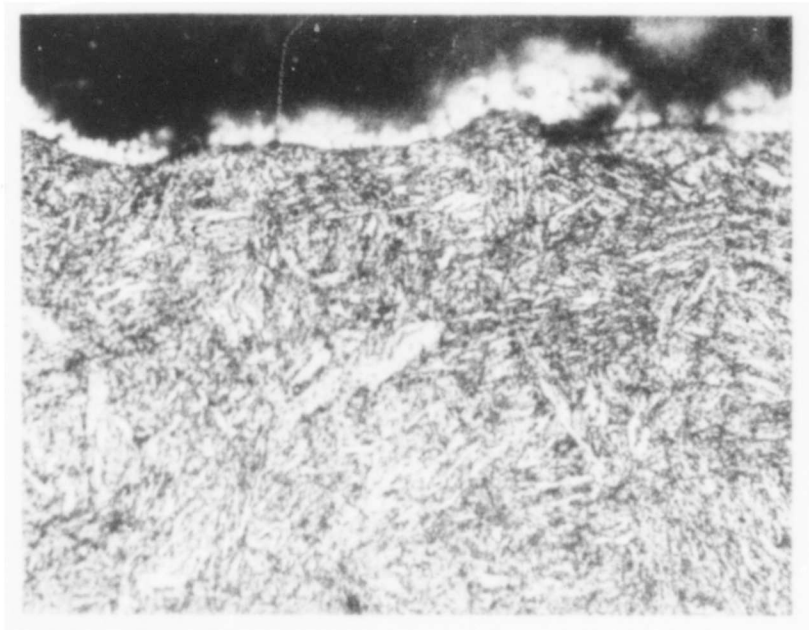
Whenever a HAZ was present, V-shaped cracks were noted which generally extended through the HAZ. Most cracks appeared to be arrested by the base metal, although some were able to penetrate through into the less hard metal. Whenever the HAZ was not present, the surface was generally good, i.e., somewhat rough, but noticeably free of cracks (compare Fig. 31 and Fig. 32).

Fig. 31 Bore sample showing cracks in HAZ, with some penetration into base metal (750 X).

Fig. 32 Bore sample showing area free of HAZ and associated surface cracks. (750 X).

The thermally altered layer invariably showed V-shaped surface cracks which were, in most cases, arrested by the softer base metal.

The hardness of the HAZ and presence of cracks make the altered layers especially susceptible to flaking, chipping, etc. by the projectile.
