155MM XM198 HOWITZER MUZZLE WEAR

R. G. Hasenbein

Watervliet Arsenal

May 1975

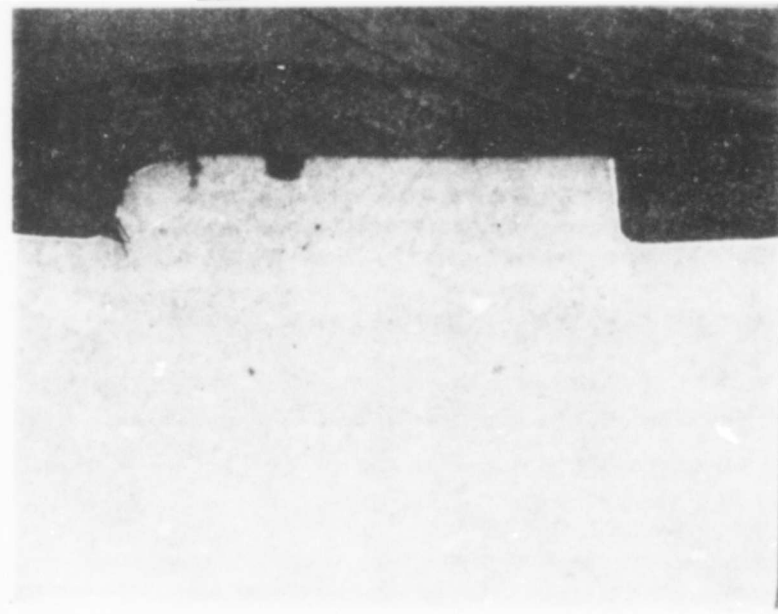
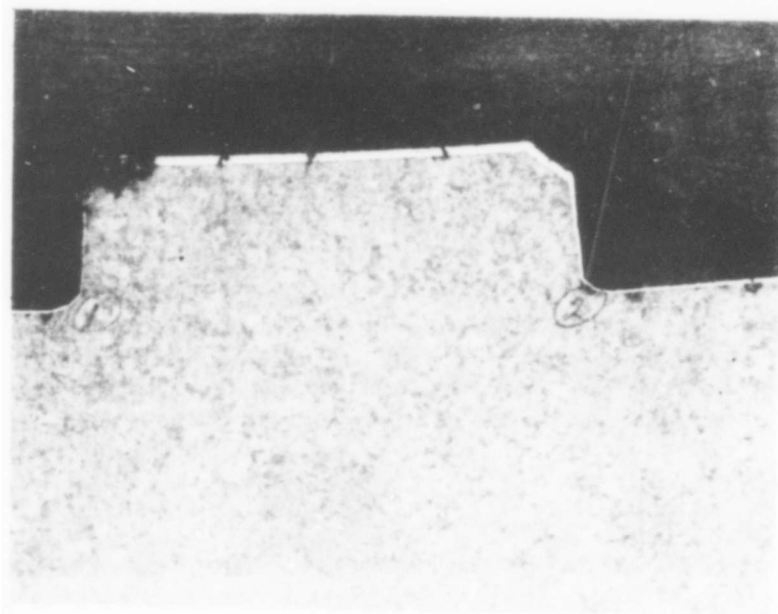
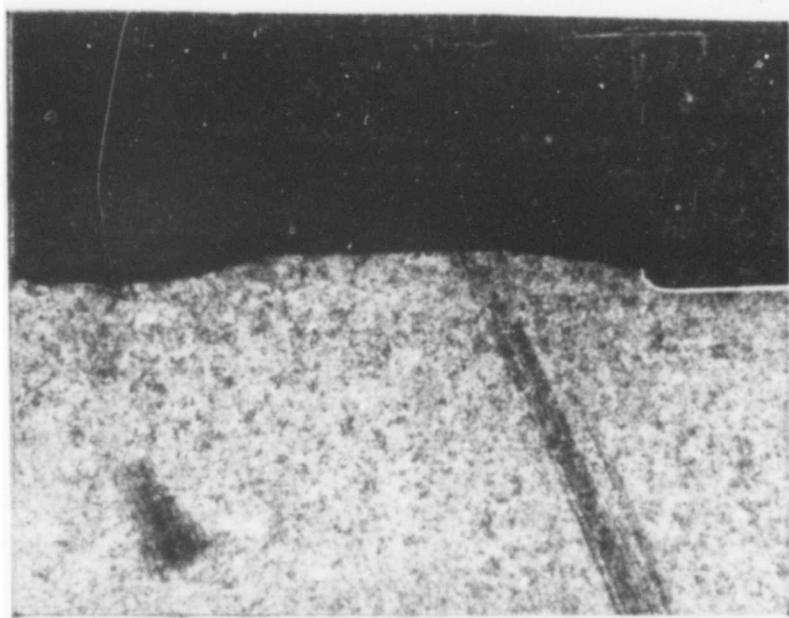
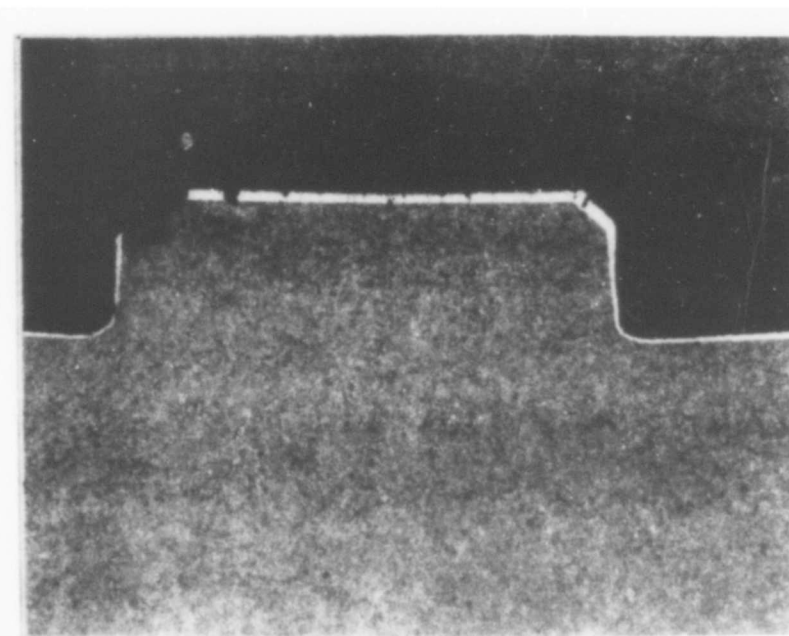
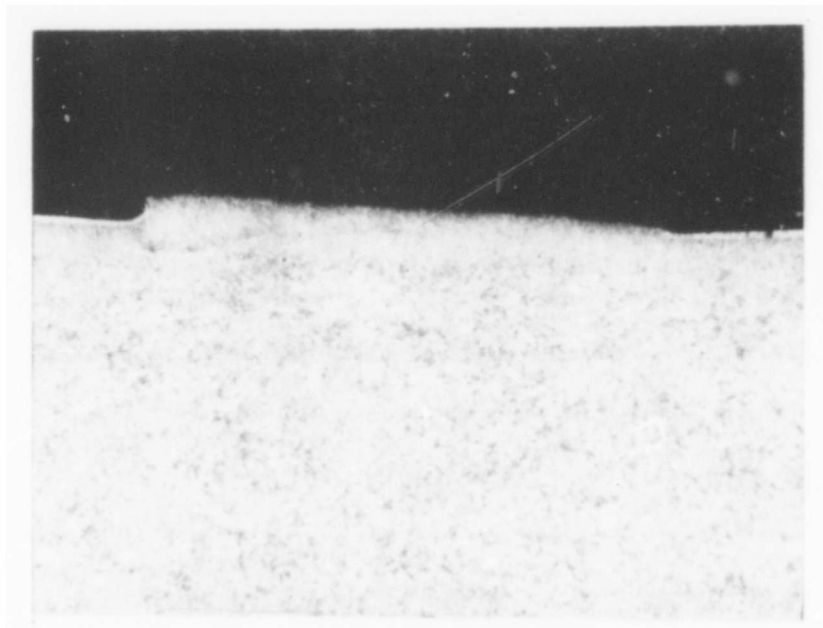
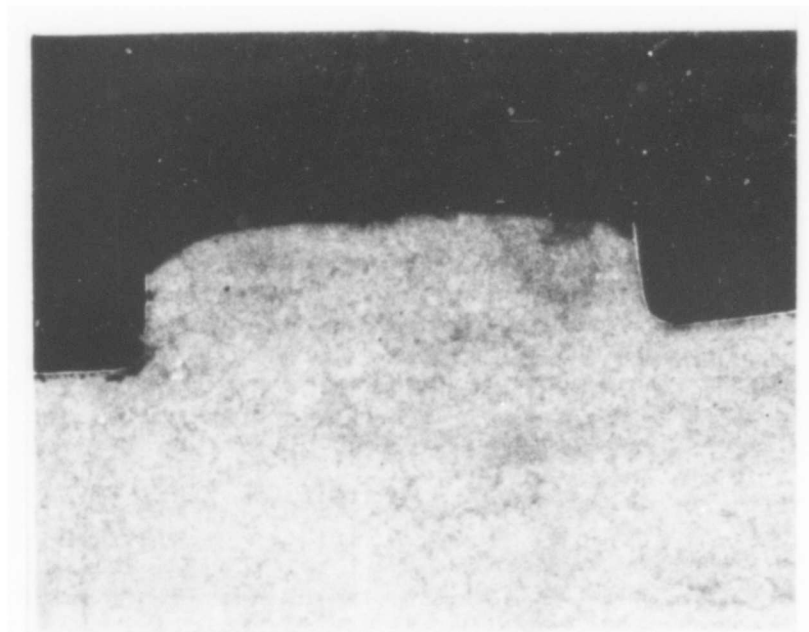
Earlier in this report it was stated that the lands do not all wear at the same rate. Rather, maximum and minimum wear are found on diametrically opposite sides of the tube. Previous reports on this subject ² have stated that muzzle wear tends to follow the twist of rifling. Photographs of tube S.N.53 show graphically that maximum muzzle wear does in fact follow a specific set of lands. Fig. 27 shows that the three sections taken from the tube are located approximately 30 inches apart. Since the twist of rifling is one turn in 20 calibers (122 inches) the rifling turns through approximately one-fourth of a revolution every 30 inches. Figures 33 and 34 show that the most worn land for S.N.53, Section 1 is located at 9 o'clock and the least worn land at 3 o'clock. As expected, the most worn land is located at 6 o'clock for section 2 (see Fig. 35 and 36) and 3 o'clock for Section 3 (see Fig. 37 and 38). Note that the lands in Figures 35 and 37 are worn down almost to the depth of the groove. The chrome in the grooves and, to a lesser extent, on the side walls is largely intact. (Fig. 33 thru 38).

Fig. 33 Tube S.N.53; Section 1; 9 o'clock.
Position of maximum wear (15 X).

Fig. 34 Tube S.N.53; Section 1; 3 o'clock.
Position of minimum wear (15 X).

Fig. 35 Tube S.N.53; Section 2; 6 o'clock.
Position of maximum wear. (15 X)

Fig. 36 Tube S.N.53; Section 2; 12 o'clock.
Position of minimum wear. (15 X).

Fig. 37 Tube S.N.53; Section 3; 3 o'clock.
Position of maximum wear (15 X).

Fig. 38 Tube S.N.53; Section 3; 9 o'clock.
Position of minimum wear (15 X).

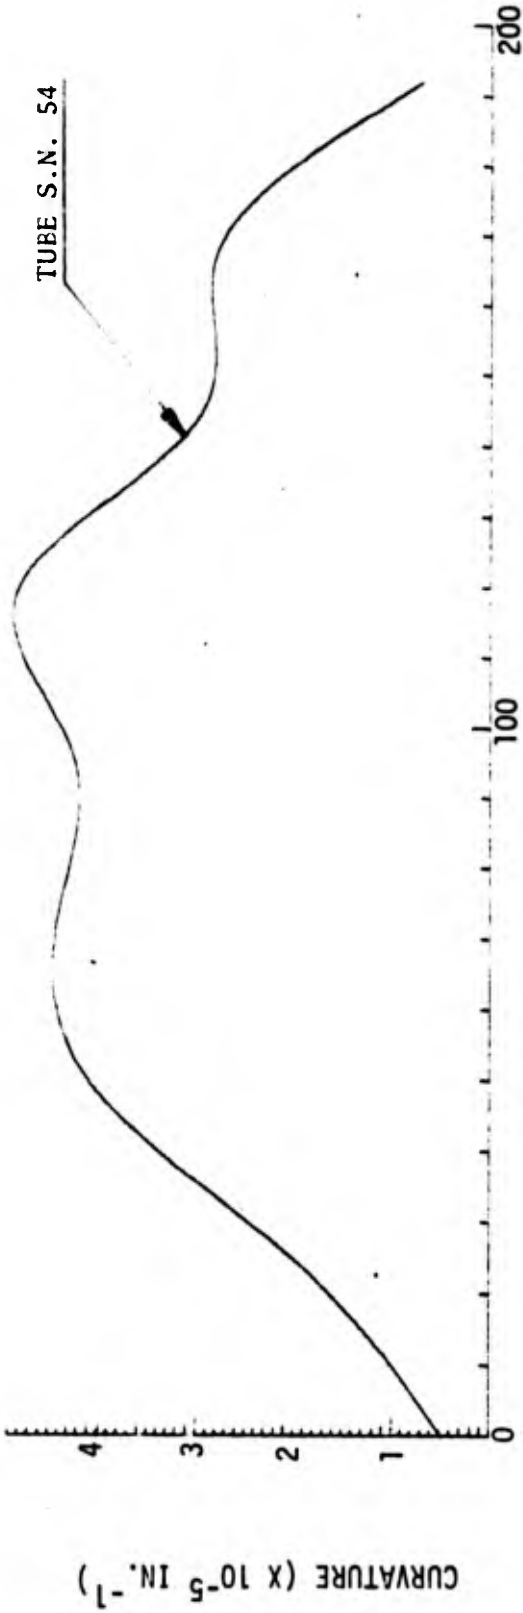
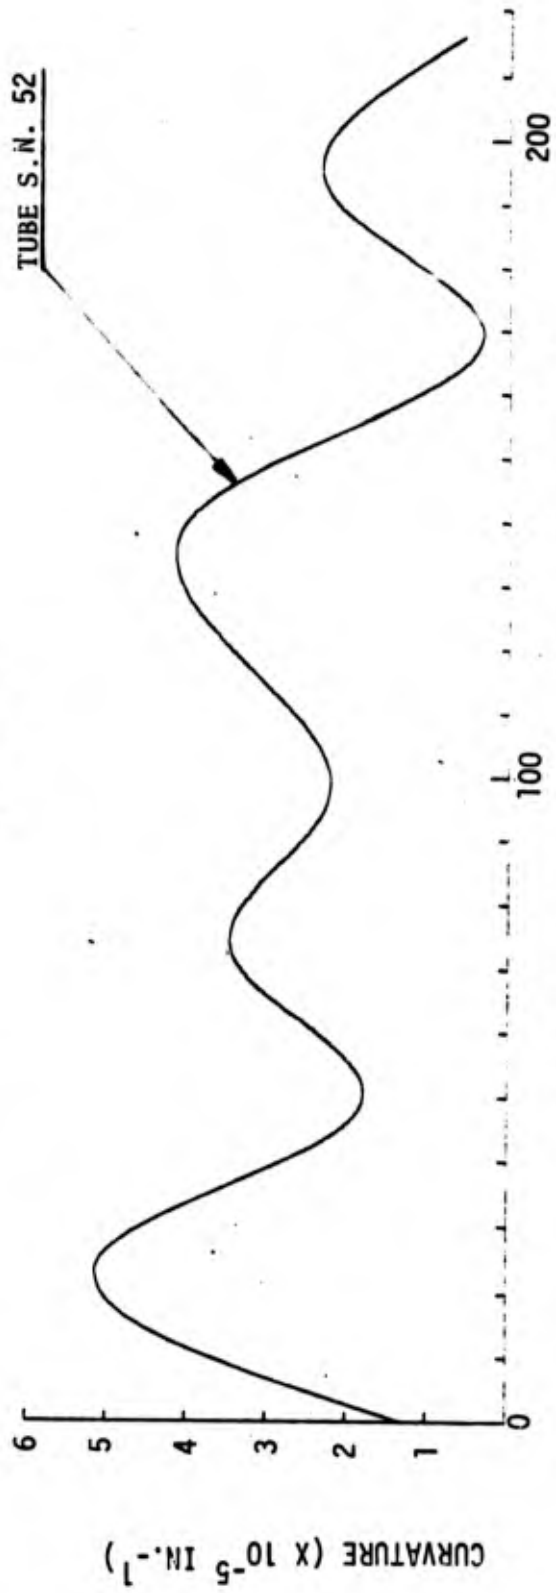
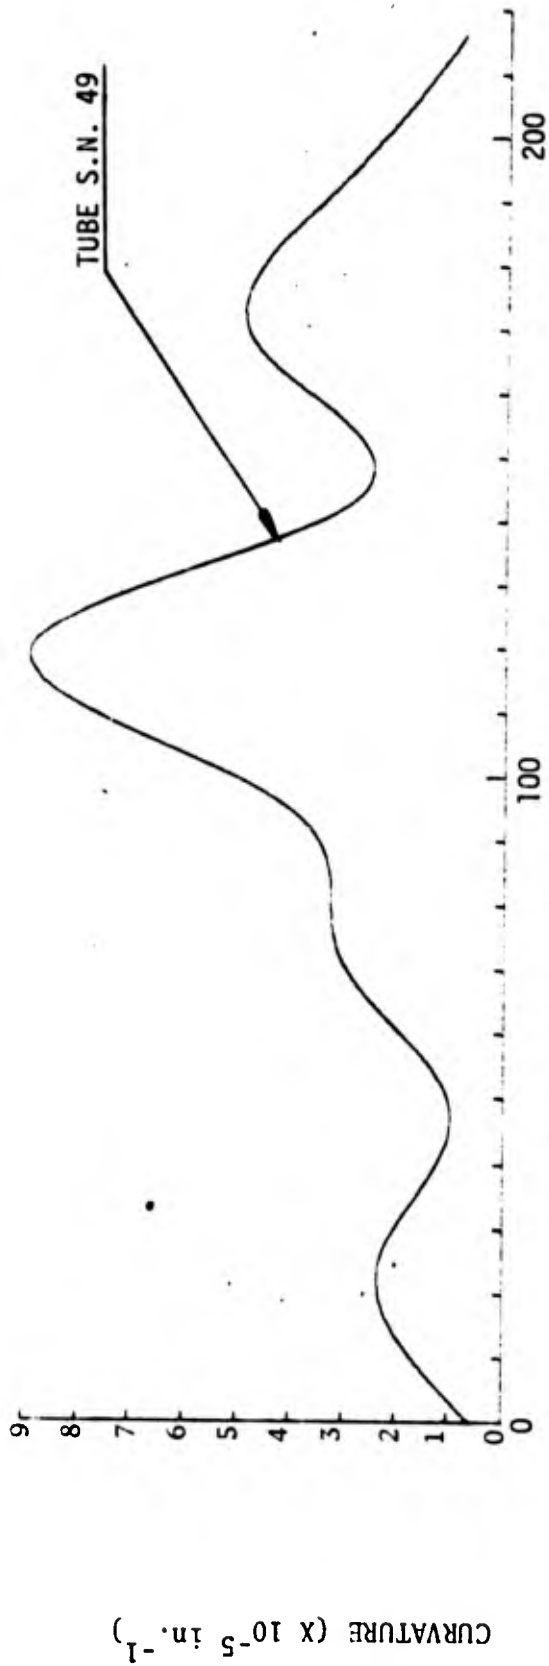
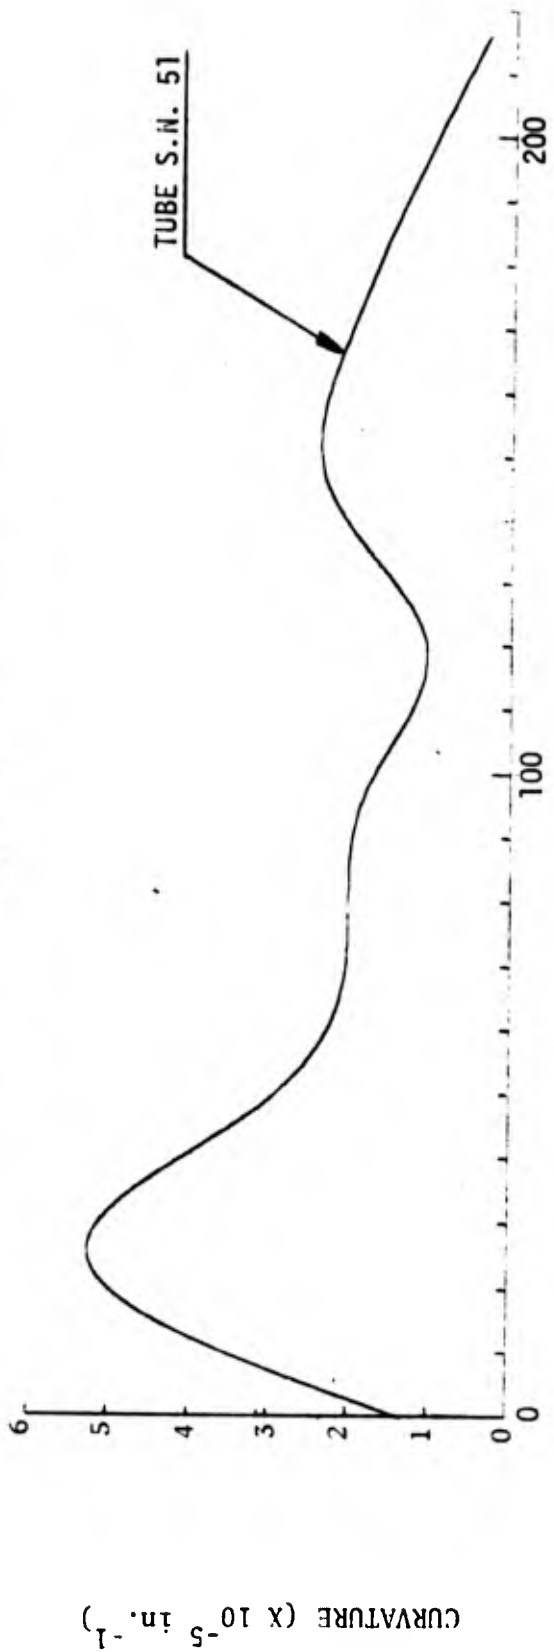
3. Bore Straightness. (excluding droop) According to drawing specifications, the bend (excluding droop) in the rifled portion of the tube shall not exceed .020 inches in any 24 inch interval nor cumulate to more than .060 inches in the entire rifled length. Measurements were taken optically in two directions normal to the axis of the tube, and all proved to be within specifications. From these data, Mr. David Finlayson (Reliability and Maintainability Engineering Office, Watervliet Arsenal) and Mr. Royce Soanes (Computer Science Office, Watervliet Arsenal) have calculated the three-dimensional curavature for each point in the rifled portion of four tubes. Calculations were performed for two low muzzle wear tubes (S.N.52 and 54) and two high muzzle wear tubes (S.N.49 and 51). These data are shown in Fig. 39thru 42. As can be seen, the greatest curvature computed is approximately 9×10^{-5} in.⁻¹ for tube S.N.49. That is, the smallest radius of curvature encountered was 11,111 inches (roughly 1/6 mile). A simple calculation indicates that the resulting acceleration normal to the path of the projectile would be on the order of 200 g's (maximum encountered). For the same tube at the same point, the acceleration tangent to the path of the projectile would be on the order of 20 times greater. In spite of

this however, Figures 39 thru 42 reveal no obvious pattern relating radius of curvature and the extent or location of muzzle wear. A report in-process by Mr. Finlayson⁴ will deal analytically with bore straightness as well as projectile imbalance and misalignment.
