ANODIC ETCHING - A METHOD OF DETECTING  
GRINDING BURNS ON CHROMIUM PLATED STEEL PARTS

NOR-75-33

# ANODIC ETCHING - A METHOD OF DETECTING GRINDING BURNS ON CHROMIUM PLATED STEEL PARTS

7 February 1975

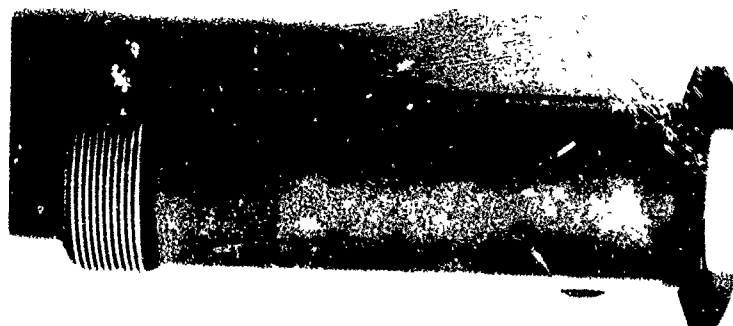
FIGURE 3. GRINDING DAMAGE ON CHROMIUM PLATE  
REVEALED BY ANODIC ETCHING

The appearance of pin number four after anodic etching is shown in Figure 3. The removal of the smeared chromium plate, caused by the grinding of the pin, leaves a dull matte finish on the chromium plate. If the chromium plate is damaged, it is normally evident immediately after anodic etching. If a burn does exist on the plate, the burn can be seen due to differences in reflectivity. This examination is best performed at 25 to 50X magnification with a stereomicroscope. As seen in Figure 3, a spiral mark (sometimes called a burn) is evident near the thread end of the pin.

Figure 10. The burns revealed by nital etching correlate very well with the burns indicated by anodic etching.

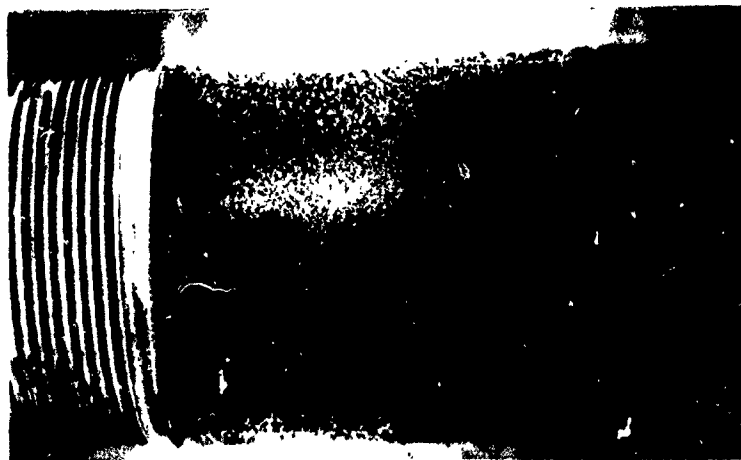
FIGURE 9. MAGNETIC PARTICLE INSPECTION ON  
PIN AFTER VARIOUS OPERATIONS

Pin number four was magnetic particle inspected after etching and stripping of the plate. Photographs are shown in Figure 9. Cracks were revealed after stripping of plate that were not evident initially.

HIGH INTENSITY INSPECTION AFTER ANODIC ETCHING

CRACKS REVEALED AFTER STRIPPING CHROMIUM PLATE

This finding is very important. It is therefore obvious that small cracks can be masked by chromium plate that magnetic particle inspection cannot detect. Only anodic etching can give an indication that such cracks may exist. This is of course by indirect means - grinding damage revealed on the chromium plate requires further investigation and stripping of the plate, which will permit detection of the cracks.
