A. FATIGUE FAILURE IN ANNEALED T1-6A1-4V  
MICROSTRUCTURES. B. FATIGUE LIFE IN ANNEALED AND  
MARTENSITIC T1-6A1-4V

George Washington University

Naval Air Systems Command

August 1975

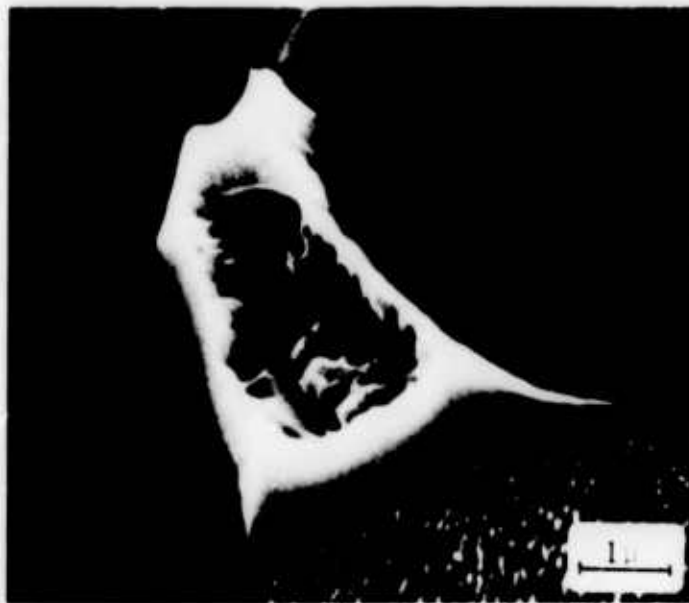
**Figure 5.** Fatigue damage in a recrystallized anneal specimen after cycling at  $\pm 0.012$  shear strain. The fatigue damage is occurring in the  $\beta$  phase.

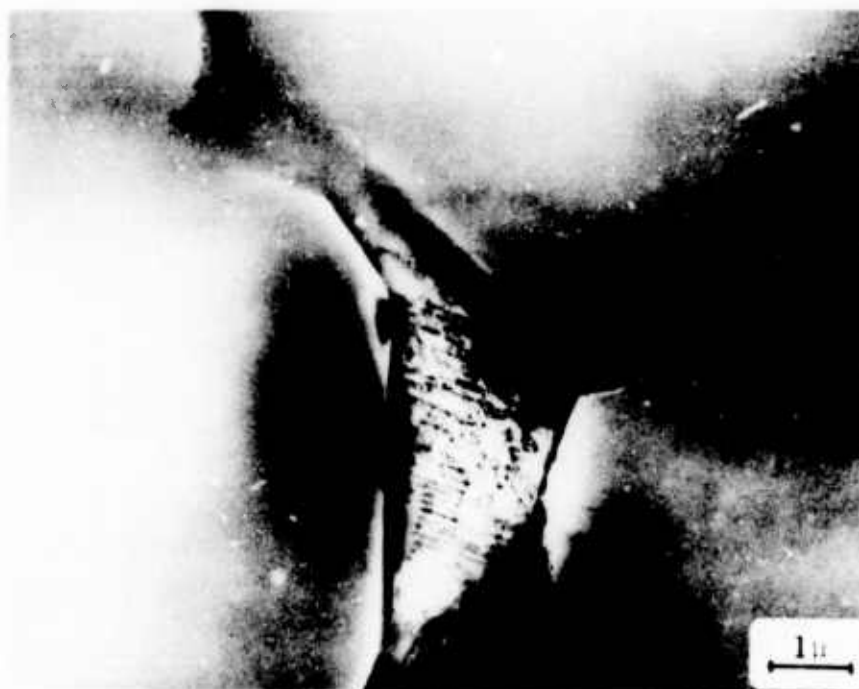
**Figure 6.** Transmission electron micrograph of the recrystallized anneal alloy. Primary  $\alpha$  is nearly defect free, the  $\beta$  phase has numerous defects.

in figure 6 shows that the recrystallized  $\alpha$  phase is nearly dislocation free but the  $\beta$  phase has numerous defects. These defects are apparently the site of fatigue damage during the cyclic straining.

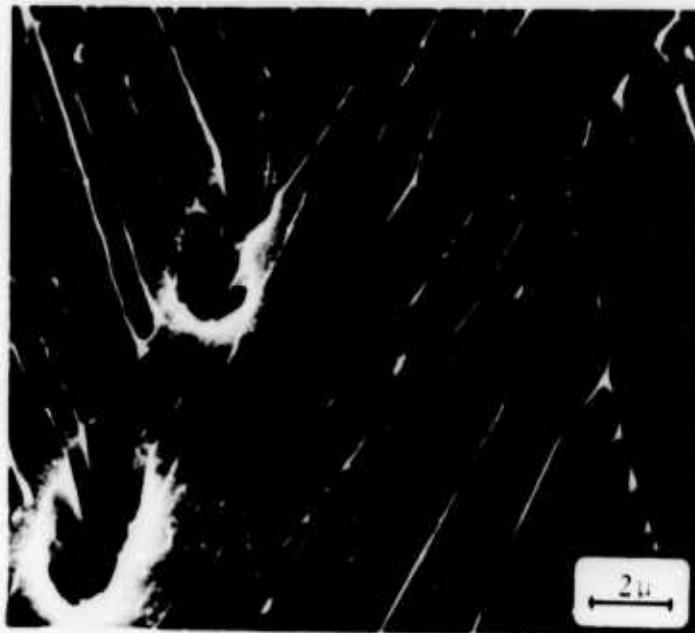
Figure 7. Fatigue damage in the  $\beta$  annealed specimen after fatigue at a shear strain of  $\pm 0.012$ .

In the  $\beta$  annealed alloy the fatigue damage is also associated with the phase boundary as is shown in figure 7 for the specimen cycled at  $\pm 0.012$  shear strain amplitude. The only difference observed between the specimens cycled at  $\pm 0.006$  and  $\pm 0.012$  is that the frequency of occurrence of crack initiation sites is much larger in the specimen cycled at  $\pm 0.012$ ; this was true for all alloy heat treatments.

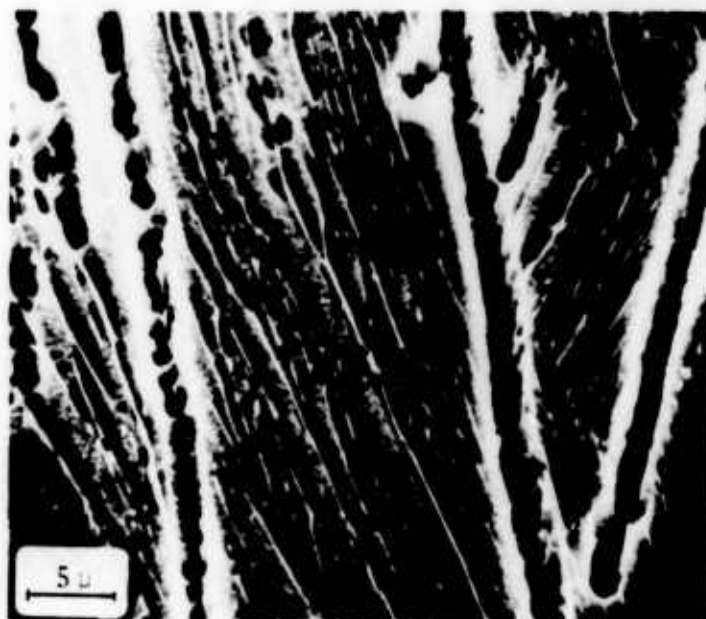
**Figure 12.** Extensive microcracking in the  $\beta$  annealed alloy fatigued to failure at a shear strain of  $\pm 0.012$ .

The explanation may lie in the number of microcracks. In the  $\beta$  annealed material many cracks and crack initiation sites are observed as in figure 12; however, in the recrystallized and  $\alpha$ - $\beta$  annealed alloys only one microcrack is usually observed, and this one grows to final failure. Thus in the  $\beta$  annealed alloy the energy of propagation must be spread over the many crack initiation and propagation sites. An individual crack may have a particularly low energy for propagation, but the strain energy is partitioned over many sites so that none of them grow at a particularly rapid rate. If this argument is a valid explanation of the relatively slow crack propagation rates in annealed titanium alloys; the desirability of this mechanism for producing a slow propagation rate must be given careful consideration. In comparison to an  $\alpha$ - $\beta$  annealed structure, the  $\beta$  annealed structure could be assumed to have many more crack initiation sites and microcracks as is demonstrated in figure 12. A crack in a structure that had been exposed to considerable service would have a difficult time competing with the myriad of microcracks and crack initiation sites already in the structure, and a slow fatigue crack propagation rate might be expected. However, it may not be necessary for the macrocrack to compete with the myriad of microcracks. If the macrocrack can grow by linking with the numerous microcracks, it is no longer necessary for the macrocrack to pass across the specimen, rather each existing microcrack only need grow a small distance to link up with its neighboring microcrack and the entire structure could be fractured by cracks that are individually

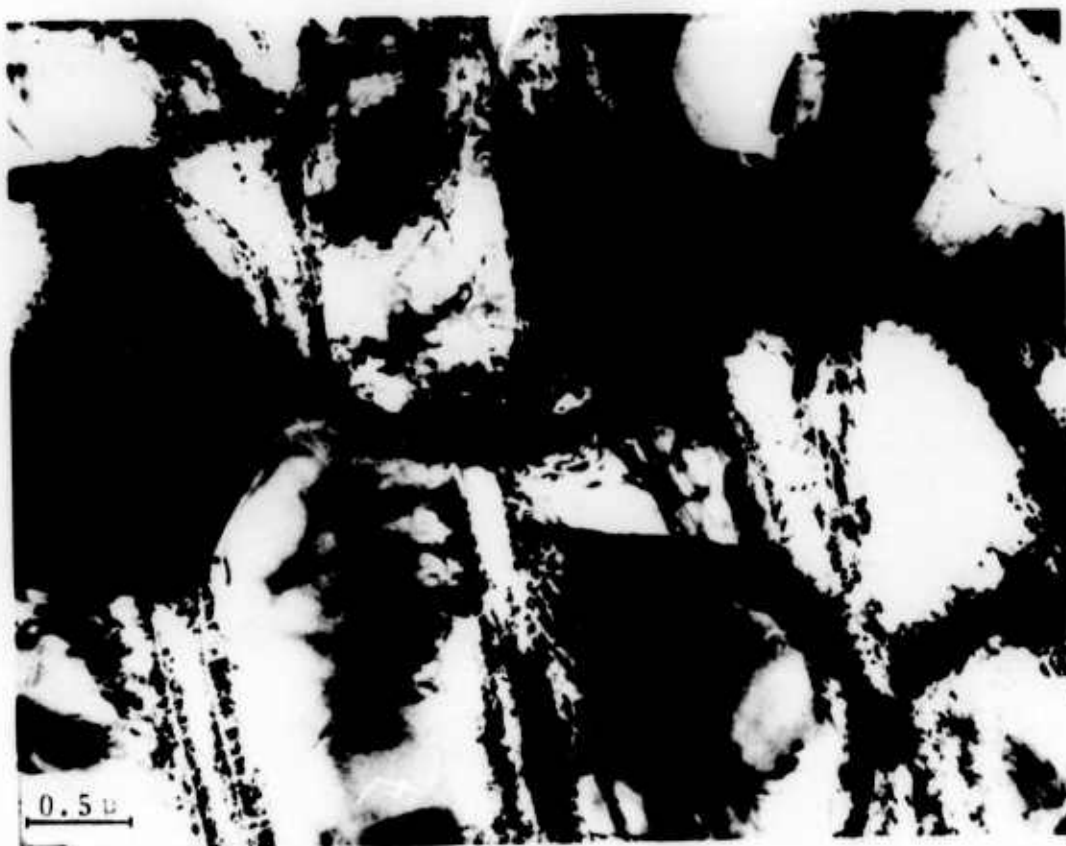
Figure 6. Transmission electron micrograph of a specimen  $\alpha$ - $\beta$  annealed.

The alloy solution treated at 1550°F and quenched (figure 9) has a microstructure quite similar to the  $\alpha$ - $\beta$  annealed material. (figure 6). Both are a mixture grain boundary  $\beta$  and primary  $\alpha$ . The alloy solution treated at 1550°F may have martensite within the  $\beta$  phase, but this has not been confirmed. The reason for the increase in fatigue life in the 1550°F solution treated and quenched specimen relative to the  $\alpha$ - $\beta$  annealed specimen is not yet clear.

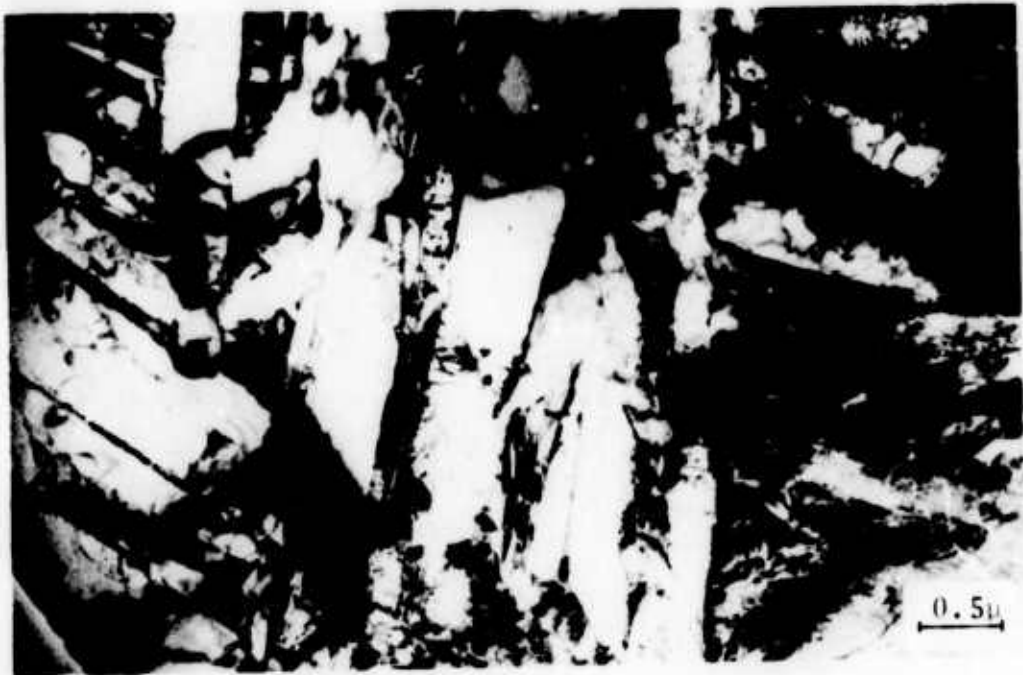
Figure 7. Transmission electron micrograph of the specimen quenched from 1950°F.

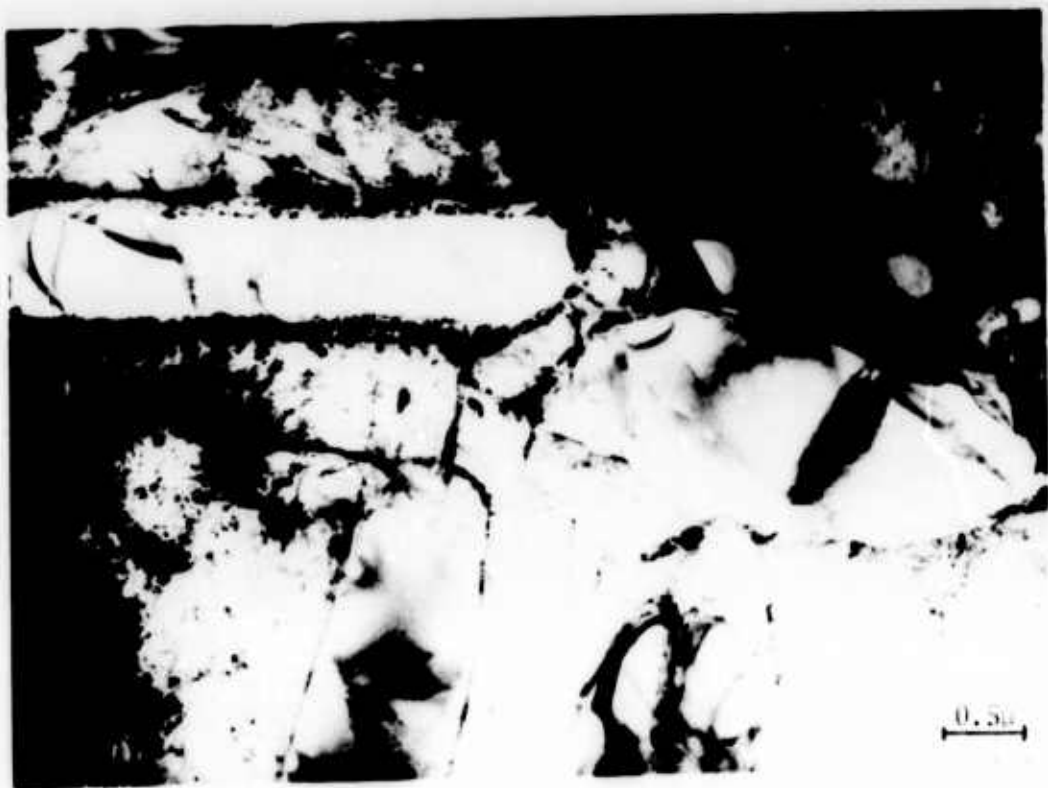
Figure 8. Transmission electron micrograph from the specimen quenched from 1650°F.

The specimen solution treated at 1650°F is shown in figure 8. The islands of dislocation free area index to be hexagonal primary  $\alpha$ . Apparently this is primary  $\alpha$  that was in equilibrium with  $\beta$  at the solution temperature. The matrix which is highly dislocated indexes to be  $\beta$  phase, but martensite reflections are present, and the dark field image in figure 10 shows the microstructure of the martensite. Unfortunately for Ti-6Al-4V it is not possible to differentiate between  $\alpha'$  and  $\alpha''$  from electron diffraction data, but according to the work of Williams et. al.<sup>5,6</sup> the martensite resulting from a quench at 1650°F solution temperatures should be  $\alpha''$  possibly mixed with some  $\alpha'$ . The  $\alpha'$  and  $\alpha''$  are structurally quite similar<sup>7</sup>. Thus the matrix of the alloy solution treated at 1650°F and quenched is composed of untransformed  $\beta$  mixed with fine martensite that transformed during the quench.

had an increase in fatigue life by more than an order of magnitude relative to the annealed microstructure. As shown in figure 8 the microstructure of this quenched alloy is a mixture of  $\alpha$  and  $\beta$ , but there are significant differences from the annealed two phase  $\alpha$  plus  $\beta$  alloy. In the 1650°F quenched alloy the matrix is  $\beta$ . The  $\beta$  matrix is heavily dislocated and martensite needles are present as is shown (figure 10) in the TEM dark field image from one of the martensite reflections. These defects should provide considerable dislocation barriers in the  $\beta$  phase. The  $\alpha$  phase forms islands within the  $\beta$  grains, the  $\alpha$  is not a grain boundary  $\alpha$ . Thus the  $\alpha$  phase is strained within a homogeneous matrix, if we can consider the mixture of  $\beta$  and  $\alpha'$  shown in figure 10 homogeneous. The absence of a grain boundary phase in the alloy quenched from a solution temperature of 1650° may be an important factor in its improved fatigue life.

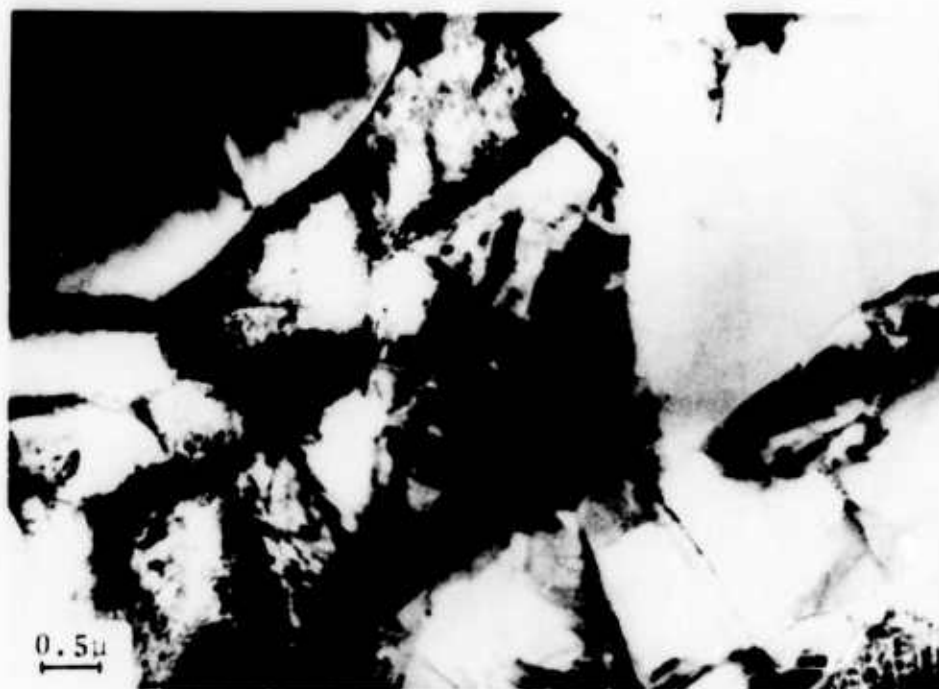
Figure 9. Transmission electron micrograph from the specimen quenched from 1550°F.

The alloy solution treated at the 1550°F temperature shown in figure 9 is a mixture of primary  $\alpha$  that is relatively dislocation free and grain boundary  $\beta$  which is highly dislocated. No martensite reflections have been observed; they may be so weak that we have not been able to observe them. Thus the 1550°F solution treatment followed by a quench results in a mixture of primary  $\alpha$  and grain boundary  $\beta$  which may have fine martensite that we have not been able to observe.
