ARMY PRELIMINARY EVALUATION YAH-IQ HELICOPTER WITH  
A FLAT-PLATE CANOPY

USAAEFA PROJECT NO. 75-18

**ARMY PRELIMINARY EVALUATION  
YAH-1Q HELICOPTER  
WITH A FLAT PLATE CANOPY**

FINAL REPORT

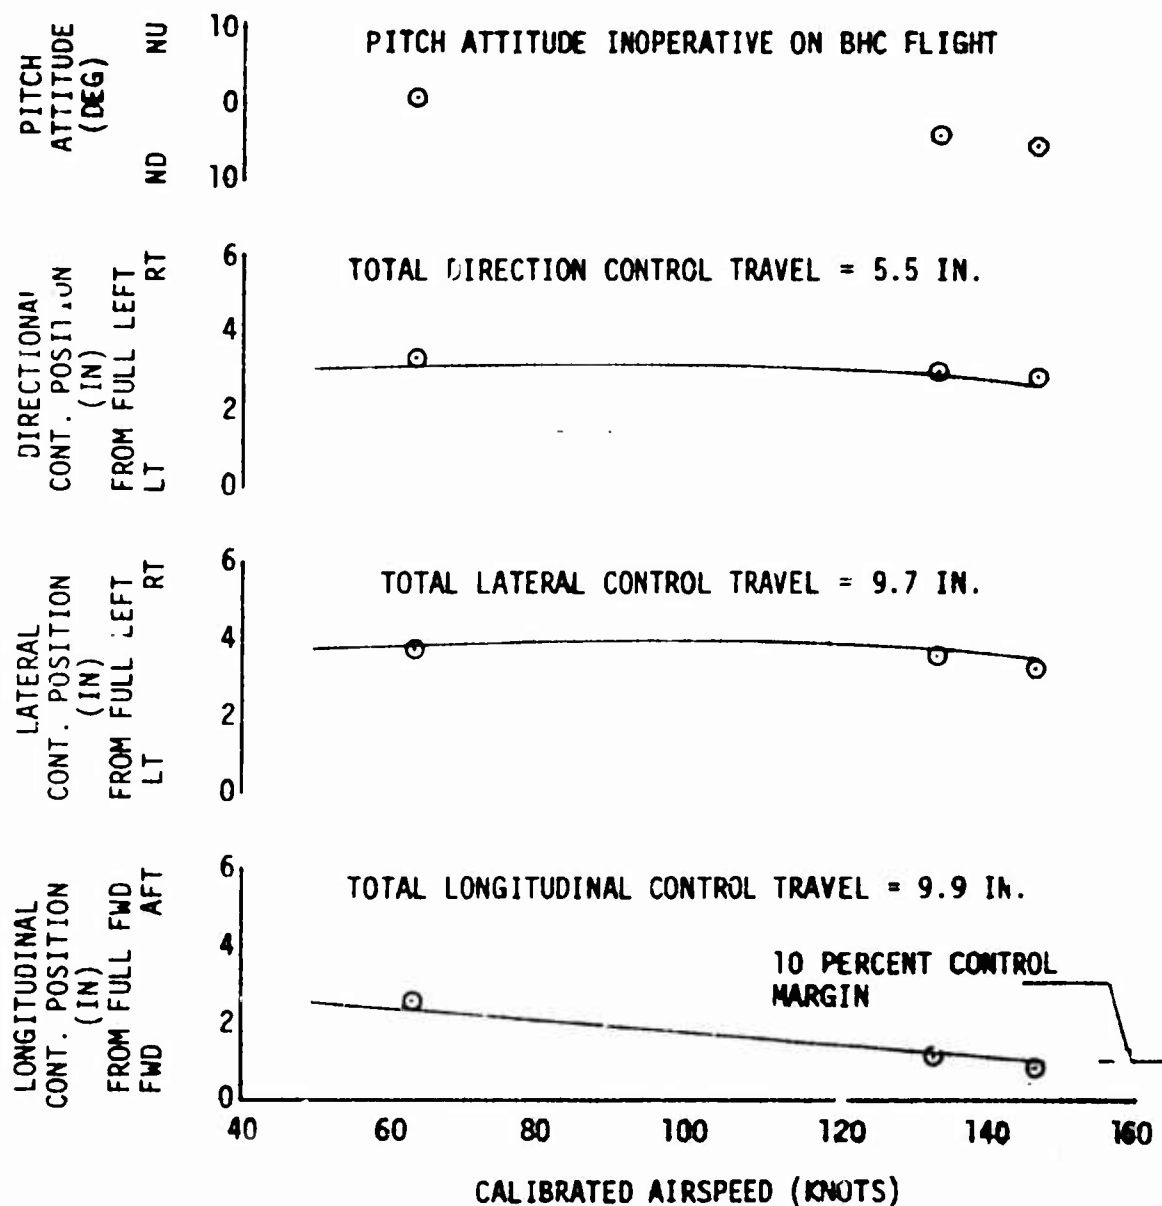
NOTE: Curves obtained from Bell Helicopter  
 Project No. 209-099-342 (ref 11, app A)

**FIGURE 2**  
**CONTROL POSITIONS IN TRIMMED FORWARD FLIGHT**  
**100-100 MPH 5/8 FL-10079**  
**(FLY-PLATE CONTROL)**

8. Control positions in trimmed forward flight were investigated in conjunction with level flight performance testing. The results are presented in figures 1 and 2, appendix E, in conjunction with data obtained by BHC. In the clean configuration (fig. 1) the forward longitudinal control margin was less than 10 percent at  $V_H$ . This is a reduction of approximately 0.8 inch longitudinal control margin from the AH-1G at similar test conditions. The lack of sufficient longitudinal control margin was also evidenced during the static longitudinal and maneuvering stability tests (paras 9 and 14, respectively). The insufficient forward longitudinal control margin in the clean configuration (aft cg) at  $V_H$  is a shortcoming. The lack of

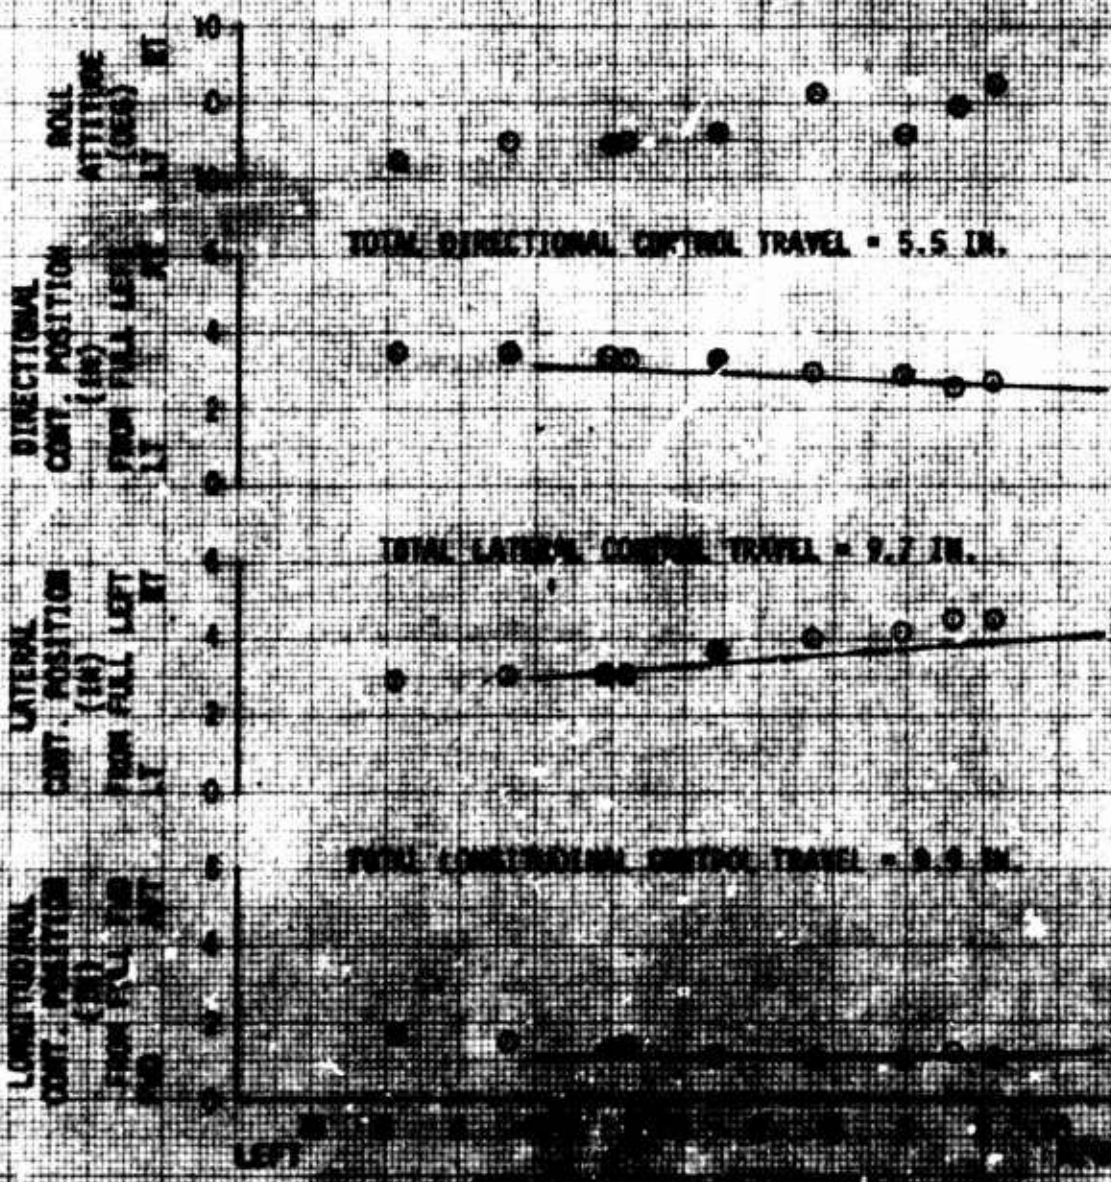
STATIC LATERAL - DIRECTION STABILITY  
YAH-1Q USA S/N 70-16019  
(FLAT-PLATE CANOPY)

- NOTE: 1) Shaded symbols denote trim  
2) Curves obtained from Bell Helicopter Project No. 209-099-342

10. Static lateral-directional stability characteristics were evaluated at the conditions listed in table 1. The tests were conducted by tracking a straight-line ground reference while stabilized at incremental sideslip angles. Control positions were recorded with the aircraft stabilized in steady-heading sideslips at the trim airspeed with the collective control fixed. Test results are presented in figures 5 and 6, appendix E.

11. For both configurations the helicopter exhibited positive directional stability (left pedal required during right sideslip). However, when the directional stability gradient of the YAH-1Q with a flat-plate canopy was compared to the AH-1G at similar test conditions, a significant loss in directional stability was evidenced (table 2). Both the flat-plate canopy and the TSU could contribute to the loss in directional stability but individual contributions cannot be determined from this test. The reduction in directional stability was qualitatively noted throughout the test, but was most noticeable in the clean configuration. During simulated attack dives in both configurations, considerable pilot compensation was required to maintain coordinated (ball-centered) flight, which is necessary for accurate delivery of 2.75-inch rockets (HQRS 5). The weak static directional stability is a shortcoming. Further testing should be conducted to determine the effect of the decreased directional stability on the accuracy of rocket fire.
