DETECTING STRUCTURAL HEAT LOSSES WITH MOBILE INFRARED
THERMOGRAPHY. PART III. SURVEY OF USA CRREL

Cold Regions Research and Engineering Laboratory
Hanover, New Hampshire

December 1975

DETECTING STRUCTURAL HEAT LOSSES WITH MOBILE INFRARED THERMOGRAPHY Part III-Survey of USA CRREL

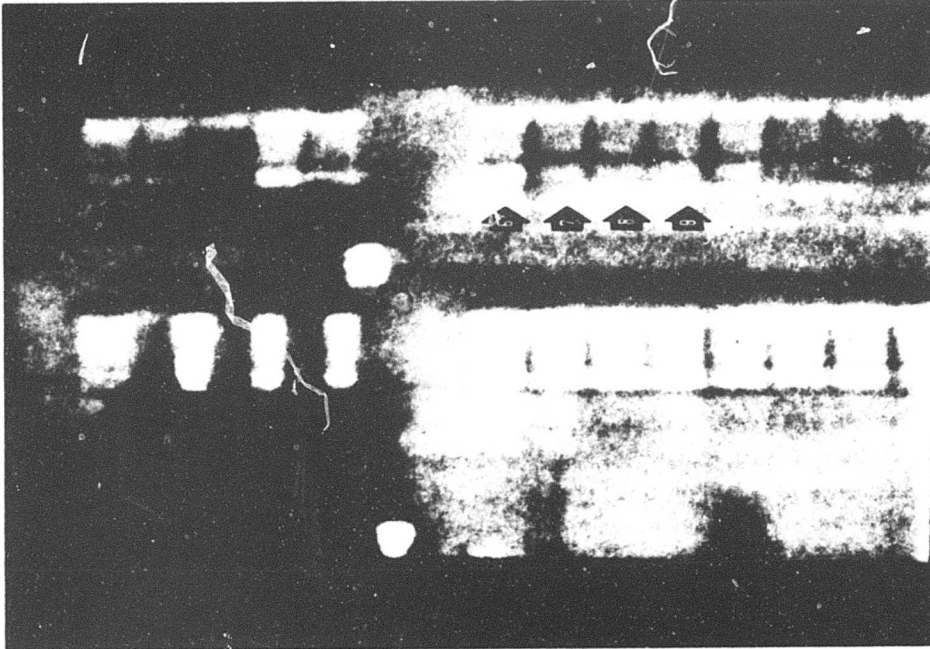
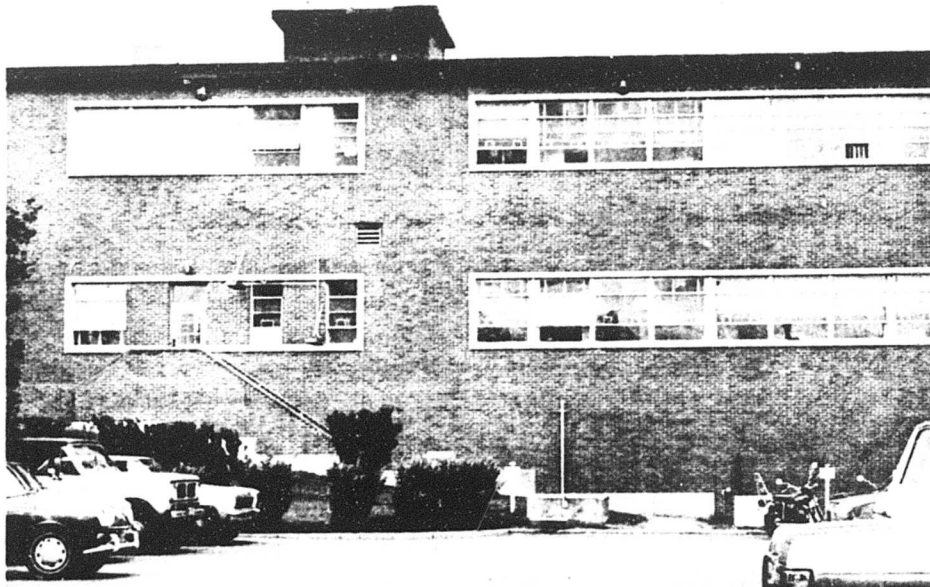
Figure 1 shows the thermogram and regular picture of the northeast side of the USACRREL building. The thermogram was taken on 13 February 1974 at approximately 2200 hours. The ambient temperature was 36°F and the wind (as measured at a station located at USACRREL) was from the south at 2 mph. The large white spot between the two rows of windows shows heat flowing out of an open vent. An interesting qualitative comparison of the relative heat flow (white to black contrast) from the five second floor windows located at the east corner of the building can be noted. Windows 1-3 are fitted with a pair of heavy drapes with a separate liner between the windows

Figure 1. Northeast side of USACRREL building. Windows are numbered to distinguish differences in heat loss. (See text.)

and the drapes, while window 6 has venetian blinds (pulled down), and windows 4 and 5 have neither blinds nor drapes. Notice that there is relatively more heat (whiter contrast) emanating from the top panes of windows 4-6 than there is from the top panes of windows 1-3. The remaining windows (all fitted with venetian blinds) on the second floor show this same pattern, indicating a rather uniform stratification of warm air near the ceiling in all the rooms in which these windows are situated. While this stratification is somewhat evident at the top panes of windows 1-3, it is obvious that the

drapeline combination does retard a noticeable amount of heat in comparison with the venetian blinds. However, in comparing windows 4 and 5 with those fitted with venetian blinds, it is obvious that the venetian blinds retard little if any of this layer of warm air near the ceiling from reaching the window surface.

Careful observation of window 6 shows heat escaping all along the left side of the window (top to bottom); this seems to indicate that there is a heat leak along the glass to metal casement joint or along the mortar to metal casement joint. Figure 2 shows a typical window at the USACRREL building. It is interesting to note that window 6 is the only one of the 24 windows shown in the Figure 1 thermogram that has a rather bad heat leak around the metal casement, indicating a direct flow of air from inside to outside. The top horizontal casement member on all the windows seems to be warmer than the lower casement member and the lower part of the vertical members, indicating that conductivity through these top horizontal members is being generated by the temperature gradient between this layer of warm air near the ceiling and the outside air.

The large bright area beneath window 6 is the heat from the radiator which has reached the outside surface of the building. The bright zone beneath windows 7, 8 and 9 indicates the presence of a radiator at that location. The bright spot beneath the window directly below window 6 likewise indicates the presence of a radiator. Also, the bright region below and to the left of this window indicates heat being transmitted through the wall at that location. At the edge of this bright region (arrows) is located (inside of the building) a wall separating the two rooms.

The relatively bright appearance of the lower row of windows (compared with the top row) would perhaps lead one to believe that abnormal heat leakage is occurring through these windows. However, the real reason for this high apparent heat loss is that during the survey of the USACRREL building the first floor room temperatures were consistently significantly higher than the second floor room temperatures. The Figure 1 thermogram illustrates one of several reasons that the

The heat loss survey of the USACRREL building showed a number of locations where heat was being lost that could be conserved if corrective actions were taken. Since almost all of the windows are single panes, corrective action needed to be taken to provide an additional insulating layer over the single panes. (As a result of this research it was decided that the most cost-effective approach in the interim was to put sheets of plastic over the inside window frames on the north side of the building.) The thermographic analysis also showed that in a number of places heat from the wall-mounted radiators was being lost by conduction through the masonry wall. This situation could be corrected by placing metal reflectors behind the radiators (but insulated from the wall).

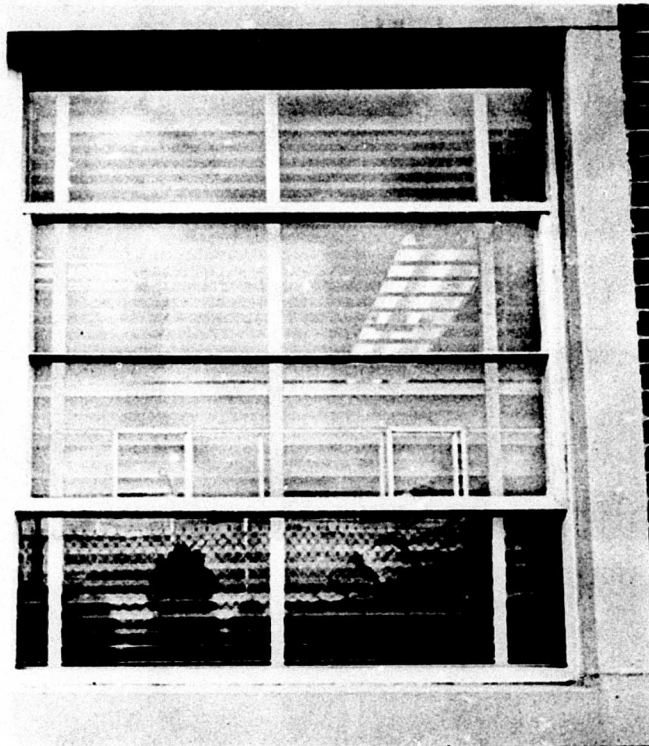
Figure 2. Typical window at USACRREL.

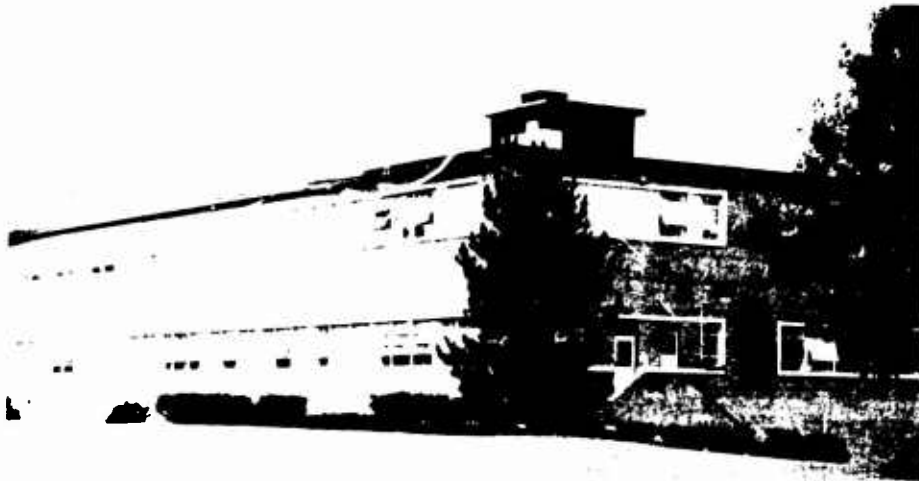
Figure 6. Northeast corner of USA CRREL building. Arrows point to wall surface heated by radiators.

Figure 6 shows the thermogram and regular picture of the northeast corner of the building. Arrows point to locations of outside wall surface heated by radiators mounted on the wall directly behind these heated areas.

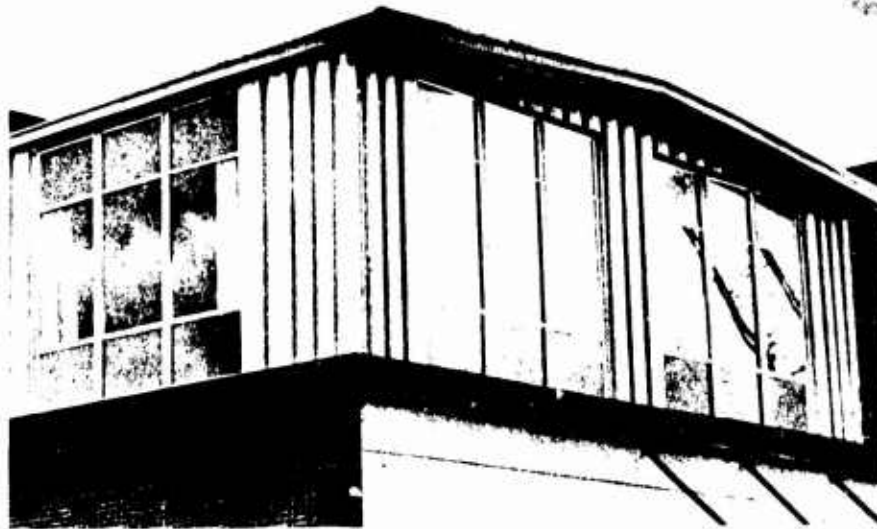
Figure 7 shows the thermogram and regular picture of the northwest corner of the cafeteria. One noticeable path of heat loss is through the metal window frames (vertical and horizontal white lines). Since metal has a relatively low emissivity, these frames should appear dark (cool) if there is no heat loss through them. However, since there is no insulation between the inside and outside frames, conductivity carries the heat directly to the outside surface where it is lost to the air through radiation and convection. The horizontal black arrows point to insulated porcelain-enamel panels

Figure 7. Northwest corner of cafeteria addition (metal building). Black arrows point to insulated porcelain-enamel panels. White arrow points to location of heat leak at roof-wall joint of metal building.

($1\frac{5}{8}$ in. thick) consisting of a sandwich fabrication. Notice that the surfaces of these panels are considerably cooler than the surfaces of the window glass (white rectangles) in spite of the fact that the drapes were drawn at the time this thermogram was taken. However, since these drapes are translucent and have no liners, their insulating effectiveness is considerably inferior to that of the drape-liner combination used in the windows shown in Figure 1.

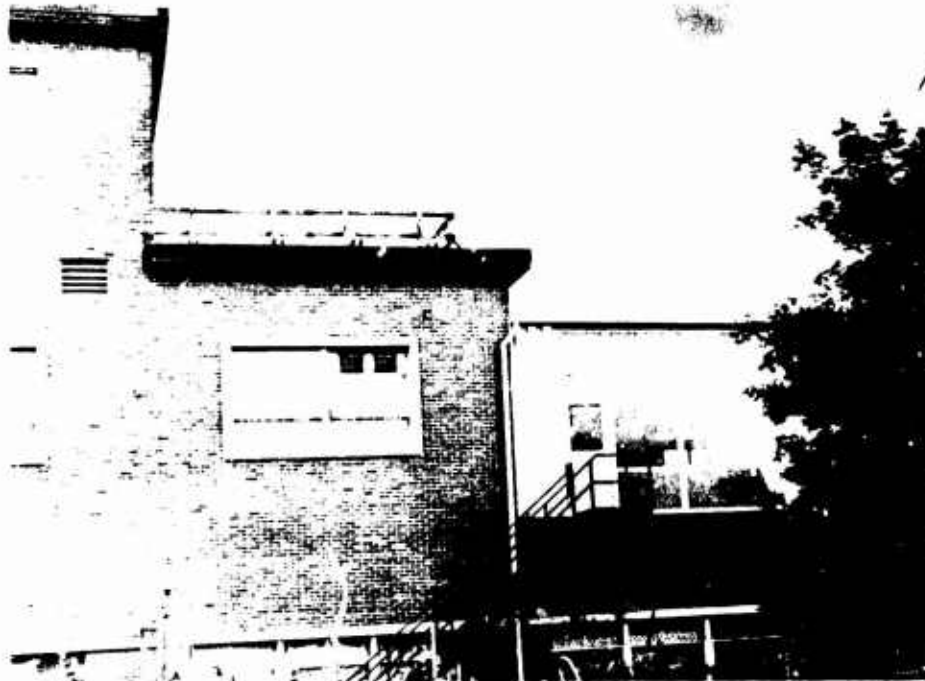
Figure 8 shows the thermogram and regular picture of the west side of the north-facing wall. The white zone (lower arrows) underneath two of the cafeteria kitchen windows indicates an excessive loss of heat at that location, attributed to a tank of hot water kept at 200°F and a section of the

Figure 8. West side of north-facing wall. Lower arrows point to heat escaping by conduction through wall of the cafeteria kitchen. Upper arrows point to heat escaping by conduction through wall of second floor office. White arrows point to location of heat leak (see Fig. 7).

room heating unit. The white zone to the upper left (upper arrows) indicates that this radiator is on and that a significant amount of the radiated heat is being conducted directly through the wall. The faint white line (white arrows) between the two large north dining area windows indicates a possible heat leak at the roof-wall joint of this metal building. Another view of this location can be seen in Figure 7 (arrow at extreme left side of thermogram).
