DEVELOPMENT OF A BACKUP COVER FOR THE AH-1 CANOPY  
REMOVAL SYSTEM

Donald R. Duffy

Teledyne McCormick Selph

REPORT USA AVSCOM TR-75-49

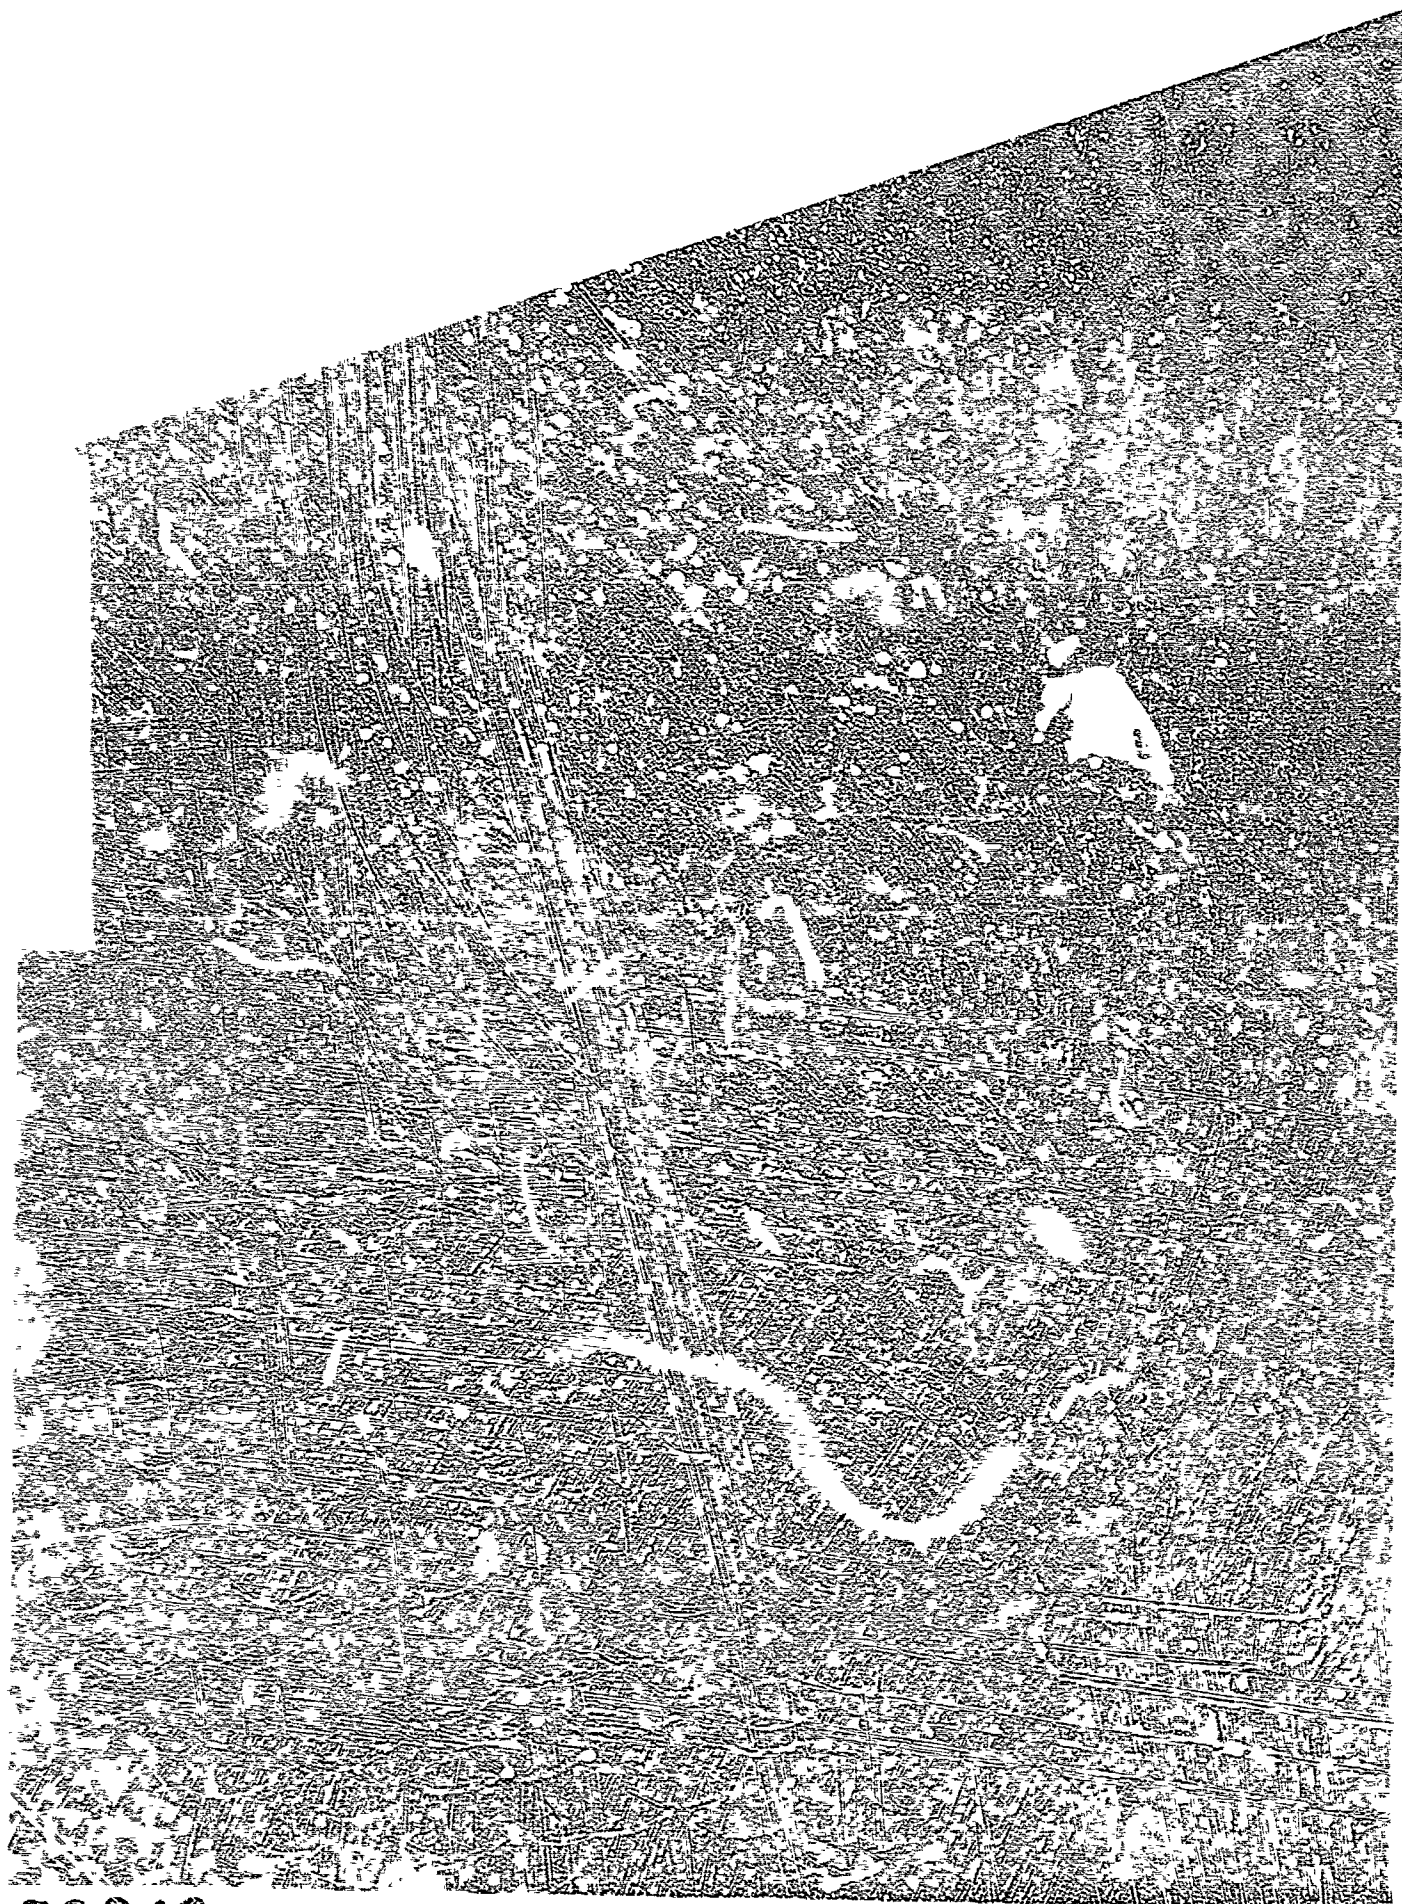
FIGURE 8 - CANOPY REMOVAL

The two WCA's on one side of the canopy structure were functioned simultaneously. Figure 8 catches the action an instant after detonation of the WCA. Note the position of engineer showing safety to external personnel. The engineer was positioned 10 feet forward and 10 feet to the side of the WCA.

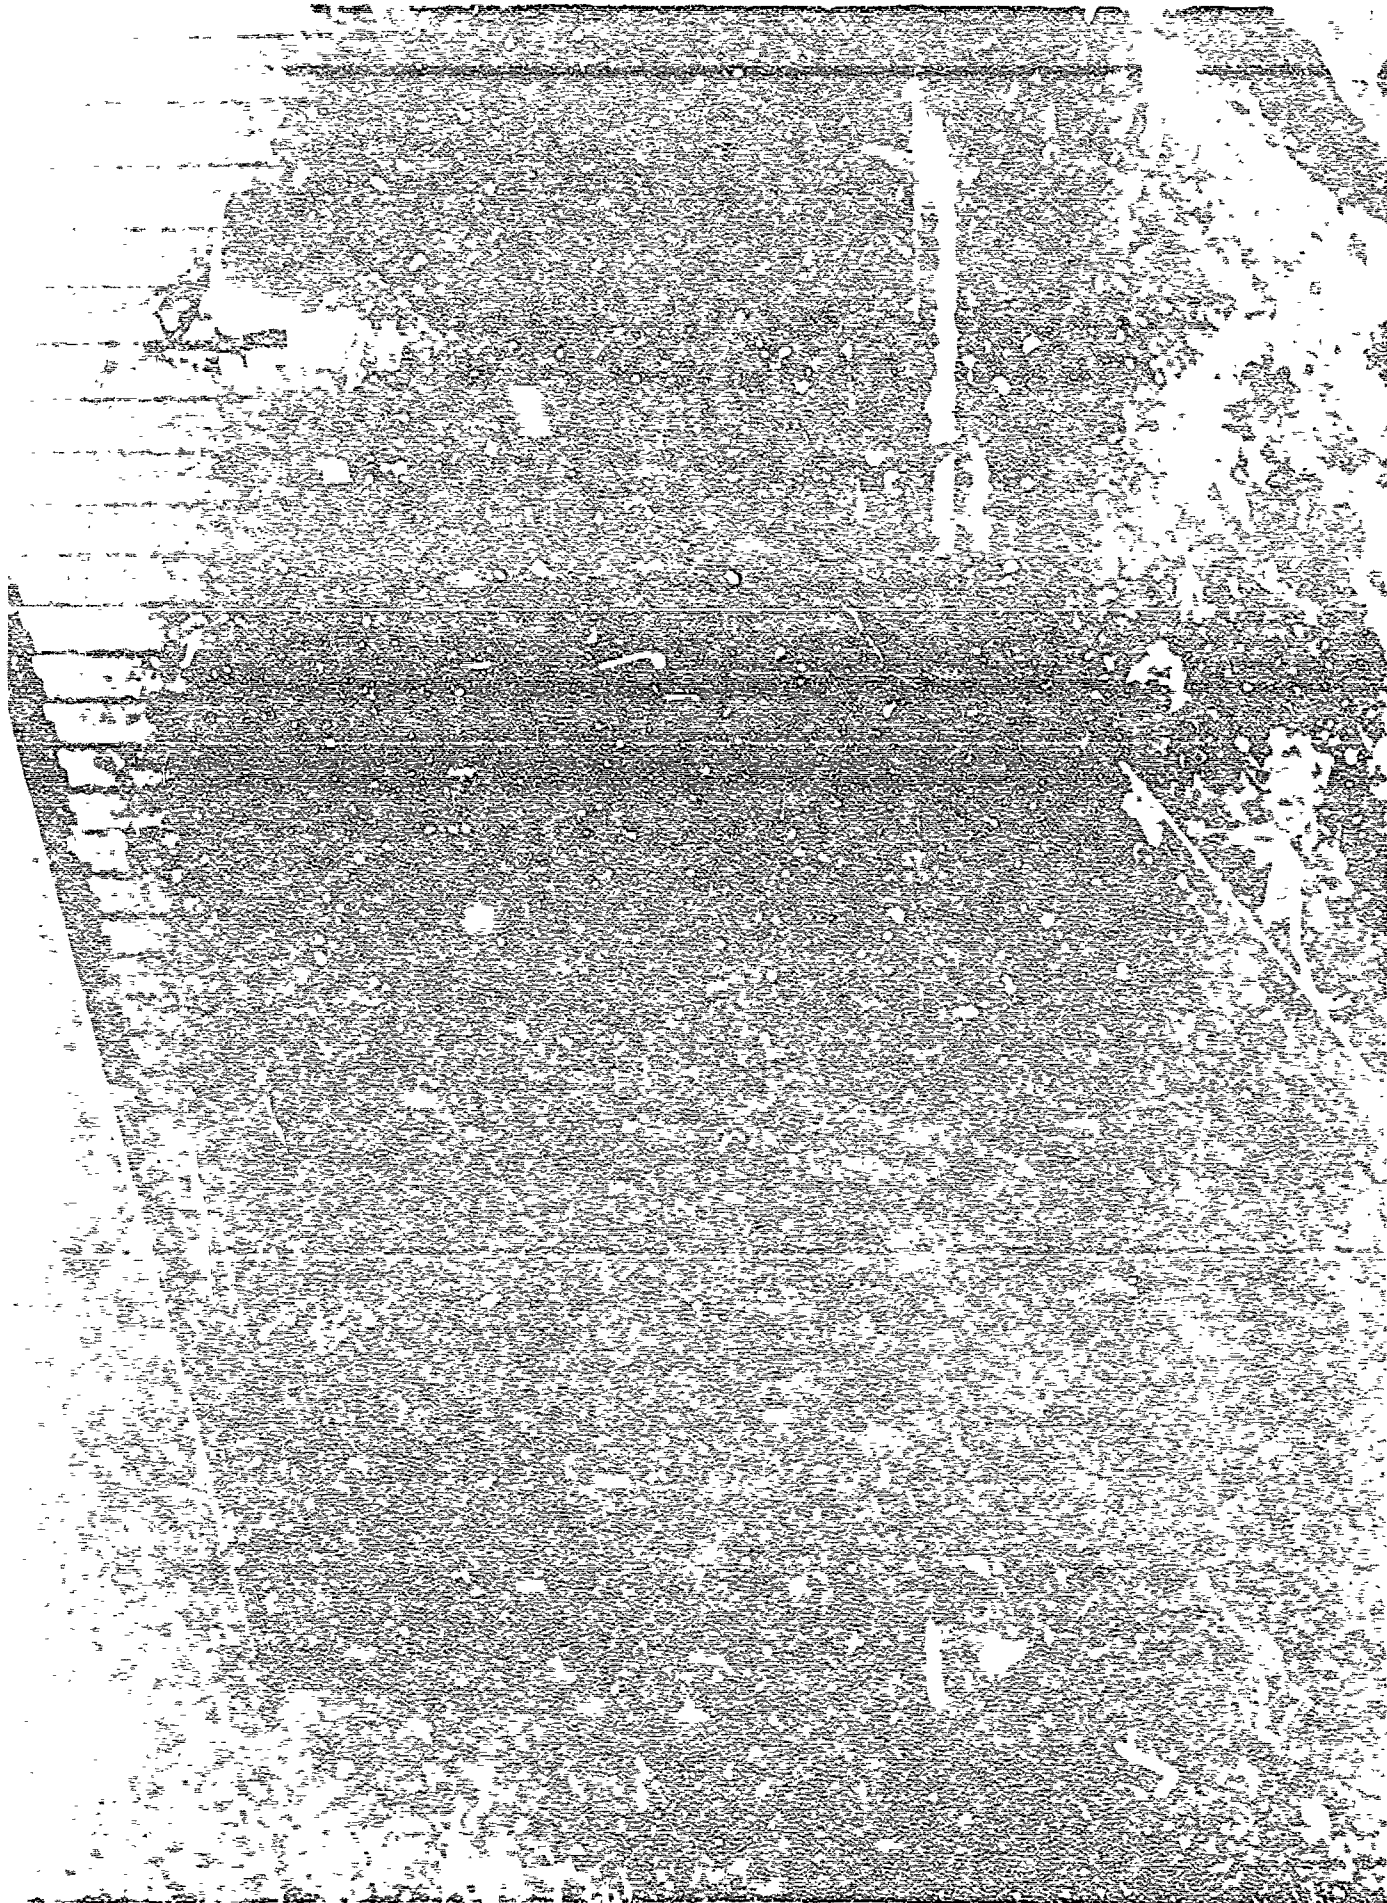
The WCA's were initiated as in the first test and the action is captured in Figure 13. The action is stopped an instant later than in the first test. Both windows were cleanly removed providing two unobstructed exits from the airframe as illustrated in Figure 14.

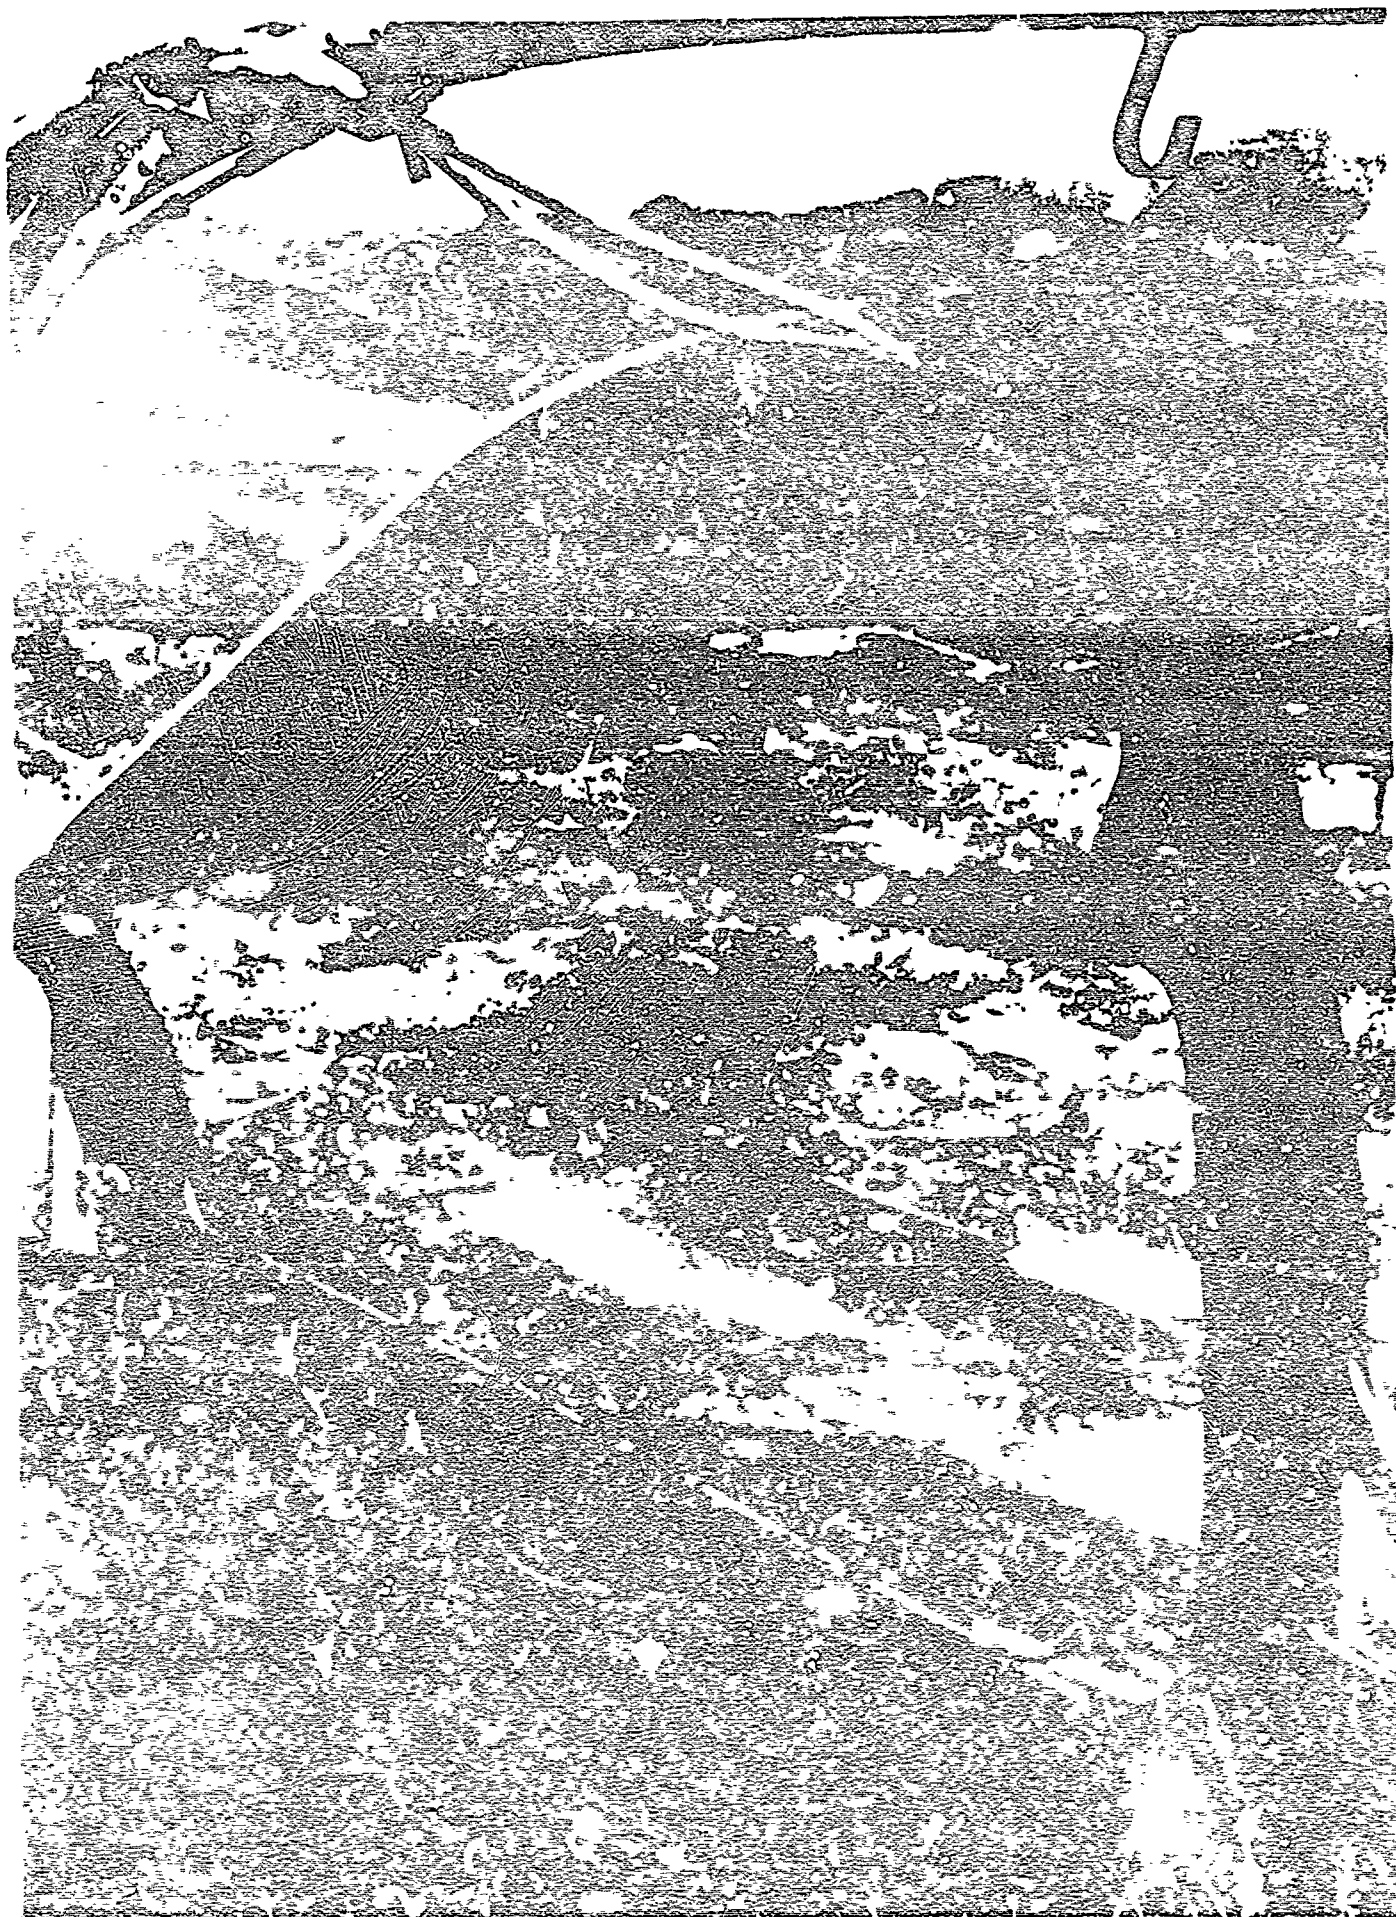
FIGURE 15 - GUNNER WINDOW REMOVAL

The shells remained intact without cracks or pulling through the rivets as in the first test. Figure 15 shows the post test condition of the gunner shell while the pilot door shell condition is documented in Figure 16.

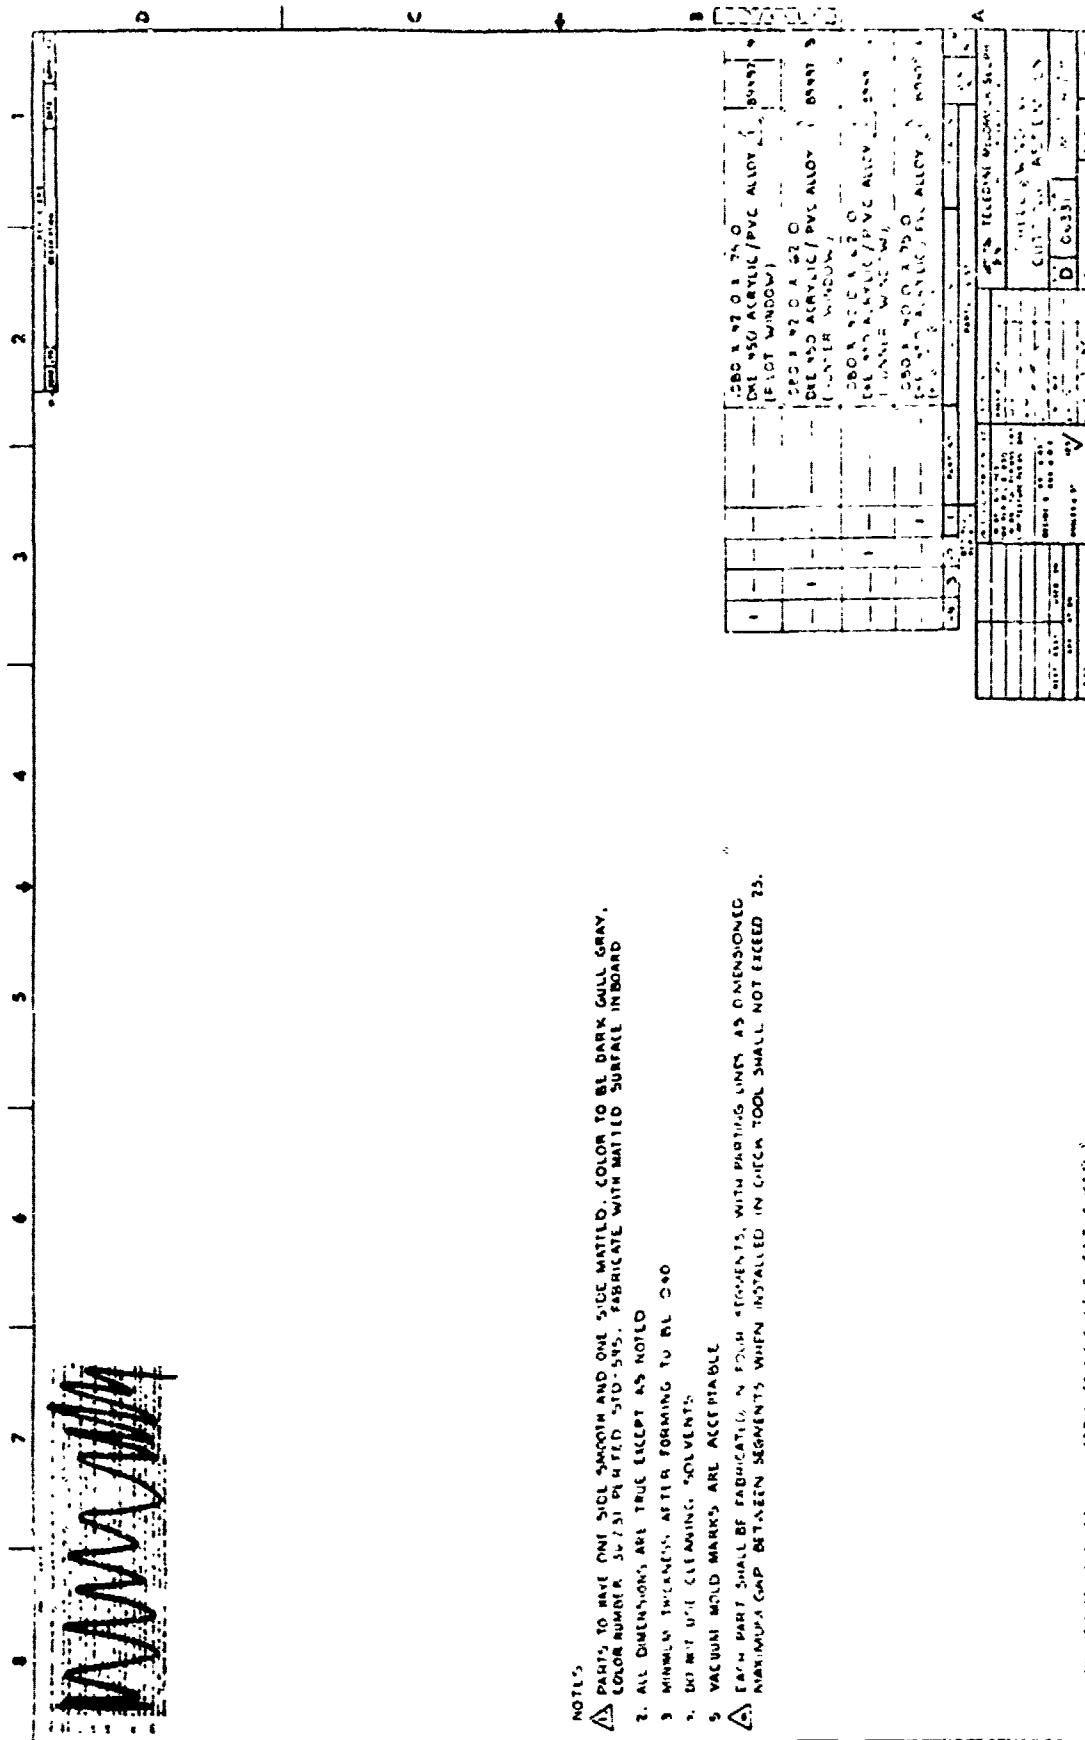
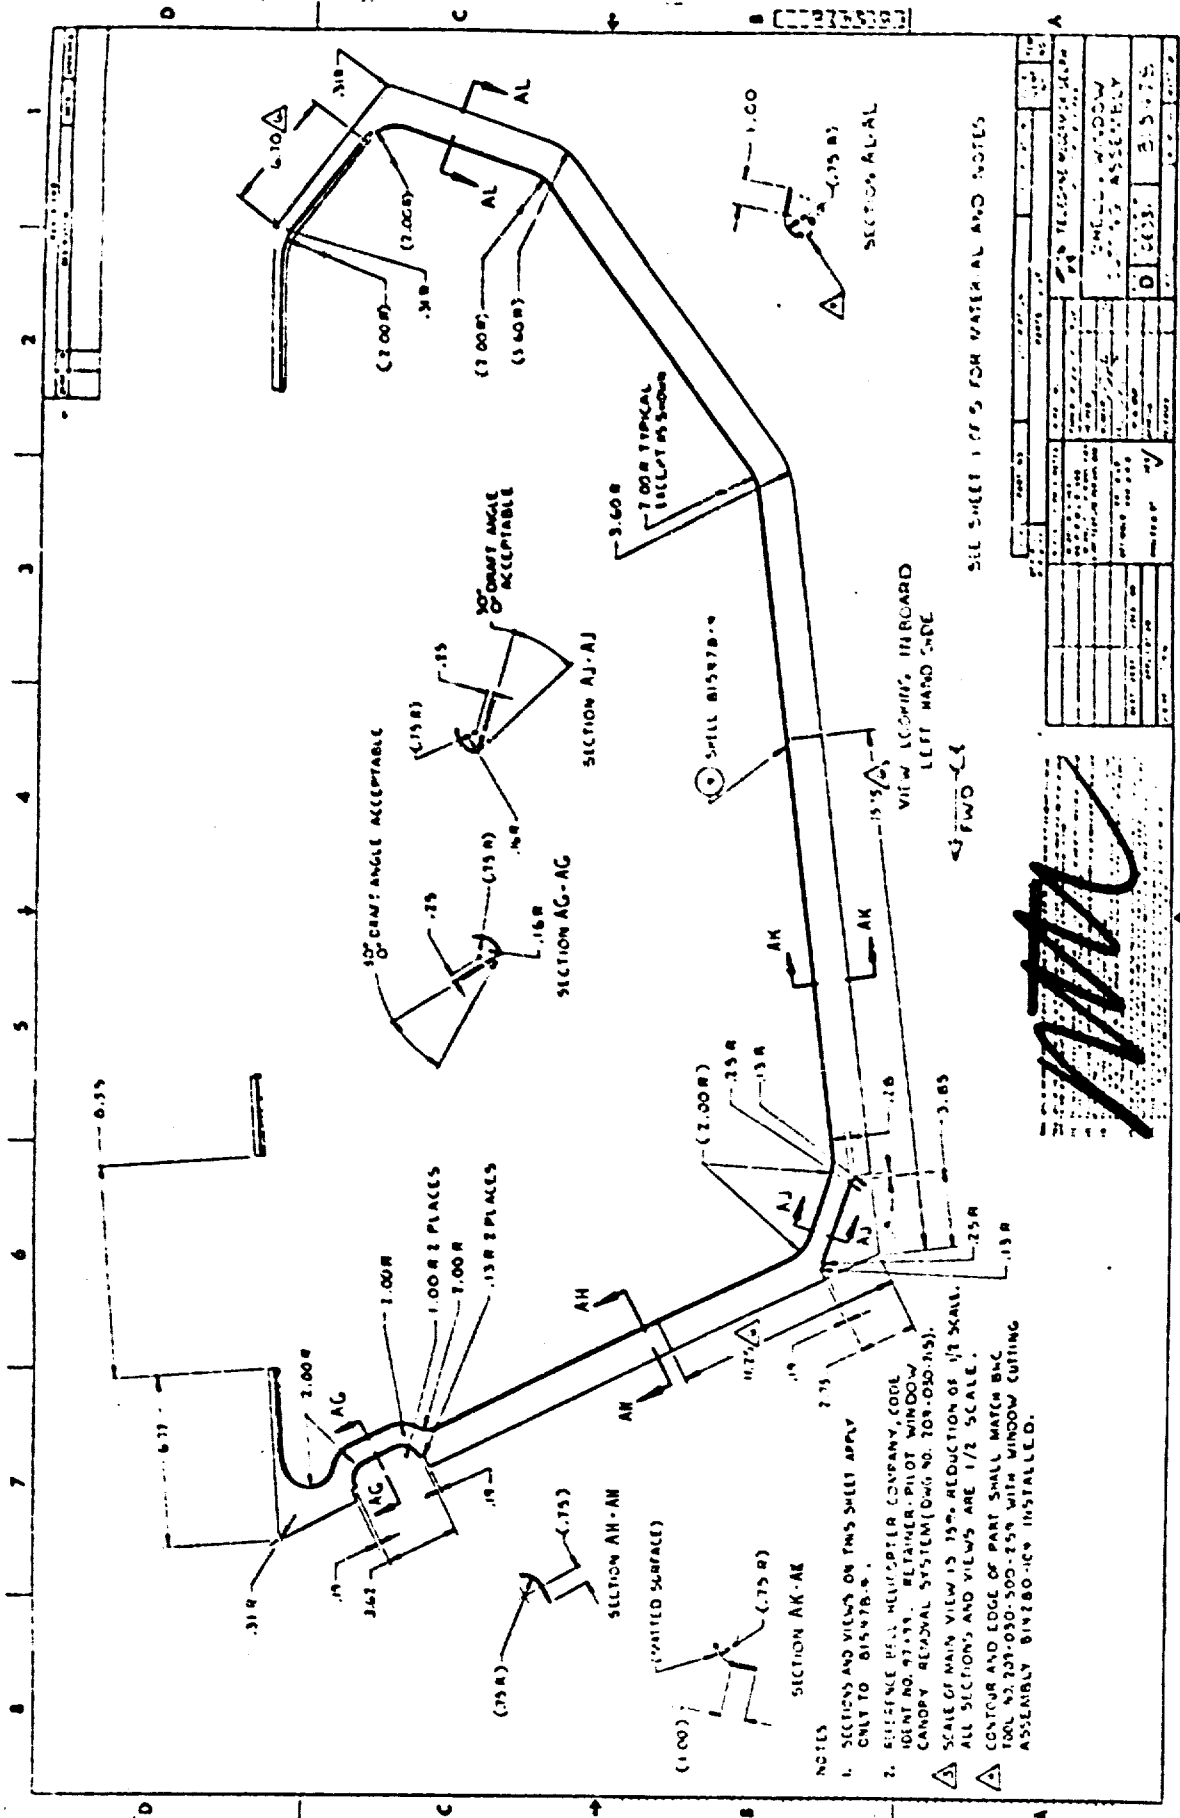
Shells were formed from flat sheets of 0.062 thick DKE-450 and trimmed to fit the appropriate WCA and associated canopy support structure. Each shell consists of four segments which, when fitted to the WCA, provide complete coverage of the WCA with the exception of the doubler area and a maximum gap of 0.25 inch between segments.

The TMc/S fabrication drawing for the shells is included as Drawing Number 815478.
