**EVALUATION OF LIQUID BINDERS FOR AIRFIELD BOMB
DAMAGE REPAIR**

AFCEC-TR-75-25

**ERIC H. WANG CIVIL ENGINEERING RESEARCH FACILITY
UNIVERSITY OF NEW MEXICO
UNIVERSITY HILL, CAMPUS POST OFFICE
ALBUQUERQUE, NEW MEXICO**

FINAL REPORT: APRIL 1974 - JUNE 1975

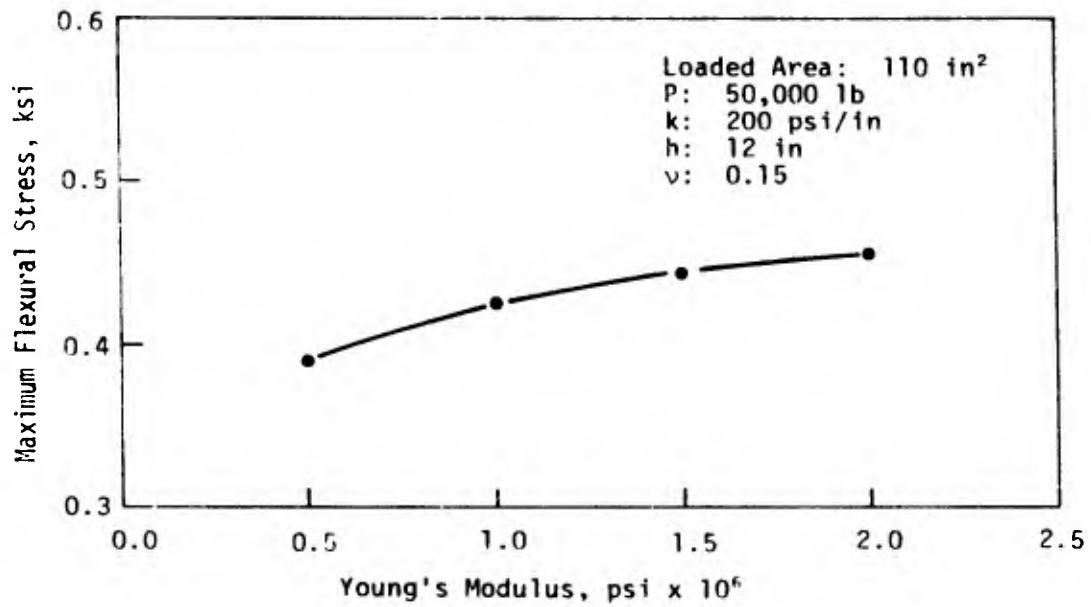
Figure 4. Flexural Stress versus Young's Modulus

The second effect studied was that of variations in Young's modulus on the flexural stress. The assumed plate thickness was 12 in and the assumed foundation modulus was 200 psi/in. The result is shown in figure 4. It may be noted that flexural stress is not very sensitive to variations in Young's modulus.

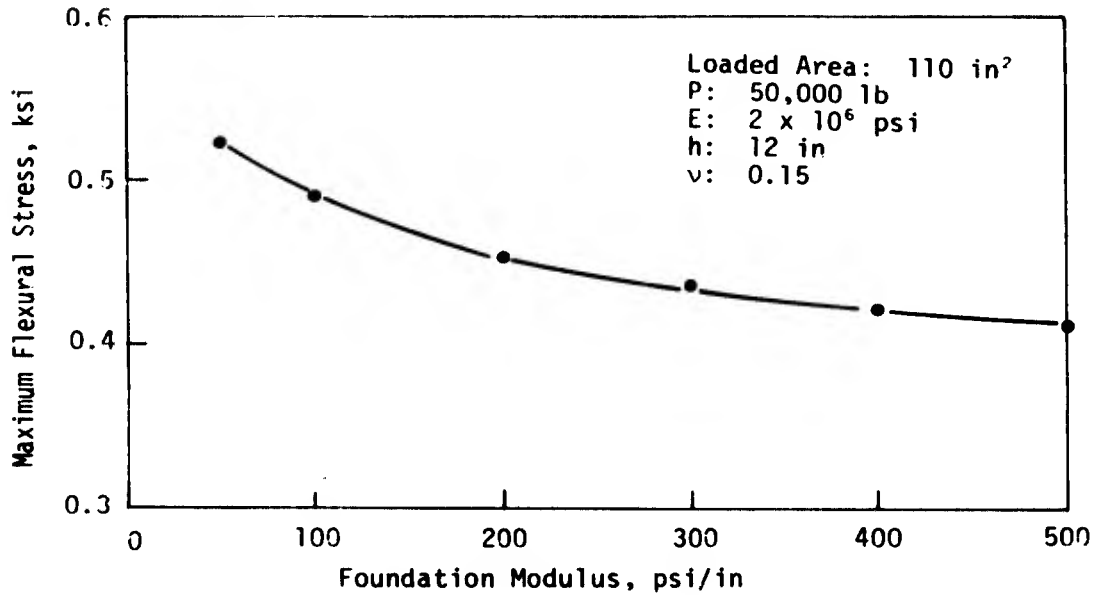
Figure 5. Flexural Stress versus Foundation Modulus

The third effect studied was that of variations in foundation modulus on the flexural stress. The assumed Young's modulus was 2×10^6 psi and the plate thickness was 12 in. The result is shown in figure 5. It is interesting to note that the flexural stress does not vary much with changes in foundation modulus.
