MODEL 540 MAIN ROTOR BLADE FATIGUE TEST

Arthur J. Gustafson, et al

USAAMRDL-TN-22

# MODEL 540 MAIN ROTOR BLADE FATIGUE TEST

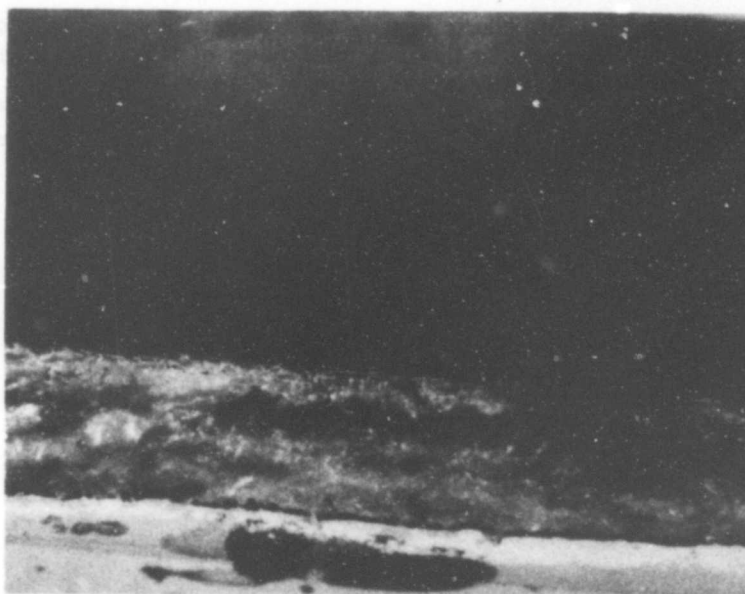
Figures 21 through 23 indicate cracks as they can be seen through a borescope. The first two figures correspond to cracks in the outermost fibers of the excess adhesive adjacent to a sound bond. The last figure corresponds to an all-the-way-through crack. It is obvious that it is almost impossible to identify the "real" crack and that the use of an alternate inspection technique is mandatory. Ultrasonic through-transmission was used to detect the extent of the crack.

**Figure 21.** Crack existing on the bondline excess adhesive viewed through a borescope.

**Figure 22.** Crack existing on the bondline excess adhesive viewed through a borescope.
