ESKIMO III. MAGAZINE SEPARATION TEST

Frederick H. Weals

Naval Weapons Center

February 1976

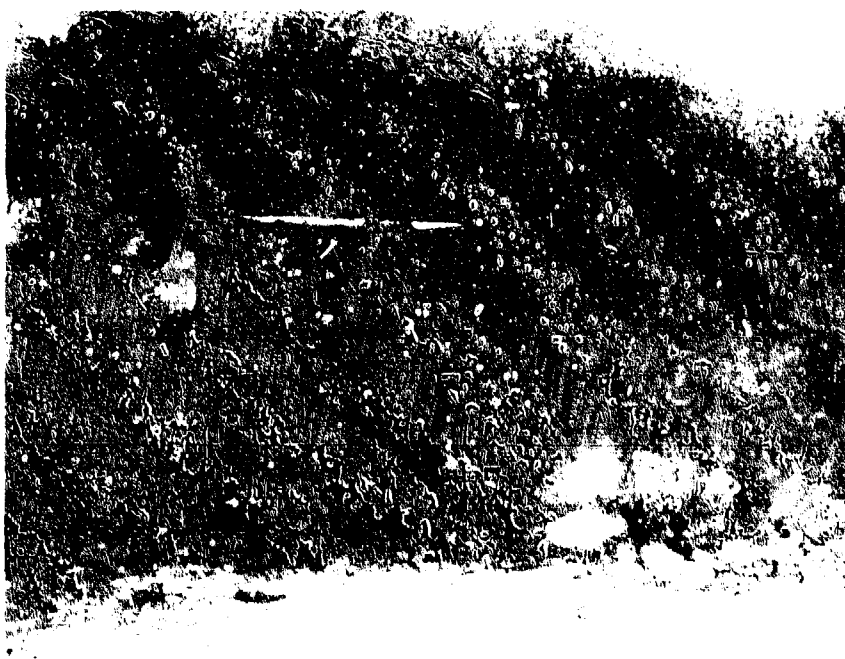
The most severe door and headwall damage was experienced by Igloo E. Here the door-leaf damage and deformation indicated that the leaves were thrown inward with significant velocity (Figures 20, 21, and 22) and would have jeopardized any stored explosives. Additionally, the steel channel used for the left doorjamb and the door head were separated from the concrete headwall (Figure 23). The headwall experienced considerable damage, with a maximum inward movement of approximately 1.5 feet where the bottom portion of the left doorjamb separated from the floor (Figure 24).

FIGURE 24. Igloo E, Doorway and Headwall. (Neg. LHL 183178)

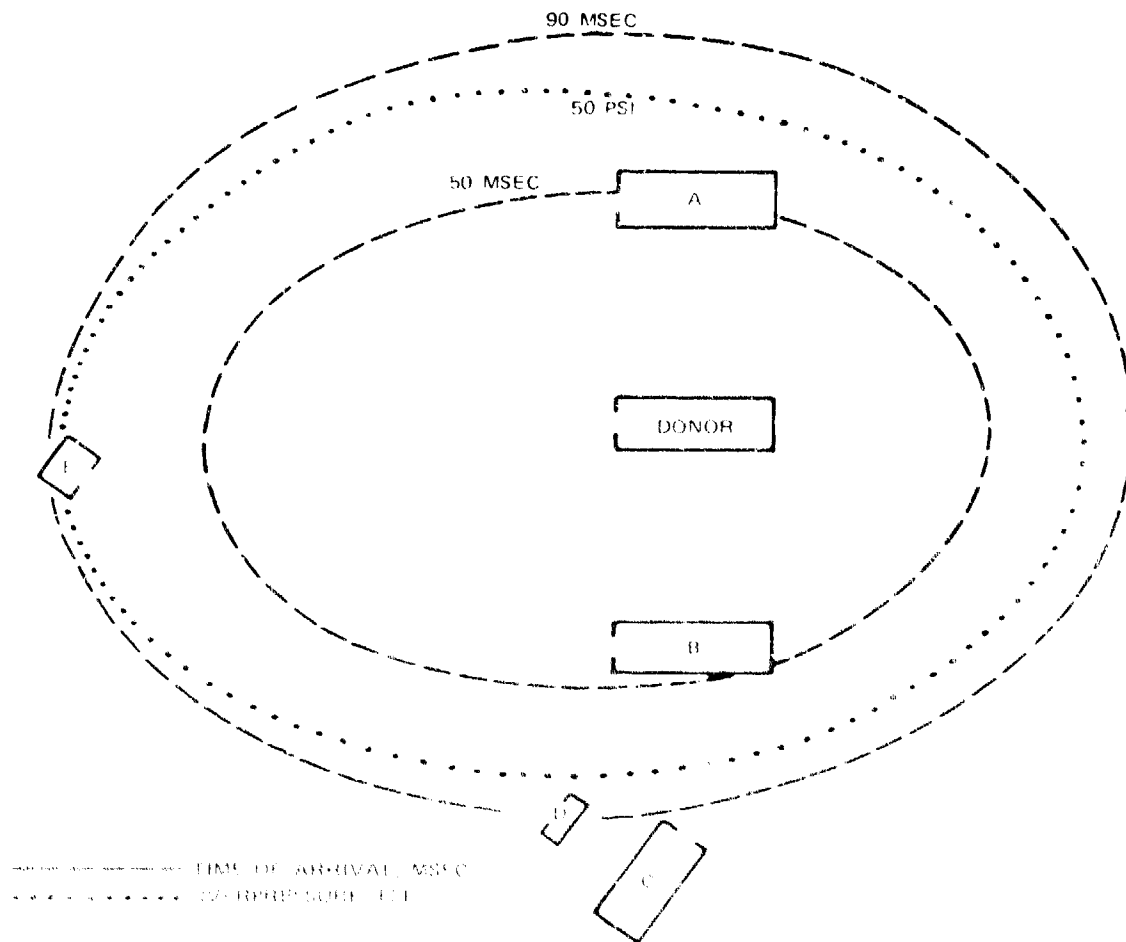
FIGURE 25. Near Field Blast Patterns.

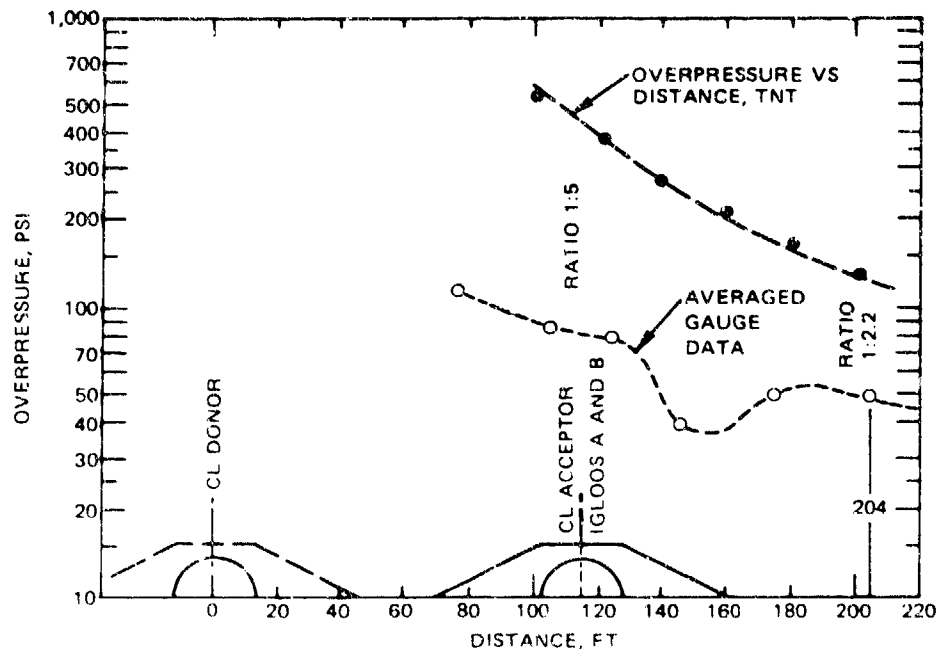
Figure 26 shows graphically the averaged overpressure data acquired in sideward directions from the donor igloo (at right angles to the longitudinal centerline) compared to expected values from an

FIGURE 26. Overpressure Versus Distance in the Near Field.

equivalent weight of TNT. This shows that expected overpressures from the unconfined TNT charge are approximately five times as great as those actually experienced at a distance equal to that from the centerline of the donor structure to the centerline of acceptor igloos A and B. The ratio reduces to 1:2.2 at sideward gauge positions 204 feet from the centerline of the donor igloo. This position approximates the position of a headwall in the minimum face-to-side orientation of  $2.75 \times W^{1/3}$ . At sideward positions 1,320 feet from the donor centerline, the ratio reduces to about 1:1. These same comparisons are shown in a different form in Figure 27 which also compares a standard TNT curve with overpressures fore and aft of the donor igloo in addition to those to the sides. Figure 27 shows that blast overpressures recorded to the rear of the donor igloo remain well below standard values for an unconfined charge<sup>3</sup> at distances out to 1,320 ( $18.7 \times W^{1/3}$ ) feet and that overpressures recorded forward of the donor exceeded standard values at near-field positions ( $\approx 300$  or  $4.25 \times W^{1/3}$  feet) but dropped below standard values for 1,320 and 2,115 ( $30 \times W^{1/3}$ ) feet. Averaged overpressure and impulse data show that at 660 feet from the center of the donor, the blast approximated that from 225,000 pounds of unconfined TNT in a hemispherical configuration. The corresponding value at 1,320 feet is 255,000 pounds of TNT.
