# NONDESTRUCTIVE EVALUATION OF CERAMICS

T. Derkacs  
I. M. Matay  
W. D. Brentnall

TRW, Inc.  
Cleveland, OH. 44117

Final Technical Report  
Contract No. N00019-75-C-0238

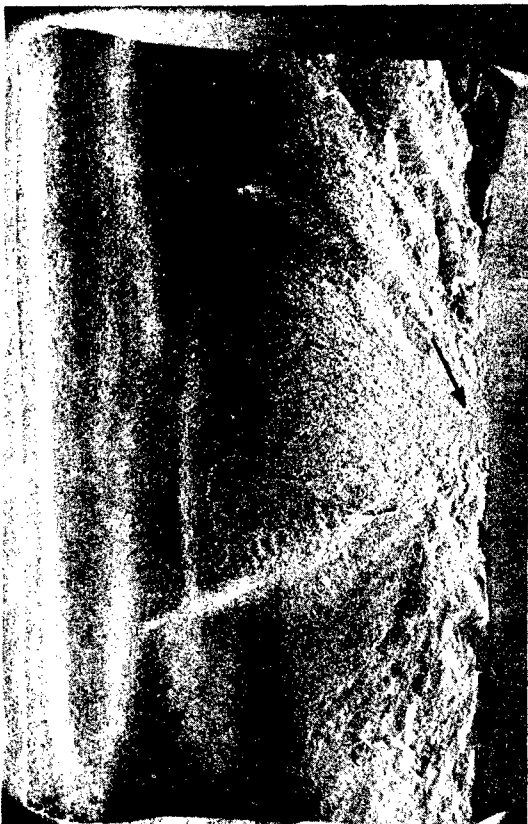
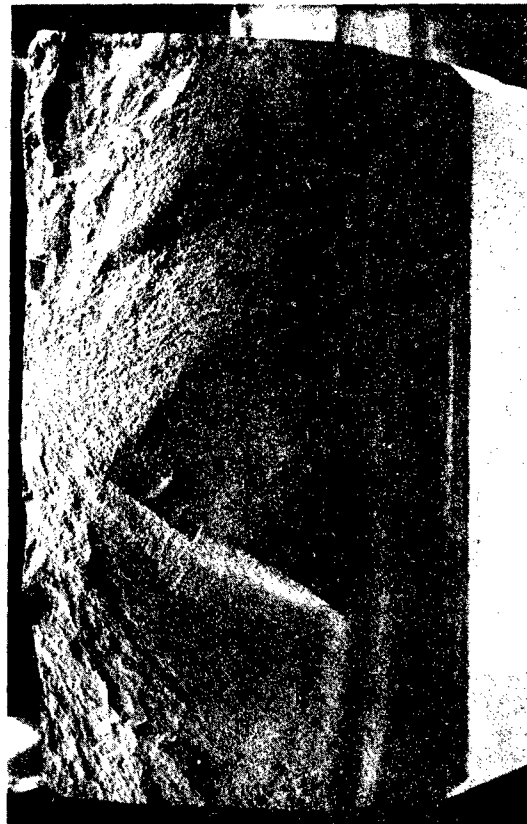
Figure 35. Fracture Surface of Hot Pressed Silicon Nitride Specimen X-4, Showing Unidentified Sub-Surface Flaw at Fracture Initiation Site.

Figure 35 shows the mating fracture surfaces of one of the control specimens (X-4) with an obvious fracture initiation site just below the tensile surface and a fairly well defined "mirror" region. At higher magnifications this defect took on the appearance of a smooth amorphous looking area. A specimen tilt of about 23° was used so that there is some image foreshortening in the vertical sense. The defect shown in Figure 36 would therefore have a width dimension of about 25  $\mu$ m and a length dimension somewhat greater than 60  $\mu$ m. Since the hot pressing direction for the material was in the specimen width direction, it would be anticipated that the defects would be elongated in the specimen thickness direction.

of the appearance of the smaller area in Figures 35 and 36 and, in fact, was also observed in other samples. In addition to the amorphous looking area, approximately 100  $\mu\text{m}$  diameter, there was a groove with a crack at the base terminating in a "penetration flaw" referred to by Gruver et al (27). Figure 45 is included to show a frequently observed fracture behavior where initiation from one corner was evident. This type of failure would indicate the presence of surface damage from machining. In this case, however, closer examination (Figure 46) indicated the presence of a 10-20  $\mu\text{m}$  diameter void close to the edge.

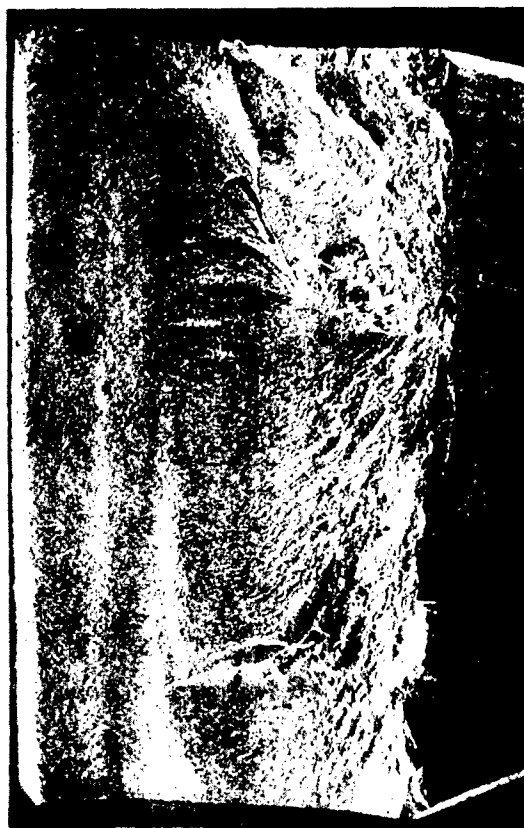
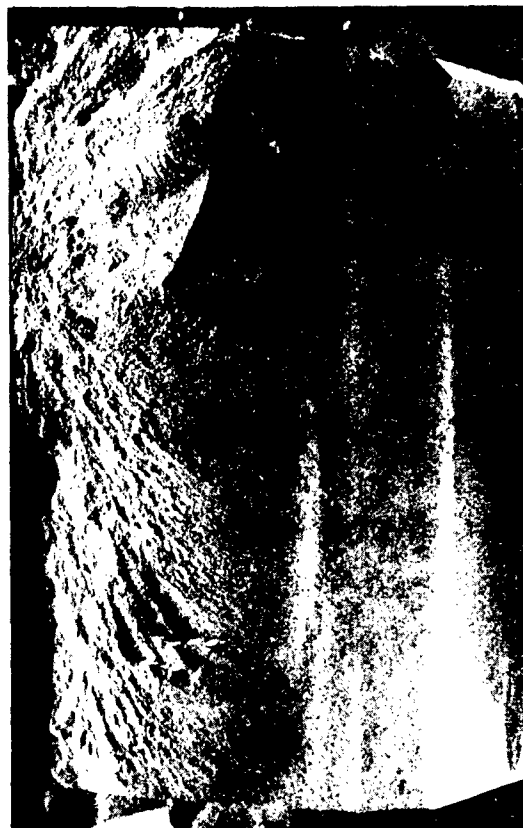
Figure 39. Fracture Surfaces of Hot Pressed Silicon Nitride Specimen 1-4, Showing Fracture Initiation Site at 25  $\mu\text{m}$  Void.

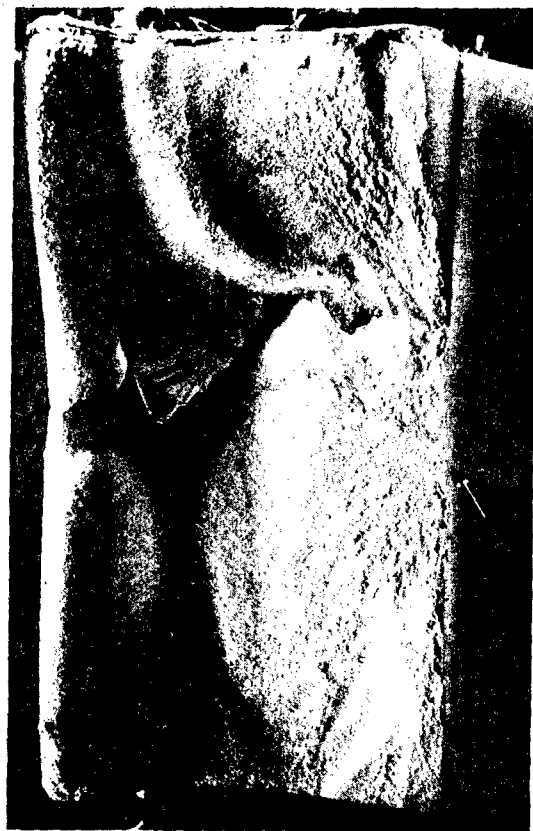
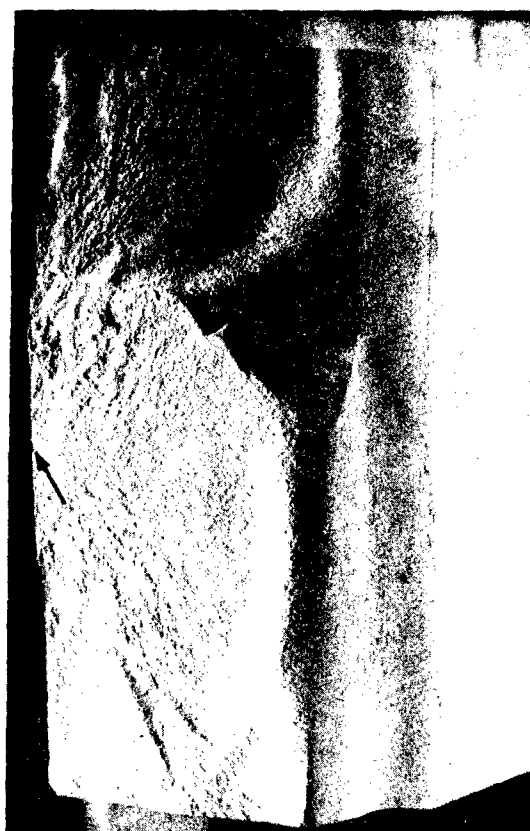
WC Seeded Defect

Figure 40. Fracture Surfaces of Hot Pressed Silicon Nitride Specimen 3-3, Showing Fracture Initiation Site at Seeded High Density Inclusion.

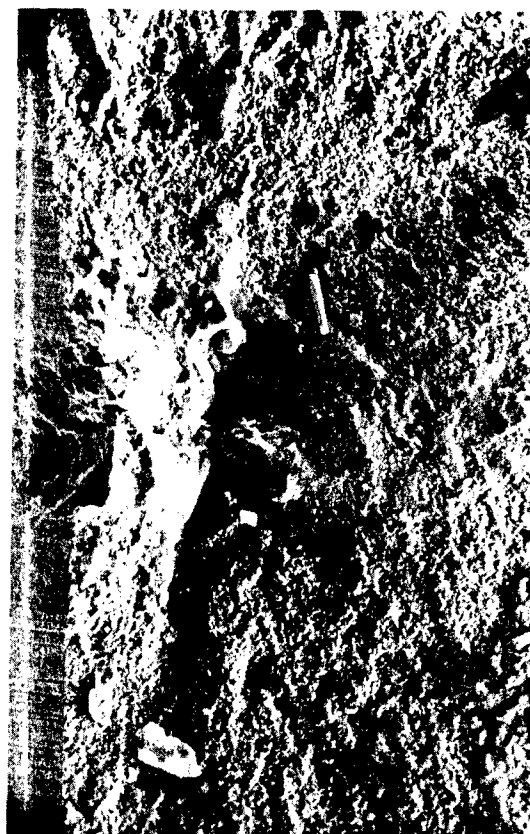
Figure 42. Fracture Surfaces of Hot Pressed Silicon Nitride Specimen 3-5, Showing Fracture Initiation Site at Seeded Low Density Inclusion.

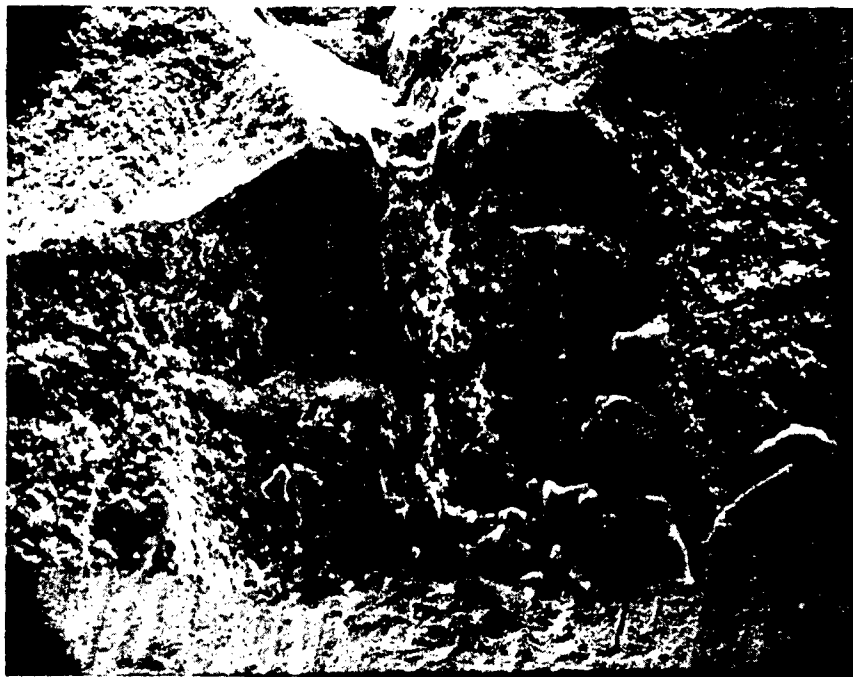
Figure 43. Seeded Defect in Specimen 3-5 at High Magnification.

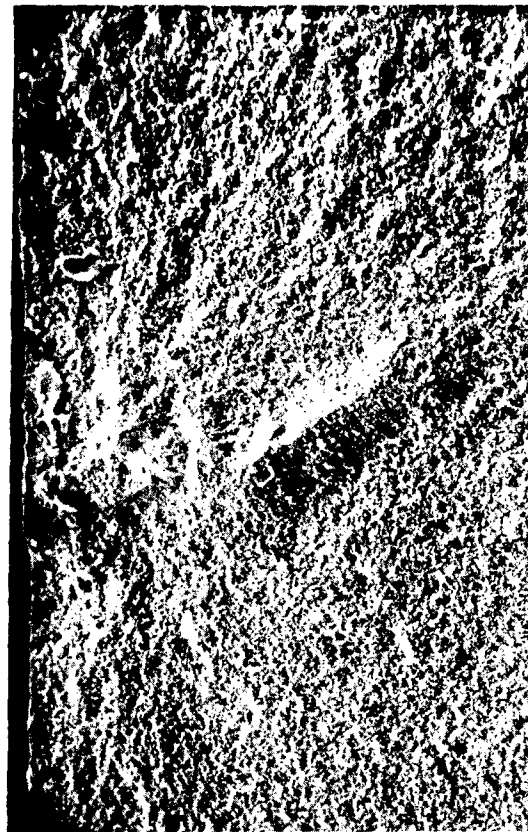
Figure 44. Fracture Surfaces of Hot Pressed Silicon Nitride Specimen 4-4, Showing Fracture Initiation Site at Unidentified Internal Flaw.

The remaining specimen with a well defined fracture origin was 4-4 (Figure 44). This specimen broke off center near one of the loading pins, however, indicating that the ultrasonically identified defect was misplaced or lost during machining, or that the defect in the fracture surface was a more potent crack initiator. Because of the high signal strength (large defect), it is likely that the former was done. The fracture origin had some

It is likely that more meaningful data would have been obtained on specimen 1-3 if the specimen had been sectioned across the defect and polished. These additional evaluations were not possible within the program schedule, however. The results obtained on specimens X-4 and 4-4 indicate that refinements in the microprobe analysis technique will be required in order to obtain useful analytical data on the type of defect shown in Figures 35 and 44.

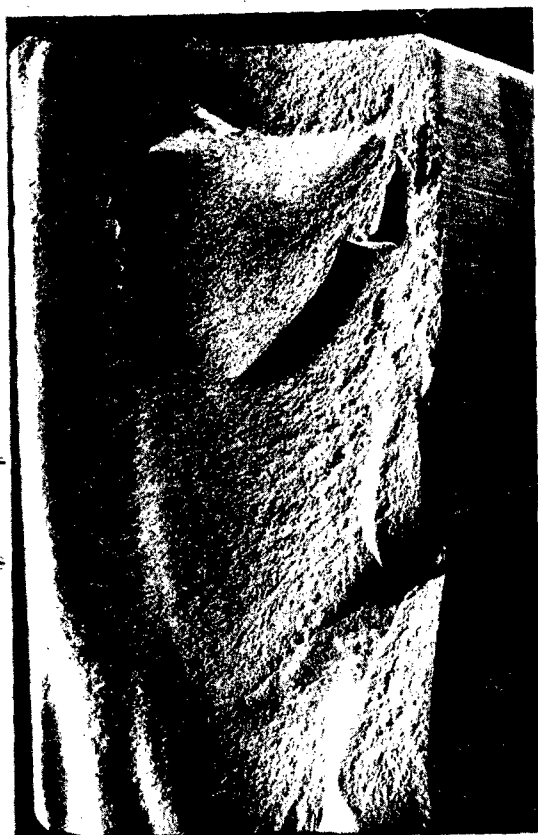
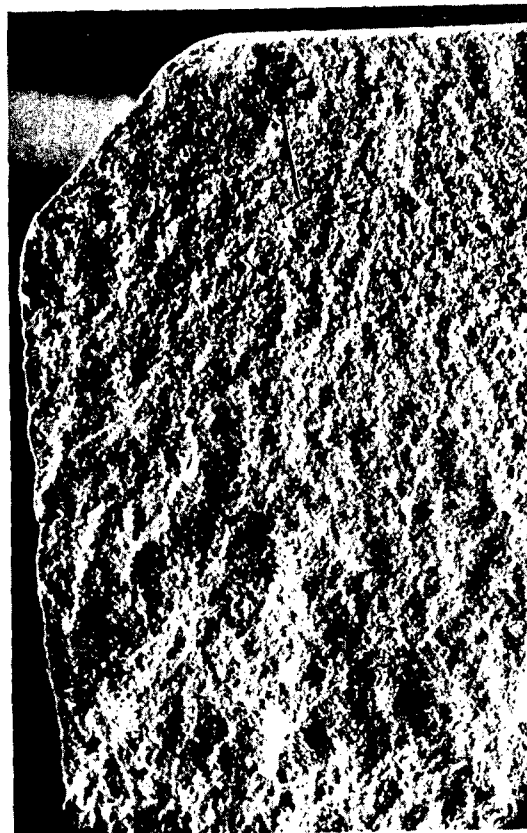
Figure 45. Fracture Surfaces of Hot Pressed Silicon Nitride Specimen 4-6, Showing Corner Fracture Initiation Site.

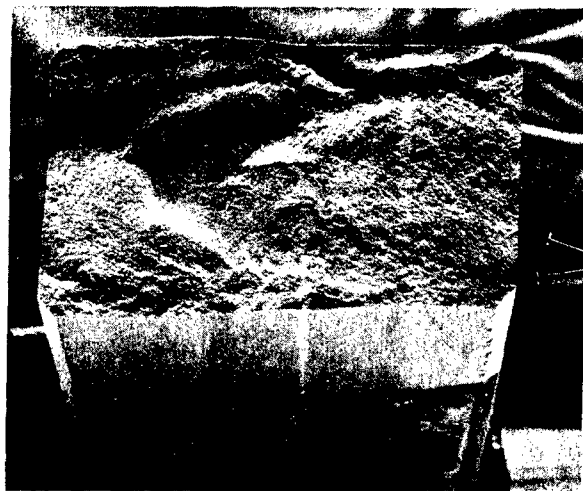
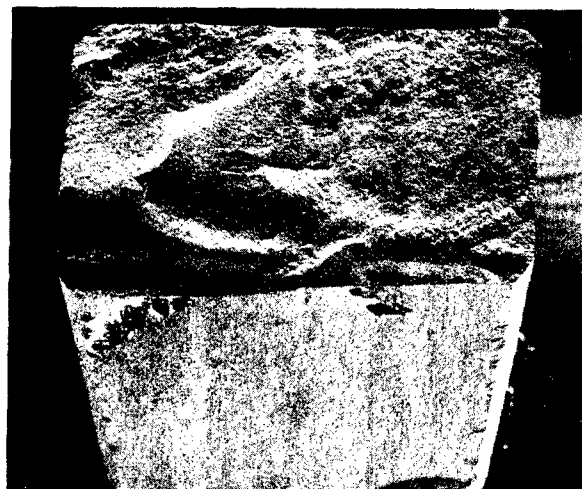
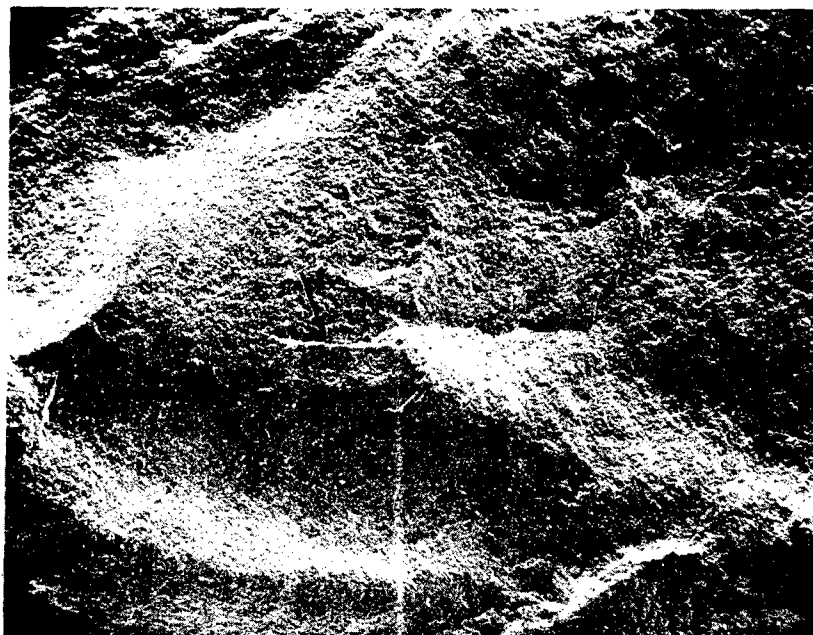
A. Corner and Edge Possible Initiation Sites Indicated.

Figure 50. Fracture Surfaces of Sintered Silicon Carbide Specimen 1-1.

B. Chipped Corner Indicated.

C. Internal Line Defect. 50X

D. Line Defect and Void Indicated.

Figure 50 is a series of SEM fractographs of Specimen 1-1 illustrating typical "flaws" found in most of these specimens. As before, the photographs are presented with the tensile surfaces, of the mating fracture surfaces, closest together. The markings visible on the compression surface in the low magnification photographs are due to residual wax pencil traces used to identify the desired load direction. In this specimen fracture appeared to
