## ION POLISHING OF OPTICAL SURFACES

Westinghouse Research Laboratories  
Pittsburgh, Pennsylvania 15235

September 1976

Final Report

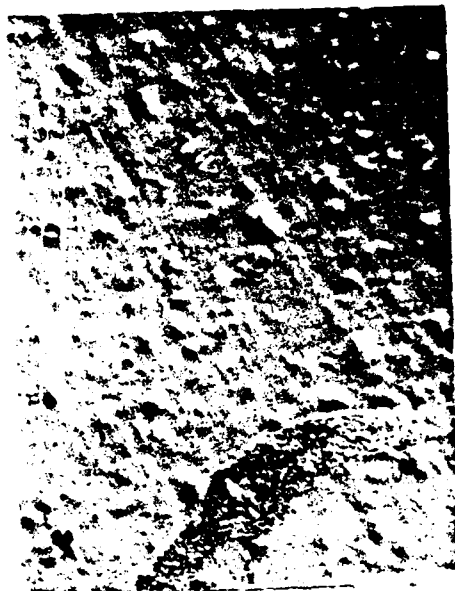
Figure 7. Interference contrast micrographs of micromachined copper at various stages in the ion polishing and vacuum annealing sequence.

Figure 7 shows interference contrast micrographs of the micromachined copper sample at the various stages in the surface preparation sequence. A significant change in the appearance of the surface occurred after the first vacuum anneal at 320°C. Because no detectable change in the surface occurred following subsequent annealing, these pictures are not included in the figure. Figure 8 contains similar photographs for another region of the surface of the same sample and shows a smaller grain structure. Referring to figures 7 and 8, it is seen that the first ion polishing step (2660 Å removed) eliminated most of the major blemishes and reduced the visibility of the machining marks. A suggestion of grain structure can be seen, particularly in figure 7b. The first annealing, 320°C for 1-1/4 hours, enhanced the grain structure further (Figs. 7c and 8c) as was seen in the annealing study. The machining marks were almost

completely eliminated, and the blemishes further reduced by the second ion polishing step (2080 Å removed with 4740 Å total removed). See figures 7d and 8d. Continuing the sequence resulted in further crystallite delineation and a roughened surface. For example, after 9080 Å were removed, the surface appeared slightly hazy to the unaided eye and was worst in the fine grained area which scattered the He-Ne alignment laser noticeably. It should be noted, however, that the measured absorptance, 0.794%, was very low.

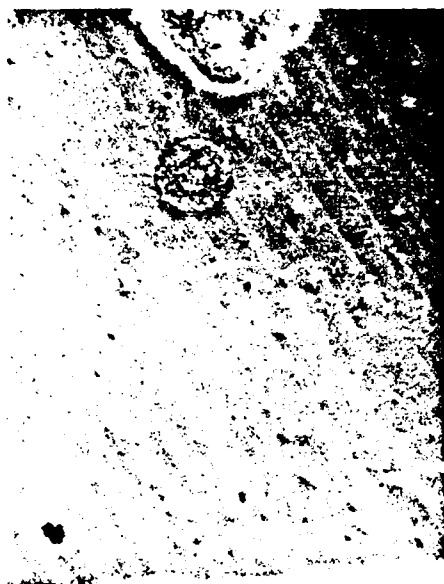
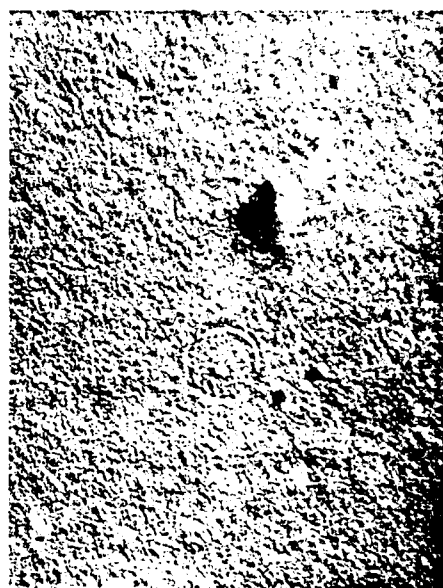
Figure 8. Interference contrast micrographs of micromachined copper at various stages in the ion polishing and vacuum annealing sequence.

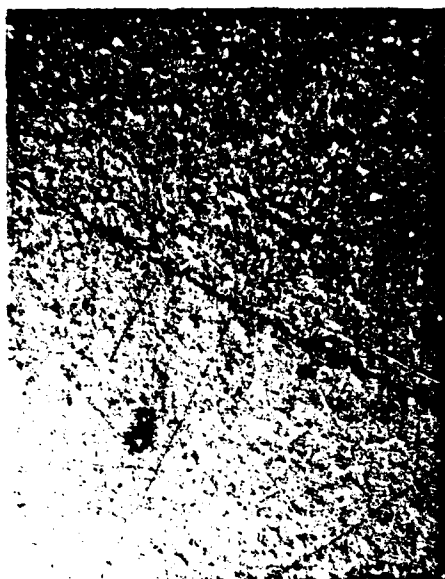
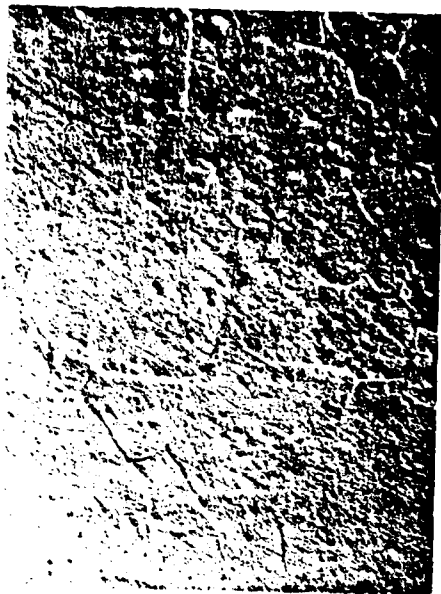
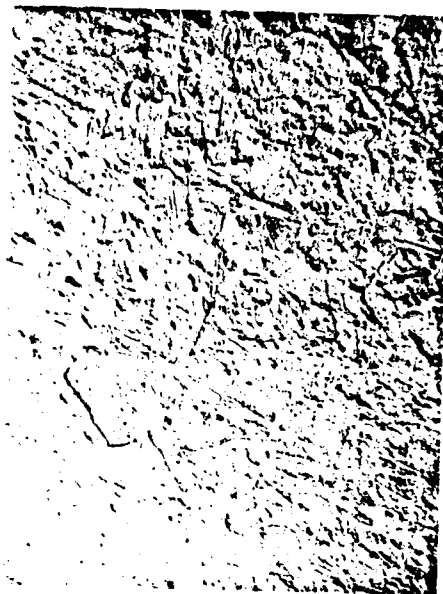
Figure 10. Interference contrast micrographs of conventionally polished copper at various stages in the ion polishing and vacuum annealing sequence.

Figure 10 shows interference contrast micrographs of the conventionally polished OFHC copper sample surface at various stages of the sample preparation sequence. The initial surface, which had a brown tint, contained numerous polishing scratches. After the first ion polishing step, in which 2290 Å were removed (Fig. 10b), the surface was a bright copper color, the polishing scratches were partially removed, and there was no evidence of grain structure caused by differential sputtering of the crystallites. Annealing at 320°C for 1-1/4 hours caused some enhancement of the grain boundaries due to grain growth or thermal etching (Fig. 10c). As mentioned previously, the sample surface accidentally became oxidized during the 450°C anneal, and figure 10d shows that various crystallites oxidized differently as a result of the fact that surfaces with different crystallographic orientations form oxides at different rates. Note also that the grain boundaries appear to be enhanced further and that the size and shape of these crystallites are very different from those of the micromachined copper (Figs. 7 and 8). The next ion polishing step (630 Å removed and 2920 Å total) was meant to remove just the oxide layer from the surface, and figure 10e shows this to be the case. The annealing at 450°C after this and subsequent ion polishing steps caused no noticeable change in the surface features, and hence these photographs are not included in the figure.

Further ion polishing resulted in an increase in the surface roughness caused by differential crystallite sputtering (Figs. 10f and 10g). After 5410 Å of material was removed, the surface appeared to have an "orange peel" finish and noticeably scattered the He-Ne alignment laser in the calorimeter.

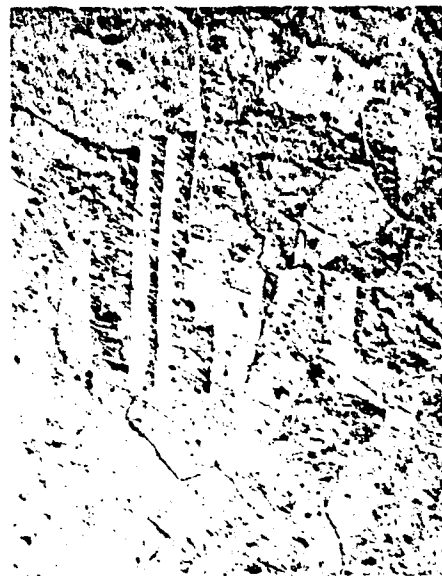
d) 450°C Anneal  
(Oxidized)

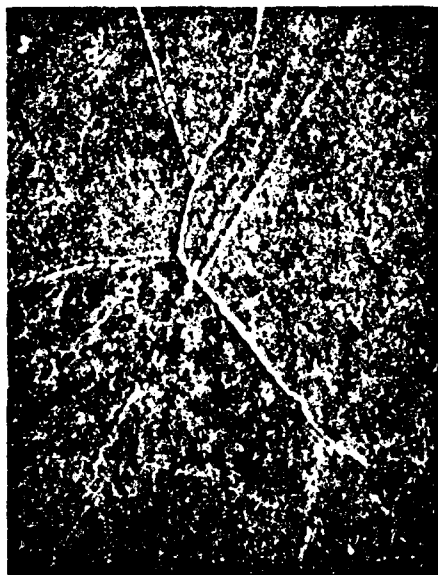
Figure 11. (cont.)

f) 5410Å<sup>°</sup> Removed

g) 8570Å<sup>°</sup> Removed

The SEM photographs in figures 11 and 12 also show the grain boundary enhancement following the 320°C anneal and the oxidation evident after the 450°C anneal. The differential oxidation rate of various crystallites is strikingly apparent in these photographs since the SEM is very sensitive to compositional differences at the surface. The oxide film was removed by the next ion polishing step (630 Å removed); see figures 11e and 12e. The polishing grit appears to have nearly disappeared after removing 5410 Å by ion polishing and to be completely gone after a total of 8570 Å was removed. The final photographs (Figs. 11g and 12g) also show smoothing of the polishing scratches and enhancement of the grain boundaries.

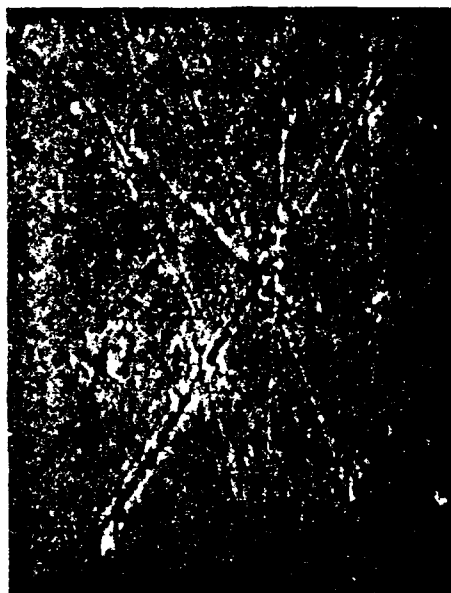
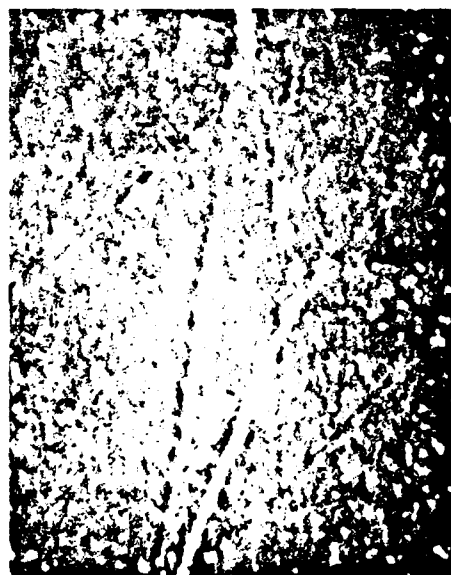
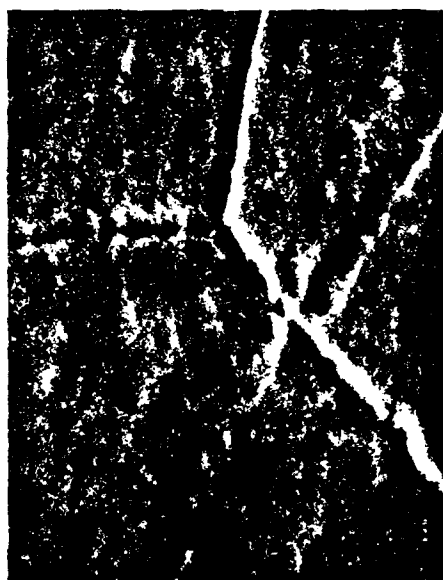
Figure 12. SEM micrographs of conventionally polished copper at various stages in the ion polishing and vacuum annealing sequence.

Ion polishing reveals the presence of polishing grit used in conventional polishing and embedded in the copper surface. This grit is removed by further ion polishing to remove more than  $5000 \text{ \AA}$ . Polishing grit embedded in a mirror surface could seriously lower its laser damage threshold, particularly if the grit has appreciable absorptance at the laser wavelength, and its removal is essential for the production of mirrors with consistently high damage thresholds.

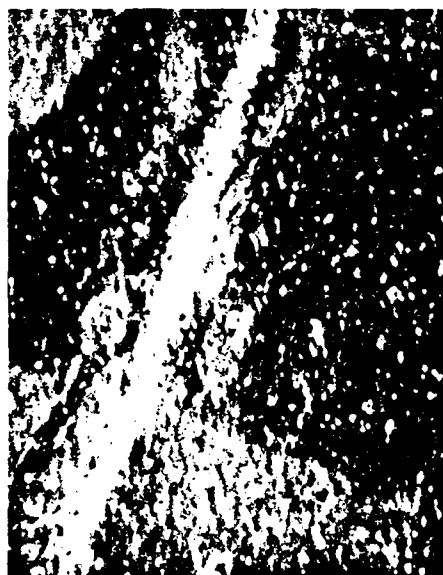
d) 450°C Anneal  
(Oxidized)

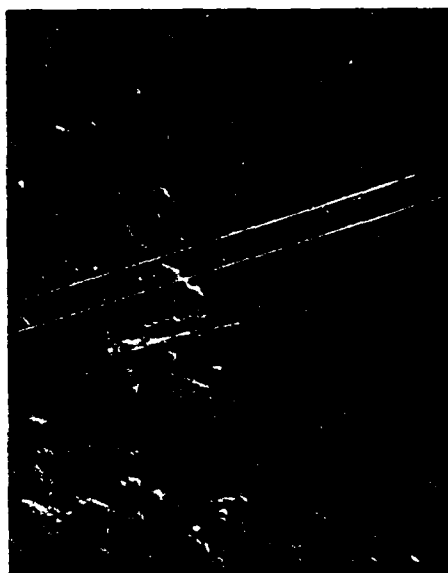
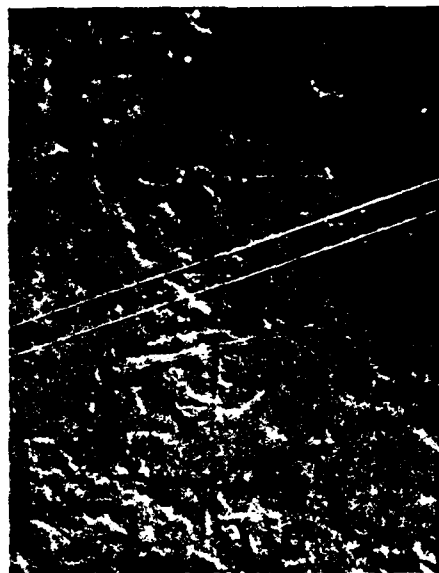
a) Before Ion  
Polishing

b) 970A Removed

c) 2750A Removed
