TECHNICAL REPORT H-76-15

# PROTOTYPE TESTS, OLD RIVER LOW-SILL CONTROL STRUCTURE, APRIL 1973-JUNE 1975

Frank M. Neilson, Allen R. Tool

Hydraulics Laboratory  
U. S. Army Engineer Waterways Experiment Station  
P. O. Box 631, Vicksburg, Miss. 39180

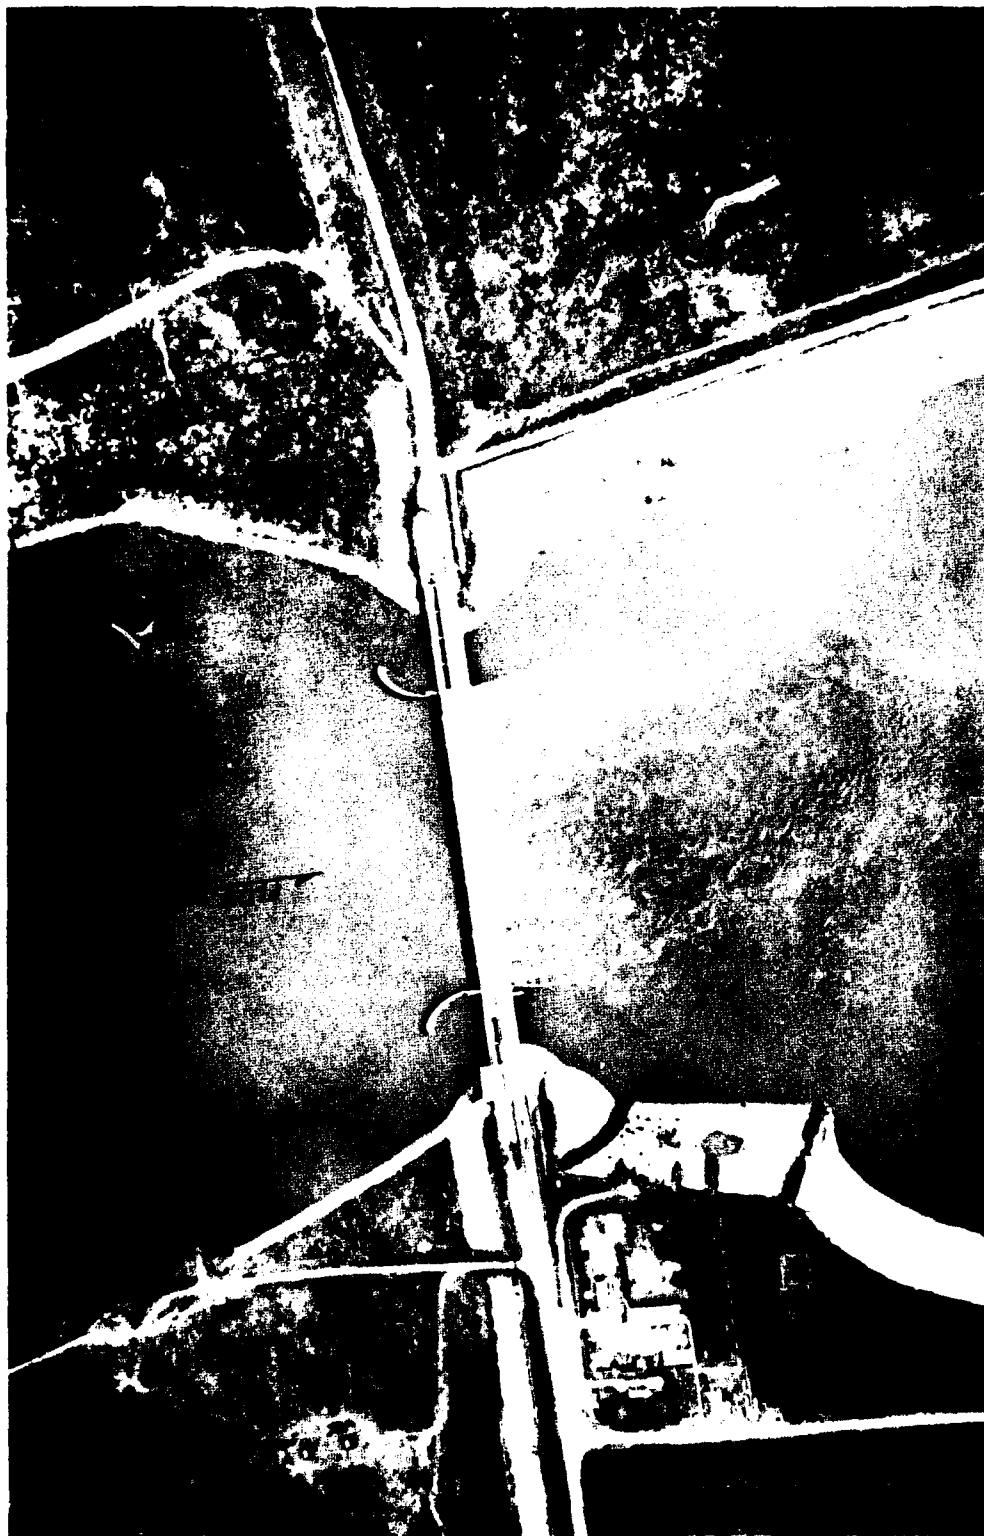
Figure 1. Old River Low-Sill Control Structure in operation. Flow is from Mississippi River (off top of photo) southwestward toward Red River. This photograph was taken before the 1973 flood

4. The Old River Low-Sill Control Structure is located on the western side of the Mississippi River about 312 river miles above Head of Passes. The structure is designed so that under project flood conditions 620,000 cfs are diverted from the Mississippi, through the Old River Low-Sill and Overbank Control Structure and outflow channel, into the Red River. The Red and Old Rivers combine to form the Atchafalaya as shown in the vicinity map in Figure 2. A view<sup>9</sup> of the low-sill structure before the wing-wall failure during the 1973 flood is shown in Figure 1.

7. Since the project became operational in 1956, it has been noted<sup>8</sup> that closure of a few gates, while others are held open, has resulted in large eddies (and local erosion) below the structure (see bottom of Figure 1). Since the 1973 flood, the structure has undergone substantial repair work. The project is currently being studied with regard to structural and operational modifications that will permit it to function according to design requirements.

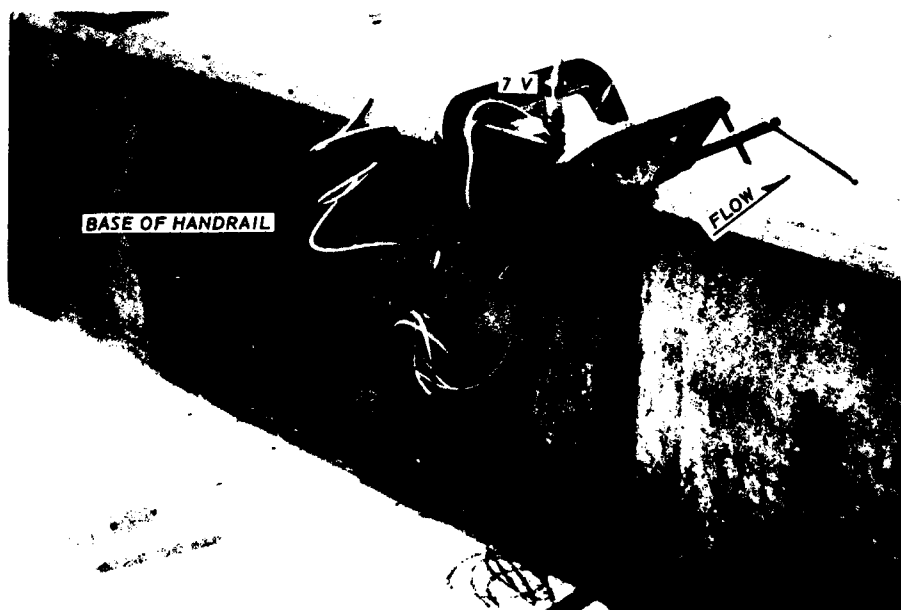
d. Transducer 7V on downstream handrail above the pier between bays 5 and 6 for vibration of cantilevered bridge support

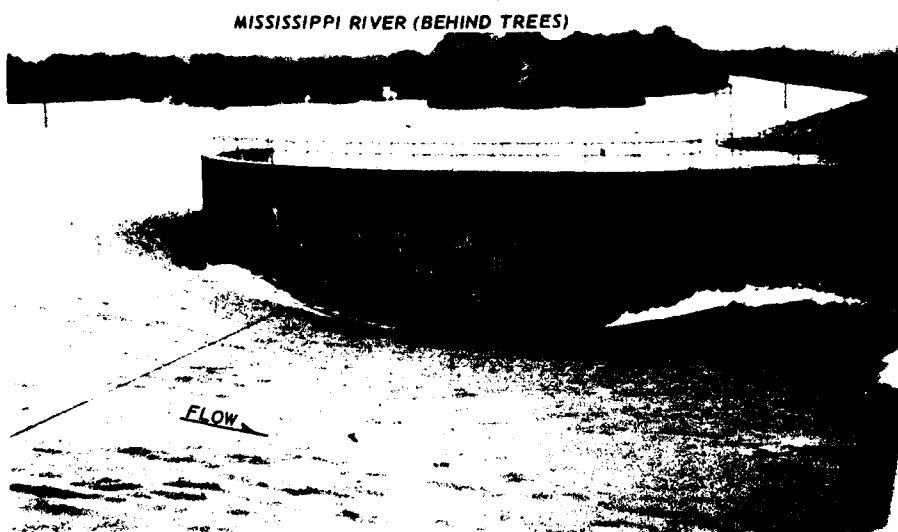
b. South upstream wing wall (note large standing wave along the wall)

15. Figures 7a and 7b indicate that undesirable flow conditions occurred along the south upstream wing wall; 7c shows that smooth flow occurred along the north upstream wall; and 7d shows the turbulent surface conditions that existed along the south downstream (stilling basin) guide wall. The extent to which the surface wave and eddy along the south upstream wall contributed to the subsequent failure of the wall cannot be determined from the subject test data. In fact, inspection of the data in the field indicated extremely small structural vibration, and none was felt when standing on the wall.

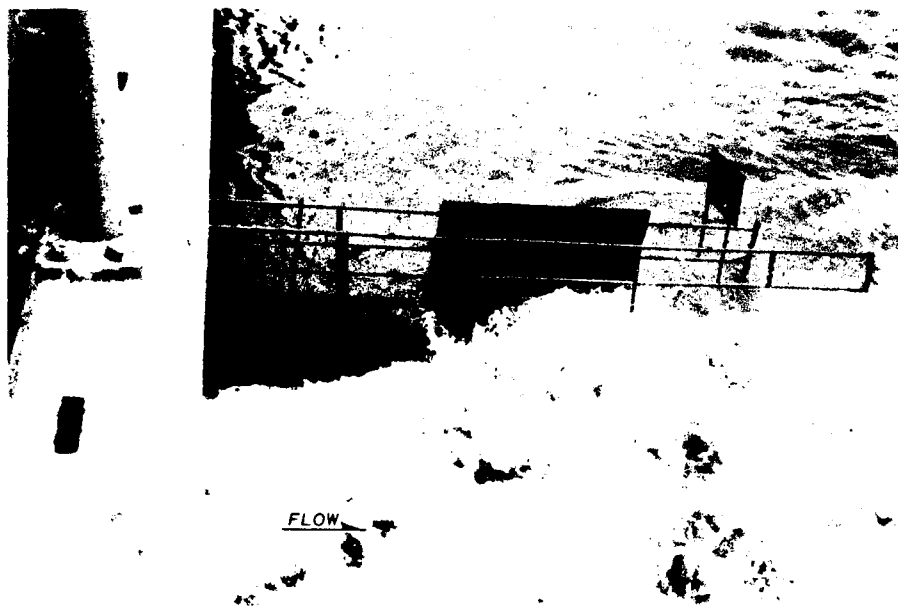
d. South downstream guide wall

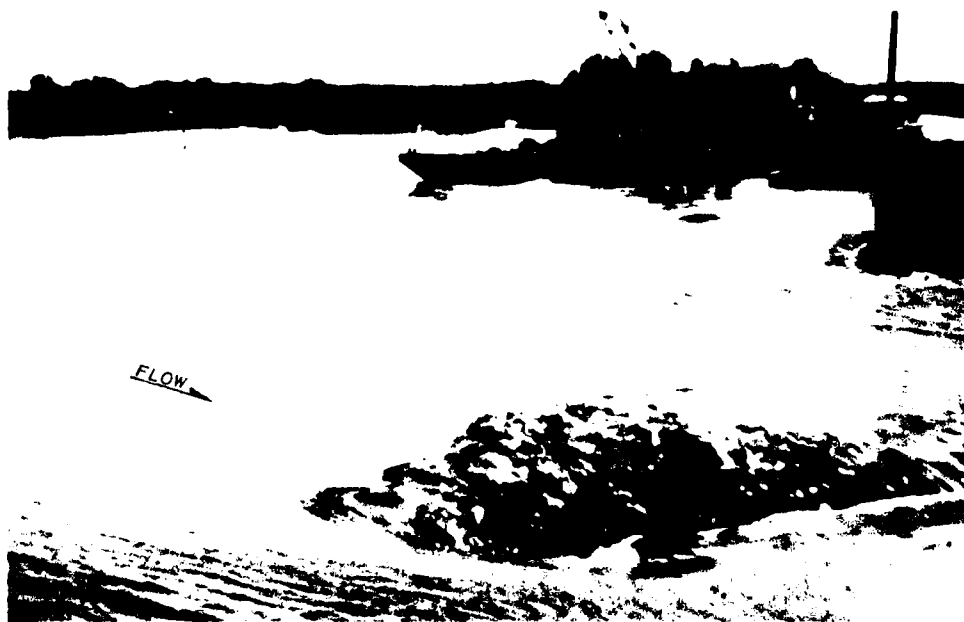
Figure 12. "Boil" in front of bay 10, 19 April 1973

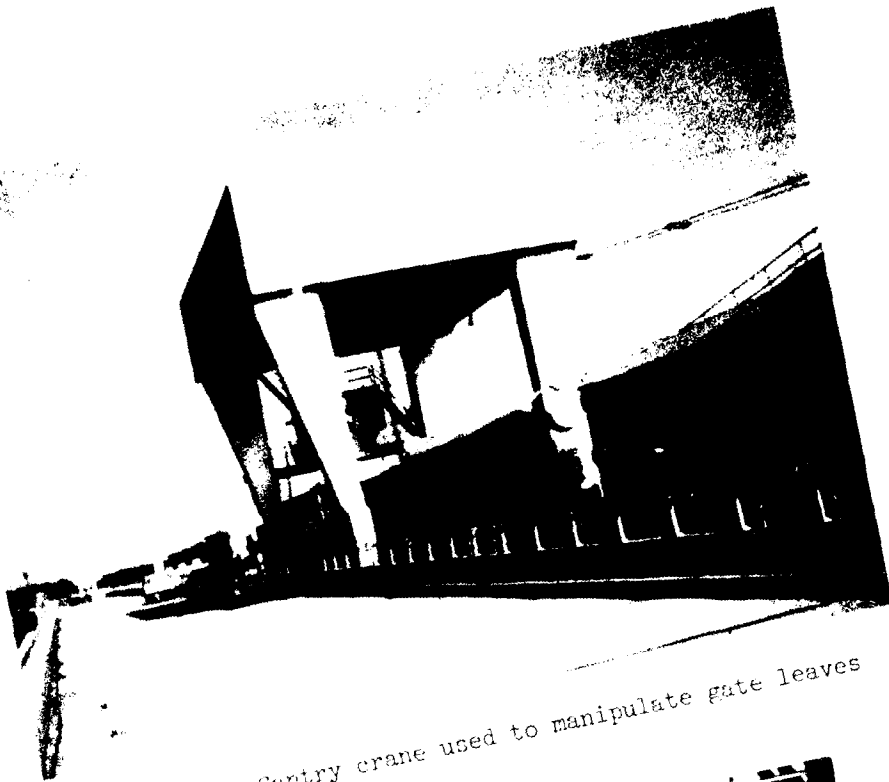
Figure 24. Gantry crane used to manipulate gate leaves

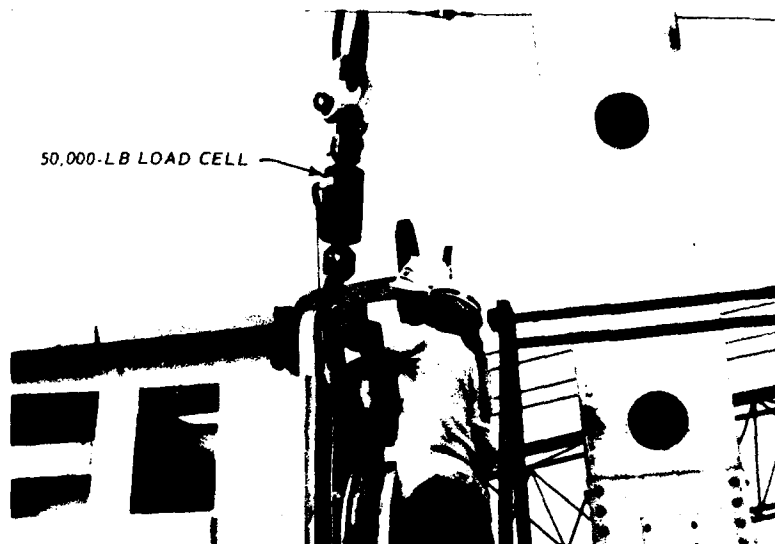
Figure 29. Load cell used to weigh gates
