LTV AEROSPACE CORP DALLAS TEX VOUGHT SYSTEMS DIV F/G 1/3
S-3A GRAPHITE/EPOXY SPOILER DEVELOPMENT PROGRAM. VOLUME II.(U)

JUL 75 E G BLOSSER, S A MCGOVERN, O E DHONAU N62269-73-C-0610
2-53443/4R-3172-VOL-2 NADC-75141-30 NL

20. ABSTRACT (Continue on reverse side if necessary and identify by block number) <p>After testing of the S-3A Graphite/Epoxy Spoilers was satisfactorily completed, under Contract N62269-73-C-0610, the contracted effort was extended to include the development of NDI standards for the composite spoiler to be included in Volume II. In addition to the fabrication of reference standards for this report, the development of field inspection techniques was pursued using the ultrasonic unit available to Navy inspection personnel. A Sonic Instruments ultrasonic unit (Federal Stock No. 6RX6635-070-6669-SXTX) borrowed</p>

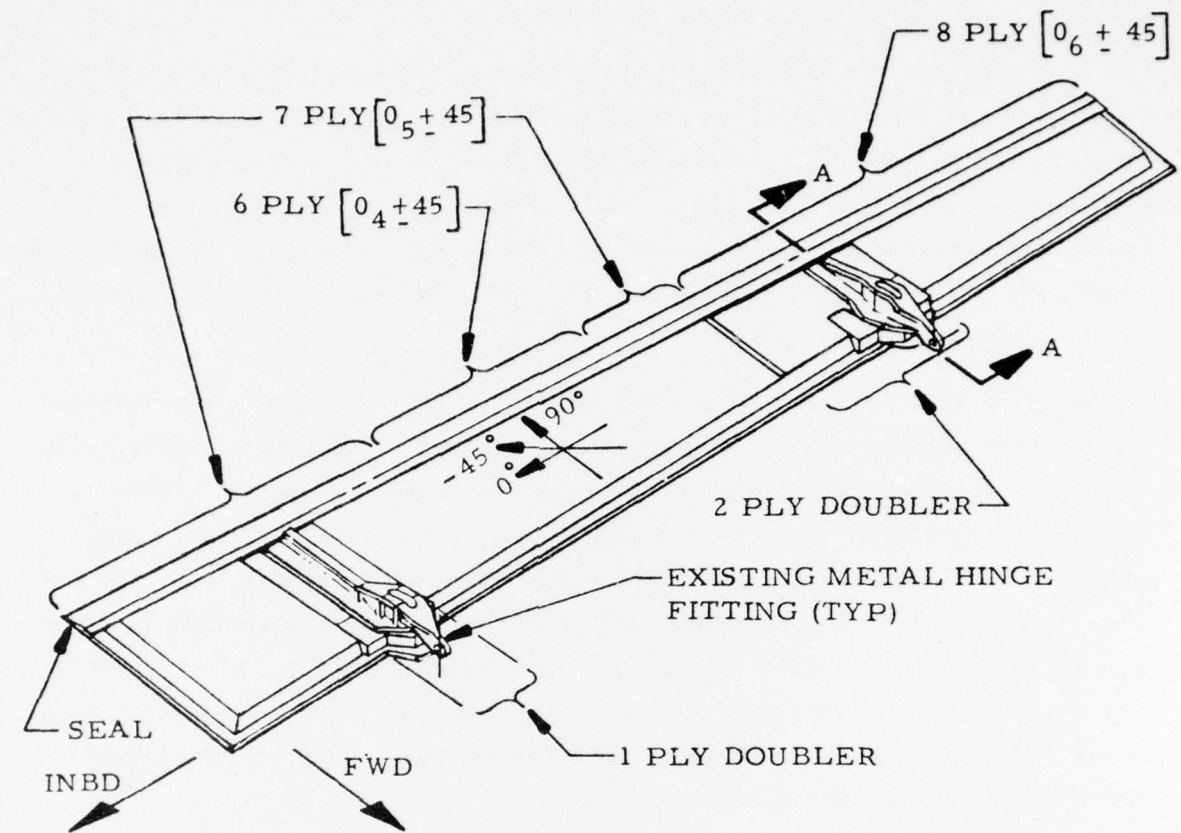
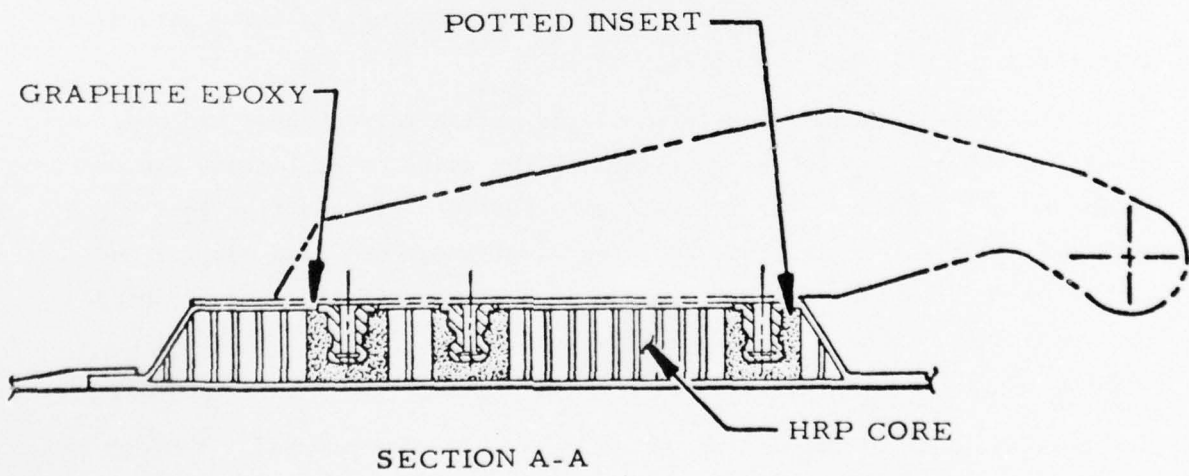
FIGURE 1 COMPOSITE SPOILER ASSEMBLY

A composite spoiler assembly composed of only four basic parts was designed as a direct replacement for the existing lower metal spoiler assembly. The complete assembly, including the trailing edge seal is shown in Figure 1. The composite spoiler fits in the same space as the existing lower metal spoiler, is hinged off the existing outer panel rear spar supports, and utilizes the same actuation system. The general dimensions are shown in Figure 2. The spoiler is composed of two contoured graphite/epoxy skins of variable thickness, a glass reinforced plastic honeycomb core, and two existing metal hinge fittings attached with fourteen bolts threaded into inserts potted in the core. The skin arrangement is shown in Figure 3.

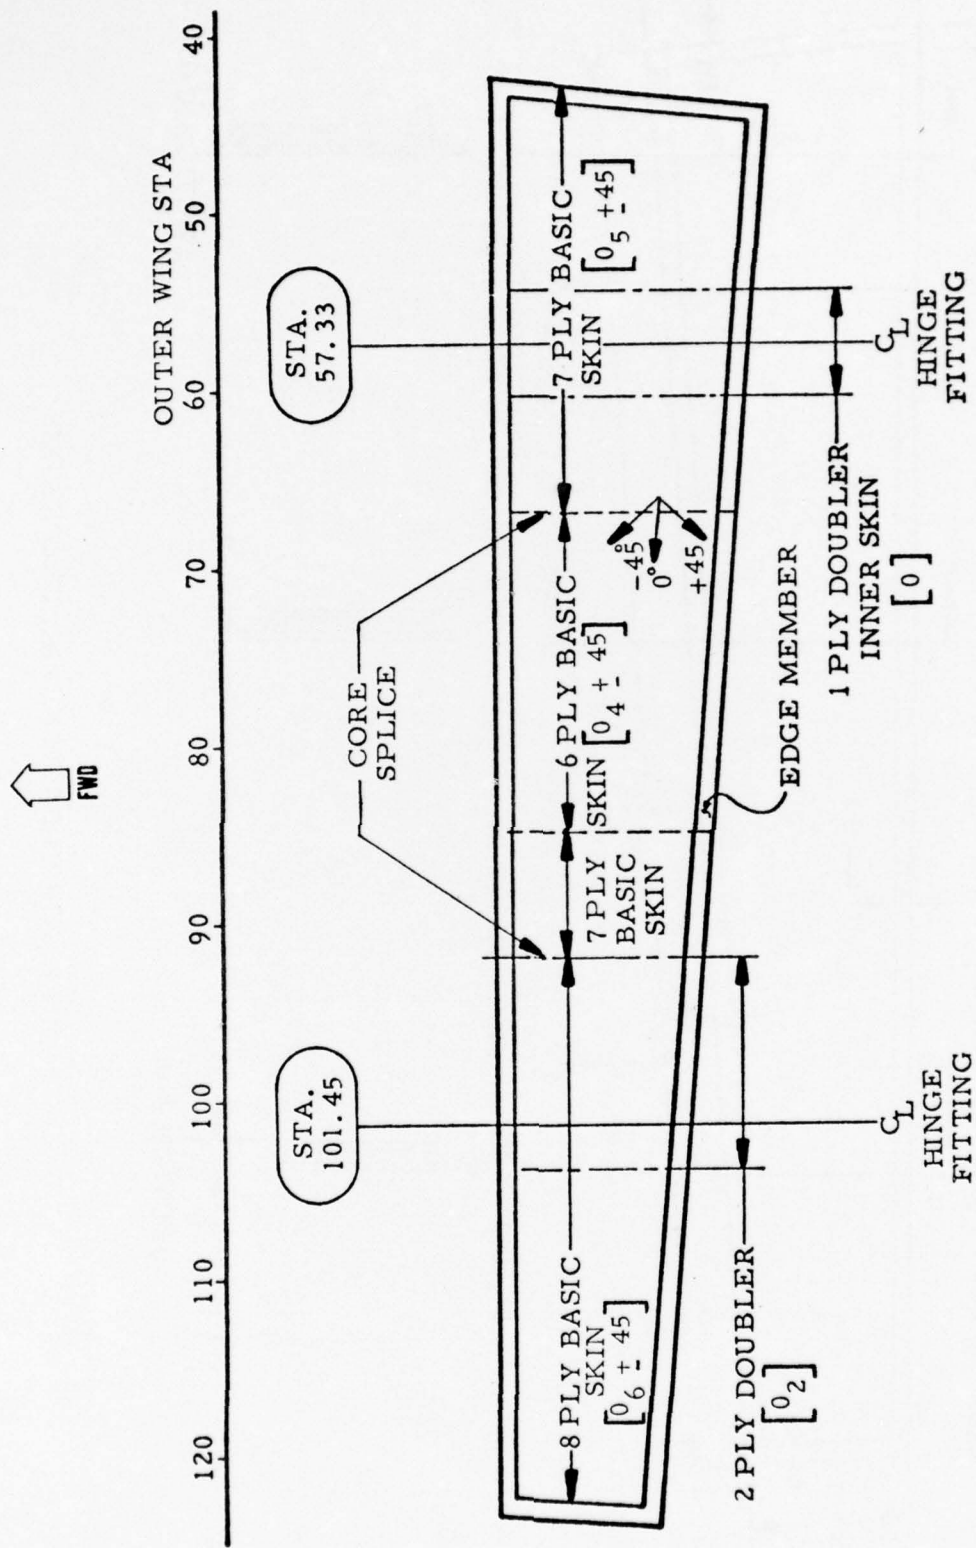
FIGURE 3 CORE AND SKIN ARRANGEMENT

CORE DENSITY IS 5.5#/FT³

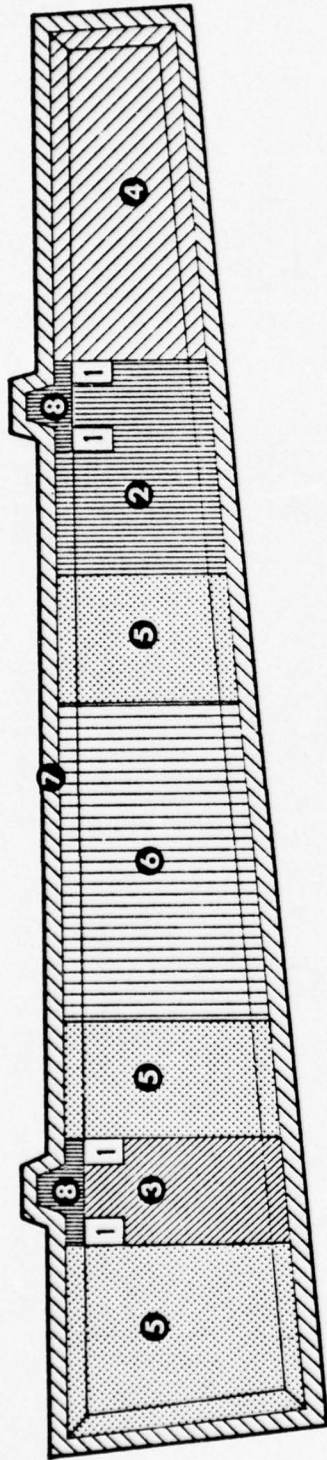
FIGURE 4: GRAPHITE / EPOXY STRUCTURAL ZONE DEFINITION

LOWER SPOILER ZONE CHART

SPOILER ZONE	DESCRIPTION
Zone 1	Sandwich, lower skin, upper skin, doubler & 4 ply tab skin
Zone 2	Sand., 8 ply lower skin, 8 ply upper skin, 2 ply doubler on upper skin
Zone 3	Sand., 7 ply lower skin, 7 ply upper skin, 1 ply doubler on upper skin
Zone 4	Sandwich, 8 ply lower skin, 8 ply upper skin
Zone 5	Sandwich, 7 ply lower skin, 7 ply upper skin
Zone 6	Sandwich, 6 ply lower skin, 6 ply upper skin
Zone 7	Solid laminate edge band (21 plies)
Zone 8	Tab stiffener over edge band at hinges

Ten experimental specimens were fabricated to provide the basis for the design and configuration of the final standard panel. The basic materials and processes used were the same as those used in the spoiler development program. These specimens were designated Quality Control Defect Specimens (QCDS) and were used both in defining fabrication techniques and inspection procedures. At the start of work all areas of the spoiler which have different cross section geometry were defined as zones. The lower spoiler has eight distinct zones of construction as required by either functional or structural constraints. Figure 4 defines these structural zones. One requirement of the specimen development work is the determination of how many different standards were required to satisfactorily inspect each of the defined spoiler zones.

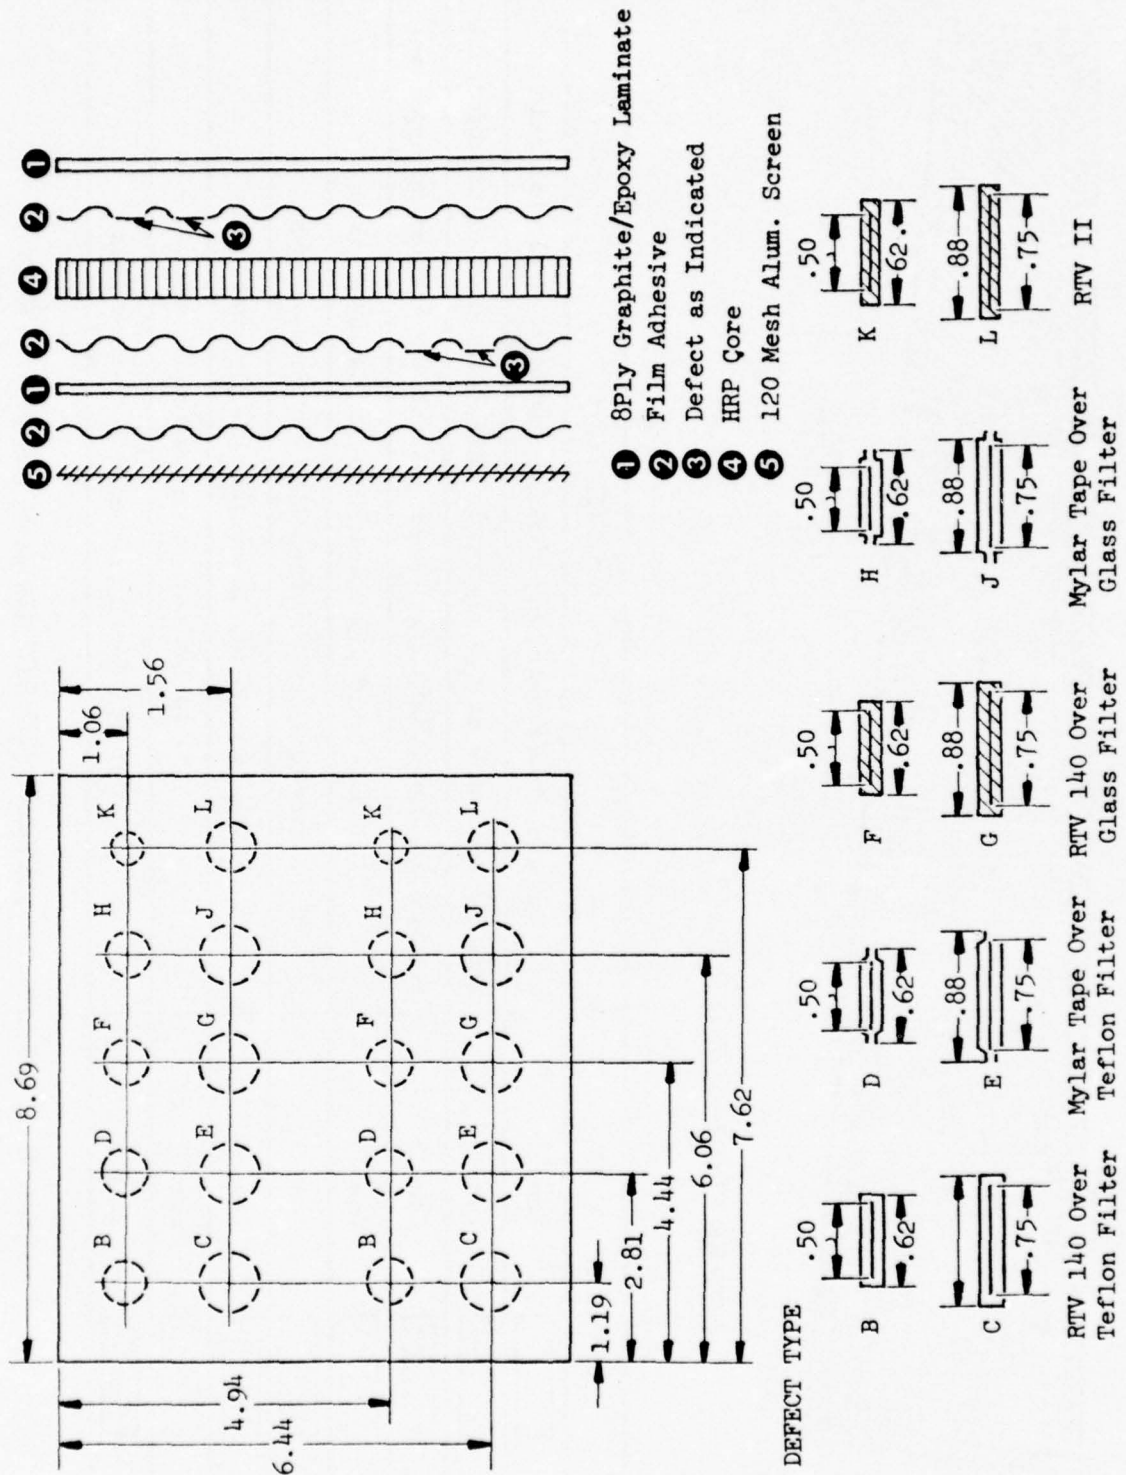
FIGURE 5: QCDS -2 SPECIMEN DETAIL

Specimen QCDS-2 was a honeycomb panel 7.62 inches by 8.69 inches, with 8 ply faces representing the average skin thickness encountered in the spoiler. This panel was used in evaluating the various materials available to simulate bond line or interlaminar defects. Five types of defect materials were placed in the adhesive bond line both above and below the core. Two types of chemical filter materials were used. The first was a type "E" glass filter, Gelman Instrument Co.; the second was a teflon Millipore filter. These materials were encased in mylar tape or RTV 140. RTV 11 was used as the fifth material. Details of QCDS-2 are shown in Figure 5. NDI results of the completed specimen indicated the best of the candidate materials was the glass filter material sealed in mylar tape.

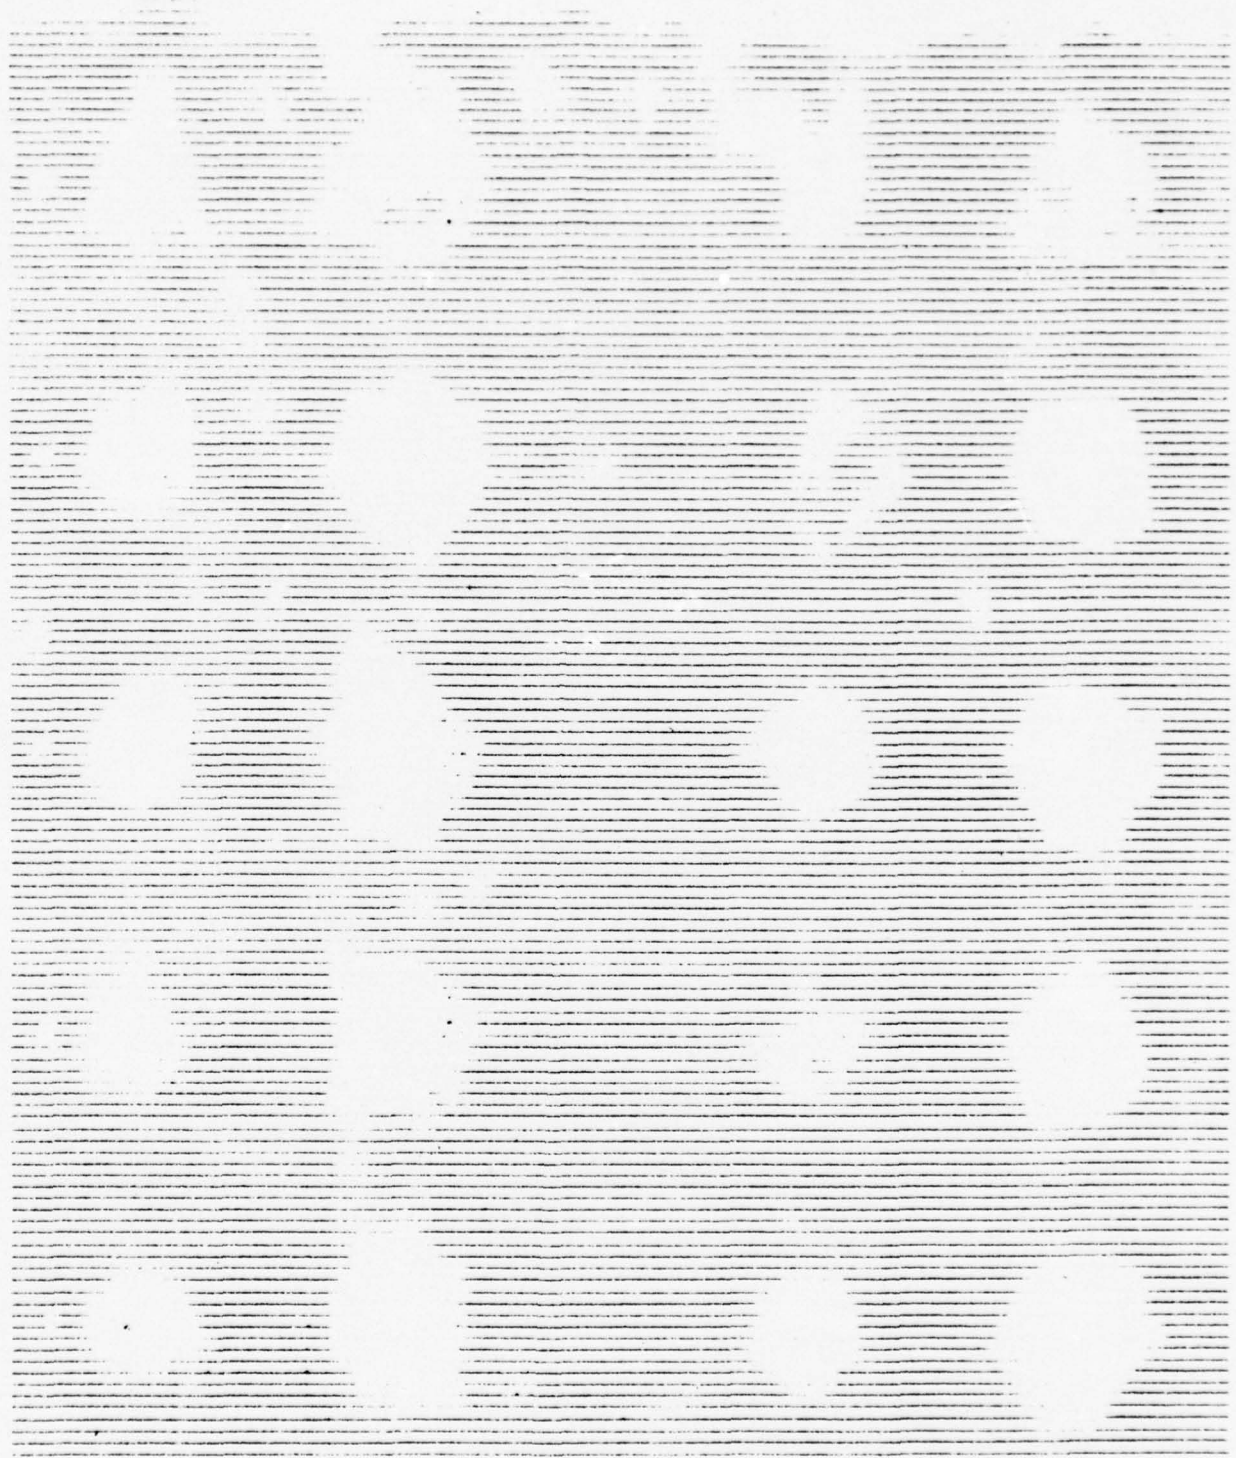
FIGURE 6: QCDS-2 ULTRASONIC RECORD @ X1+3

Figures 6, 7, and 8 show reproductions of the C-scan recordings at increasing gain settings obtained with ultrasonic through transmission with the panel immersed in water. The gain settings for the Sperry UM 721 unit used for immersed through transmission are shown with a notation such as X1+3. The X1 indicates the machine setting of the Coarse gain adjustment, while the +3 indicates the Fine gain setting. The larger the gain setting, the greater the amplification of the received ultrasonic signal. Other machine settings given include the frequency of pulse tuning (Tuned), the pulse length (PL), and the reject setting. The types of transducers used for transmitting (T) and receiving (R) are also indicated. The glass fiber filter sealed in mylar tape (#4) was selected as the one of the five materials used which best represented a lack of bond between skin and core.

X1+3 TUNED 1 MHz PL 50%
T&R 1/2' 1MHz Foc REJECT 0

Two honeycomb sandwich reference panels were fabricated representing the minimum and maximum numbers of skin plies present in the spoiler. QCDS-4 had six ply upper and lower skins, while QCDS-5 had eight ply lower and ten ply upper skins. Each specimen contained 6 defects fabricated from glass filters enclosed in mylar tape; construction details are shown in Figure 23. The information furnished by these two panels along with the examination of the ply drop-off area in one of the static test spoilers provided a basis for deciding whether or not the final reference standard should include a separate reference area for each ply thickness in the spoiler. Three ultrasonic C-scan recordings of QCDS-4 and 5 using immersion through transmission are shown in Figures 24, 25, and 26. Both these panels were more highly attenuating than QCDS-2 (compare gain settings Figures 6 and 24) and QCDS-5

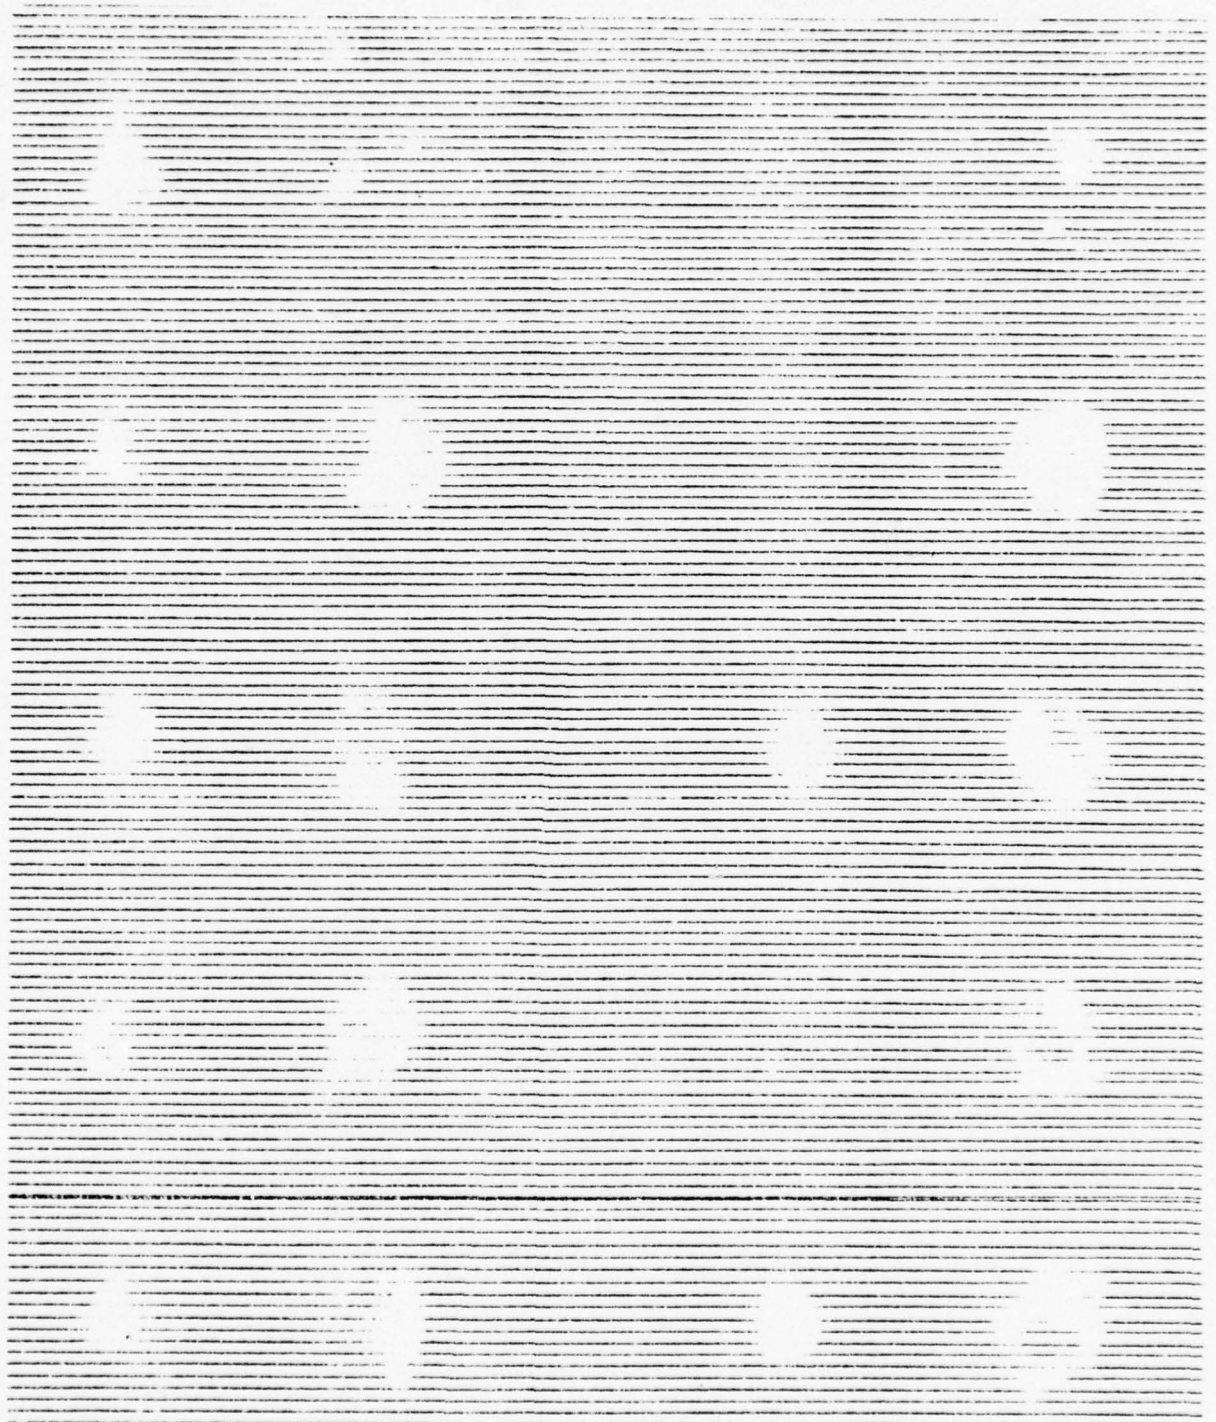
FIGURE 7: QCDS-2 ULTRASONIC RECORD @ X1+6

X1+6 TUNED 1 MHz PL 50%
T&R 1/2" 1MHz Foc REJECT 0

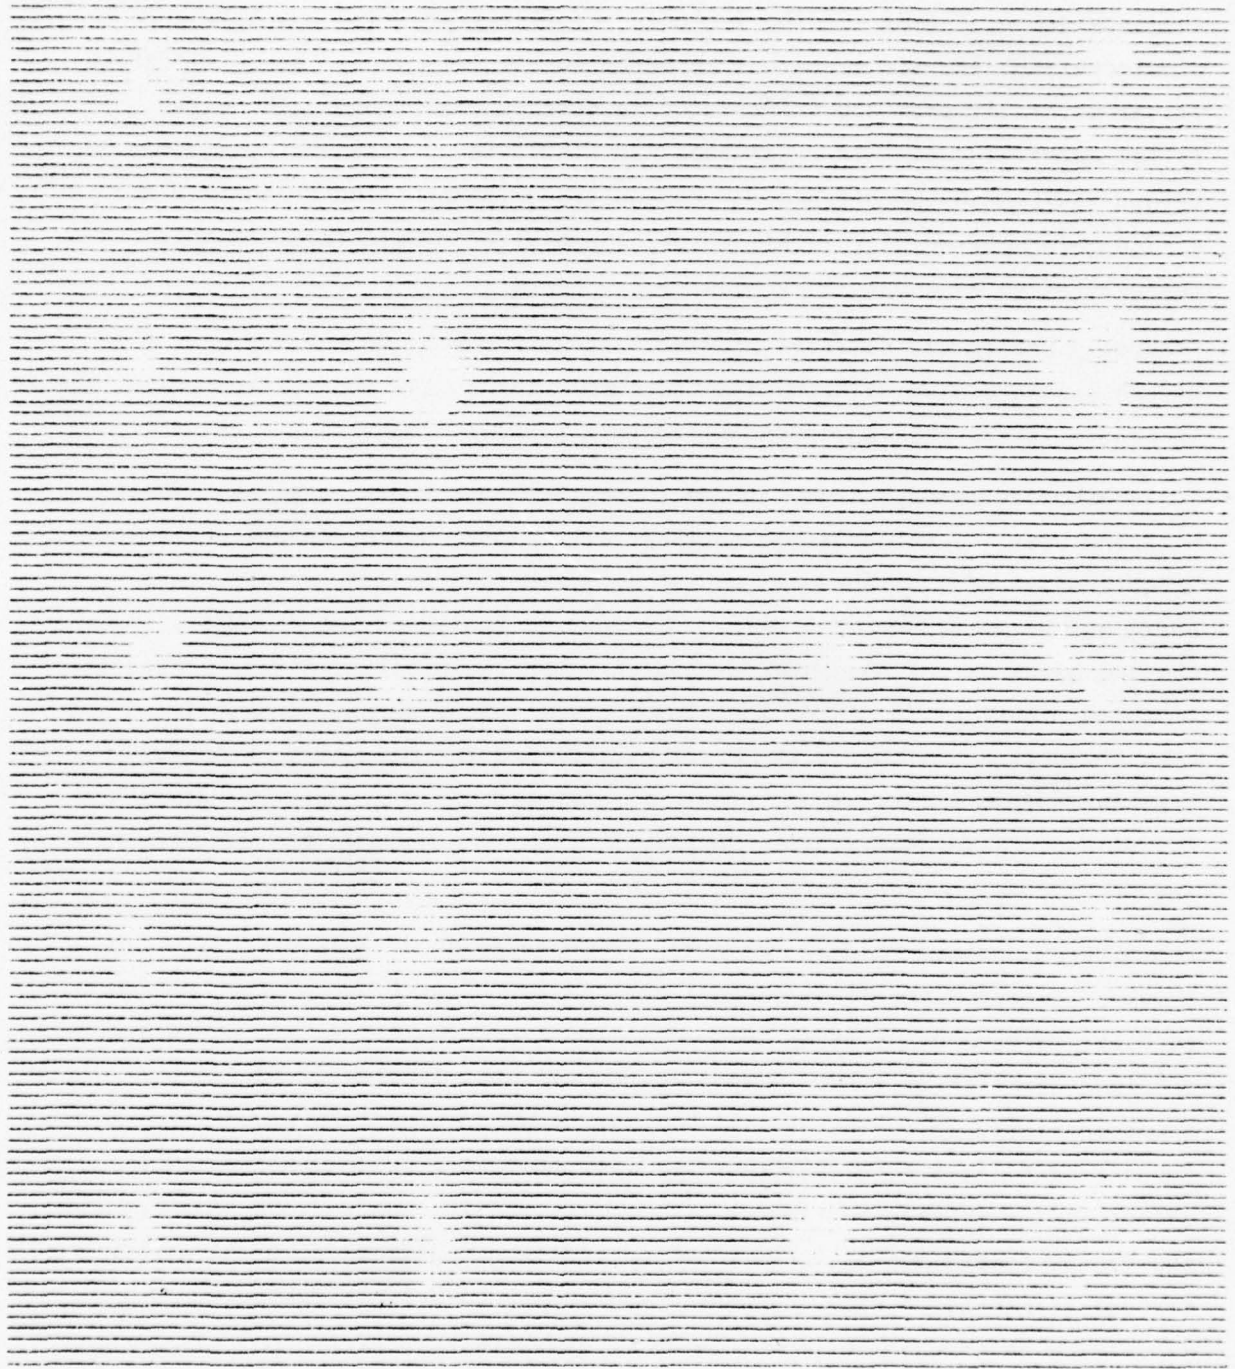
FIGURE 8: QCDS-2 ULTRASONIC RECORD @ X1+8

X1+8 TUNED 1 MHz PL 50%
T&R 1/2" 1MHz Foc REJECT 0

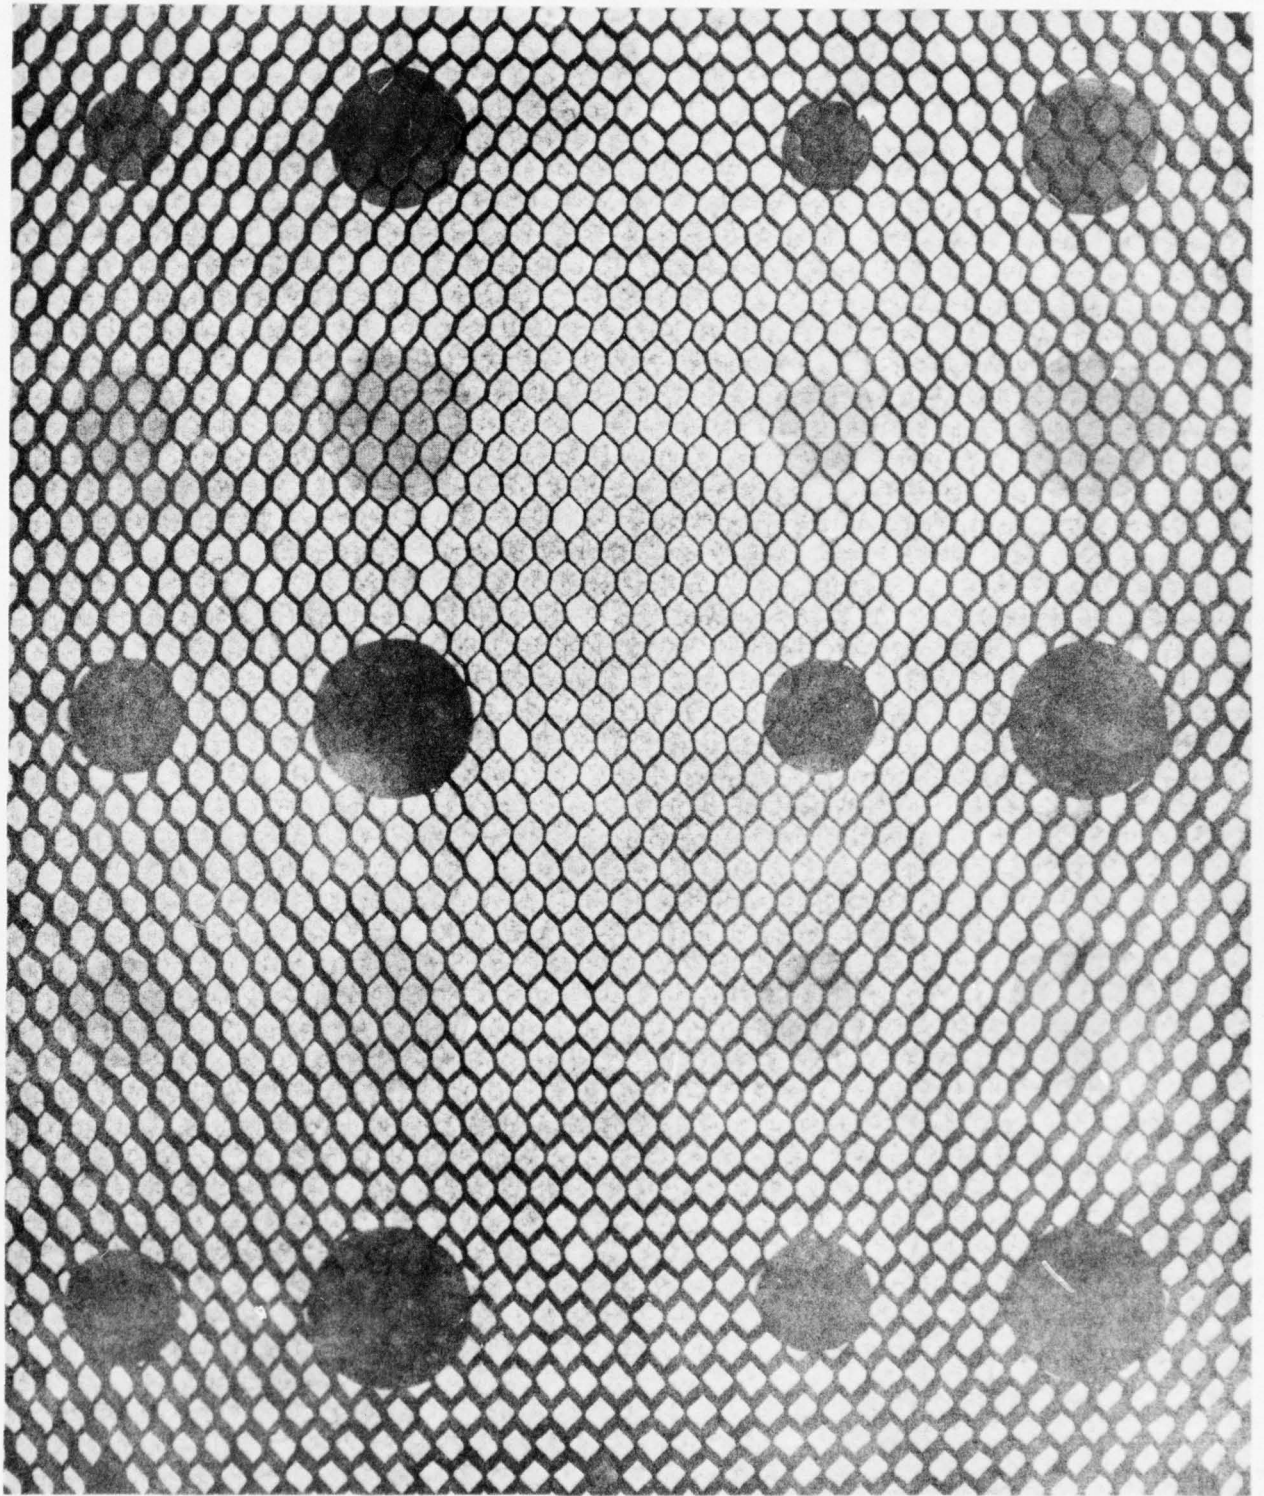
FIGURE 9: RADIOGRAPH OF QCDS-2 SPECIMEN (PLAN VIEW)

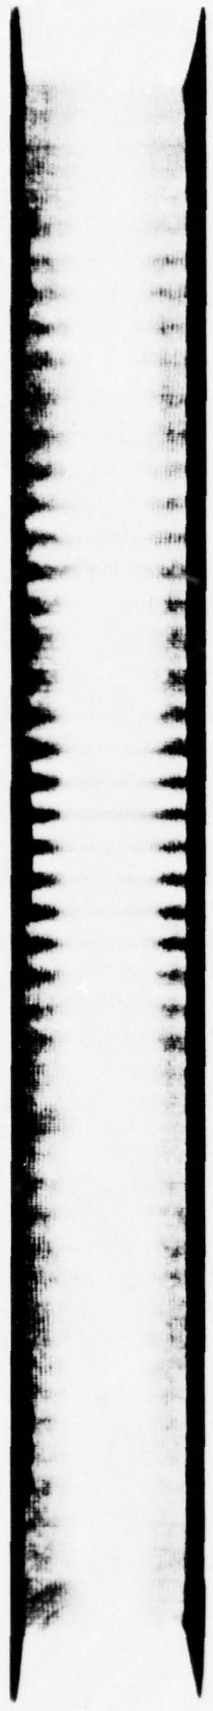
FIGURE 10: RADIOGRAPH OF QCDS-2 SPECIMEN (EDGE VIEW)

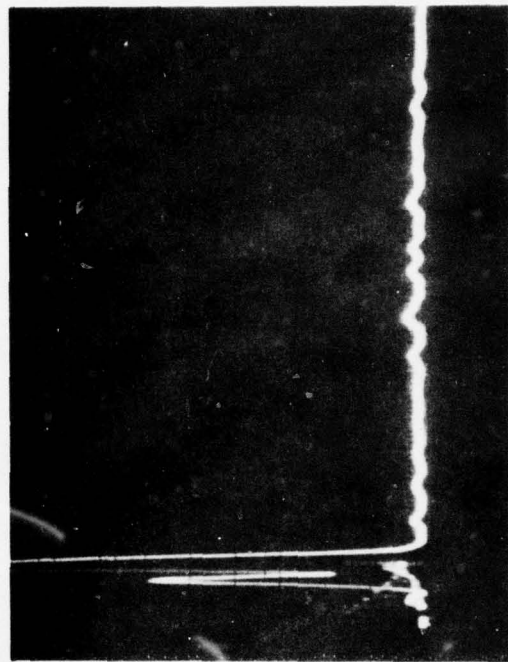
Pulse-echo and through transmission inspection techniques were investigated with the Navy's Sonic unit. A satisfactory pulse-echo method was not found since a meaningful difference in display between normal and defect areas could not be obtained. The difficulty in distinguishing the responses in the two areas is not encountered when through transmission is used. Figure 11 shows a photograph of the instrument display in a through transmission mode transmitting with a 2.25 MHz transducer and receiving with a 1 MHz transducer in a normal area. Figure 12 shows the display when the transducers are placed over a built-in defect. The responses in the two areas are readily recognized.

FIGURE 12: CRT SCOPE DISPLAY OF QCDS-2 SPECIMEN IN DEFECT AREA BY THRU TRANSMISSION

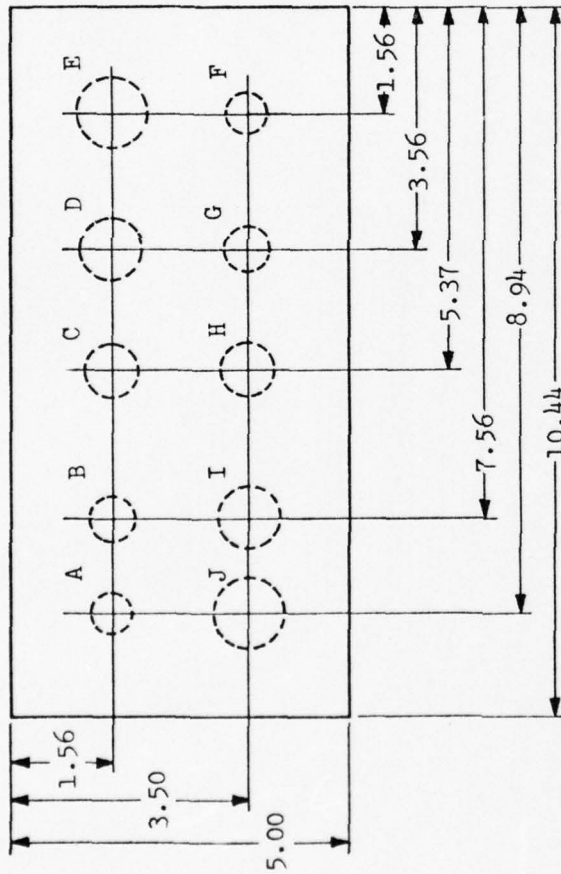
FIGURE 13: QCDS-3 SPECIMEN DETAIL

The QCDS-3 specimen is a 21 ply solid laminate as shown in Figure 13. Two types of defect material were used; one set was glass fiber filters sealed in mylar tape, and the other set was teflon tape. Defect sizes ranged from 3/8 inch diameter to 1 inch diameter, and all were located in Ply 13 as shown in Figure 13. The results of these embedded materials again show the sealed filters to give a gainlevel response more representative of a defect in the material. Figures 14, 15, 16, and 17 show reproductions of the C-scan recordings at increasing gain settings obtained with ultrasonic through transmission with the panel immersed in water. The defects constructed with the teflon tape show two disadvantages: First they disappear from the recording at a lower gain setting (Fig. 16) than the glass in mylar defects, two of which still show up at the maximum gain setting (Fig. 17).

DEFECT TYPE A - E

D material is mylar tape
d material is glass filter

DEFECT	D dim.	d dim.
A	.50	.37
B	.62	.50
C	.75	.62
D	1.00	.88
E	1.12	1.00

- 1 21 ply graphite/epoxy laminate
- 2 defects in ply 13
- 3 film adhesive (M1113)
- 4 120 mesh alum. screen

DEFECT	d dim.
F	.37
G	.50
H	.62
I	.88
J	1.00

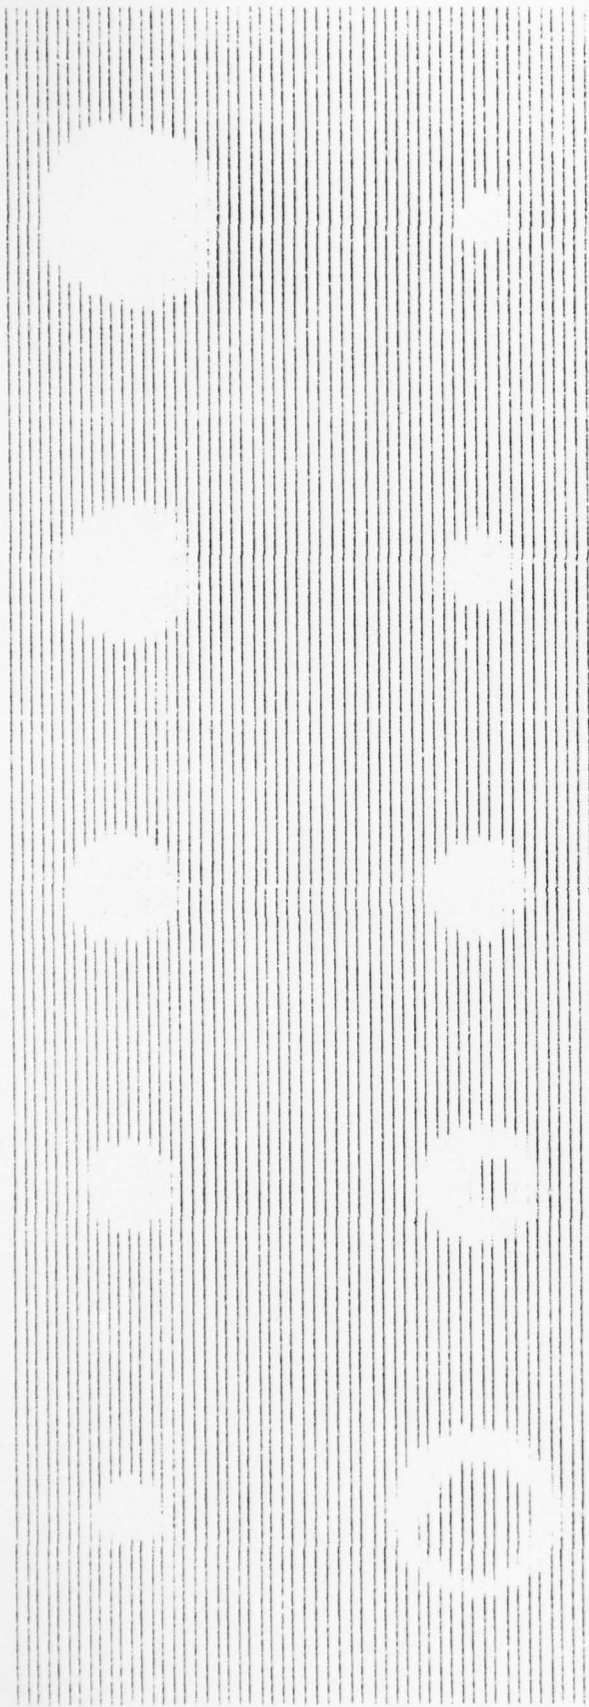
FIGURE 14: QCDS-3 ULTRASONIC RECORD @ X0.1 + 2

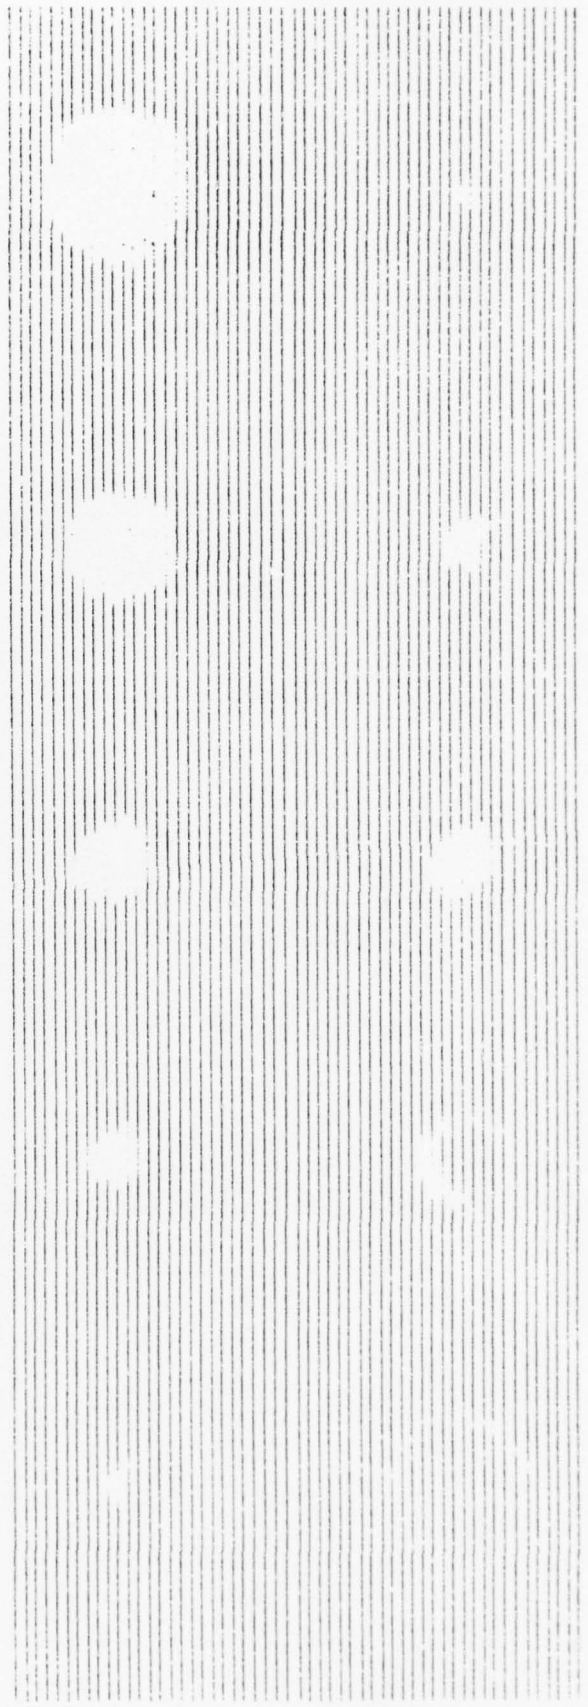
FIGURE 15: QCDS-3 ULTRASONIC RECORD @ X1 + 3

Second, the two teflon defects of the largest diameter disappear before the smaller defects (Fig. 15). The inconsistency of results with the teflon material and the desirability of results at high gain settings led to the choice of glass fiber filter sealed in mylar tape as the defect material to be used in following preliminary specimens and in the final standards.

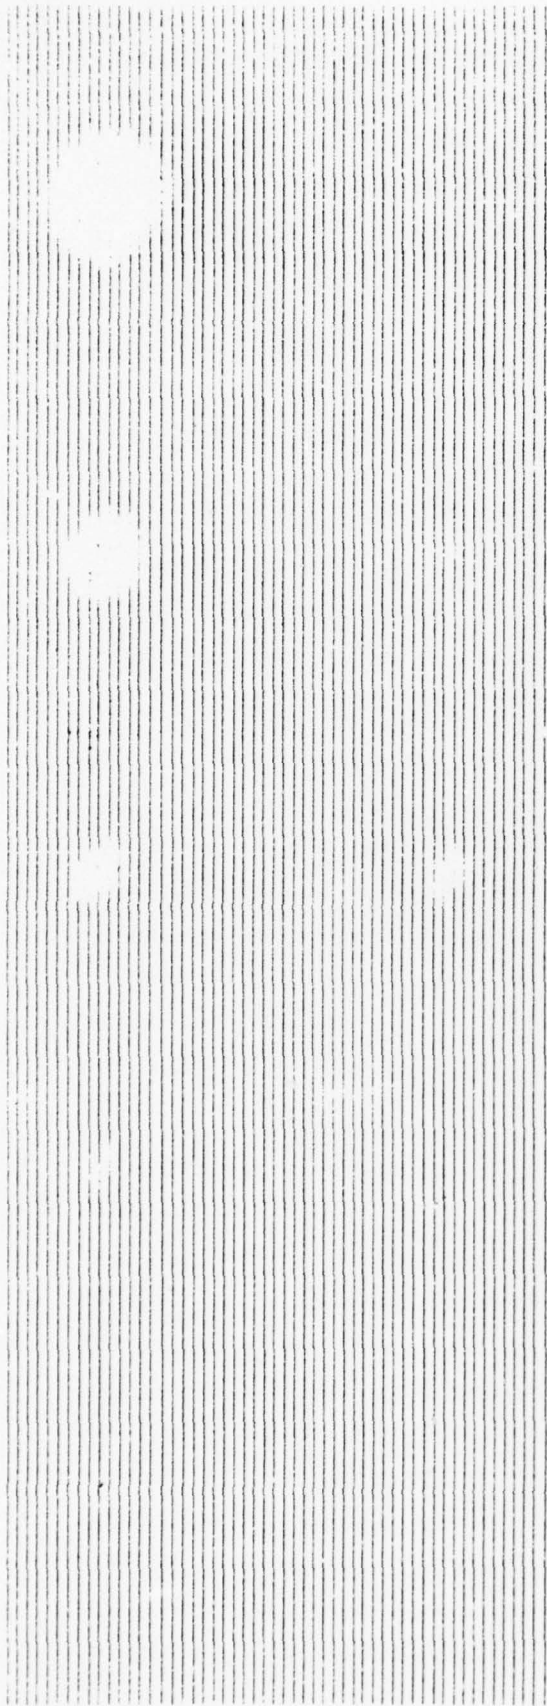
FIGURE 16: QCDS-3 ULTRASONIC RECORD @ X10 + 0.4

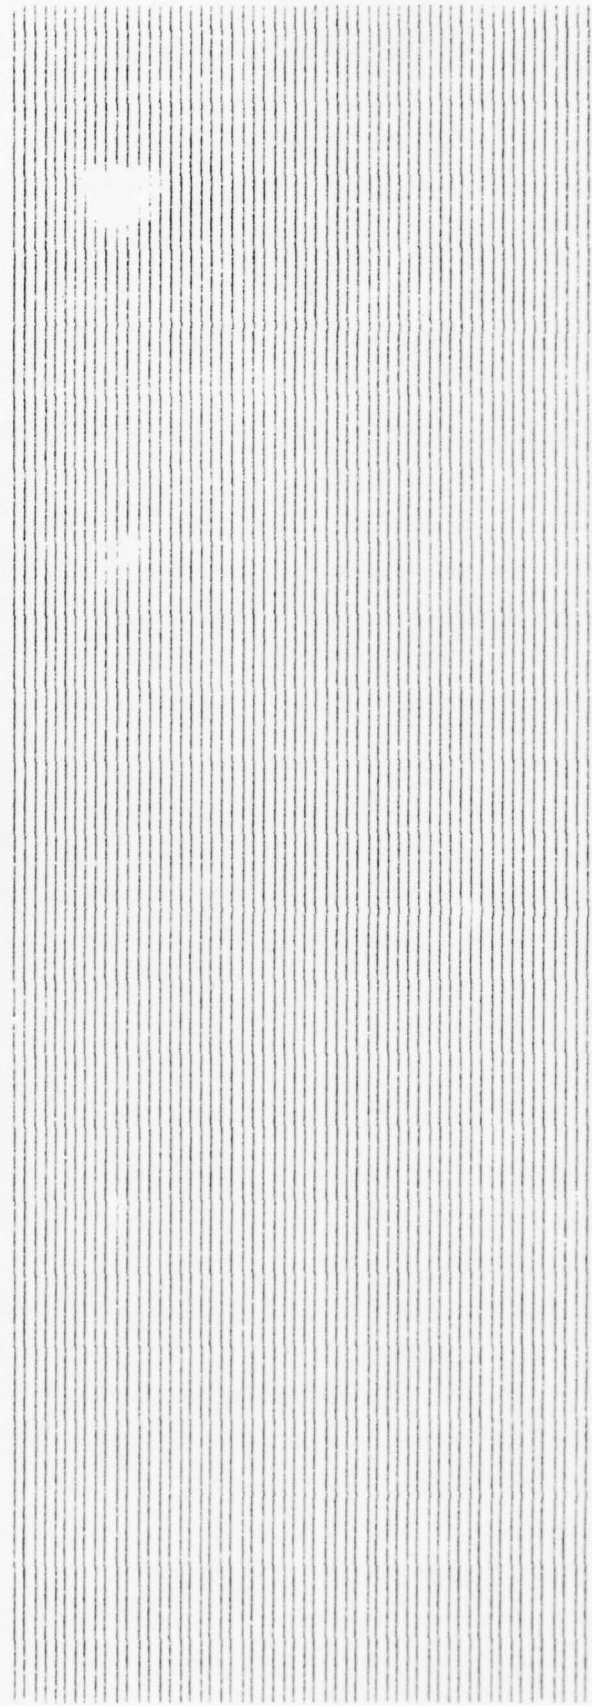
FIGURE 17: QCDS-3 ULTRASONIC RECORD @ X10 + MAX

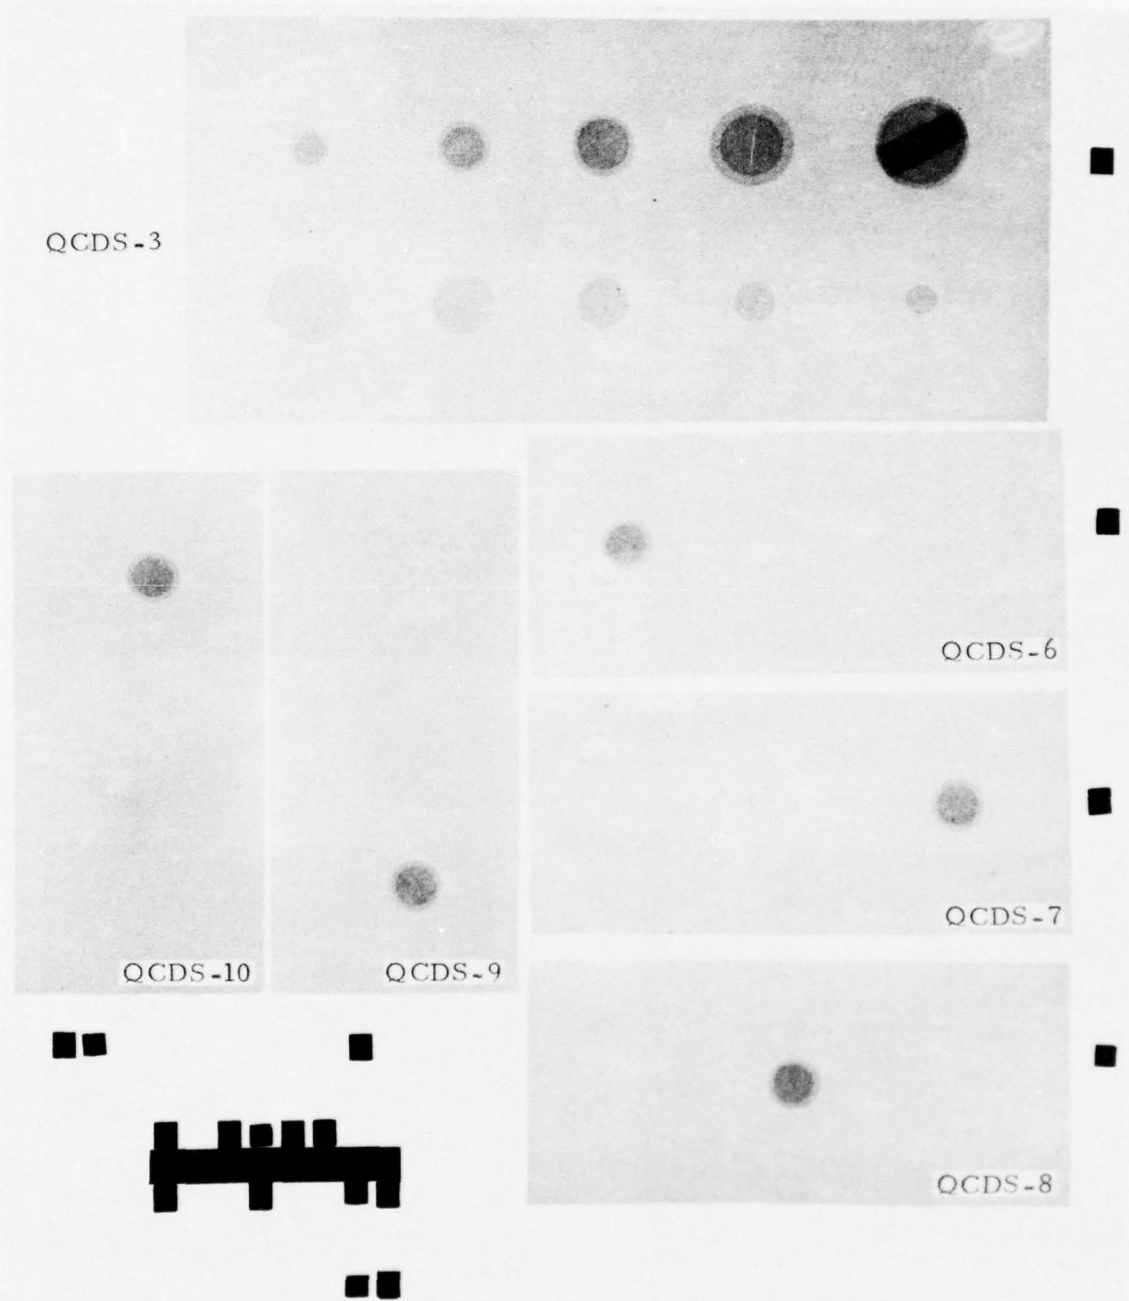
FIGURE 18: RADIOGRAPH OF DEFECT SPECIMENS

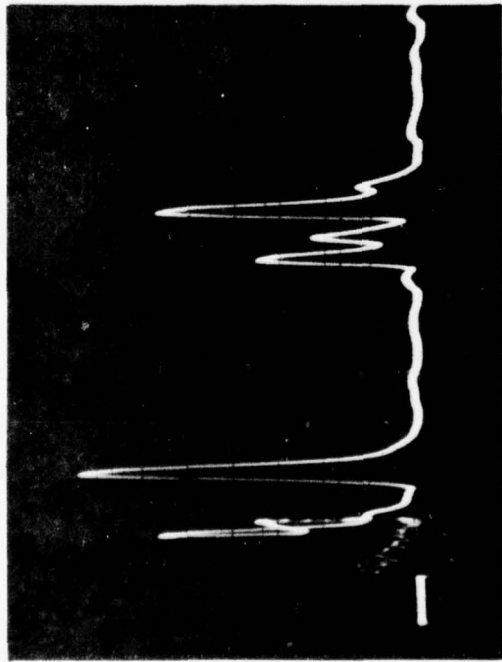
Pulse-echo and through transmission inspection techniques were investigated for the solid laminate using the Navy ultrasonic unit. Figure 19 shows the instrument display when using a 2.25 MHz transducer in the pulse-echo mode in a normal section of laminate. The shorter return time for the signal over a built-in defect is shown in Figure 20. Since thickness variations in a laminate will also produce a time shift in the display, much caution should be used in drawing conclusions from pulse-echo time shifts.

FIGURE 19: CRT SCOPE DISPLAY FOR PULSE ECHO ON QCDS-3 NORMAL AREA

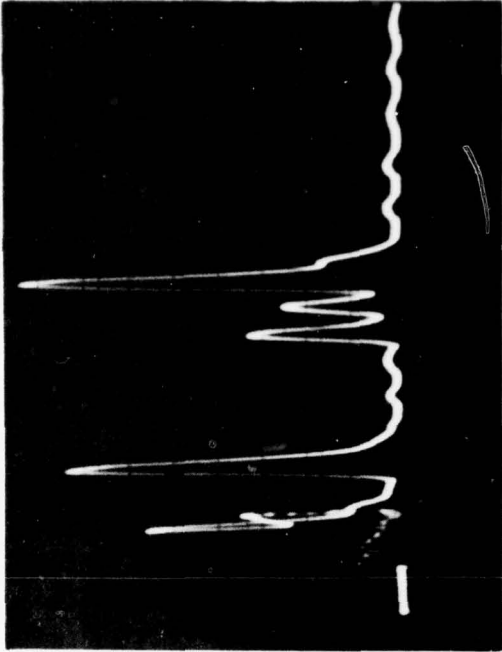
FIGURE 20: CRT SCOPE DISPLAY FOR PULSE ECHO ON QCDS-3 IN DEFECT AREA

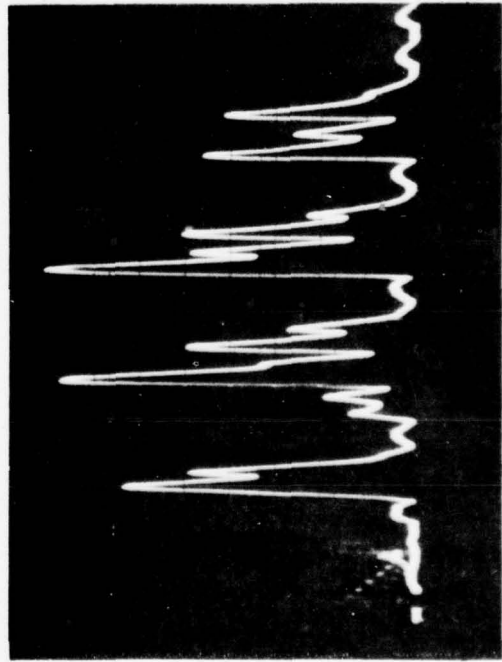
Figures 21 and 22 show the instrument display obtained using a through transmission method on the same normal and defect areas. The transducers used were a 0.5" diameter 2.25 MHz for transmitting and 1.0 MHz for receiving. The simple contrast of large received signals in Figure 21 and no received signal in Figure 22 is more obvious than the time shift seen with the pulse-echo method. Thickness variations in the laminate would only cause small amplitude changes in the peaks seen in Figure 21. It should also be noted that depth of a defect from the surface is not obtainable with "C" scan thru transmission ultrasonic inspection.

FIGURE 21: CRT SCOPE DISPLAY FOR QCDS-3 WITH THRU TRANSMISSION IN NORMAL AREA
