LTV AEROSPACE CORP DALLAS TEX VOUGHT SYSTEMS DIV F/G 1/3
S-3A GRAPHITE/EPOXY SPOILER DEVELOPMENT PROGRAM. VOLUME II.(U)

JUL 75 E G BLOSSER, S A MCGOVERN, O E DHONAU N62269-73-C-0610
2-53443/4R-3172-VOL-2 NADC-75141-30 NL

20. ABSTRACT (Continue on reverse side if necessary and identify by block number) <p>After testing of the S-3A Graphite/Epoxy Spoilers was satisfactorily completed, under Contract N62269-73-C-0610, the contracted effort was extended to include the development of NDI standards for the composite spoiler to be included in Volume II. In addition to the fabrication of reference standards for this report, the development of field inspection techniques was pursued using the ultrasonic unit available to Navy inspection personnel. A Sonic Instruments ultrasonic unit (Federal Stock No. 6RX6635-070-6669-SXTX) borrowed</p>

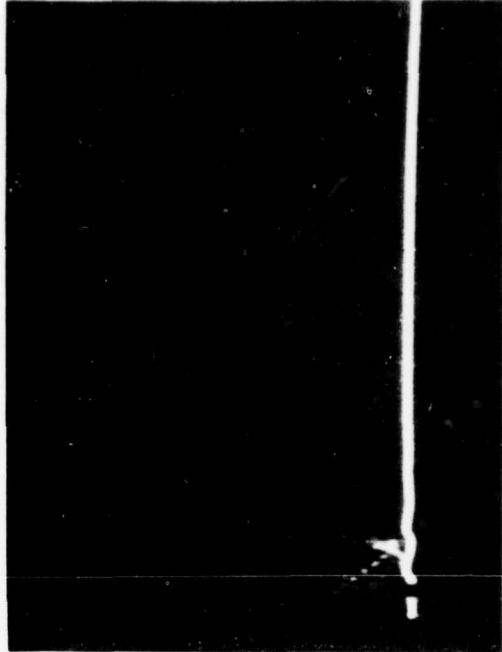
Figures 21 and 22 show the instrument display obtained using a through transmission method on the same normal and defect areas. The transducers used were a 0.5" diameter 2.25 MHz for transmitting and 1.0 MHz for receiving. The simple contrast of large received signals in Figure 21 and no received signal in Figure 22 is more obvious than the time shift seen with the pulse-echo method. Thickness variations in the laminate would only cause small amplitude changes in the peaks seen in Figure 21. It should also be noted that depth of a defect from the surface is not obtainable with "C" scan thru transmission ultrasonic inspection.

FIGURE 22: CRT SCOPE DISPLAY FOR QCDS-3 WITH THRU TRANSMISSION IN DEFECT AREA

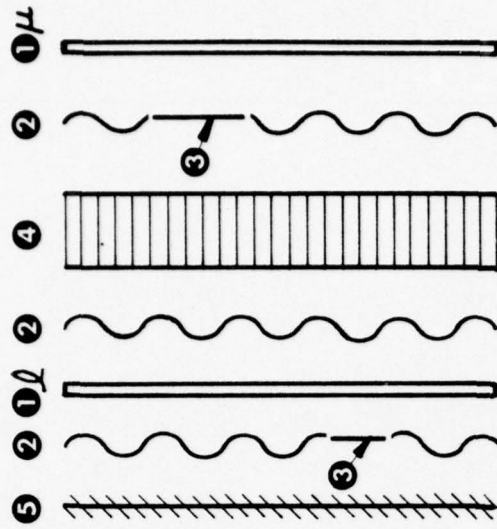
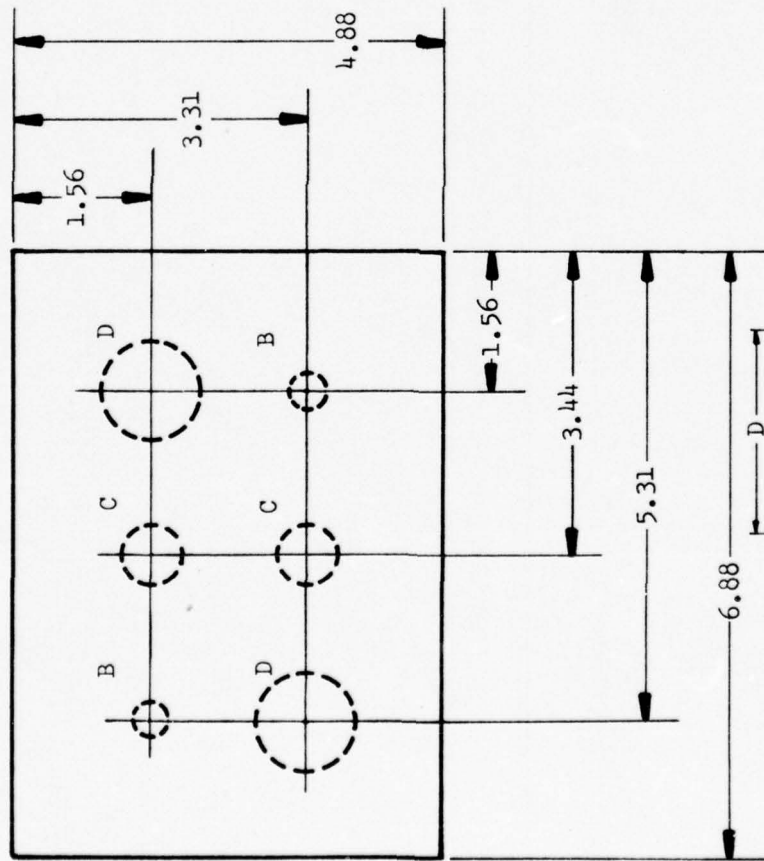
FIGURE 23: QCDS-4 AND QCDS-5 SPECIMEN DETAIL

Two honeycomb sandwich reference panels were fabricated representing the minimum and maximum numbers of skin plies present in the spoiler. QCDS-4 had six ply upper and lower skins, while QCDS-5 had eight ply lower and ten ply upper skins. Each specimen contained 6 defects fabricated from glass filters enclosed in mylar tape; construction details are shown in Figure 23. The information furnished by these two panels along with the examination of the ply drop-off area in one of the static test spoilers provided a basis for deciding whether or not the final reference standard should include a separate reference area for each ply thickness in the spoiler. Three ultrasonic C-scan recordings of QCDS-4 and 5 using immersion through transmission are shown in Figures 24, 25, and 26. Both these panels were more highly attenuating than QCDS-2 (compare gain settings Figures 6 and 24) and QCDS-5

- 1.0 GRAPHITE / EPOXY LAMINATE
(6 PLY QCDS-4, 10 PLY QCDS-5)
- 1/4 GRAPHITE / EPOXY LAMINATE
(6 PLY QCDS-4, 8 PLY QCDS-5)
- 2 FILM ADHESIVE (MILL3)
- 3 DEFECT MATERIAL
- 4 HRP CORE
- 5 120 MESH ALUMINUM SCREEN

GLASS FILTER IN MYLAR TAPE

DEFECT	D dim	d dim
B	.37	.25
C	.67	.50
D	1.12	1.00

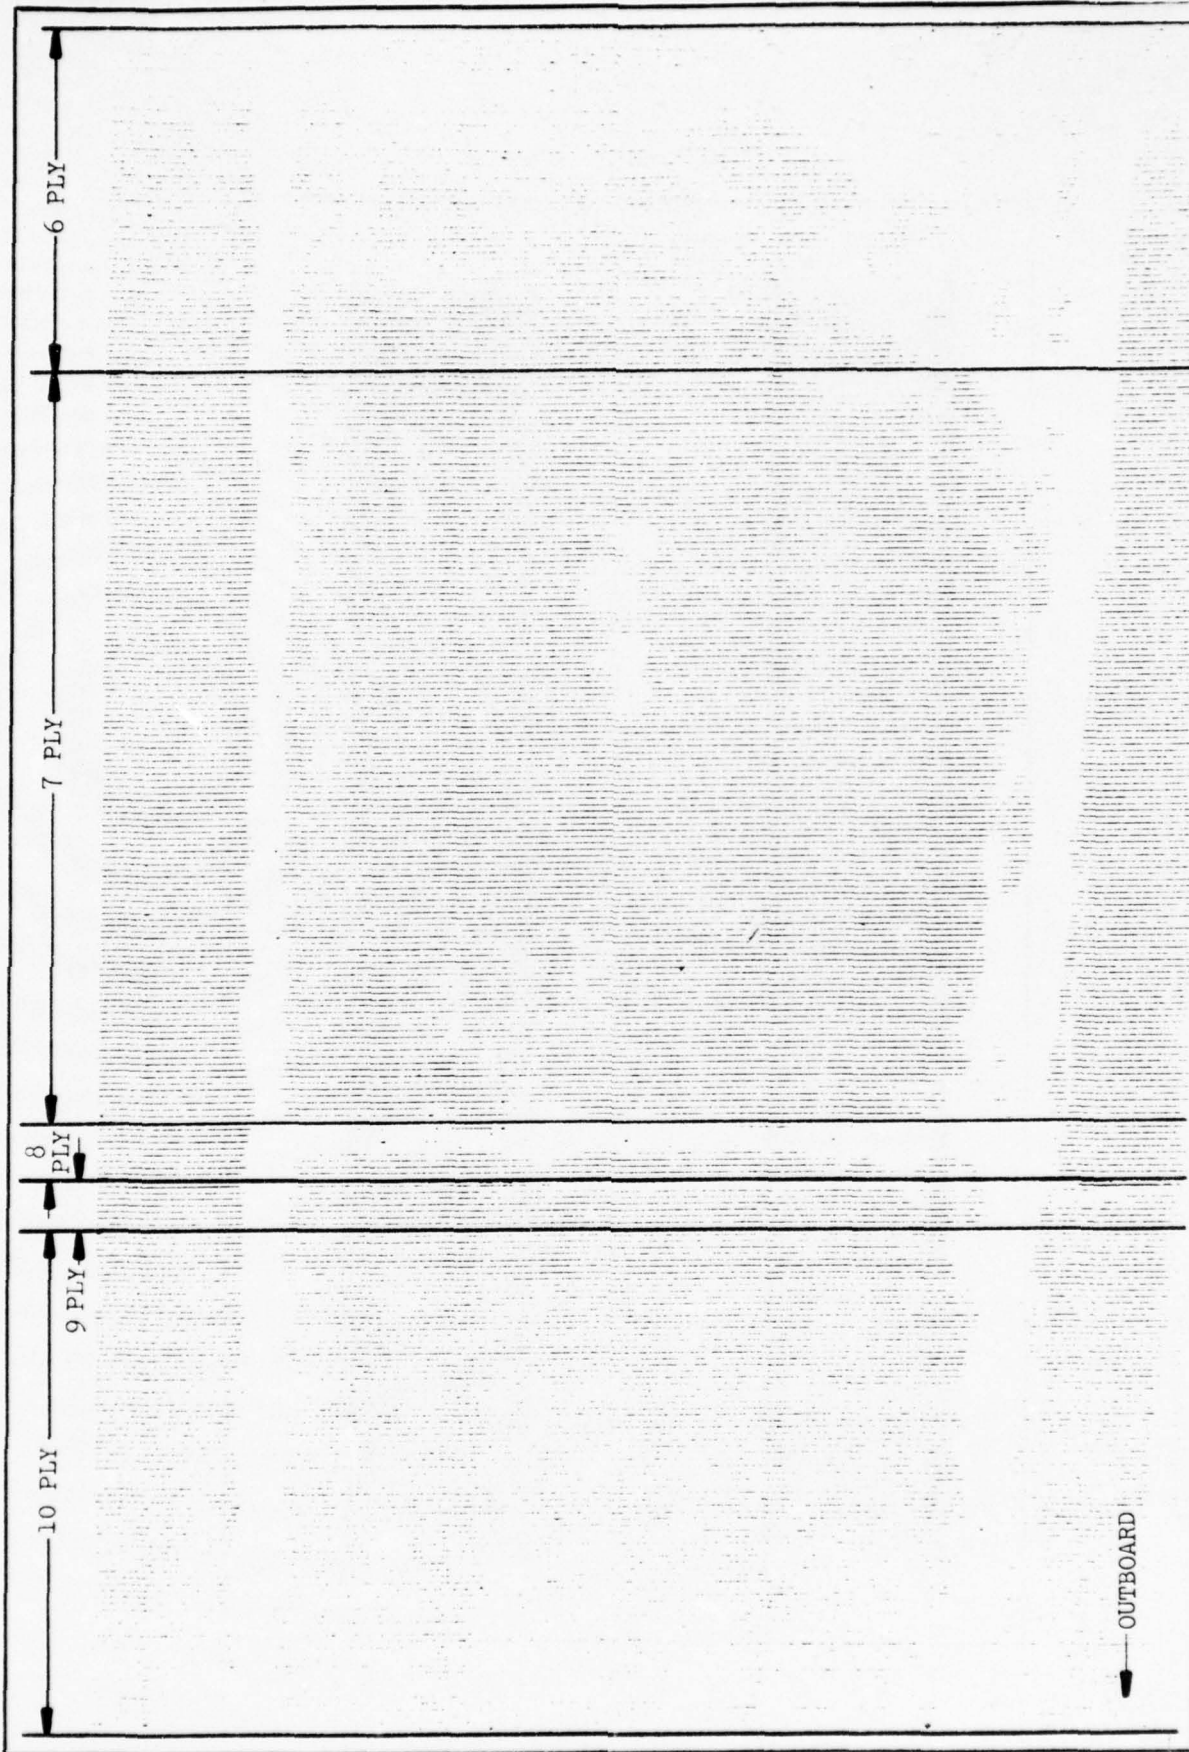
Static test article #2 was examined ultrasonically and radiographically in the section where skin plies drop from 10 ply to 6 ply. Figure 29 shows a reduced reproduction of the ultrasonic through transmission C-scan recordings of the spoiler. Numbers indicate the number of skin plies. No difference in attenuation level is noticed as the ply number changes. However, it will be noted that the core splice area and the beveled edge always show as attenuating areas because of the change in local densities. Figure 30 shows a positive print of the radiograph made of this area. Skin ply changes are only discernible as gradual density variation.

FIGURE 29: ULTRASONIC RECORD OF # 2 STATIC SPOILER IN AREA OF SKIN PLY VARIATION

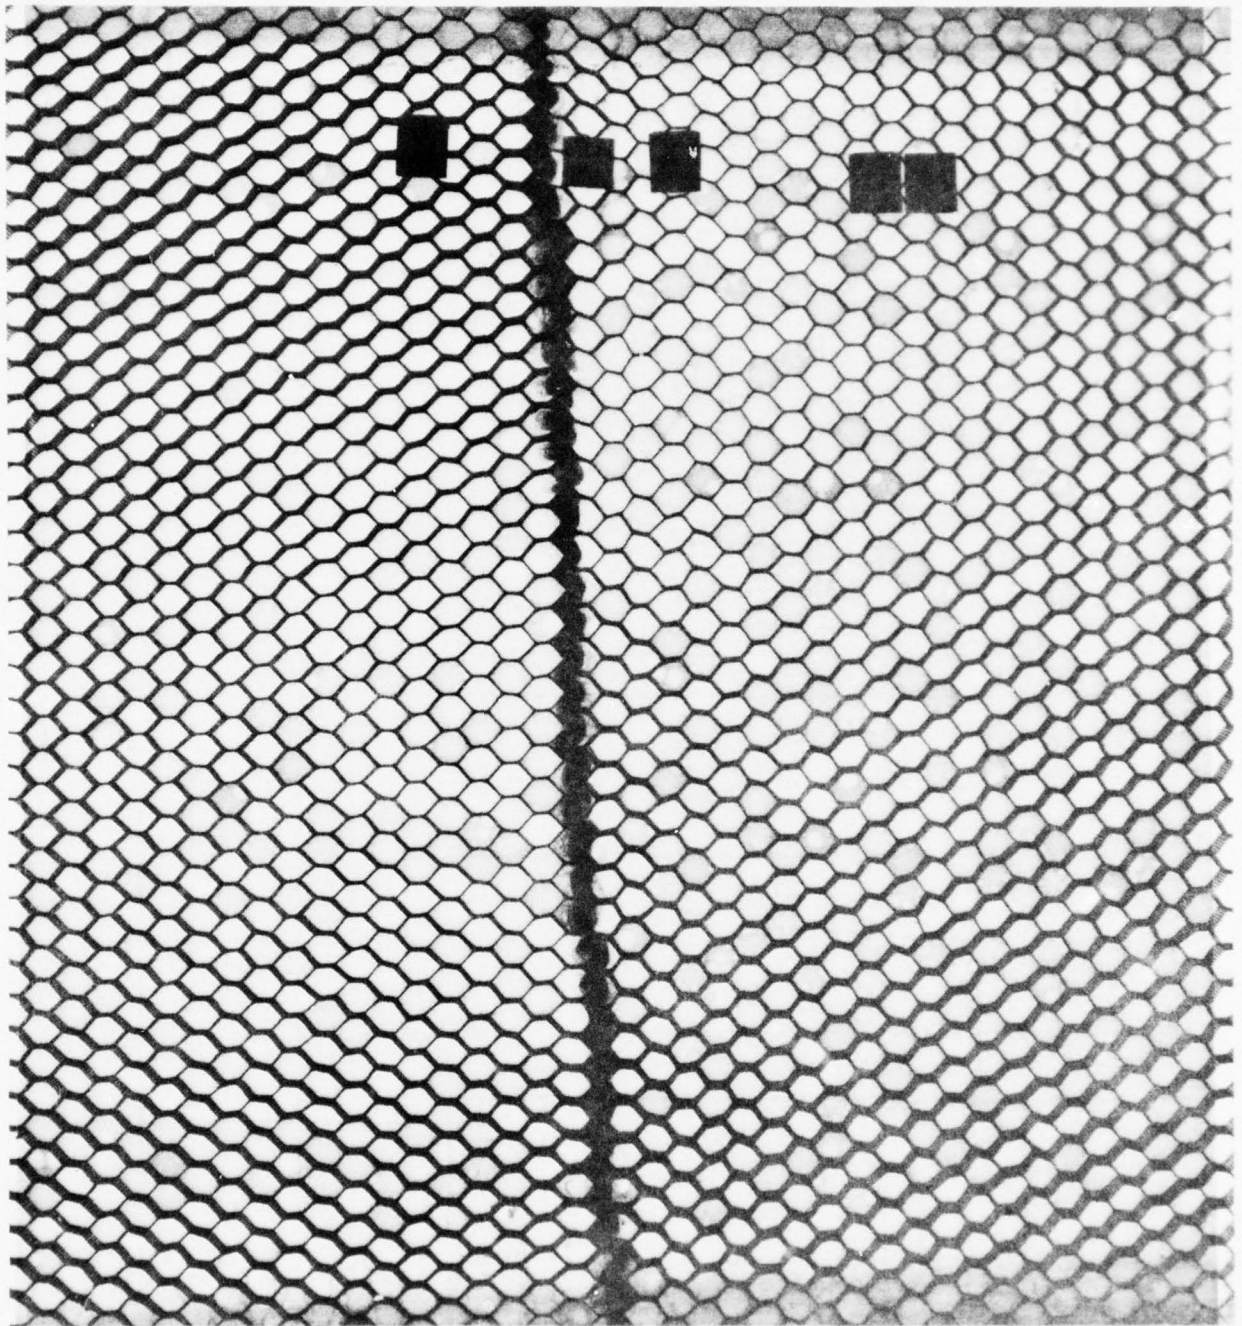
FIGURE 30: RADIOGRAPH OF #2 STATIC SPOILER IN AREA OF SKIN PLY VARIATION

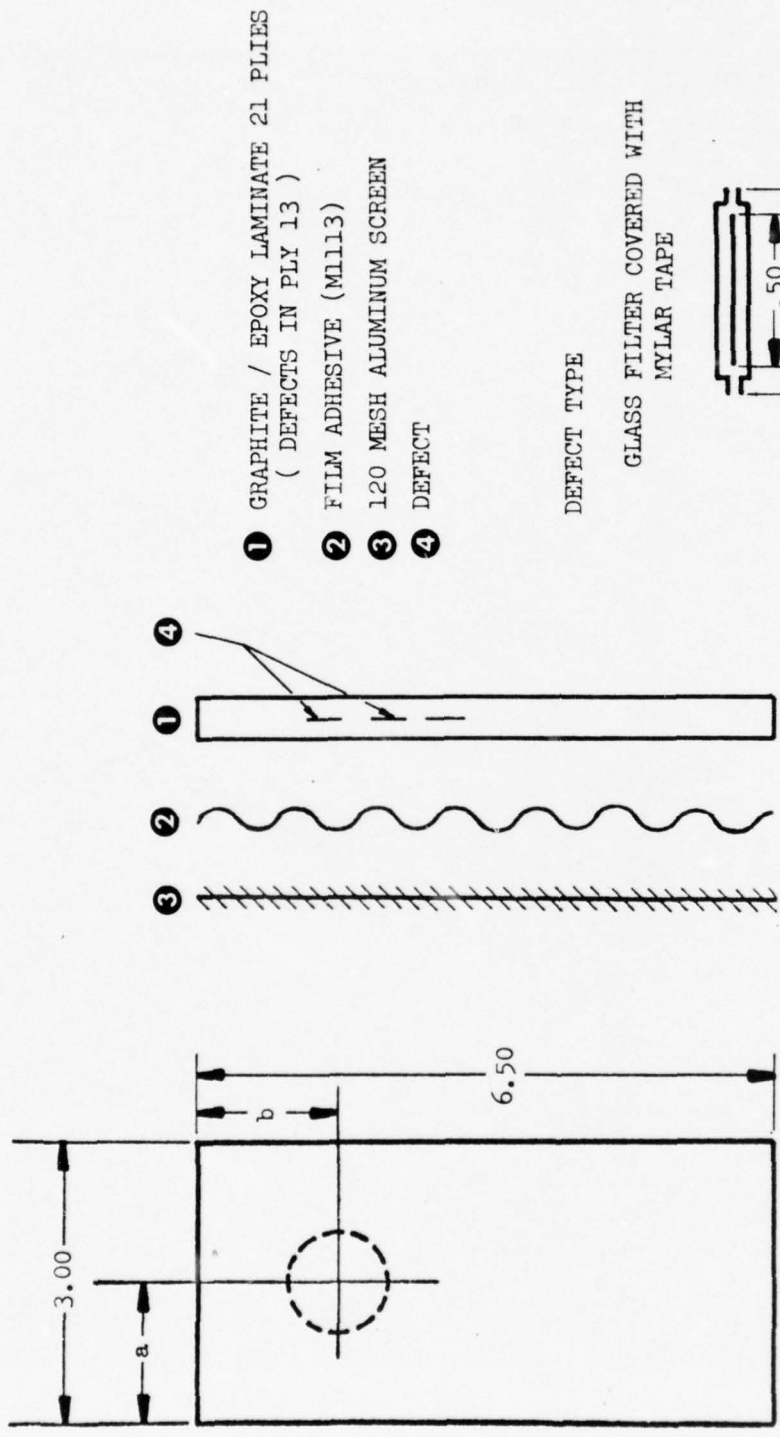
FIGURE 31: QCDS-6 THRU QCDS-10 SPECIMEN DETAIL

Five 21-ply solid laminate panels designated QCDS-6, -7, -8, -9 and -10 were fabricated to determine the effect of over or under bleeding resin from the advanced composite material on physical properties including thickness, fiber volume, ultrasonic and radiographic responses. Construction details of these specimens are shown in Figure 31. Each specimen contained one defect as indicated for reference in radiographic and ultrasonic evaluation. The number of bleeder plies used for each specimen and the effect on thickness and fiber volume percent is shown in Table I. Figure 32 presents a reduced reproduction of the ultrasonic thru transmission recordings for each of the five specimens and a radiograph for each is shown in Figure 18. Neither ultrasonics or radiography indicates a measurable difference in the panels evaluated.

- 1 GRAPHITE / EPOXY LAMINATE 21 PLYS
(DEFECTS IN PLY 13)
- 2 FILM ADHESIVE (M1113)
- 3 120 MESH ALUMINUM SCREEN
- 4 DEFECT

SPECIMEN NO.	a dim	b dim
QCDS-6	1.69	1.31
QCDS-7	1.31	5.19
QCDS-8	1.50	3.25
QCDS-9	1.31	1.31
QCDS-10	1.69	5.19

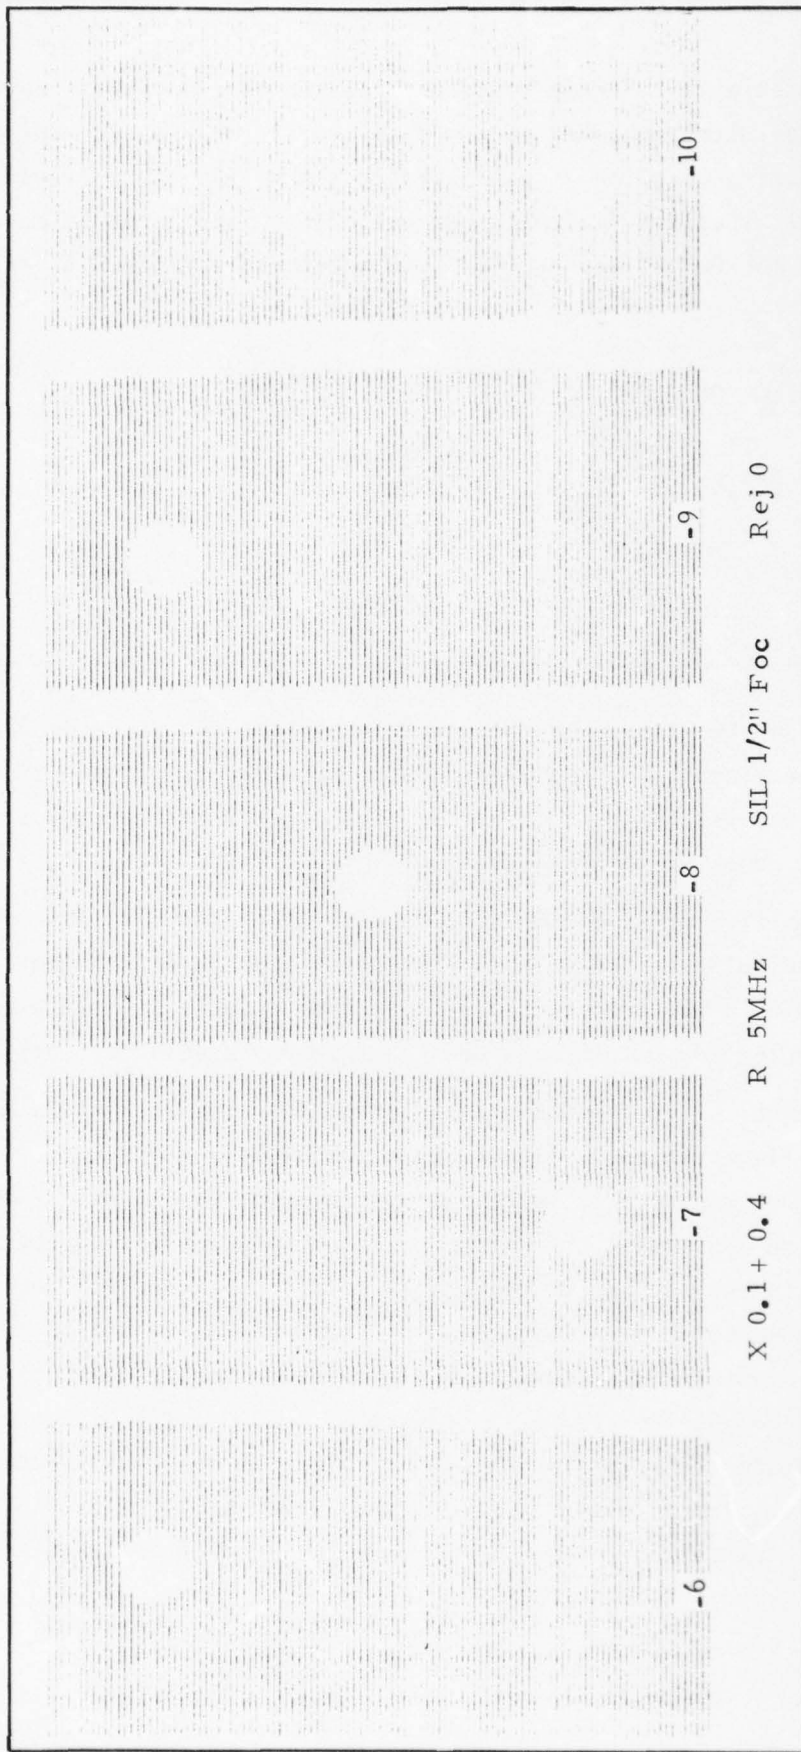
FIGURE 32: ULTRASONIC RECORD OF QCDS -6 THRU -10 AT X 0.1 + 0.4

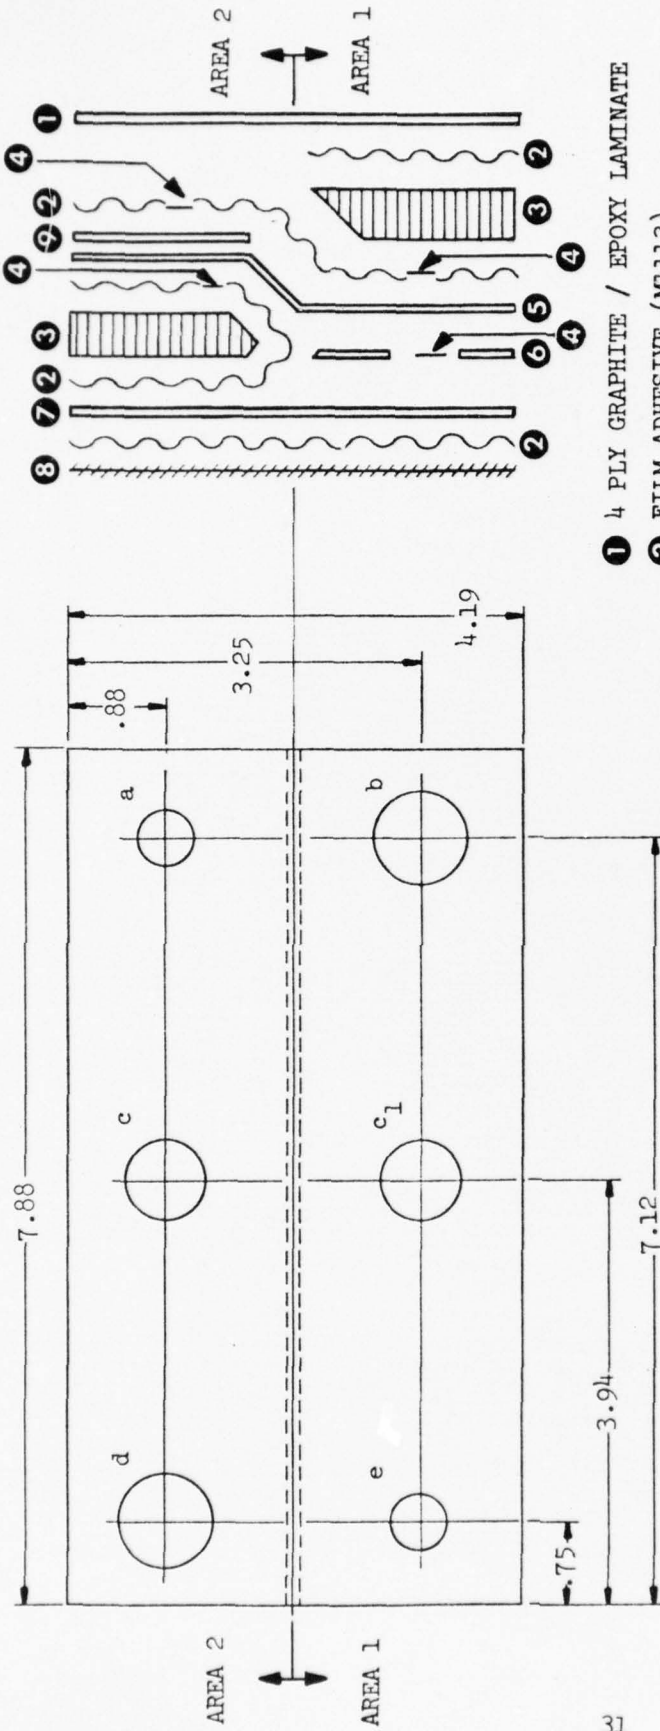
FIGURE 33: QCDS-11 SPECIMEN DETAIL

A single specimen designated QCDS-11 was fabricated to represent the area of the outboard tab stiffener. The basic difference in construction is due to the addition of a precured skin and core stiffener area to the basic spoiler cross section. The section of the specimen which represents the spoiler

honeycomb with added skin is referred to as Area 2; the section which represents the spoiler edge with the added core and skin stiffener is referred to as Area 1. Configuration details are presented in Figure 33. Several defects were simulated in this specimen including two which were fabricated by removing adhesive from the bond line and four with added glass filters covered with mylar tape.

- 1 4 PLY GRAPHITE / EPOXY LAMINATE
- 2 FILM ADHESIVE (M1113)
- 3 HRP CORE
- 4 DEFECT OR VOID
- 5 8 PLY GRAPHITE / EPOXY LAMINATE
- 6 5 PLY GRAPHITE / EPOXY LAMINATE (DEFECT IN TOP PLY)
- 7 8 PLY GRAPHITE / EPOXY LAMINATE
- 8 120 MESH ALUMINUM SCREEN
- 9 2 PLY GRAPHITE / EPOXY LAMINATE

DEFECT	d dim	D dim	TYPE	LOCATION
a	.50	.62	glass & mylar	in adhesive above 8 ply laminate
b	.88	1.00	" "	" " " " " "
c	.75	.88	" "	in adhesive between core and 8 ply upper laminate
c ₁	.75	.88	" "	in top ply of 5 ply laminate
d	-	1.00	void only	in adhesive above upper 8 ply laminate
e	-	.62	void only	" " " " " "

Evaluation of this panel using the Sonic unit showed that the area containing the precured tab stiffener (Area 1, Figure 33) gave slightly different responses than the area representative of the main body of the spoiler (Area 2, Figure 33). Figure 37 shows a photograph of the instrument display obtained when using a through transmission mode in the precured tab stiffener section (Area 1; transmitting with 2.25 MHz and receiving with 1 MHz transducers). Figure 38 shows the display when the transducers are placed over a built-in defect. The displays shown in Figures 39 and 40 are those obtained when placing the transducers in corresponding positions in the other section of the panel (Area 2). The displays in Areas 1 and 2 are similar, but the gain settings were: Coarse 4 and Fine 7 for Area 1 while in Area 2 settings were Coarse 6, Fine 5.

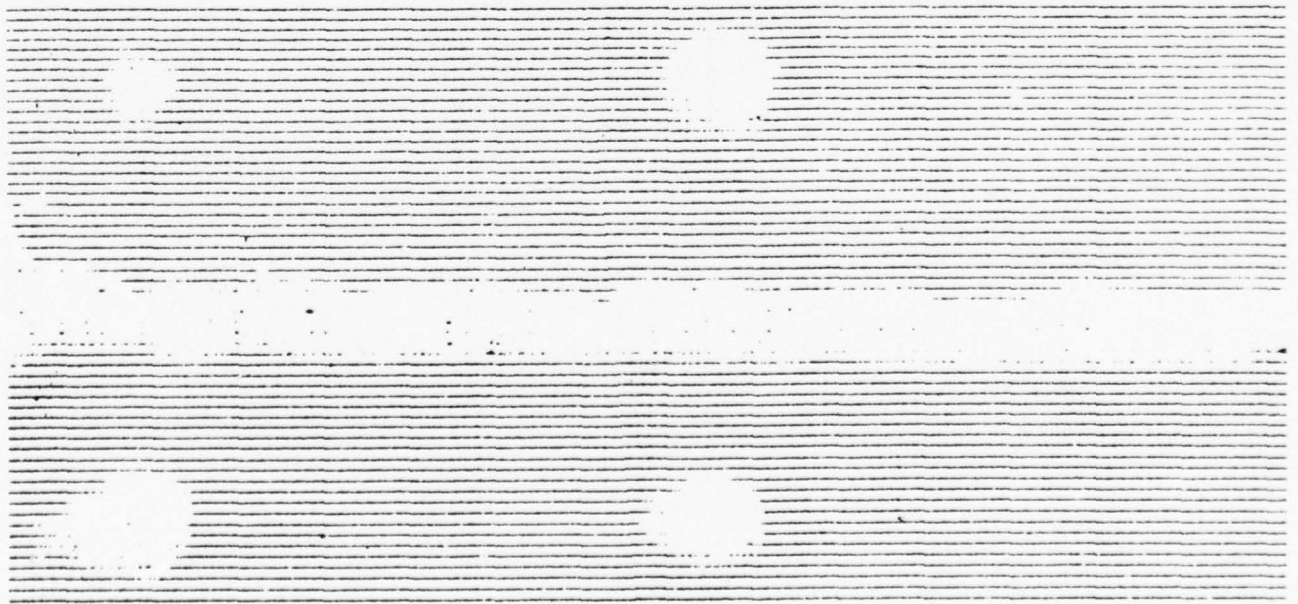
FIGURE 35: QCDS -11 ULTRASONIC RECORD AT X10+1

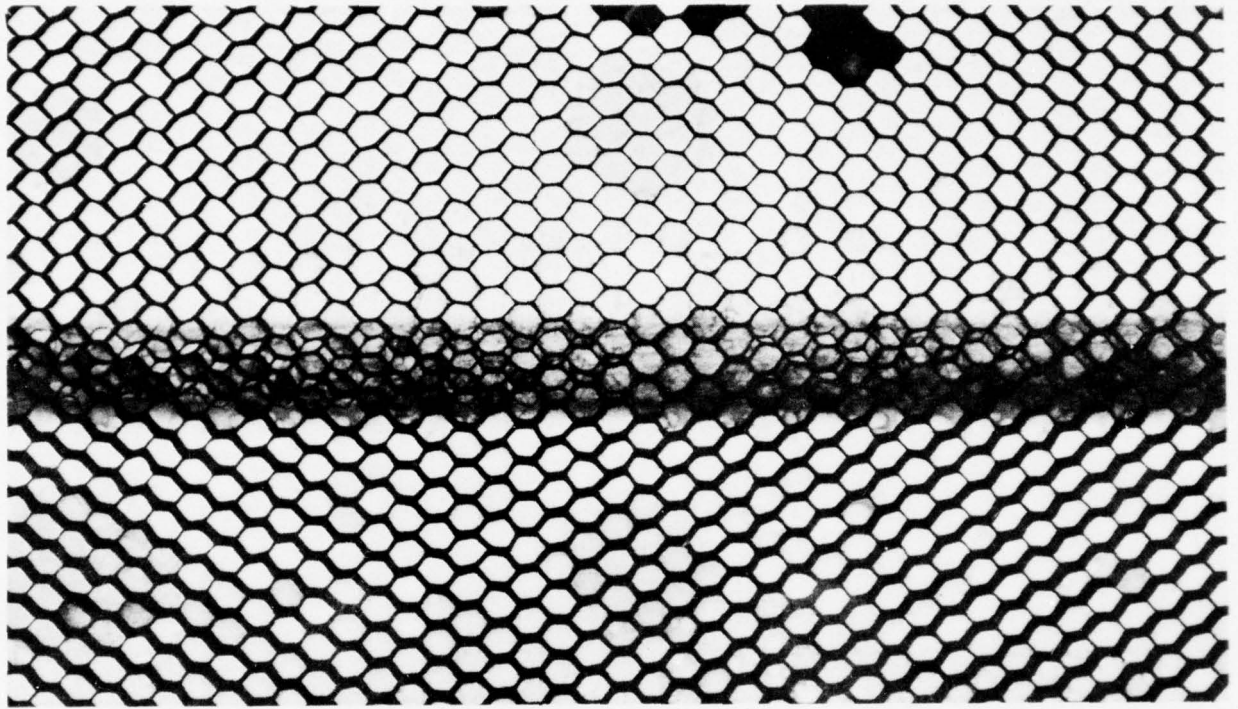
PLAN VIEW

Figure 36 shows a positive print of radiographs made of the panel. A view with the beam perpendicular to the skin surface and a view made with the beam parallel to the skin surface are shown. The four defects created with added material are detected, but those where adhesive was removed are not.

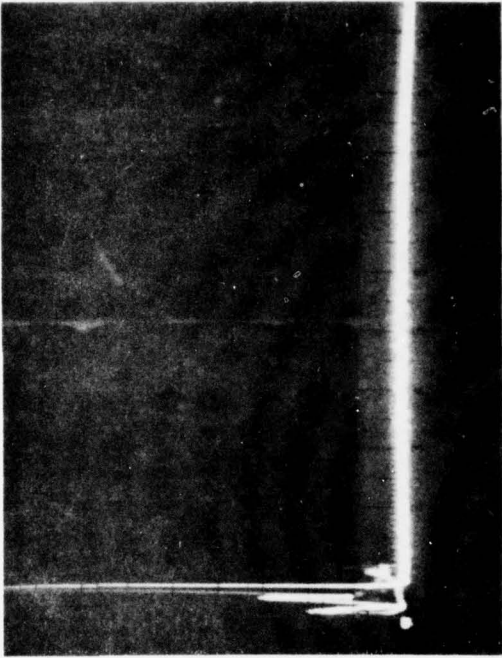
FIGURE 38: CRT SCOPE DISPLAY OF QCDS-II
AREA 1 FOR DEFECT

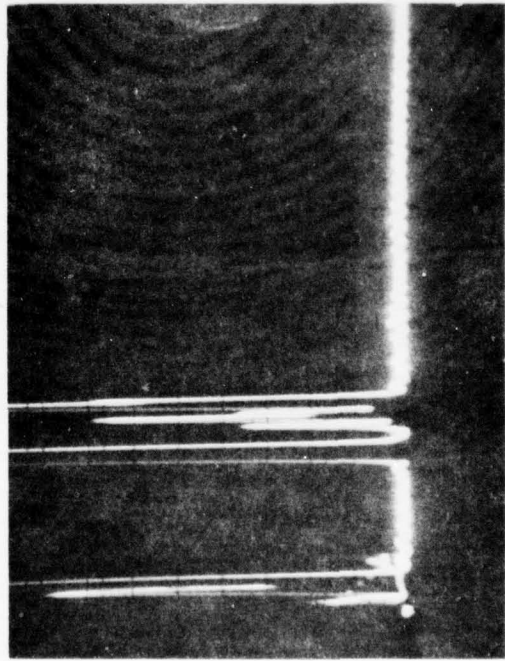
FIGURE 39: CRT SCOPE DISPLAY OF QCDS-II
AREA 2 FOR NORMAL COMPONENT

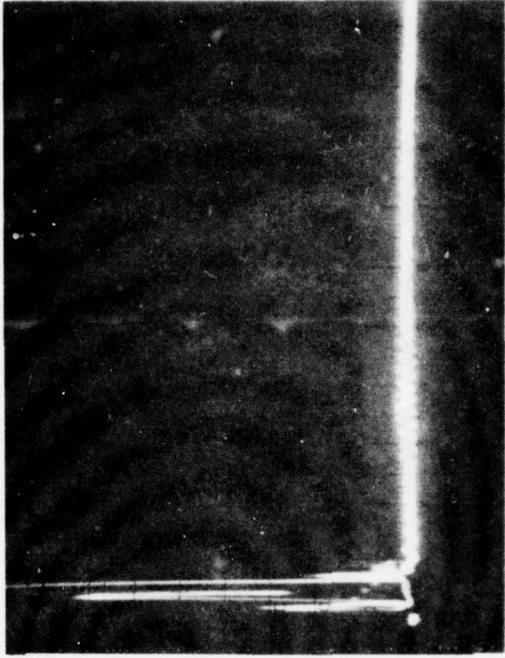
FIGURE 40: CRT SCOPE DISPLAY OF QCDS-II
AREA 2 FOR DEFECT

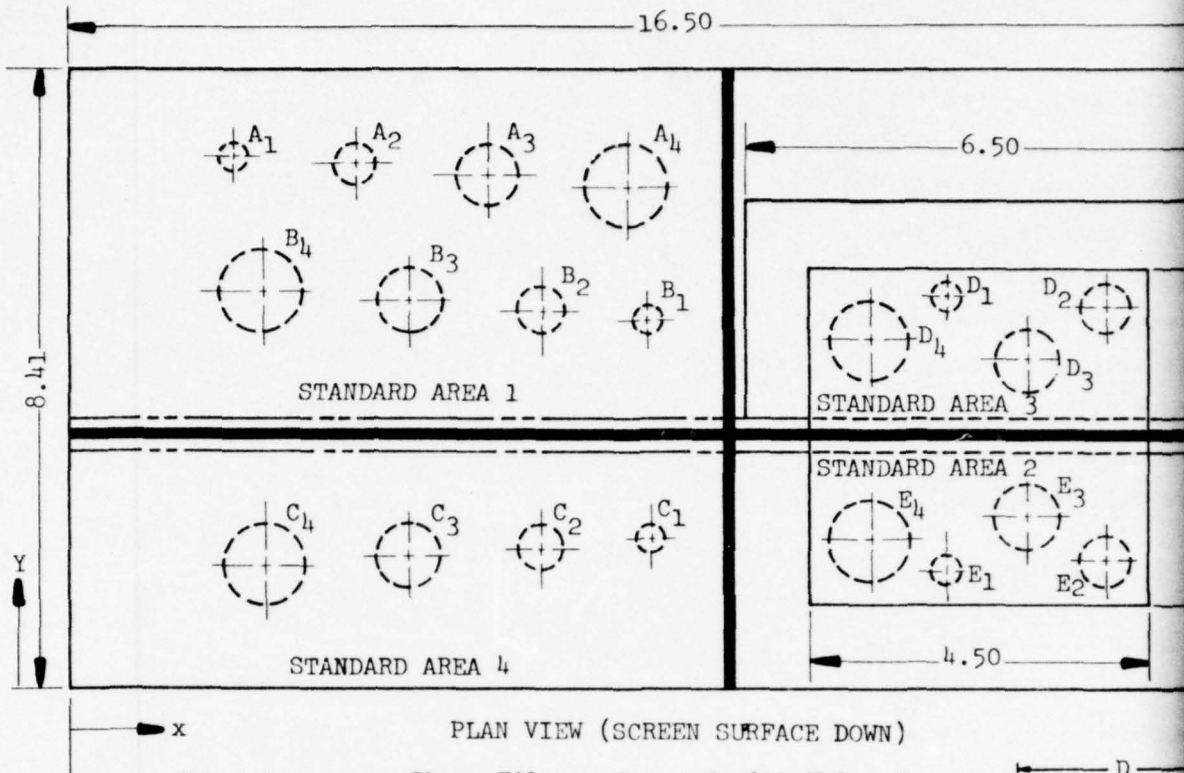
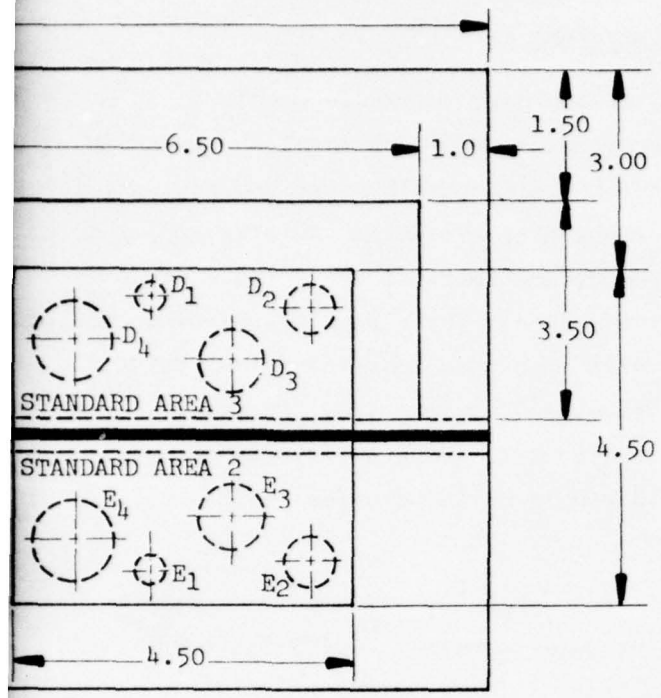
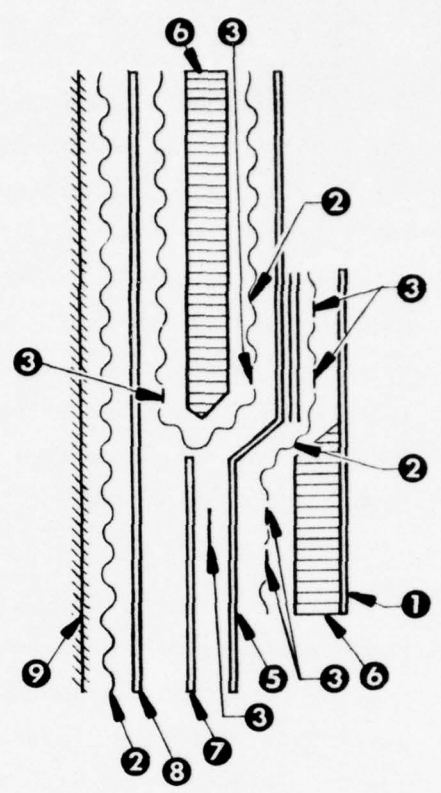
FIGURE 41: FINAL STANDARD SPECIMEN DET

All Defects are Glass Filters Covered with Mylar Tape

DEFECT	DEFECT SIZES		DEFECT LOCATIONS		REMARKS
	d	D	x	y	
A ₁	.250	.275	2.15	7.25	Located in lower skin to core bond line STANDARD AREA 1
A ₂	.500	.625	3.75	7.15	
A ₃	.750	.875	5.50	7.00	
A ₄	1.000	1.125	7.60	6.85	
B ₁	.250	.375	7.85	5.00	Located in upper skin to core bond line STANDARD AREA 1
B ₂	.500	.625	6.35	5.15	
B ₃	.750	.875	4.55	5.30	
B ₄	1.000	1.125	2.50	5.40	
C ₁	.250	.375	7.85	2.00	Located in ply 13 of edge band (solid laminate) STANDARD AREA 4
C ₂	.500	.625	6.35	1.85	
C ₃	.750	.875	4.55	1.70	
C ₄	1.000	1.125	2.50	1.55	
D ₁	.250	.375	12.10	5.35	Located in bond line between tab skin and upper skin STANDARD AREA 3
D ₂	.500	.625	14.10	5.30	
D ₃	.750	.875	13.00	4.65	
D ₄	1.000	1.125	10.85	4.75	
E ₁	.250	.375	12.10	1.55	Located in bond line between tab honeycomb and edge laminate. STANDARD AREA 2
E ₂	.500	.625	14.10	1.75	
E ₃	.750	.875	13.00	2.35	
E ₄	1.000	1.125	10.85	2.00

1. Simulated tab stiffener (fabricated from material made for contract N 62269-74-C-0629)
2. Film adhesive (M1113)
3. Defects
4. Two ply 0° doubler (simulates outbd hinge area)
5. 8 ply upper skin
6. HRP core
7. 5 ply (+ 45°) spacer
8. 8 ply lower skin
9. 120 mesh aluminum screen

STANDARD SPECIMEN DETAIL (QCDS-12, -13 & 14)

The information gained from the preliminary reference panels, QCDS-2 through -11 indicated that the composite spoiler should be inspected by calibration for four separate inspection areas: (1) the main honeycomb section, (2) the tab stiffener area which extends out over the solid laminate, (3) the tab stiffener area within the main honeycomb section, under the 2-ply skin doubler, and (4) the solid laminate edge. Three panels including each of these four areas were designed with each area containing four defects fabricated with glass fiber filters covered by mylar tape. Defect sizes range from 1/4 inch diameter to 1 inch diameter. Figure 41 shows details of the layout and construction of these panels which were designated QCDS-12, -13, and -14.

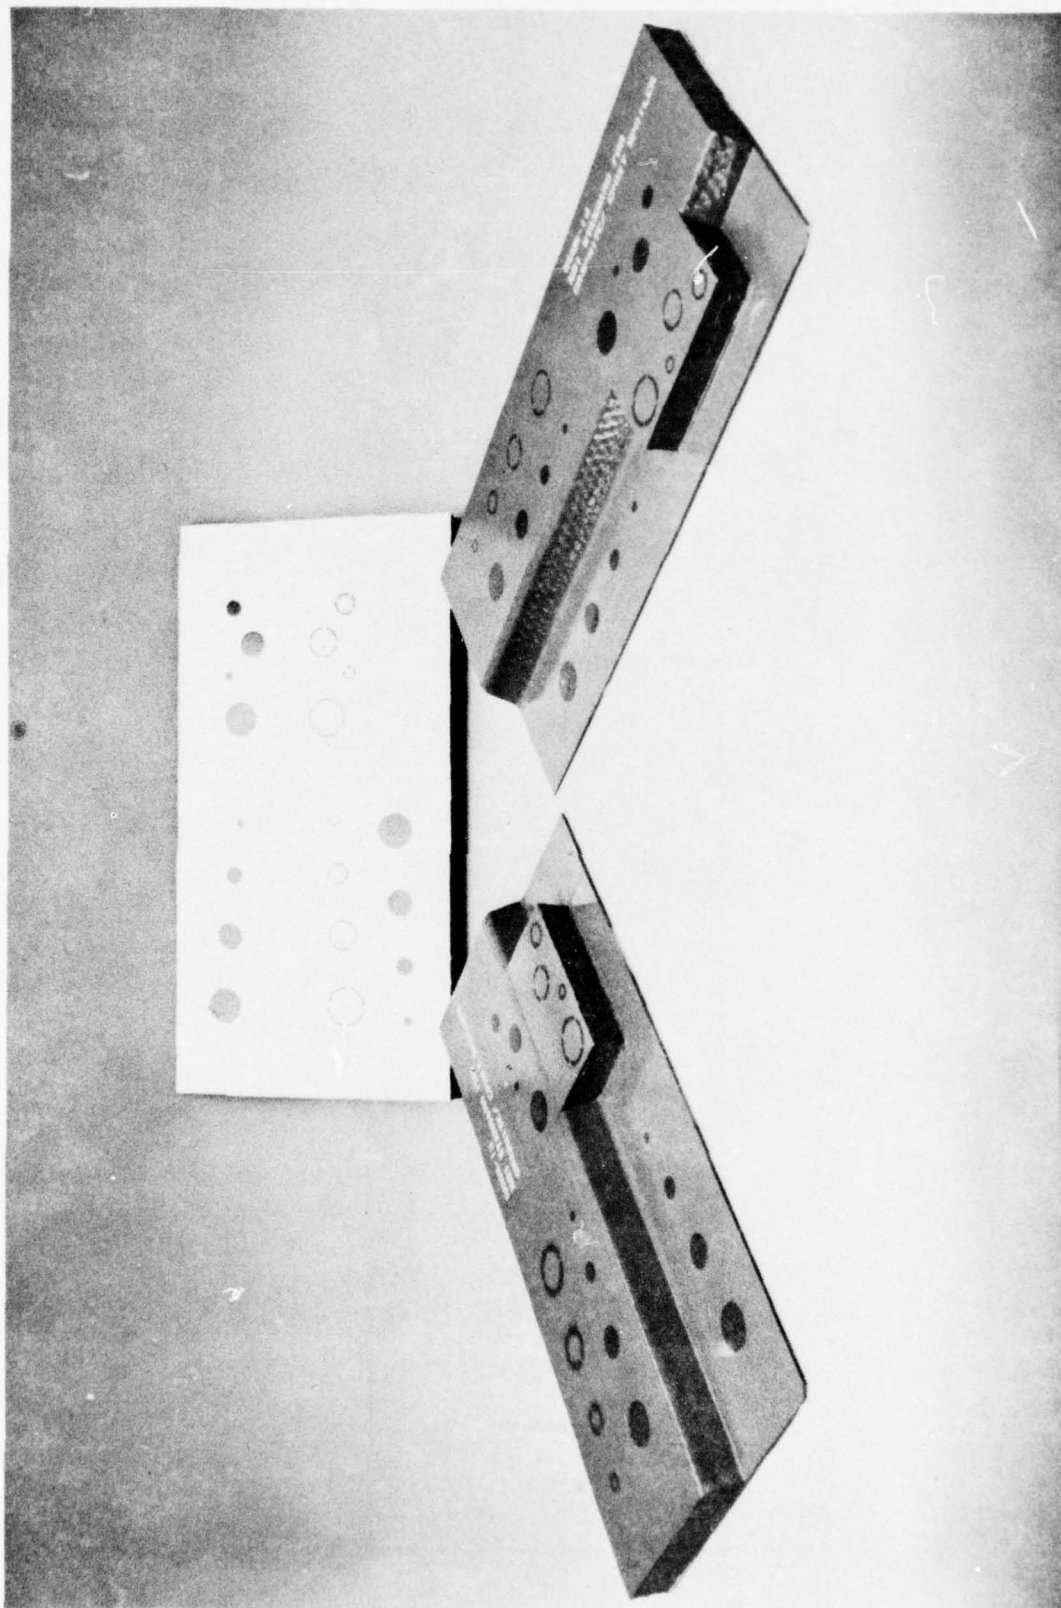
FIGURE 42: FINAL STANDARD SPECIMENS, QCDS-12, -13 AND -14

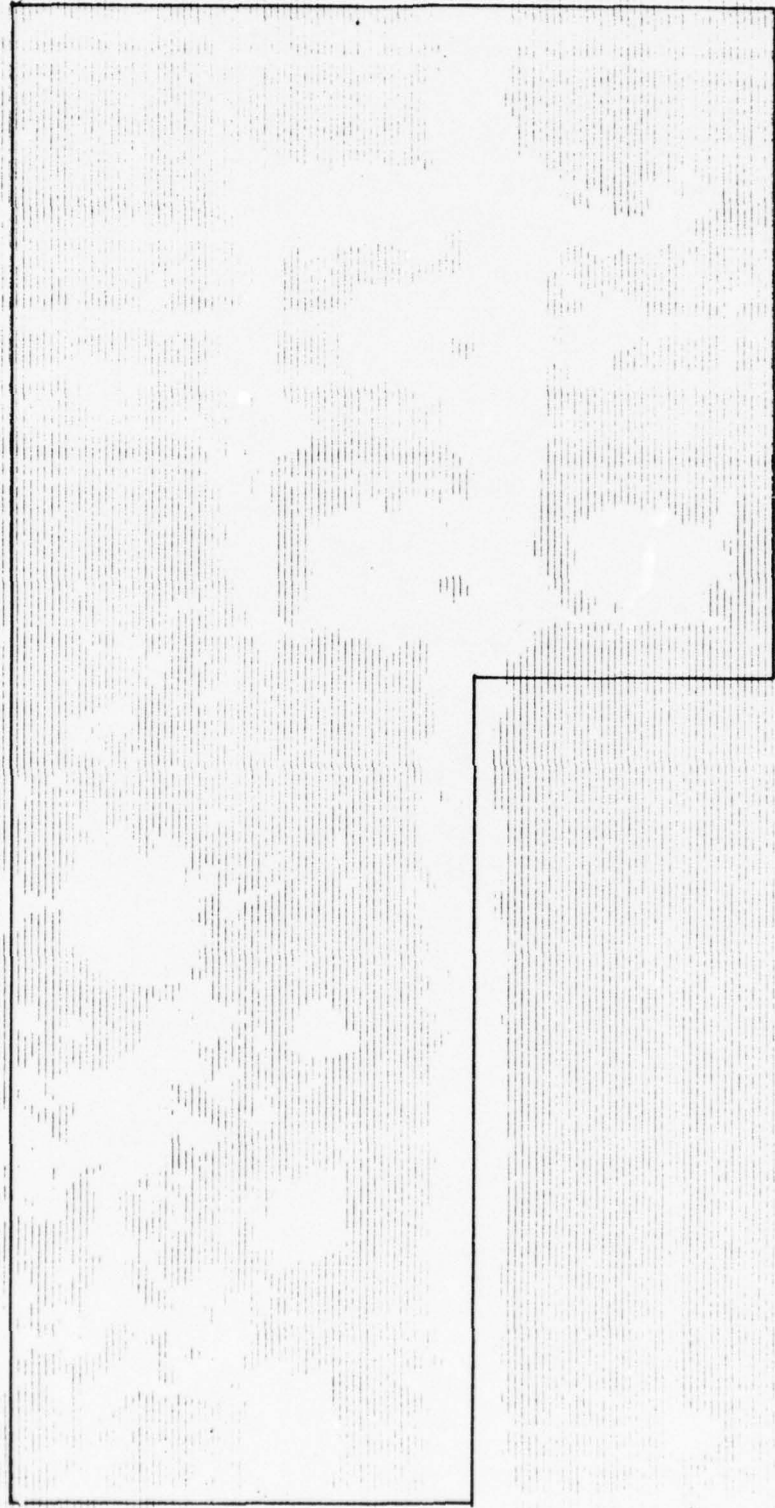
FIGURE 44: ULTRASONIC RECORD OF AREAS 1, 2 & 3
(HONEYCOMB AND TAB) AT X10+3.6

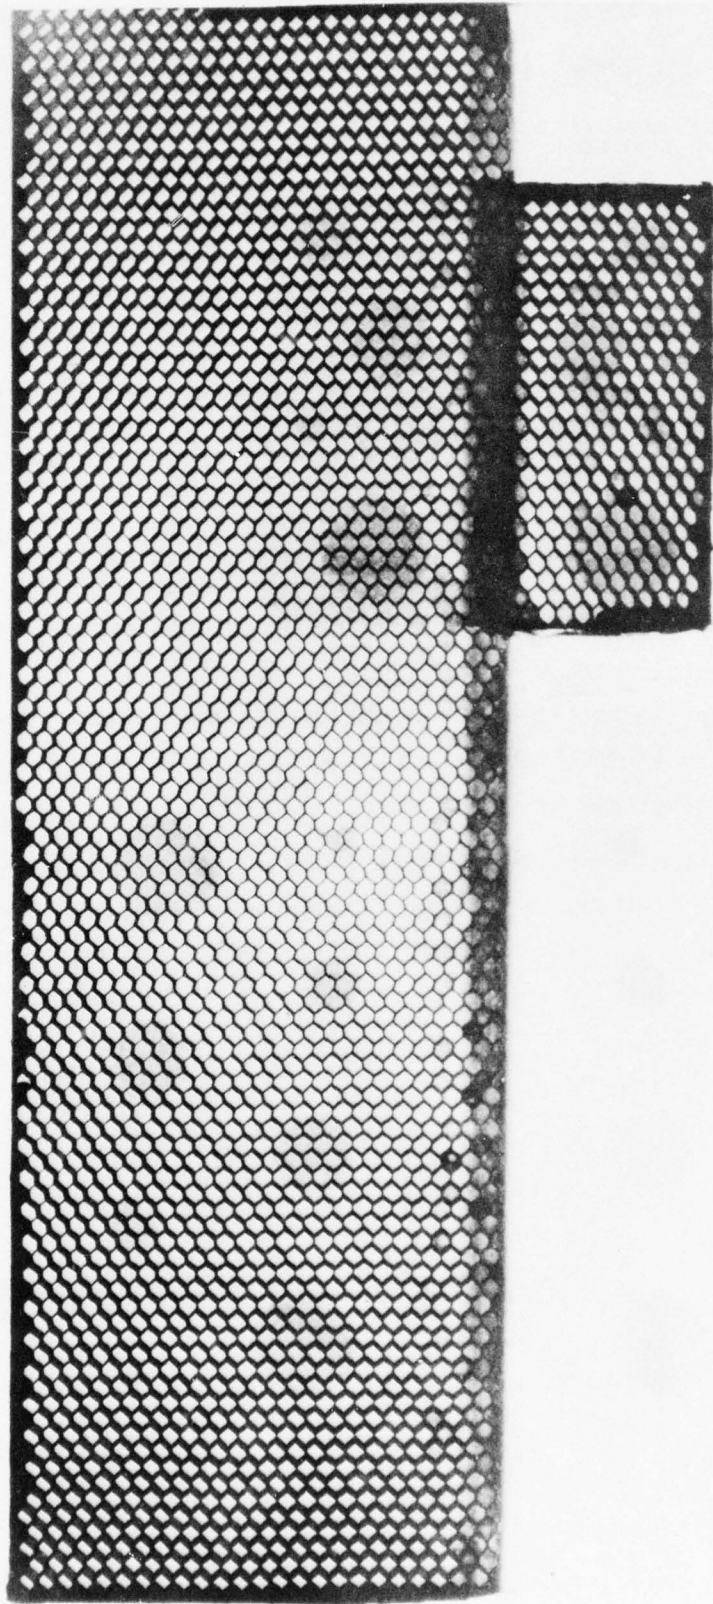
FIGURE 46: RADIOGRAPH OF FINAL STANDARD SPECIMEN

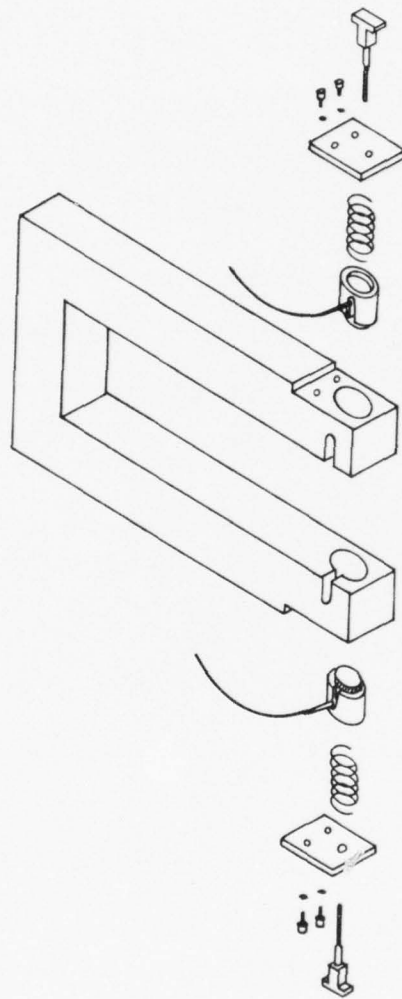
FIGURE A-1: TRANSDUCER HOLDER

1. Place transducers in holder. Attach cables to transducers. Attach cable from 2.25 MHz transducer to "T" receptacle and 1 MHz transducer cable to "R" receptacle on instrument. Turn on instrument for warm up.
2. Select area of inspection using inspection area/reference standard usage instruction, Figure A-2. Turn to procedure sheet specified for this area and follow calibration and inspection instructions.
3. Inspect all of the selected area before proceeding to another area of inspection.

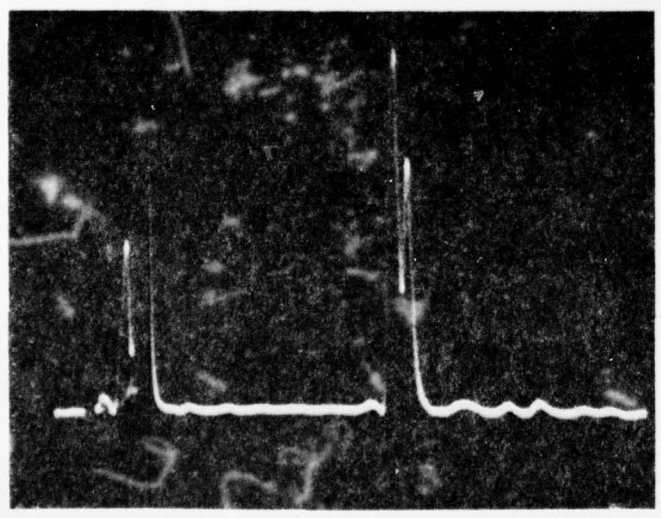
FIGURE A-4: SCOPE DISPLAY FOR NORMAL RESPONSE IN AREA 1

5. Adjust gain controls, if necessary, to produce the display shown in Figure A-4.
6. Move transducers over largest marked defect. Display should be as in Figure A-5.

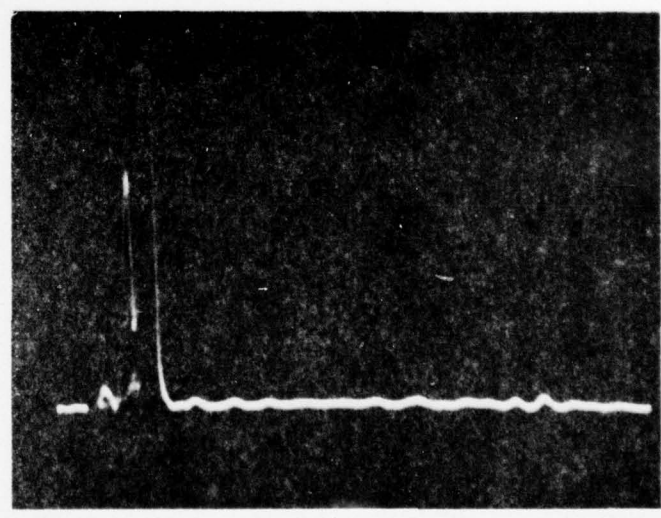
FIGURE A-5: SCOPE DISPLAY FOR DEFECT IN AREA 1

11. A display like that shown in Figure A-5 will indicate a probable delamination or debond.
12. Mark and report defect indications.

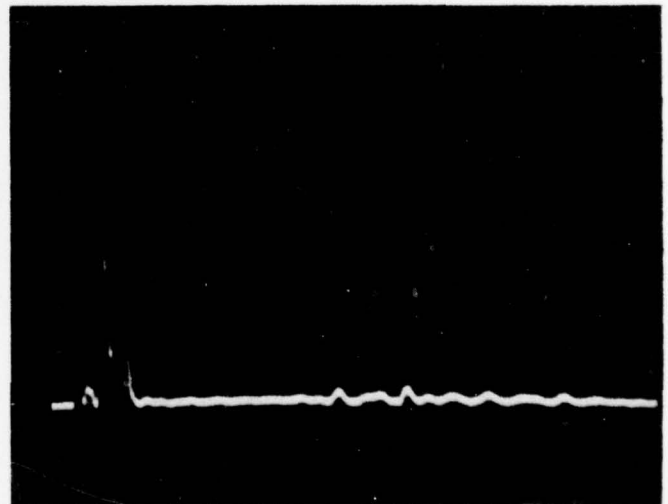
FIGURE A-8: SCOPE DISPLAY OF DEFECT IN AREA 2

5. Adjust gain controls, if necessary, to produce the display shown in Figure A-7.
6. Move transducers over largest marked defect. Display should be as in Figure A-8.

11. A display like that shown in Figure A-8 will indicate a probable delamination or debond.
12. Mark and report defect indications.

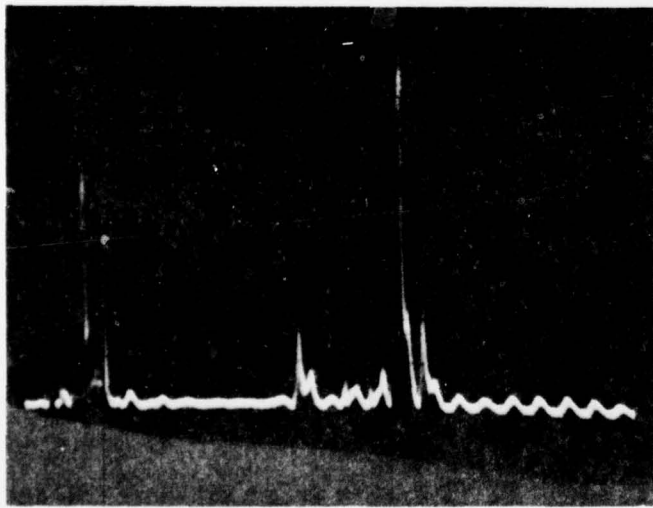
FIGURE A-9: SCOPE DISPLAY FOR NORMAL RESPONSE IN AREA 3

5. Adjust gain control, if necessary, to produce the display shown in Figure A-9.
6. Move transducers over largest marked defect. Display should be as in Figure A-10.

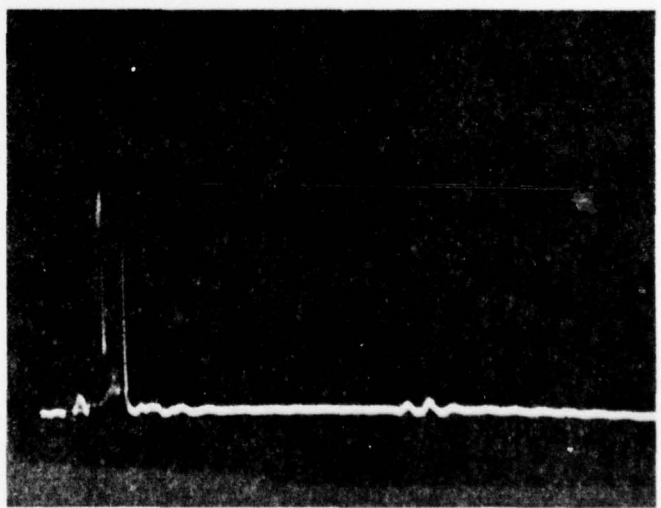
FIGURE A-10: SCOPE DISPLAY OF DEFECT IN AREA 3

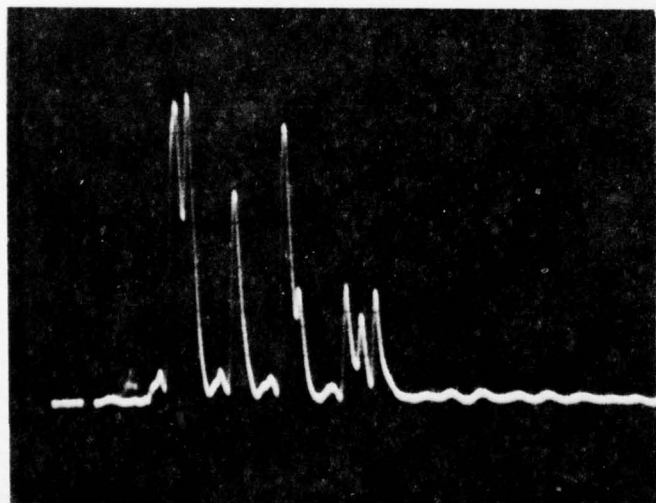
FIGURE A-12: SCOPE DISPLAY FOR NORMAL RESPONSE IN AREA 4

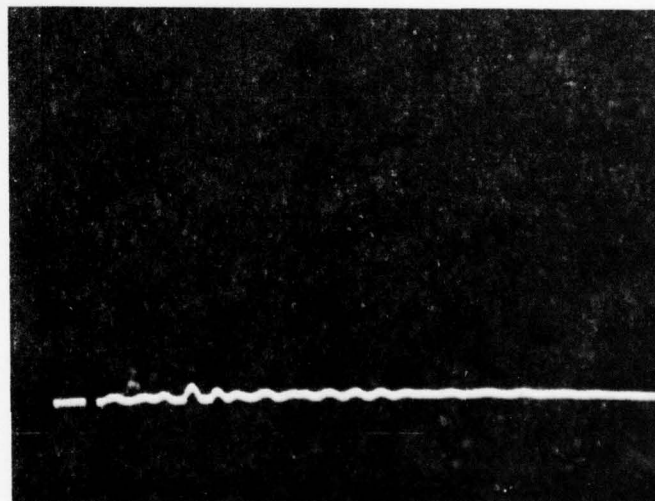
FIGURE A-13: SCOPE DISPLAY FOR DEFECT IN AREA 4
