LTV AEROSPACE CORP DALLAS TEX VOUGHT SYSTEMS DIV F/G 1/3
S-3A GRAPHITE/EPOXY SPOILER DEVELOPMENT PROGRAM. VOLUME II.(U)

JUL 75 E G BLOSSER, S A MCGOVERN, O E DHONAU N62269-73-C-0610
2-53443/4R-3172-VOL-2 NADC-75141-30 NL

20. ABSTRACT (Continue on reverse side if necessary and identify by block number) <p>After testing of the S-3A Graphite/Epoxy Spoilers was satisfactorily completed, under Contract N62269-73-C-0610, the contracted effort was extended to include the development of NDI standards for the composite spoiler to be included in Volume II. In addition to the fabrication of reference standards for this report, the development of field inspection techniques was pursued using the ultrasonic unit available to Navy inspection personnel. A Sonic Instruments ultrasonic unit (Federal Stock No. 6RX6635-070-6669-SXTX) borrowed</p>

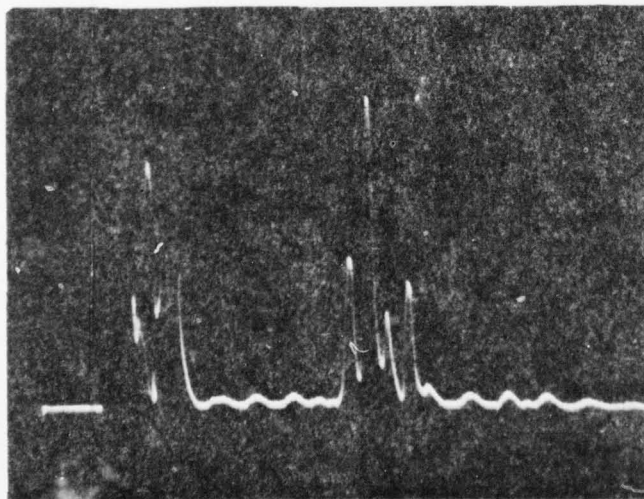
FIGURE A-14: SCOPE DISPLAY FOR NORMAL RESPONSE IN AREA 4

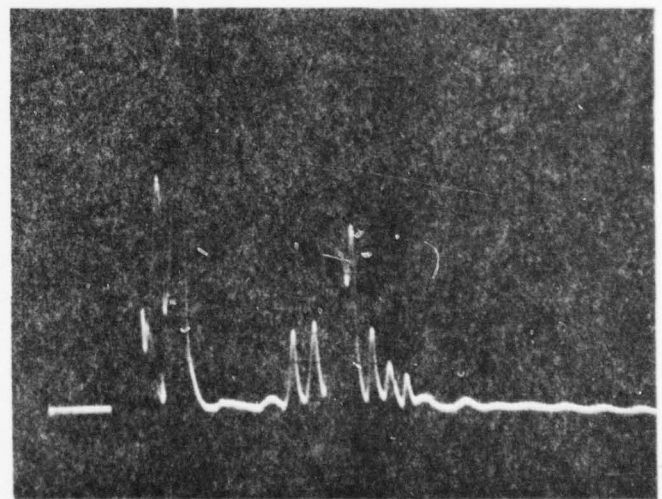
FIGURE A-15: SCOPE DISPLAY OF DEFECT IN AREA 4
