# NAVAL POSTGRADUATE SCHOOL Monterey, California

## THESIS

MICROSTRUCTURAL COMPARISON OF  
 POSITIVE FLOAT AND TRICKLE DISCHARGE  
 OPERATIONS ON THE POSITIVE ELECTRODES  
 OF SUBMARINE STORAGE BATTERIES  
 WITH LEAD-CALCIUM ALLOY GRIDS

Michael Thomas Coyle

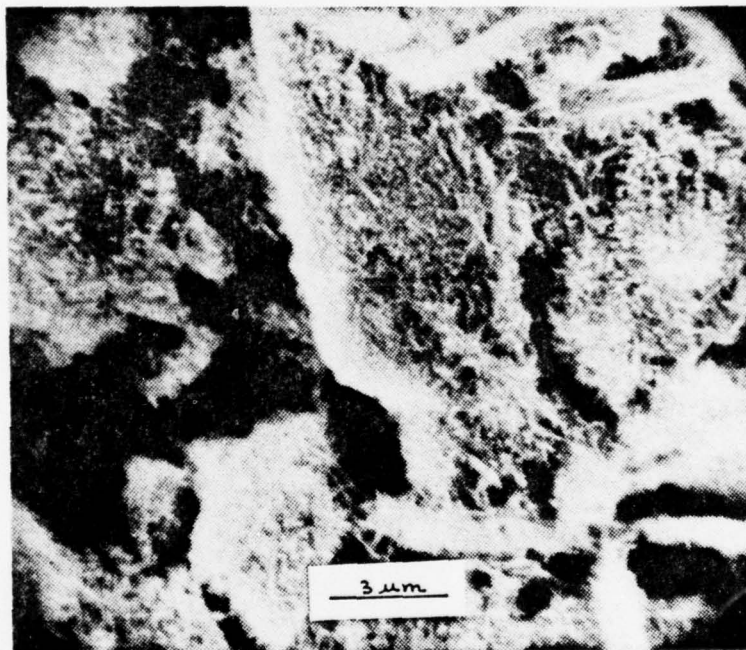
Figure 69 - Active material, 10 cycle PbCa positive plate operated in the trickle discharge routine, plate is fully charged. Substructure of active material showing spiny crystals and some pebbly grains, 5700x.

The active material substructure of floated plates was characterized by the asperity-covered grains previously noted in the corrosion layer. Figure 68 shows a high magnification picture of these grains. In comparison, Figure 69 shows the active material substructure from a trickle discharged plate and a difference in crystalline forms is noted. The trickle discharged plate contains larger linear spiny crystals in addition to some of the asperity-covered grains.
