CCC-CED-76-DTEP-014

DEB STAGE 1-COMUS LINK TESTING
INTERIM REPORT

OCTOBER 1976

HEADQUARTERS
US ARMY COMMUNICATIONS-ELECTRONICS ENGINEERING INSTALLATION AGENCY
Fort Huachuca, Arizona 85613

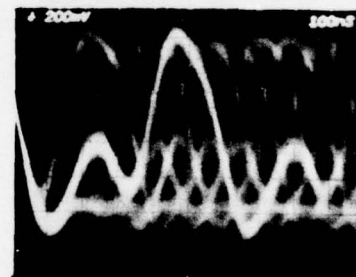
Figure 15. Oscillographs of Eye Patterns for Baseband Repeater Operation

3.4.3.3 Figure 15 includes seven oscillographs of the three-level partial response eye pattern. The clarity and symmetry of these patterns is an indication of the signal quality at each succeeding repeater terminal. Degradation can be seen to accumulate and appear especially poor at Site Sibyl (4th terminal) where interference from another transmitter located at Mount Lemmon was a factor.

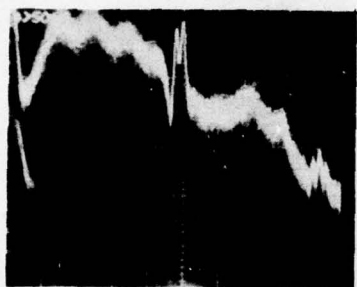
Figure 16. Part I-Oscillographs of Sequential Baseband Spectra
(Repeater Operation)

3.4.3.4 Figure 16 includes ten oscillographs of the baseband spectra. The 8.1 and 8.5 MHz subcarriers are evident as spikes in the spectrum. The shape of the spectrum and lack of distortion products is an indication of signal quality. The degradation as measured in other tests does not appear clearly in these oscillographs as the number of repeaters was increased. NOTE: The slight drop in response evident at the low frequency portion of the spectra is due to test equipment limitations.
