MISCELLANEOUS PAPER S-74-16 ✓

# FIELD TESTS OF THE CUCARACHA FORMATION, PANAMA CANAL, 1942-1946

Conducted by U. S. Army Engineer Waterways Experiment Station  
Soils and Pavements Laboratory  
Vicksburg, Mississippi

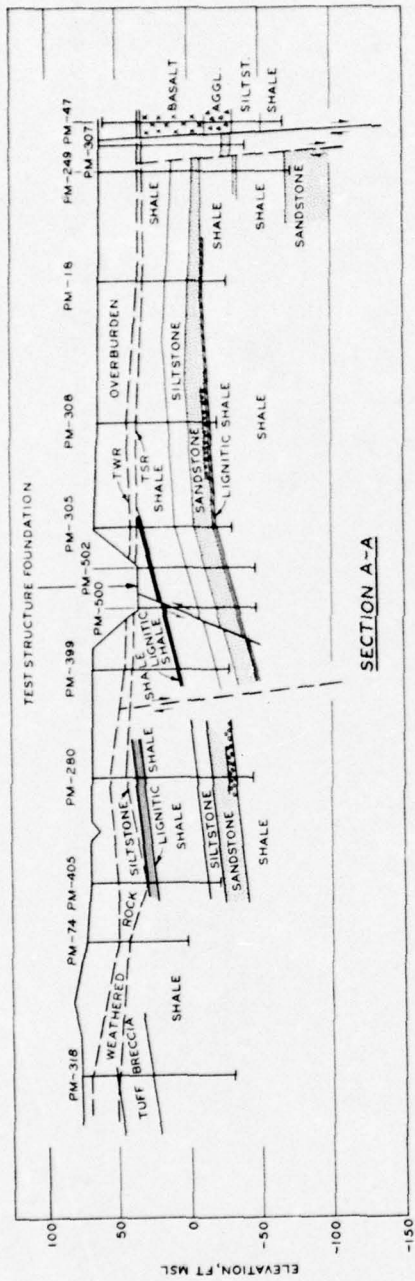
SECTION A-A

SECTION B-B

NOTE: SEE FIG. 3 FOR LOCATIONS.  
 VERTICAL: HORIZONTAL SCALE  
 EXAGGERATION IS 2:1 AS IN  
 FIG. 2.  
 SECTION A-A IS PREFERRED  
 OVER EARLIER INTERPRETATIONS  
 ALONG SAME LINE IN FIG. 2

8. Test Pit No. 3 (excavated in 1942) and the foundation test in 1944 were located on the lines of the right and left lock walls, respectively. Five borings were made near corners of the foundation test base to establish geological details immediately below. The locations of exploratory borings for the lock walls and test excavations and of the additional borings at the foundation test base are shown in fig. 3. Revised geological cross sections through the two test sites are given in fig. 4.

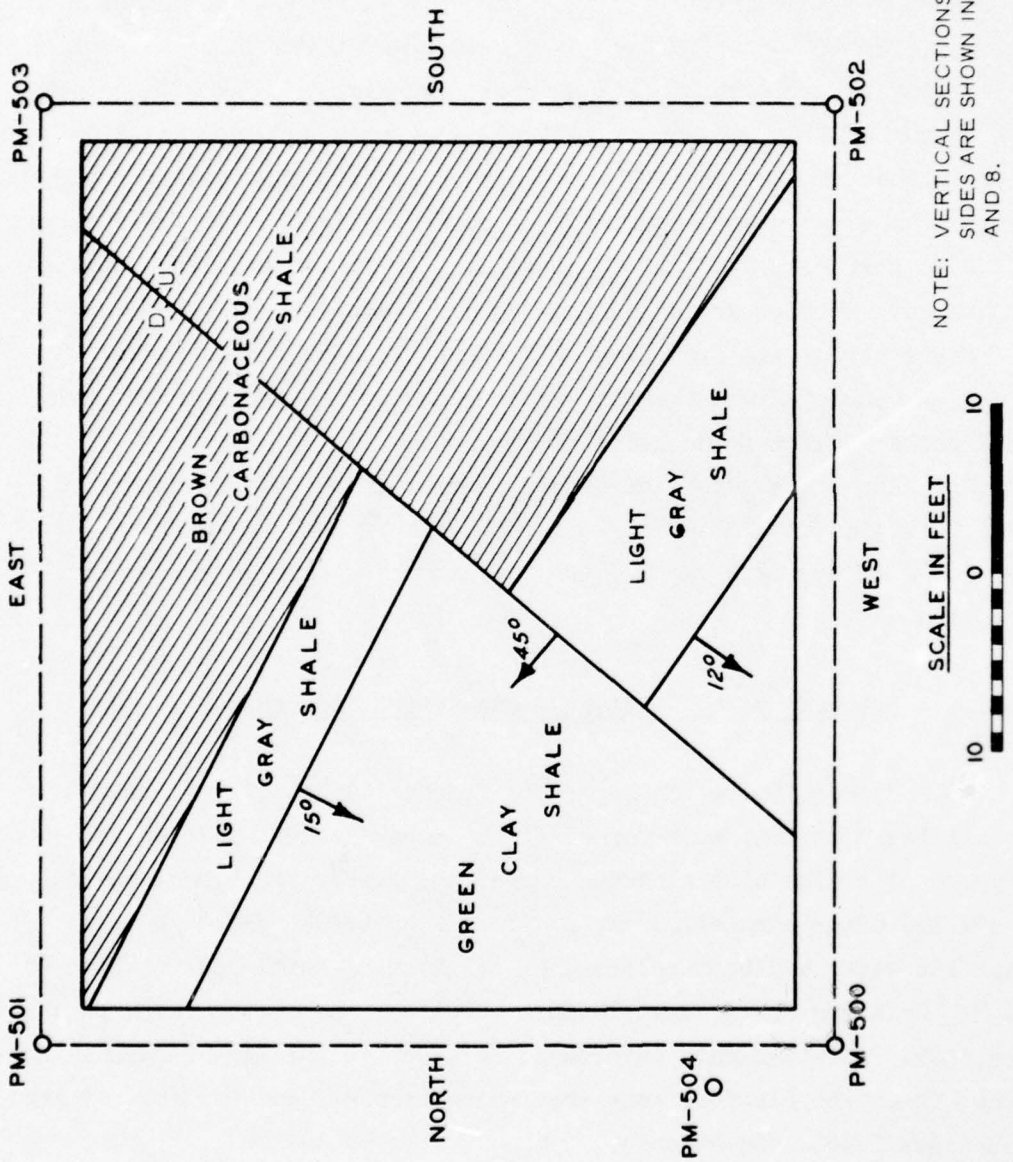
Fig. 6. Geologic plan of test structure base

30. A carbonaceous shale exposed on the test base (fig. 6) was the weakest member, and its presence was believed by Thompson<sup>3</sup> to be the prime factor in the settlement observed (see Part V). Beds of this character occur as lenses scattered throughout the Cucaracha formation along the Panama Canal, but aggregate only about 6 percent of its total thickness and are generally less than 6 ft thick. Stresses created by regional folding have been relieved by slippage along bedding laminae with resultant mashing. This slippage is locally reflected by small seams or lenses of soft, brown carbonaceous clay found at various locations within the beds but without large lateral extent. These interbedded gouge seams are soft and plastic, and because of their considerable organic content absorb much water after release of confining pressure.

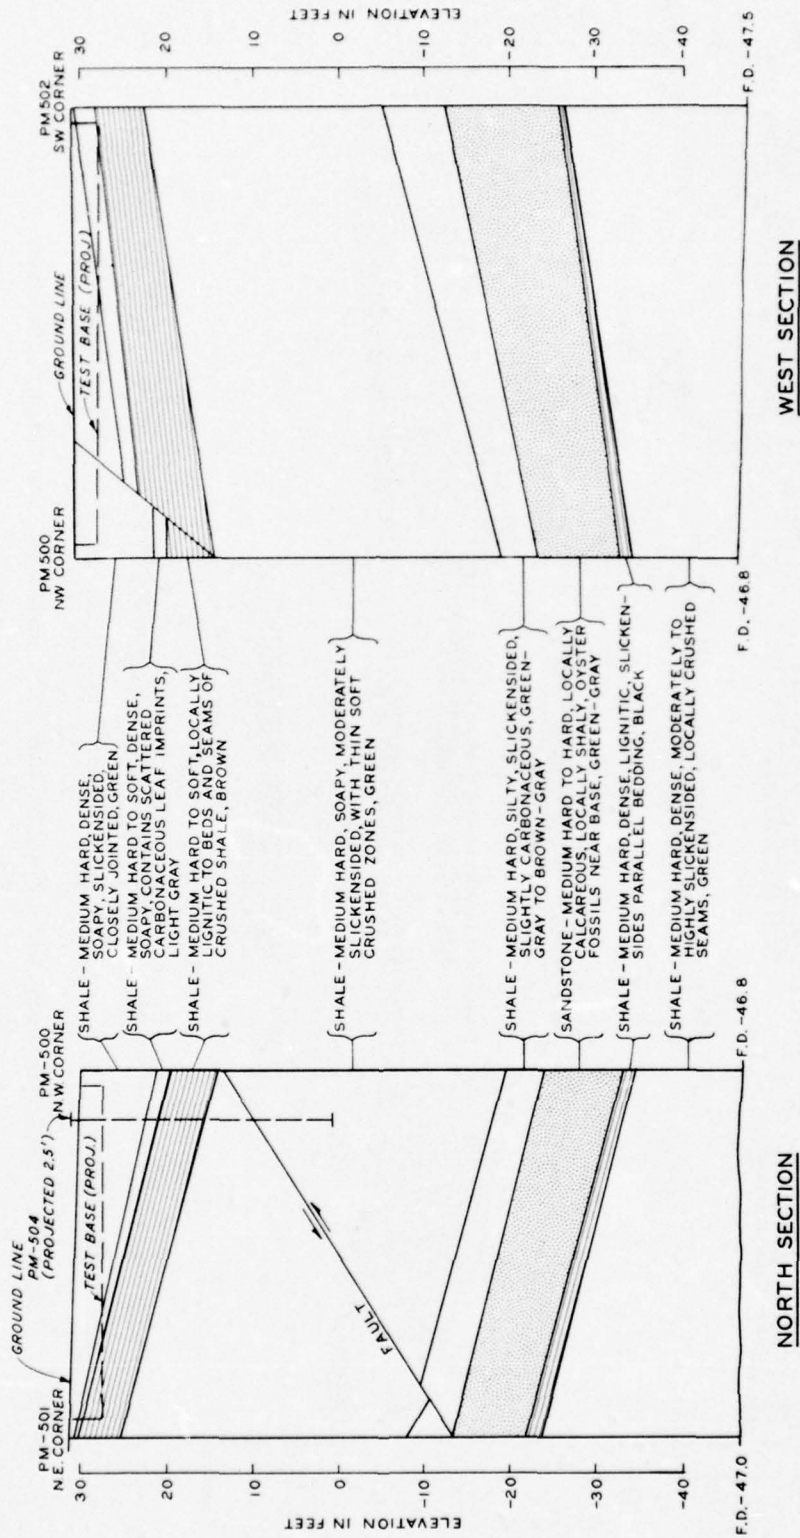
Fig. 7. Geologic sections of north and west sides of test structure base

32. Green shale, three beds of which were encountered (figs. 7 and 8), was similar to typical shale of the Cucaracha. Strength of the green shale varies depending on slickenside spacing and degree of

33. The green-gray sandstone bed shown on figs. 7 and 8 has a maximum thickness of about 12-1/2 ft. The rock is variably calcareous and argillaceous and accordingly has a considerable range in strength. Its subsurface trend along the right wall of the proposed New Pedro Miguel Lock (fig. 6) can be traced 650 ft southeast, and it thins considerably in that direction. This bed is the strongest revealed in foundation test borings and is comparable in strength to similar units occurring in the lower third of the Cucaracha formation and the upper portion of the Culebra. Thickness variations beneath the test site reflected the presence or absence of shaly interbeds. A layer rich in oyster shells was used as a reference in determining the subsurface structure.

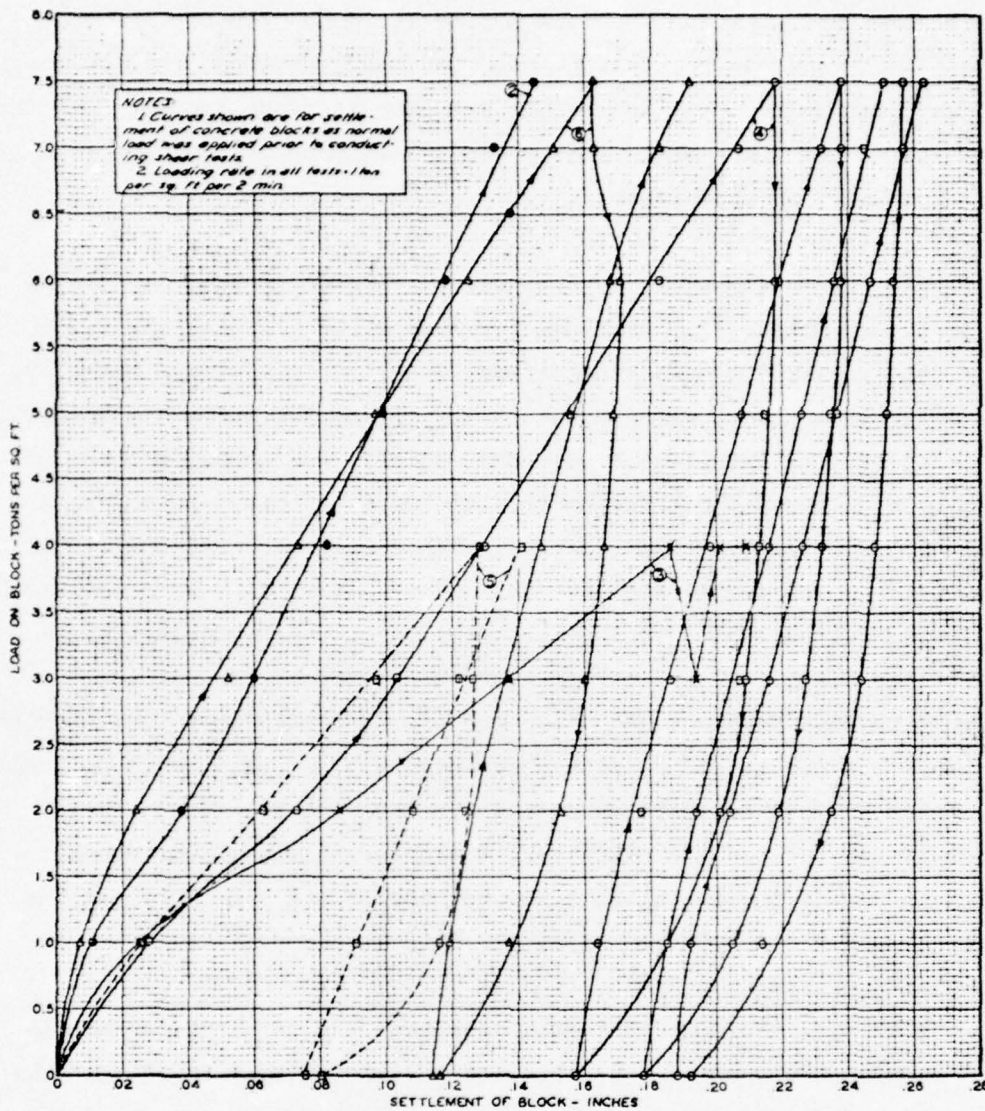
Fig. 9. Load versus settlement of concrete blocks prior to conducting field shear tests, Pedro Miguel Test Pit No. 3

settlement tests are shown in fig. 9 and table 1.

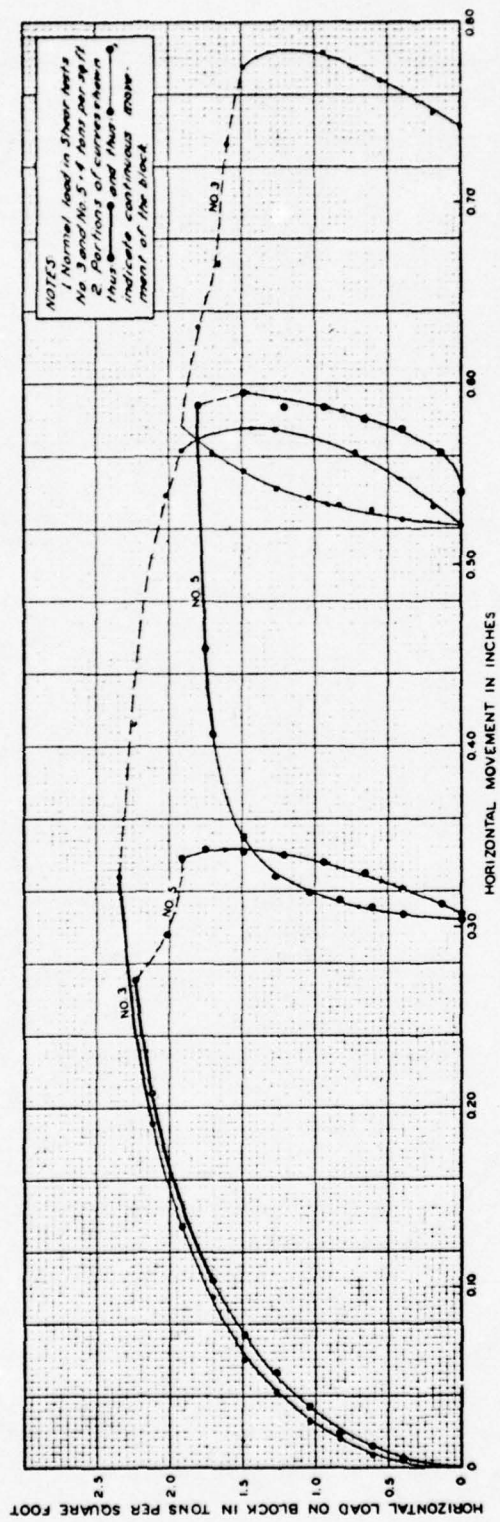
Fig. 10. Load versus movement, field shear tests 3 and 5, Pedro Miguel Test Pit No. 3

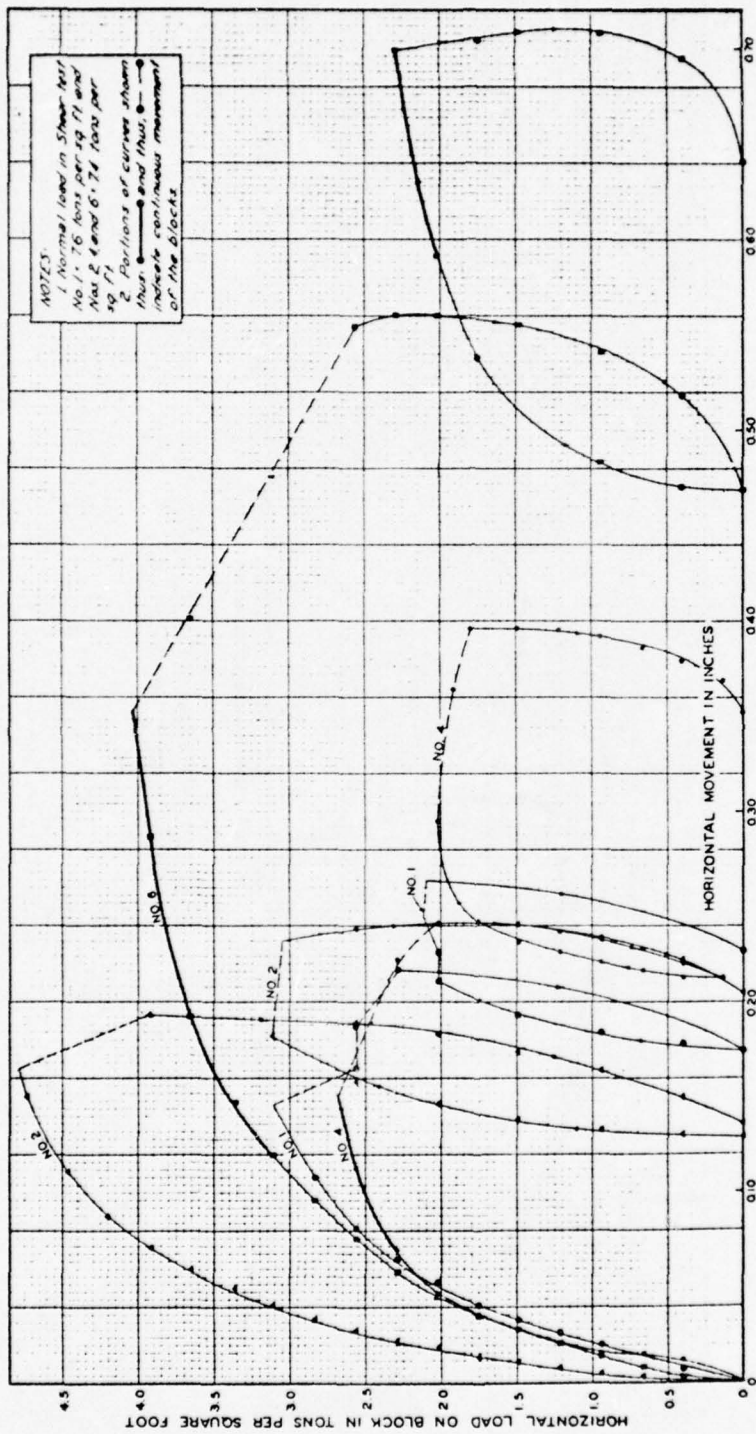
Fig. 11. Load versus movement, field shear tests 1, 2, 4, and 6, Pedro Miguel Test Pit No. 3

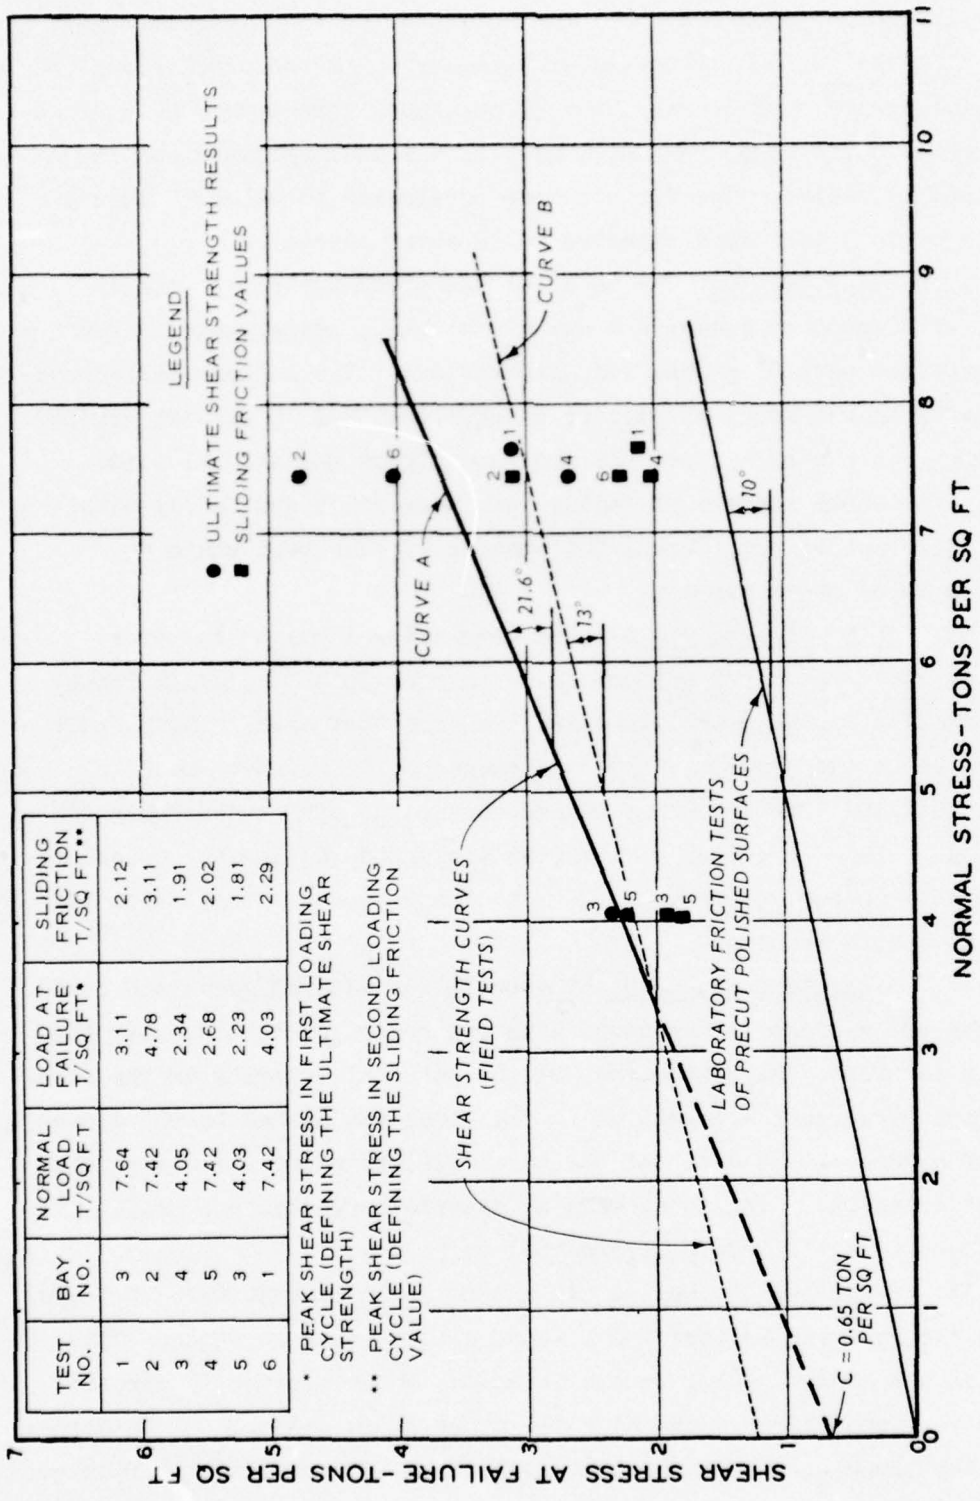
Fig. 12. Shear strength curves for field tests and laboratory friction tests, Pedro Miguel Test Pit No. 3

48. Fig. 12 shows that good agreement was obtained between the two tests at 4-tsf normal load but the ultimate strengths of the four tests at 7.5-tsf normal load varied over a large range. An analysis of the variations in the material and of the irregularities in the type of failure produced in each test was made in an effort to determine which, if any, of the tests could be omitted as not representative. A summary of the factors considered is presented in the following paragraphs.

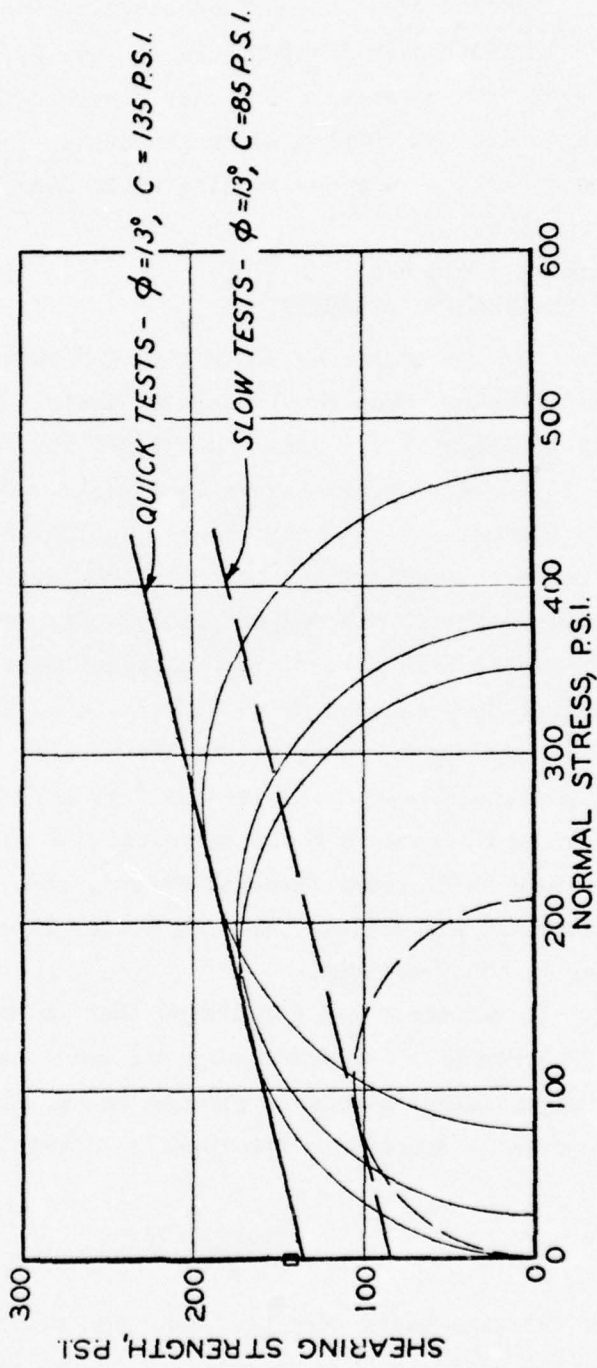
LATERAL STRESS P. S. I.	LOADING RATE	ULTIMATE STRENGTH				NO. TESTS
		MAX. P. S. I.	MIN. P. S. I.	MEAN P. S. I.	AVE. P. S. I.	
0	SLOW	463	69	210	214	20
0	QUICK	550	138	338	349	14
25	"	623	147	310	374	9
75	"	609	317	449	468	9
SINGLE SHEAR	"	215	78	151	144	5

NOTES:  
 FULL DEFORMATION UNDER EACH INCREMENT OF LOAD IN SLOW TESTS  
 AVERAGE STRENGTHS USED IN MOHR'S CIRCLE PLOTS.  $\phi = 13^\circ$  ASSUMED FOR SLOW TESTS  
 AVERAGE OF SINGLE SHEAR TESTS SHOWN THUS  $\phi$

61. Results of 34 unconfined compression tests (14 quick and 20 slow) are summarized in tabular form in fig. 13, and average values are plotted as Mohr's circles in the same figure. Test data included in the averages are for samples generally better than the average clay shale and do not include any results which were known to be influenced by slickensides.

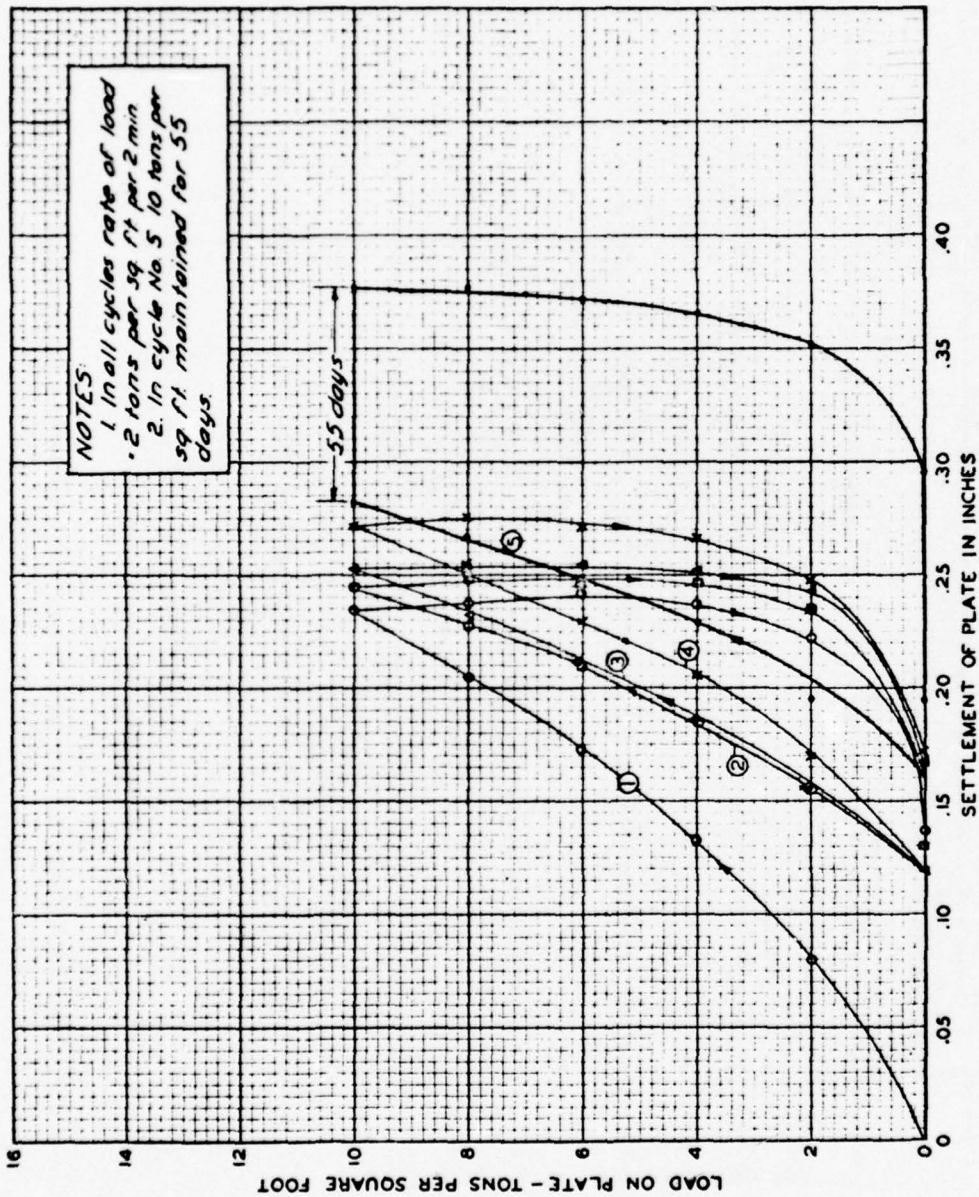
Fig. 14. Load versus settlement, 40-in.-diam plate bearing test, Pedro Miguel Test Pit No. 3

71. A total of five bearing tests on circular plates were performed in the field. Tables 2 and 3 are summaries of the results of these tests. Figs. 14-21 show the load versus settlement curves, and figs. 22-27 show the time versus settlement curves.

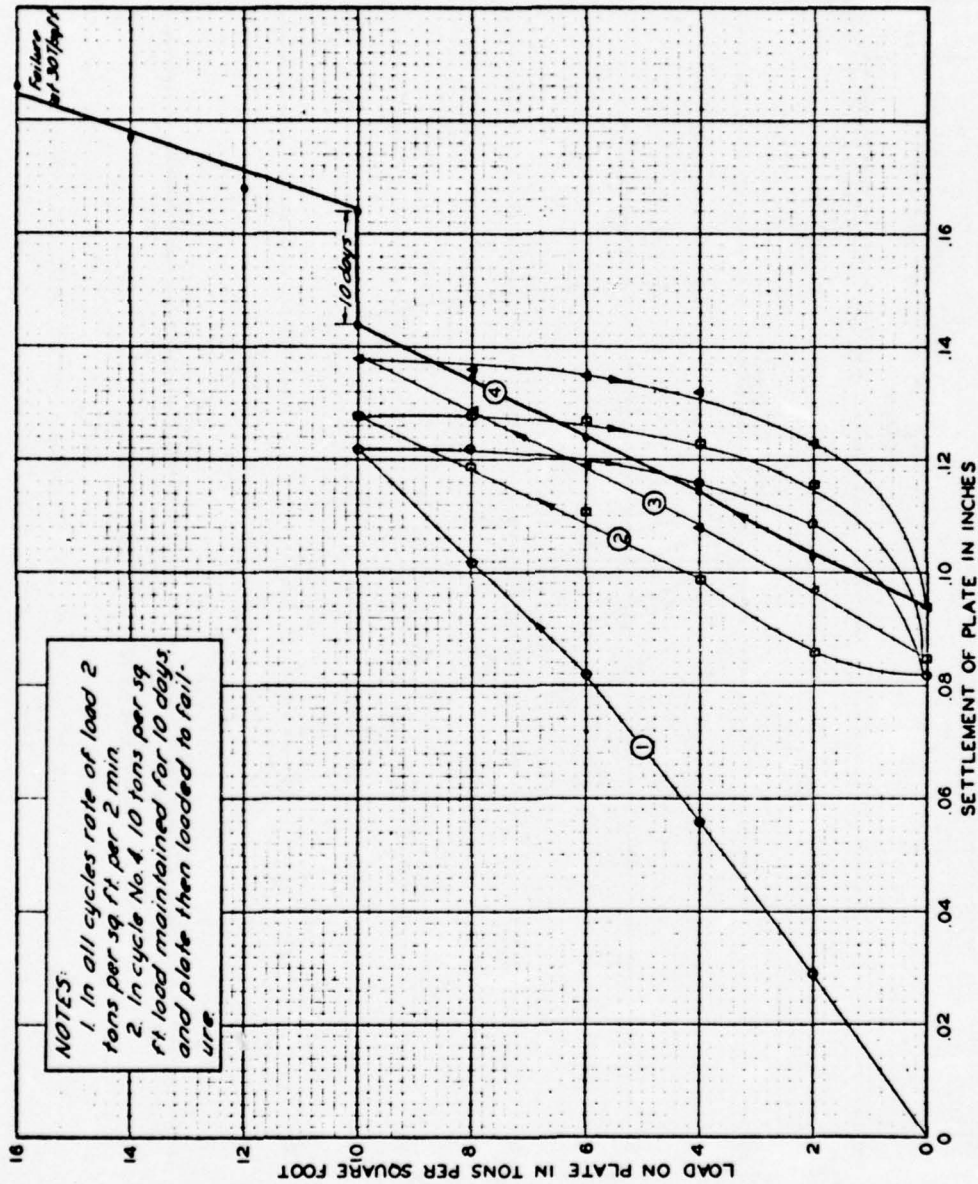
Fig. 15. Load versus settlement, 16-in.-diam plate bearing test, Pedro Miguel Test Pit No. 3

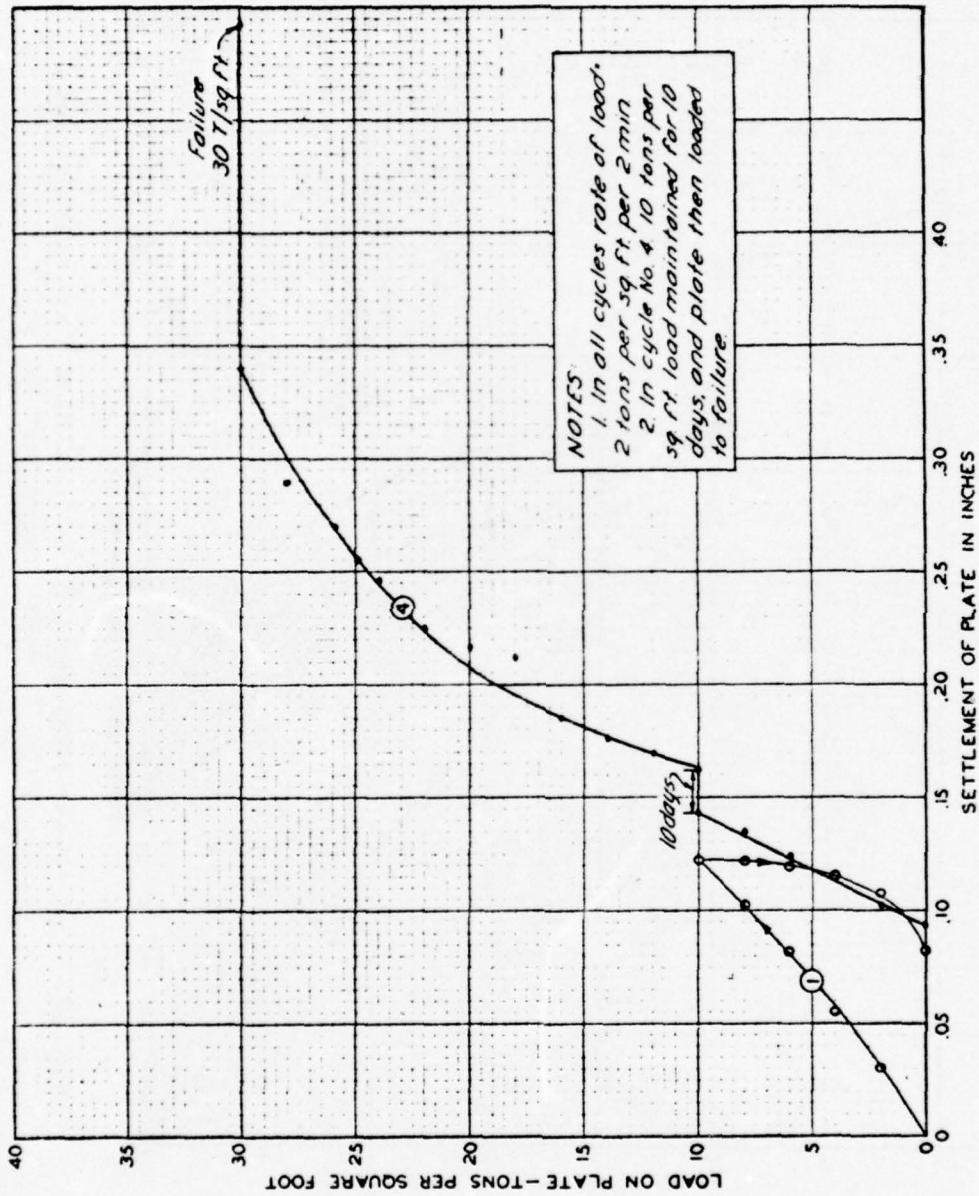
NOTES:  
 1. In all cycles rate of load.  
 2 tons per sq ft per 2 min  
 2. In cycle No 4 10 tons per  
 sq ft load maintained for 10  
 days, and plate then loaded  
 to failure

Fig. 16. Load versus settlement, 16-in.-diam plate bearing test, Pedro Miguel Test Pit No. 3

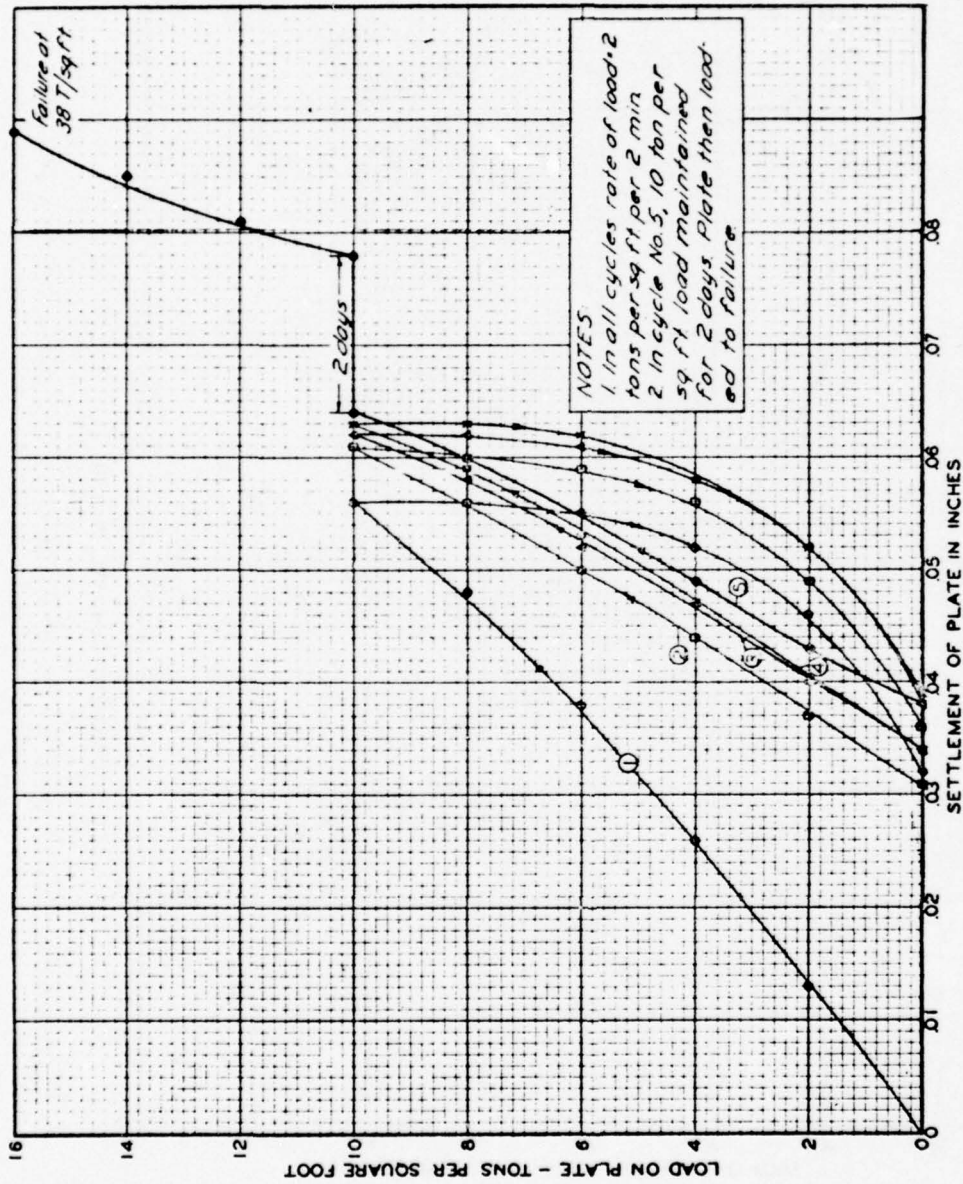
Fig. 17. Load versus settlement, first 8-in.-diam plate bearing test (cycles 1 and 5), Pedro Miguel Test Pit No. 3

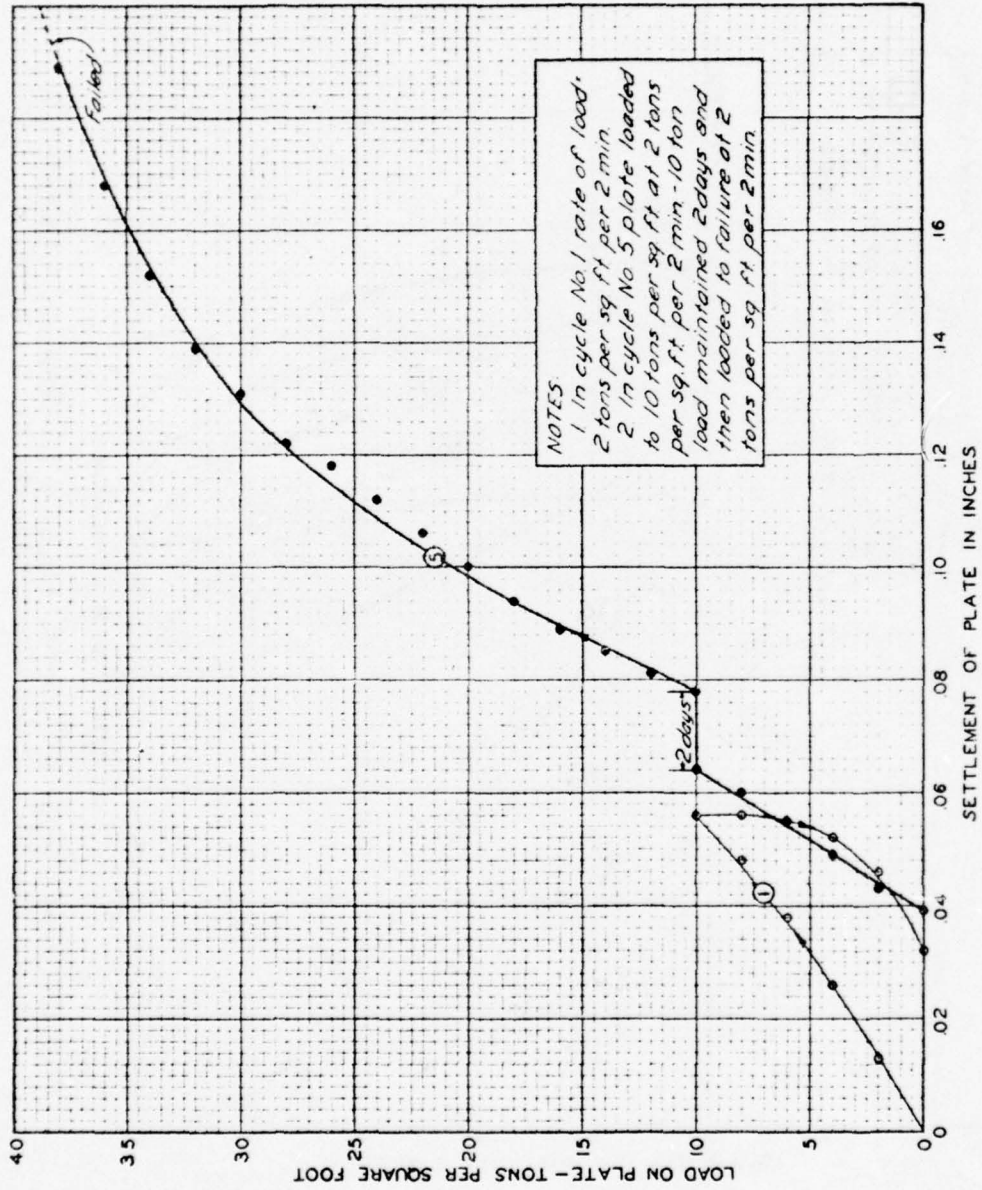
Fig. 18. Load versus settlement, first 8-in.-diam plate bearing test (cycles 1 and 5), Pedro Miguel Test Pit No. 3

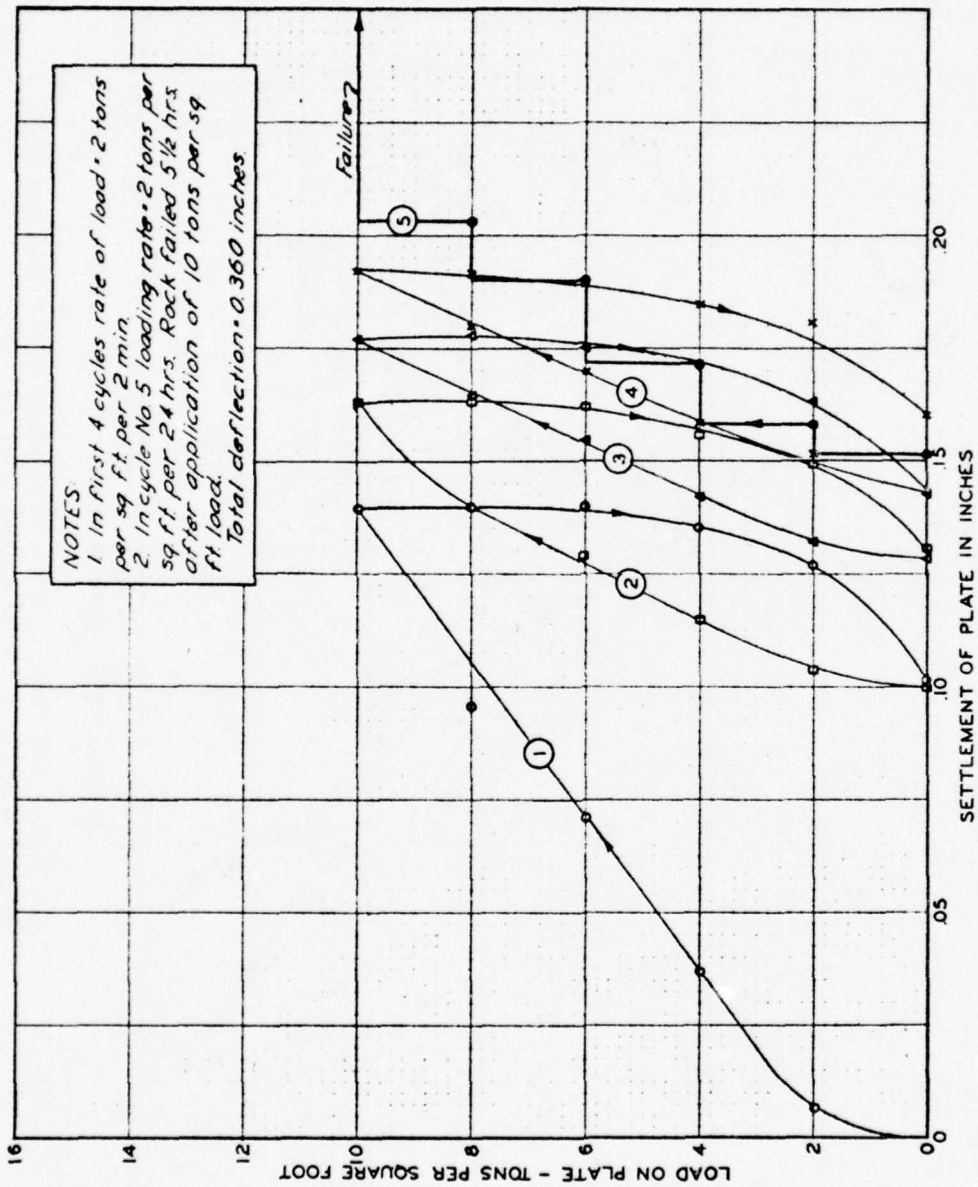
Fig. 19. Load versus settlement, second 8-in.-diam plate bearing test, Pedro Miguel Test Pit No. 3

72. The ultimate bearing value of 10 tsf obtained from the second test of the 8-in.-diam plate is not considered to be representative of the mass, since it was performed in the same bay as the test of the 40-in.-diam plate. Since the 10-tsf load was maintained for 55

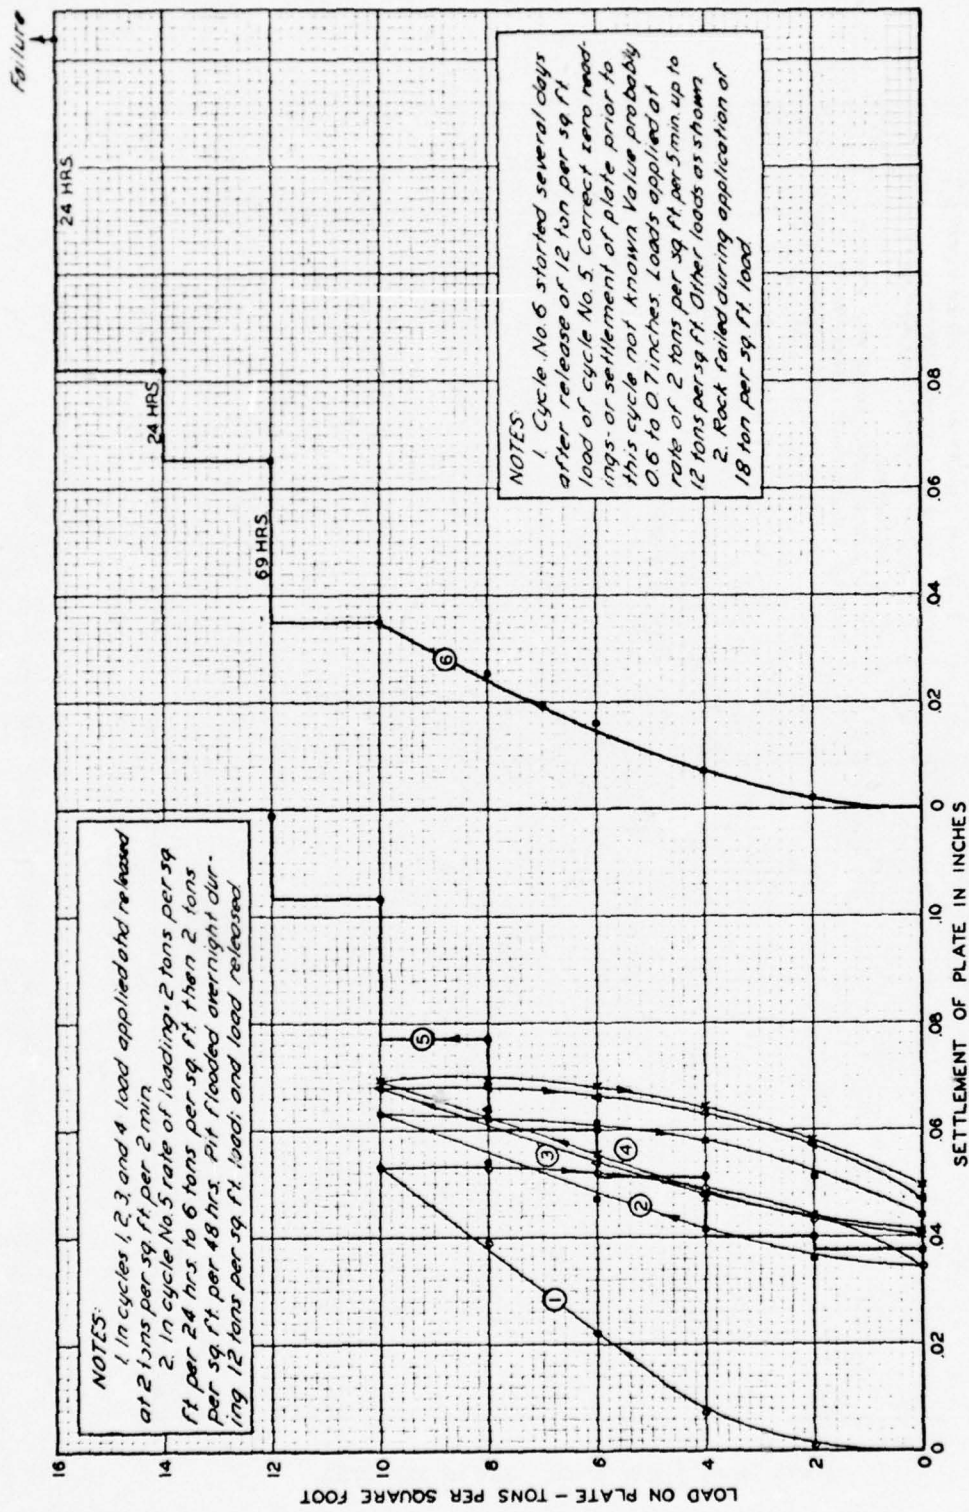
Fig. 20. Load versus settlement, third 8-in.-diam plate bearing test, Pedro Miguel Test Pit No. 3

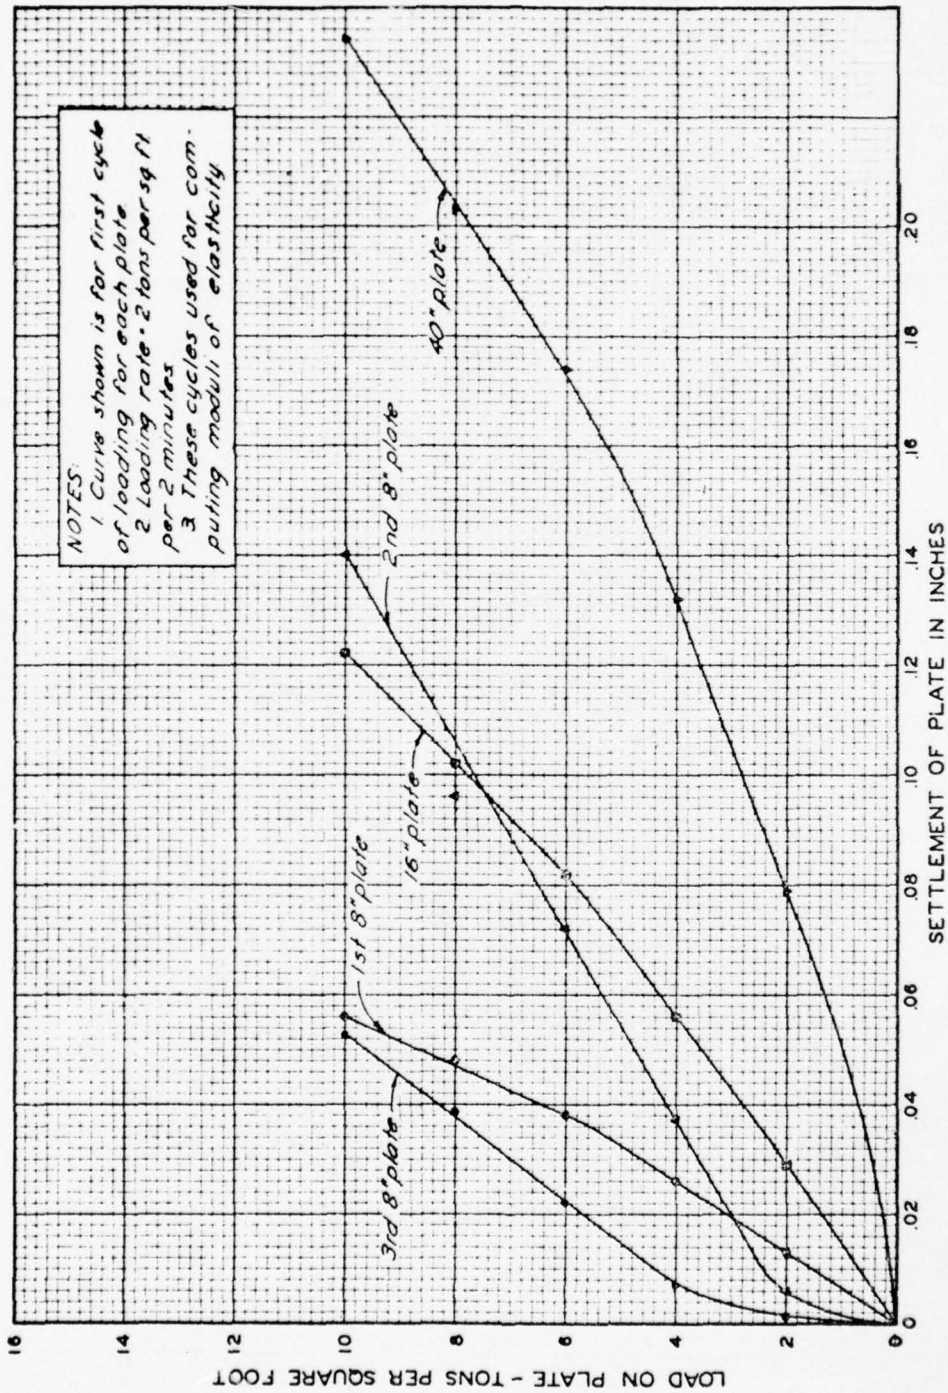
Fig. 21. Load versus settlement, first loading cycle for all field plate bearing tests, Pedro Miguel Test Pit No. 3

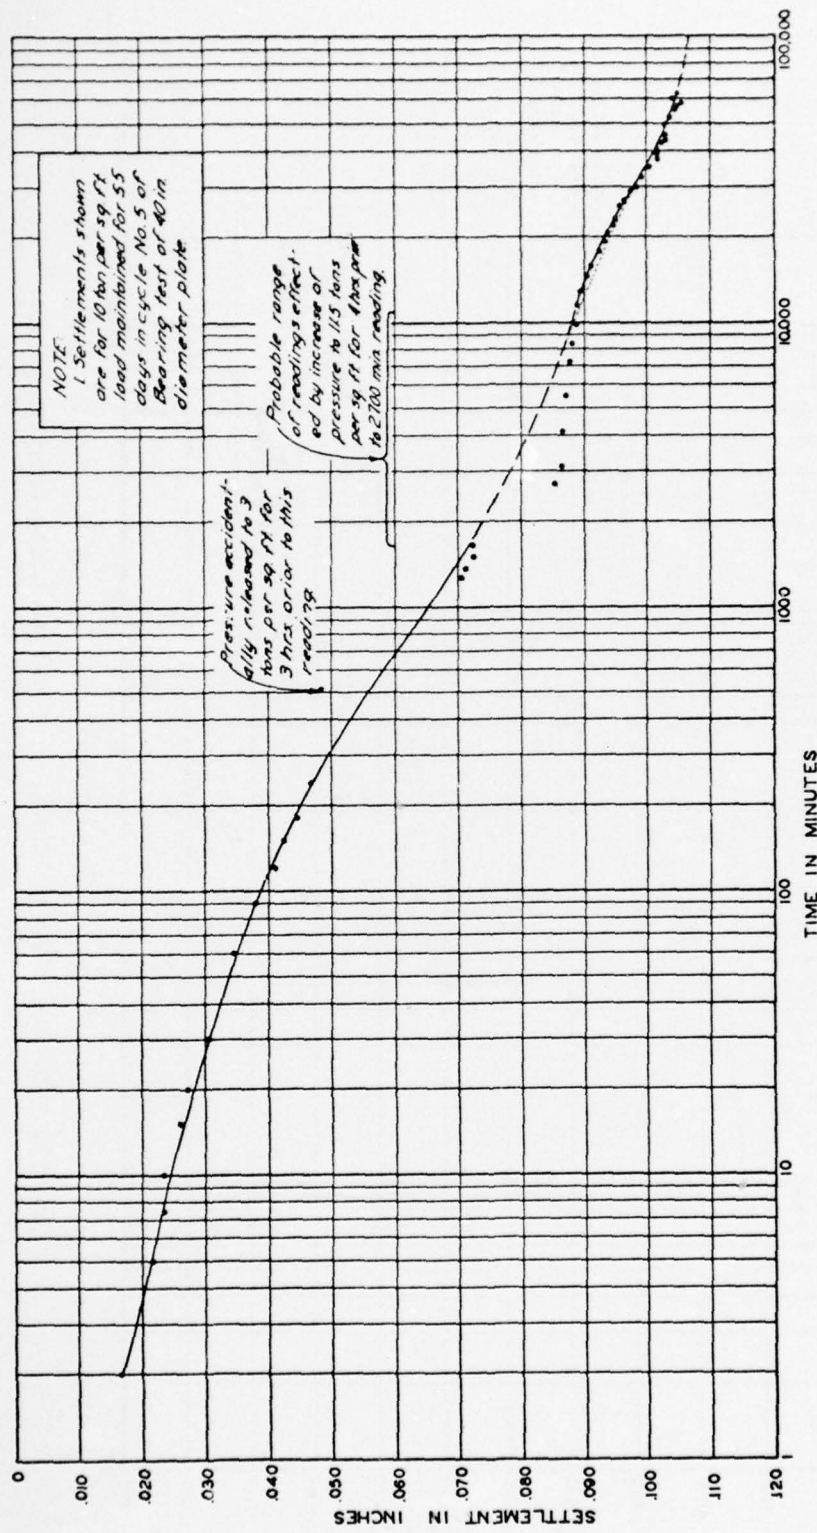
Fig. 22. Time-settlement curve, 40-in.-diam plate bearing test, Pedro Miguel Test Pit No. 3

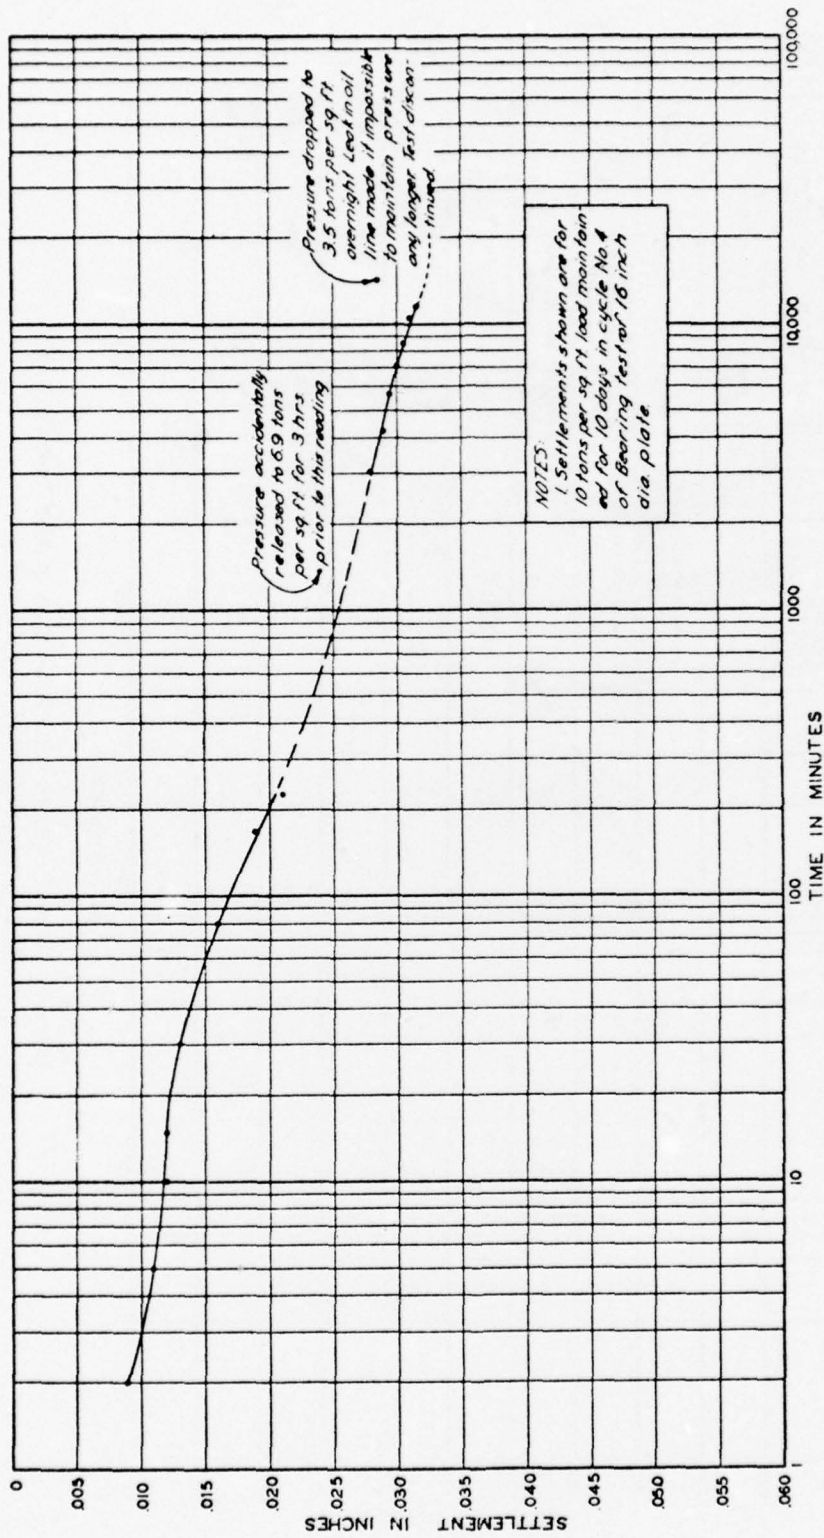
Fig. 23. Time-settlement curve, 16-in.-diam plate bearing test, Pedro Miguel Test Pit No. 3
