MISCELLANEOUS PAPER S-74-16 ✓

# FIELD TESTS OF THE CUCARACHA FORMATION, PANAMA CANAL, 1942-1946

Conducted by U. S. Army Engineer Waterways Experiment Station  
Soils and Pavements Laboratory  
Vicksburg, Mississippi

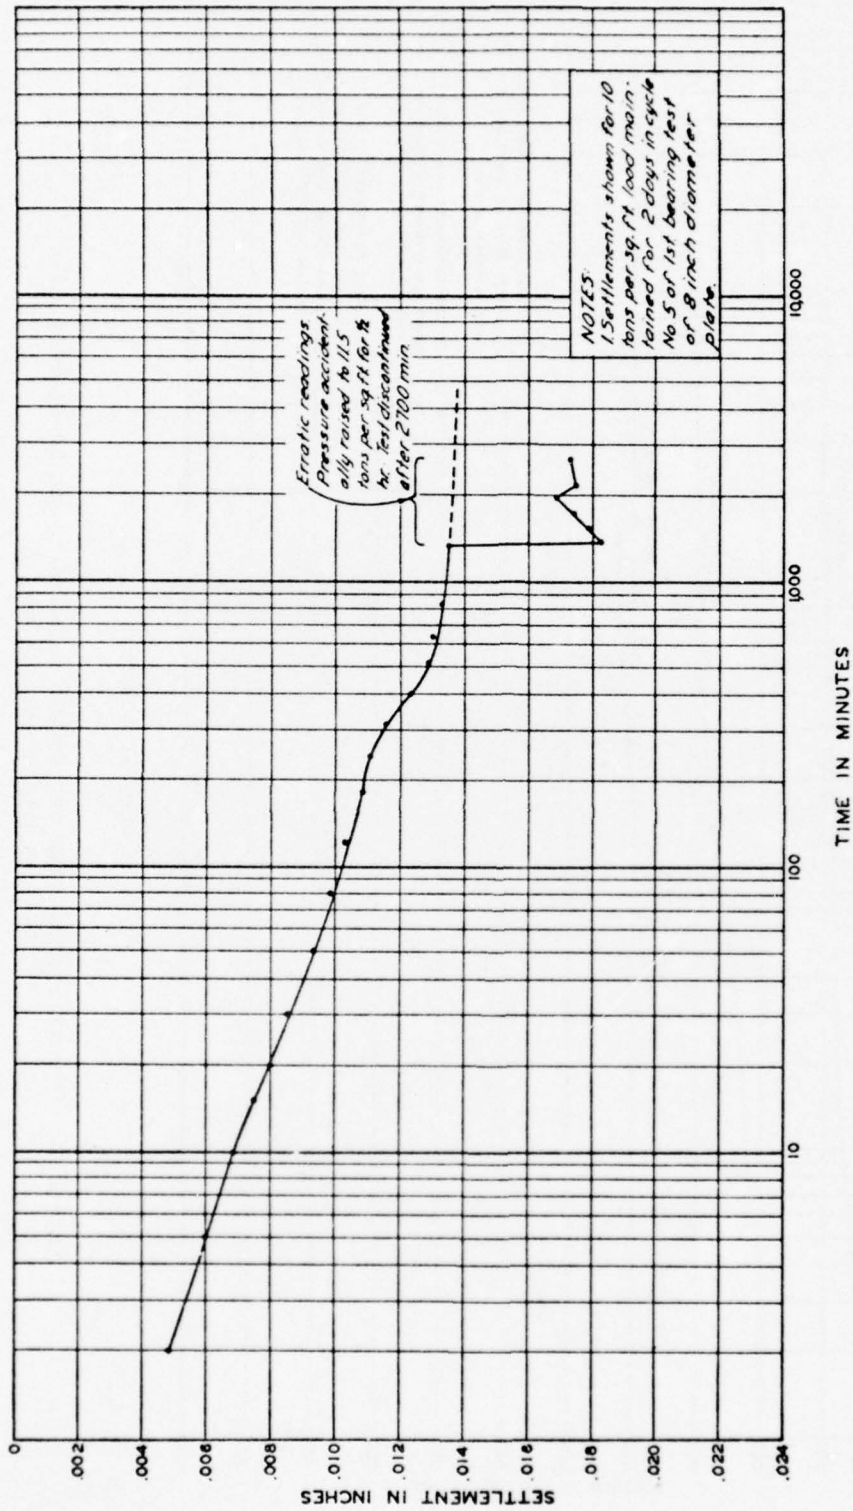
Fig. 24. Time-settlement curve, first 8-in.-diam plate bearing test,  
Pedro Miguel Test Pit No. 3

71. A total of five bearing tests on circular plates were performed in the field. Tables 2 and 3 are summaries of the results of these tests. Figs. 14-21 show the load versus settlement curves, and figs. 22-27 show the time versus settlement curves.

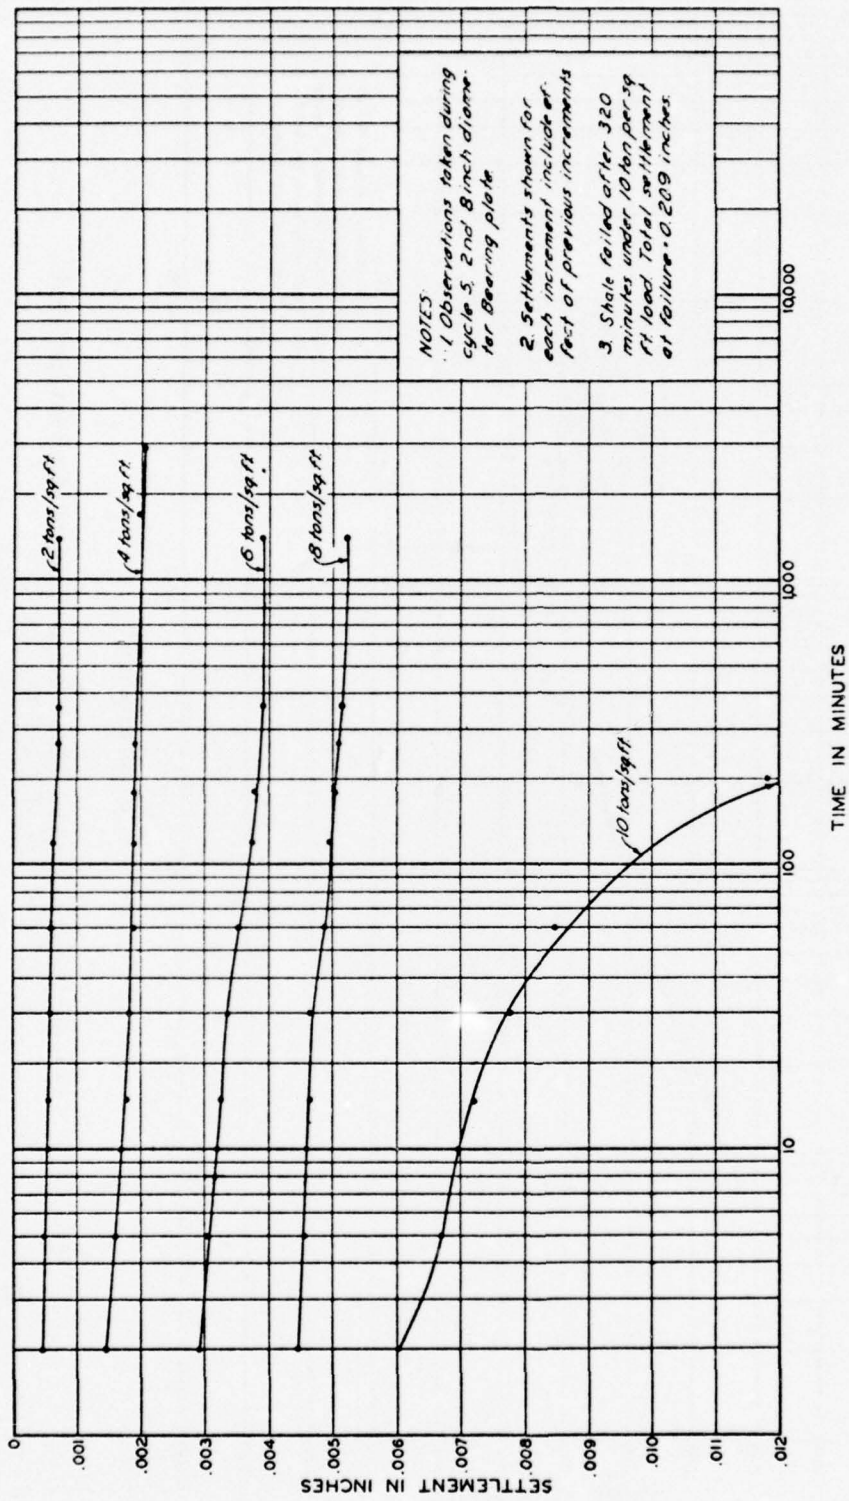
Fig. 25. Time-settlement curves, second 8-in.-diam plate bearing test, Pedro Miguel Test Pit No. 3

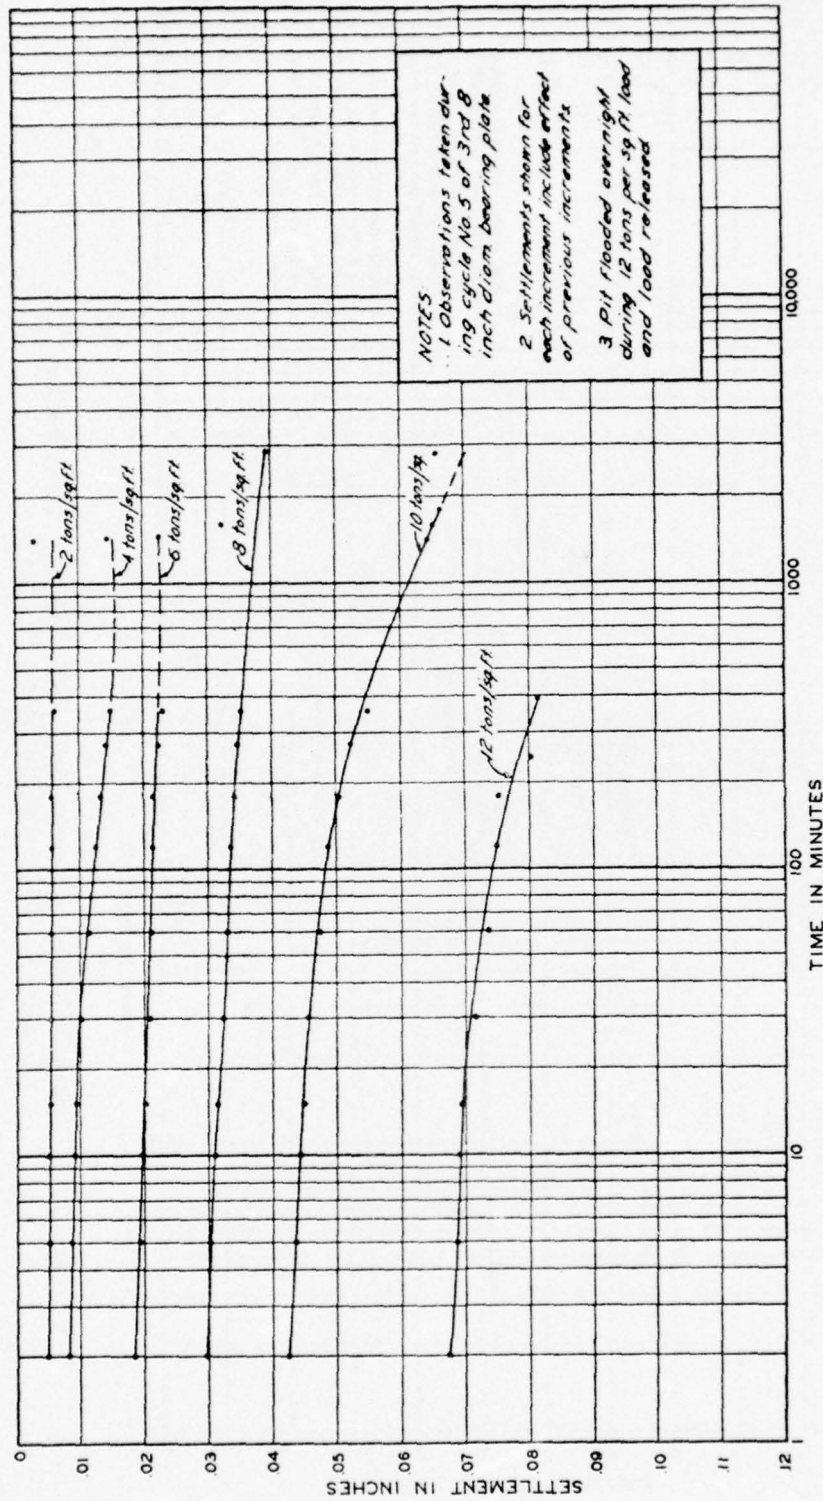
Fig. 26. Time-settlement curves, third 8-in.-diam plate bearing test (cycle 5), Pedro Miguel Test Pit No. 3

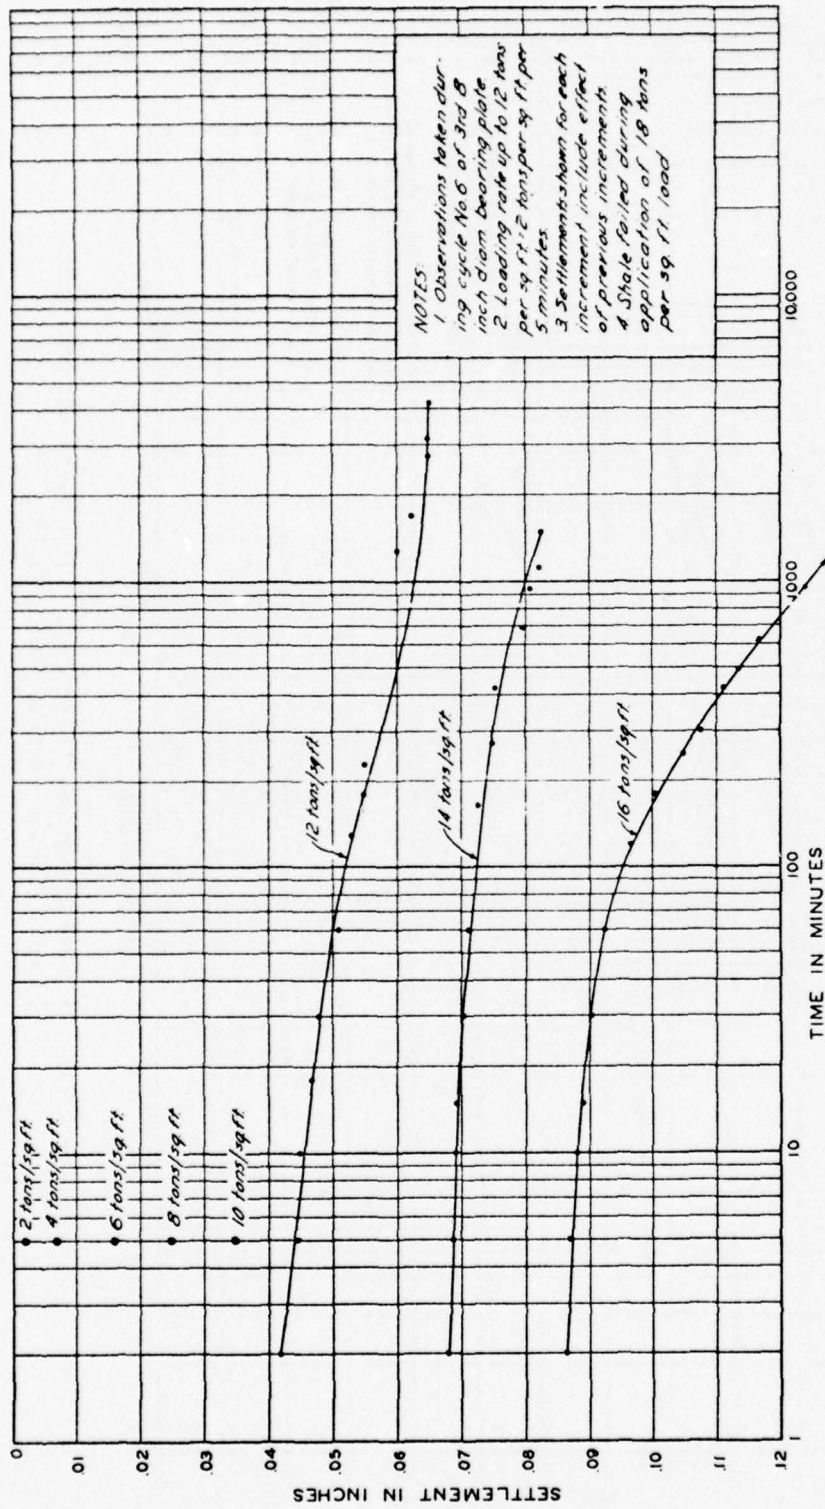
Fig. 27. Time-settlement curves, third 8-in.-diam plate bearing test (cycle 6), Pedro Miguel Test Pit No. 3

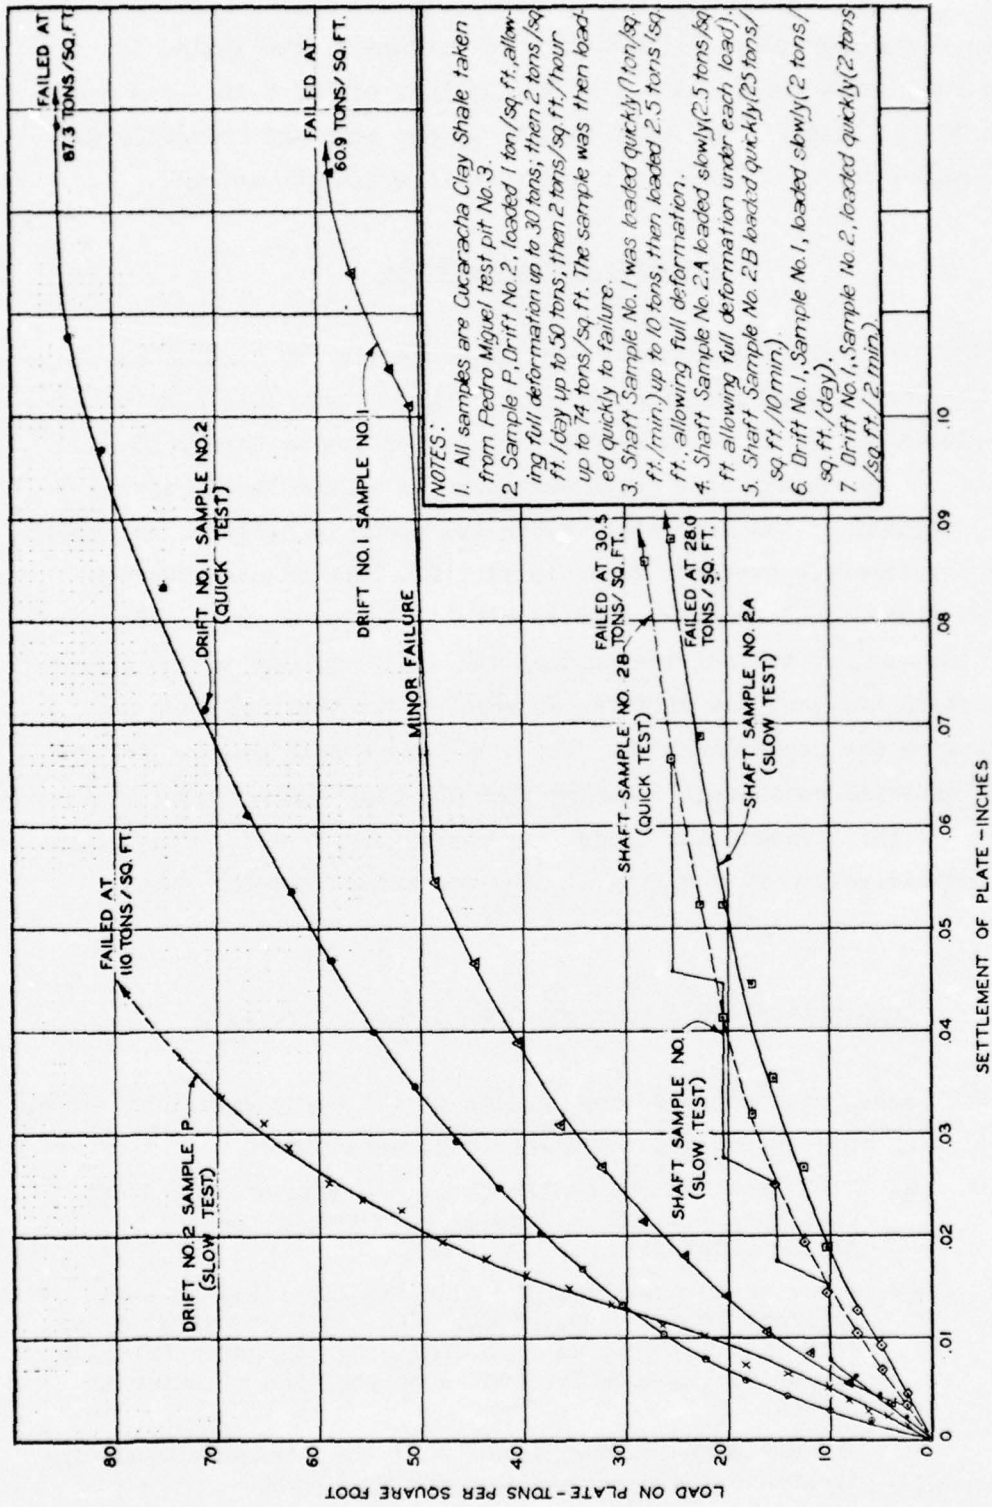
Fig. 28. Load versus settlement, laboratory plate bearing tests, Pedro Miguel Test Pit No. 3

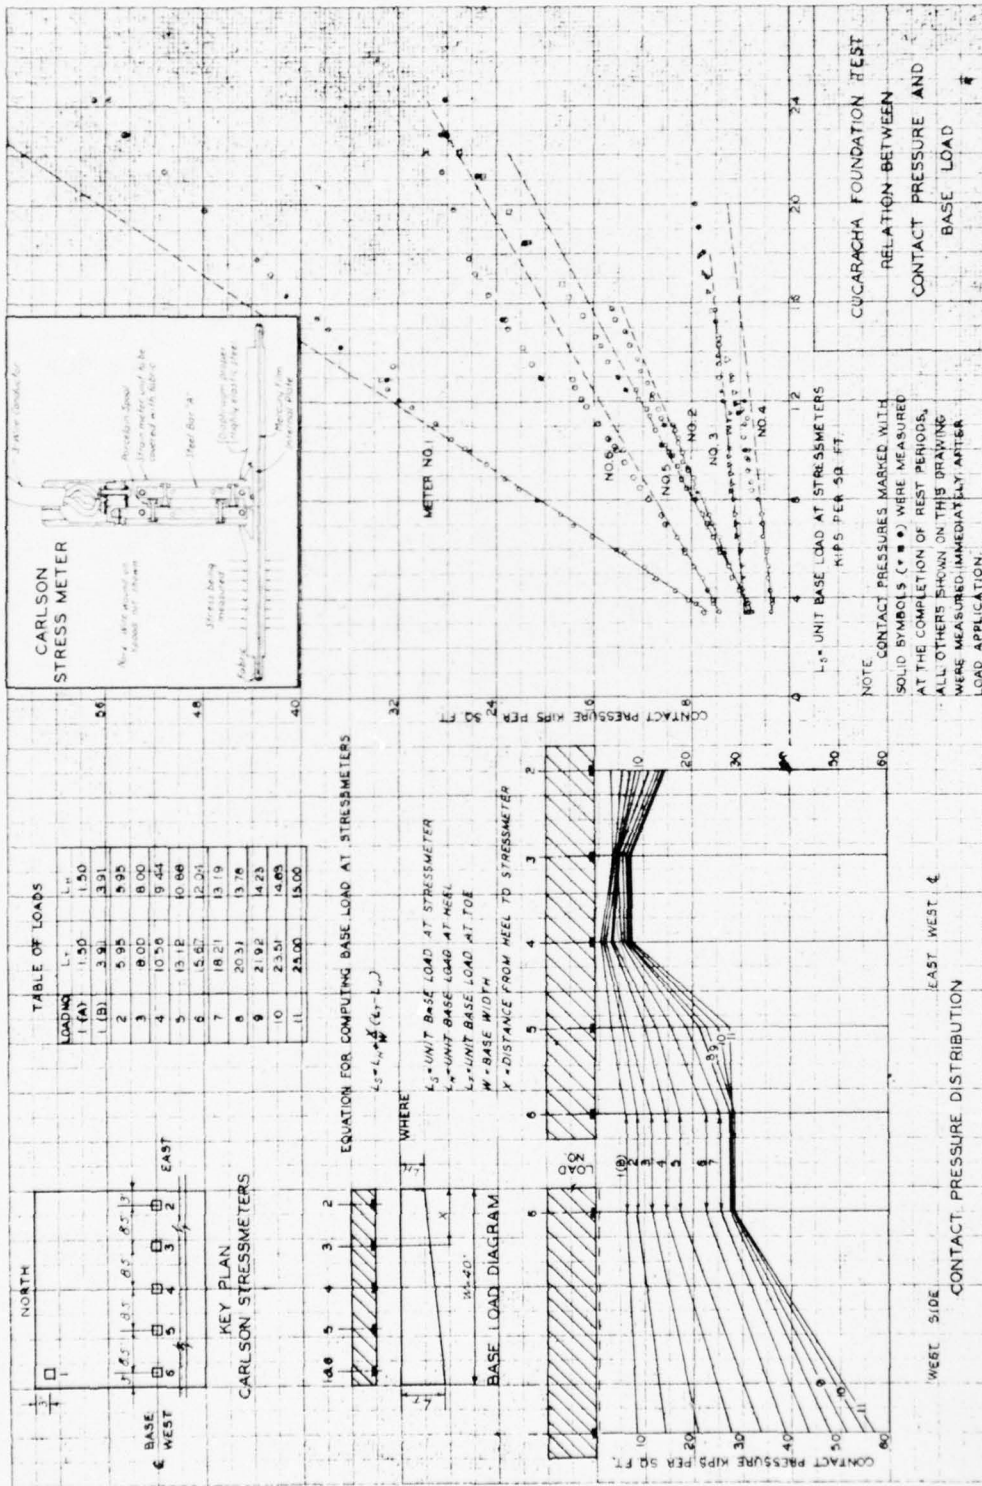
Fig. 31. Contact pressures and base loads

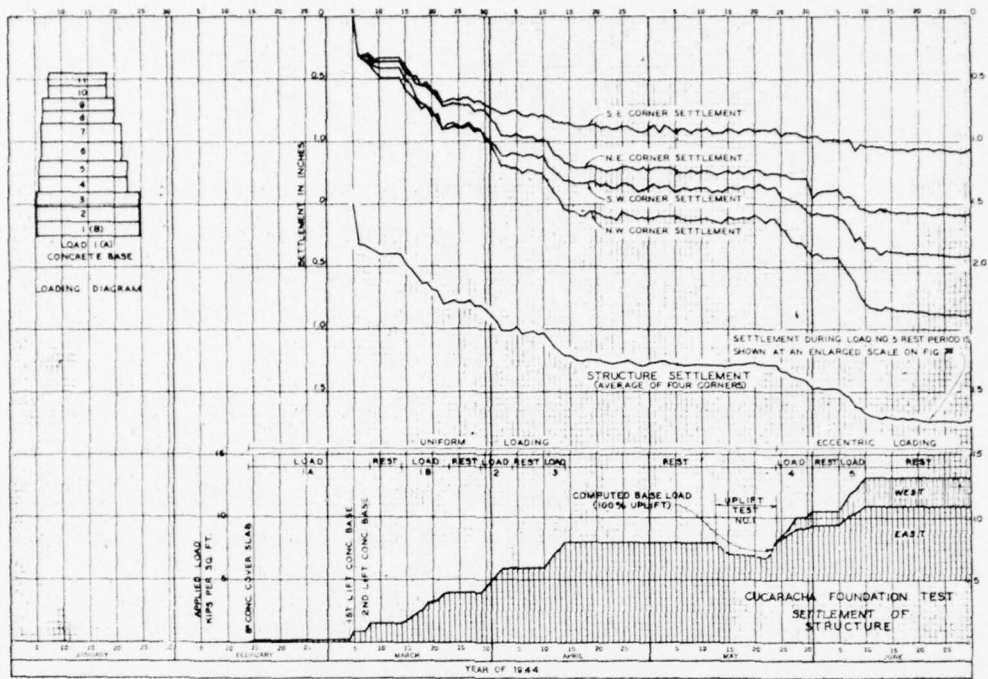
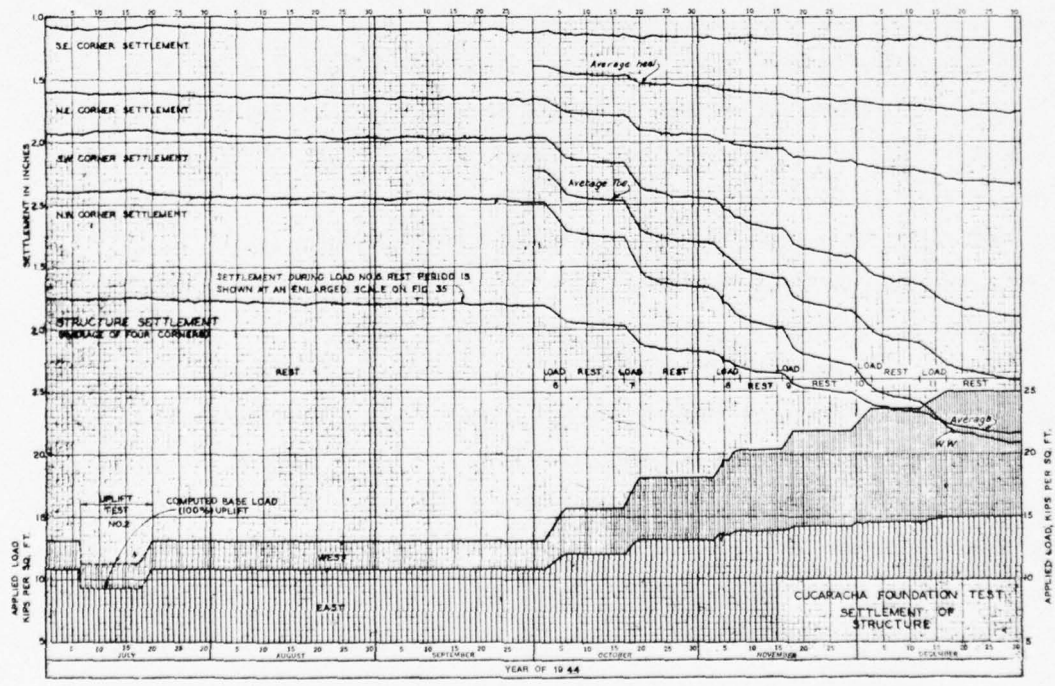
Fig. 32. Settlement of test structure during 1944

83. Settlement of the test structure was influenced by the soft plastic carbonaceous layer which dipped below the northwest corner. The settlement at this corner was approximately 3-1/2 times the settlement observed at the southeast corner, which is underlain to a great depth with typical gray-green Cucaracha. The base of the structure

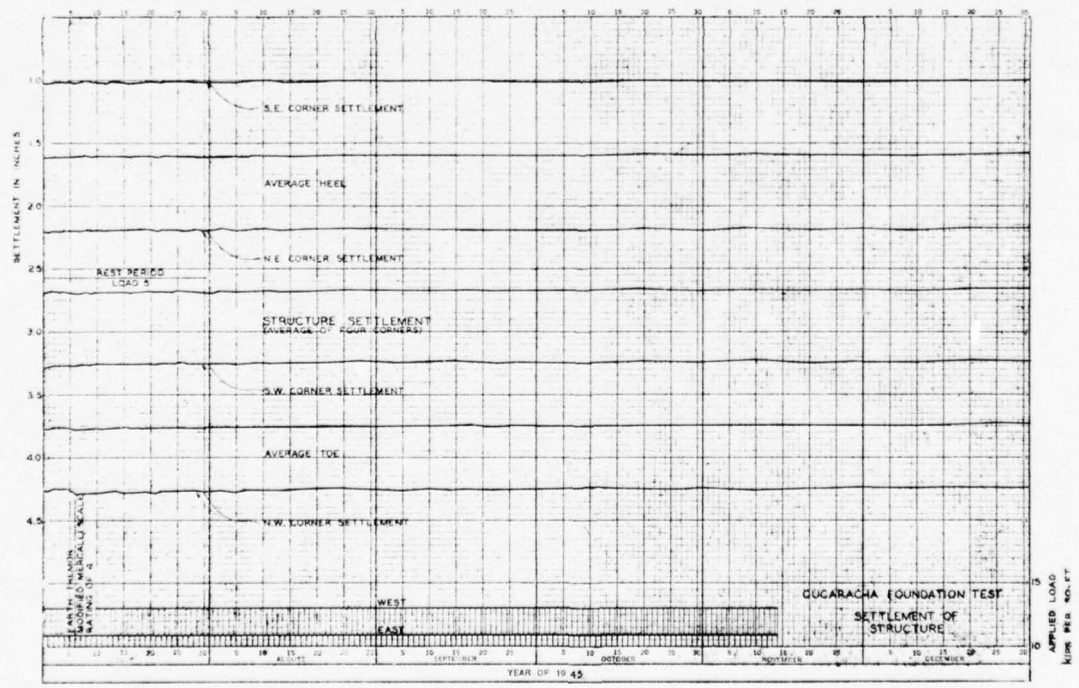
Fig. 33. Settlement of test structure during 1945

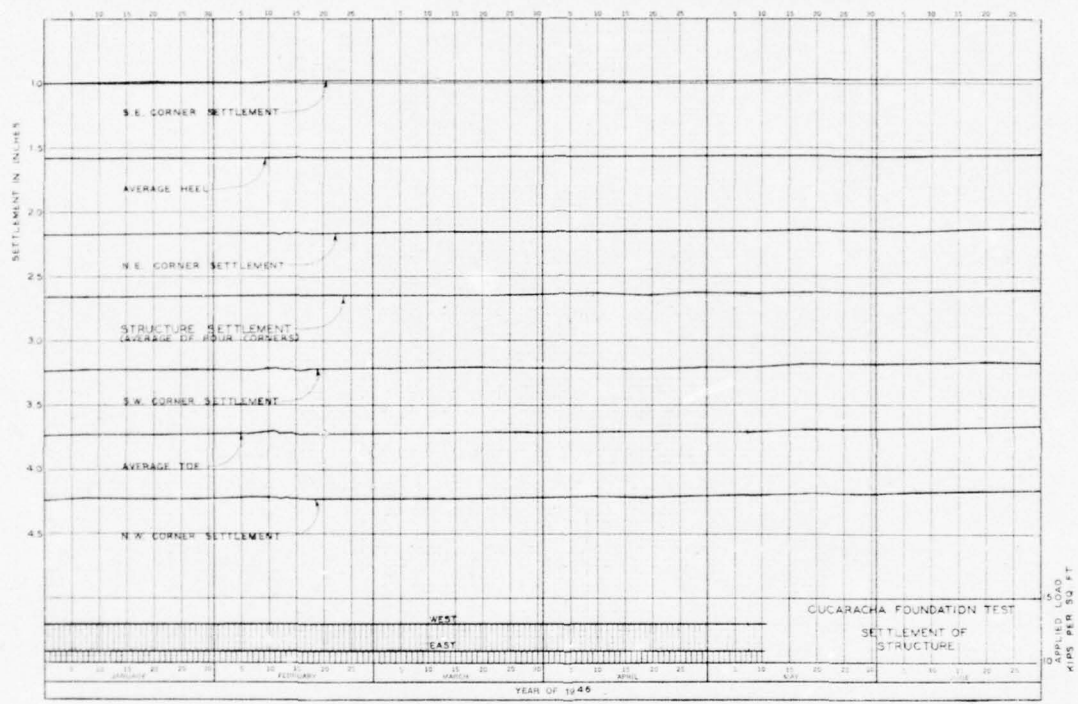
Fig. 34. Settlement of test structure, January-May 1946

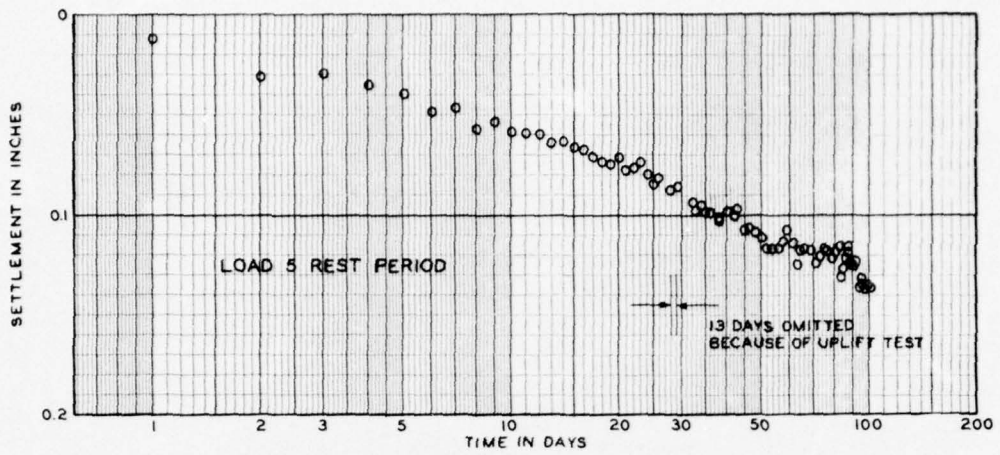
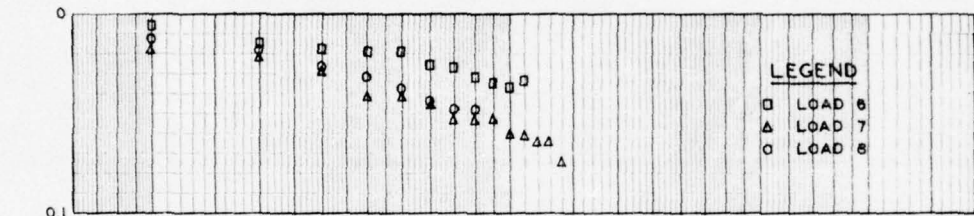
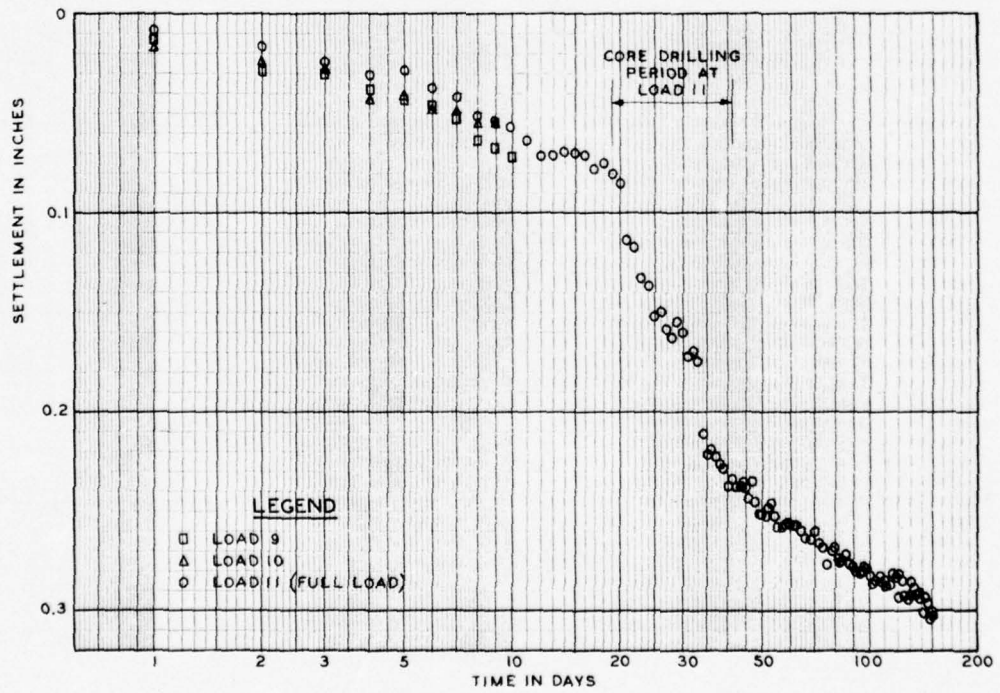
Fig. 35. Time-settlement curves for loads 5-11

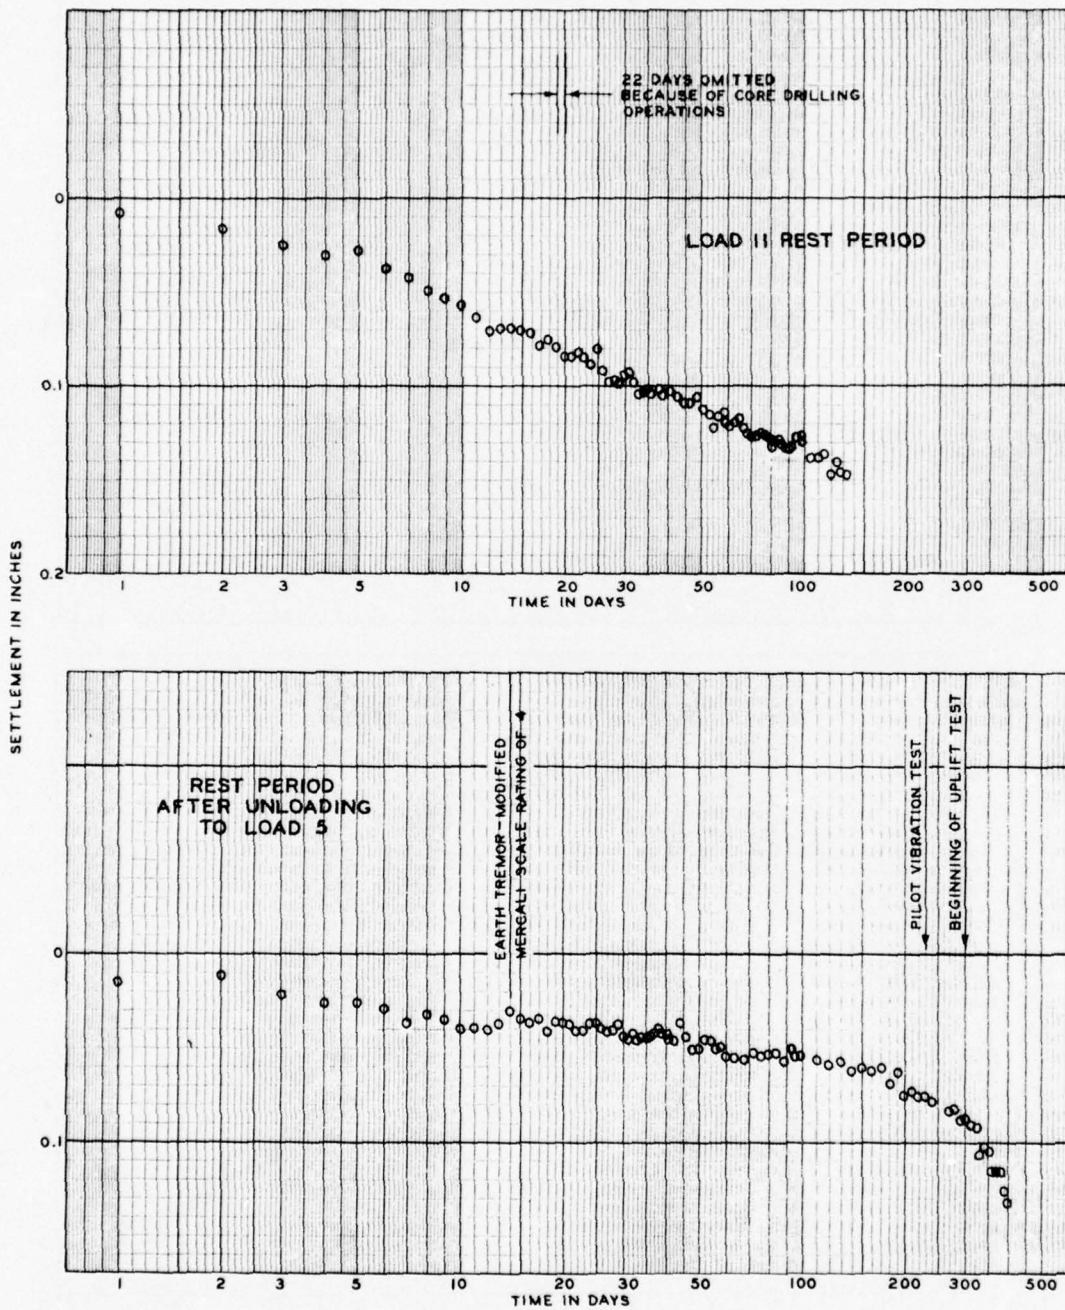
Fig. 36. Time-settlement curve for load 11 rest period and rebound after unloading to load 5

85. When the structure was unloaded to an average base load of 12 ksf, a 300-day rest period followed to observe long-time rebound characteristics. Observed rebound data have been plotted on a semilog scale in fig. 36. The rebound was only 32.2 percent of the observed settlement under the same load. The test loading during rebound was held constant for a period approximately twice as long as the earlier settlement rest period.

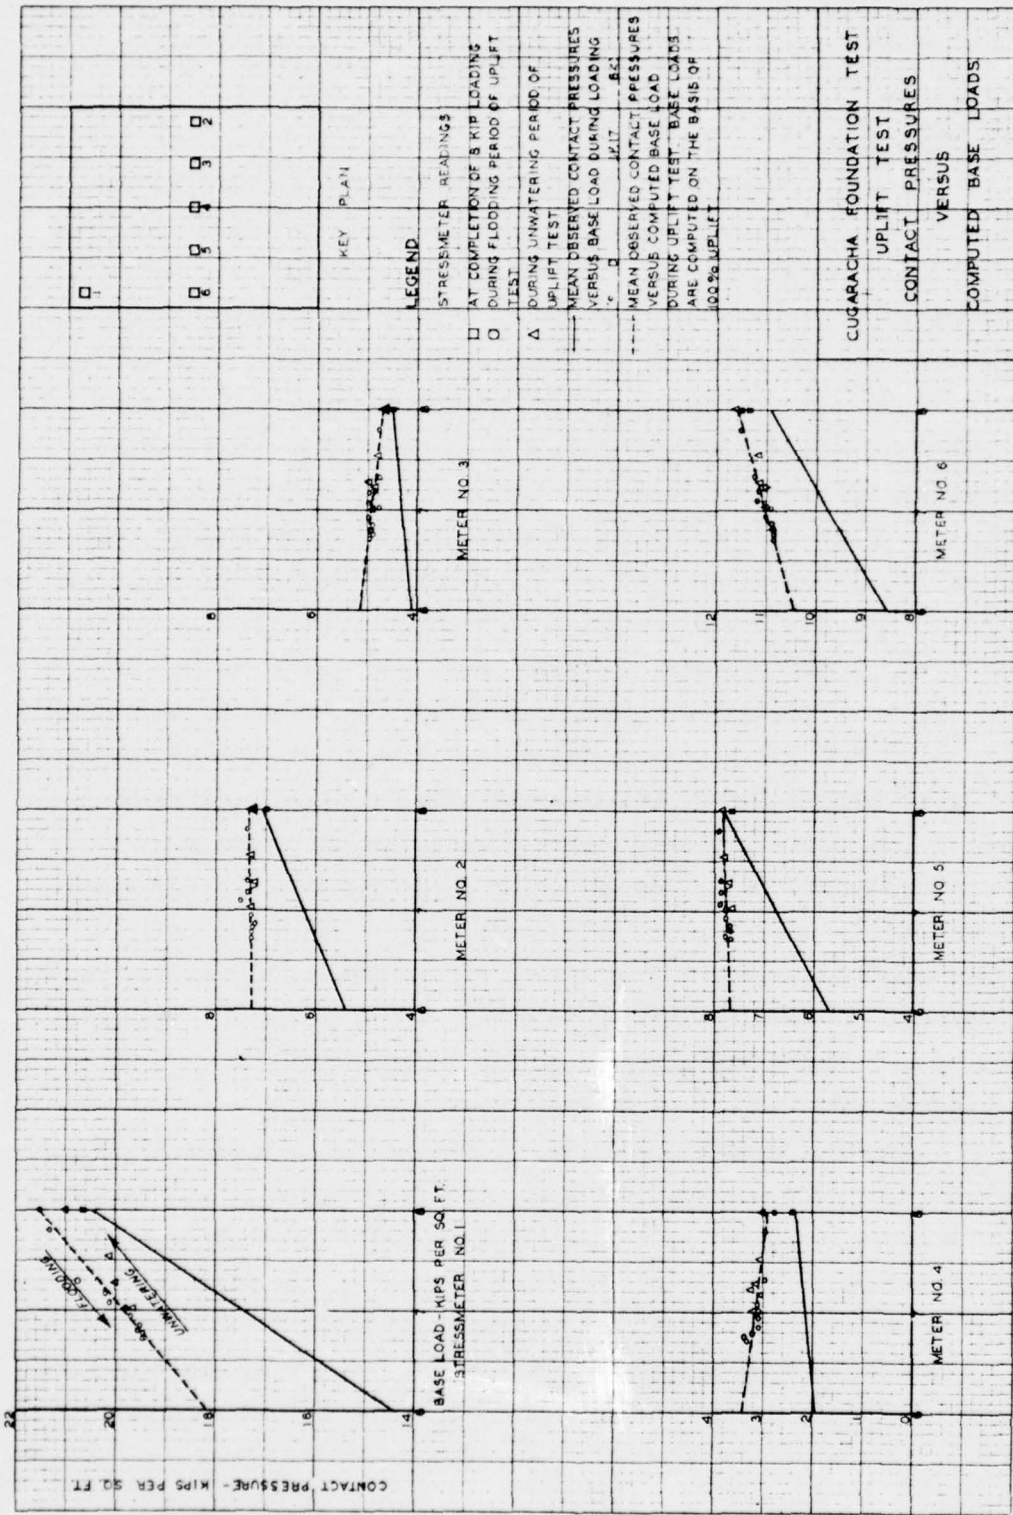
Fig. 37. Contact pressures versus computed base loads

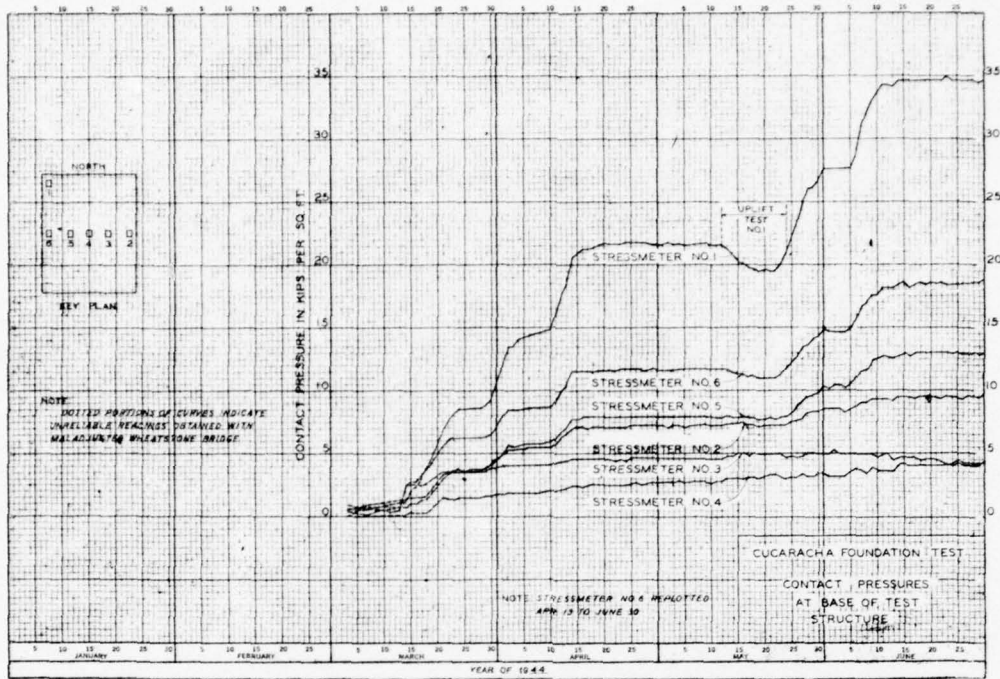
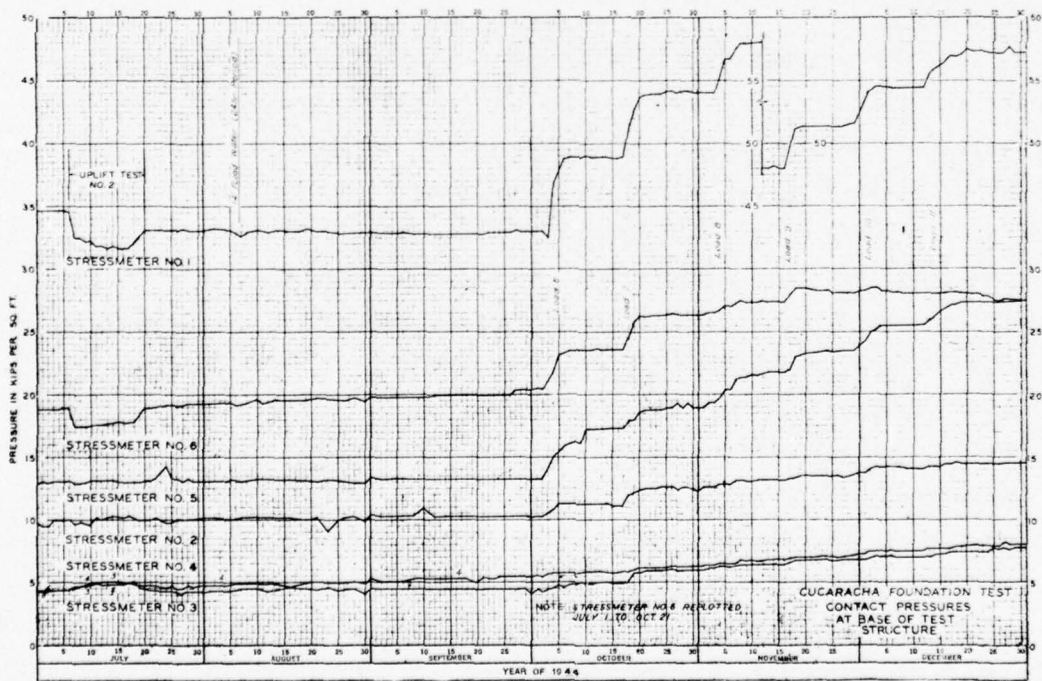
Fig. 38. Contact pressures at base of test structure during 1944

locations. The six cells had been available from Third Locks Project equipment and were located in the structure to determine the transverse pressure distribution only. In a foundation material such as the Cucaracha, adequate information on pressure distribution could only have been obtained by a large number of cells distributed over the whole area. Pressure distribution across the transverse axis of the structure is indicated in fig. 31. It shows that edge pressures were considerably in excess of center pressures and the highest pressures were located at the corner.

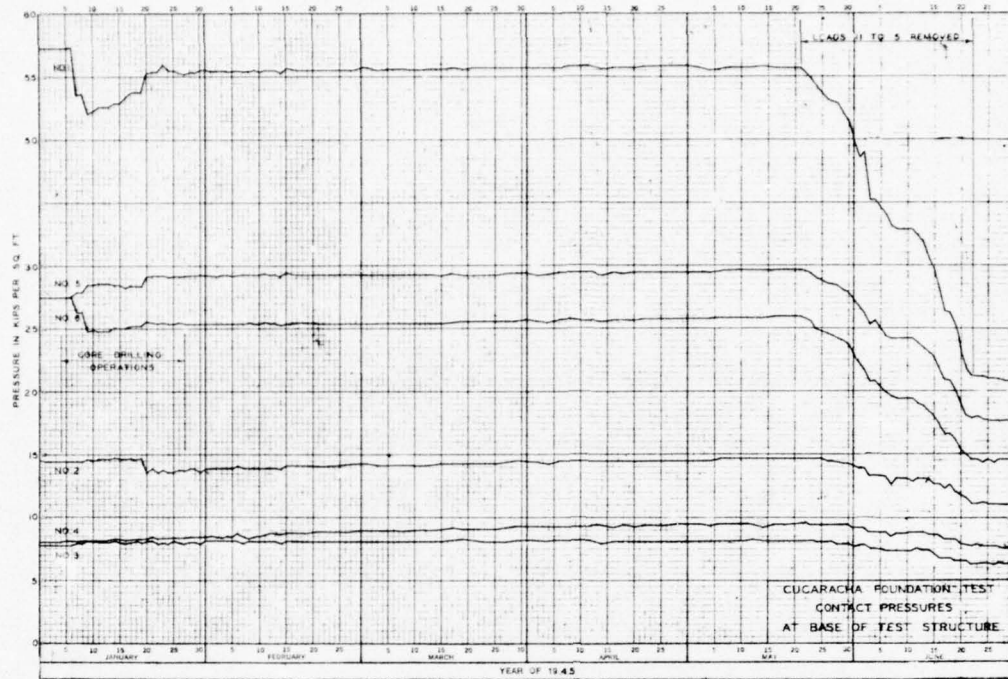
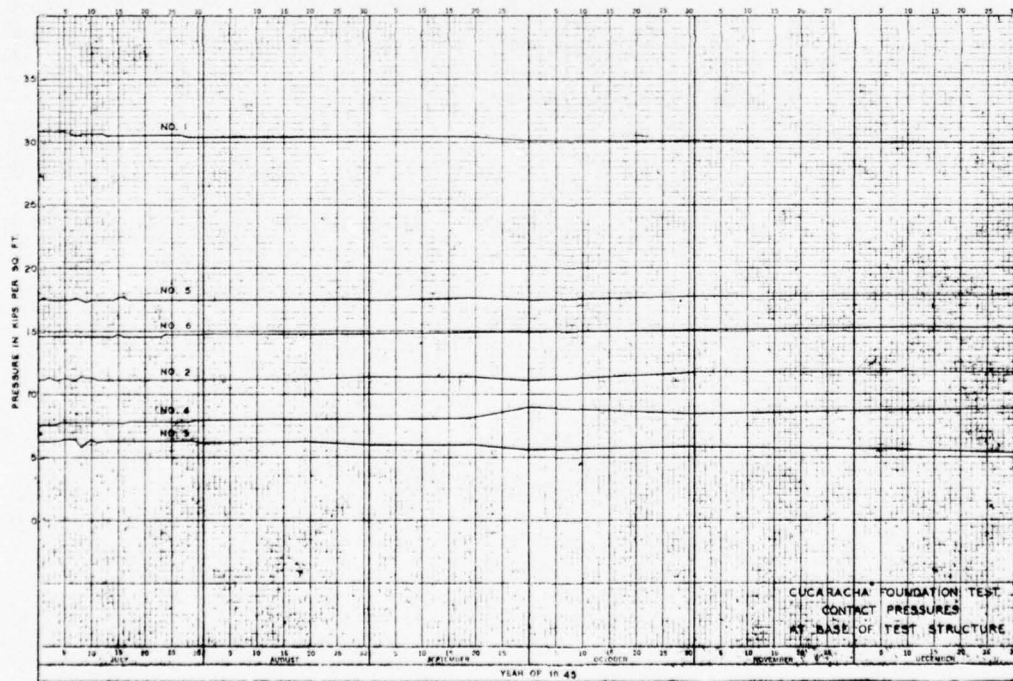
Fig. 39. Contact pressures at base of test structure during 1945

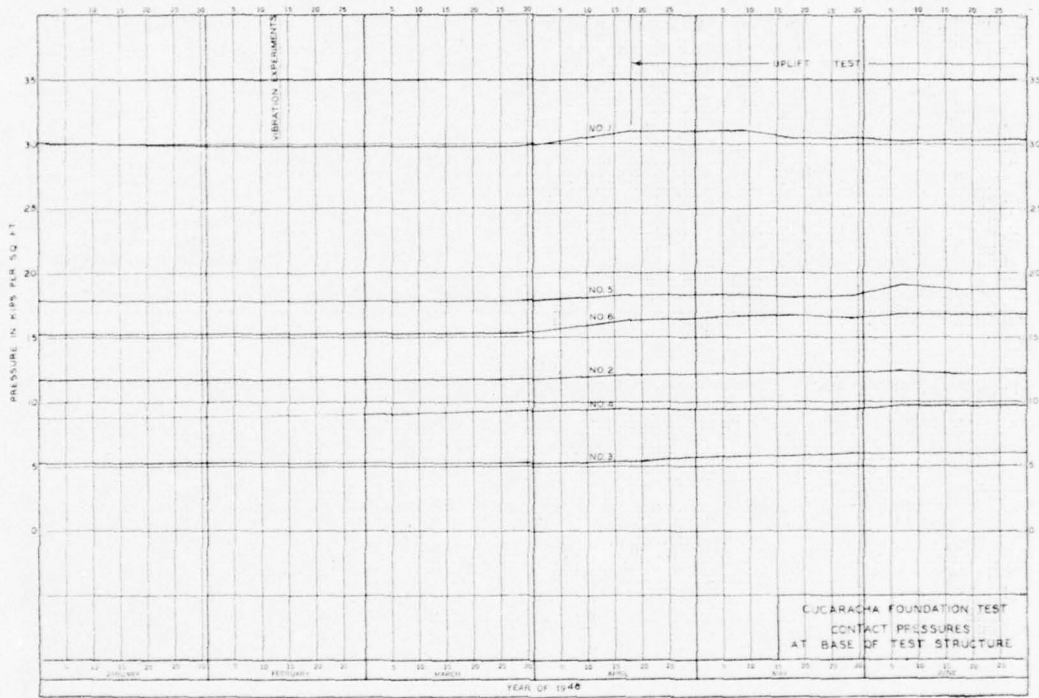
Fig. 40. Contact pressures at base of test structure, January-June 1946

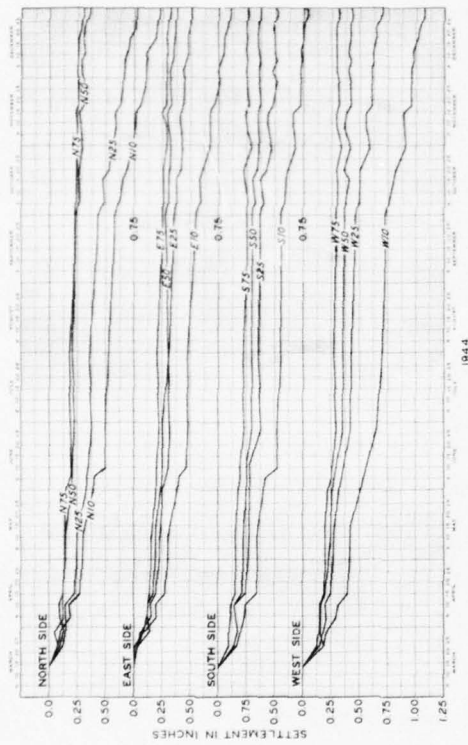
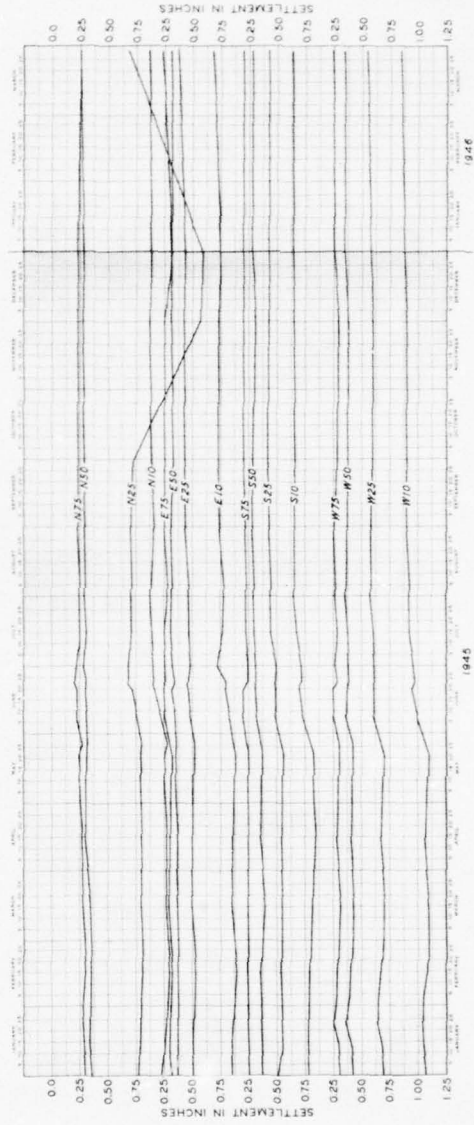
NOTE LETTER AND NUMERAL DESIGNATIONS ON CURVES IDENTIFY SETTLEMENT POINTS. SETTLEMENT POINTS DESIGNATED BY LETTERS WERE LOCATED AT DEPTHS OF 10, 25, 50 AND 75 FEET BELOW FOUNDATION GRADE. NEAR POINTS DESIGNATED BY LETTERS AND NUMERALS N, E, S, AND W IDENTIFY THE STRUCTURE SIDE, AND 10, 25, 50, AND 75 THE DEPTH BELOW FOUNDATION GRADE.

Fig. 41. Settlement of subsurface points, test structure foundation, 1944-1946

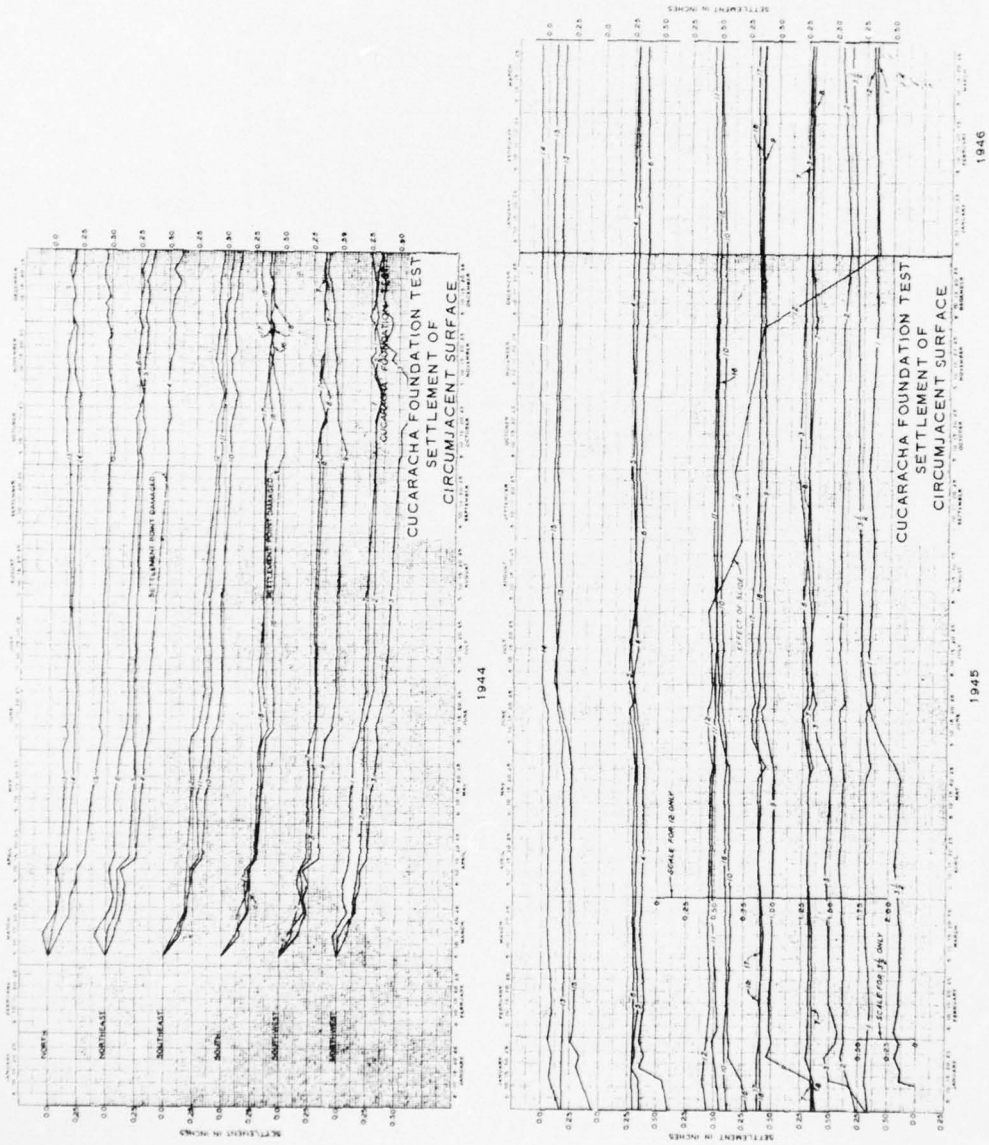
Fig. 43. Settlement of ground surface adjacent to test structure, 1944-1946

93. Settlement of the circumjacent shale surface was very small. Curves of settlement versus time are shown in fig. 43. It is significant that the settlement of the shale surface was less at the north end,

where settlement of the structure was greater, than at the south end. This feature can be attributed to the weaker character of the shale at the north end: it compresses more under load but is less capable of transferring stress to areas outside of the loaded area.
