MISCELLANEOUS PAPER S-74-16 ✓

# FIELD TESTS OF THE CUCARACHA FORMATION, PANAMA CANAL, 1942-1946

Conducted by U. S. Army Engineer Waterways Experiment Station  
Soils and Pavements Laboratory  
Vicksburg, Mississippi

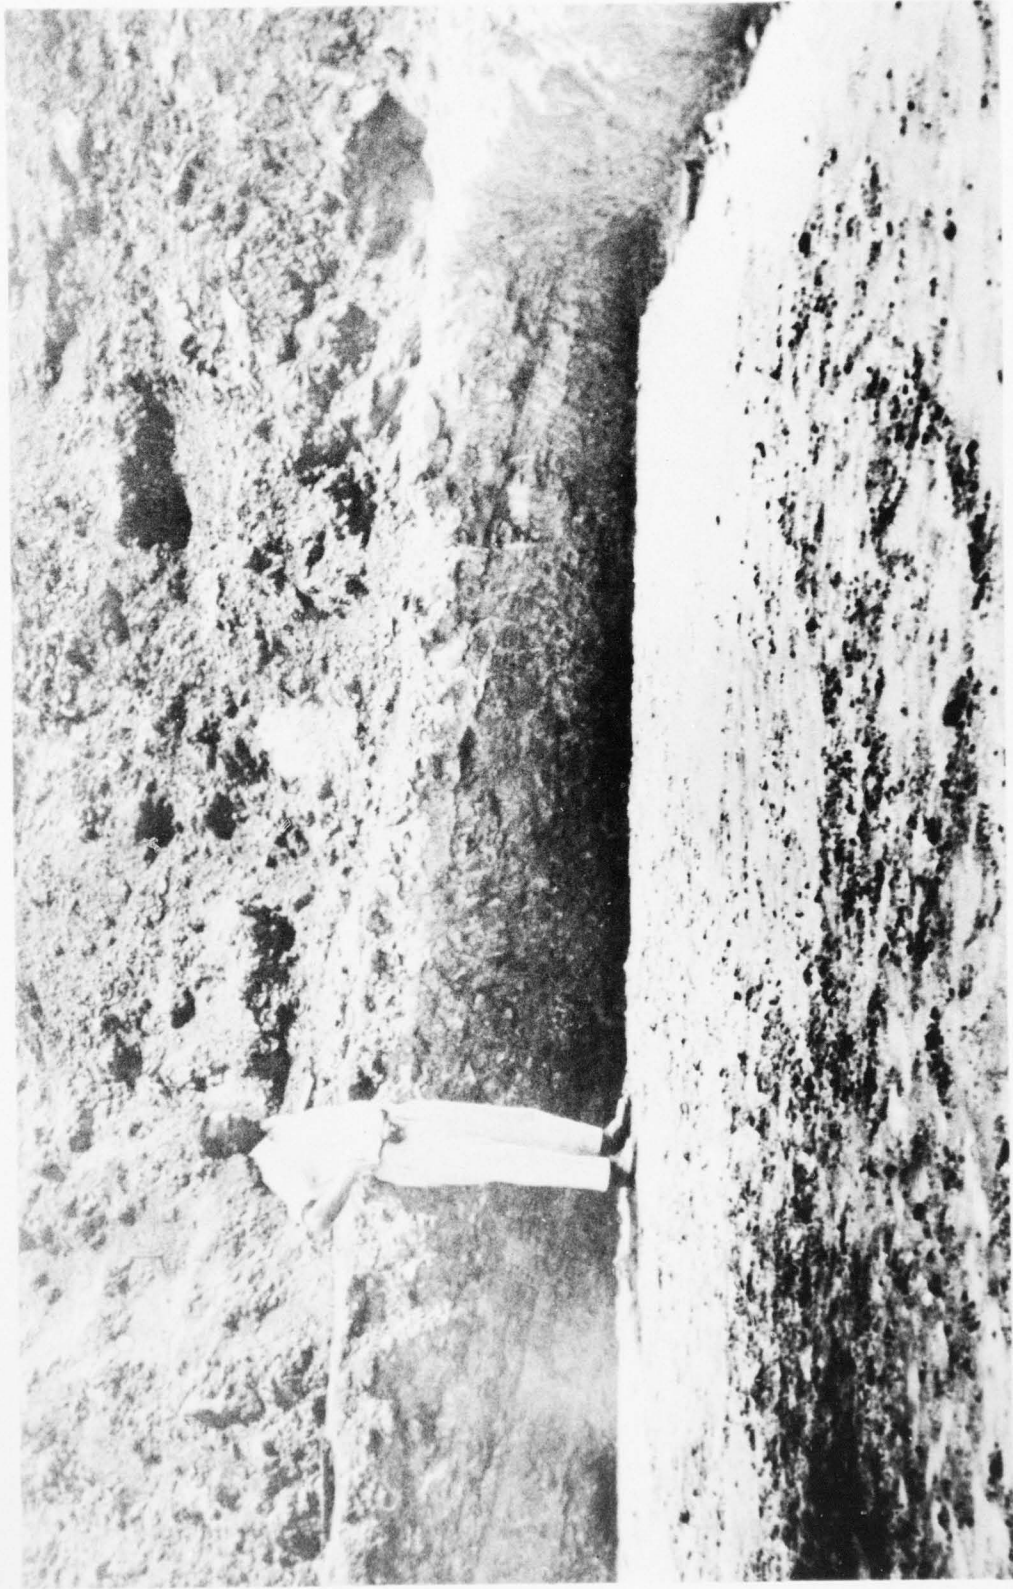
Photo 1. Interbedded black carbonaceous shale and typical green-gray Cucaracha clay shale.  
Southwest corner of excavation

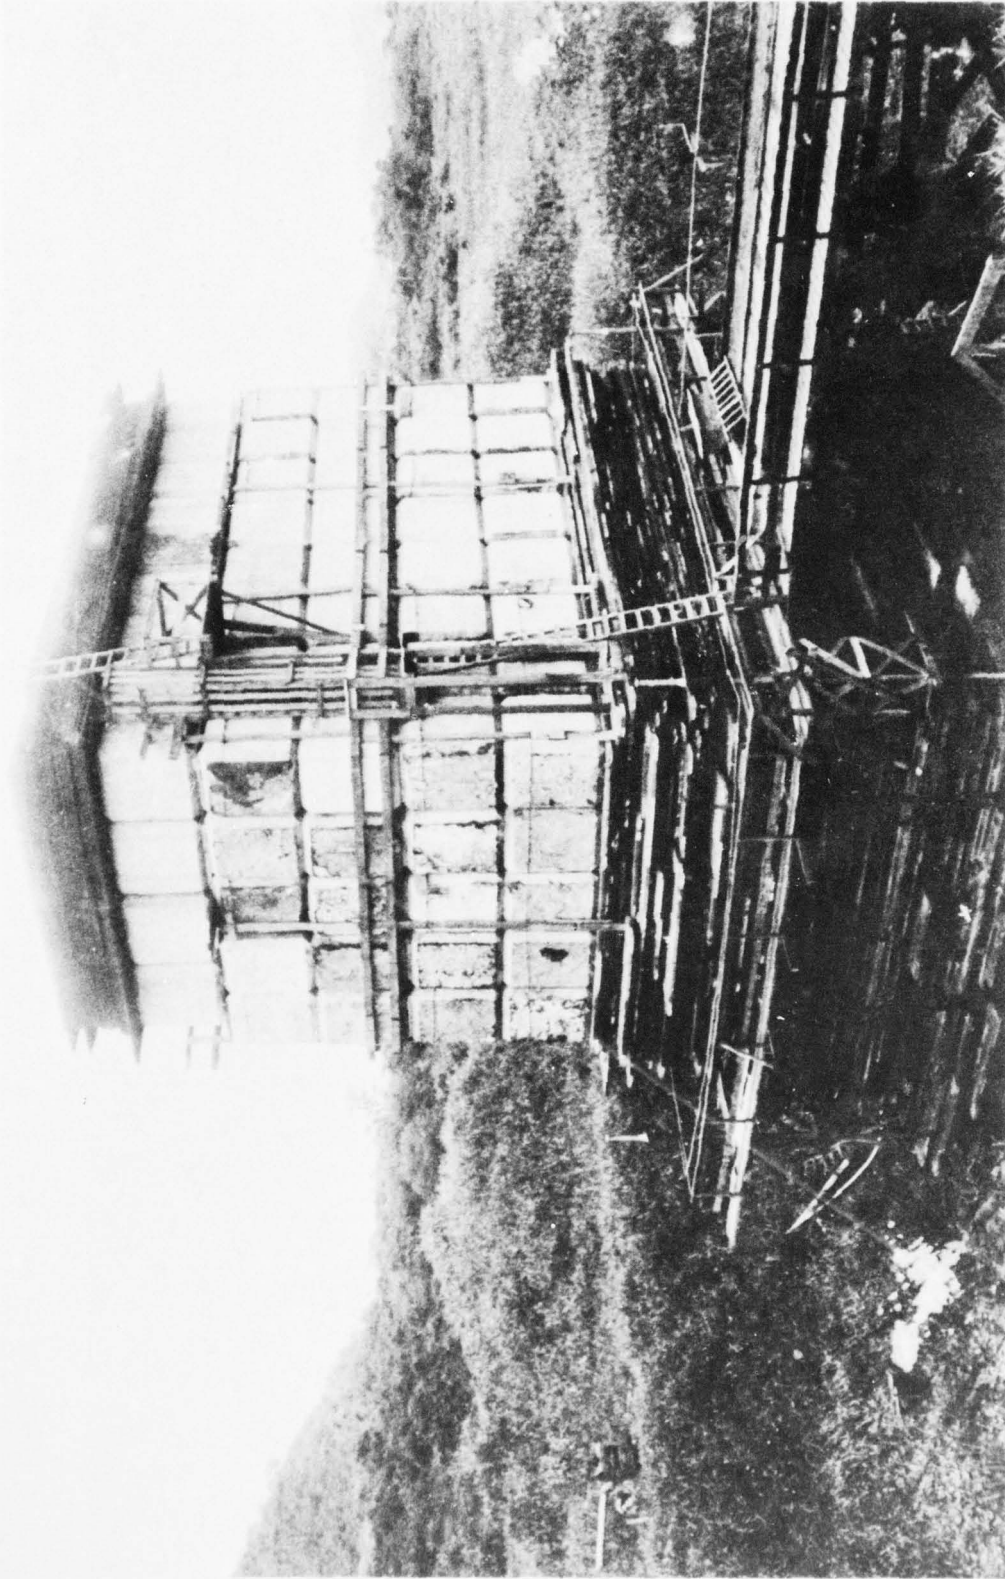
Photo 2. Test structure under maximum loading. Viewed from northwest corner

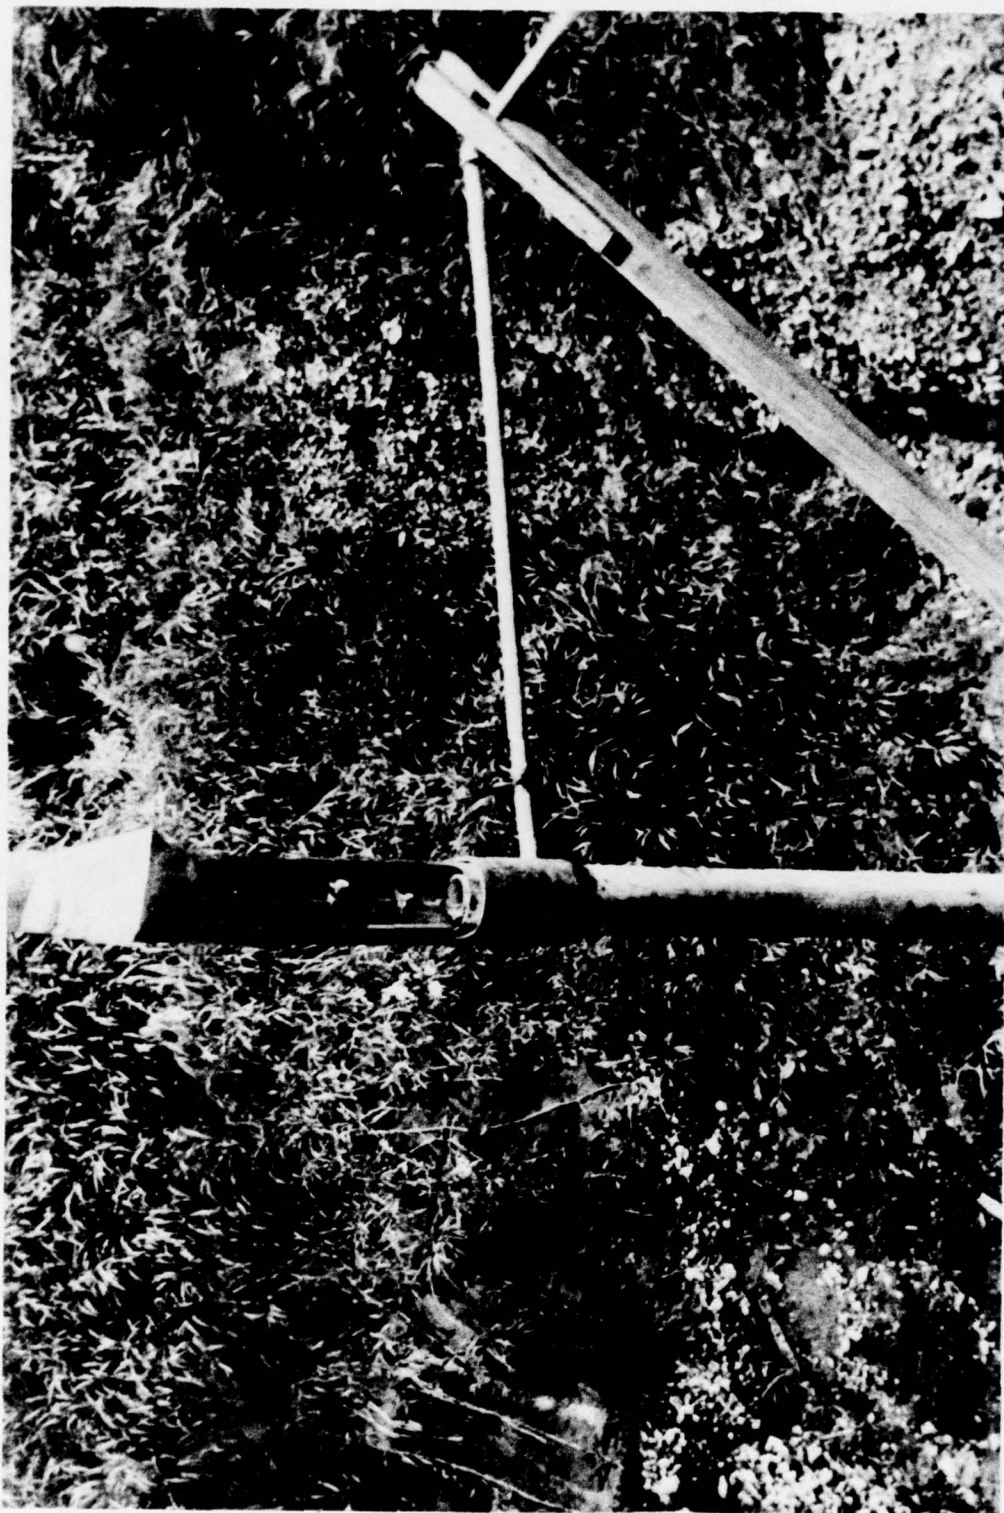
Photo 3. Hook gage assembly for measuring settlement at corners of test structure

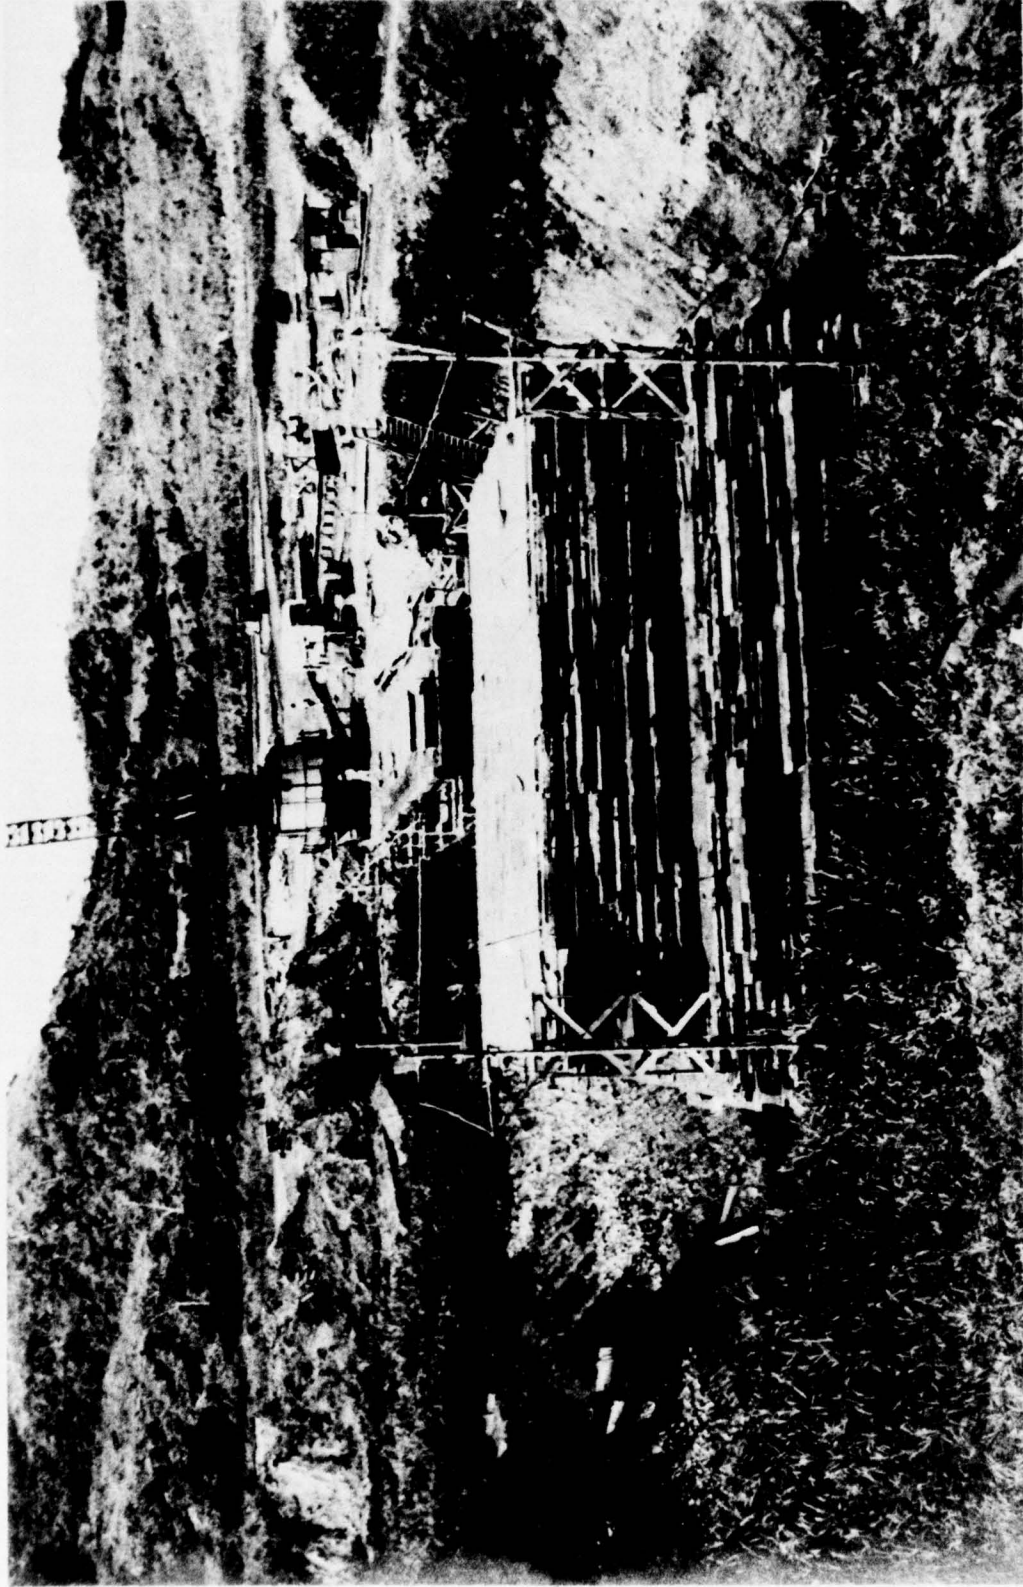
Photo 4. Water line from bench mark in center background to pipe standards for settlement measurements at corners (looking westerly during rest period under load 5)

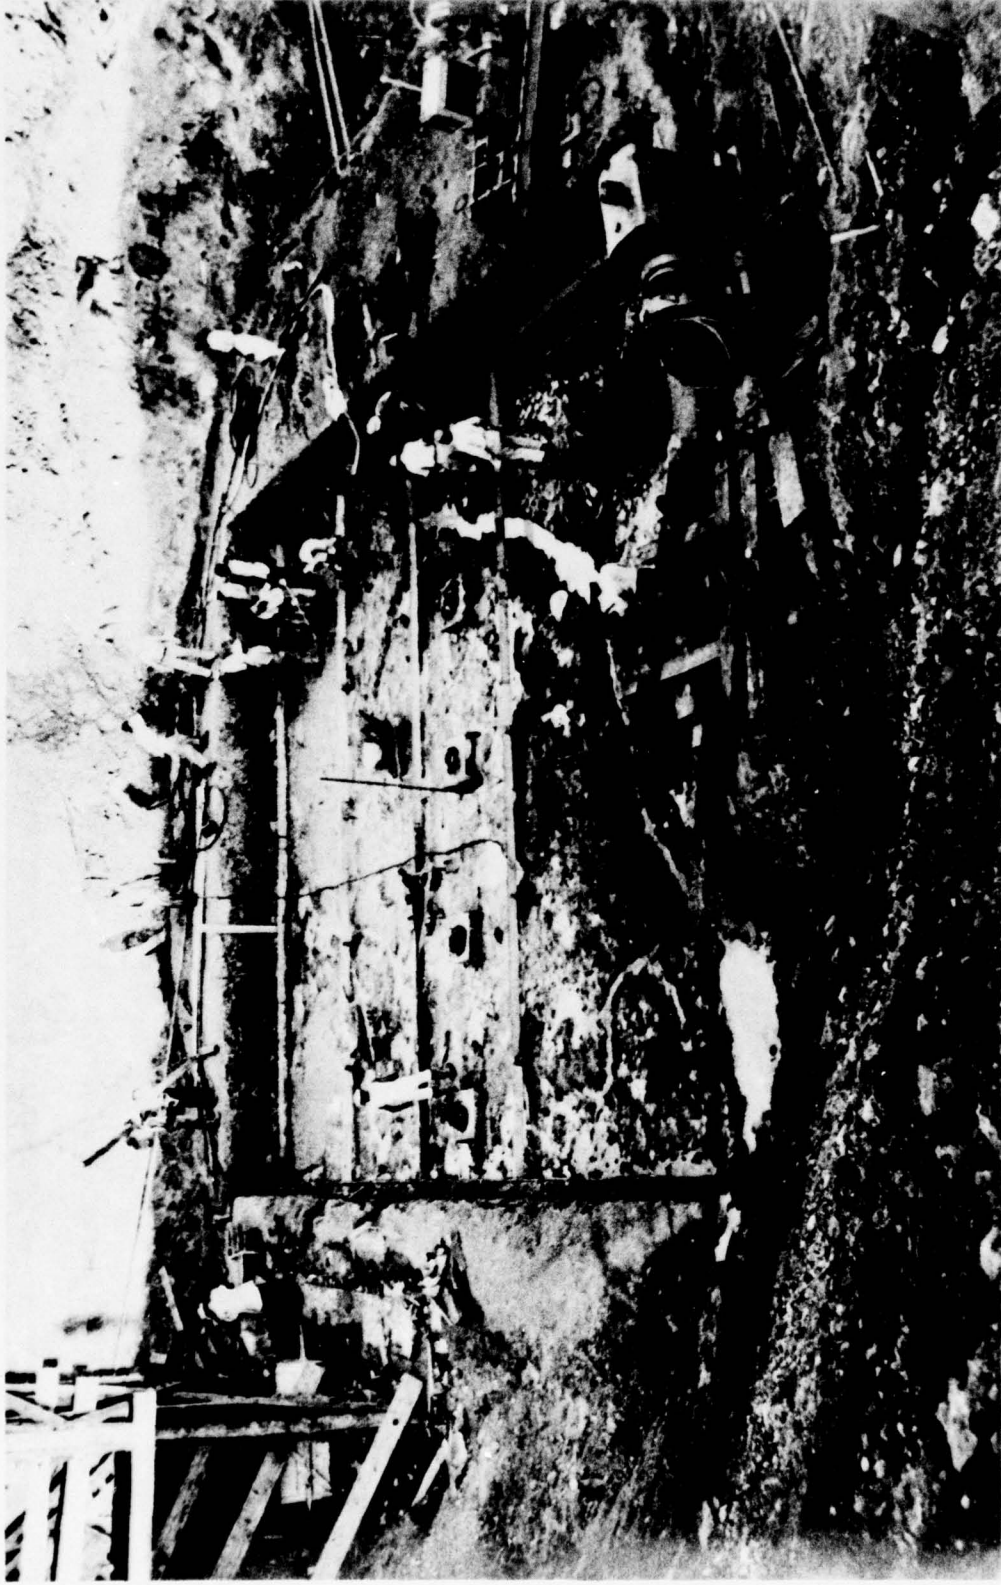
Photo 5. Carlson stress meters on foundation along east-west axis, prior to concrete placement

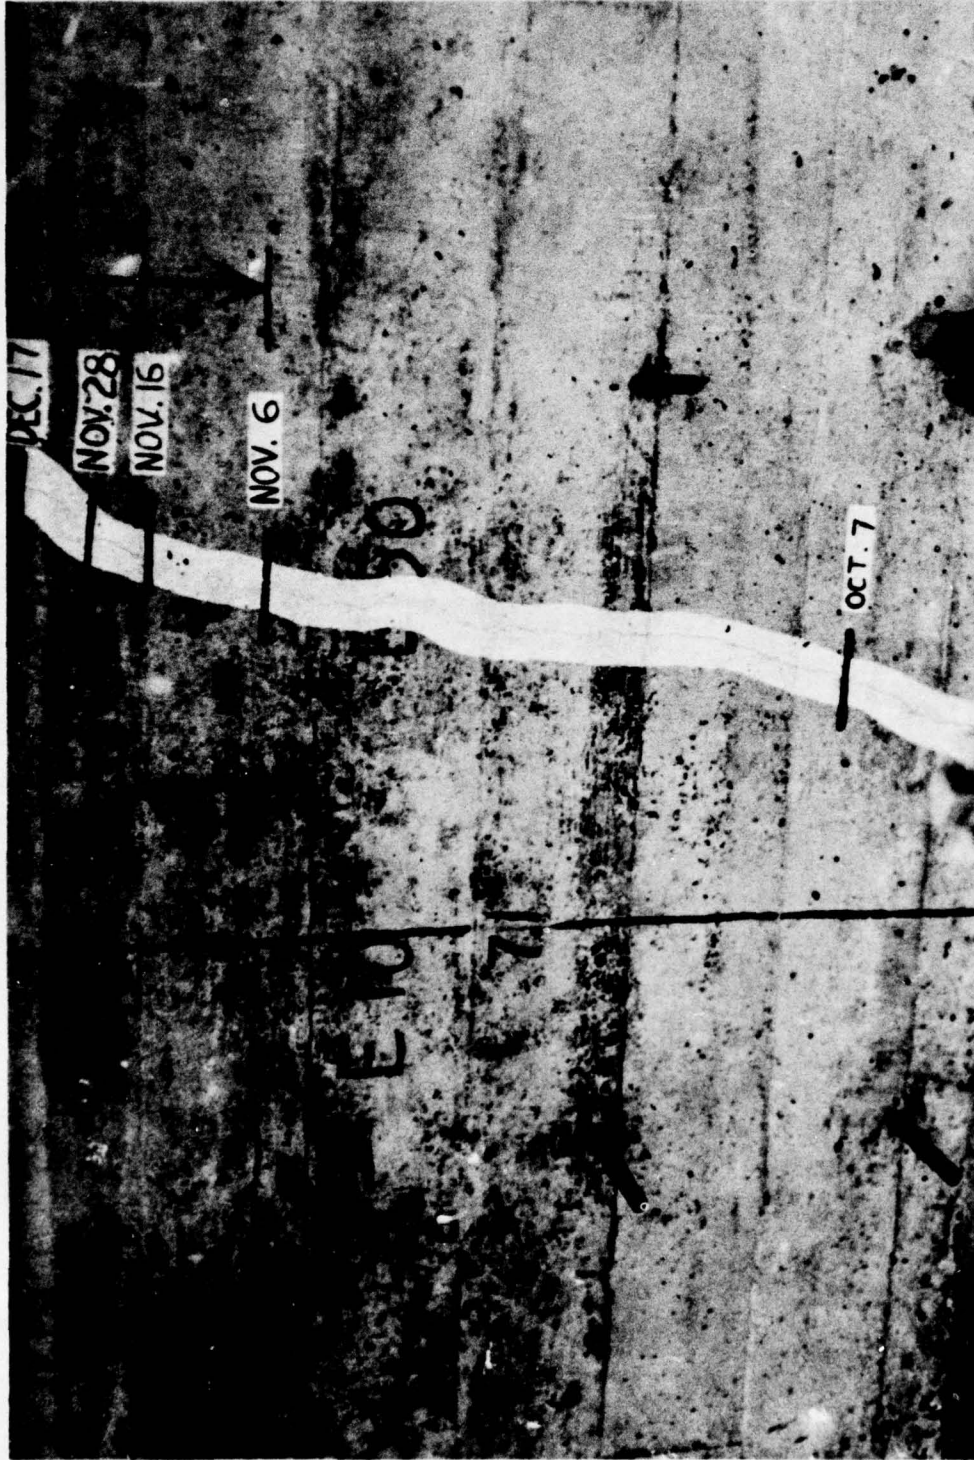
Photo 6. Crack on east side showing rate of development

appeared to act at all times like a rigid plate, although late in the test a crack developed approximately at the transverse axis as shown in photos 6 and 7. There is some indication that a foundation failure may have occurred when the average load on the west side of the structure was approximately 18 ksf. Perimeter heave points adjacent to the west side of the structure show a rise after this time (November 1944, see fig. 43.) The evidence is partly disproved by the continuation of the rise of pressure indicated by the Carlson cells and by the rebound which occurred when the structure was unloaded.

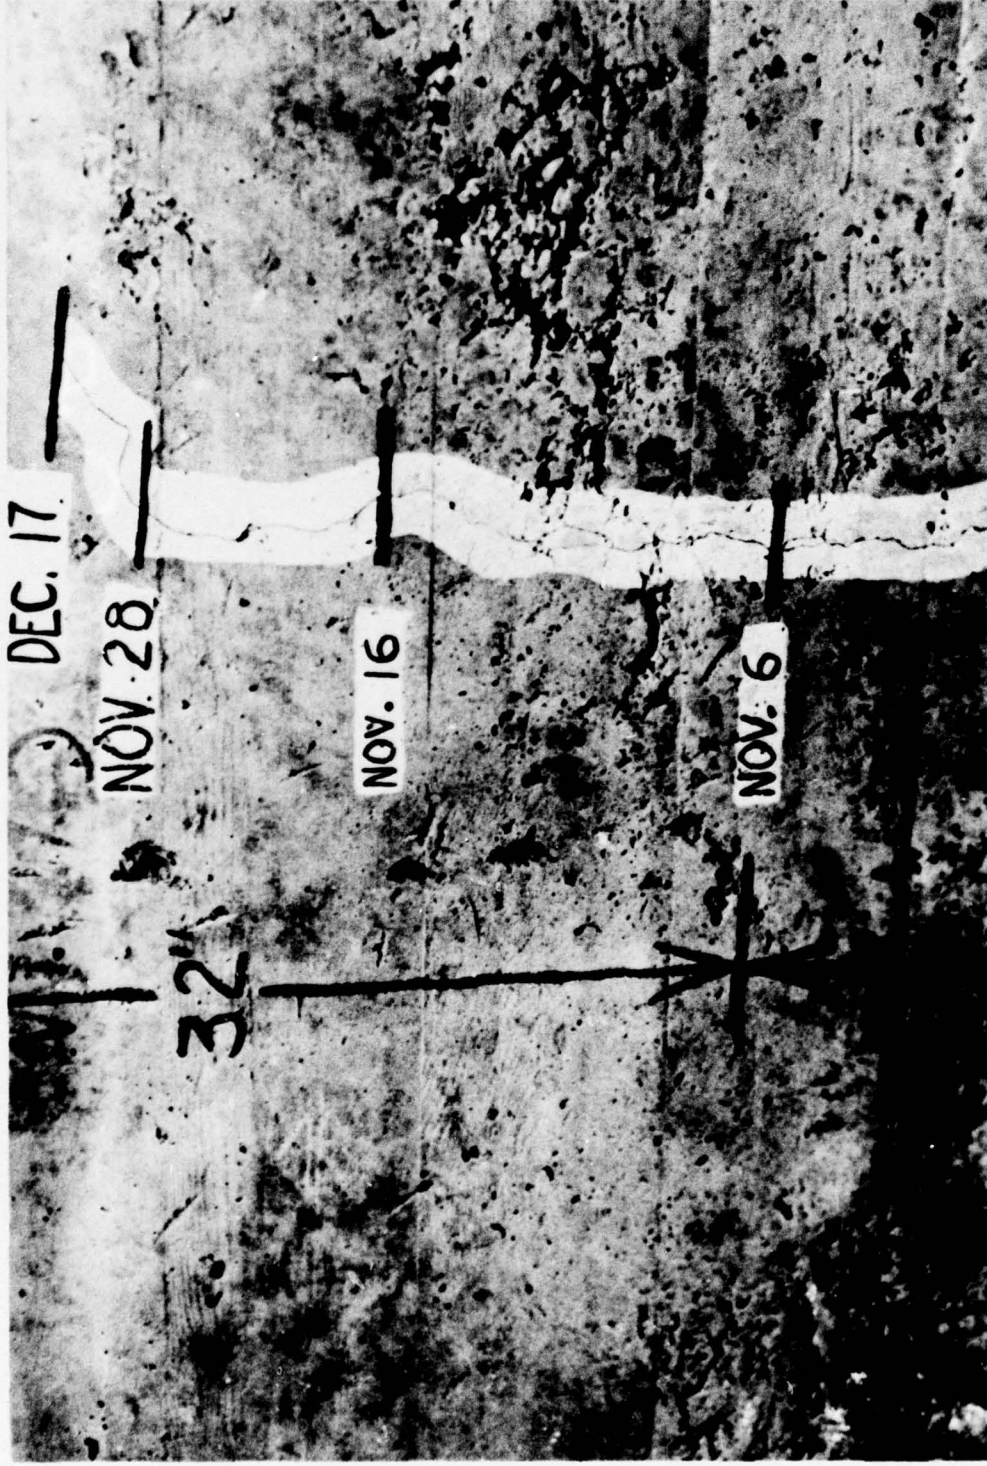
Photo 7. Crack on west side showing rate of development
