METALLURGICAL CHANGES IN THE HIGH TEMPERATURE  
FRETTING OF Ni AND Ti ALLOYS

First Technical Report

R. B. Waterhouse

October 1976

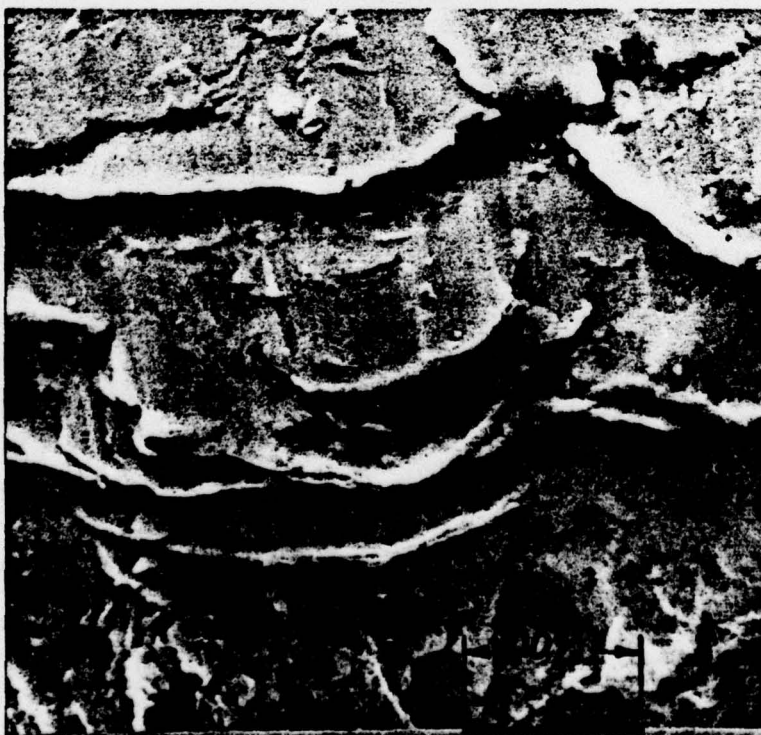
Fig. 6. Scanning electron micrograph of surface of Ti-6Al-4V (IMI 318) specimen tested at 200°C in air at a fatigue stress =  $16 \pm 6$  tons/in<sup>2</sup>.

A detailed examination of the damaged surfaces was made on the specimens tested at 200°C. At room temperature the fretting damage on Ti-6Al-4V is essentially of the delaminating type, showing removal of flat plates of material about 2 μ in thickness. At 200°C the damage was considerably different and showed the development of a layered structure as in Fig. 5. The multiple layers of material can be seen in the vicinity of the fracture, Fig. 6. The specimens tested at 600°C have yet to be examined in the scanning microscope.
