BOEING VERTOL CO PHILADELPHIA PA  
TRANSMISSION CONDITION ASSESSMENT.(U)  
DEC 76 O L SANDORA  
D210-11067-1

USAAMRDL-TR-76-36

TRANSMISSION CONDITION ASSESSMENT

Final Report

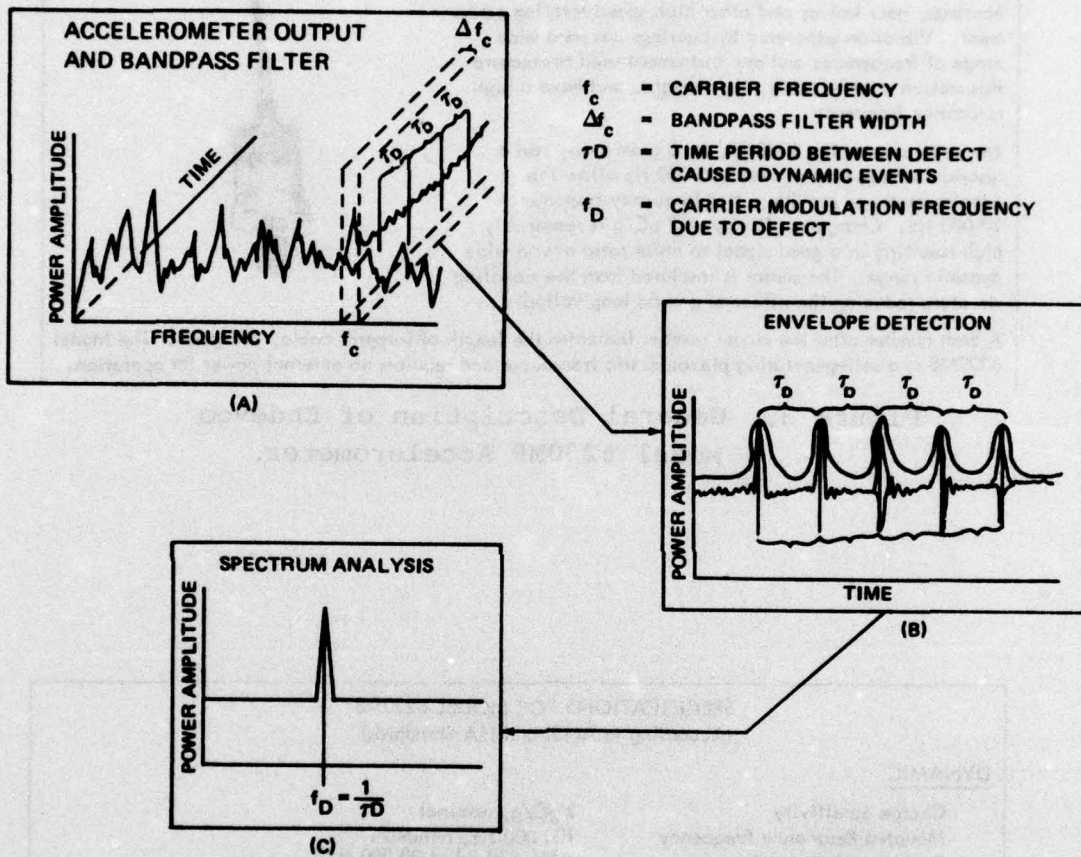
- A) A CARRIER FREQUENCY IS SELECTED AT A SUFFICIENTLY HIGH VALUE ( $> 25$  kHz) THAT IT IS NOT AFFECTED BY NORMAL TRANSMISSION NOISE, BUT AT A LOW ENOUGH VALUE ( $< 500$  kHz) THAT IT IS AMPLITUDE MODULATED BY PERIODIC DEFECTS.
- B) THE BANDPASS-FILTERED CARRIER FREQUENCY SIGNAL IS AMPLITUDE DEMODULATED (ENVELOPE-DETECTED) BACK INTO A LOW FREQUENCY (0-20 kHz) SIGNAL.
- C) THE DEMODULATED CARRIER IS SPECTRUM ANALYZED AND THE LIMIT EXCEEDANCE IS MONITORED TO DETECT AND ISOLATE THE DEFECT (VIA ITS CHARACTERISTIC FREQUENCY IN THE MACHINE).

Figure 2. "Demodulated Carrier" High-Frequency Vibration Analysis.

A bandpass filter can detect the energy in a relatively narrow band centered on a selected carrier frequency and monitor the amplitude modulations of the carrier frequency as a function of time (Figure 2A). The time-varying carrier frequency will be modulated by the impact each time a rolling element impacts the spall. The impacts will occur at the ball-pass frequency over the spall, and the ring-down frequency will be a function of the mounted resonance of the spalled race. Since the race-mounted resonant frequency is difficult to predict, and not as easily measurable or clearly characteristic of a particular bearing and defect as the ball-pass frequency, the bandpass-filtered carrier frequency is demodulated (envelope-detected). This converts it to a relatively low-frequency signal whose frequency is equal to the ball-pass frequency of the outer race of the particular spalled bearing (Figure 2B). Therefore, the envelope-detected signal can be spectrum analyzed or bandpass-filtered at the ball-pass frequency, and the limit exceedance can be monitored, to detect bearing surface defects (Figure 2C).

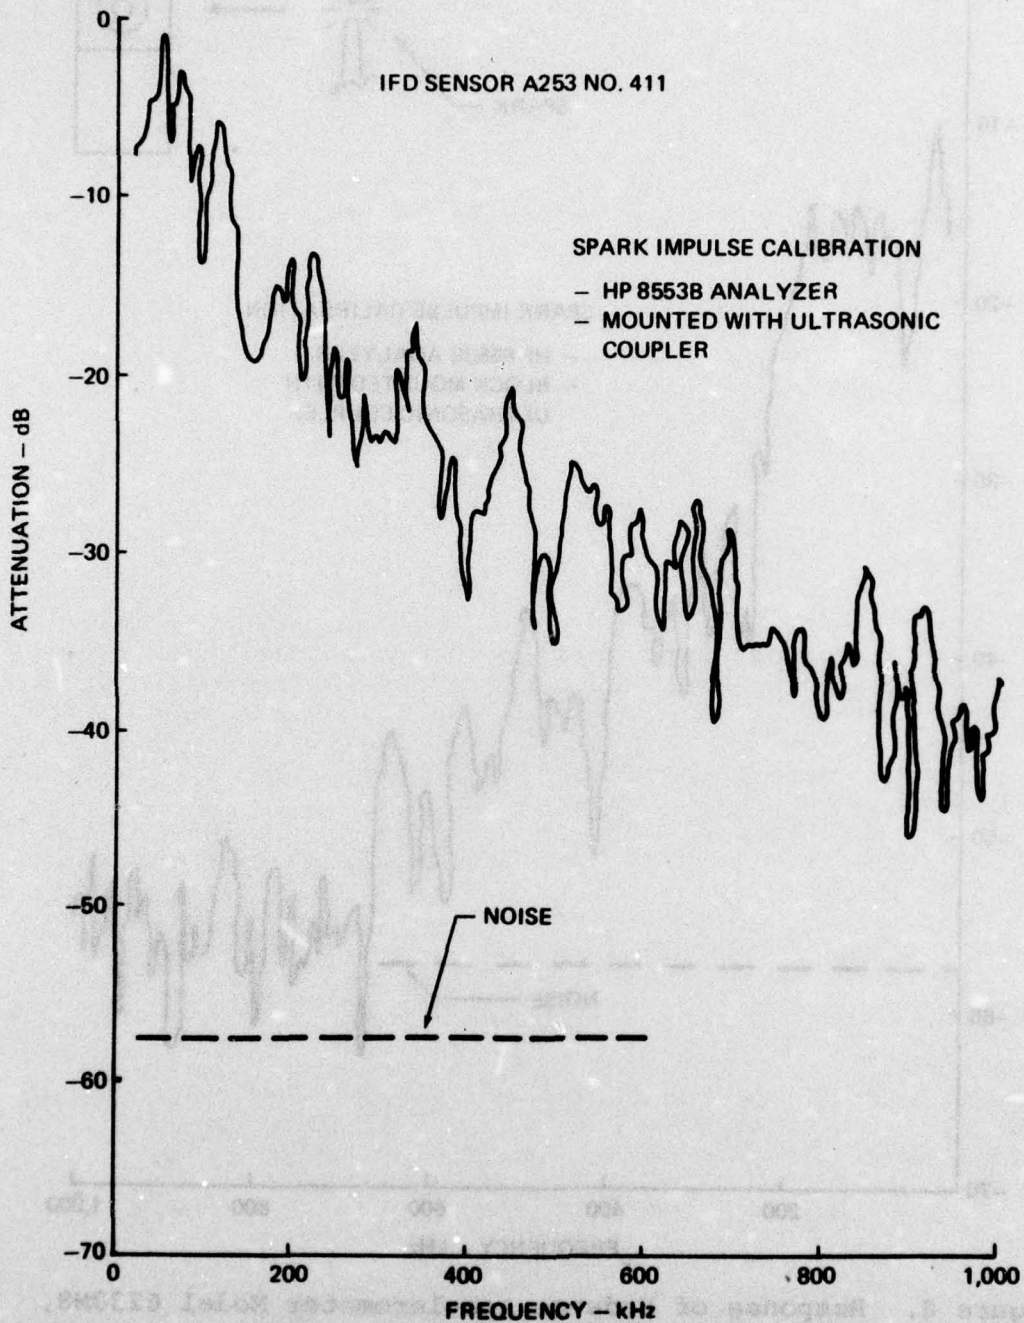
Figure 9. Response of Boeing Accelerometer Model 253, Serial No. 411--No Mounting Block - Ultrasonic-Compliant Bonded.

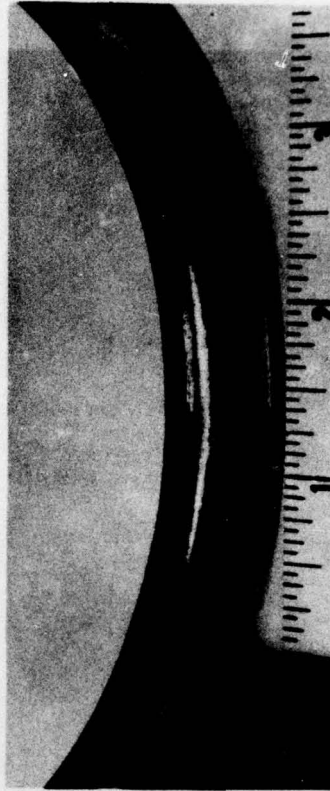
SPALLED INNER RACE

WORN/DISTORTED CAGE  
SPALLED ROLLING ELEMENTS

SPALLED OUTER RACE

Figure 25. 114DS251 Bearing.

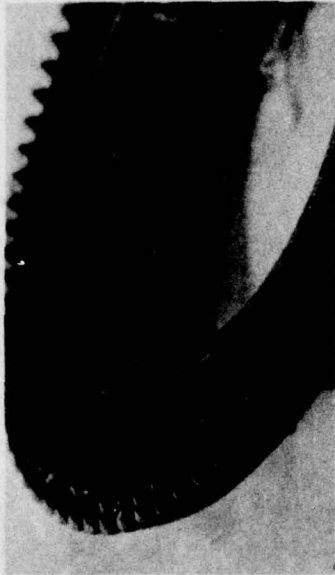
Figure 26. 114D2063 Gear Teeth Damage.
