INTERIM REPORT

Contract Number DAAK02-75-C-0138

APPLICATION OF CERAMIC NOZZLES
TO 10KW ENGINE

SOLAR DIVISION OF INTERNATIONAL HARVESTER COMPANY

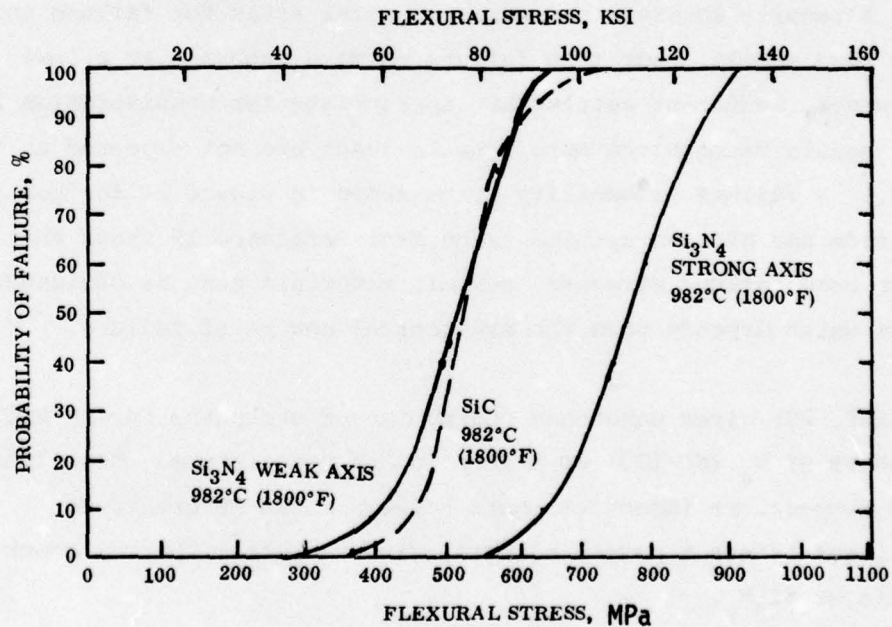
FIGURE 11. FAILURE PROBABILITY FOR NORTON HOT PRESSED Si₃N₄, HS-130, AND NORTON HOT PRESSED SILICON CARBIDE AT 982°C (1800°F) (REF. 19).

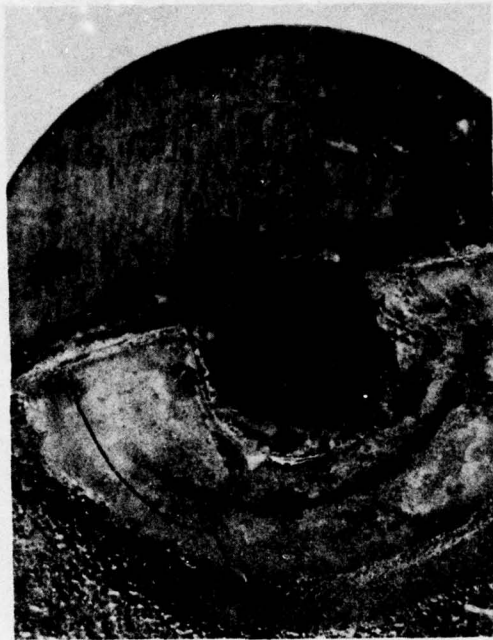
FIGURE 88. THERMAL CRACK IN BOTTOM CERAMIC SHROUD AT HOLDING PIN "B"

A crack developed at locating pin 'B' during test and propagated towards the center of the upstream shroud. It is shown in Figures 87 and 88. Other cracks occurred at locating pin 'A' (see Fig. 89) but did not propagate beyond the pin region. It appears that the cracks resulted from localized thermal stresses since the pins run relatively cool because of direct mounting to the water cooled stainless steel plate. The refrasil insulation wafers between the holding pin head and lower shroud were found to be impregnated with molten products at locations 'A' and 'B'. The insulating wafer at location 'C' was relatively free of molten materials. Since location 'C' on the lower shroud showed no cracking it seems probable that the short circuiting of the thermal insulation at location 'A' and 'B' was
