TECHNICAL REPORT 5009

**BLAST CAPACITY EVALUATION OF SINGLE
REVETTED BARRICADES**

NOVEMBER 1976

PICATINNY ARSENAL
DOVER, NEW JERSEY

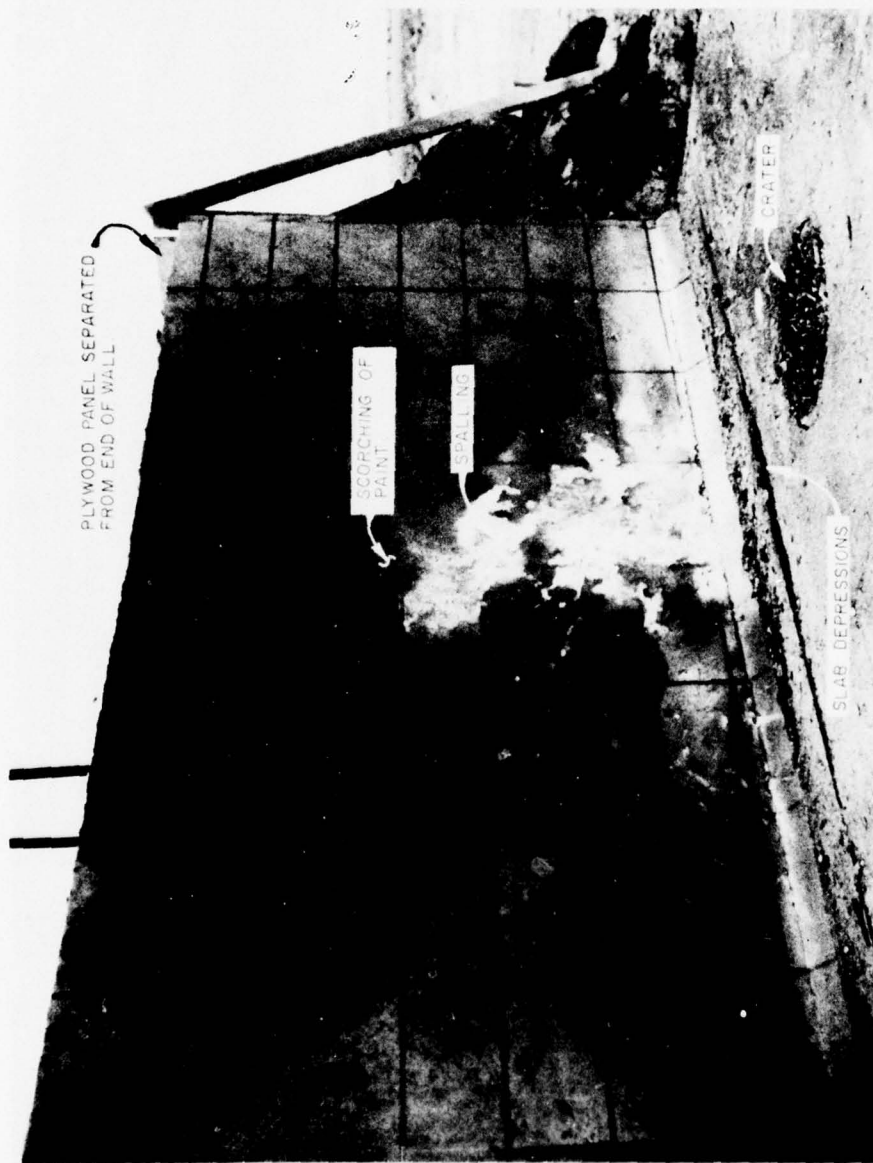
Fig 12 Front face damage, Wall No. 1, Test No. 1

The damage sustained by Wall No. 1 was relatively minor (Fig 12). A small portion of the wall immediately in front of the explosion (see Figure 2 for test setup) was spalled to a depth of approximately 0.8 mm (1/32-in.). Minor hairline cracks were formed at the intersection of the top of the haunch and wall (Fig 13). Formation of these cracks indicated that the center of the wall settled relative to both ends. This settlement was attributed to the high reflected pressures produced on the floor slab immediately in front of the explosive.

Figure 12 illustrates the concrete spalling of the wall. The dark area around the spalling is attributed to the scorching of the concrete paint by the fireball. Also shown in this photo is the size of the crater formed in the non-monolithic portion of the slab. The depth of the crater did not extend the full depth of the slab. In addition to the crater formation, the non-monolithic slab was depressed downward by the blast, a greater amount than was the portion of the slab which was cast monolithic with the wall. Here, the non-monolithic slab merely acted as a slab on an elastic foundation, whereas the interaction between the monolithic slab and wall tended to span the slab loads across the wall as a beam. In actual construction, advantage should be taken of this beam action of the wall in order to reduce the overall slab depressions.

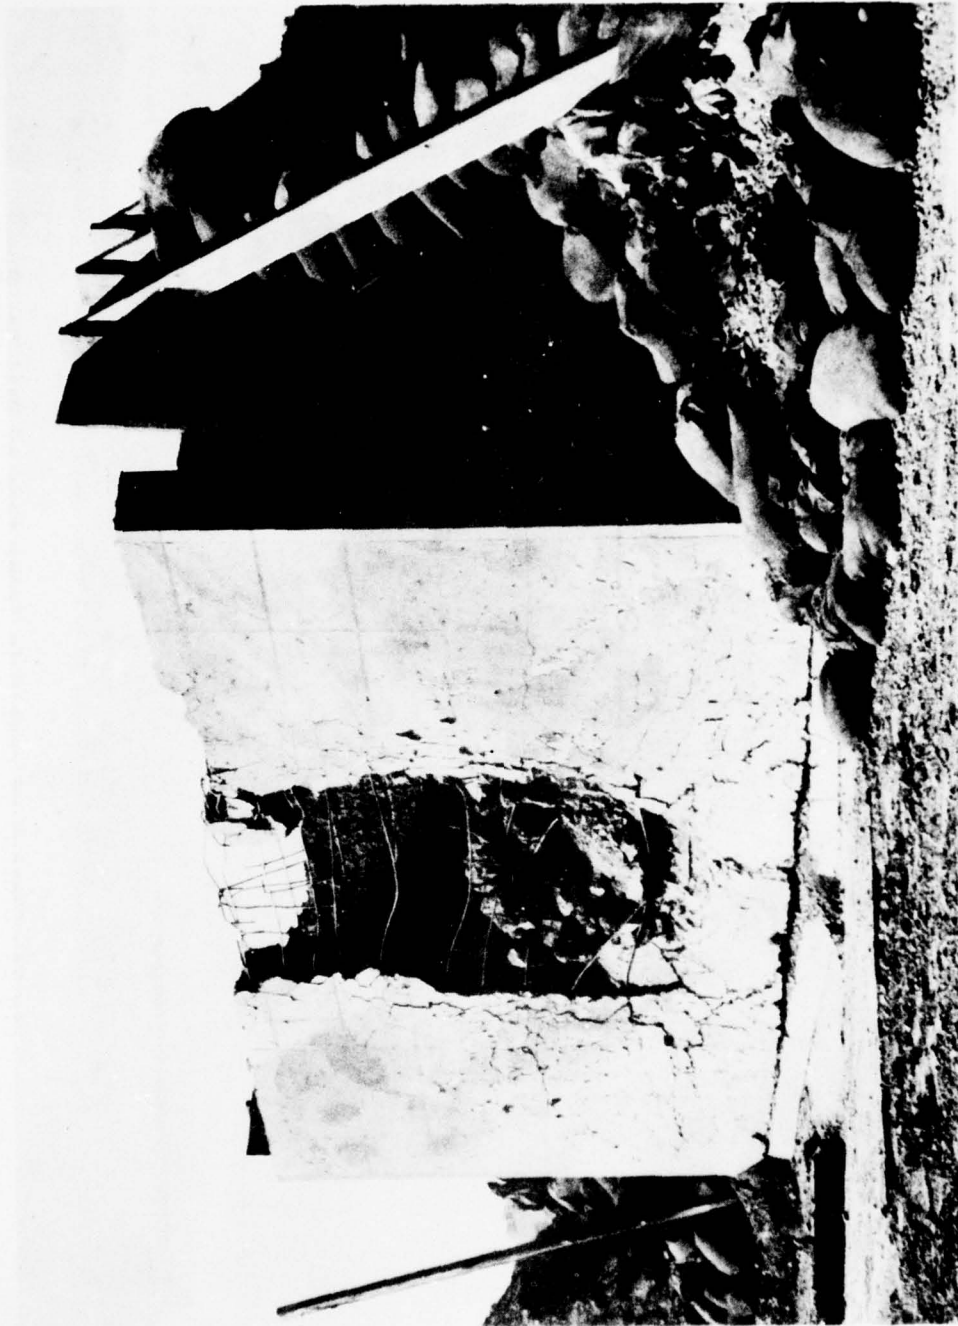
Fig 23 Front face damage, Wall No. 2, Test No. 4

Significant damage was sustained by the wall. The center one-third of the wall was completely destroyed (Fig 23) with the blast pressures penetrating through the earth-mound. The
