**THE LICE EARTHQUAKE IN SOUTHEASTERN TURKEY:  
A GEOGRAPHY OF THE DISASTER**

**CAPTAIN WILLIAM A. MITCHELL**

**DECEMBER 1976**

**FINAL REPORT**

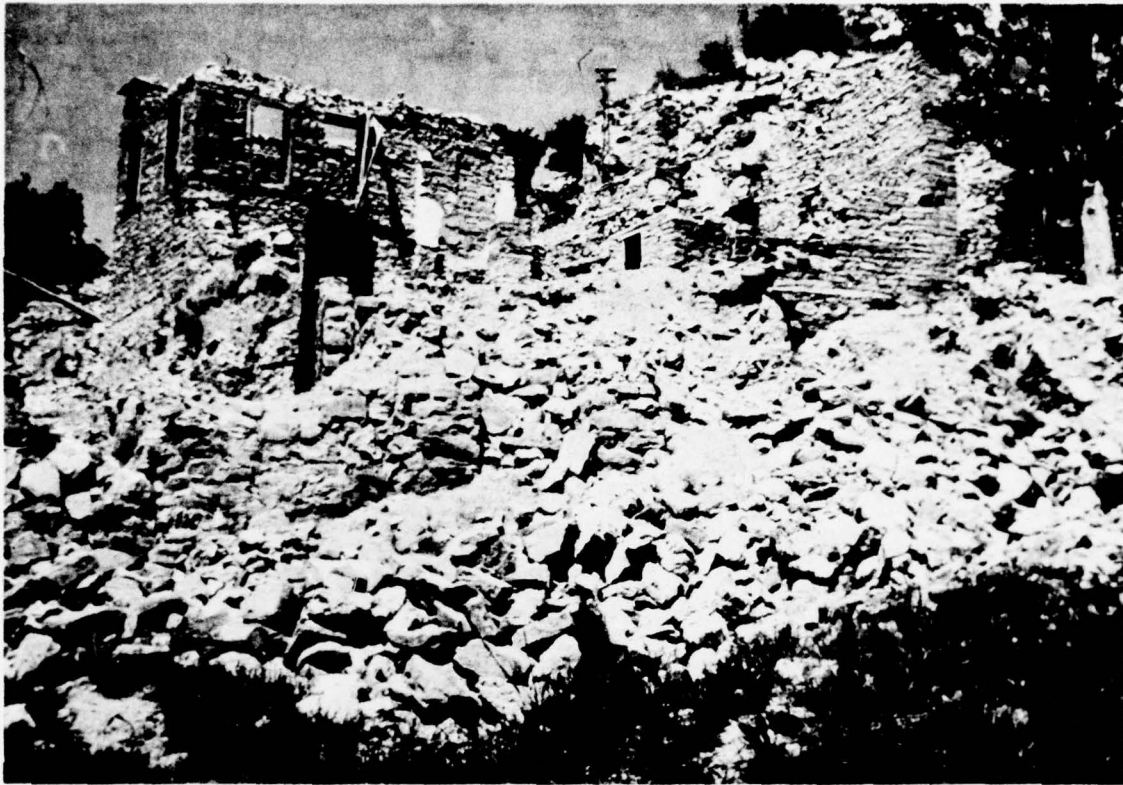
Figure A1. Typical uncemented adobe construction.  
The few logs and poles which were used  
for ceiling supports have been removed.

collapsed tons of stones, mud, and logs from the roofs of houses, onto the people inside (Figures 15, 16, A1, A2, A3).<sup>21</sup>

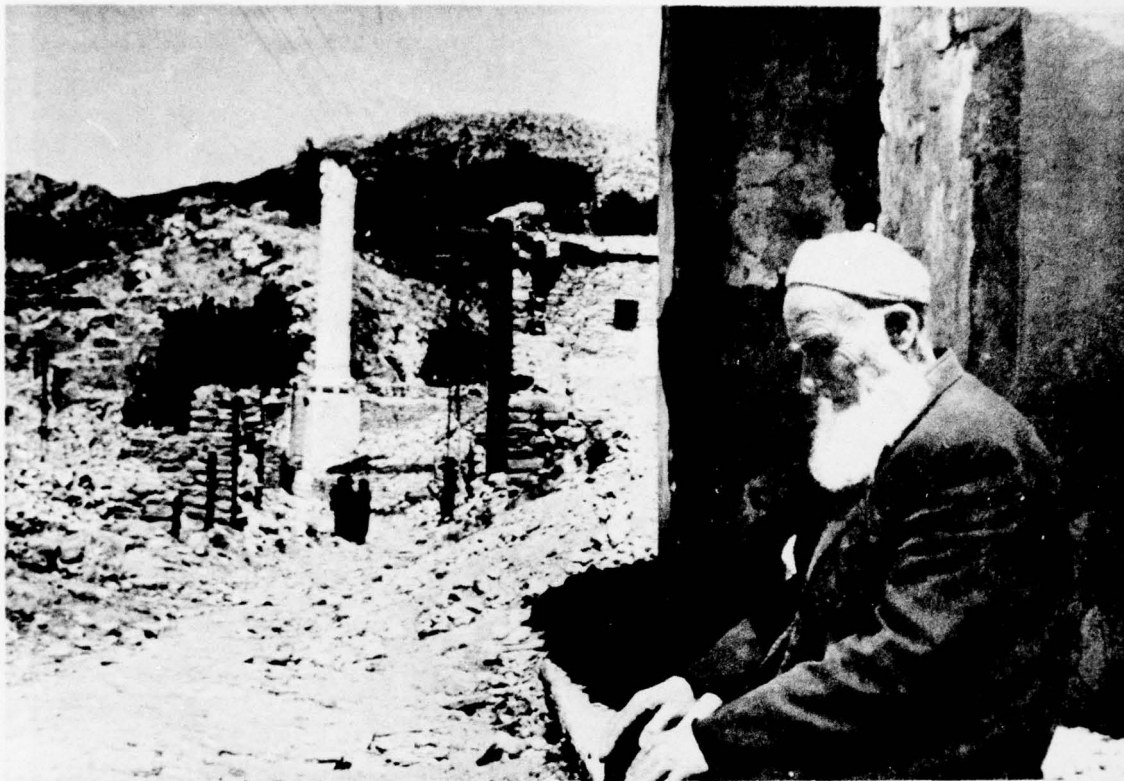
Figure A2. Although no one lives in old Lice, former residents still walk through the ruins and visit their old homesites. Note the damaged minaret in the center.

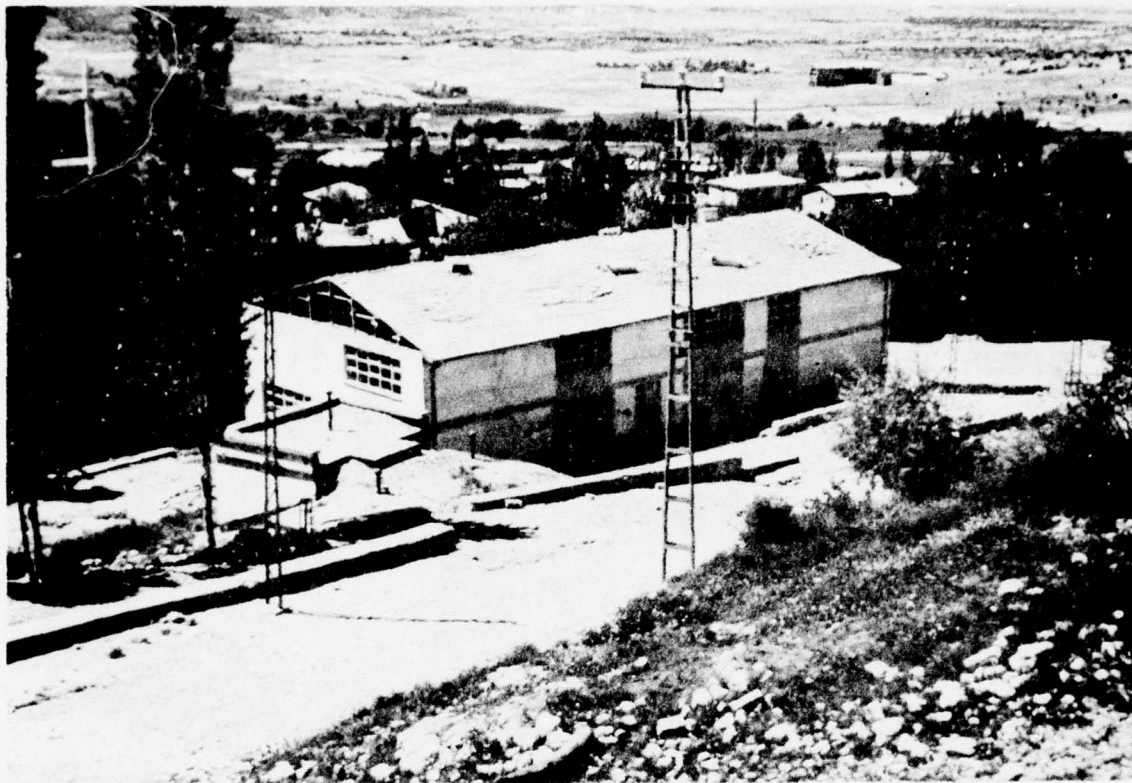
Figure A5. A completely ruined high school building in Lice. Notice the sunken tile roof. A new school has been constructed in the new town.

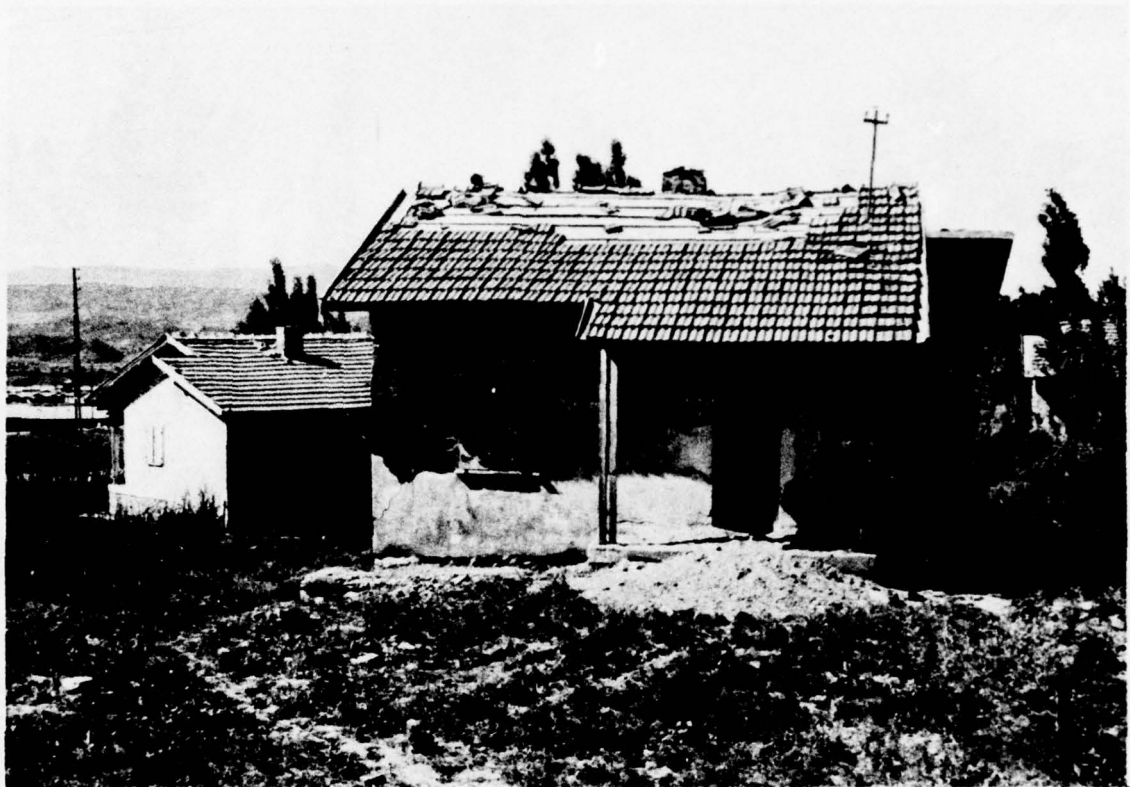
Figure A21. One of the earthquake resistant houses built in Lice by the Ministry of Reconstruction and Resettlement several years ago after a rockslide. Note the dislocated tiles on the roof and the fallen plaster.

remained occupied after the earthquake (Figures A21 and A22). Some houses had fallen and cracked plaster, and dislocated roof tiles, but none had severe structural damage.

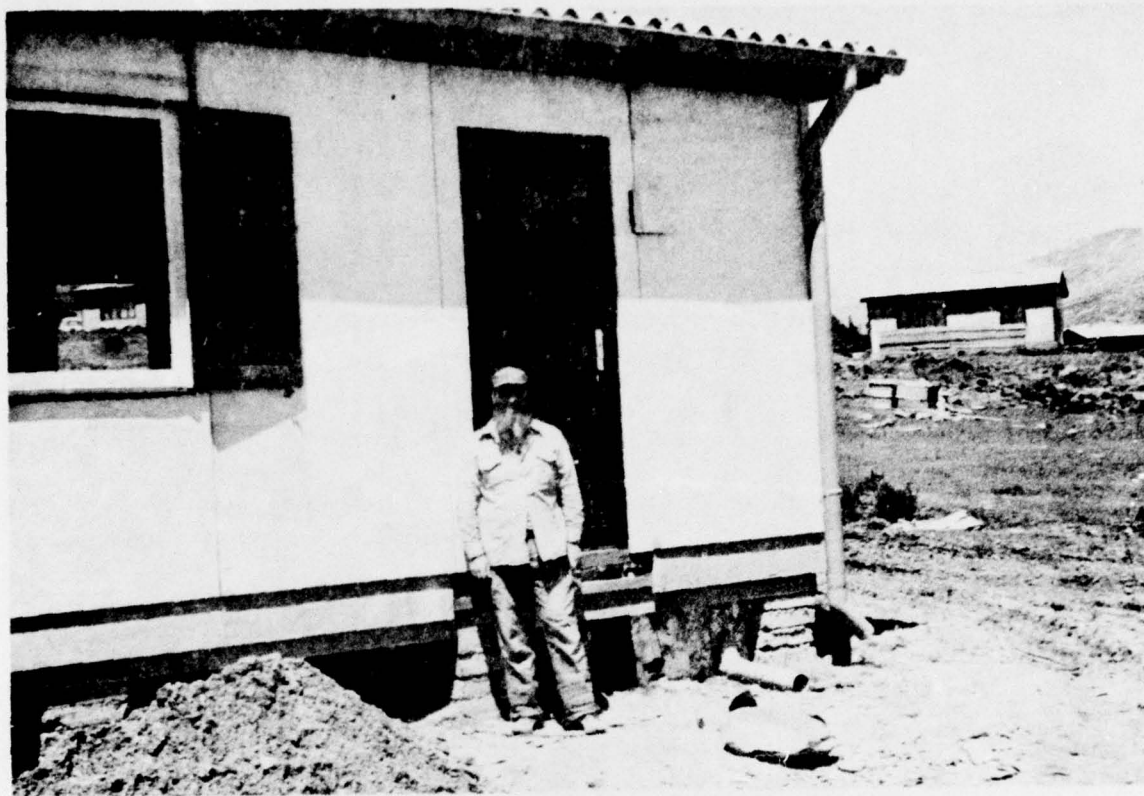
Figure A37. German style construction near Kulp.  
As with most new houses, there are no  
operational facilities for toilet or  
kitchen drainage.
