# THESIS

LOW ENERGY IMPACT LOADING  
OF GRAPHITE-EPOXY PLATES

December 1976

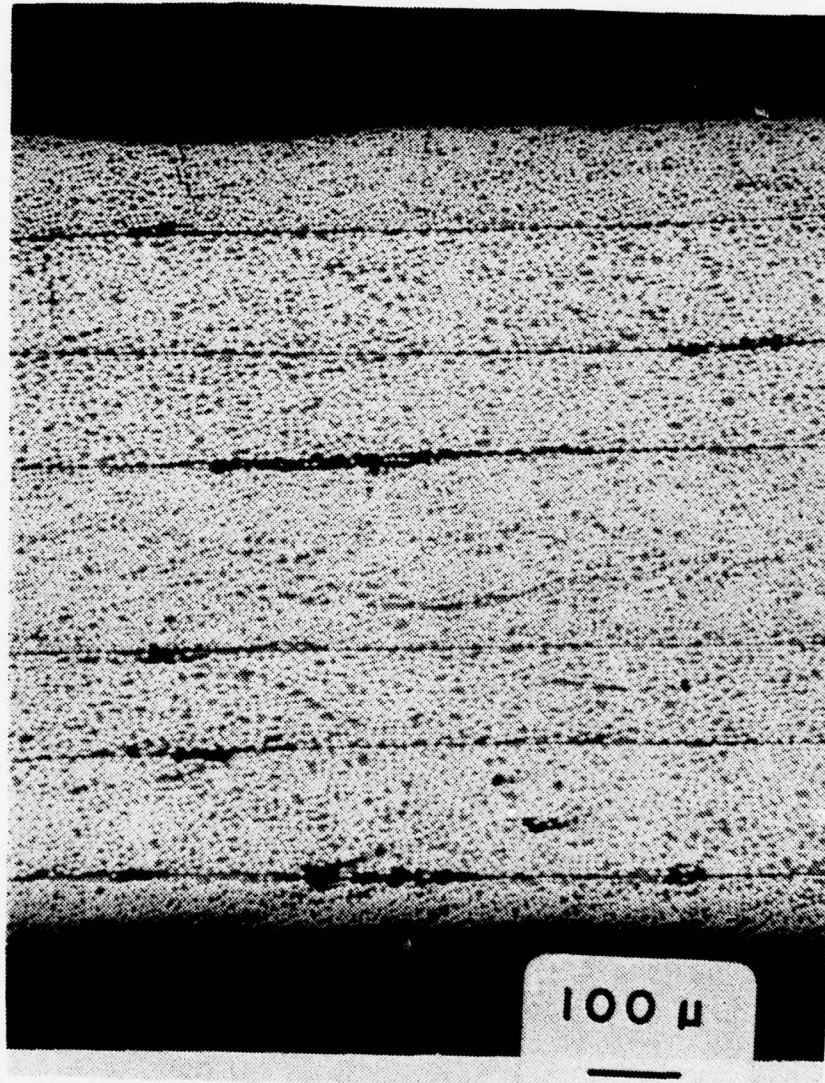
Section 1A3 [Fig. 18] was cut and mounted for light microscope examination. Figure 21 shows the region outside of the gross delamination area typical of failure. This section appears relatively intact with very minor delamination. There are several small lamina fractures in the outer two layers running with the fiber directions in the matrix, and these minor cracks are associated with a slight delamination.

Figure 21 - LIGHT MICROSCOPE, FAILURE SURFACE EXAMINATION,  
SECTION 1A3, 100X

In Figures 21, 22, and 24 the damage is most intense on only one side of the plate. The outer two layers on the side opposite the applied load appear almost intact. A quantitative examination of all failed plates showed an even distribution of damaged outer layers. Some plates showed gross lamina fracture in both outer layers. Other panels had damage on only the loaded side and vice-versa. Thus, the two intact layers are not considered significant.

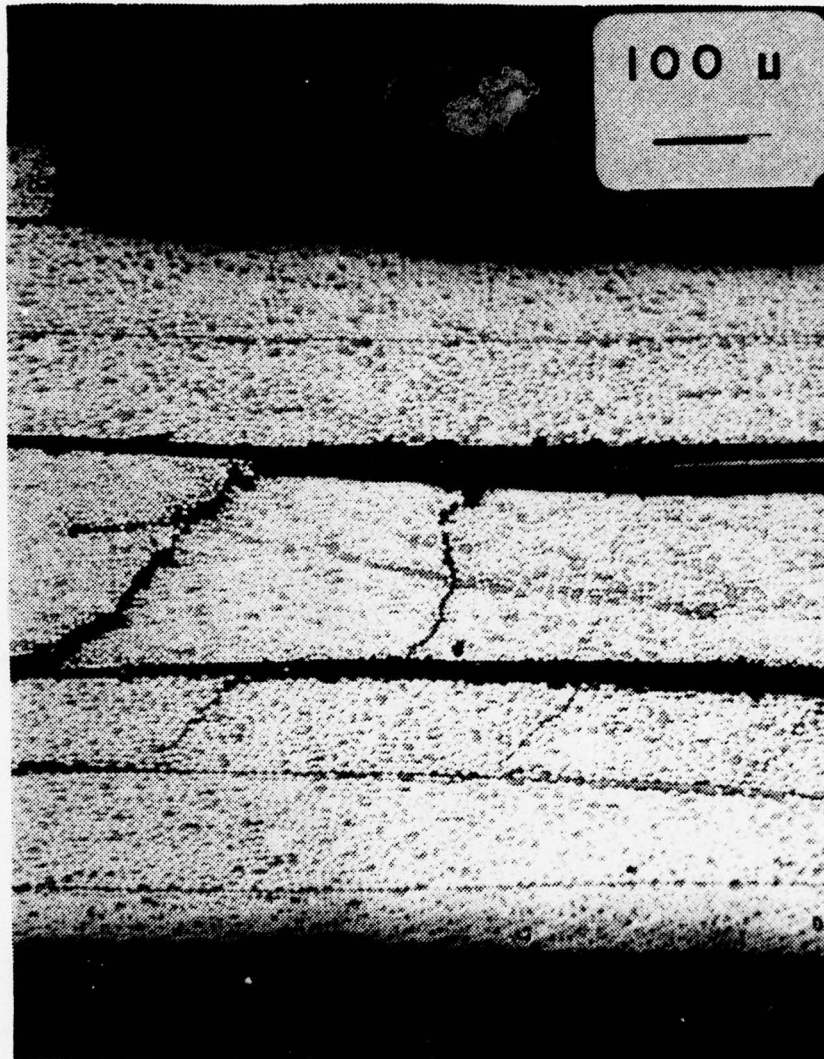
Figures 22, 23, and 24 show the lamina in the gross delamination region. These show extensive delamination, and numerous large cracks in the matrix, between fibers, penetrating entire laminae. Each delamination between laminae appears to have at least one crack penetrating the lamina directly above or below. Figure 24 illustrates this, with delaminations and associated fractures of the adjacent laminae.

Totally flexural failure damage should have been concentrated in the outermost layers where the largest stresses occurred. Figures 22, 23, and 24 all demonstrate a significant failure of the middle two layers in their

transverse direction. The assumption that the middle surface of the plate did not experience extension, therefore, is invalid. This would indicate that theoretical analysis based on small deflection theory is inappropriate.

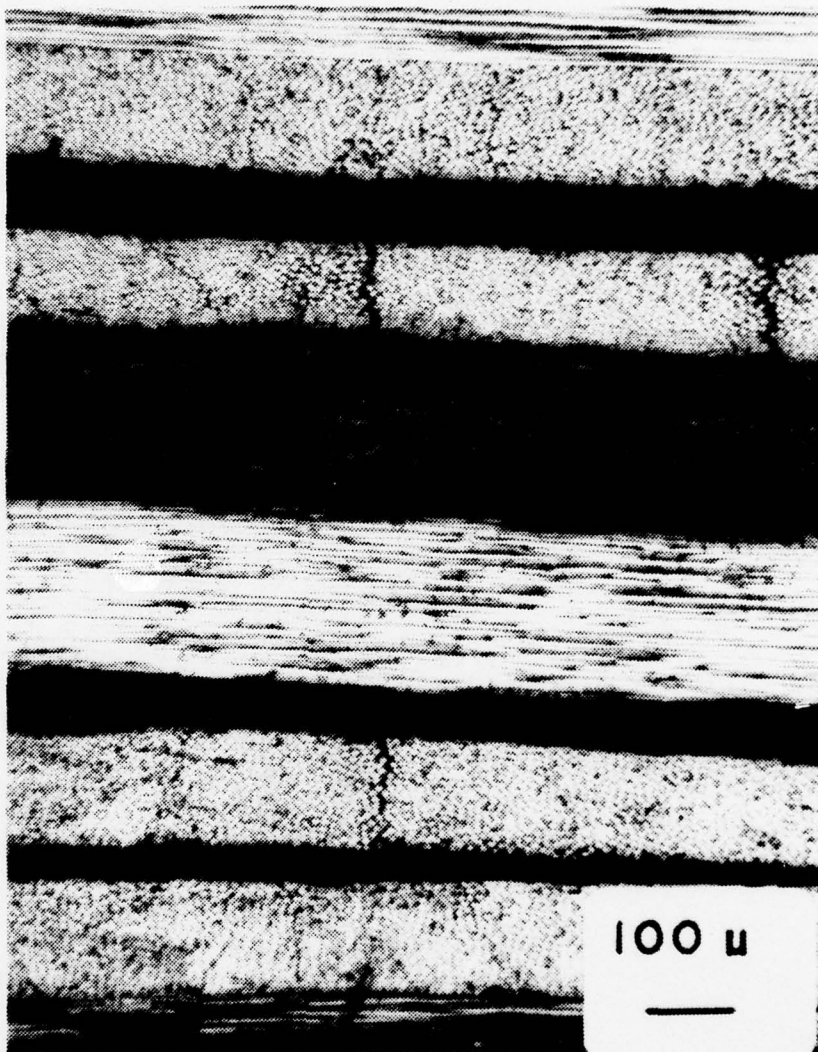
The "bruise" delamination and the typical failure differ. In the "bruise" area, more lamina are involved extensively without as many associated matrix failures in adjacent lamina. There are also no failures of the inner two laminas in the transverse direction.

This damage mechanism is theorized to be a form of spalling caused by the intensive compressive stress wave traveling through the thickness of the material on impact; Ref. 10 applies.

Early in each test, damage was observed in the plates. This damage was localized in the immediate area of impact. When it started it was barely discernible using the liquid crystal technique, but as the tests progressed it became easier to see. After many impacts, the damaged area was delaminated, and this could be determined by careful tactile examinations. It did not appear to have any effect on the the ultimate failure energy. This "bruised" area was subjected to a microscopic examination. It was section 1A2 in Fig. 18 and is shown enlarged in subsequent figures.
