NWHC REPORT 7676
30 SEPTEMBER 1976

NAVAL WEAPONS HANDLING CENTER TECHNICAL REPORT

TEST AND EVALUATION
OF
PROTOTYPE CONTAINER MK 592 MOD O
FOR
HARPOON WARHEAD AND EXERCISE SECTIONS

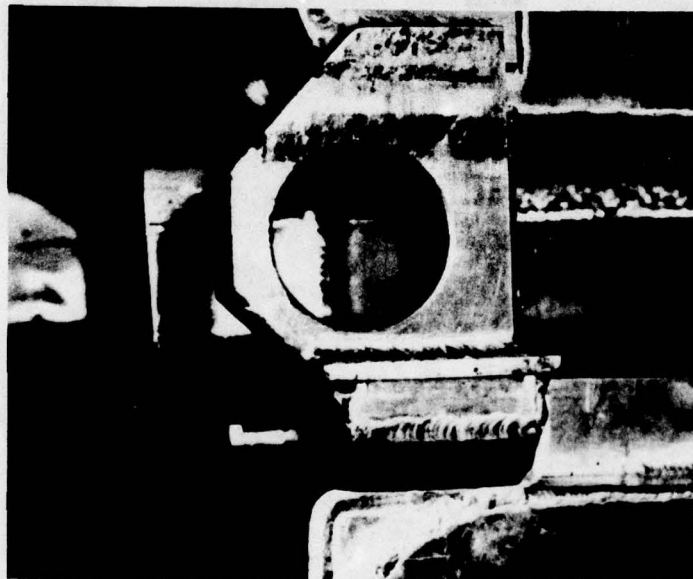
FIG. 17 MISALIGNMENT OF CONTAINER SECURING BOLTS.

7. Stacked containers were not able to be mechanically secured to each other by the bolts and nuts provided for this purpose. The skirts of the top stacked container (used in the test program) were bent slightly upwards thereby creating a misalignment condition that restricted the entrance of the bolts through the mating bracket holes of the lower container.

10. To facilitate stacking of containers it is recommended that the stacking alignment tabs be repositioned to eliminate excessive clearance.
