# RESULTS OF ENVIRONMENTAL TESTING OF MODIFIED OH-58A TAIL ROTOR DRIVE SHAFT BEARING ASSEMBLIES

D. J. Ward  
BELL HELICOPTER COMPANY  
Post Office Box 482  
Fort Worth, Texas 76101

30 October 1970

FINAL REPORT

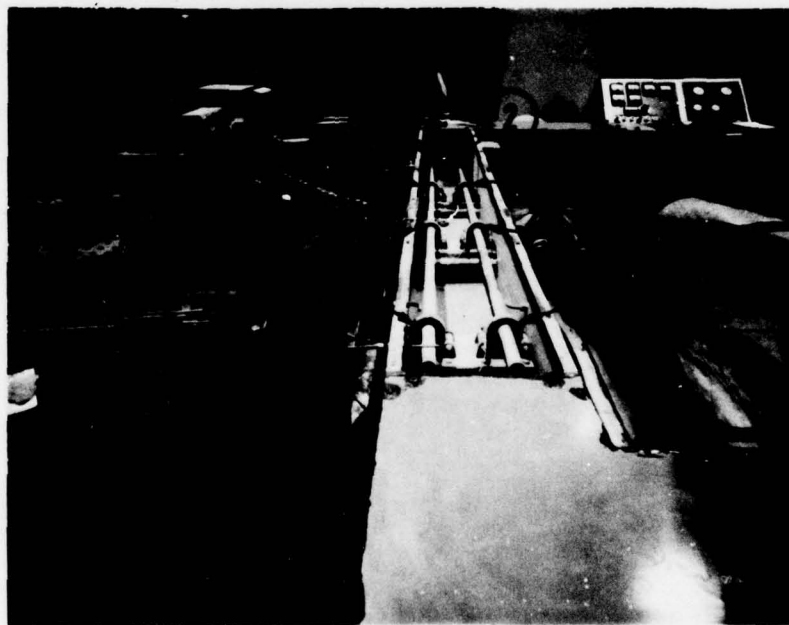
Figure 3

Test stand with top removed. Numbers indicate sequence of numbering of test bearing positions. Also note wind velocity manometers, pitot tubes and thermocouple wires.

Testing of all bearing assemblies was accomplished by running them at 5700 rpm in the wind-tunnel-like apparatus shown in Figures 2 and 3. Air cleaner test dust conforming to SAE test specification J726A was introduced on the following schedule. Upon starting test at 0800, add 1/2 pound fine dust, and at noon add 1/2 pound coarse dust. The test was shut down before leaving at night. The dust/air mixture was directed into the side of bearing positions 1 and 2, then over 3 and 4 at 25 mph, over 5 and 6 at 42 mph, and over 7 and 8 at 78 mph. Airflow was produced by a 30-inch centrifugal fan powered by a 30 hp Varidrive (Fig. 11). Temperature of each bearing assembly was measured at the split line of the hanger assembly by thermocouples routed out of the test section to a 24-point Honeywell temperature recorder set to record one minute in six (Fig. 12). Due to the stabilizing effect of the large air mass flow passing over the test bearings, only minor temperature variations could be observed between individual test bearings. Even at the point of bearing failure, only 20 to 30 degrees Fahrenheit temperature increase could be detected. It was necessary, therefore, to maintain close scrutiny of the test in order to detect failure by a minor change in a bearing's temperature level, or by an increase in sound level, or by physical signs of catastrophic failure. Ambient temperature in the test box stabilized at 140 to 150 degrees Fahrenheit. Bearing temperatures were generally 140 to 170 degrees Fahrenheit.

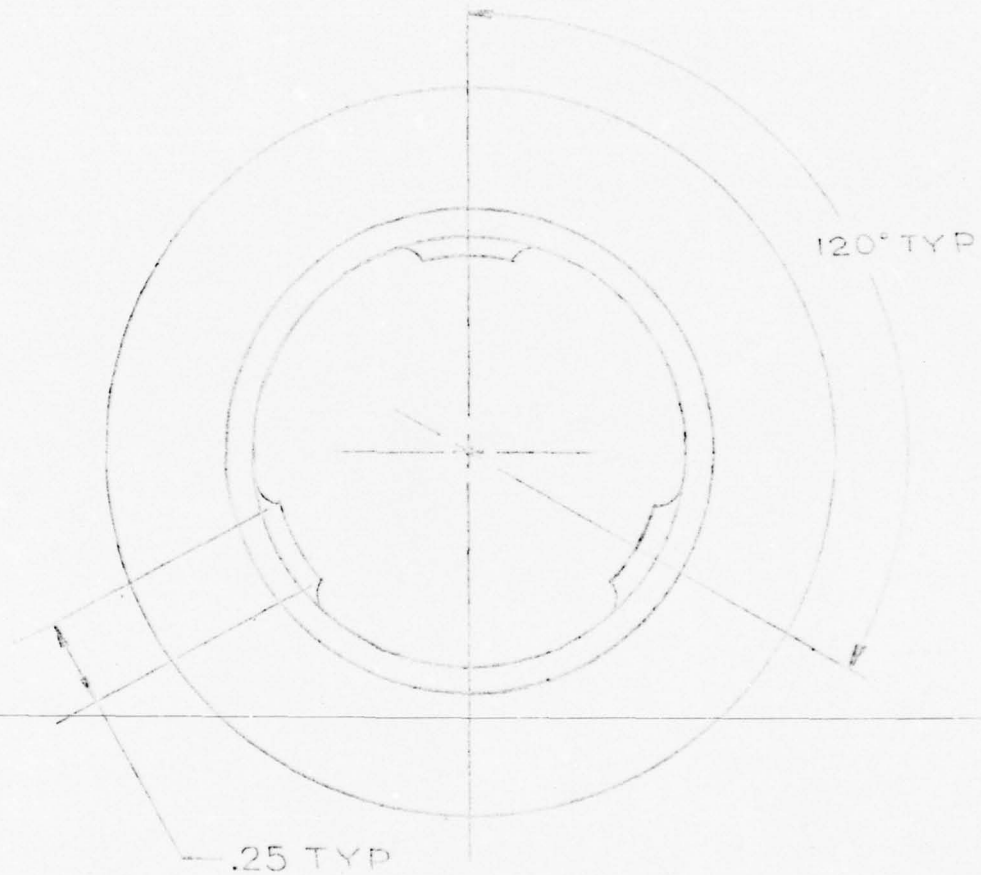
Figure 15. 206-040-349 Collar Final Configuration

| <p>Figure 15 onto a 206-040-350-1 collar modified to a locking ring diameter of 1.175/1.168 while the collar was installed on the tail rotor drive shaft. It was found that this combination could be assembled provided that considerable patience was used in the assembly. However, two bearings assembled by this method, running in positions 1 and 2 had the shields back away from the bearing approximately 1/16" on both sides of the bearing after approximately 5 hours of run time.</p> <p>Subsequent experimentation with assembly and disassembly techniques resulted in a successful combination using the 206-040-349-1 shield modified as shown in Figure 15 and the 206-040-350-1 collar modified to a locking ring diameter of 1.175/1.168 by prepositioning the -350 collar on the shaft then bonding the collar in place, using Silastic RTV bonding compound.</p> | | |

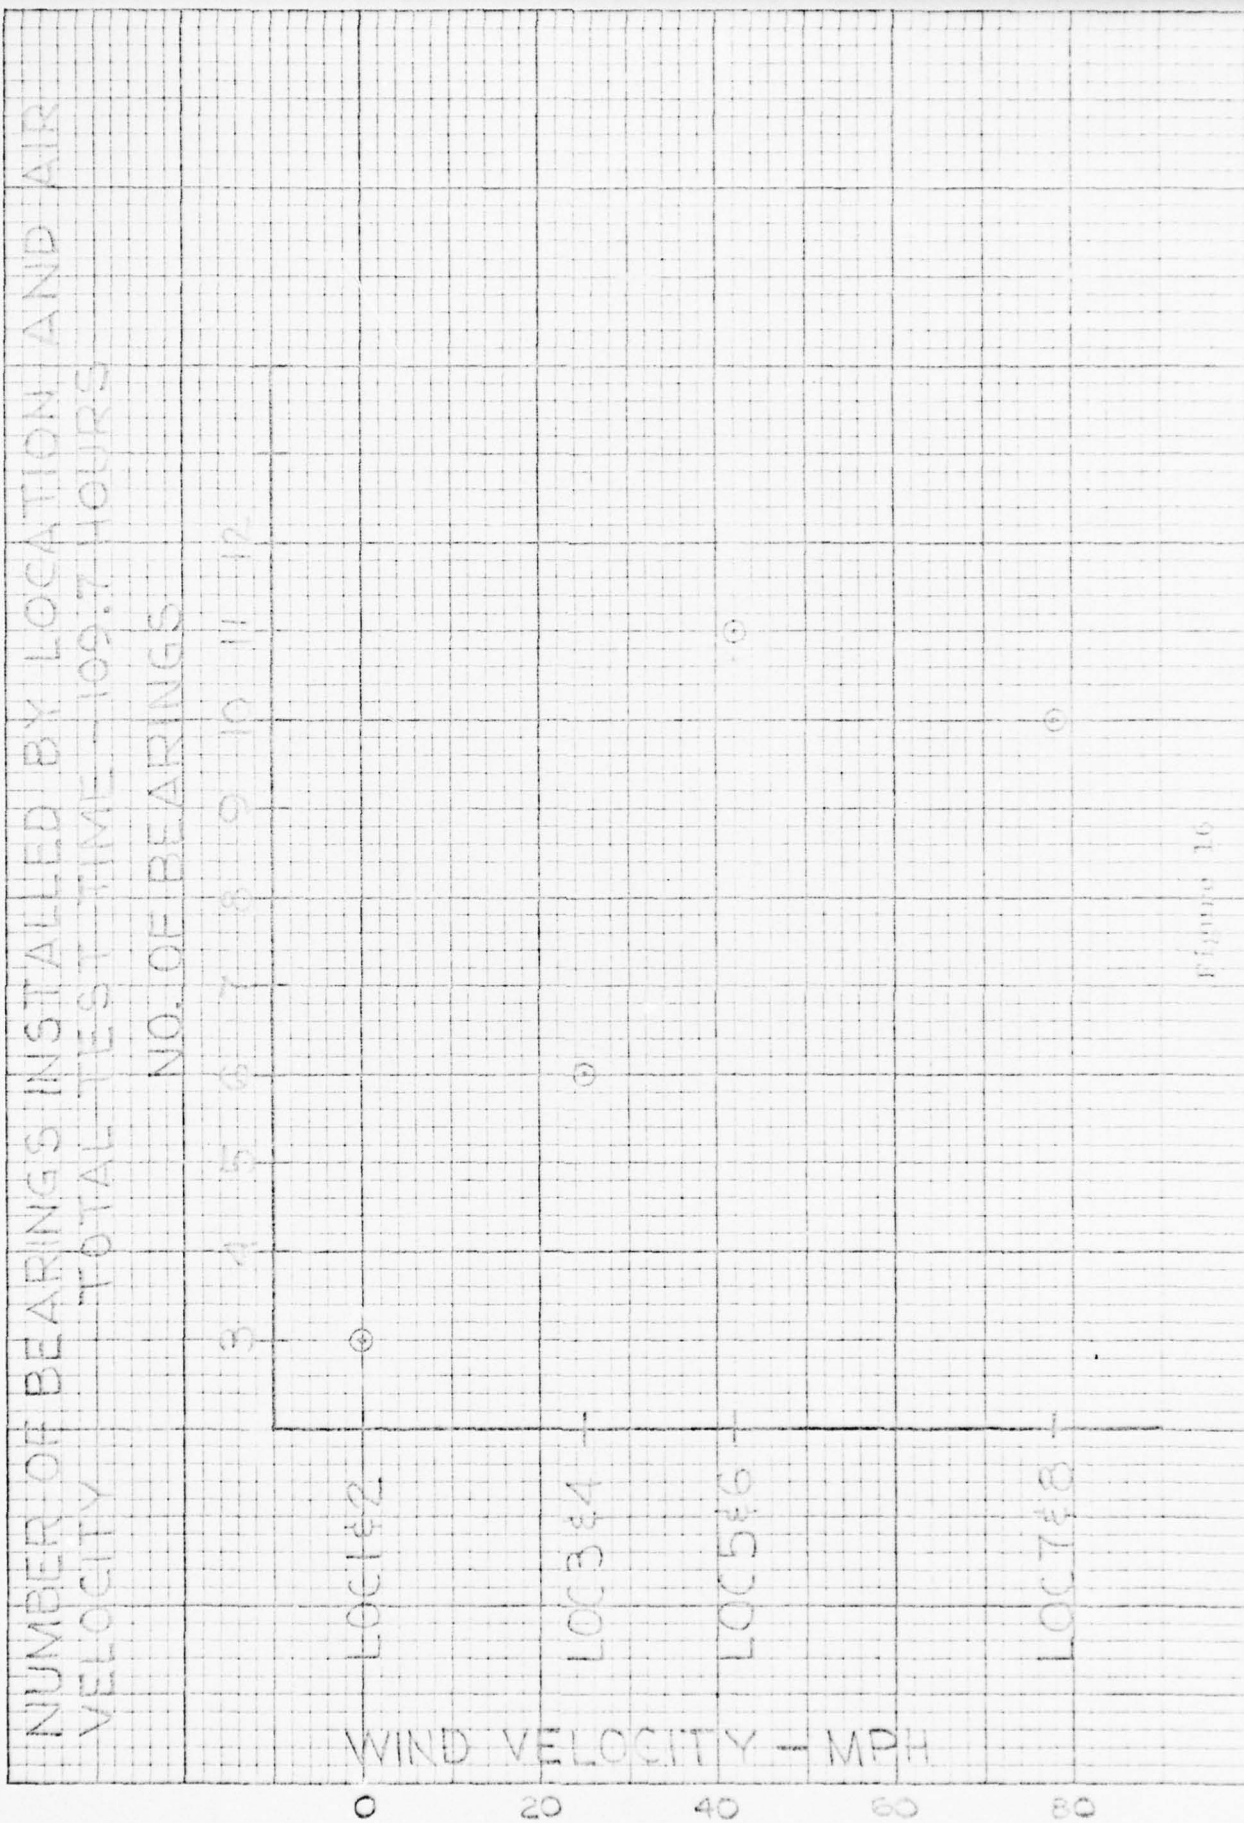
The affect of air velocity on the life of shielded bearings is demonstrated in Figure 16. There is an apparent peak affect at approximately 40 miles per hour, where eleven (11) failures occurred (locations 5 and 6). The influence of air velocity predominates over bearing load as evidenced by the load distribution shown in Table 1. Locations 5 and 6 are subjected to lower loads than locations 3 and 4, and yet 5 and 6 experienced a higher number of failures. Some variation of the failure distribution in Figure 16 may be expected with a change in load, especially at the higher velocity at locations 7 and 8, where ten (10) failures occurred with no measurable load.

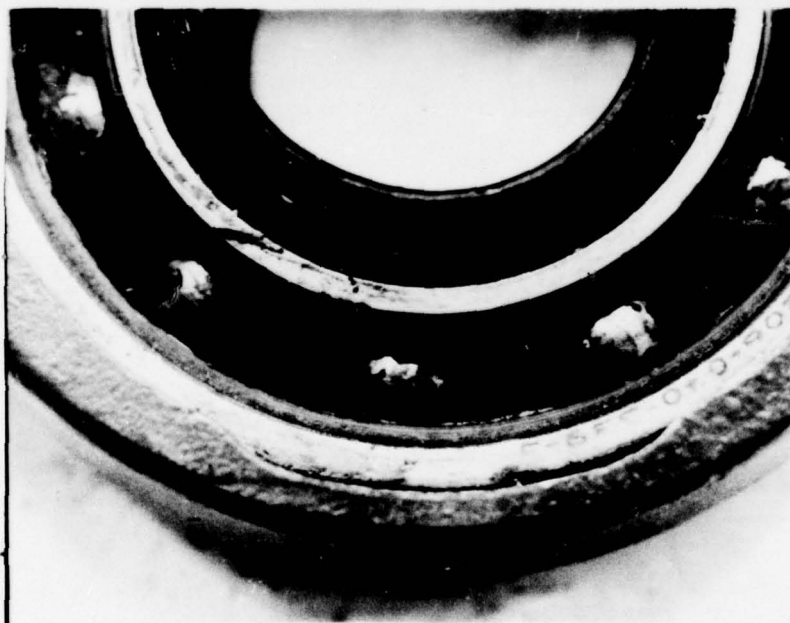
Figure 20. Bearing S/N TRL-3.  
2.5x Enlarged View.

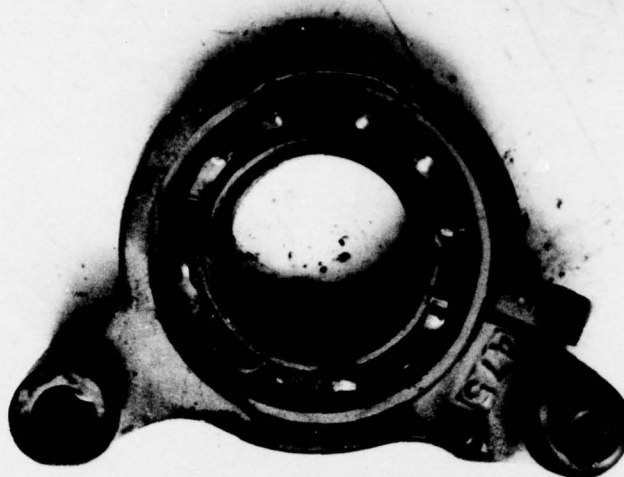
Figure 21. Bearing S/N TRL-4. Removed Position 7  
With 11.6 Hours Time. Shown With Seal  
Removed.

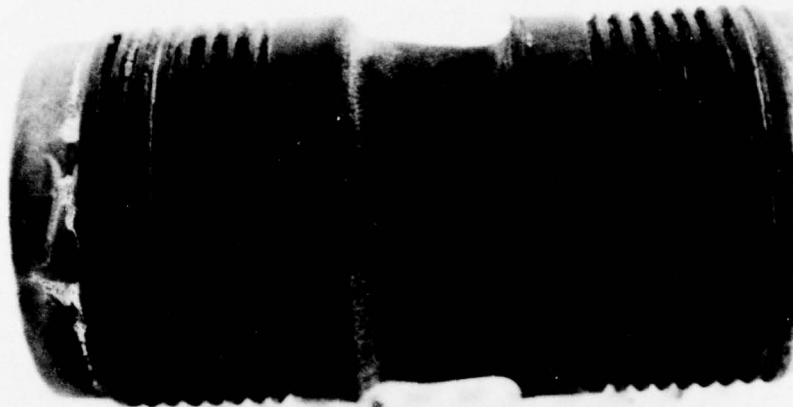
Figure 43. 2x Enlarged View of 206-040-350-1  
Removed From Bearing TRL-14.
