IMPACT RESISTANCE OF STRUCTURAL CERAMICS

Part II: BALLISTIC TESTS

TECHNICAL REPORT AFML-TR-76-56, Part II
FINAL REPORT FOR PERIOD JUNE 1975 - FEBRUARY 1976

AIR FORCE MATERIALS LABORATORY
AIR FORCE WRIGHT AERONAUTICAL LABORATORIES
AIR FORCE SYSTEMS COMMAND
WRIGHT-PATTERSON AIR FORCE BASE, OHIO 45433

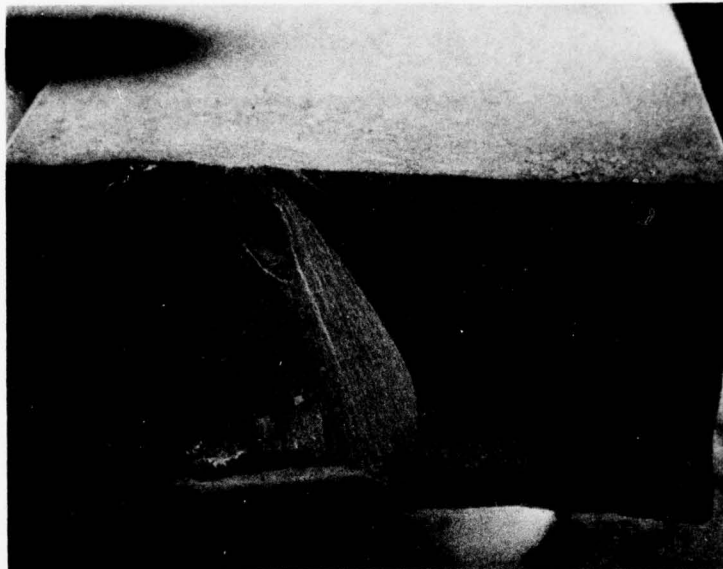
Figure 9. Hertzian Cone Crack on Fracture Surface of 0.1" Thick Bend Bar, Si_3N_4 (NC-132), Anvil Support, (a) 926 f/s, (b) 825 f/s

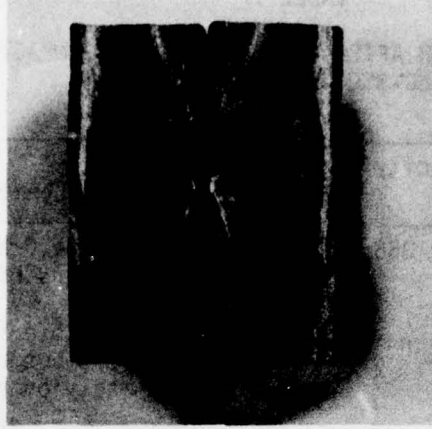
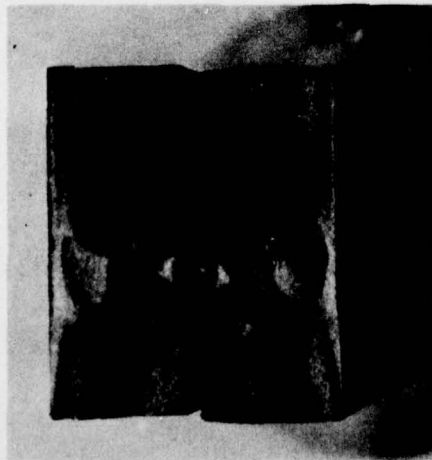
Figure 12. Fracture Surface of Residual Strength Bars, SiC (NC-203),
(a) 667 f/s, (b) 698 f/s, (c) 585 f/s

The Hertzian fracture of specimen 8098 showing a complete cone is shown in Figure 11. Partial cone cracks were visible on the fracture surface of several of the bars used for residual strength. Examples are given in Figure 12 for specimens impacted at 667, 698, and 585 f/s. Below 400 f/s none of the residual strength bars failed at the point of impact.

initiates at secondary cracks produced at the point of impact. A semi-circular surface crack having a radius of 165μ and oriented normal to the tensile stress would reduce the bend strength to $300 \text{ MN/m}^{3/2}$. Essentially the same observation was made for NC-203, the 1 mm deep crack shown in Figure 12b only reducing the strength to 370 MN/m^2 .
