# EFFECTS OF LABORATORY SIMULATED PRECIPITATION STATIC ELECTRICITY AND SWEEP STROKE LIGHTNING ON AIRCRAFT WINDSHIELD SUBSYSTEMS

DOUGLAS AIRCRAFT DIVISION  
MCDONNELL DOUGLAS CORPORATION  
3855 LAKEWOOD BOULEVARD  
LONG BEACH, CALIFORNIA 90846

TECHNICAL REPORT AFFDL-TR-76-75  
FINAL REPORT FOR PERIOD NOVEMBER 1975 - MAY 1976

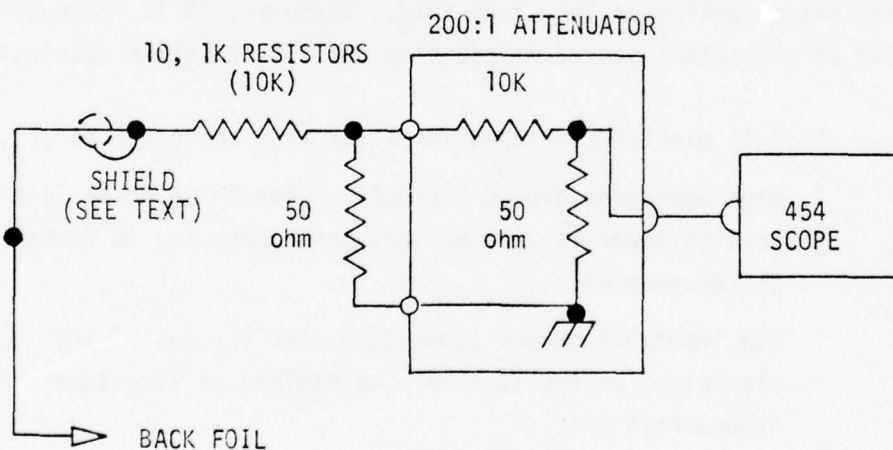
Figure 24. Schematic of high impedance voltage measurement test setup.

High impedance voltage response measurements were made using the test setup depicted in Figure 24.
