TECHNICAL REPORT S-77-1

INVESTIGATION OF CONSTRUCTION TECHNIQUES FOR TACTICAL BRIDGE APPROACH ROADS ACROSS SOFT GROUND

Soils and Pavements Laboratory
U. S. Army Engineer Waterways Experiment Station
P. O. Box 631, Vicksburg, Miss. 39180

February 1977

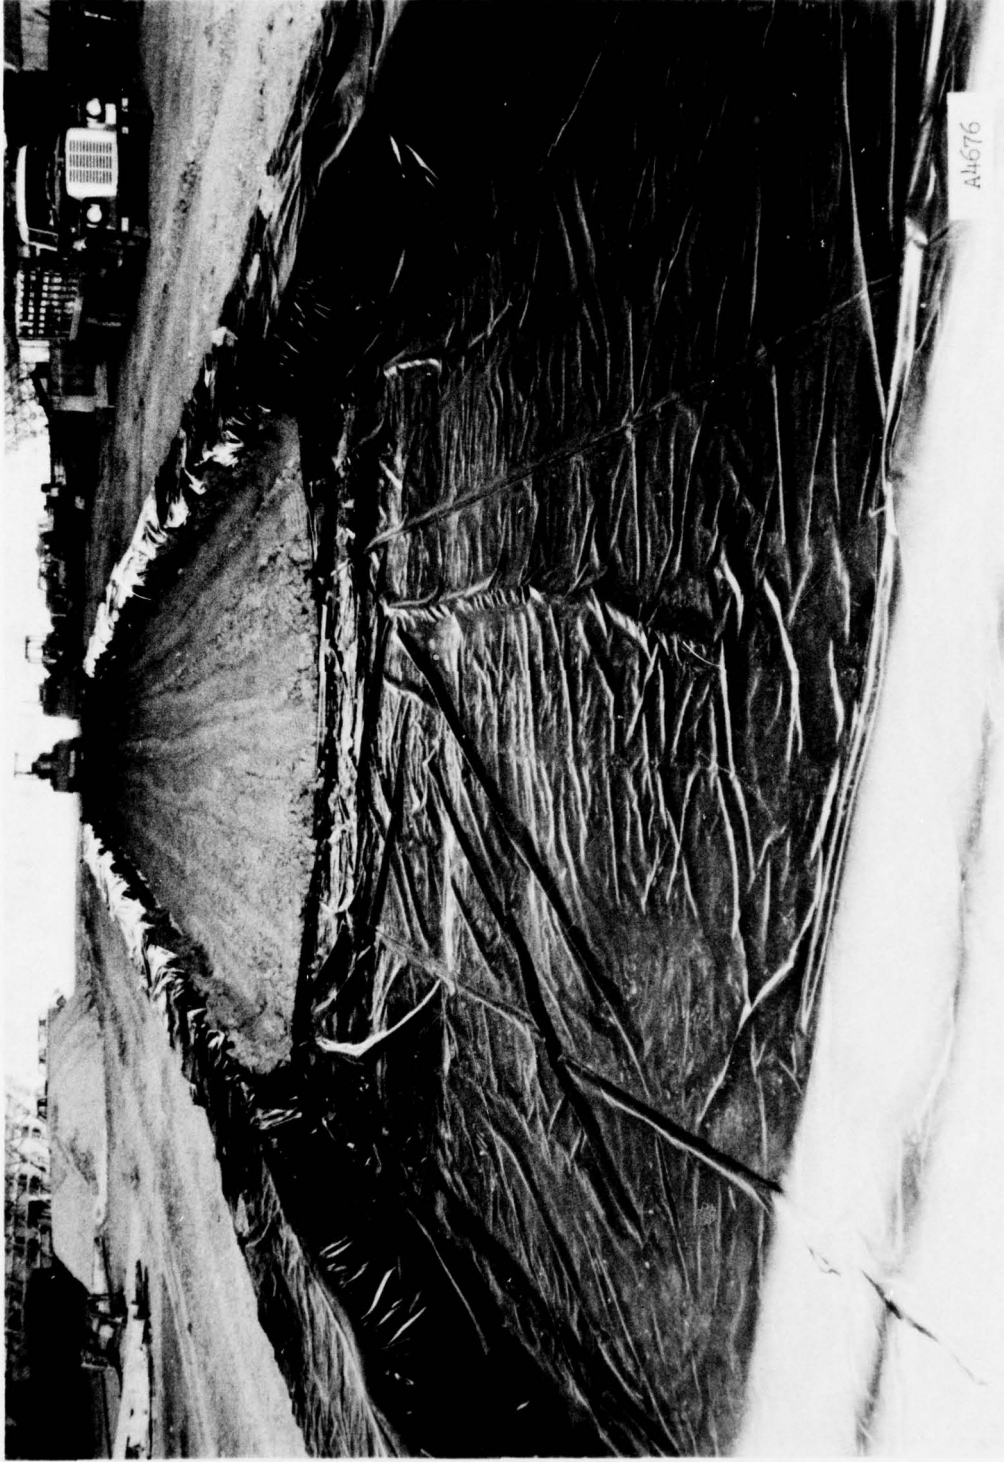
Photo 1. Installing soft clay subgrade on polyethylene

18. First, an area 210 ft long and 20 ft wide was excavated to a depth of approximately 24 in. below the existing ground. The walls and bottom of the excavation were lined with polyethylene to protect the subgrade from drying. The subgrade material, which had been processed to the desired moisture in a processing area, was placed and compacted in 6-in. lifts (Photo 1). The water content of the subgrade ranged from 35 to 37 percent. However, CBR test pits in the subgrade indicated higher CBR strengths than desired; the strengths generally increased with depth and ranged from 1.5 to 2.3 CBR. Therefore, the top 10 in. of subgrade was re-processed in place using a pulvimixer. The water content of this material

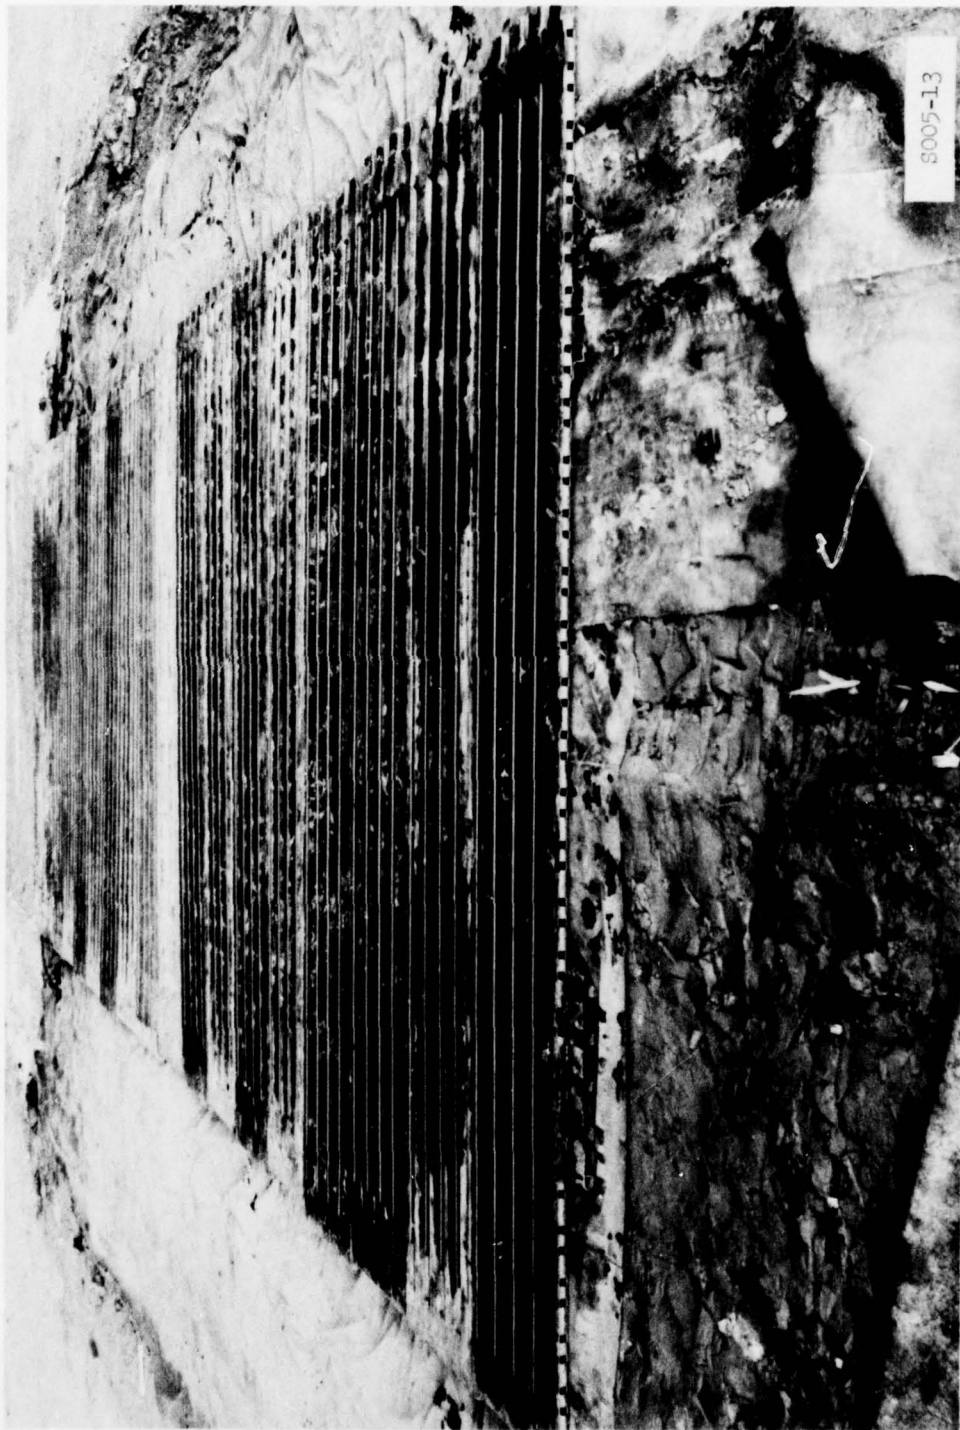
Photo 2. Item 1, M8Al mat installed on runners

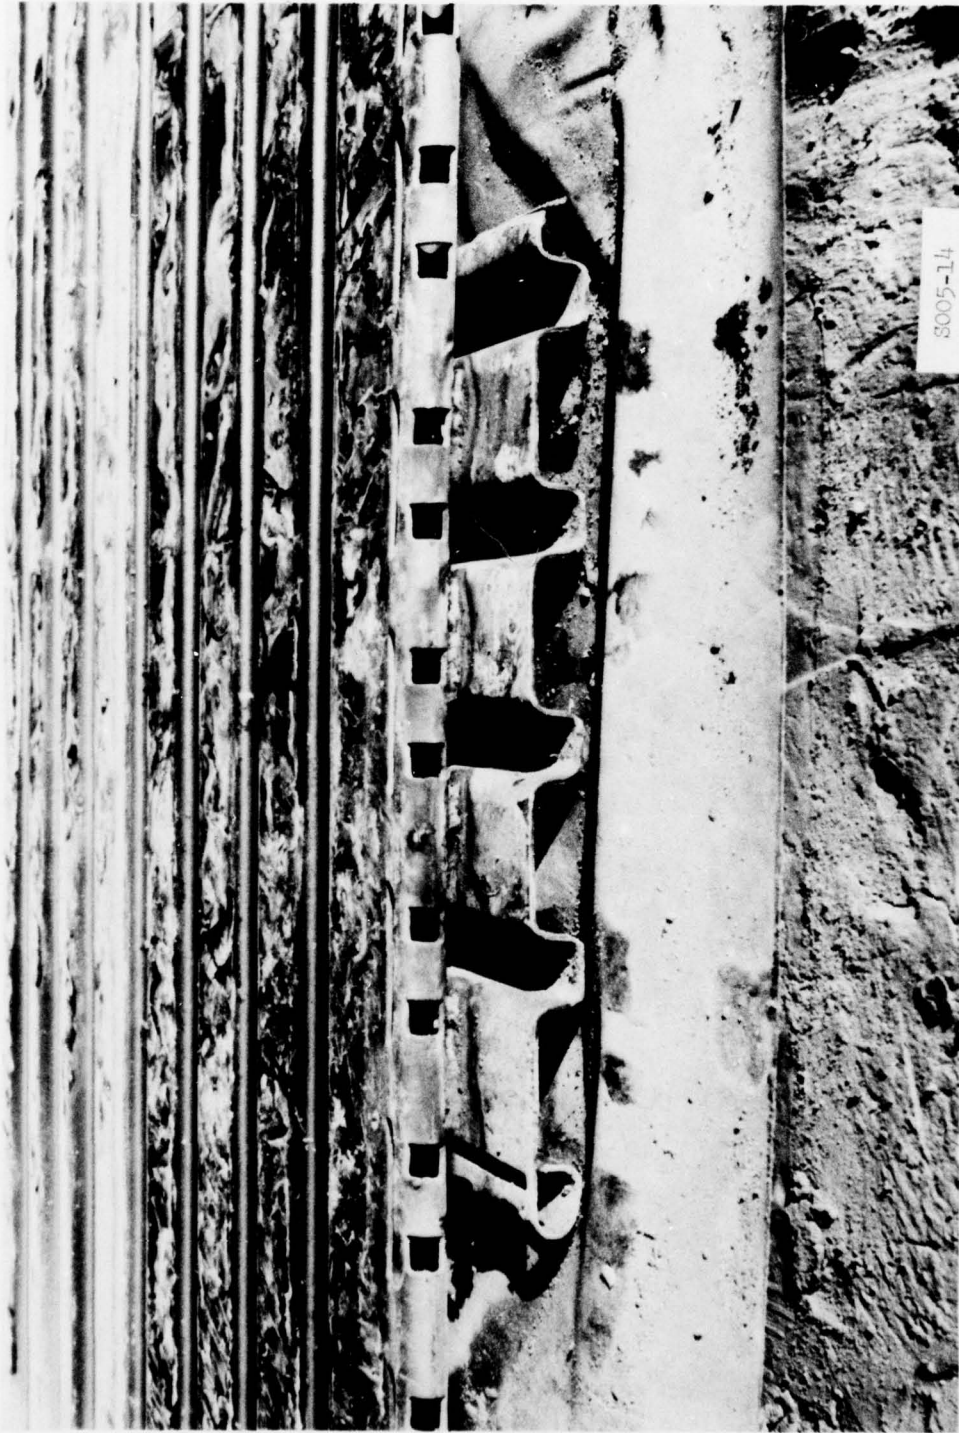
Photo 3. Item 1, close-up view of weld between front edge of mat panel and runner

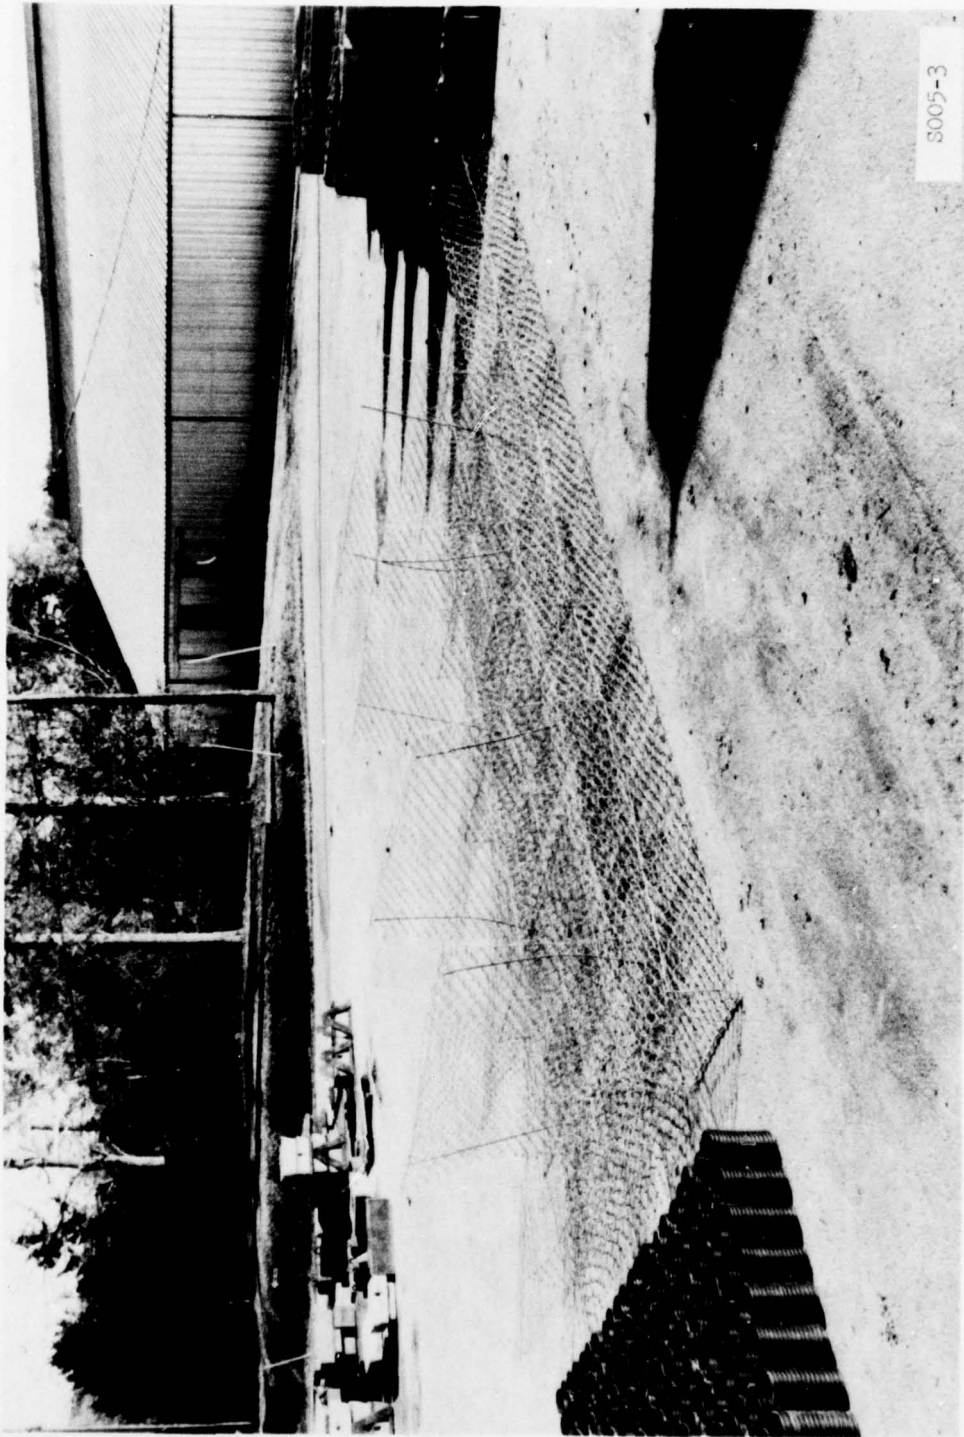
Photo 4. Assembled gabions for item 2

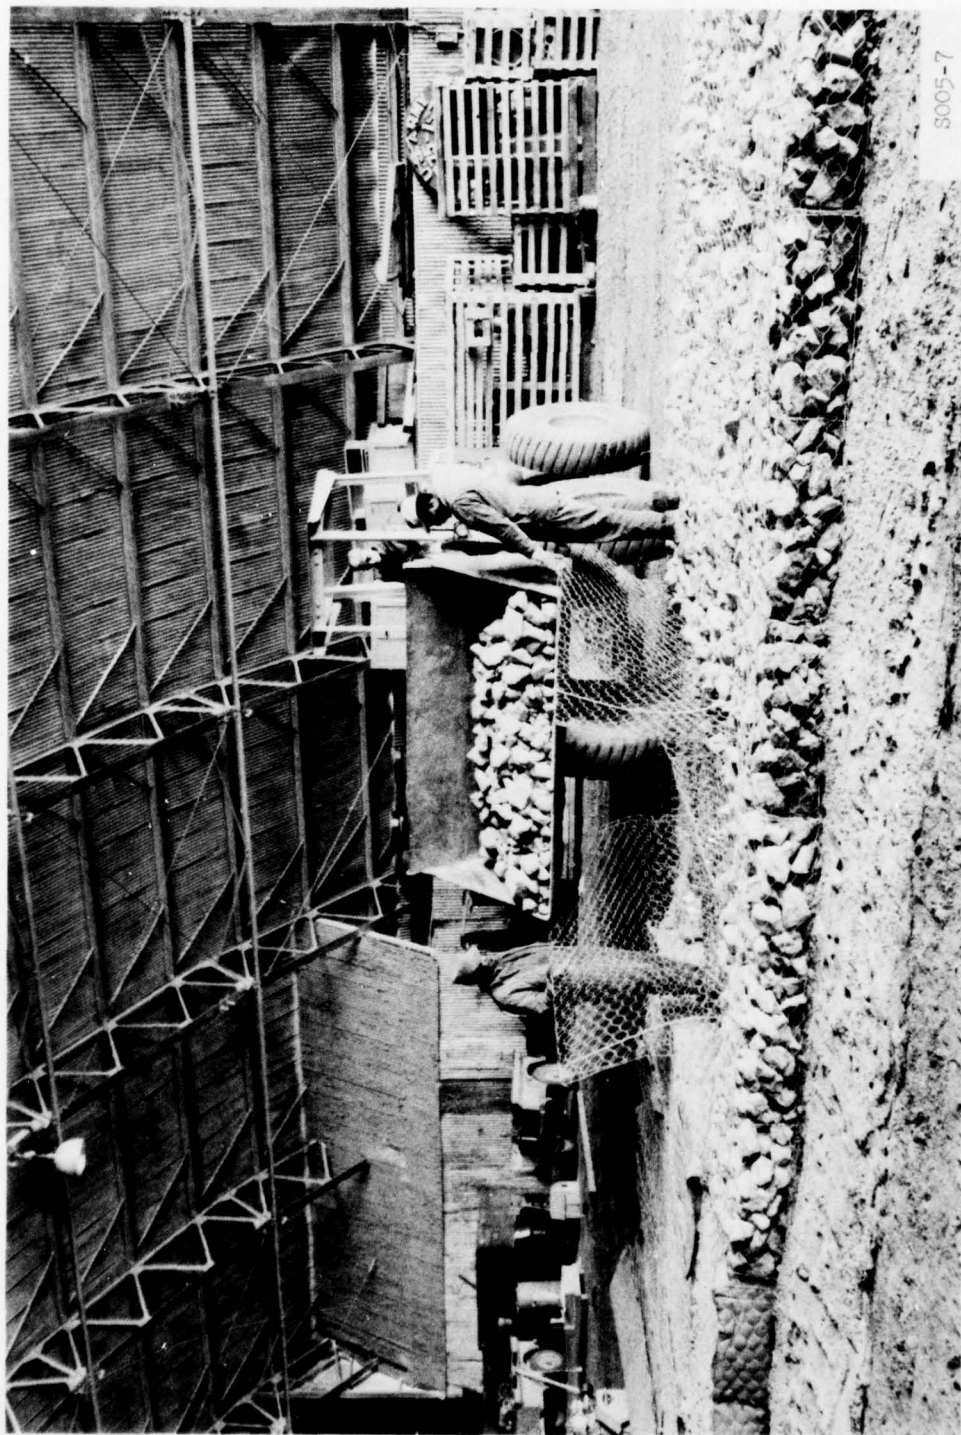
Photo 5. Item 2, installing rocks in gabions

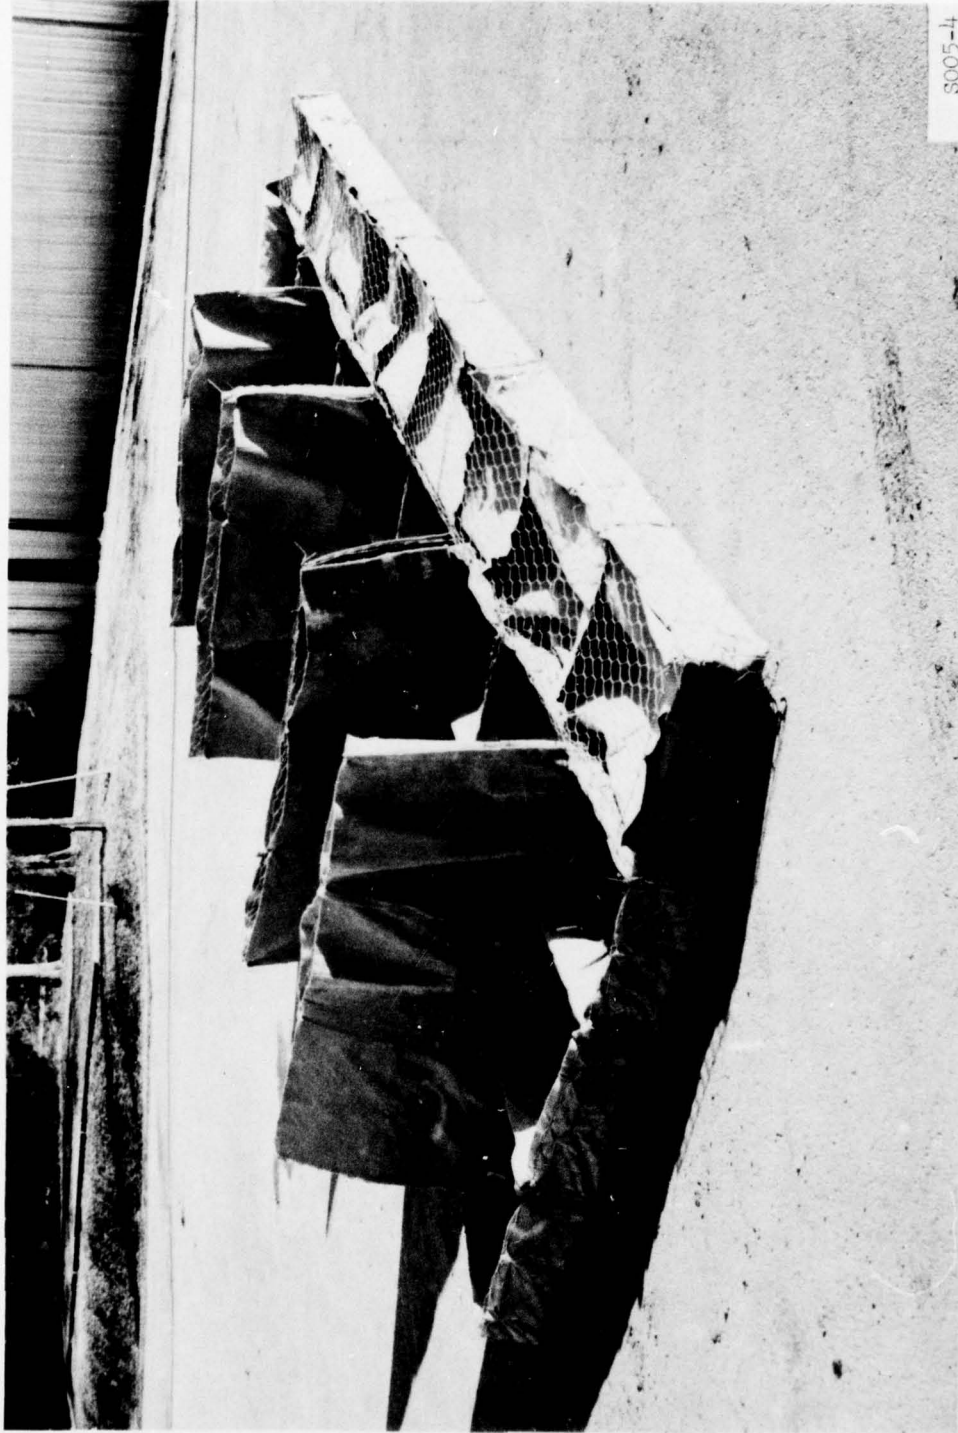
Photo 6. Fabric-lined gabions for item 3

22. The gabions used in item 3 were preassembled as in item 2. Each gabion compartment was then lined with polyester fabric as shown in Photo 6. The fabric-lined gabions were then placed on the subgrade and filled with sand as shown in Photo 7. The sand was compacted using a vibratory plate compactor, and then the gabion lids were wired shut sealing the sand in the gabion compartments. The 2-in. crushed-stone wearing surface was then placed and compacted as in item 2.

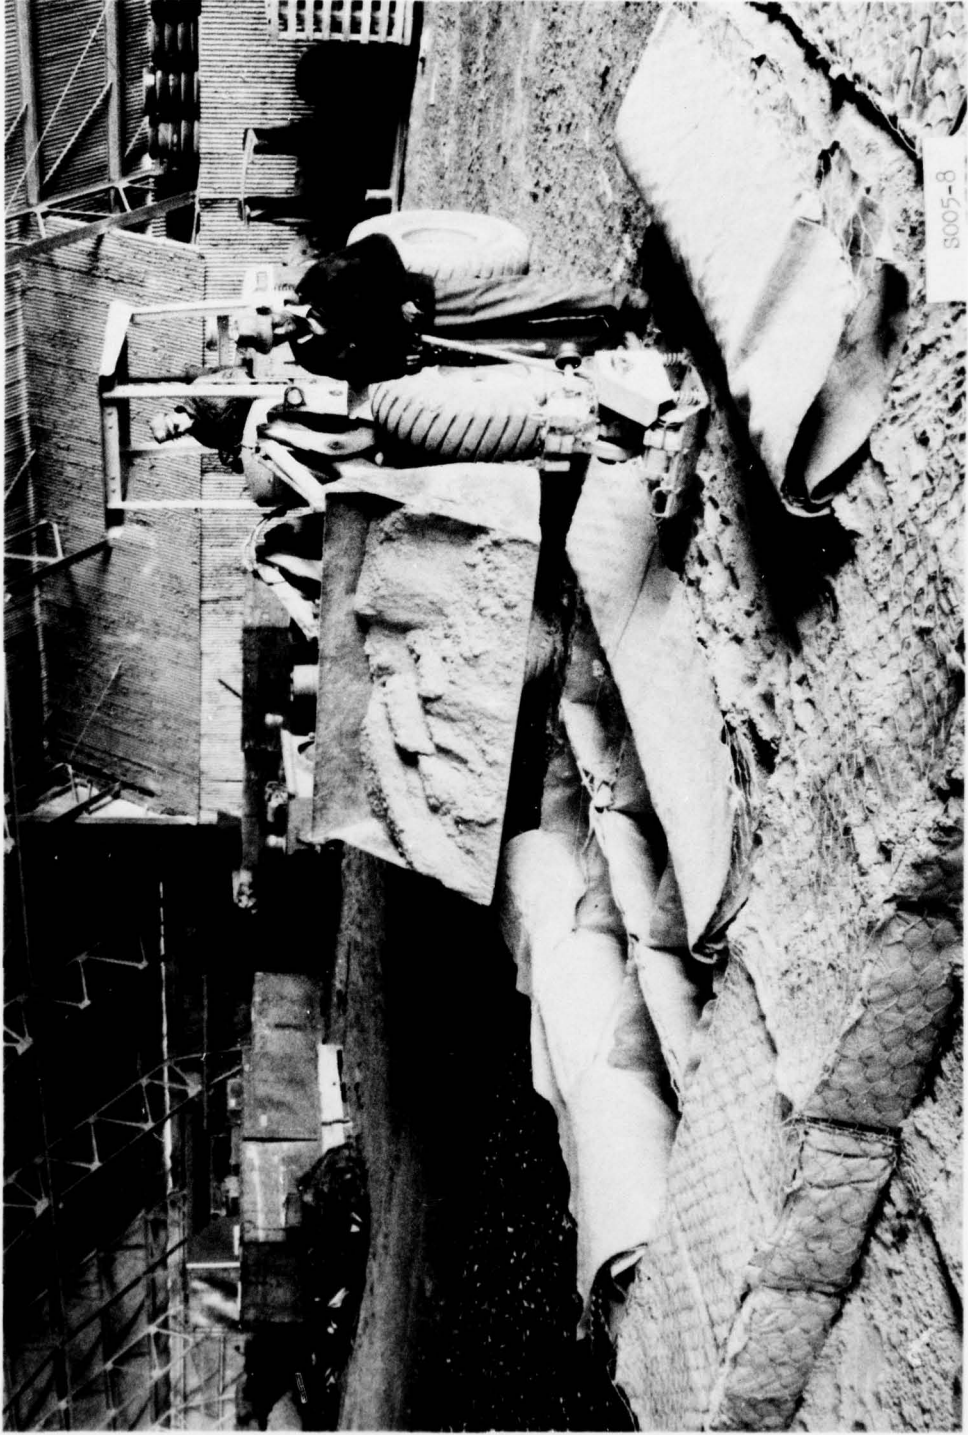
Photo 7. Item 3, installing and compacting sand in fabric-lined gabions

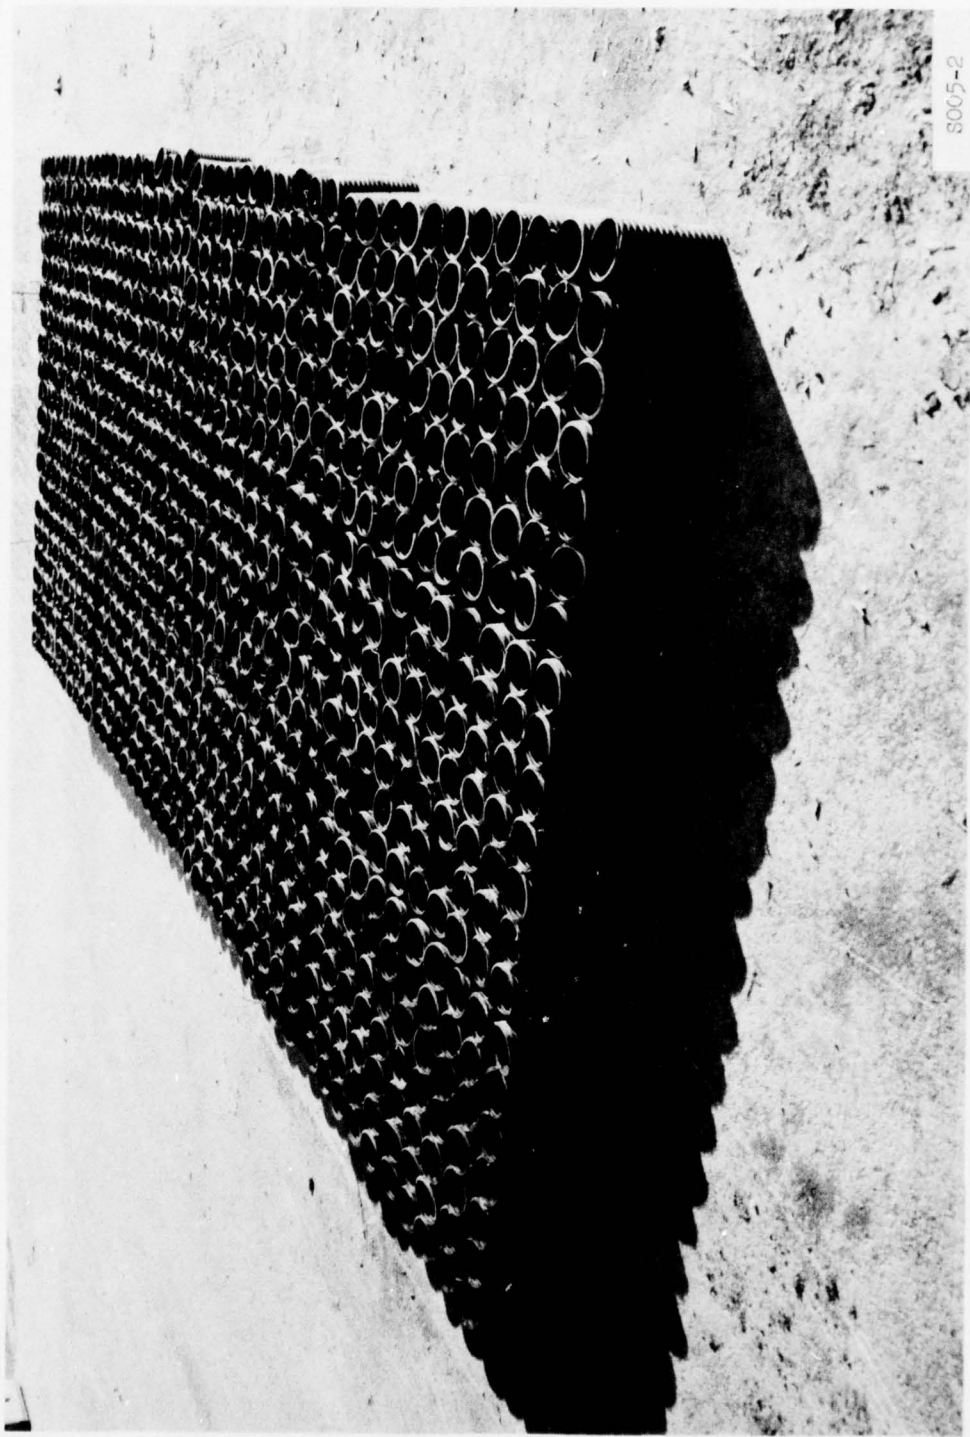
Photo 8. Honeycombed arrangement of plastic tubing for item 4

23. The 1-ft-long sections of plastic tubing used in this item were assembled and fastened together in a honeycomb arrangement as shown in Photo 8. This arrangement was then placed on the subgrade and filled with sand as shown in Photo 9. The vibratory plate compactor was used to vibrate the sand into and between the sections of tubing. The 2-in. crushed-stone wearing surface was then placed as in items 2 and 3.

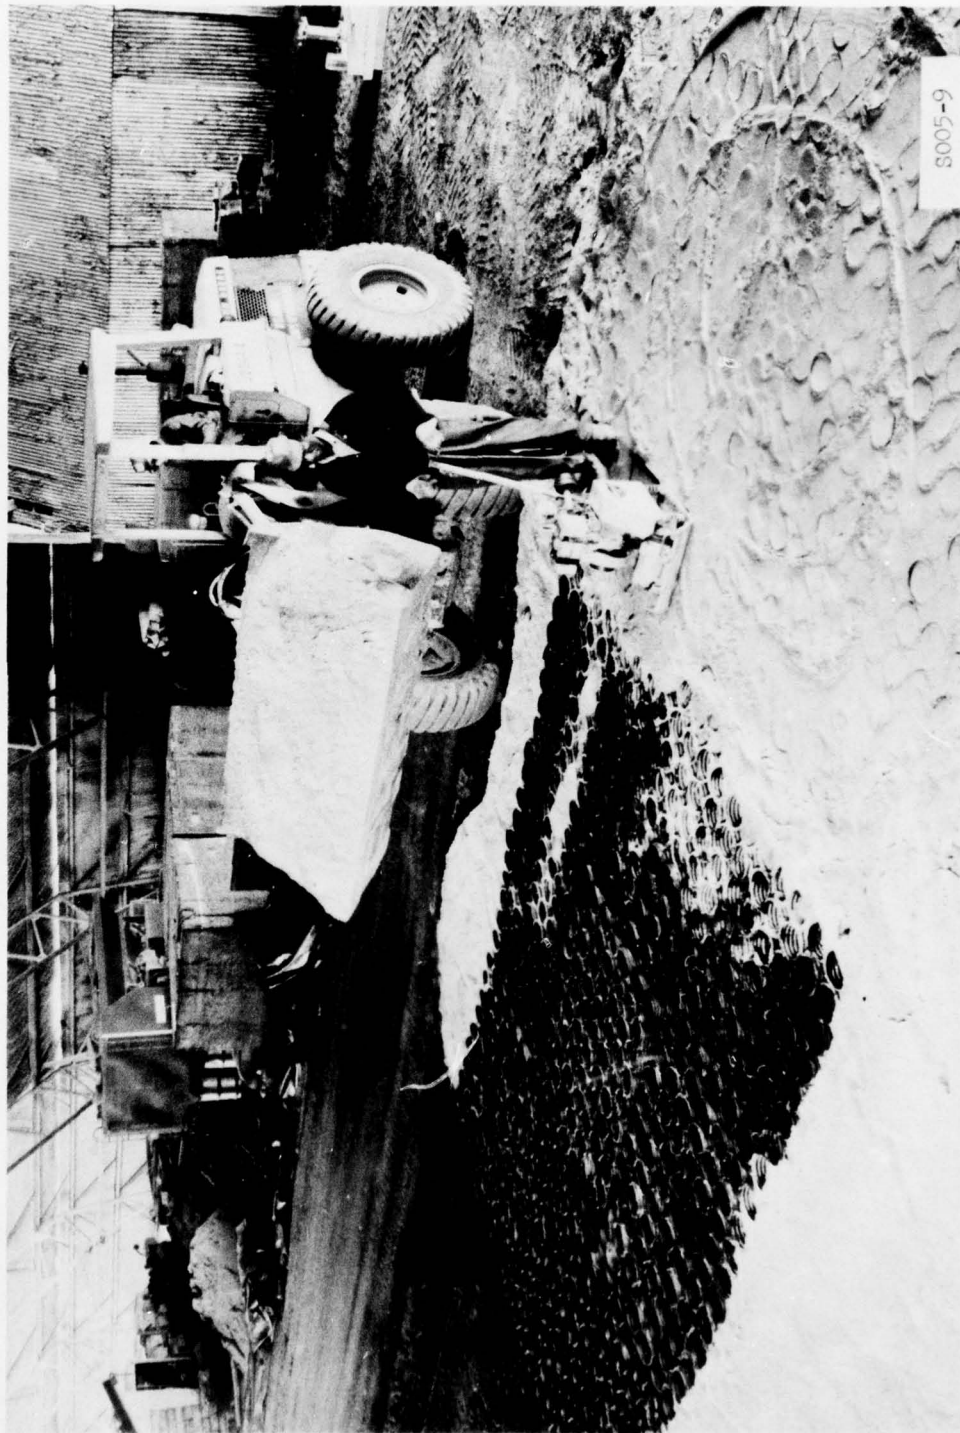
Photo 9. Item 4, installing and compacting sand in plastic tubing

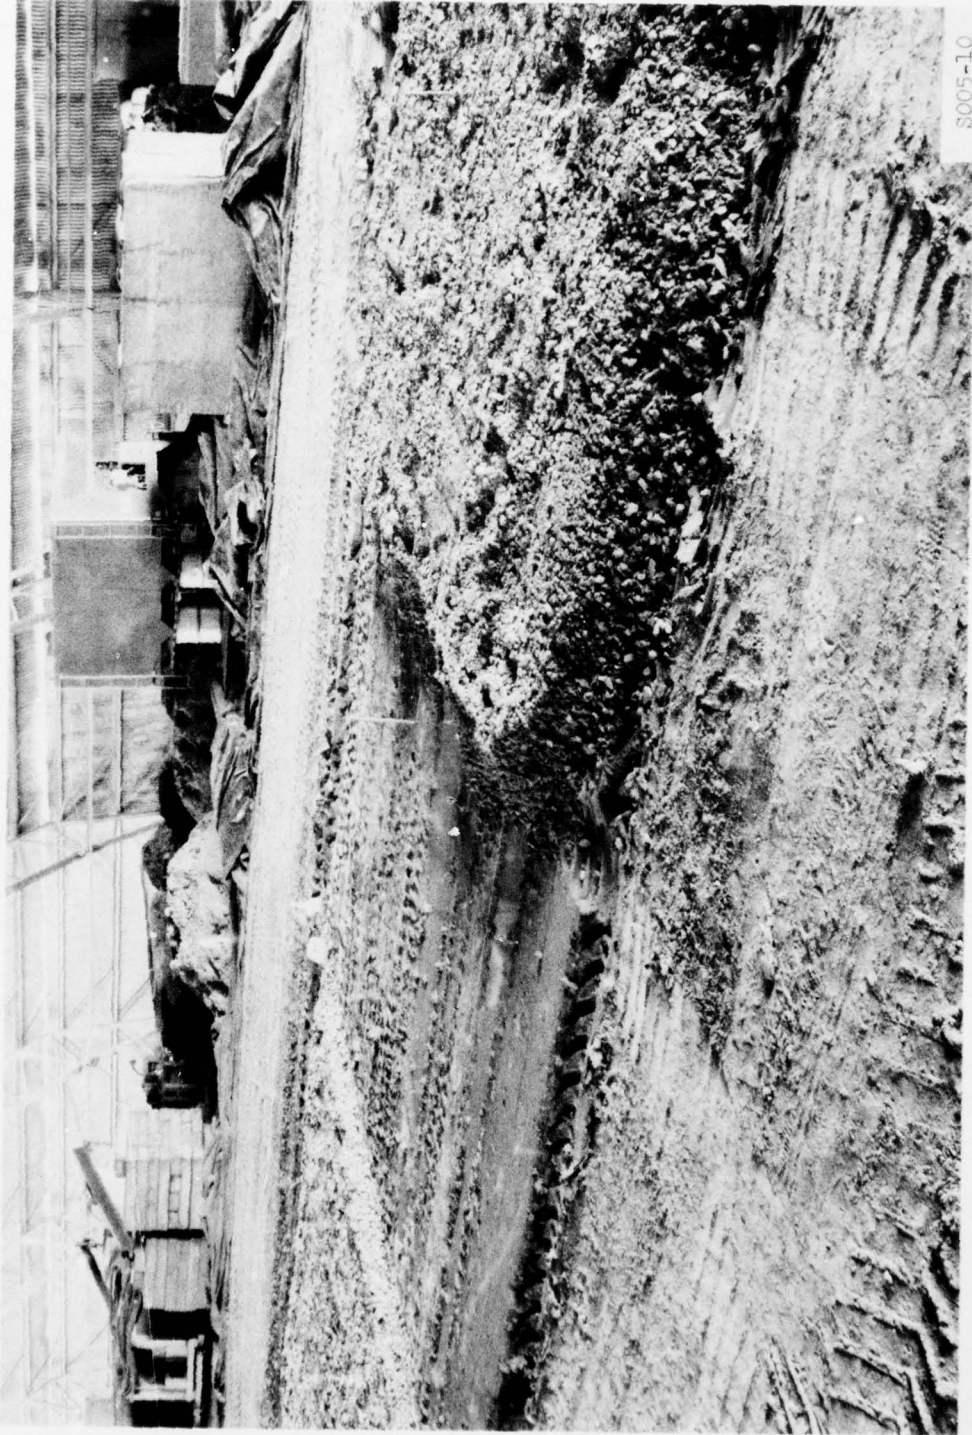
Photo 10. Item 5, crushed-stone base on soft subgrade

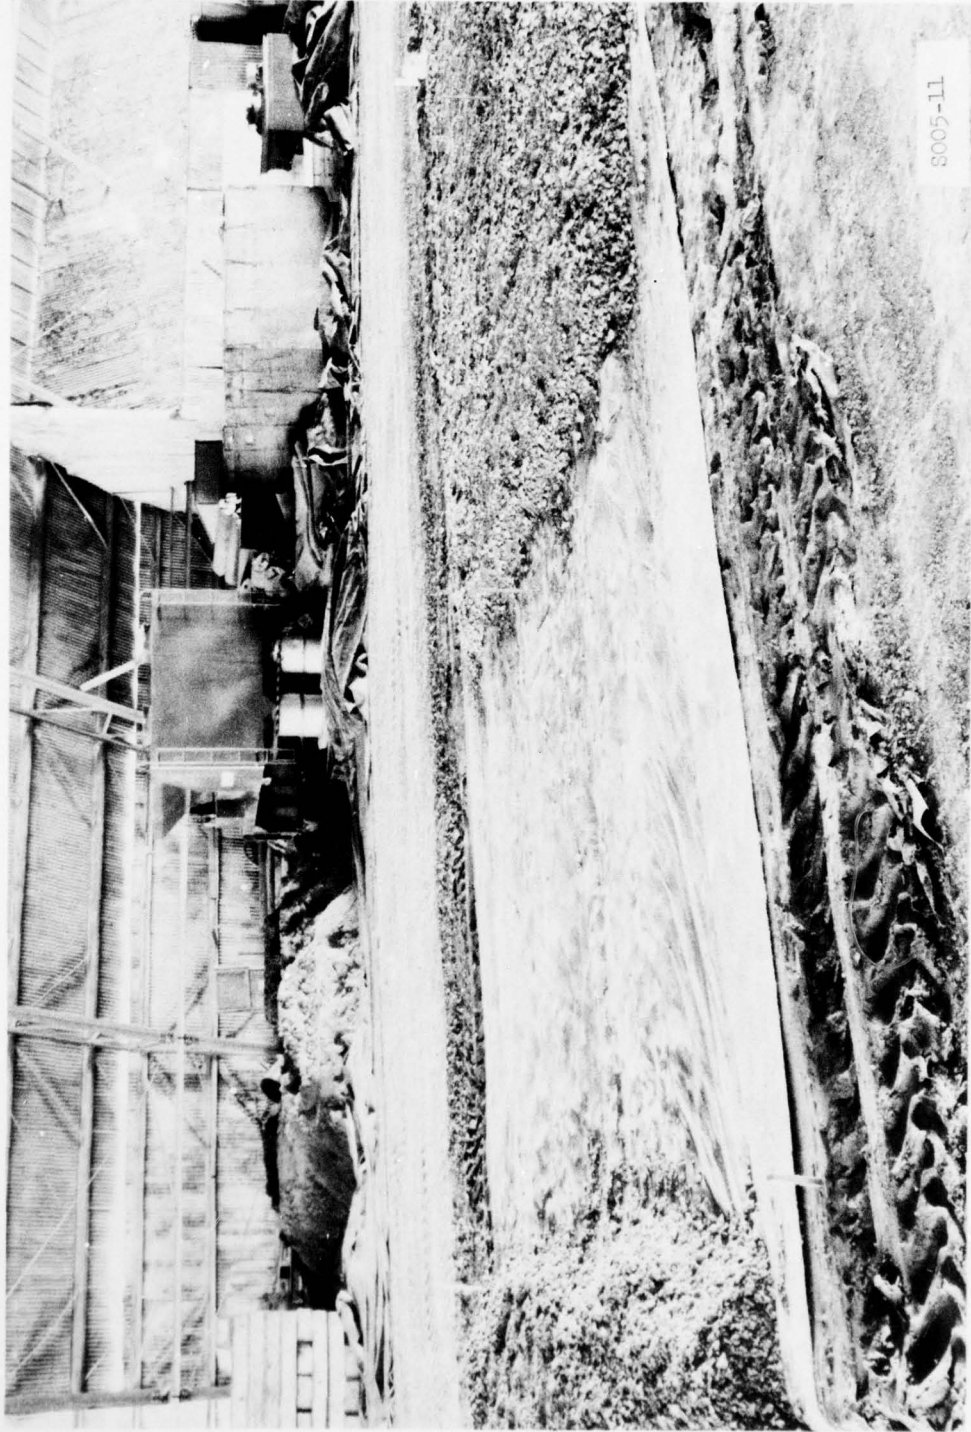
Photo 11. Item 6, crushed-stone base on polyester fabric

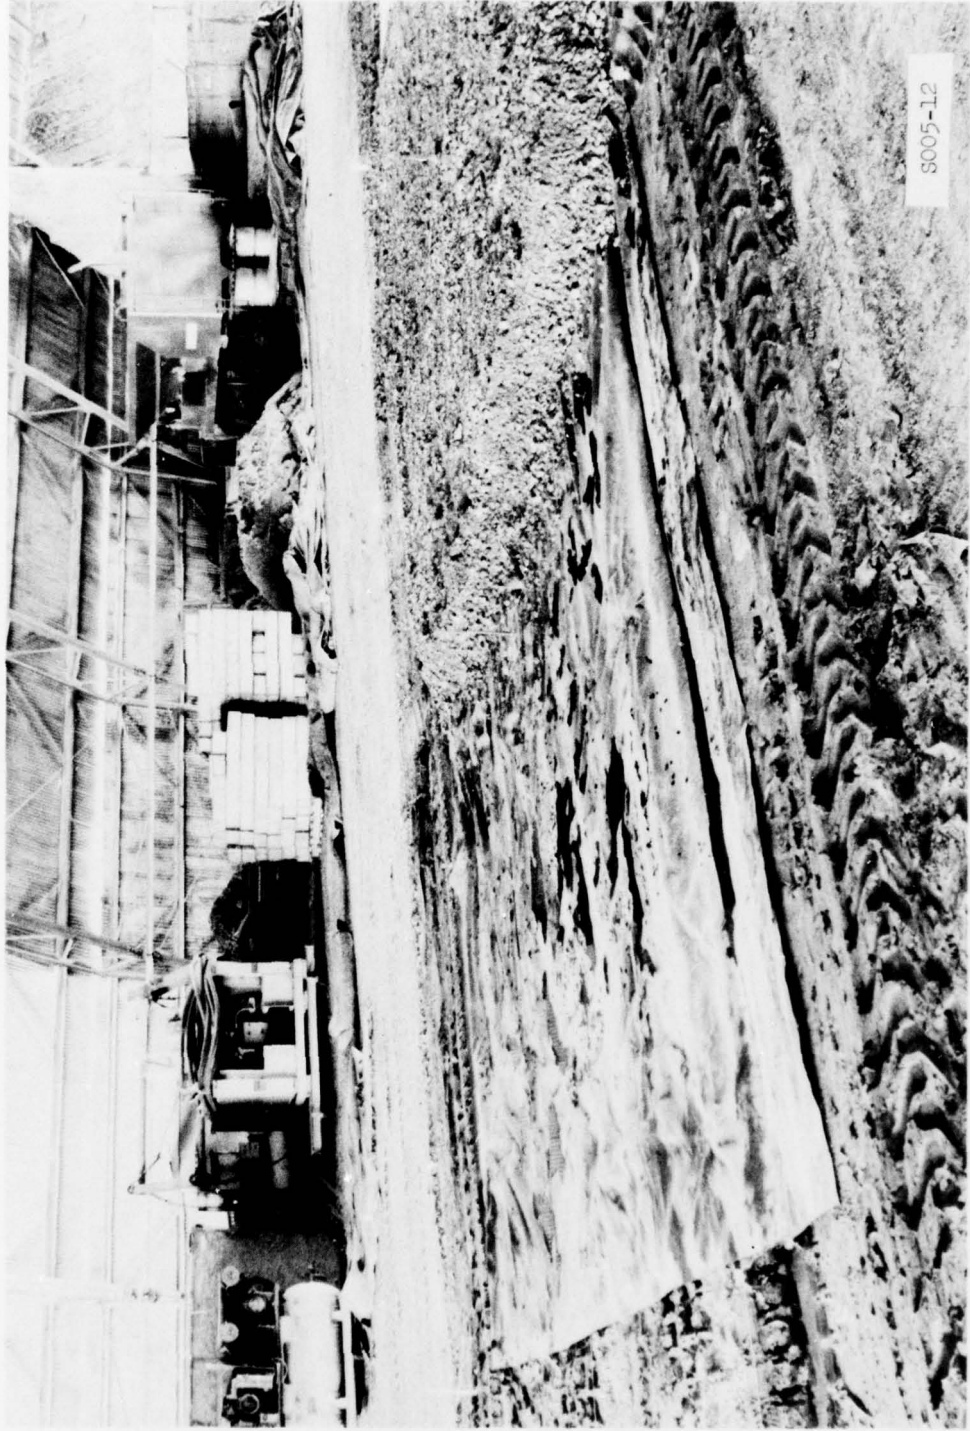
Photo 12. Item 7, crushed-stone base on T-16 membrane

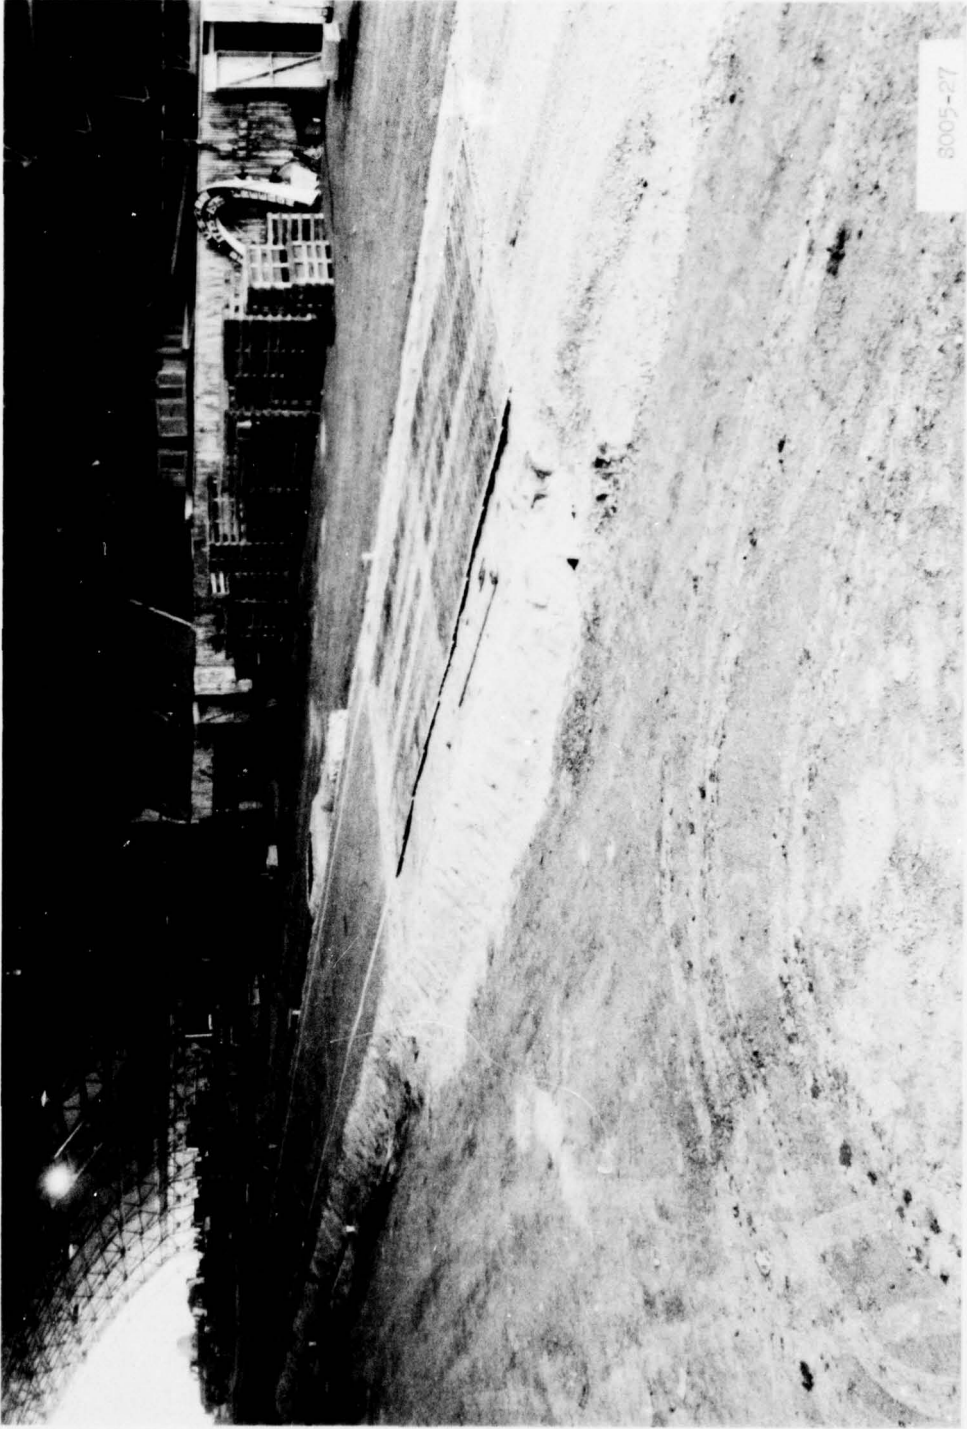
Photo 13. View of completed test section

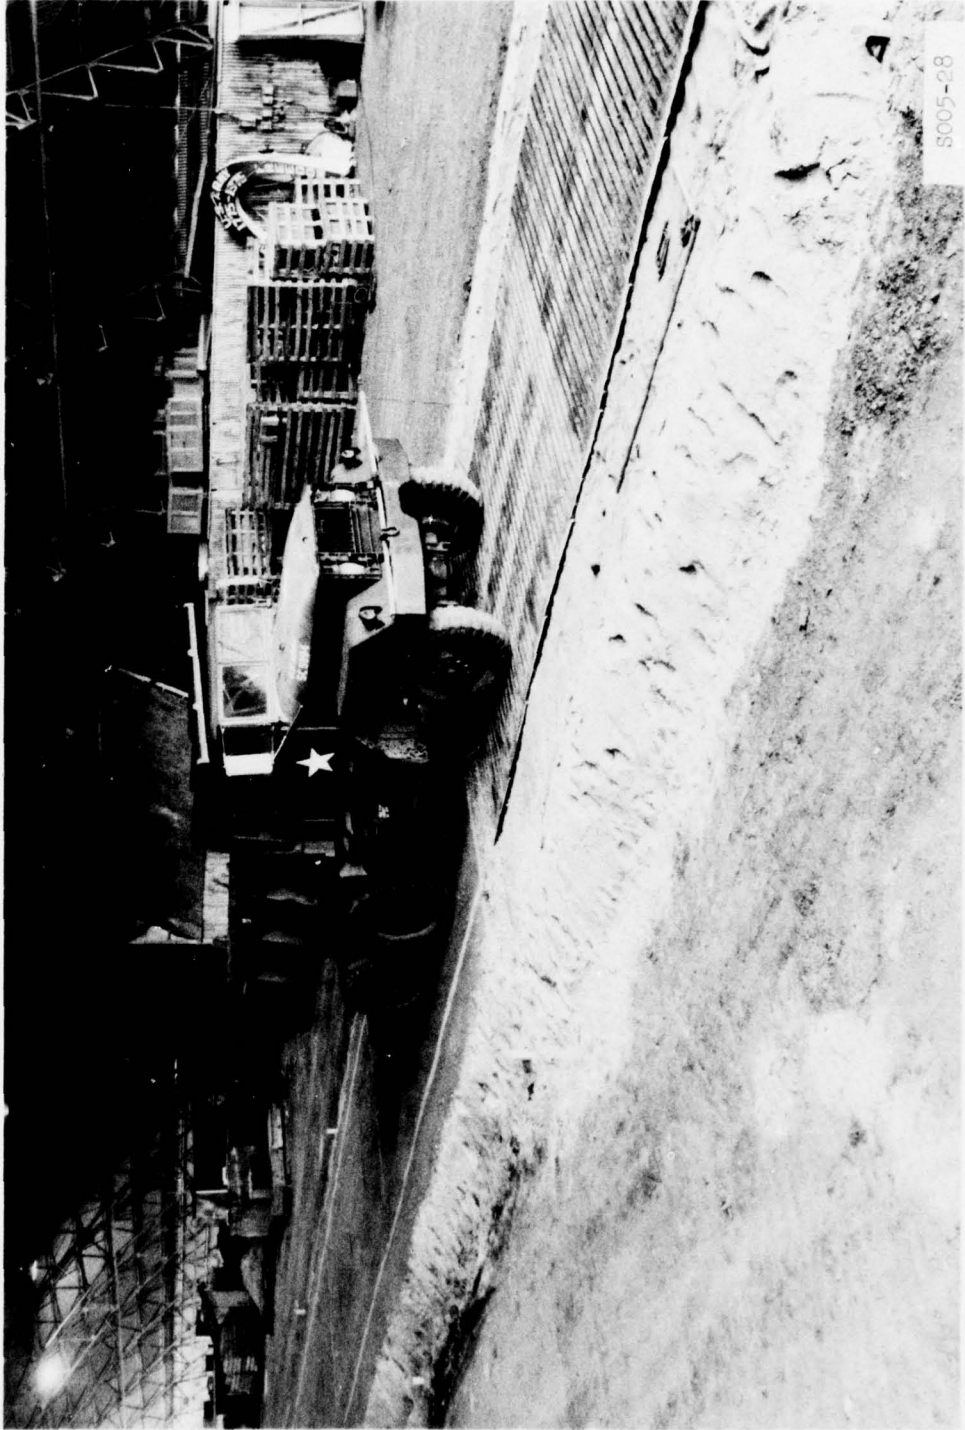
Photo 14. Vehicle used for traffic tests

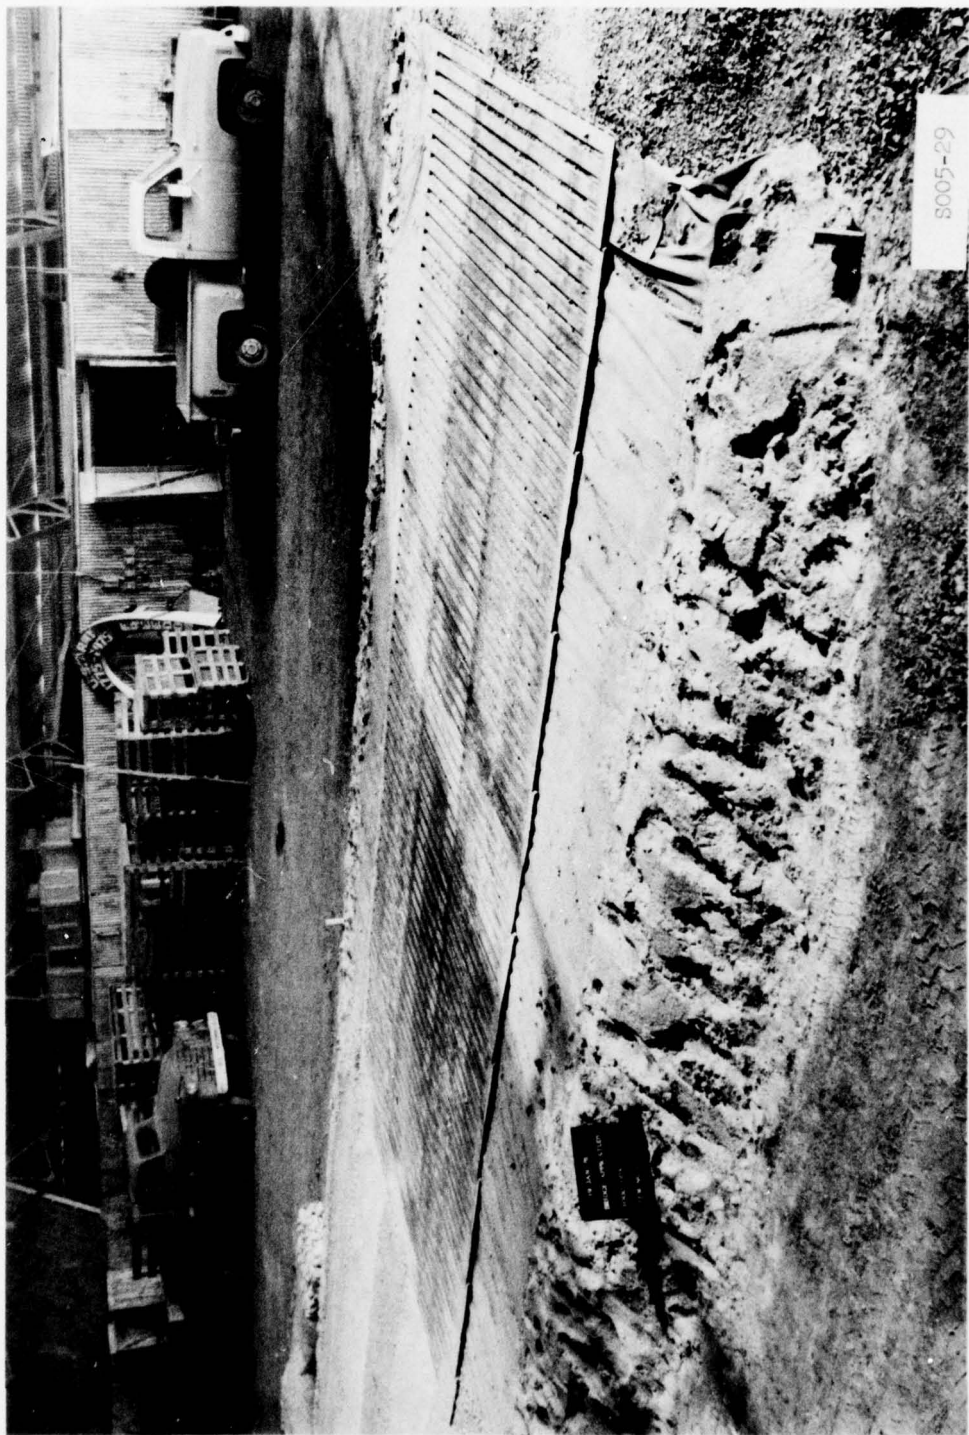
Photo 15. Item 1 after 1000 coverages

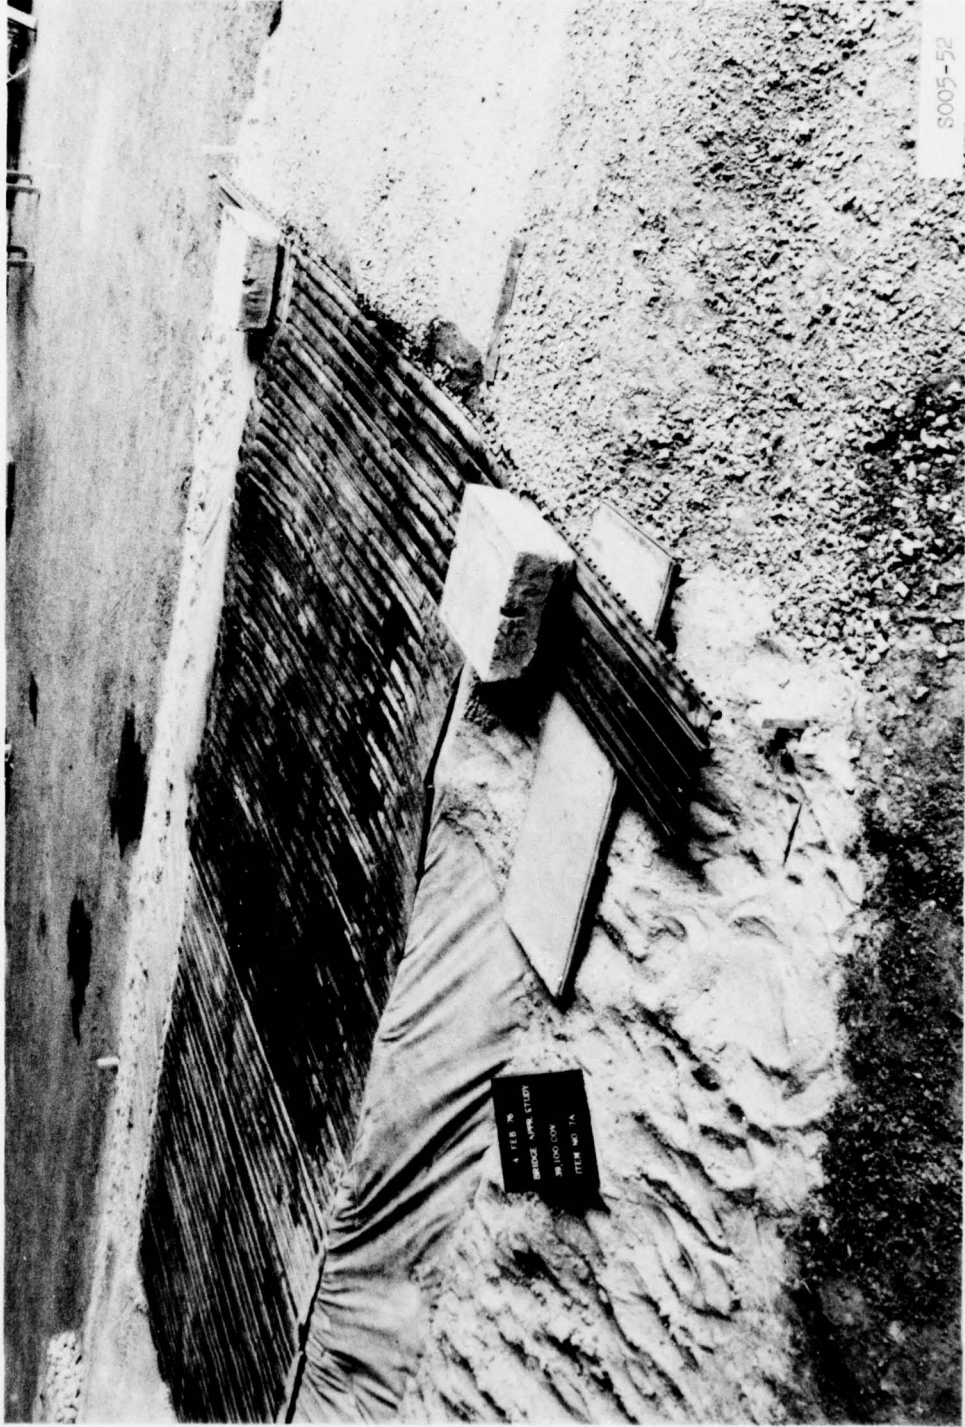
Photo 16. Item 1A after 39,100 coverages

33. Since it appeared that the mat would handle a large amount of additional traffic without damage, the mat runners were removed from half the item to compare the item performance with and without the runners. The portion of item 1 without runners was designated item 1A. Since initial traffic on item 1A caused substantial movement in both the mat and subgrade, lead weights were used to anchor the end of the mat on item 1A. After 39,100 coverages (Photo 16), item 1A was considered failed. One mat panel was broken and many of the bayonet side connectors had broken off. Plate 3 shows a typical cross section of the mat surface at zero and at 39,100 coverages. Approximately 2 to 3.5 in. of subgrade soil had been displaced under each wheel path.
