TECHNICAL REPORT S-77-1

INVESTIGATION OF CONSTRUCTION TECHNIQUES FOR TACTICAL BRIDGE APPROACH ROADS ACROSS SOFT GROUND

Soils and Pavements Laboratory
U. S. Army Engineer Waterways Experiment Station
P. O. Box 631, Vicksburg, Miss. 39180

February 1977

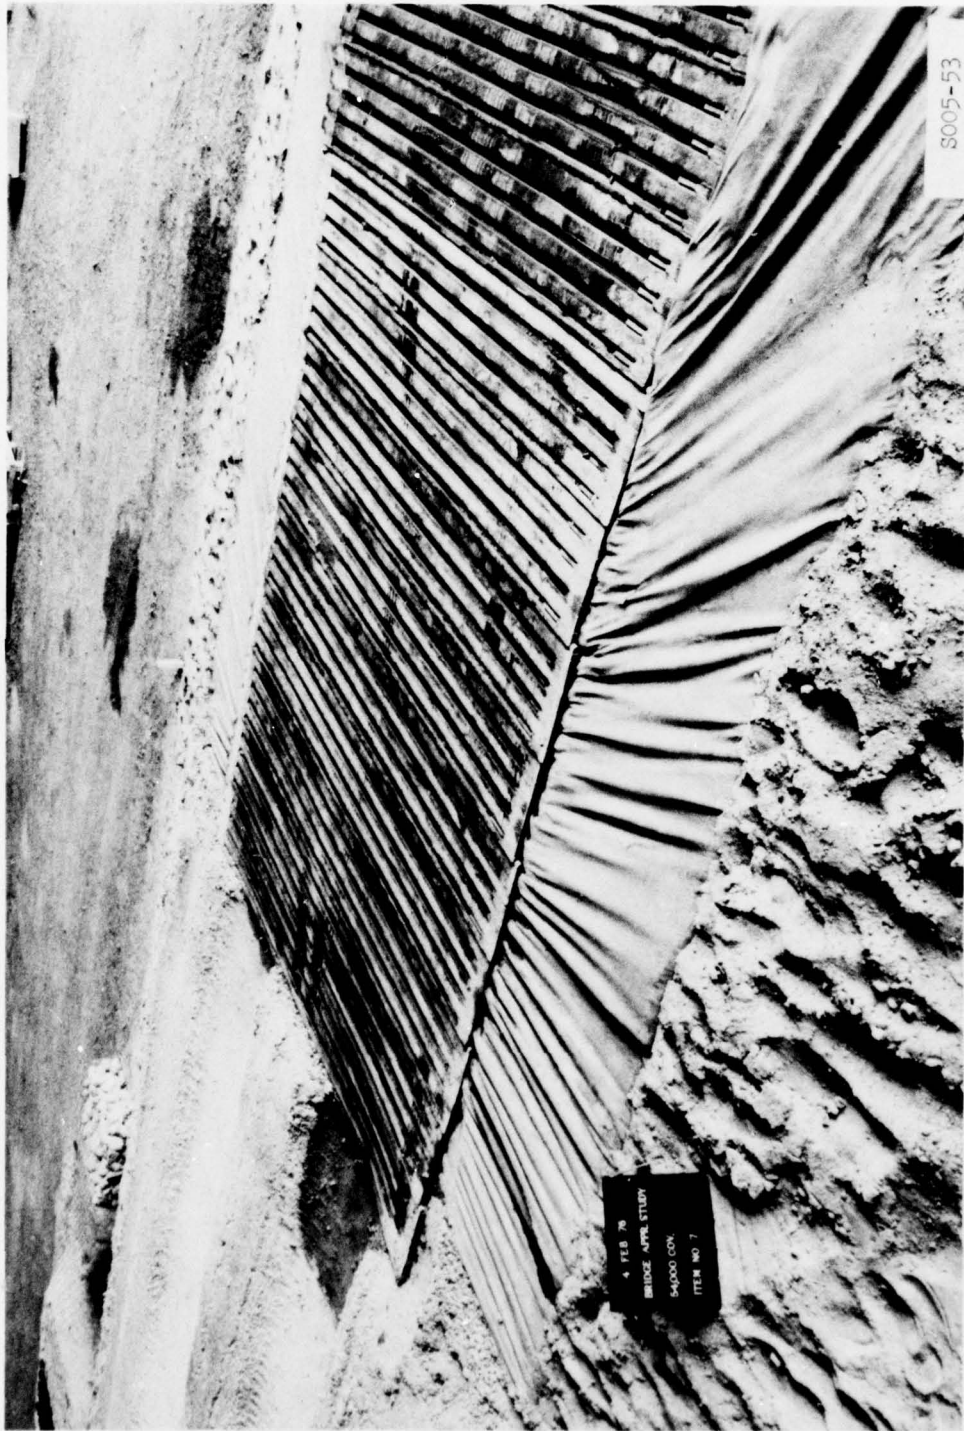
Photo 17. Item 1 after 54,000 coverages

34. The remaining portion of item 1 remained in excellent condition at the conclusion of traffic after 54,000 coverages (Photo 17 and Plate 3).

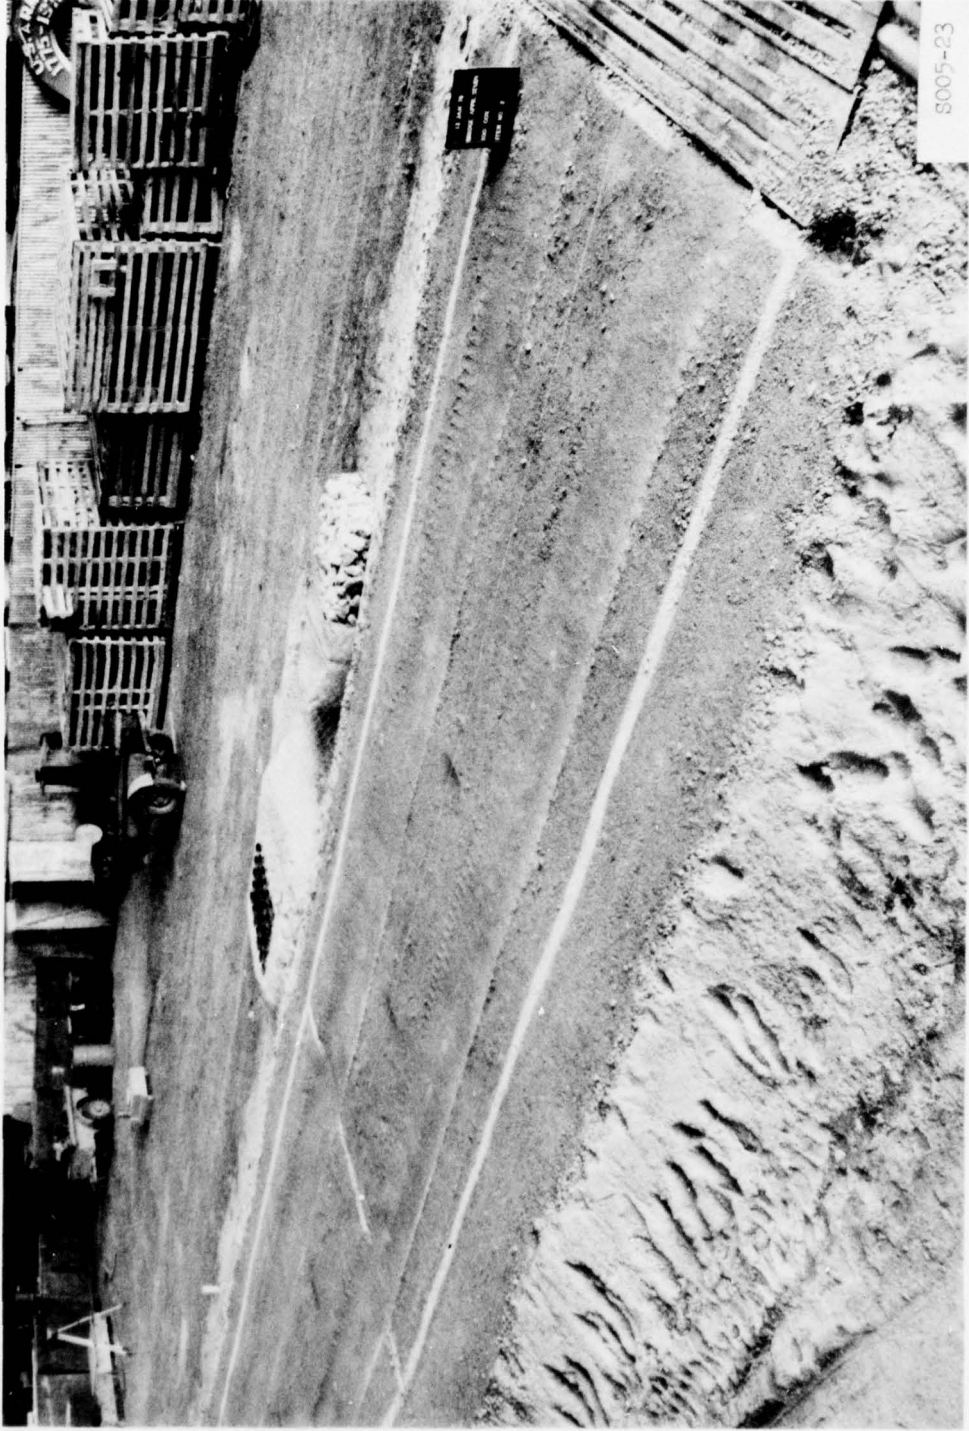
Photo 18. Item 2 after 100 coverages

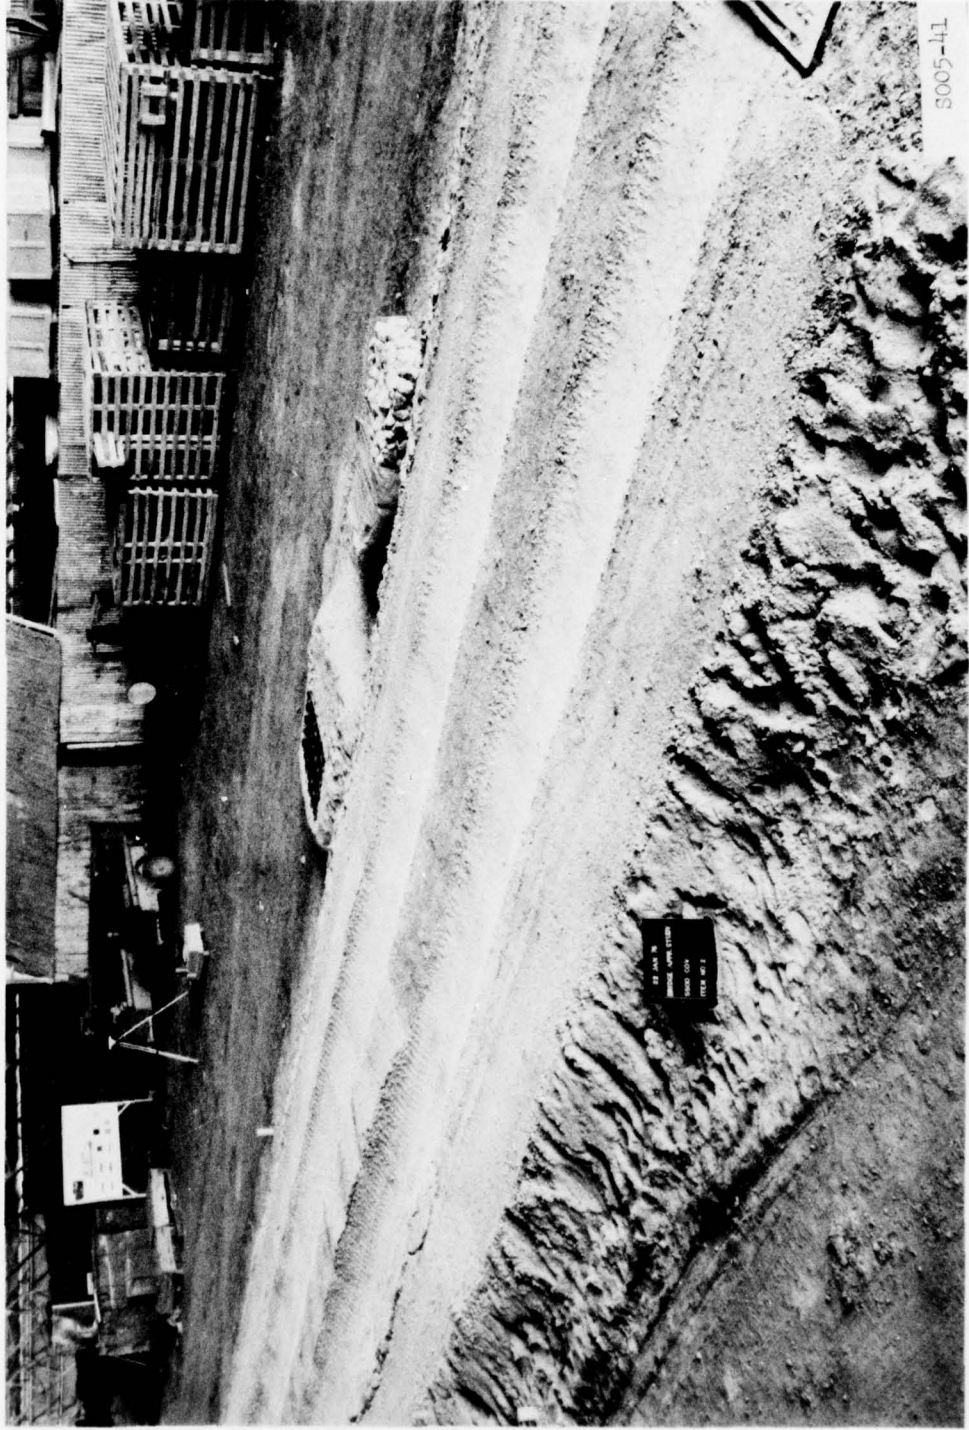
Photo 19. Item 2 after 5500 coverages

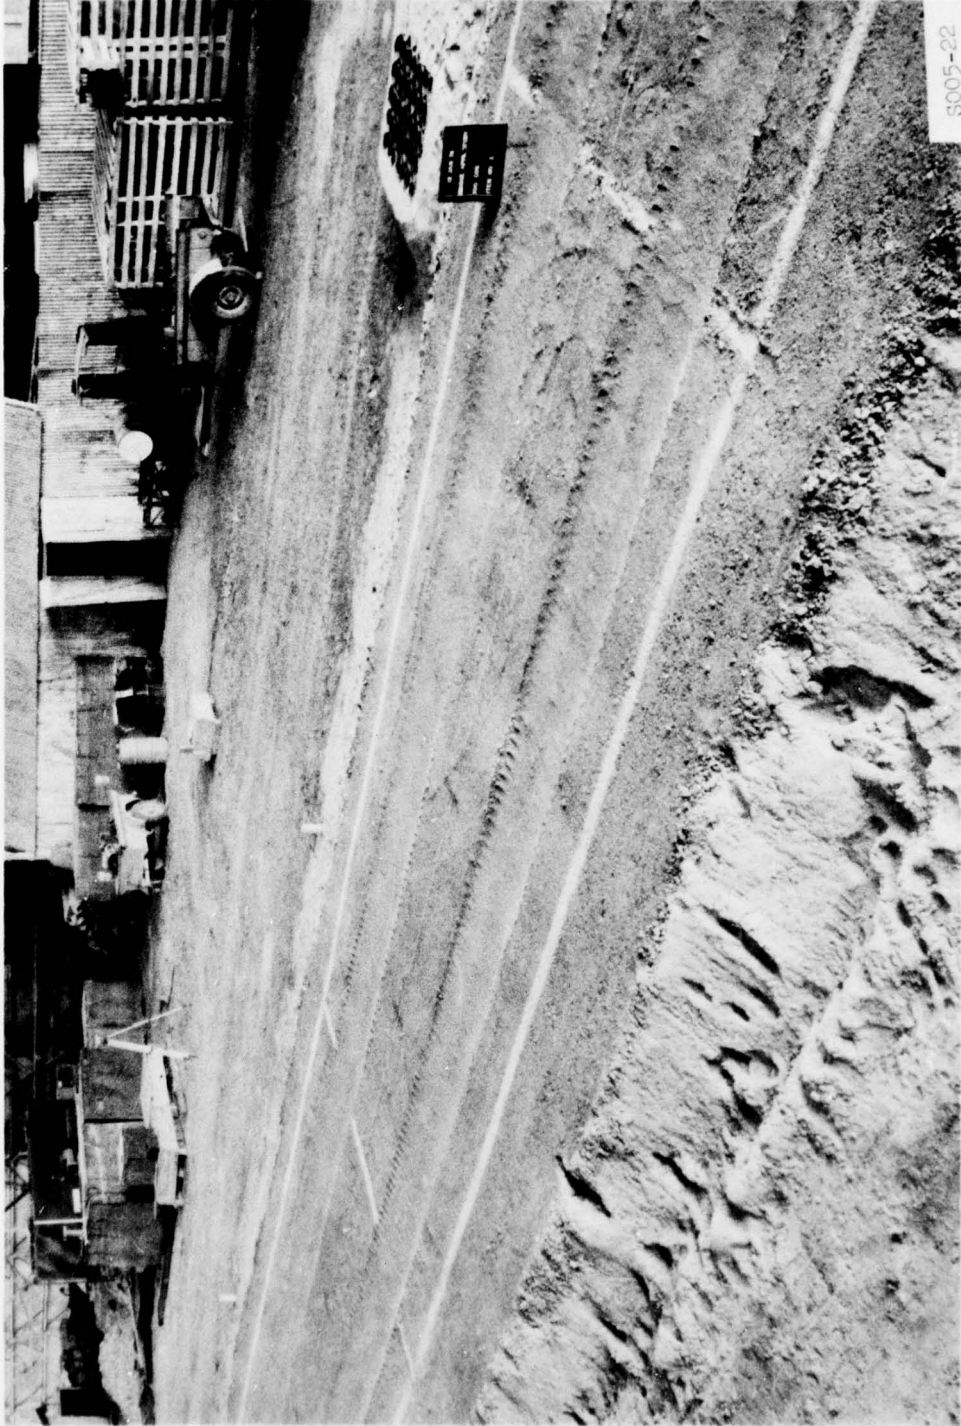
Photo 21. Item 3 after 100 coverages

37. Performance of this large-compartment sand-confinement item was surprisingly good. A total of 11,500 coverages were applied before an 11-in. rut developed in the west wheel path. At 100 coverages (Photo 21) the item was in excellent condition and had an average rut of 2.2 in. At 5500 coverages (Photo 22), the average rut was 7.3 in. and signs of upheaval and shifting of sand within the compartments could be seen. Photo 23 shows the item after 11,500 coverages when 11 in. of rutting had finally developed in the west (foreground) wheel path. Typical cross-section data for this item are shown in Plate 5. The gabion wire and the polyester fabric were still in excellent condition at the conclusion of traffic.

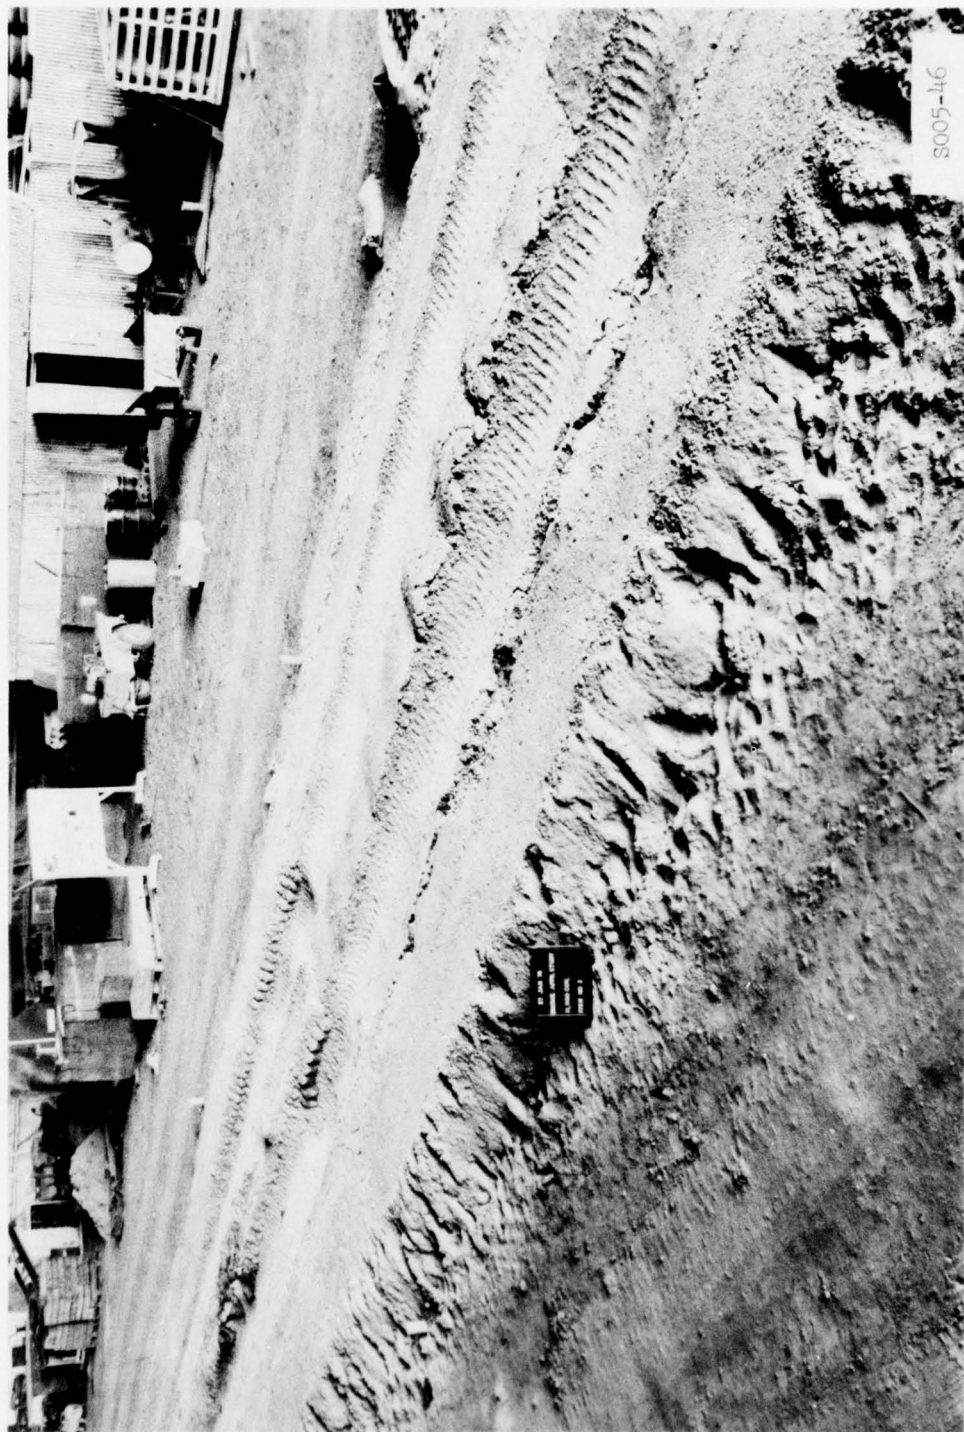
Photo 23. Item 3 after 11,500 coverages

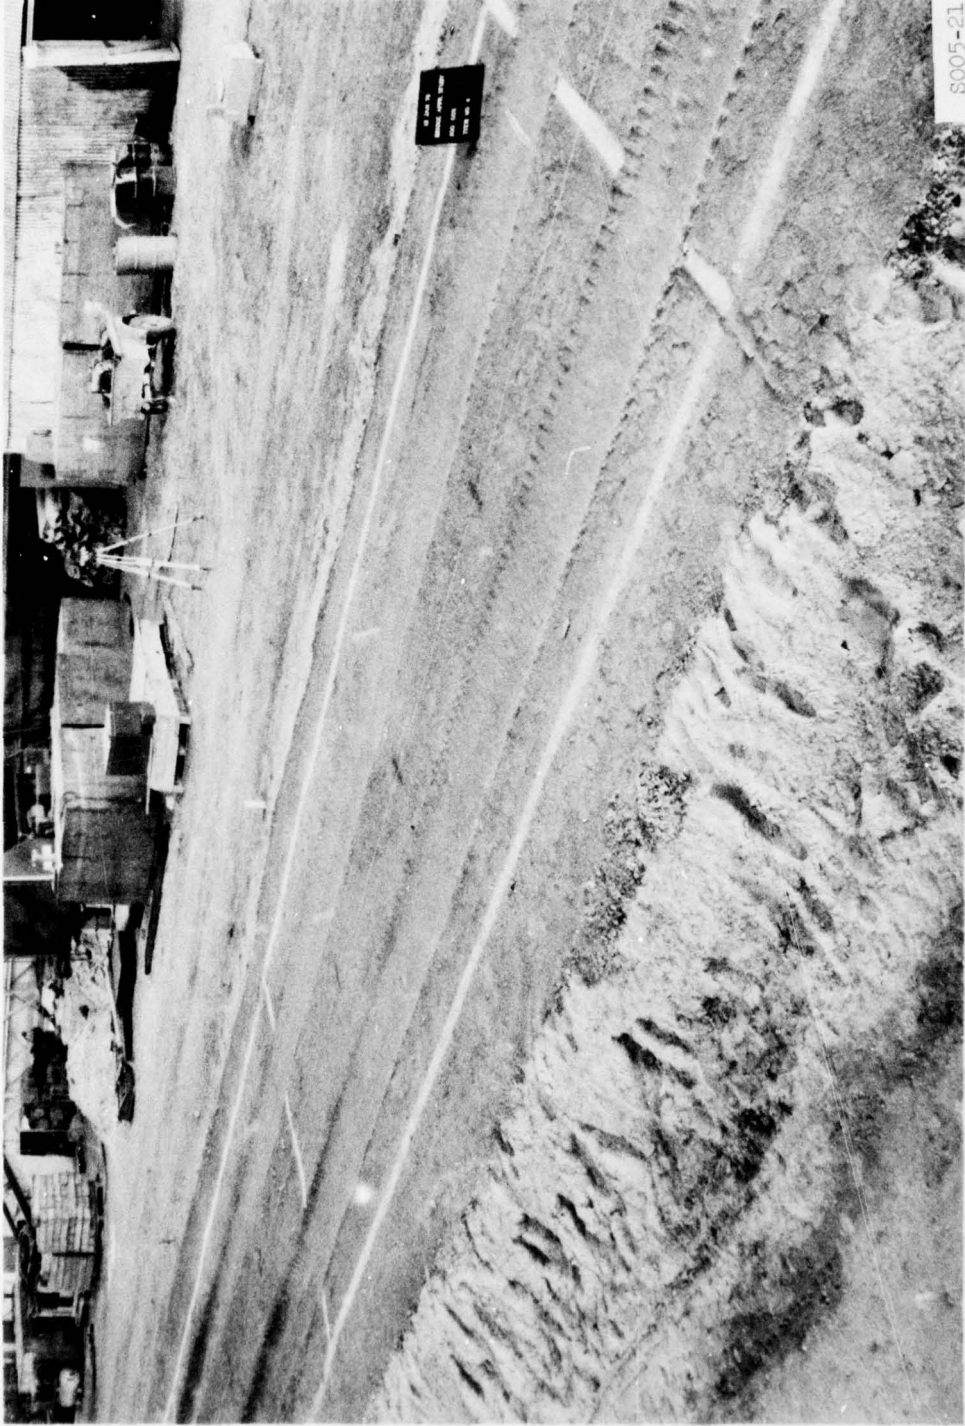
Photo 24. Item 4 after 100 coverages

38. This small-compartment sand-confinement item performed extremely well during the first 500 coverages. After 100 coverages (Photo 24), the average rut depth was 1.5 in. Visual observation showed this item to be very stable during the first 500 coverages. However, after 500 coverages, the tandem-axle load was increased from 25,000 to 35,000 lb, and the item performed significantly different with the new traffic load. Additional traffic caused a spot type failure to start to develop in the west wheel path. Photo 25 shows the item after 1000 coverages when the potential failure was noticed. Photo 26 shows the item after 2500 coverages when the average rut depth was slightly over 6 in. At this coverage level, the plastic tubing became visible as the spot failure continued to develop. After 5500 coverages (Photo 27), an 11-in. rut had developed at one spot, and the differential of the truck began to lift the plastic tubes from the item. It should be noted in Photo 27 that although half the item had developed an 11-in. rut, the remaining portion had an average rut of

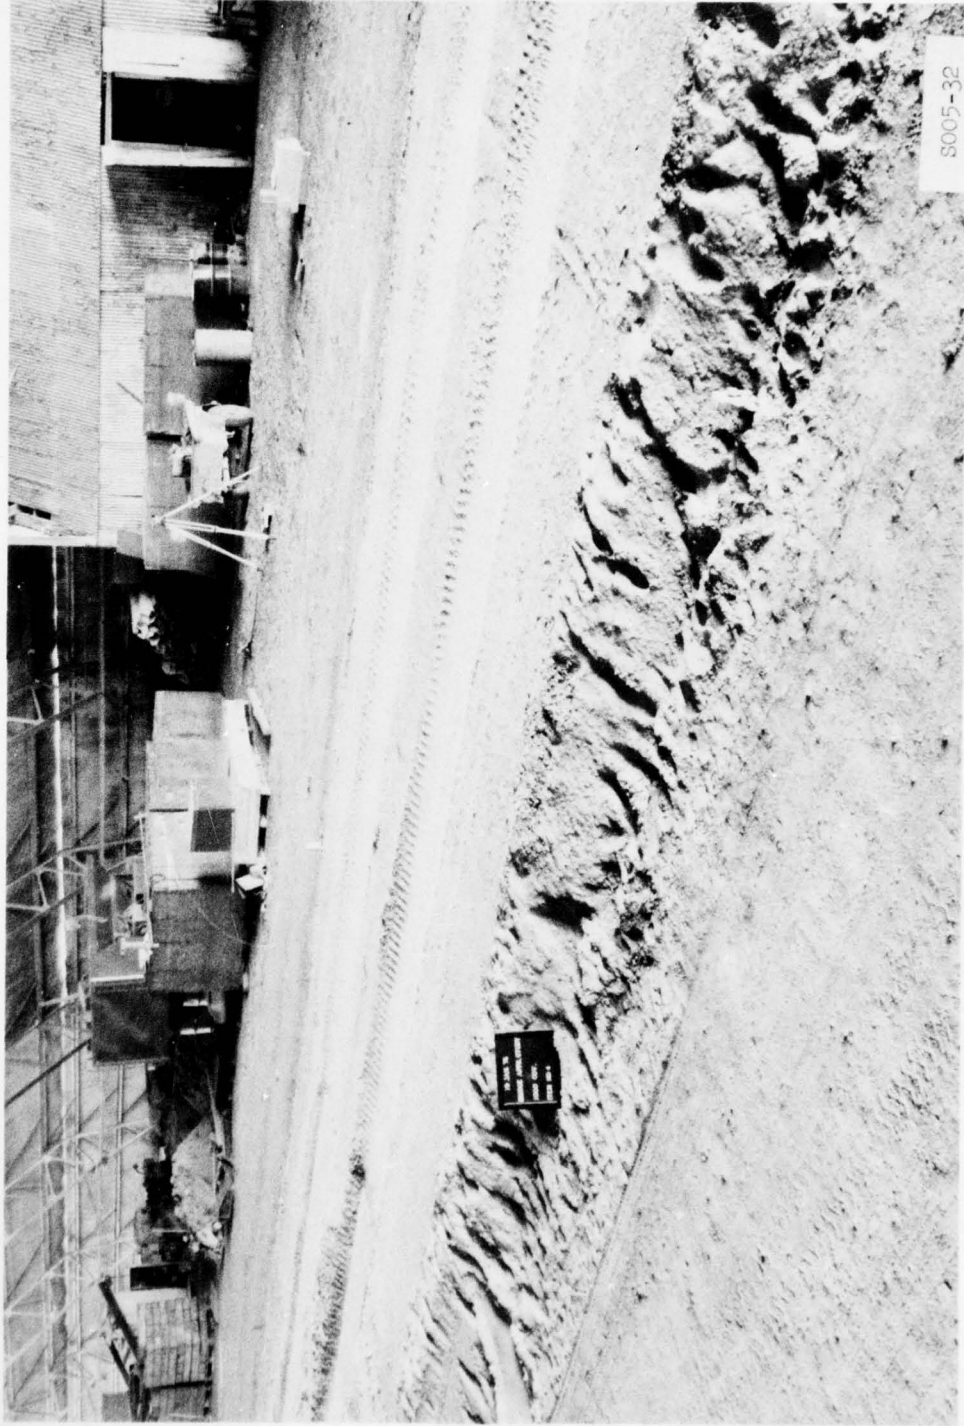
Photo 25. Item 4 after 1000 coverages

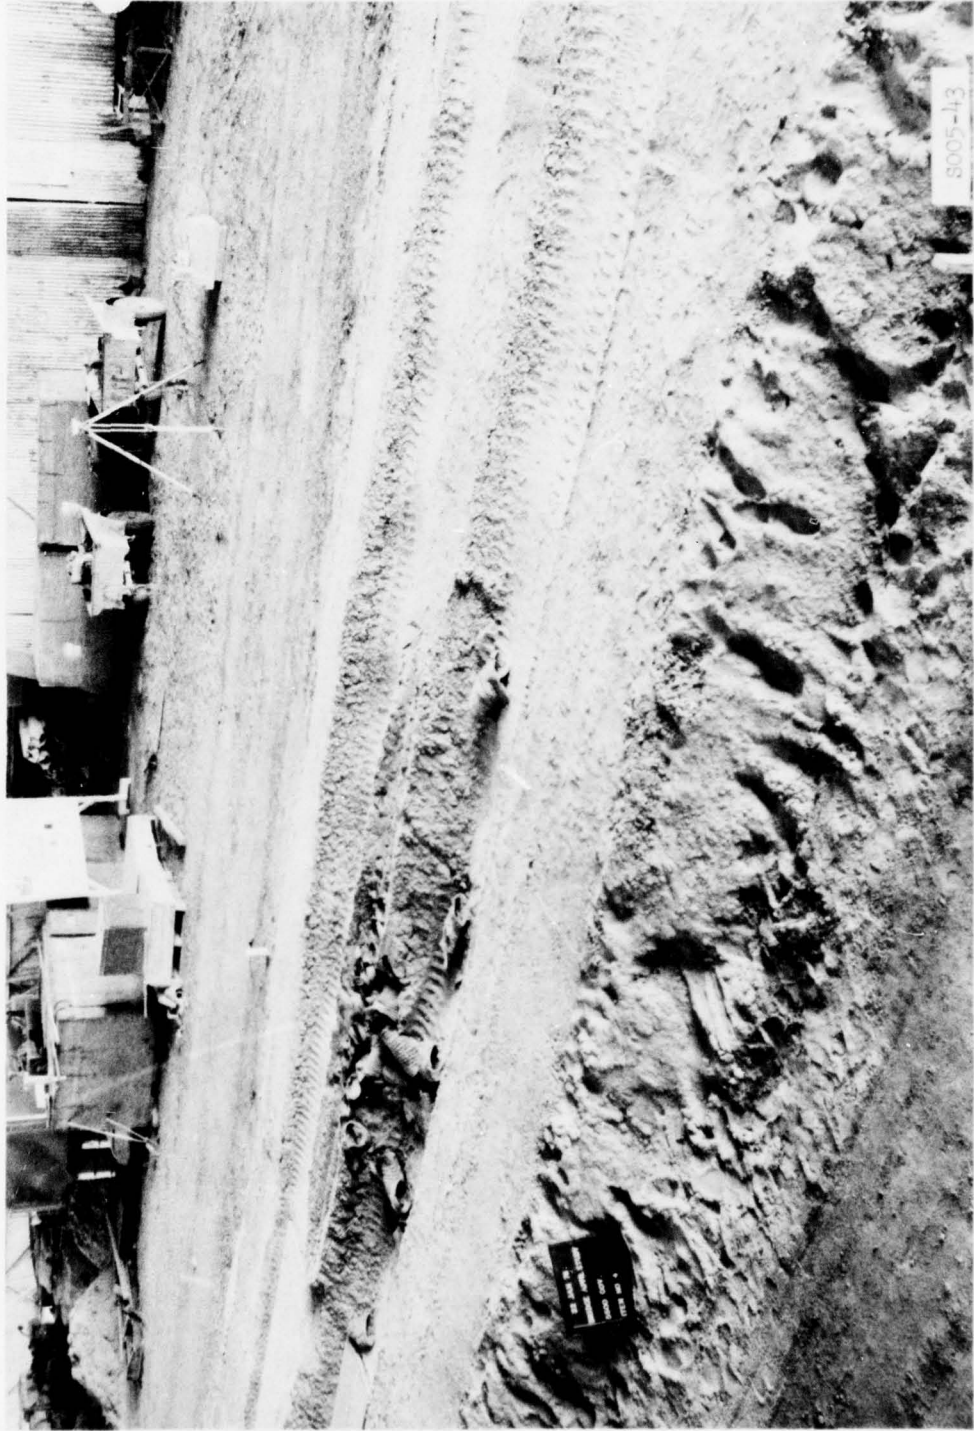
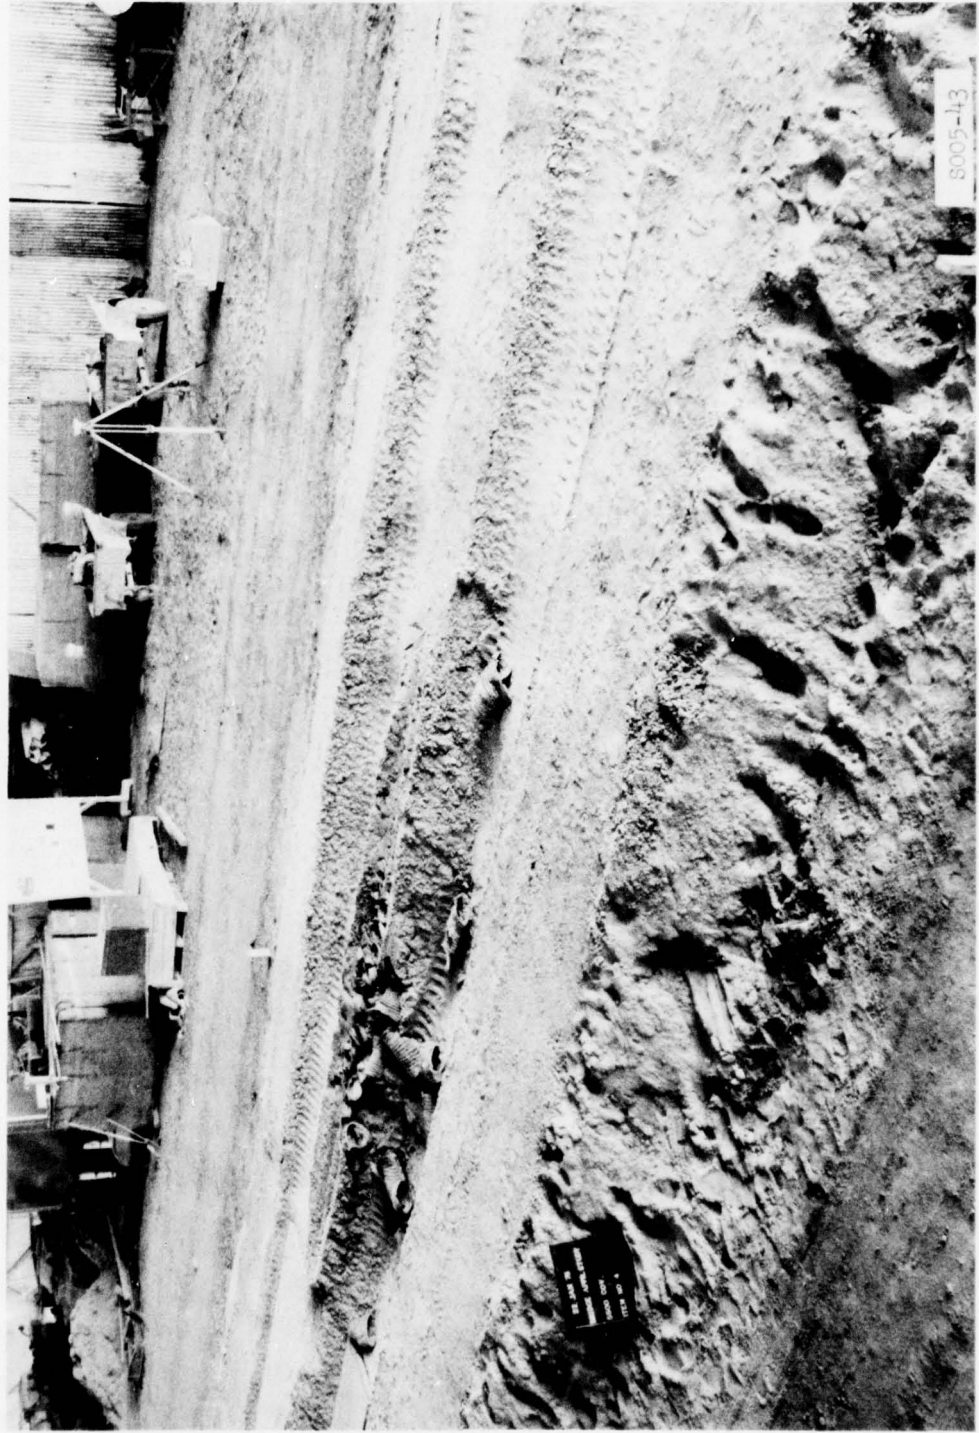
Photo 27. Item 4 after 5500 coverages

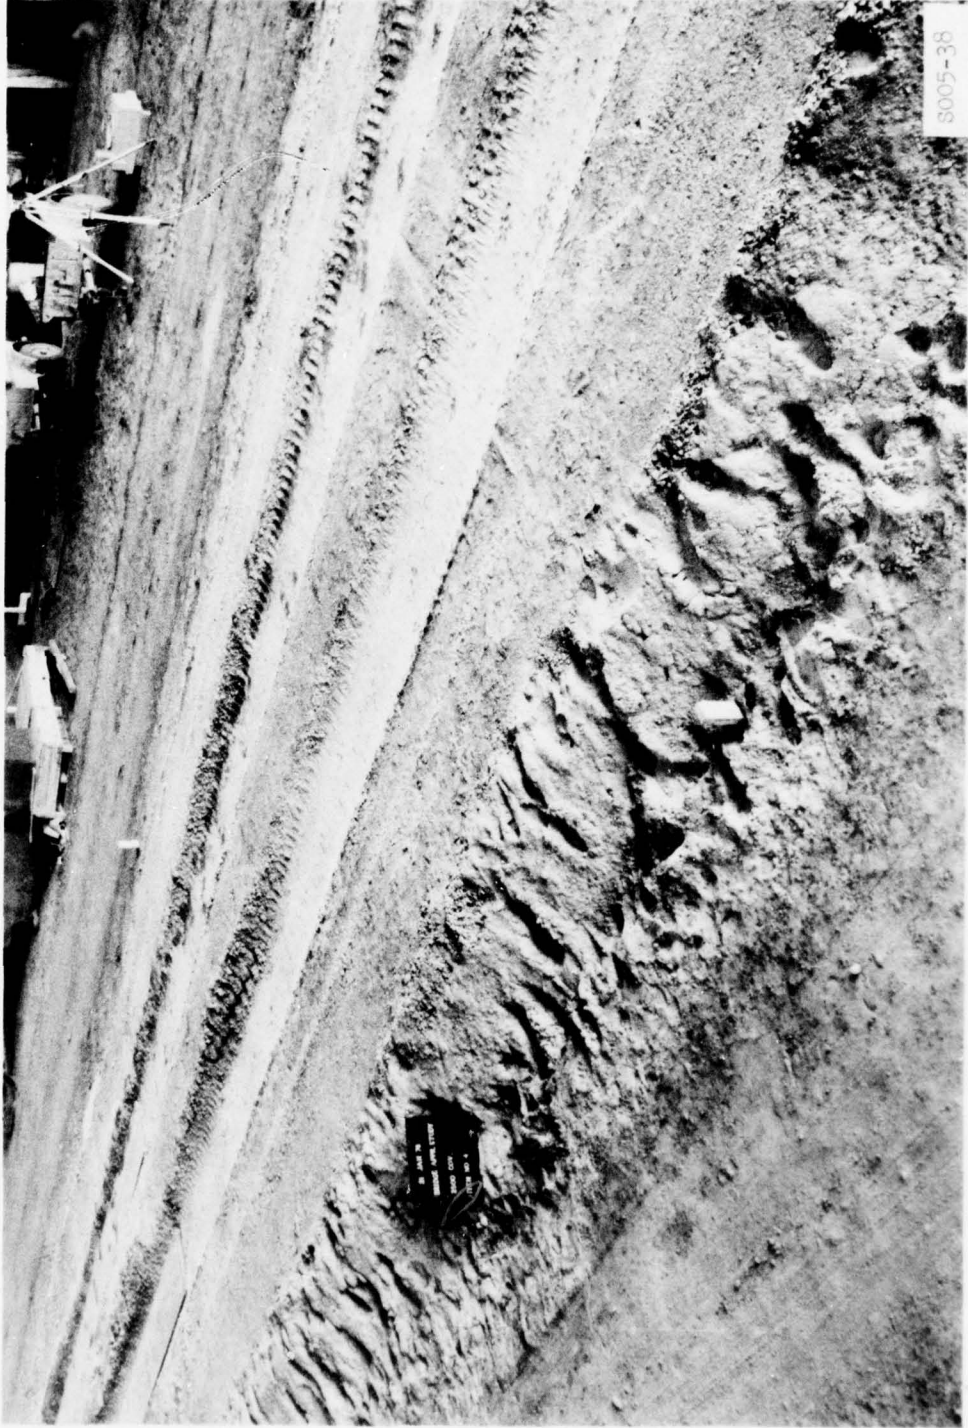
Photo 26. Item 4 after 2500 coverages

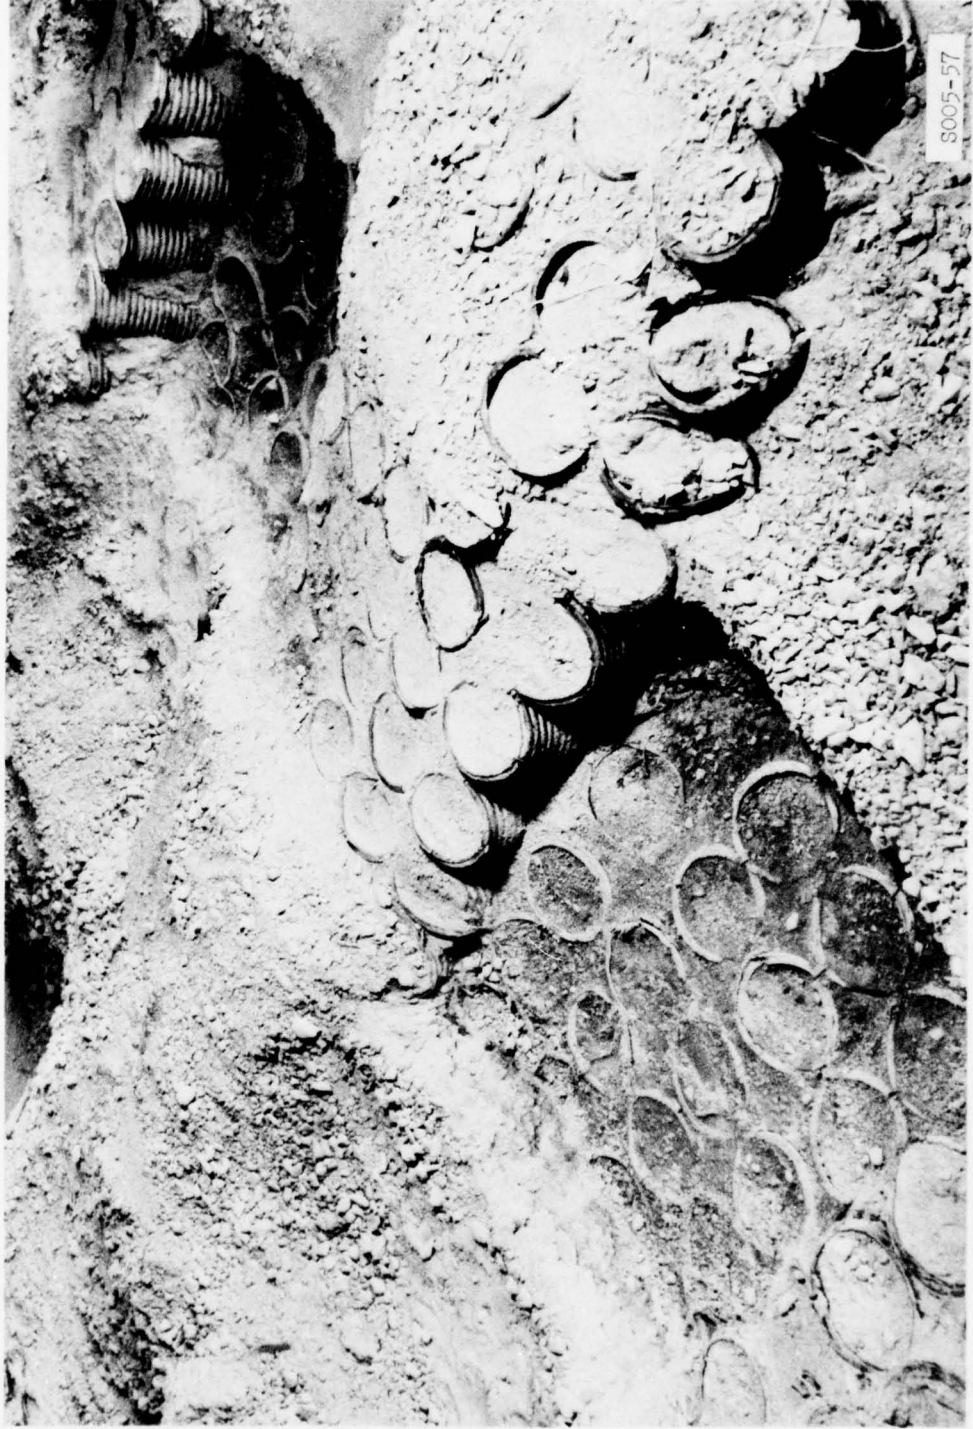
Photo 28. Item 4 with wearing surface removed after 5500 coverages

only approximately 6 in. Typical cross-section data are shown in Plate 6. Photo 28 shows a typical cross-section view after the wearing surface was removed after 5500 coverages. The individual sand-filled plastic tubes along each wheel path had been pushed into the subgrade. This caused the subgrade to upheave between the wheel paths and along the outer edge of each wheel path.

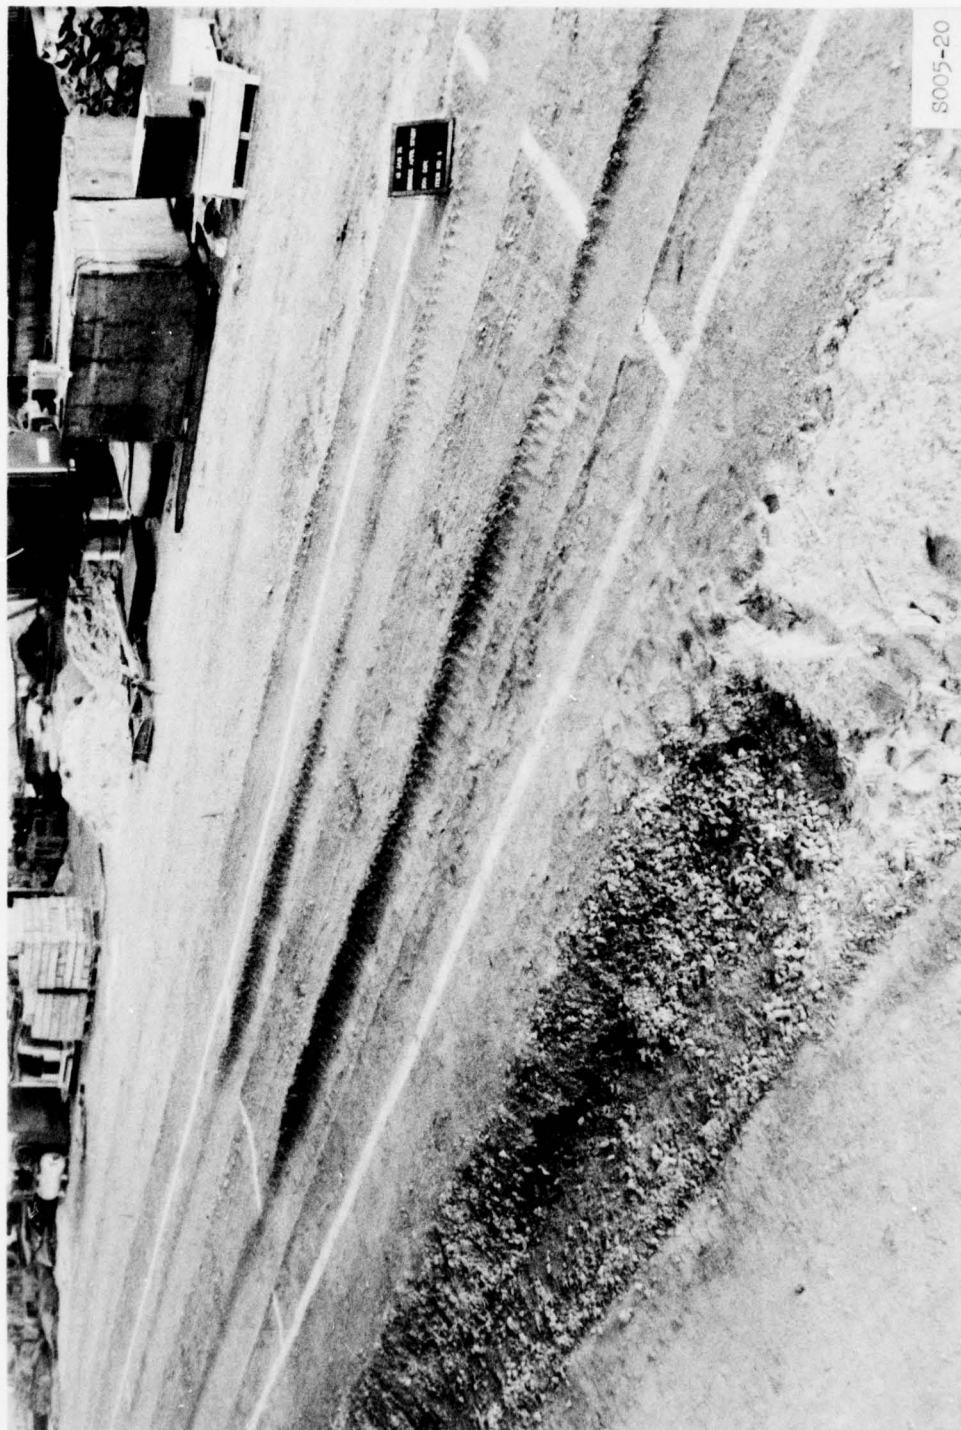
Photo 29. Item 5 after 100 coverages

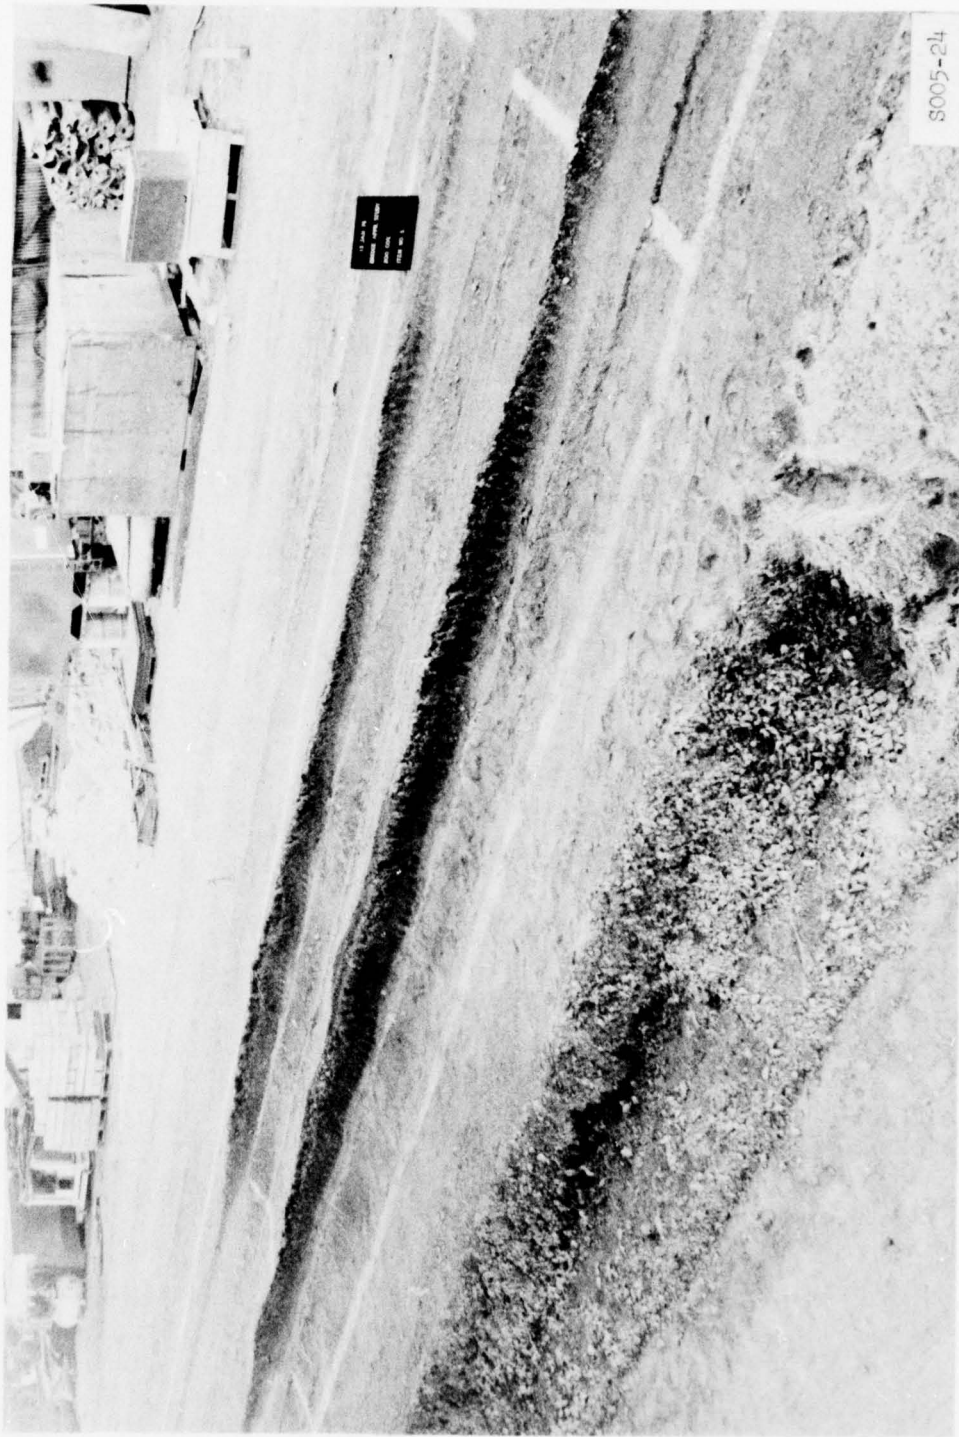
Photo 30. Item 5 after 2000 coverages

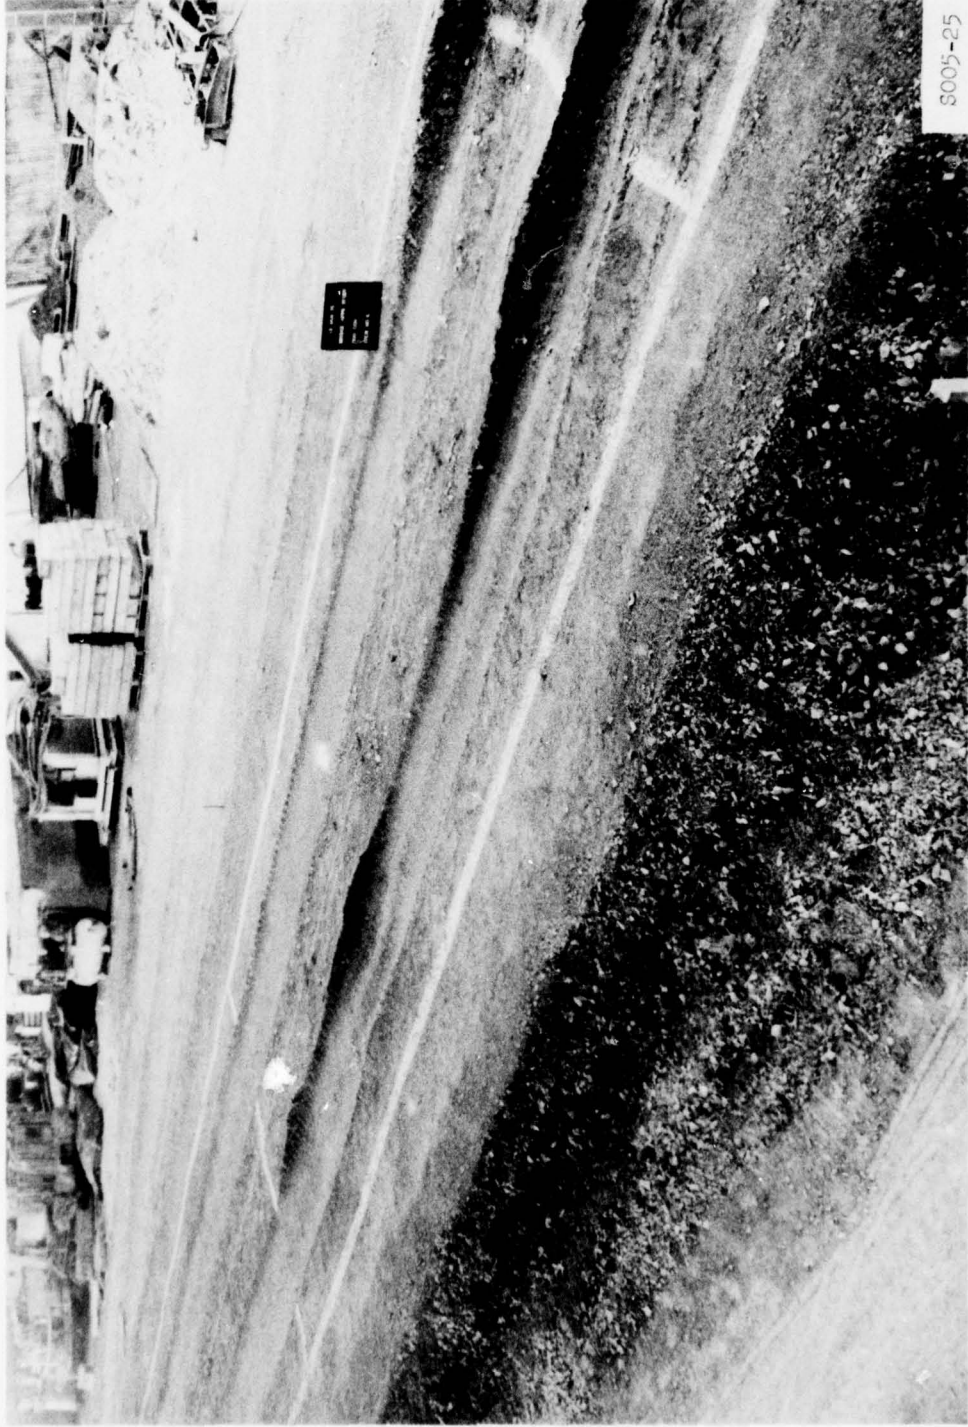
Photo 32. Item 6 after 200 coverages

42. Performance of this item was significantly better than that of the control item. After 100 coverages (Photo 31), the average rut depth was 1.8 in. After 200 coverages (Photo 32), the average rut depth was only 2.6 in. Photo 32 shows some transitional rutting resulting from failure of the control item and also some spot rutting at two locations. A test hole was dug into the larger spot rut to see if the polyester fabric had been damaged. The fabric was found to be in good condition but did show some signs of stretching.

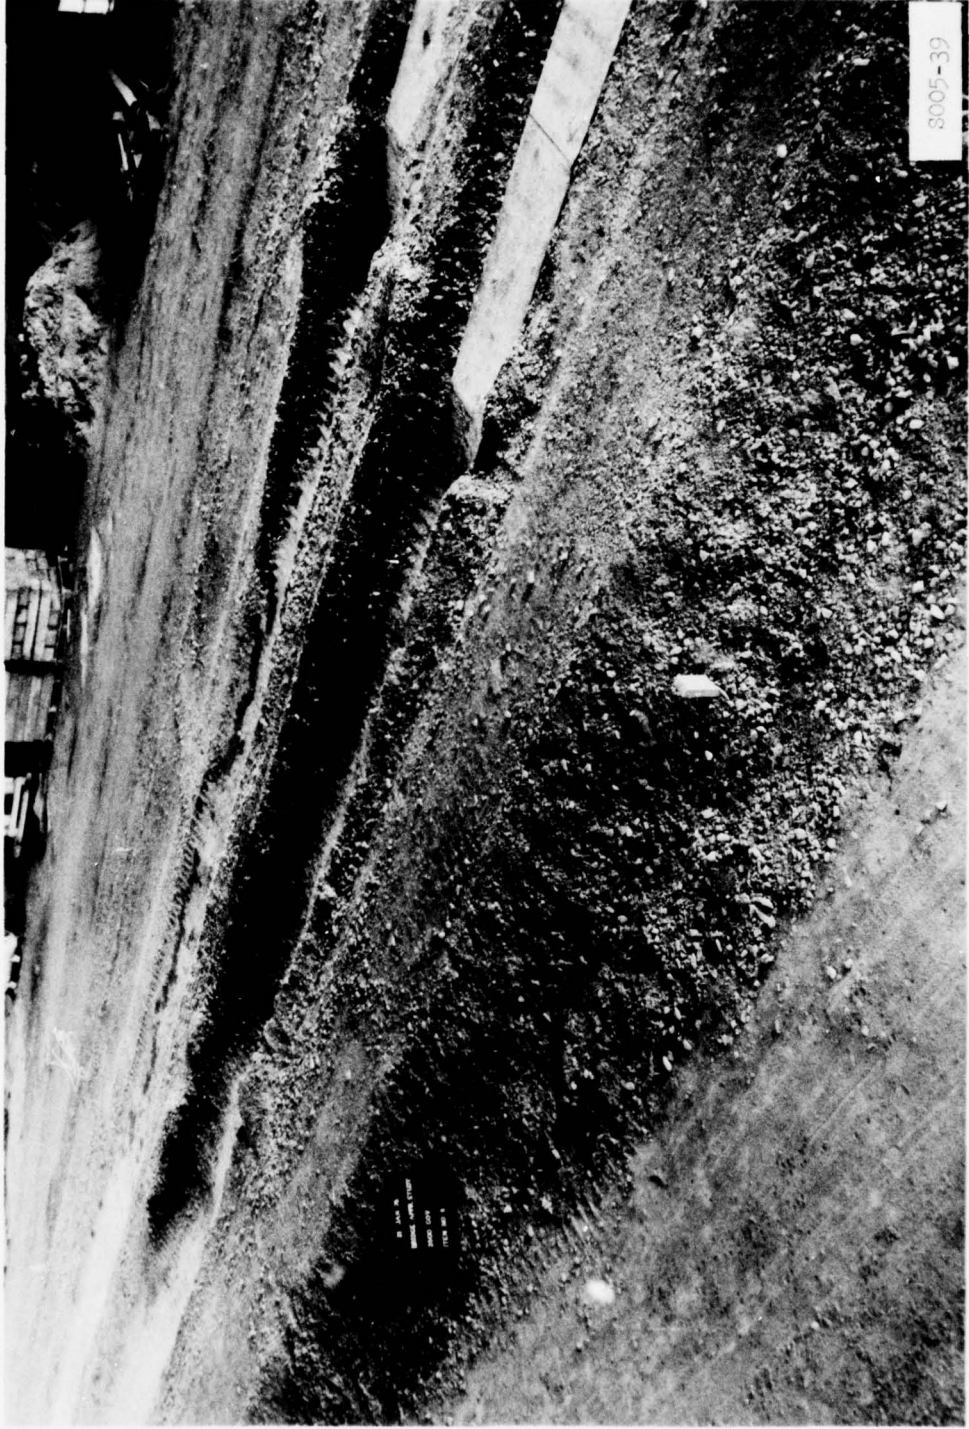
Photo 33. Item 6 after 2500 coverages

30. Normal tracking procedure was to allow test traffic to continue on an item until an 11-in. rut developed, at which point the differential on the truck would drag. The item would be considered failed at this time, and test data would be taken. The ruts in a failed item were lined with a runner of landing mat (Photo 33) to allow traffic to continue on unfailed items.
