TECHNICAL REPORT S-77-1

INVESTIGATION OF CONSTRUCTION TECHNIQUES FOR TACTICAL BRIDGE APPROACH ROADS ACROSS SOFT GROUND

Soils and Pavements Laboratory
U. S. Army Engineer Waterways Experiment Station
P. O. Box 631, Vicksburg, Miss. 39180

February 1977

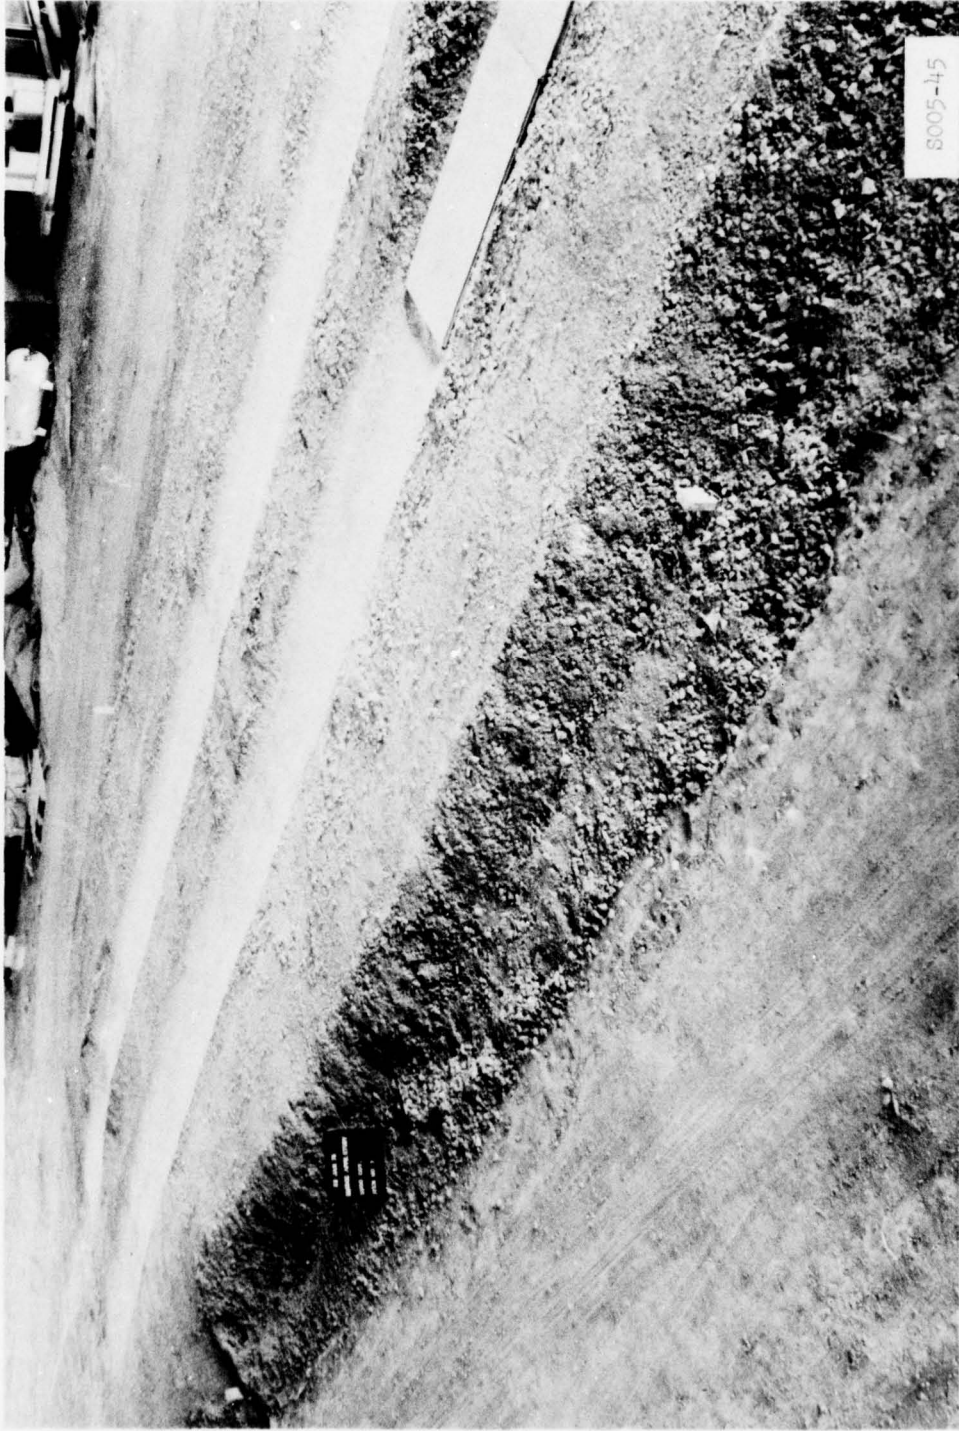
Photo 34. Item 7 after 5500 coverages

45. Performance of this item was outstanding. Photo 34 shows this item after 5500 coverages. Average rut depth was only 1.8 in. An 11-in. rut did not develop until 37,000 coverages. Traffic on this item was continued to 54,000 coverages (Photo 35) to see if the T-16 membrane would tear. However, after 54,000 coverages, the membrane was still in good condition. Plate 9 shows cross-section data for this item. It is interesting to note that failure was caused by subgrade rutting and was not accompanied by base flow from under the wheel paths.

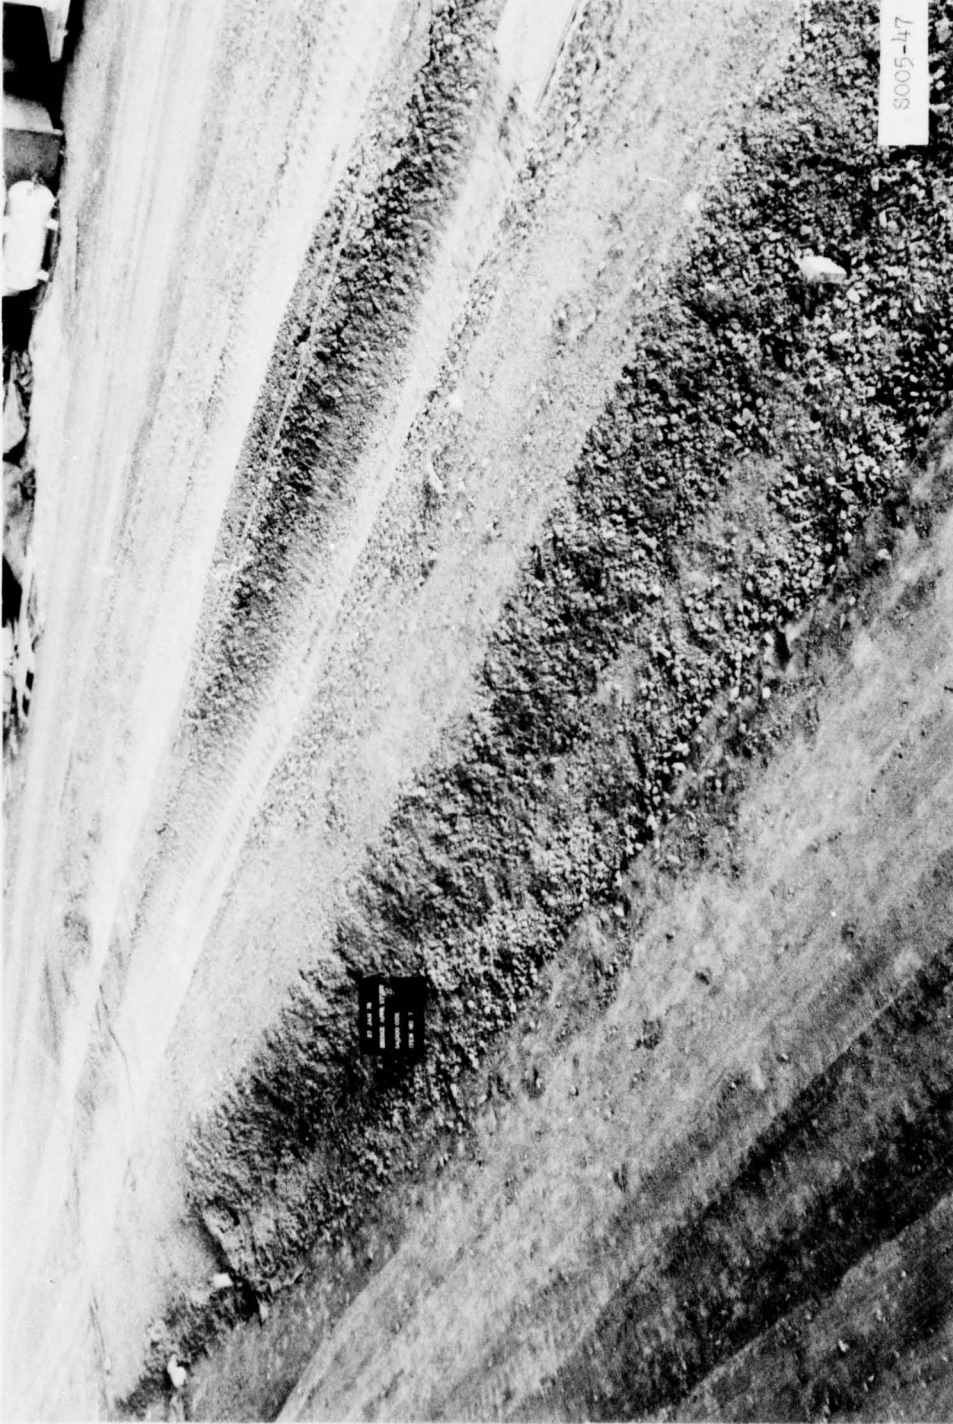
Photo 35. Item 7 after 54,000 coverages

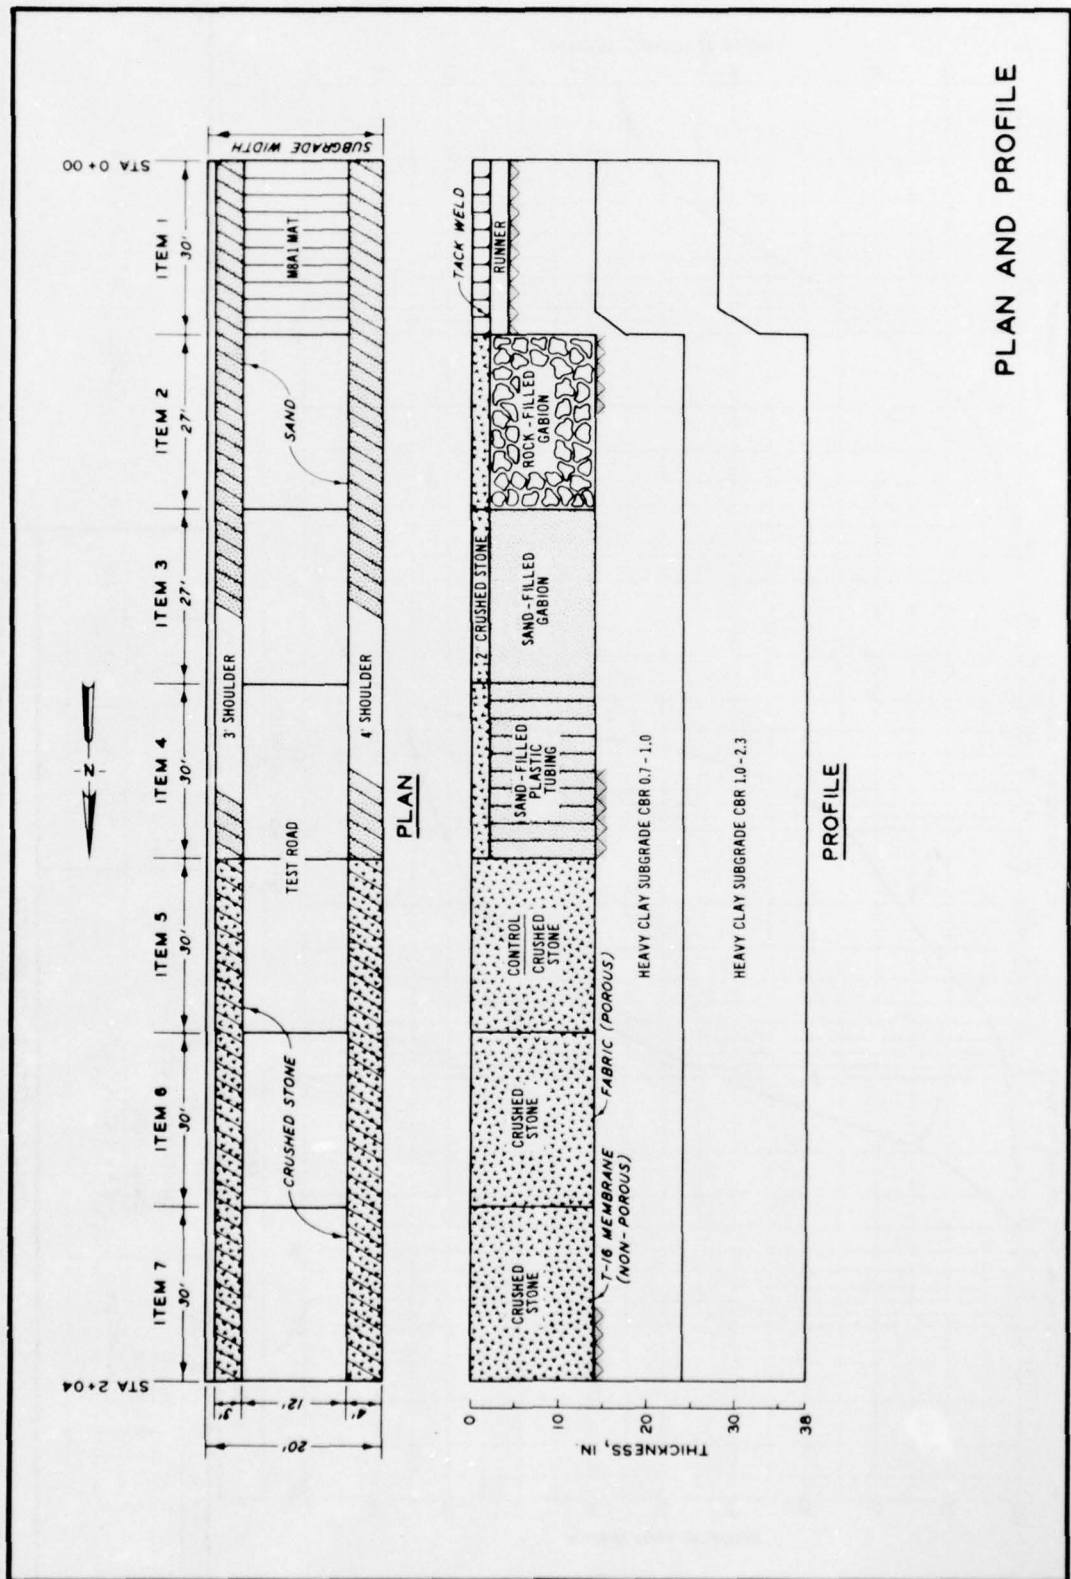
PLAN AND PROFILE

6. A plan and profile of the test section are shown in Plate 1. The test road was 204 ft long and 12 ft wide and consisted of seven test items. Items 2 and 3 (gabion items) were each 27 ft long; all other items were 30 ft long. Item 1 consisted of M8Al mat, spot welded to runners, placed directly on the subgrade. All other items had a total thickness of 14 in. All items were constructed directly on the heavy clay subgrade, which had an initial strength of 0.7 to 1.0 CBR for a depth of 10 in. The strength of the remaining 14 in. of subgrade below this 10-in. depth ranged from approximately 1.0 to 2.3 CBR. The west and east shoulders of the test section were 4 ft and 3 ft wide, respectively. The shoulder material for items 5, 6, and 7 was the same crushed stone as used in the base course for these items. The shoulder material for items 1 through 4 was sand. All items except item 1 contained a 2-in. wearing surface consisting of the same crushed stone as used in the base course for items 5, 6, and 7.

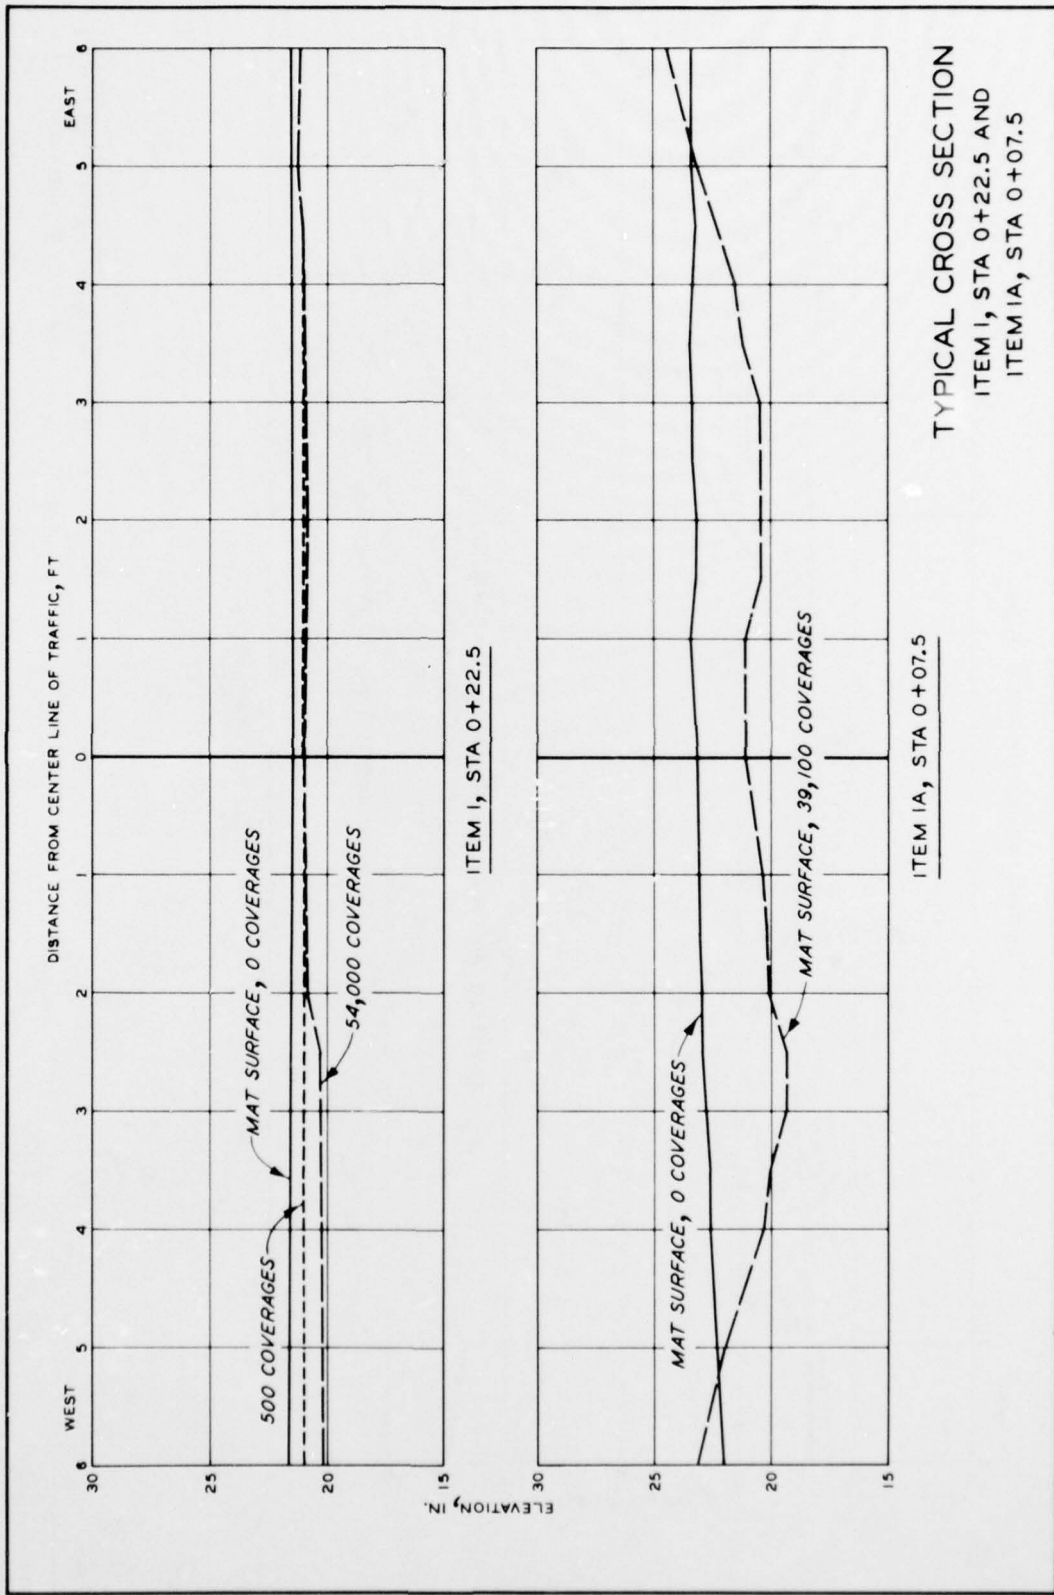
TYPICAL CROSS SECTION
 ITEM I, STA 0+22.5 AND
 ITEM IA, STA 0+07.5

32. During the first 500 coverages of test traffic, the M8A1 mat item with runners tended to seat itself into the soft subgrade. Plate 3 shows a typical cross section showing the elevation of the mat surface before traffic and after seating at 500 coverages. Photo 15 shows the mat in excellent condition after 1000 coverages. The mat was very stable during traffic and did not shift or require any anchoring. After 15,000 coverages, the mat was still in excellent condition and showed no signs of damage.

34. The remaining portion of item 1 remained in excellent condition at the conclusion of traffic after 54,000 coverages (Photo 17 and Plate 3).

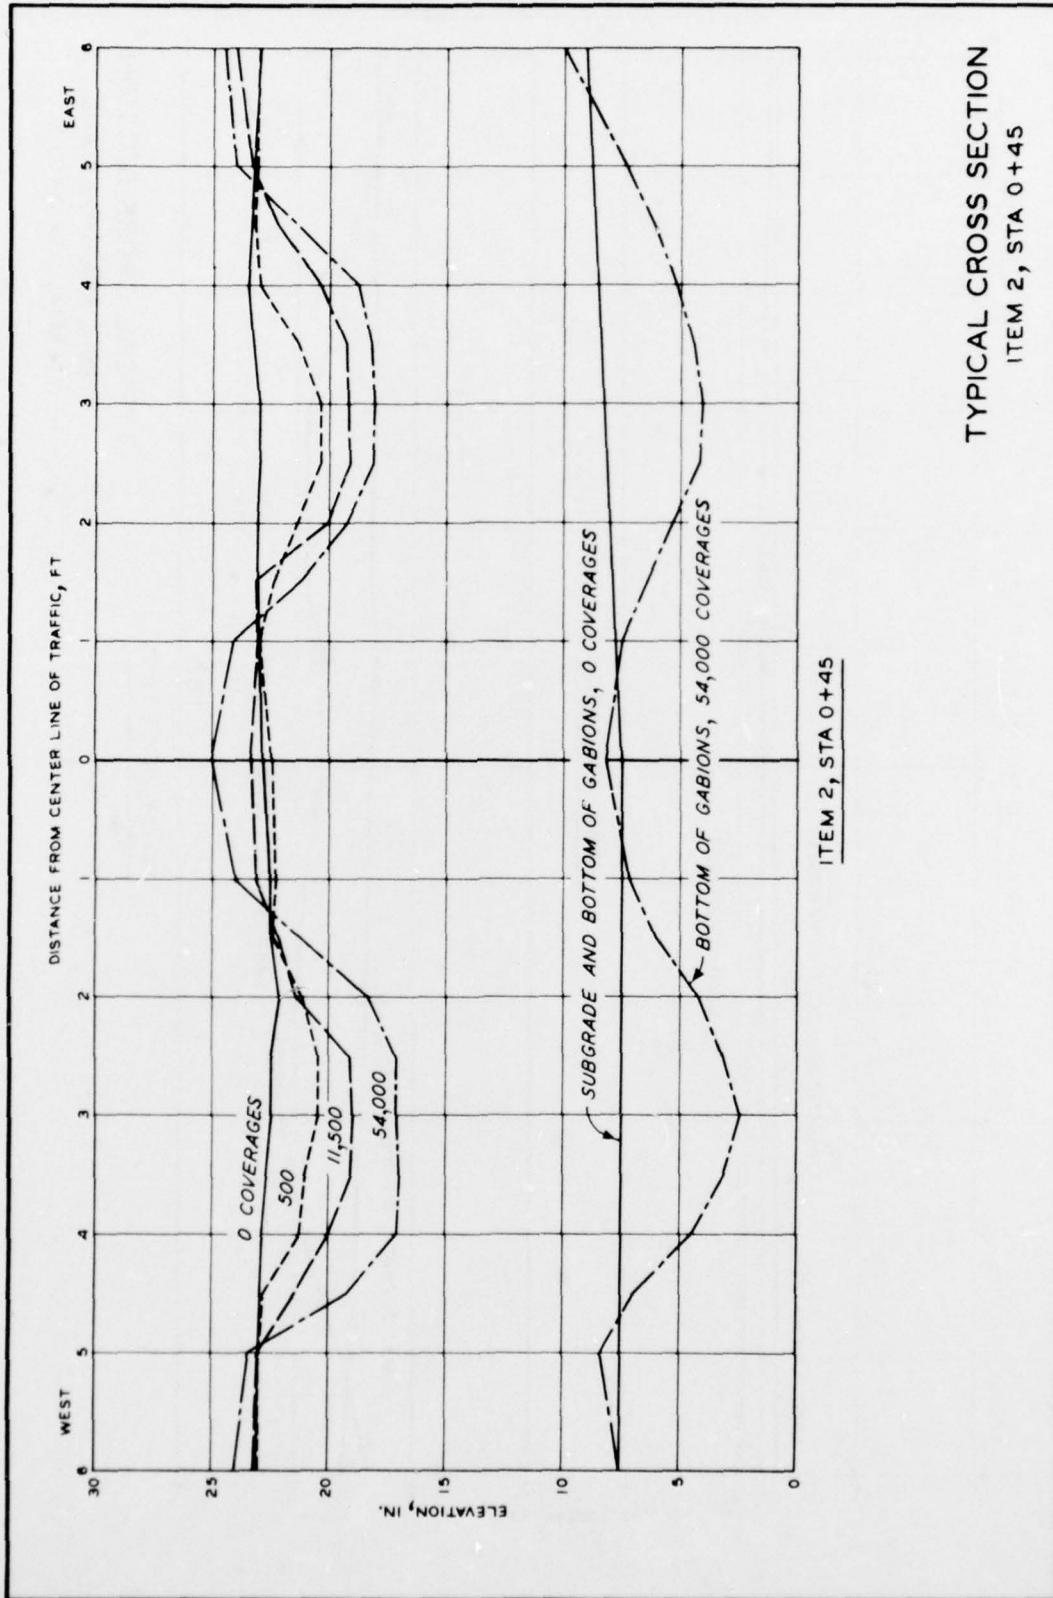
PLATE 4

TYPICAL CROSS SECTION
ITEM 2, STA 0+45

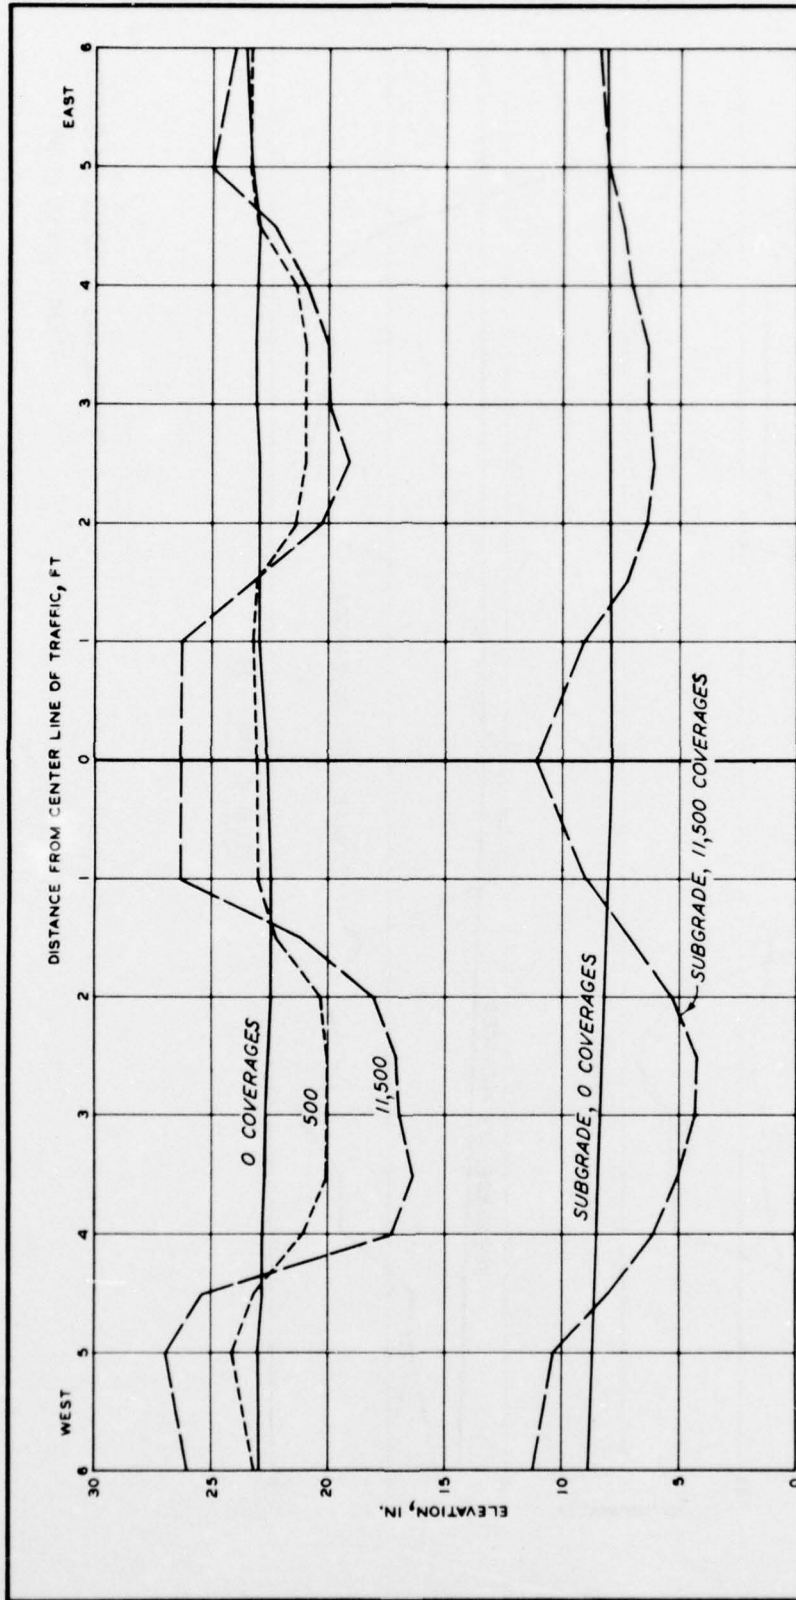
TYPICAL CROSS SECTION
ITEM 3, STA 0+75

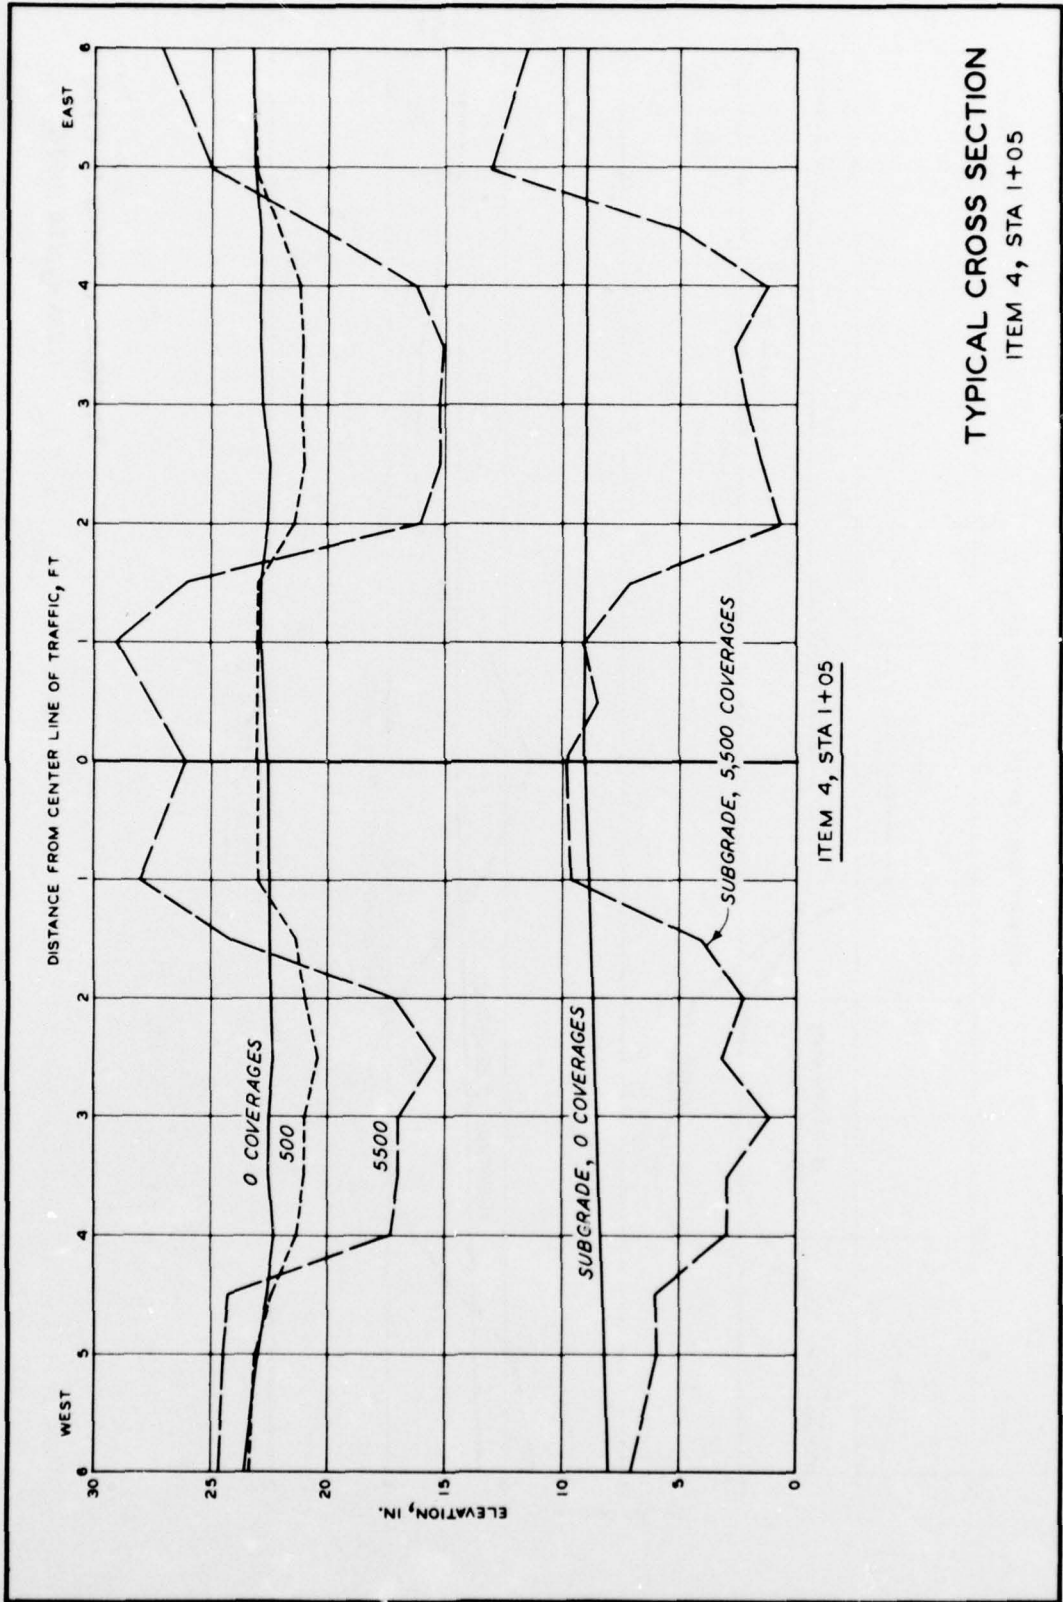
TYPICAL CROSS SECTION
ITEM 4, STA 1+05

only approximately 6 in. Typical cross-section data are shown in Plate 6. Photo 28 shows a typical cross-section view after the wearing surface was removed after 5500 coverages. The individual sand-filled plastic tubes along each wheel path had been pushed into the subgrade. This caused the subgrade to upheave between the wheel paths and along the outer edge of each wheel path.

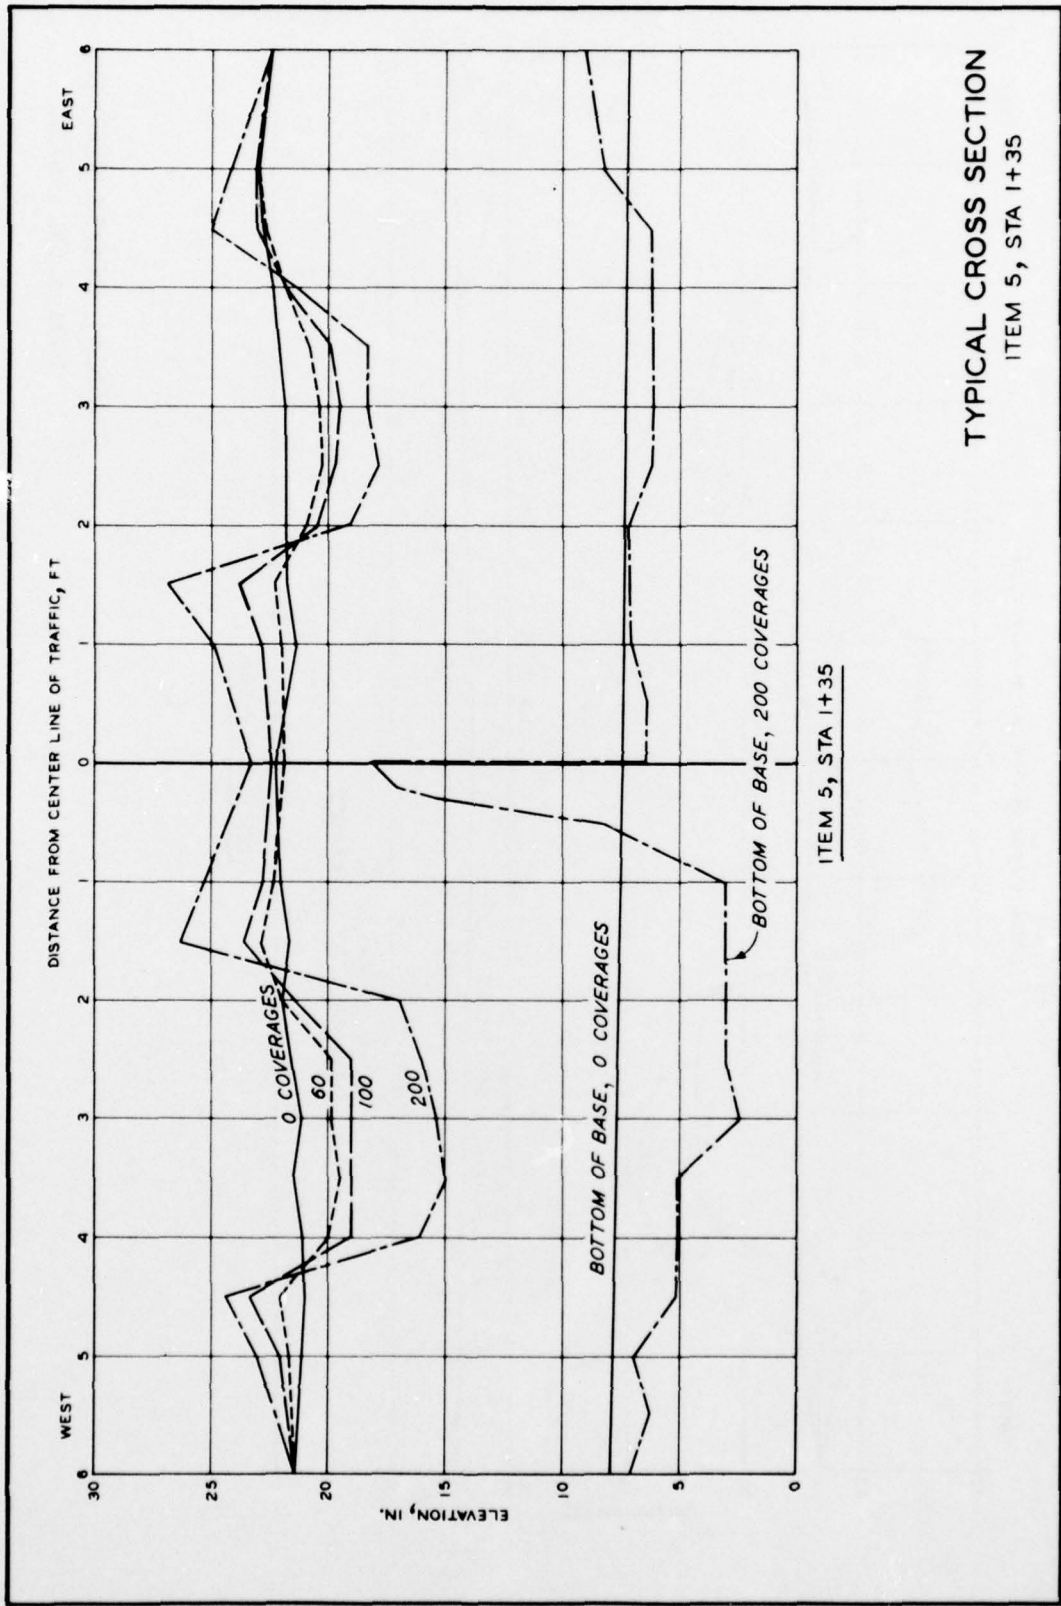
TYPICAL CROSS SECTION
ITEM 5, STA 1+35

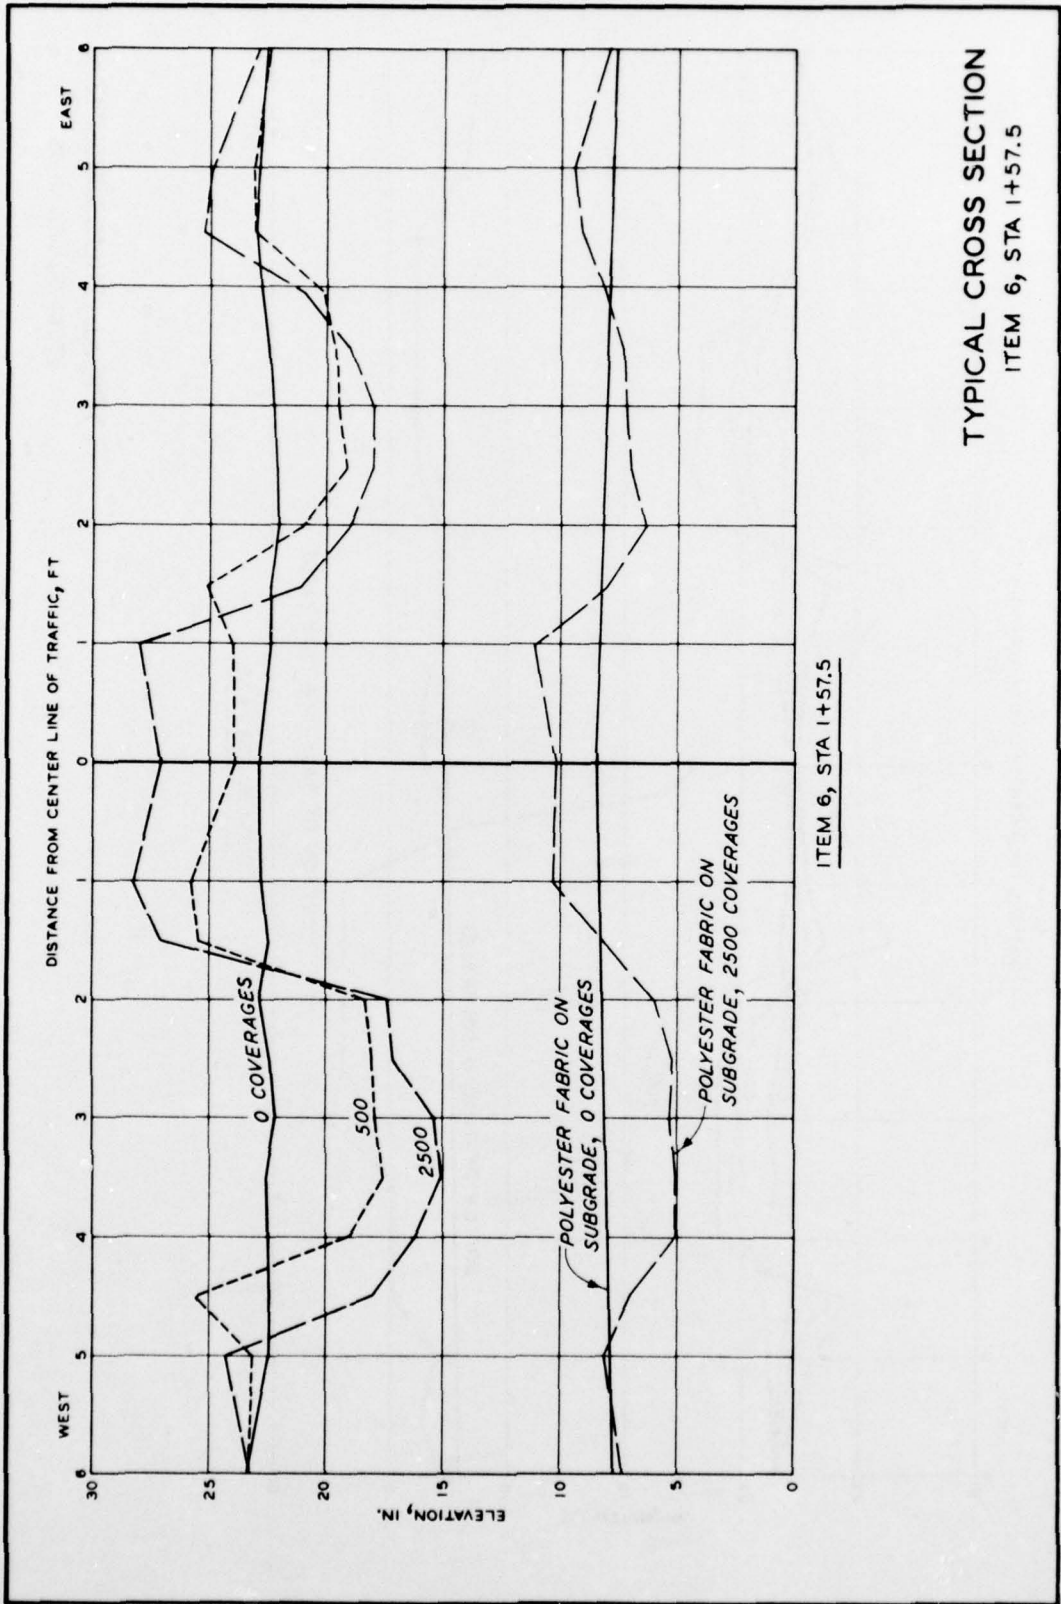
PLATE 8

TYPICAL CROSS SECTION
ITEM 6, STA 1+57.5

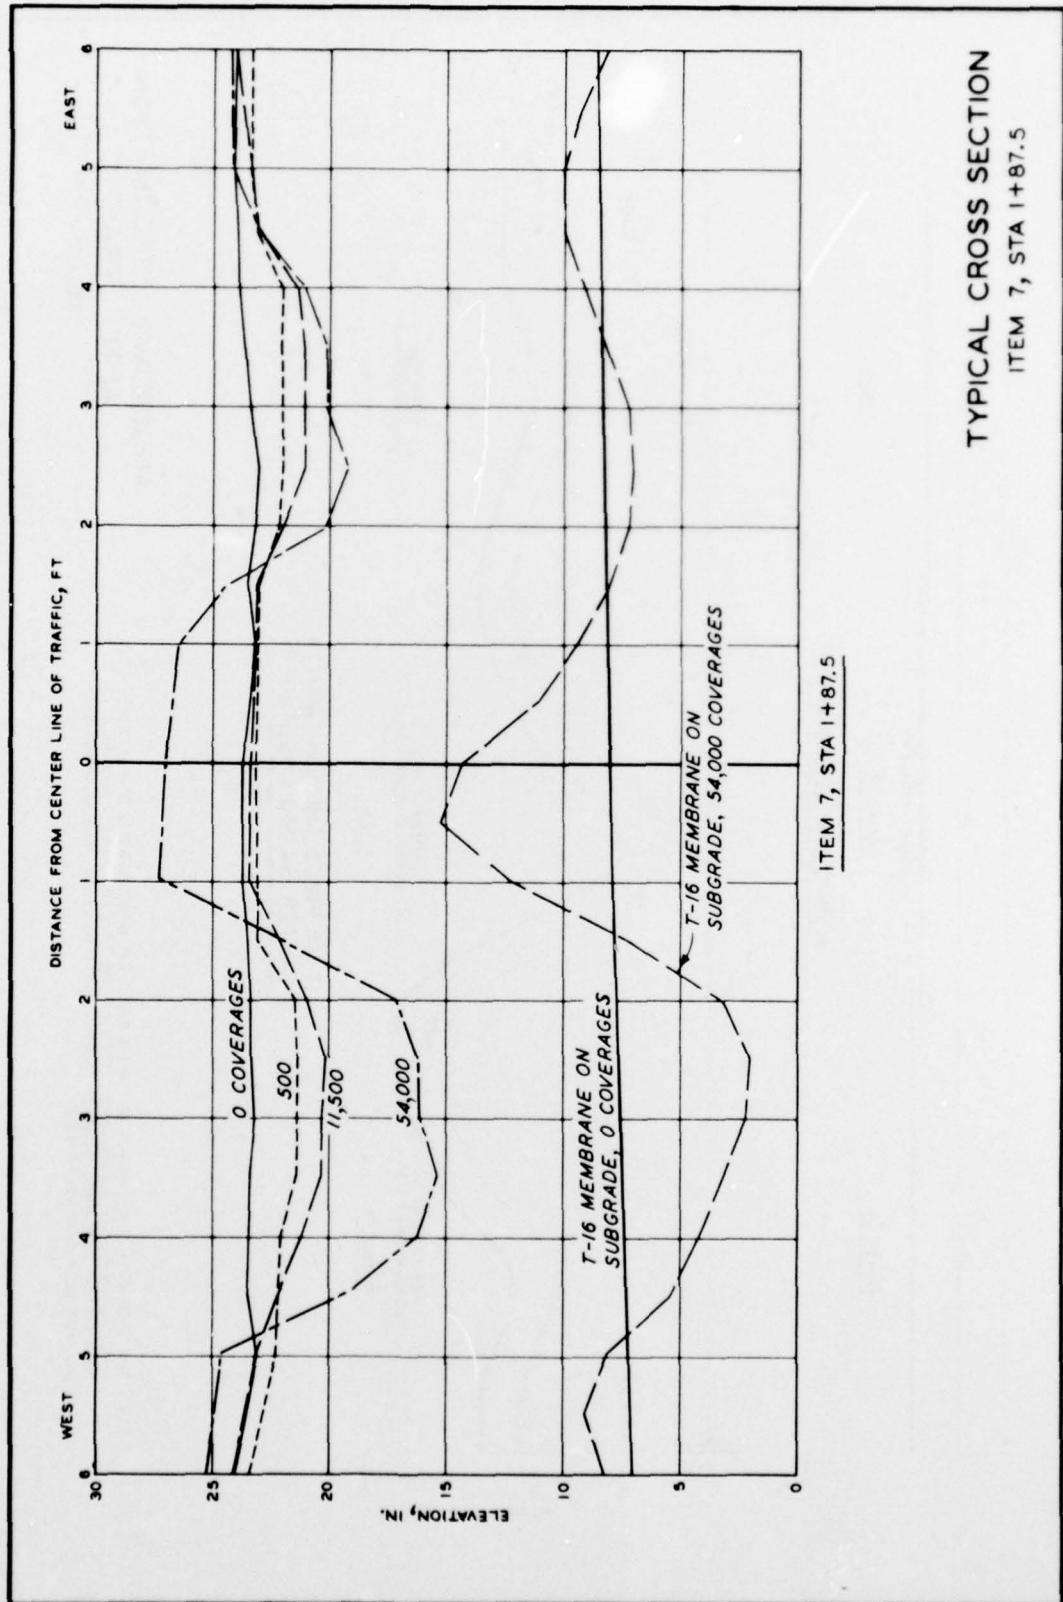
TYPICAL CROSS SECTION
ITEM 7, STA 1+87.5

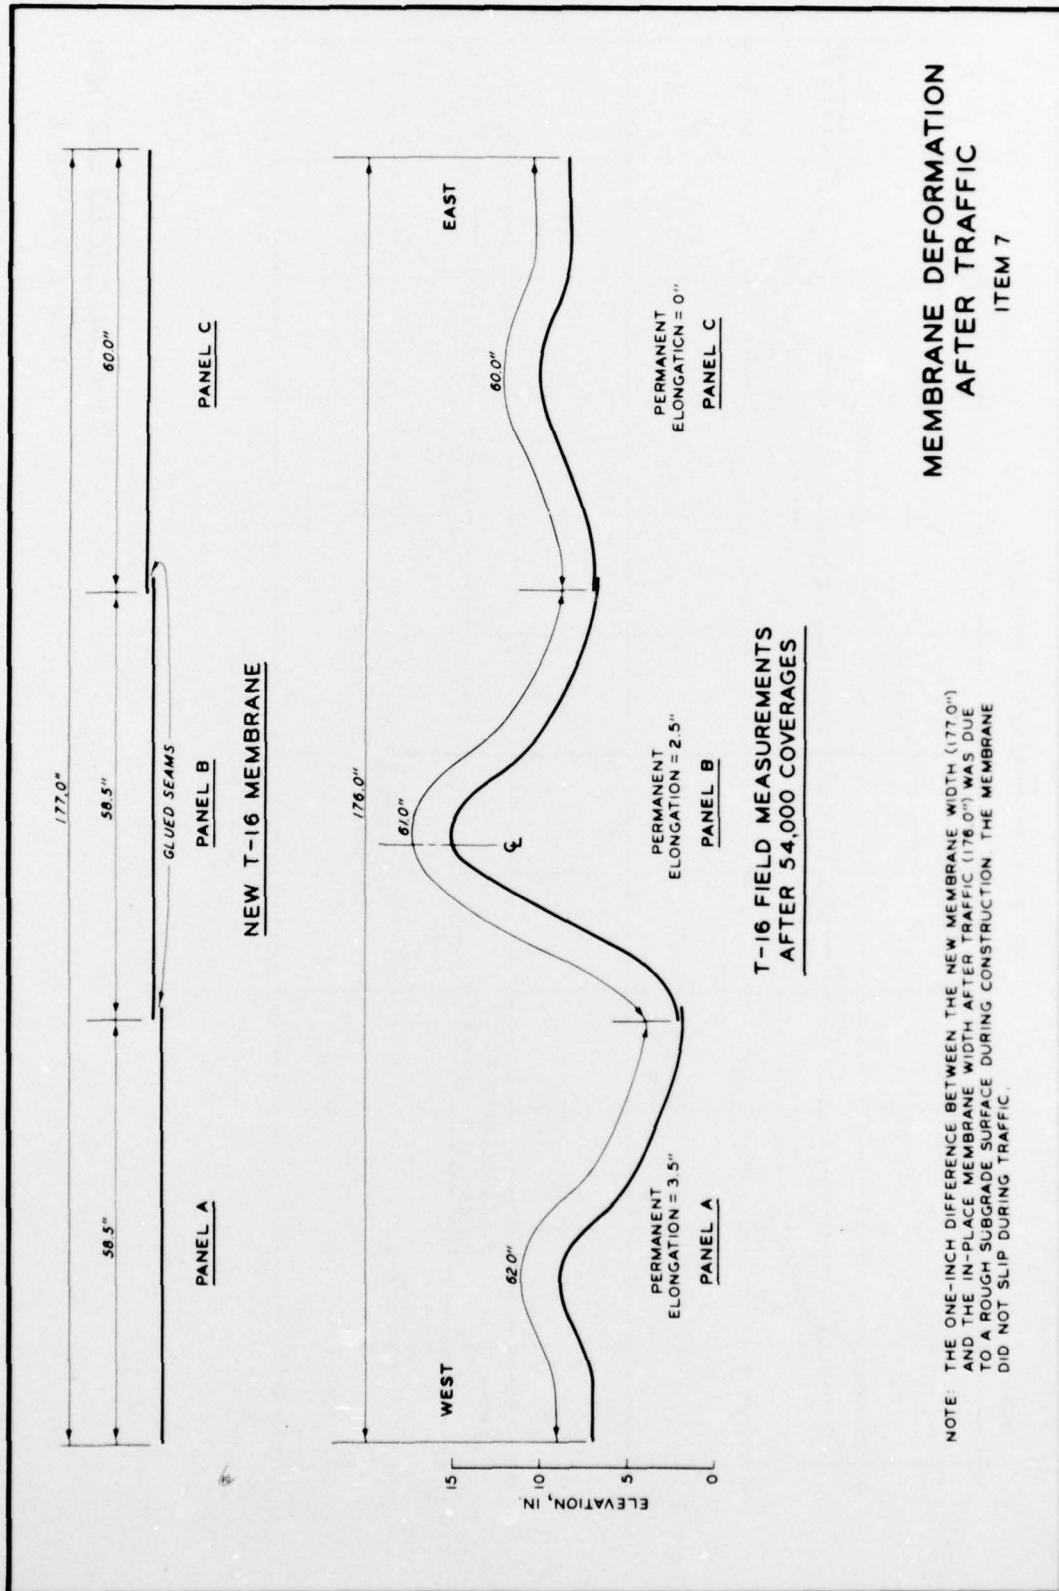
**MEMBRANE DEFORMATION
AFTER TRAFFIC
ITEM 7**

NOTE: THE ONE-INCH DIFFERENCE BETWEEN THE NEW MEMBRANE WIDTH (177.0") AND THE IN-PLACE MEMBRANE WIDTH AFTER TRAFFIC (176.0") WAS DUE TO A ROUGH SUBGRADE SURFACE DURING CONSTRUCTION. THE MEMBRANE DID NOT SLIP DURING TRAFFIC.

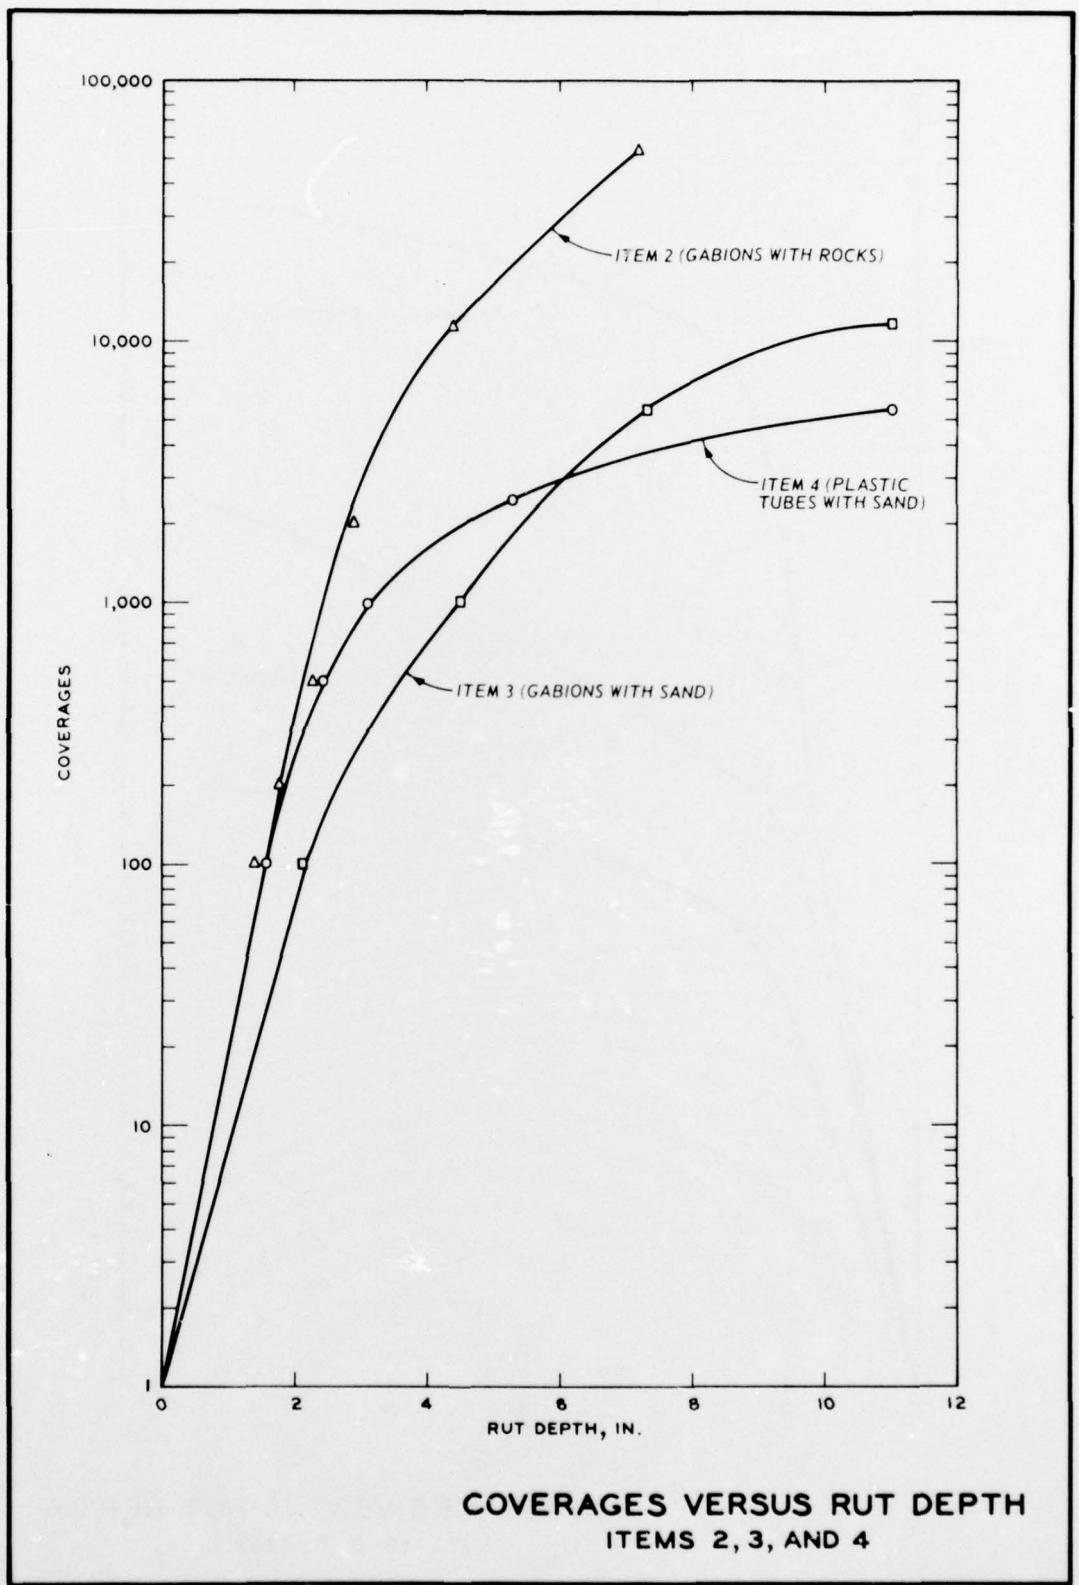
**COVERAGES VERSUS RUT DEPTH
ITEMS 2, 3, AND 4**

52. Using the actual traffic coverage data from the test section (Plates 11 and 12), a performance thickness in in. was determined for test items 2 through 7 using the CBR design plots shown in Plate 13. A performance thickness was determined using coverage data obtained at 3-, 6-, and 11-in. rut depths. These data were plotted as shown in Plate 14. The CBR design criteria for the 3-in. rutting failure criteria were also plotted and extrapolated for the 6- and 11-in. rutting failure criteria using the performance of the control item 5 as a guide. This extrapolation was necessary since no mathematical expression of CBR design relations presently exists for the 6- and 11-in. rutting failure criteria.

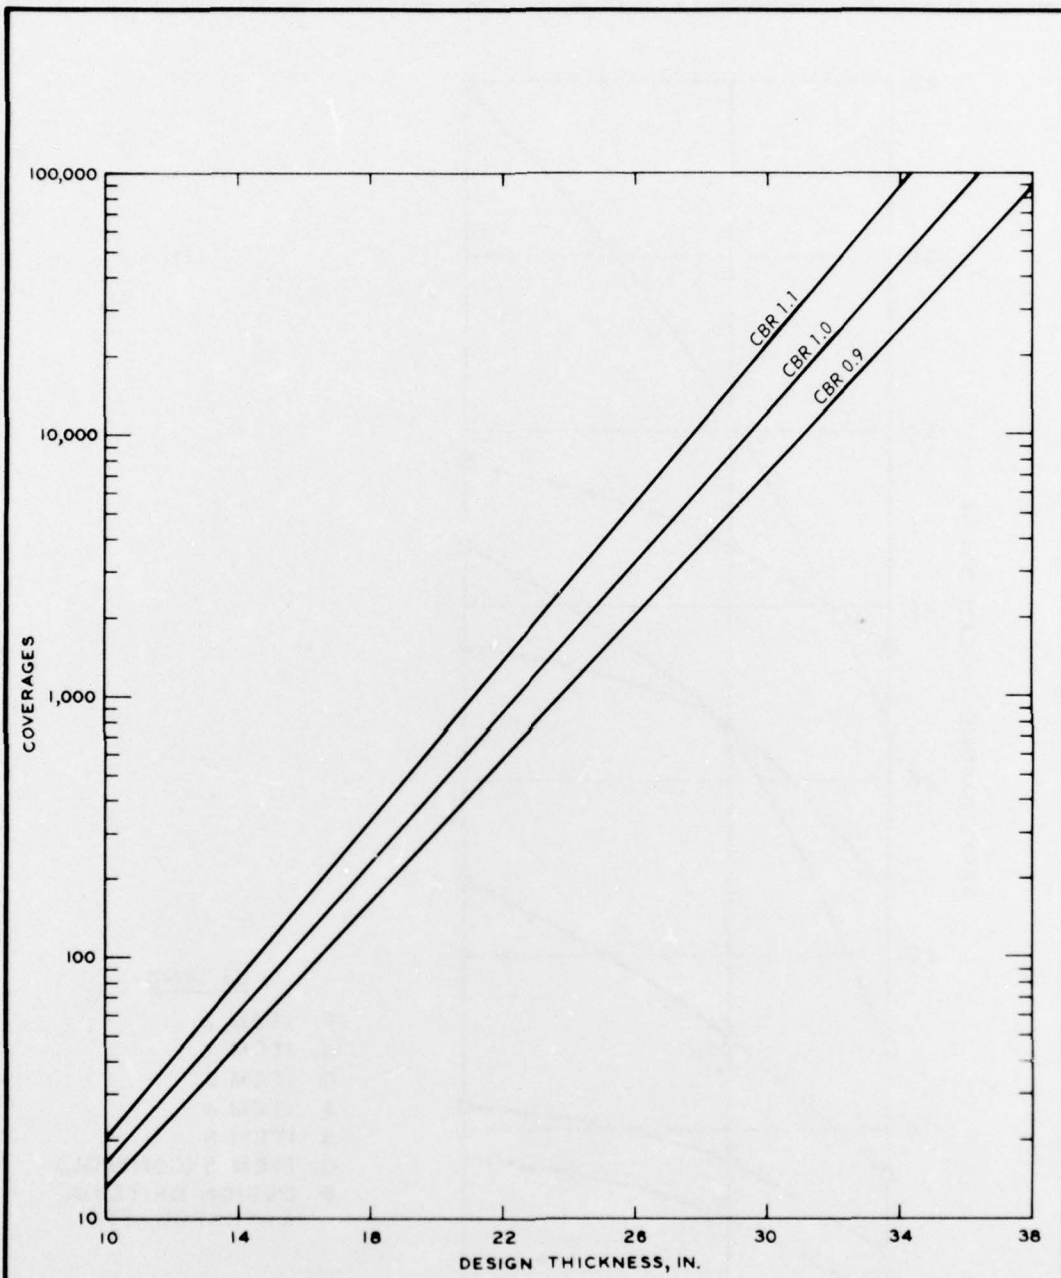
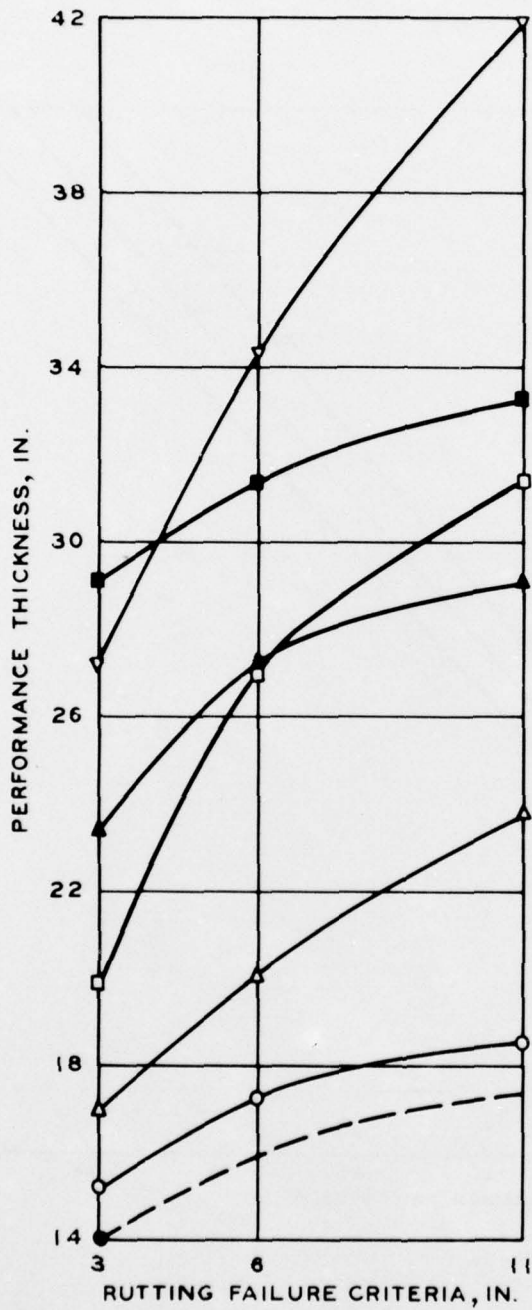
COVERAGES VERSUS DESIGN THICKNESS FOR UNSURFACED ROADS

18-KIP SINGLE-AXLE
DUAL-WHEEL LOAD
