LIGHTWEIGHT LIGHTED BUOY DEVELOPMENT
FOR USE AS DISCREPANCY NAVAIDS

W. E. Colburn, Jr.
and
W. R. Thompson

December 1976

FINAL REPORT

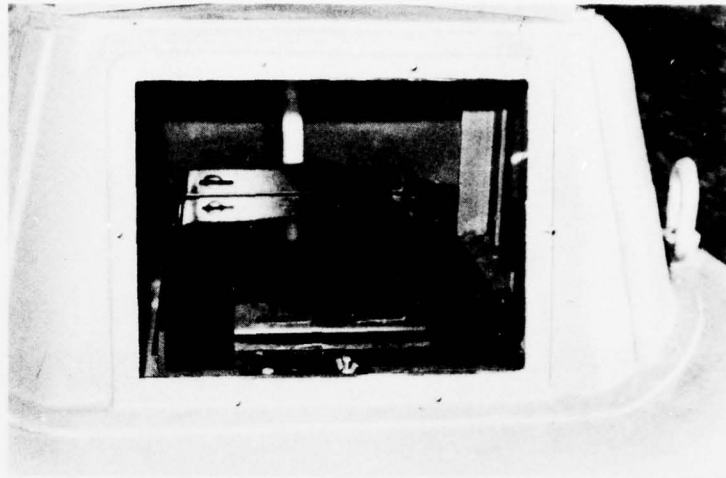
FIGURE 3

THE IMPROVED BATTERY COMPARTMENT ON THE PRE-PROTOTYPE BUOYS WITH THE STANTIONS INSIDE THE COMPARTMENT TRANSFERRING THE DAYMARK LOAD DIRECTLY TO THE HULL, THE DOUBLER PLATE ON THE COMPARTMENT'S TOP SURFACE, AND THE PVC ANGLE EXTENDING TO THE EDGE OF THE DOUBLER PLATE.

A vented battery compartment is fixed to the top of the flotation collar and contains a removable battery tray. Several types of batteries can be attached to the tray and the tray can then be inserted into the battery compartment. A rectangular door closes the battery compartment and this door is held in place by a series of nuts around its perimeter. The improved battery compartment is shown in Figure 3.

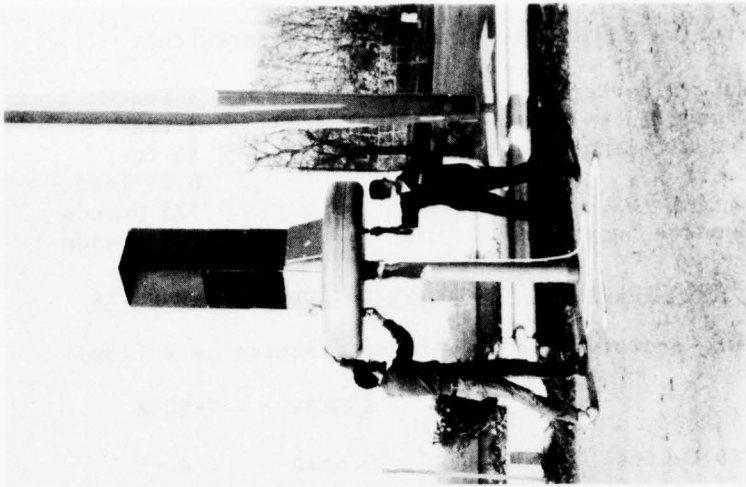
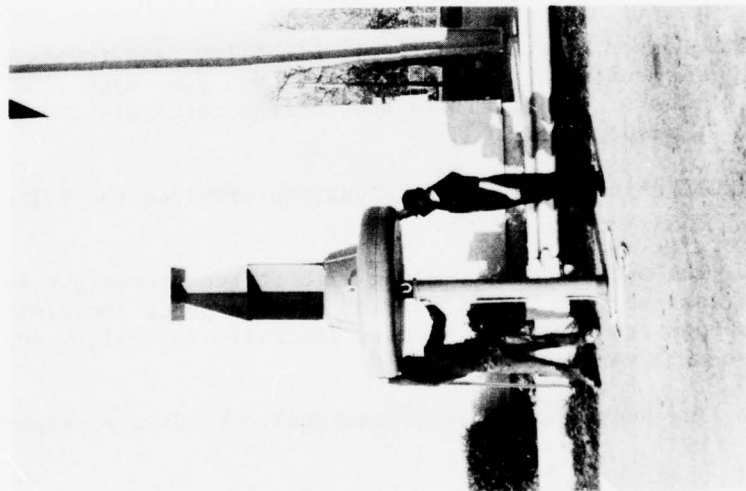
FIGURE 4
NUN AND CAN VERSIONS OF THE PPEWDB BUOY

This buoy is the same as the PPSWDB with the exception of size. The flotation collar is five feet in diameter and the center tube extends six feet below the flotation collar (Figure 4). The radar reflector/daymark is larger than on the PPSWDB buoy.

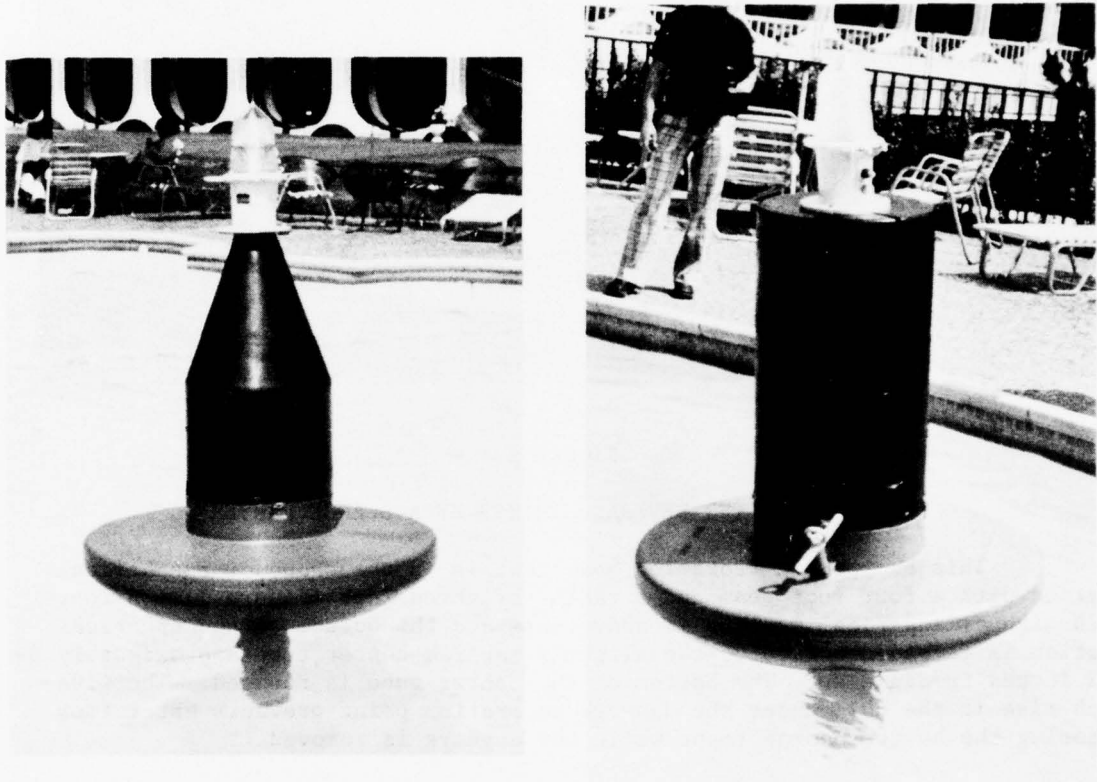
FIGURE 5

WGDB BUOY WITH NUN AND CAN DAYMARKS

This buoy is designated WGDB because of its wine glass hull shape. The WGDB sheltered water discrepancy buoy was designed from scratch using the knowledge gained from the previous discrepancy buoys and fast water buoys. The NUN and CAN versions of this buoy are shown in Figure 5.

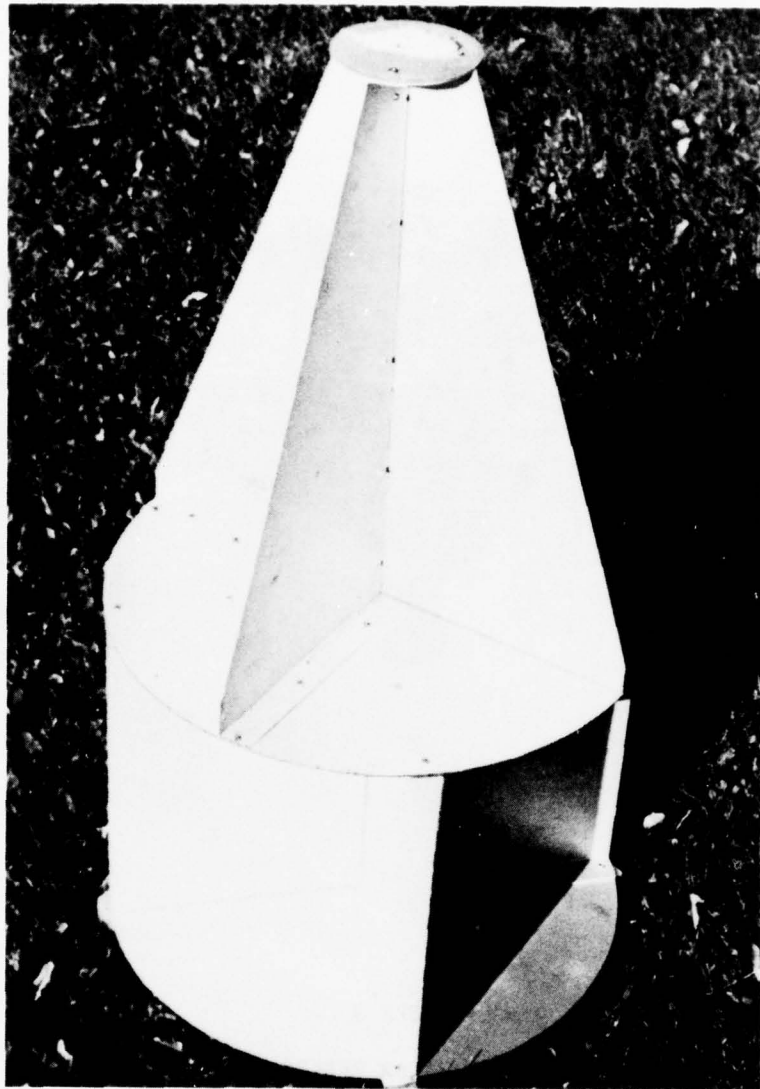
FIGURE 8

WGDB BUOY RADAR REFLECTOR

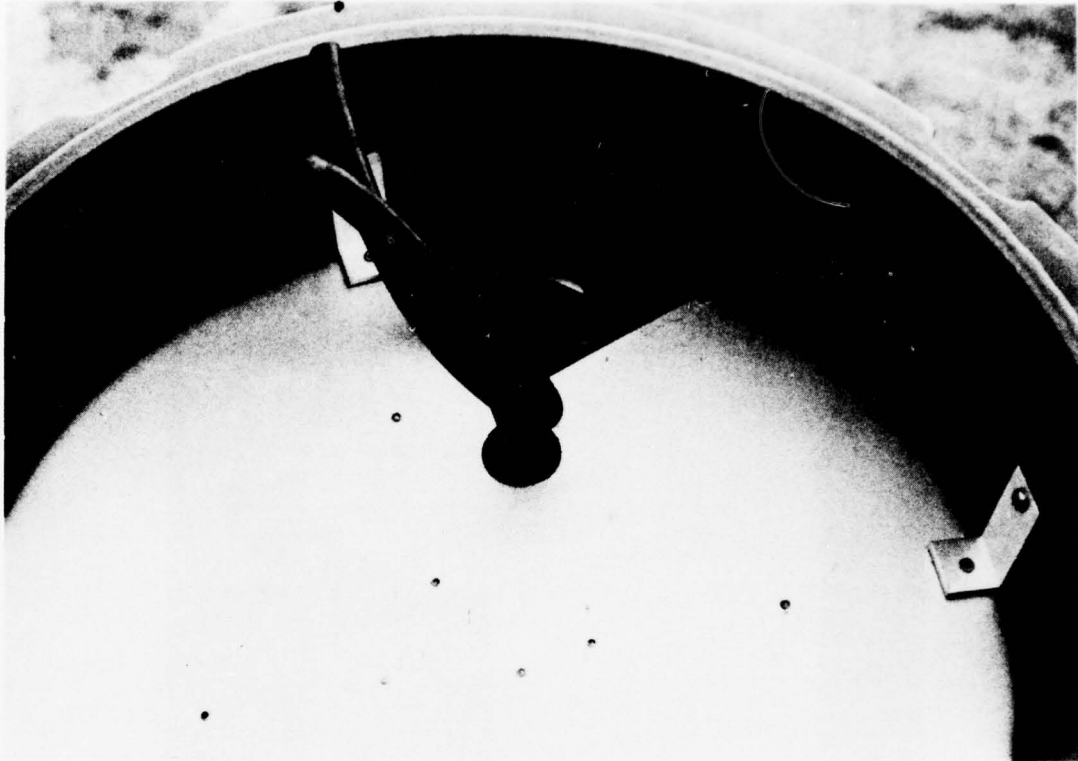
FIGURE 9

THE ATTACHMENT OF THE RADAR REFLECTOR IN EITHER THE
NUN OR CAN (THE WIRE LEADS THROUGH A STUFFING TUBE
IN THE DAYMARK AND THEN TO THE LANTERN.

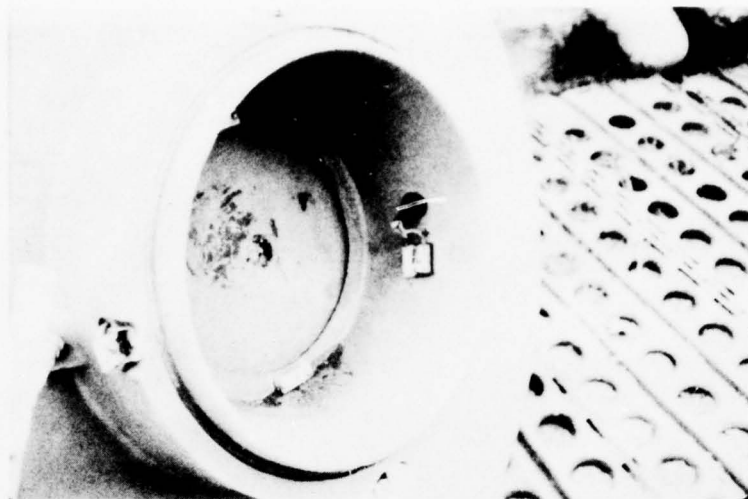
FIGURE 11

THE LEAD-UP WIRE FROM THE PERMANENT BATTERIES (7 BUOYS ONLY)
IS USED TO RECHARGE THE BATTERIES AND SUPPLY POWER TO THE LANTERN

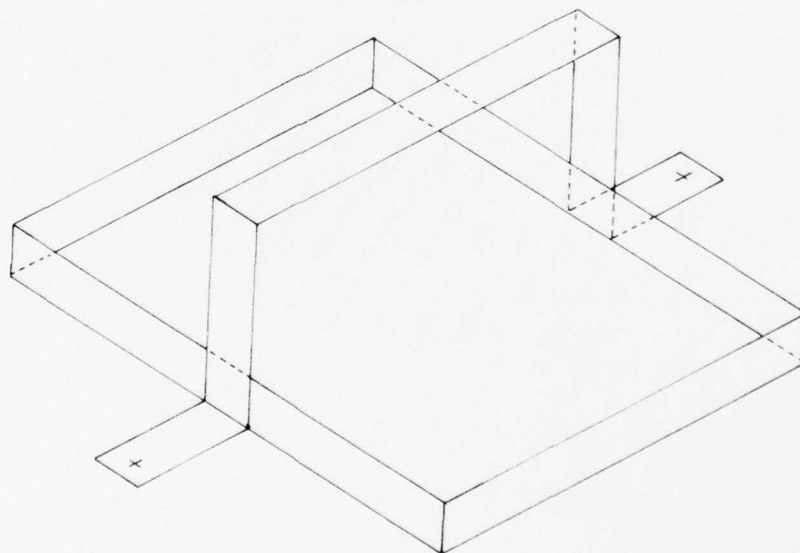
FIGURE 12

BATTERIES ((a), HOT SHOT BATTERIES ARE SHOWN HERE) ARE LOCATED UNDER THE DAYMARK AND ARE HELD IN PLACE WITH THE HOLDDOWN SHOWN (b) OR BY A STRAP.

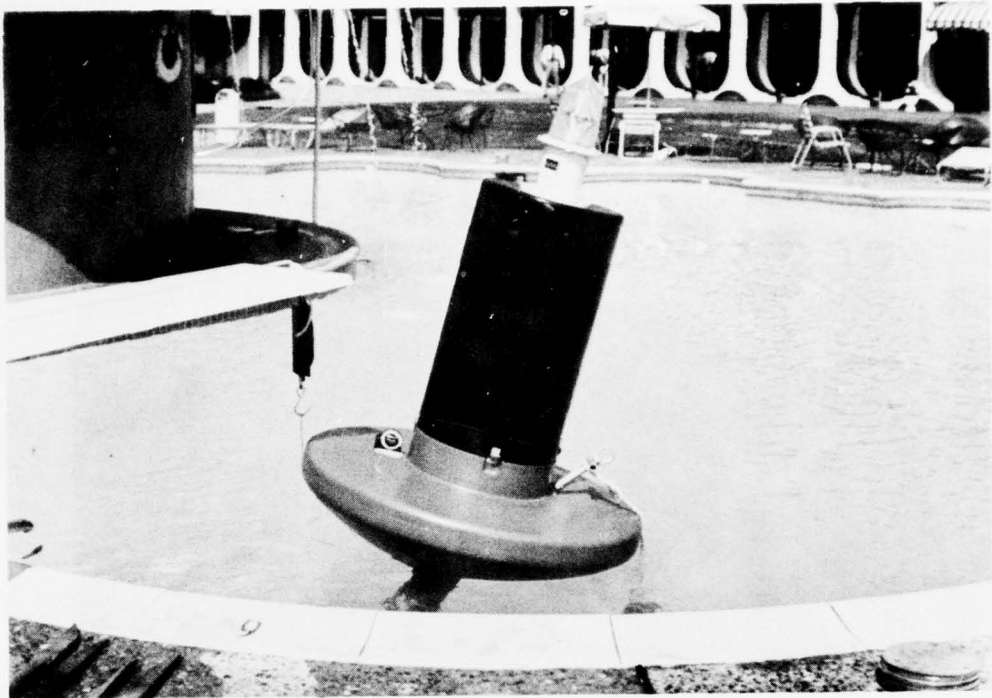
FIGURE 13

INCLINING EXPERIMENT OF THE FIRST WGDB BUOY TO VERIFY STABILITY CALCULATIONS.

An initial inclining experiment (Figure 13) was performed near the fabricators plant on the first buoy cast in the WGDB mold. This was done to verify initial stability calculations. A slight increase in counterweight provided sufficient righting moment to prevent the buoy from capsizing in 40-knot winds. The testing also confirmed the buoy's ability to self-right under all conditions (Figure 14).

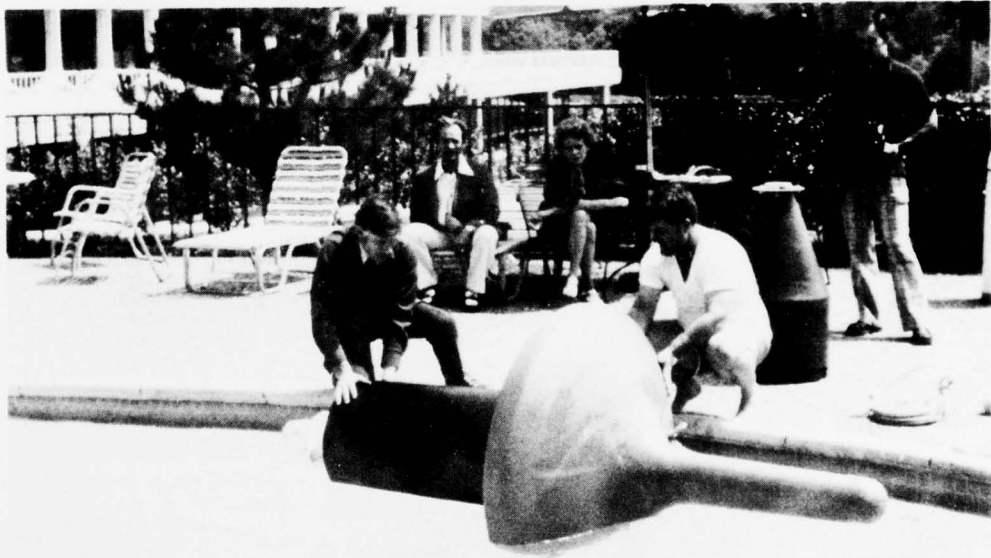
FIGURE 14

WGDB SELF-RIGHTING TEST SHOWED THAT THE BUOY WOULD NOT REMAIN CAPSIZED UNDER ANY CONDITIONS.

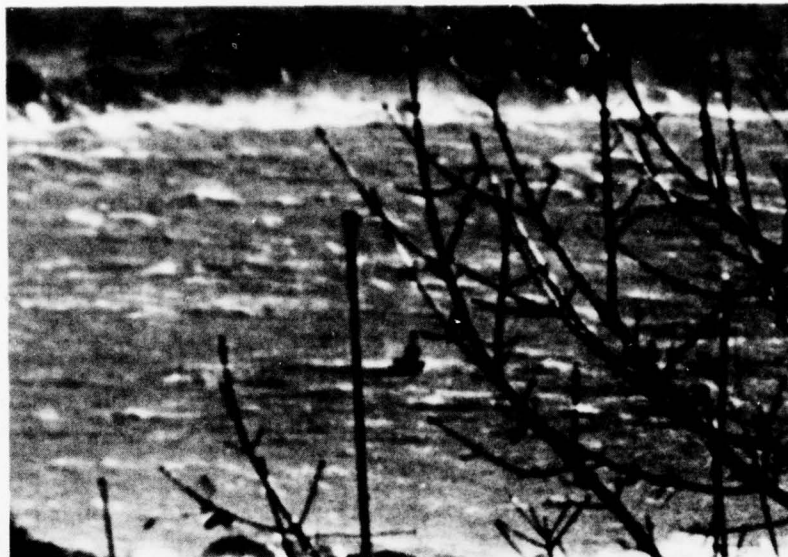
FIGURE 15

A WGDB BUOY RIDING WELL IN A 40-KNOT STORM

Deployments of two buoys at the R&D Center's Pine Island test site plus an additional two buoys placed in Long Island Sound in conjunction with a NAVAID positioning project have been very satisfactory. The buoys survived the effects of Hurricane Belle in August 1976. Although the buoy is difficult to view in the photograph, Figure 15, the buoy is shown riding well in a 40-knot storm.

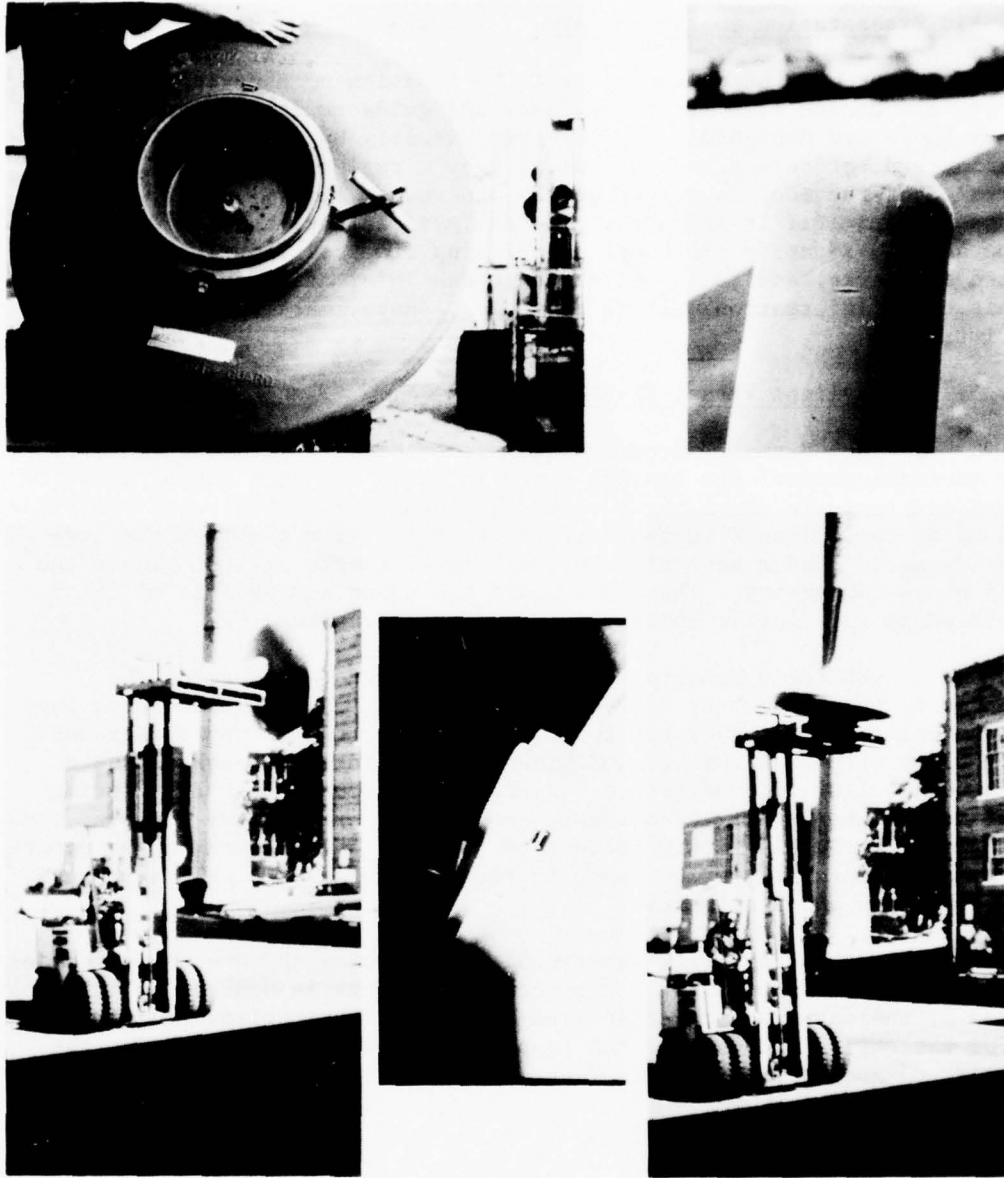
FIGURE 16

DESTRUCTIVE TESTING OF THE WGDB BUOY

The buoy was dropped from a loading dock (a) onto its gunwale and on the counterweight tube (b) with only minor distortion and abrasion damage. Then, it was dropped from a forklift (c) onto its top (d) with limited distortion (daymark still fits), and onto its counterweight tube from the forklift (e) with minimal damage. The buoy is still operational.

- a. Rolling the buoy hull from a loading dock (Figure 16a - no damage).
- b. Throwing the hull off the loading dock such that it would land on the counterweight tube (Figure 16b - some minor distortion and abrasion).
- c. Dropping the hull from a forklift (Figure 16c) onto its top (Figure 16d -distortion but the daymark still fits).
- d. Dropping the hull from a forklift (Figure 16e) onto its counterweight tube (more distortion than b. above but would not affect the buoy's use).
- e. Backing into the hull (upside down and against a wall) with the forklift from about 20 feet away (distortion of the deck near the points of impact but would not affect the buoy's use).

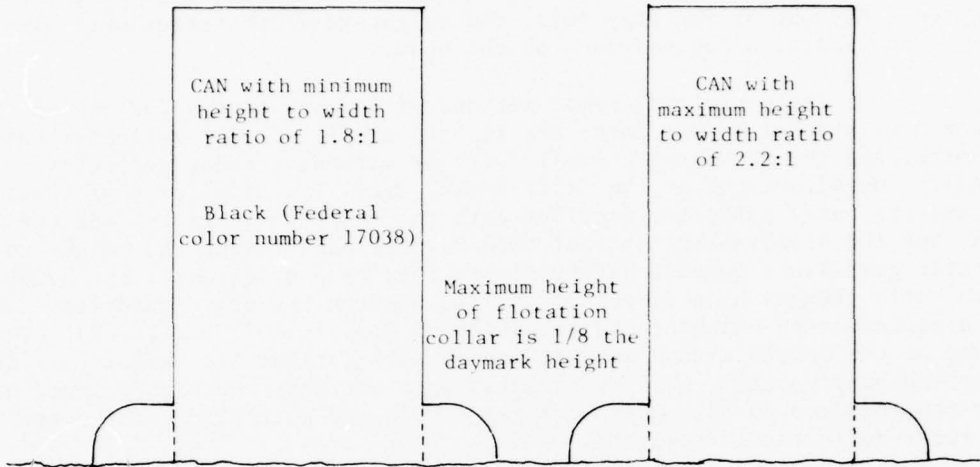
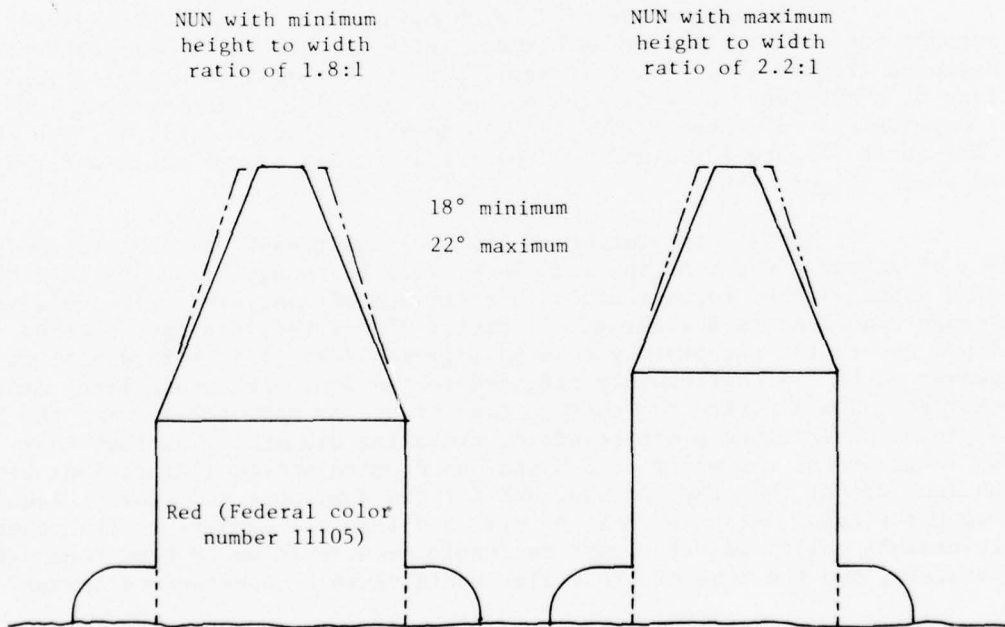
FIGURE 19

SIX METHODS OF INTERCHANGING
RED NUN AND BLACK CAN DAYMARKS

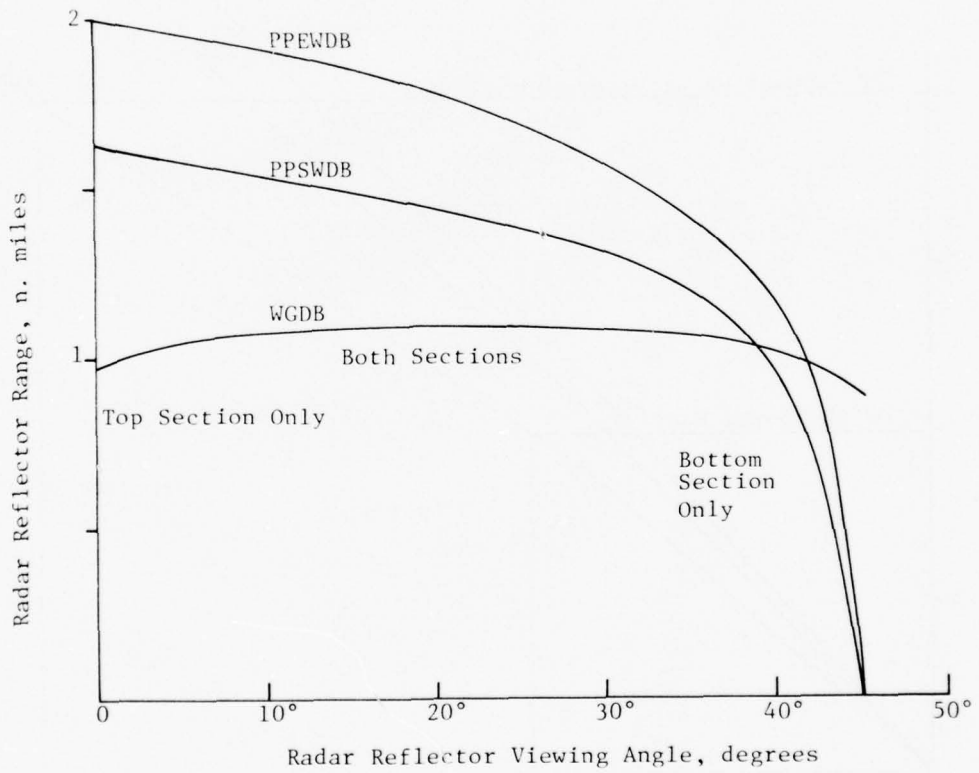
FIGURE 21

Theoretical radar range of the WGDB, PPSWDB, and PPEWDB buoys for a 3kw stereotype radar set as a function of the viewing angle (repeats beyond 45°).

Theoretical analysis to determine the minimum radar reflector size that would be required to fulfill the original TOR using a stacked bi-plane reflector of the type used in the WGDB buoy and assuming the 3kw stereotype radar set. This analysis led to the reduction in the TOR.

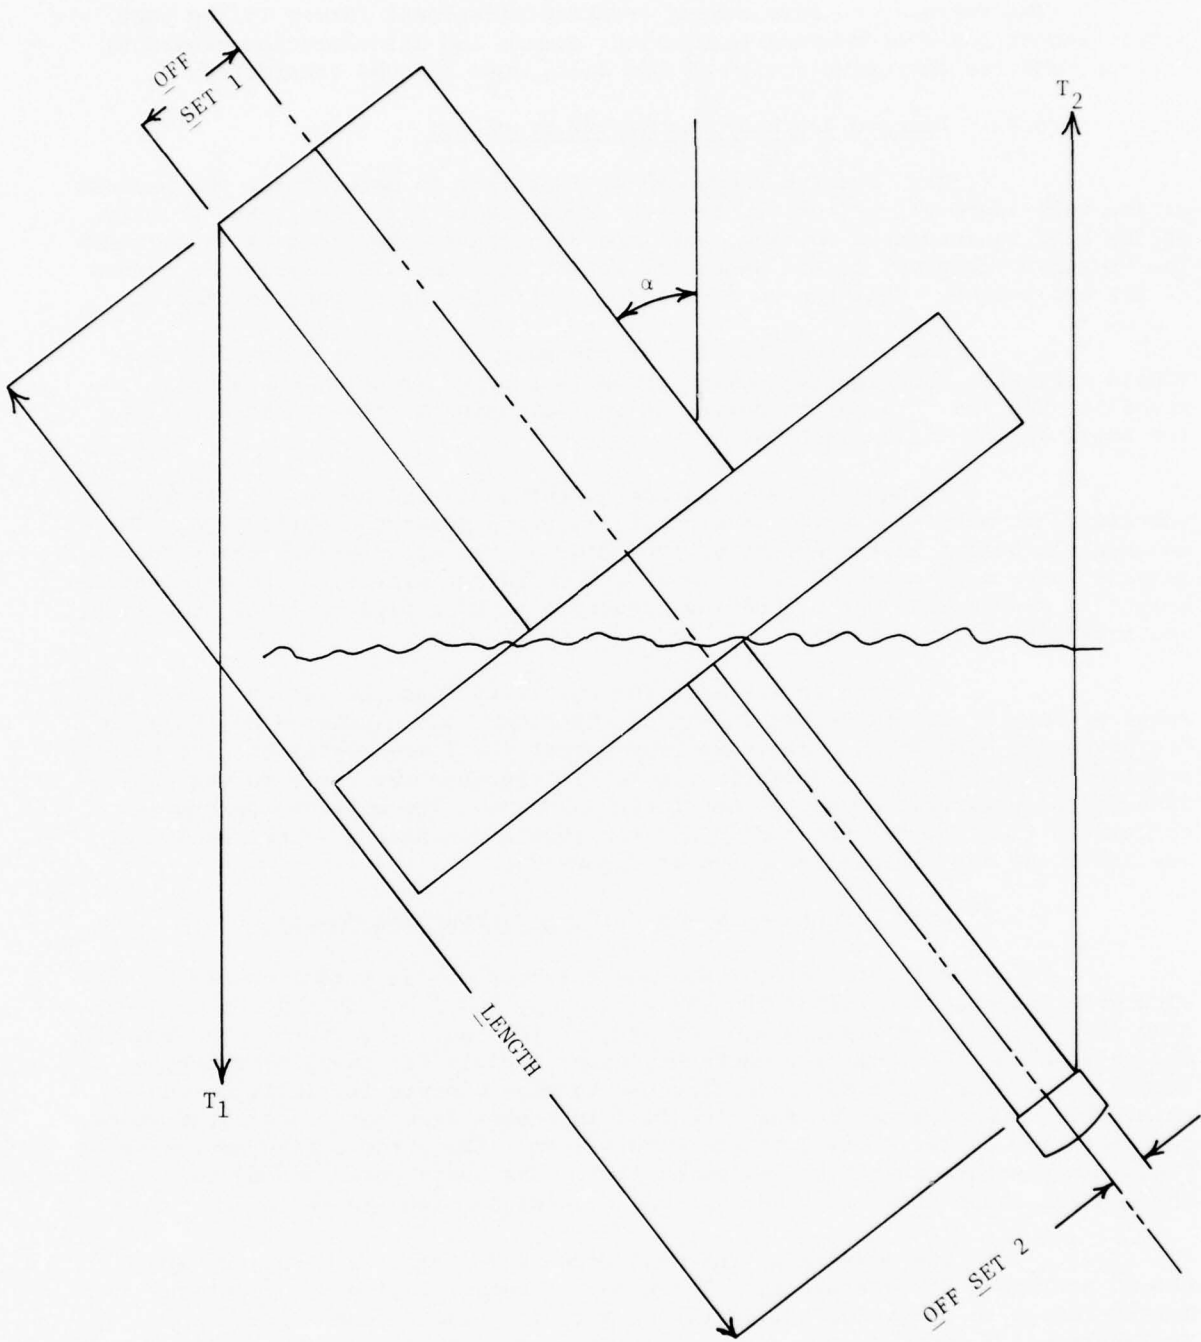
FIGURE 22

Inclining experiment method, where the righting moment is equivalent to the overturning moment. The overturning moment is induced by the "couple" with the magnitude of force being $T_1 = T_2 = T$, and an effective arm of $[L \sin \alpha + (Os_1 + Os_2) \cos \alpha]$, thus the righting moment is: $Rm = T[L \sin \alpha + (Os_1 + Os_2) \cos \alpha]$.

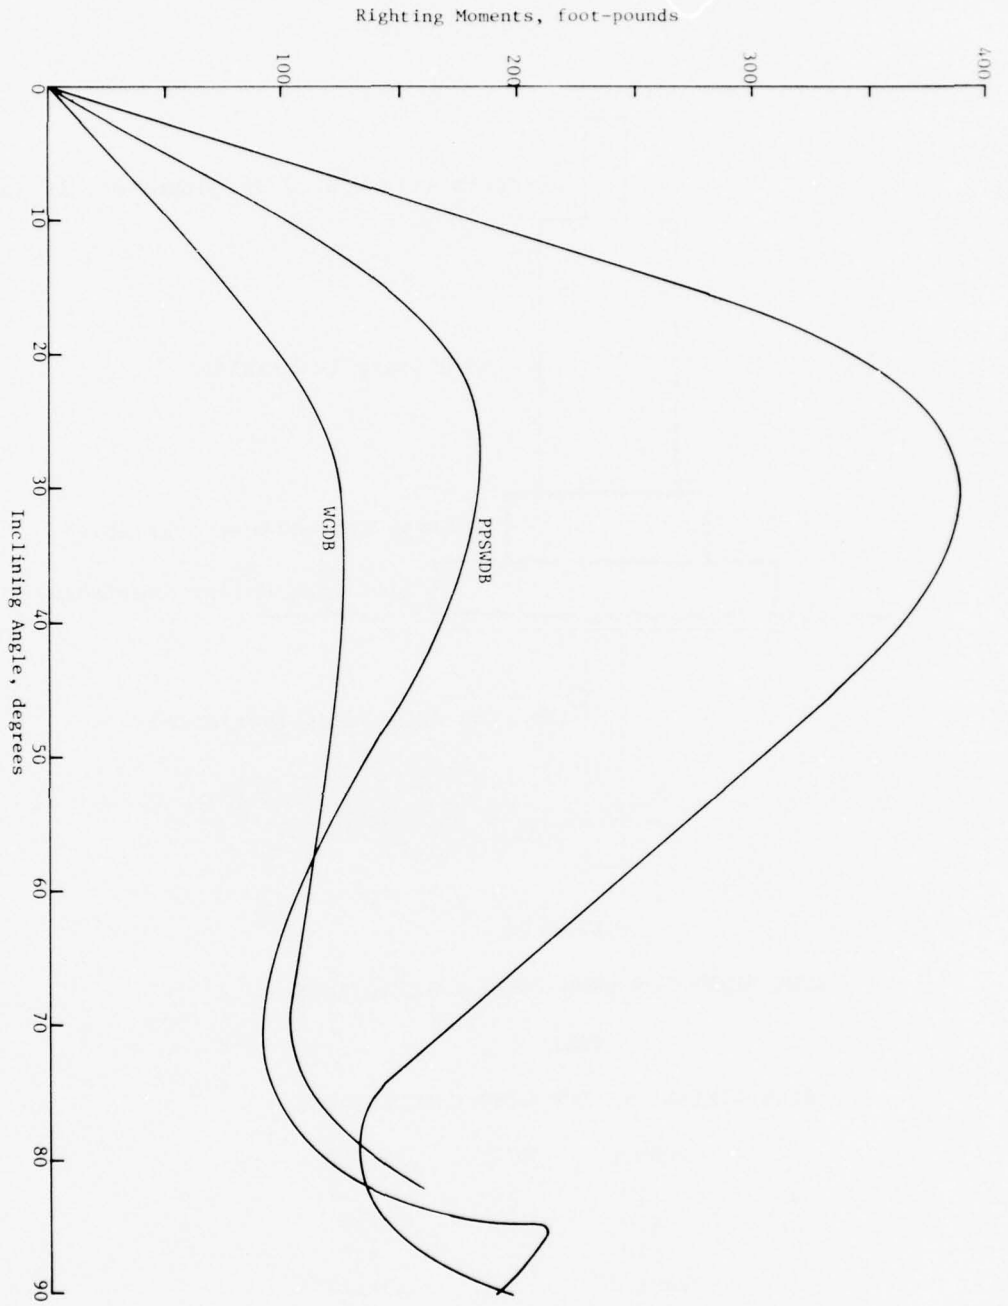
FIGURE 23
 RIGHTING MOMENT CURVES FOR THE WGDB, PPSWDB, AND PPEWDB BUOYS

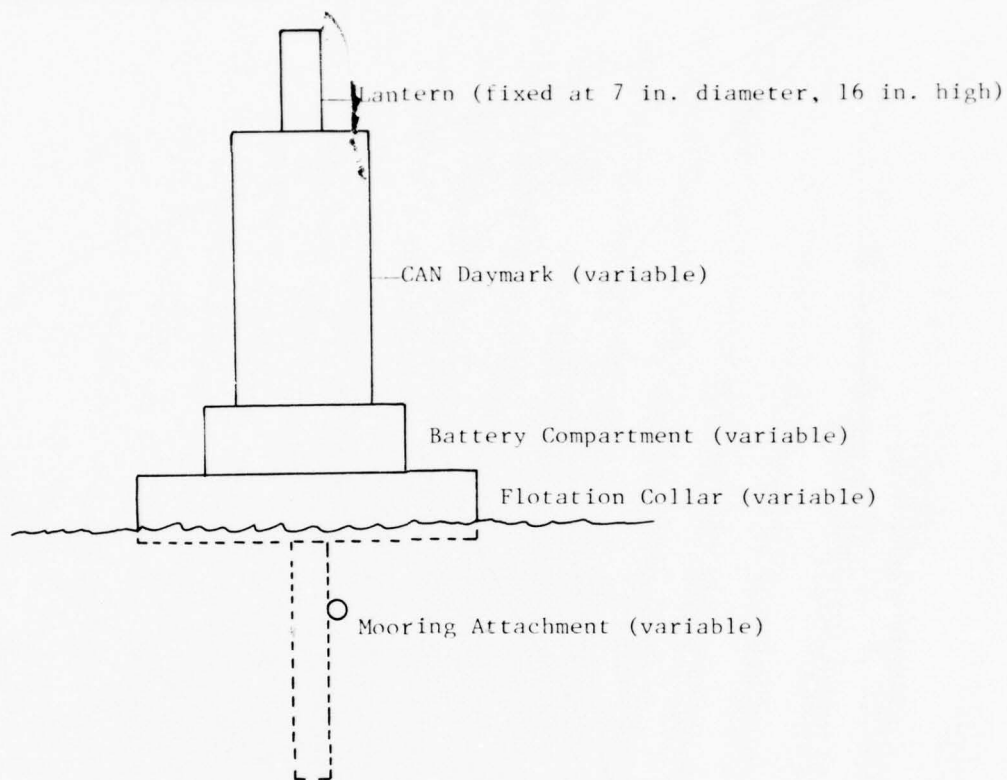
FIGURE 24

BUOY SHAPE FOR WIND FORCE CALCULATIONS

Net horizontal force and the overturning moment caused by the wind were calculated by using the standard drag equation with a coefficient of drag of 1.2 and the maximum projected area of the can. The overturning moment was taken about the mooring attachment points (bridle for the pre-prototype buoys). The wind force and resulting overturning moments initially decreases as a cosine function as the angle of list increases from zero to a point where the flotation collar rises into the wind stream. Thus, the cosine approximation is not accurate at high angles of list. The buoys were assumed to be of the general shape shown in Figure 24 and dimensions given in Table 5.

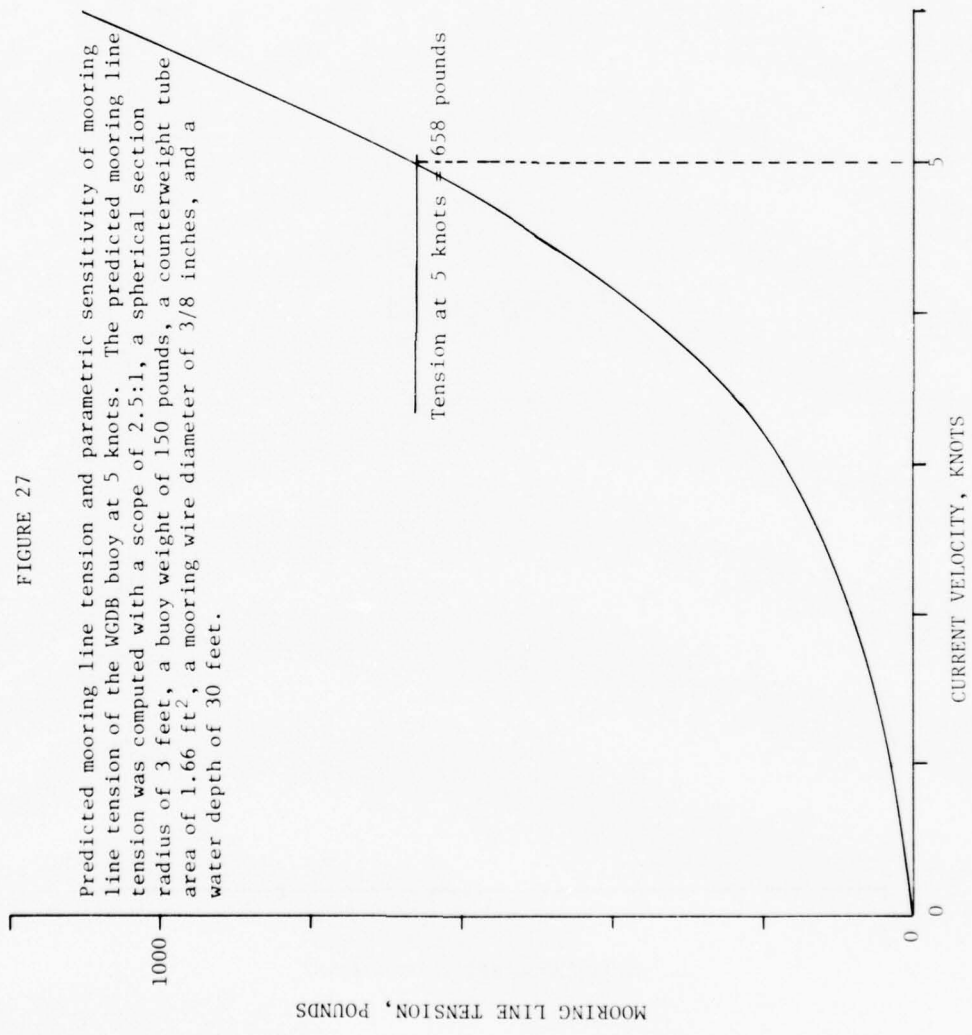
FIGURE 27

Predicted mooring line tension and parametric sensitivity of mooring line tension of the WCDB buoy at 5 knots. The predicted mooring line tension was computed with a scope of 2.5:1, a spherical section radius of 3 feet, a buoy weight of 150 pounds, a counterweight tube area of 1.66 ft², a mooring wire diameter of 3/8 inches, and a water depth of 30 feet.

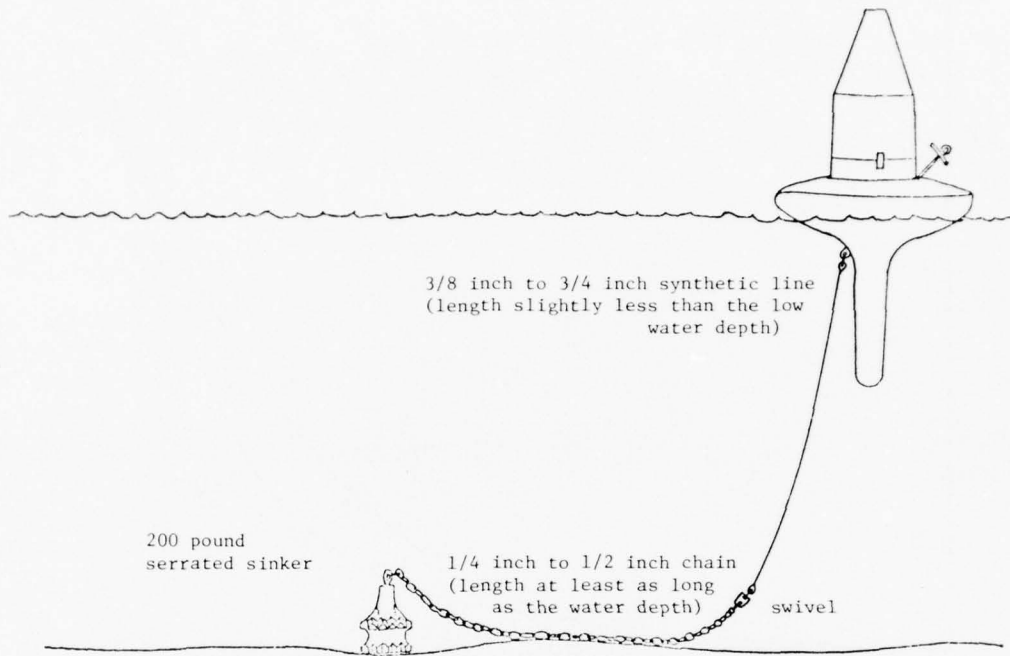
FIGURE 32b
MOORING SYSTEM FOR EXPOSED WATER OR
HIGH CURRENT ENVIRONMENTS

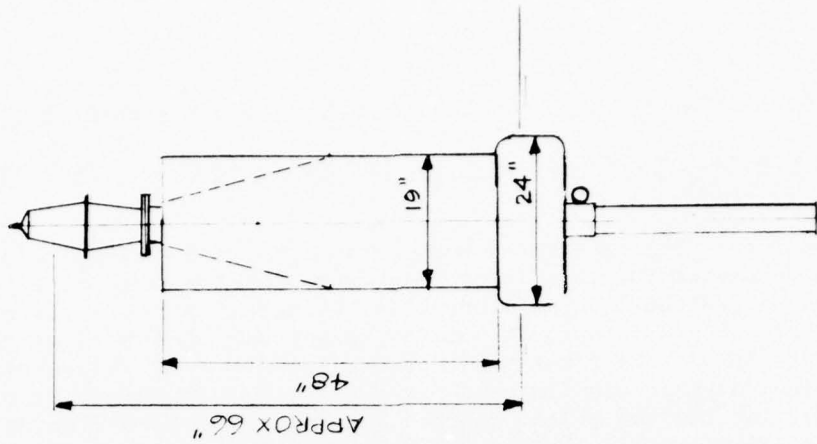
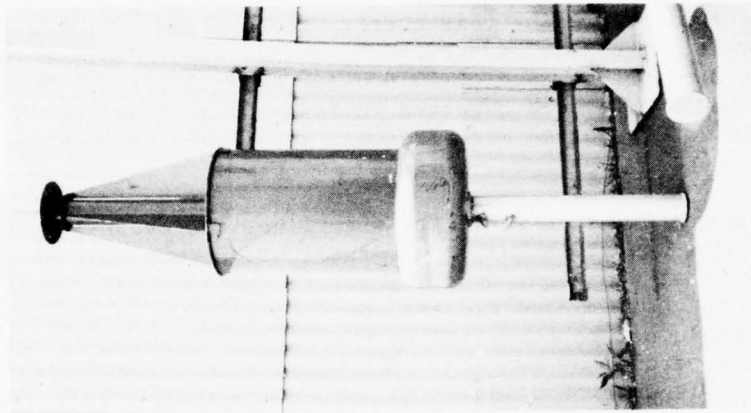
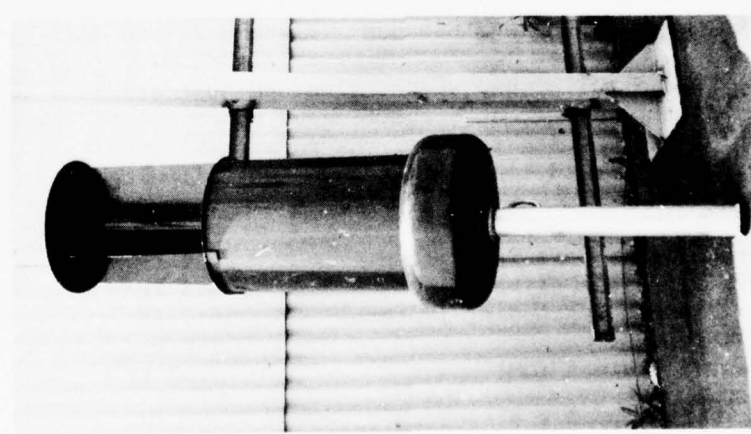
FIGURE 1A
FIRST GENERATION MODIFIED BORG-WARNER SHELTERED WATER BUOY

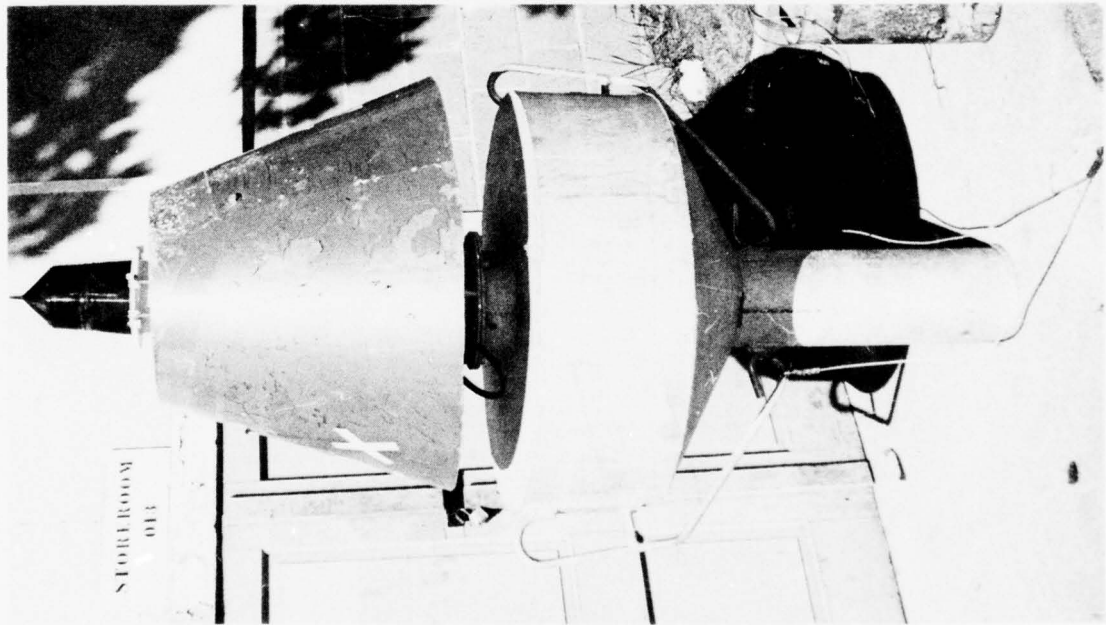
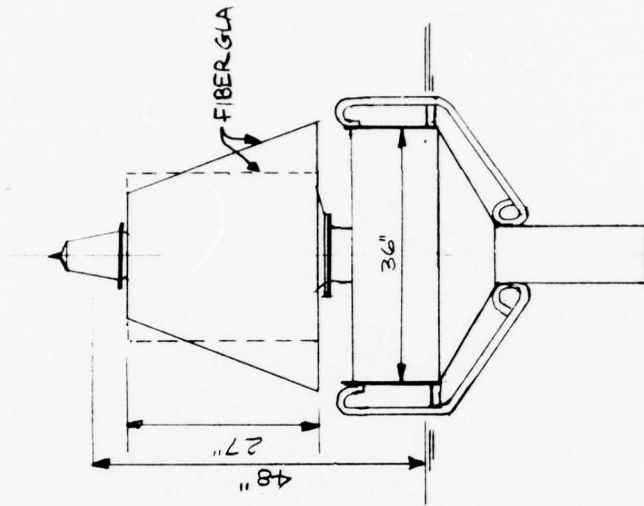
FIGURE 2A
FIRST GENERATION ALUMINUM SHELTERED
WATER DISCREPANCY BUOY (IGS, BEFORE
MODIFICATION TO THE MOORING ATTACHMENT)

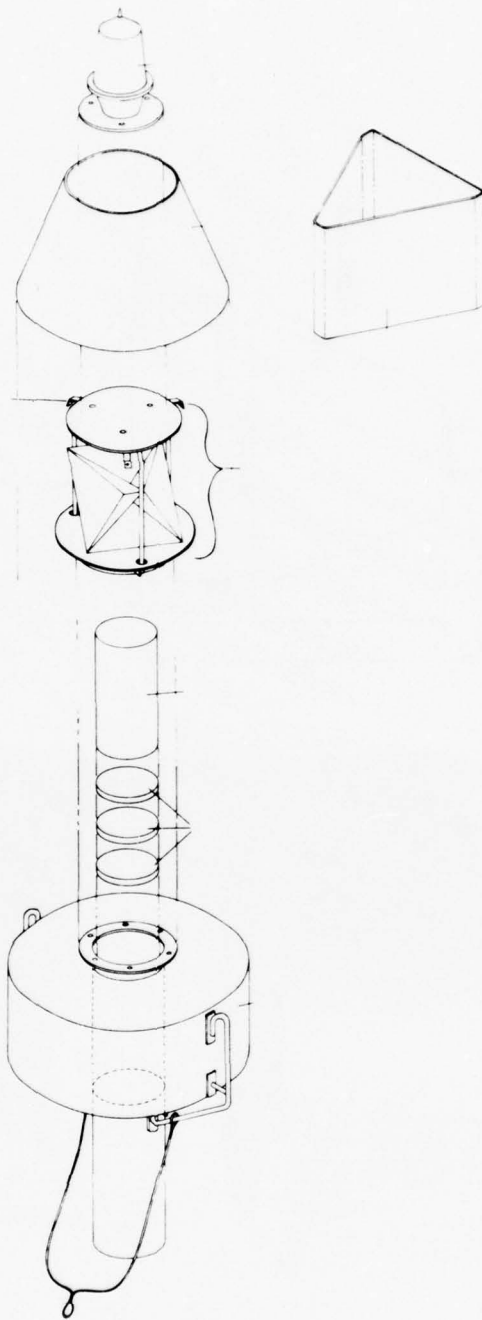
FIGURE 3A
EXPLODED VIEW OF THE 1GS BUOY
(BEFORE MODIFICATION TO THE MOORING ATTACHMENT POINT)

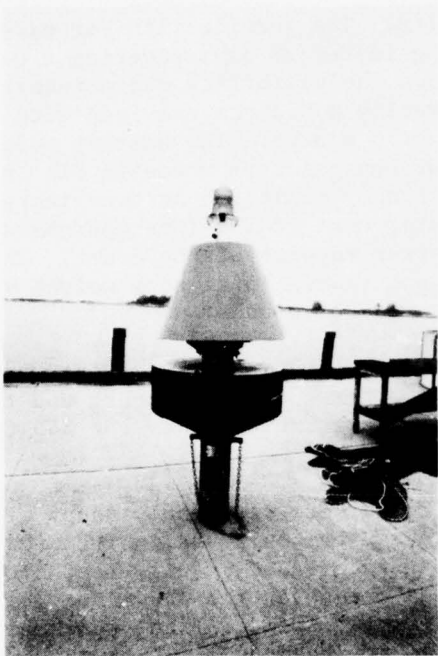
FIGURE 4A
IGS BUOY AFTER MODIFICATION TO
THE MOORING ATTACHMENT POINTS

Several problems arose during early deployments. The 1/4-inch stainless steel wire mooring bridle attachment points wore very quickly. In one case the aluminum rod attachment points were worn to 60% of their original area after only 39 days on station. Two buoys sank because of water flooding the hull. (One buoy was holed when it struck the wreck it was marking; the other had leaked through an air test fitting.) Field modifications were made to the buoys to correct these problems. The mooring bridle was changed to 1/4-inch galvanized chain, and the attachment modified such that all wear is on the last link of chain rather than on the buoy hull or fittings. Two-part polyurethane foam was expanded in the hull to provide positive buoyancy. The modified buoy is shown in Figure 4A.

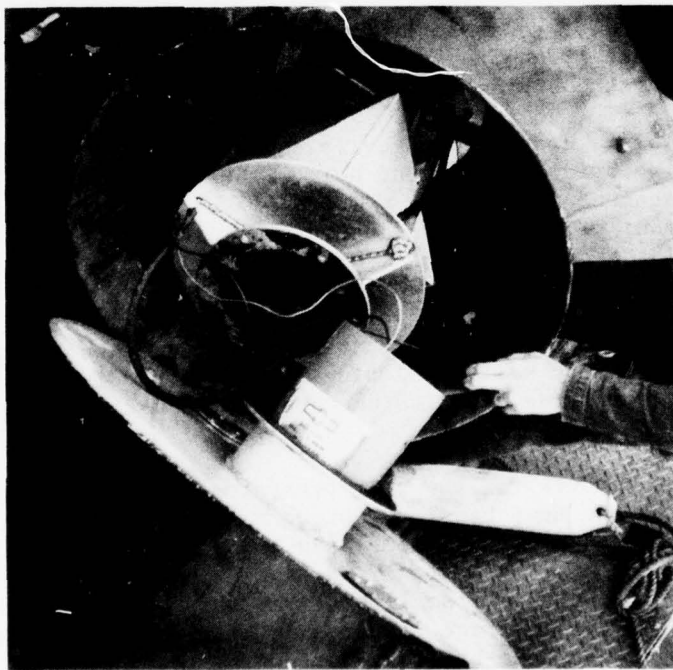
FIGURE 5A
BATTERY REPLACEMENT ON THE IGS BUOY

Servicing or recovery of the buoy presented operational problems. To replace the battery, the buoy had to be brought aboard the boat in order to remove the upper structure held in place by six bolts (Figure 5A).

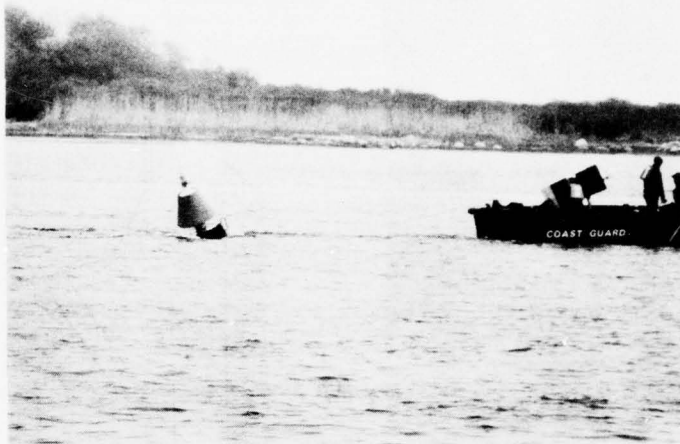
FIGURE 6A
TOWING OF THE IGS BUOY

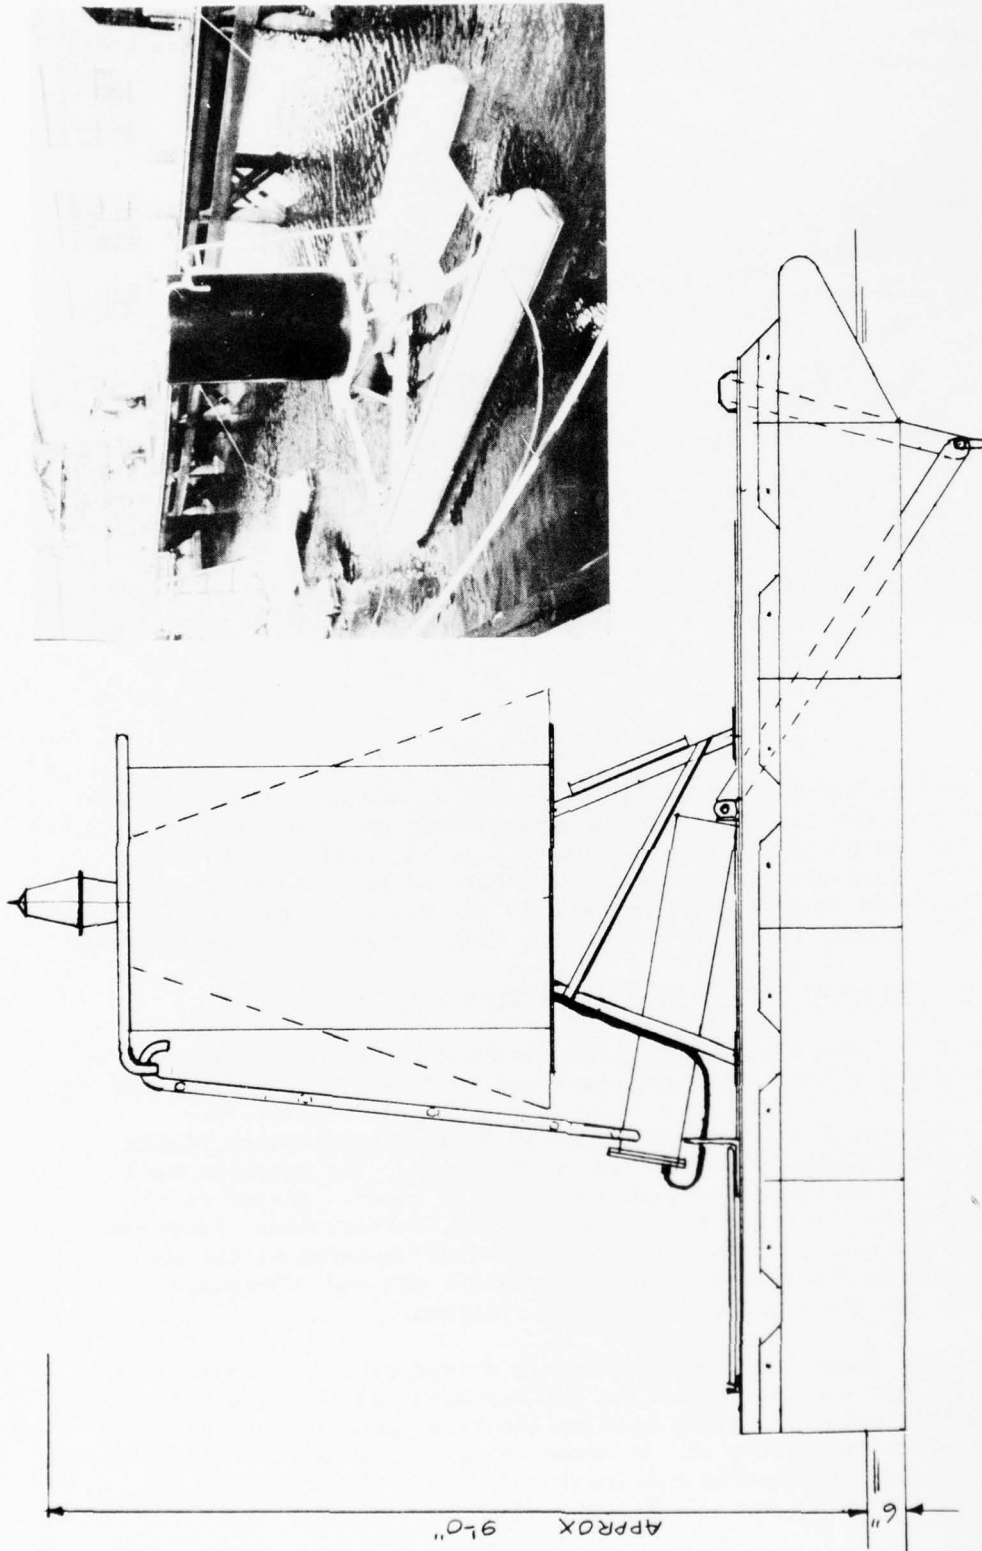
FIGURE 7A
 FIRST GENERATION EXPOSED WATER DISCREPANCY BUOY (IGE)
 BEFORE MODIFICATION TO THE MOORING ATTACHMENT

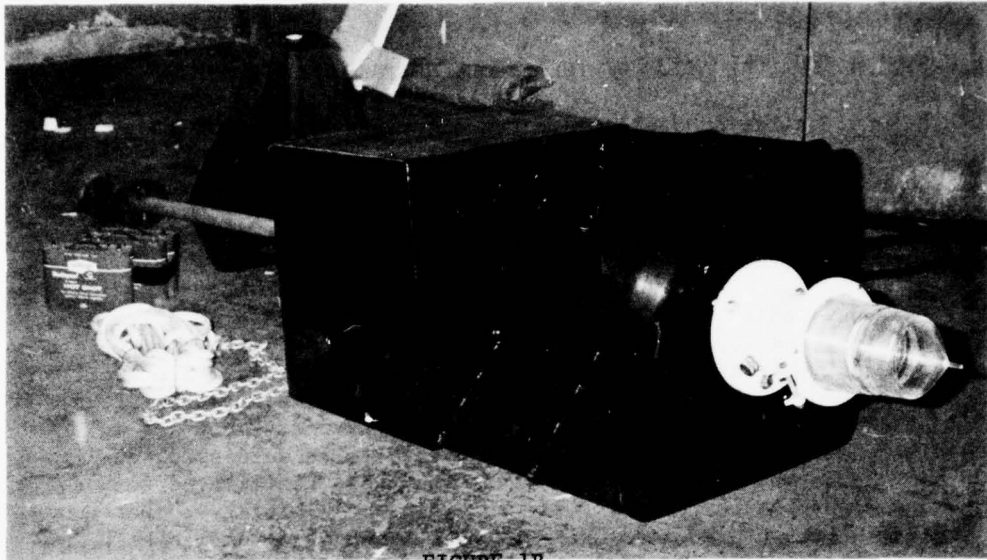
FIGURE 1B

SECOND GENERATION SHELTERED WATER DISCREPANCY BUOY (2GS) AND ASSOCIATED HARDWARE

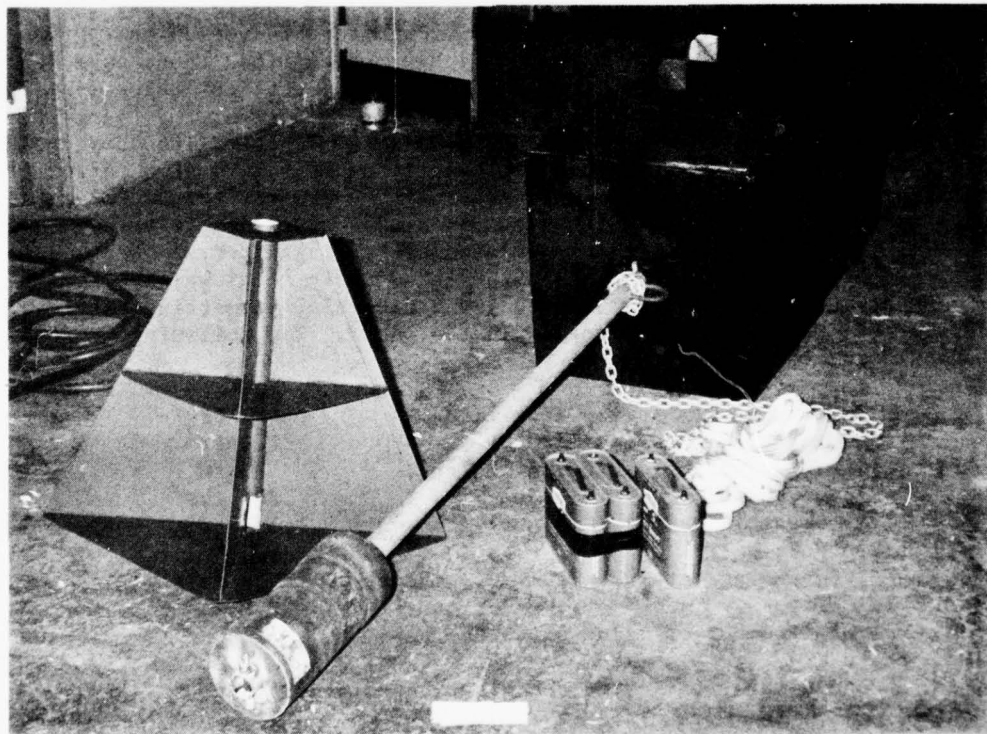
FIGURE 2B
BATTERY COMPARTMENT OF THE 2GS BUOY
