LIGHTWEIGHT LIGHTED BUOY DEVELOPMENT
FOR USE AS DISCREPANCY NAVAIDS

W. E. Colburn, Jr.
and
W. R. Thompson

December 1976

FINAL REPORT

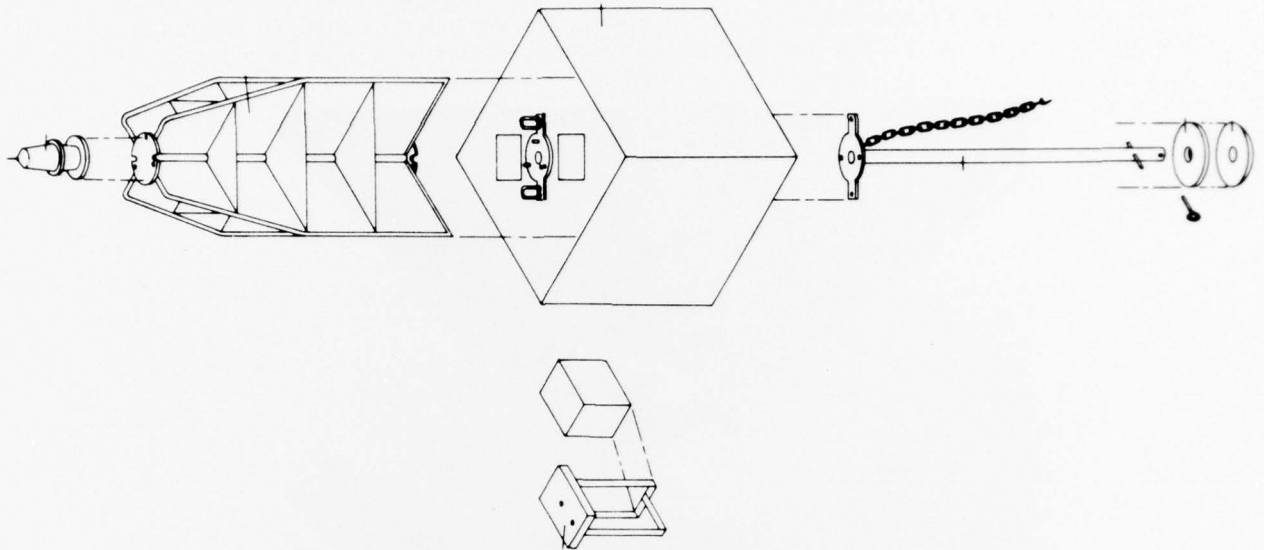
FIGURE 4B
 SECOND GENERATION EXPOSED WATER
 DISCREPANCY BUOY (2GE)

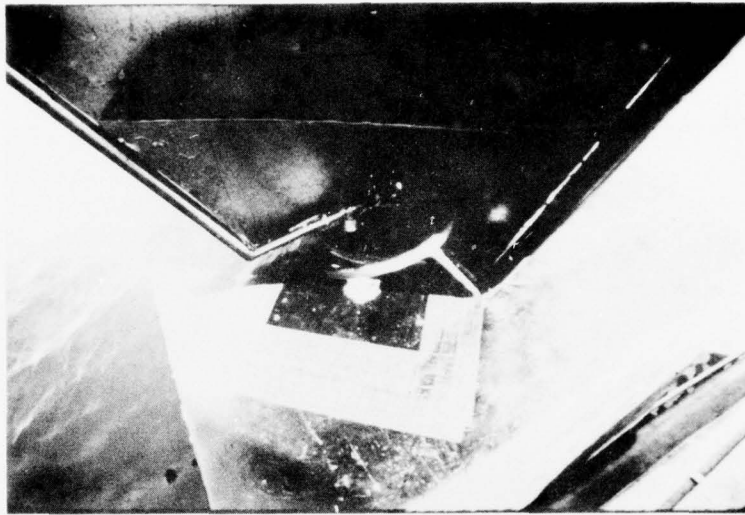
FIGURE 5B
BATTERY STORAGE LOCATION IN THE 2GE BUOY

were wired in parallel. Tests conducted at the R&D Center indicated a usable life of 102 days for this battery combination while powering a 0.55 ampere lamp and a F14(.4) characteristic at 32°F for 13 hours per day at a cutoff voltage of 10.8 volts. This selection actually resulted in a battery weight increase of 32 pounds but a cost savings of \$31 (initial) as compared to the primary batteries used in the catamaran buoy. Of more significance was the demonstrated ability to use readily available batteries. In an emergency situation, automobile batteries purchased en route to the deployment area could be utilized. Figure 5B shows one of the two battery storage locations in the buoy hull.

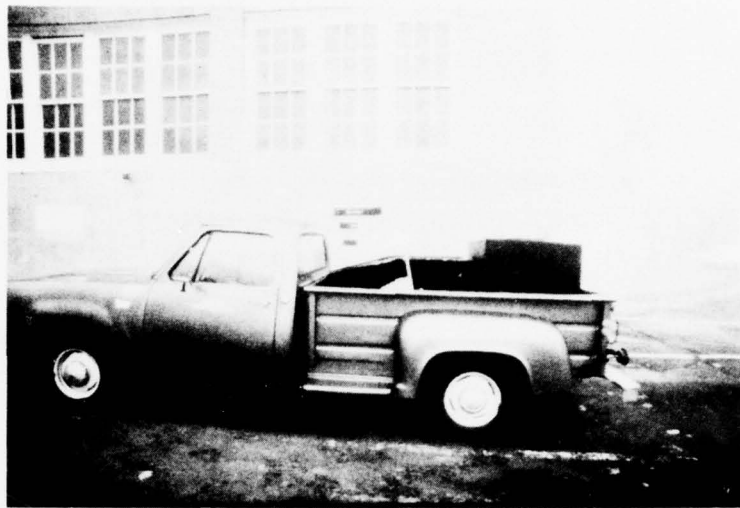
FIGURE 6B

men and that could be transported in a 3/4 ton pickup truck. Assembly by two men in less than 3/4 hour was demonstrated. Figure 6B shows the transport of this buoy by pickup truck.

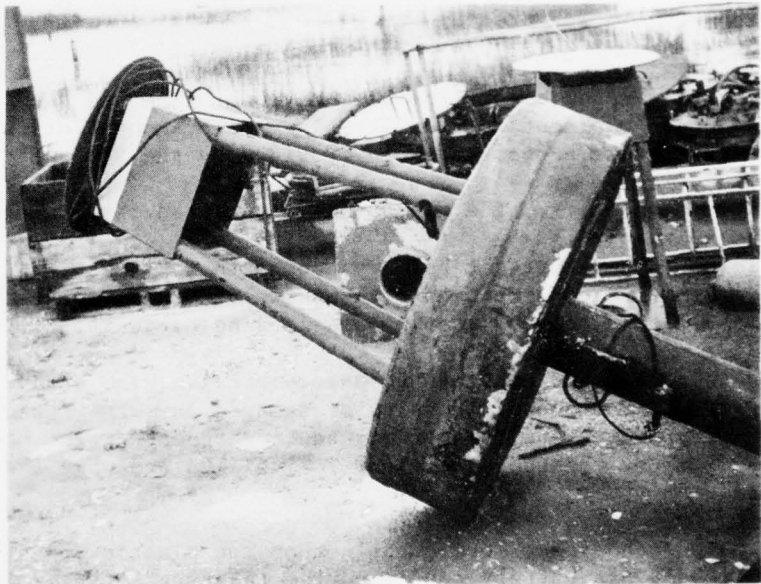
FIGURE 1C
ALERP BUOY

The Base Mayport buoy, a later generation of the Seventh District's ALERP buoy, was of all aluminum construction and had a cylindrical foam-filled body penetrated by an aluminum "I" beam to which a concrete counterweight was attached at the lower end. Figure 1C shows the older ALERP buoy and Figure 2C shows the Base Mayport buoy.

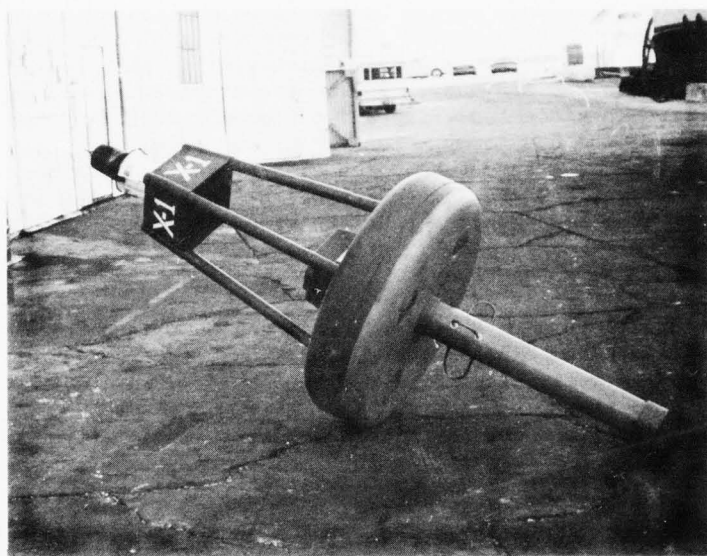
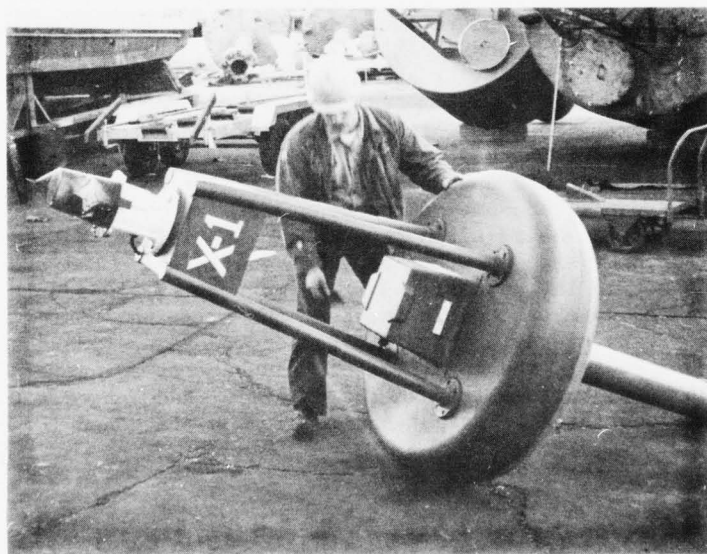
FIGURE 3C

BASE CHARLESTON BUOY (4-FOOT DIAMETER)

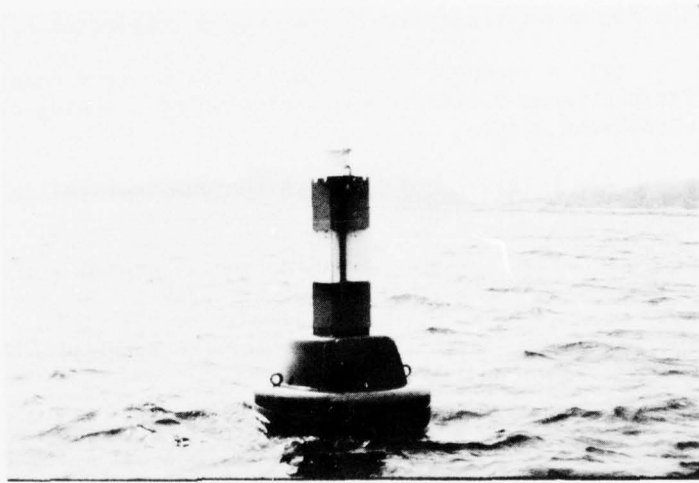
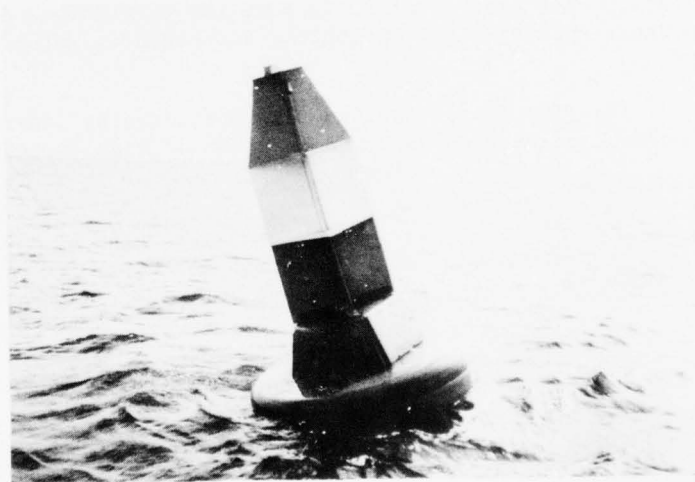
(a) THIRD GENERATION SHELTERED WATER DISCREPANCY BUOY (3GS)

(b) THIRD GENERATION EXPOSED WATER DISCREPANCY BUOY (3GE)

The basic soundness of the Base Charleston buoy hull combined with its light weight led to development of the third generation buoys (Figure 1D).
