AFIT/GNE/PH/76-3

A METHOD FOR ANALYSIS OF
ELECTROSTATIC PROBE SIGNALS
RELATING TO JET-ENGINE MICRODISTRESSES

THESIS

William E. Gifford III, B.S.

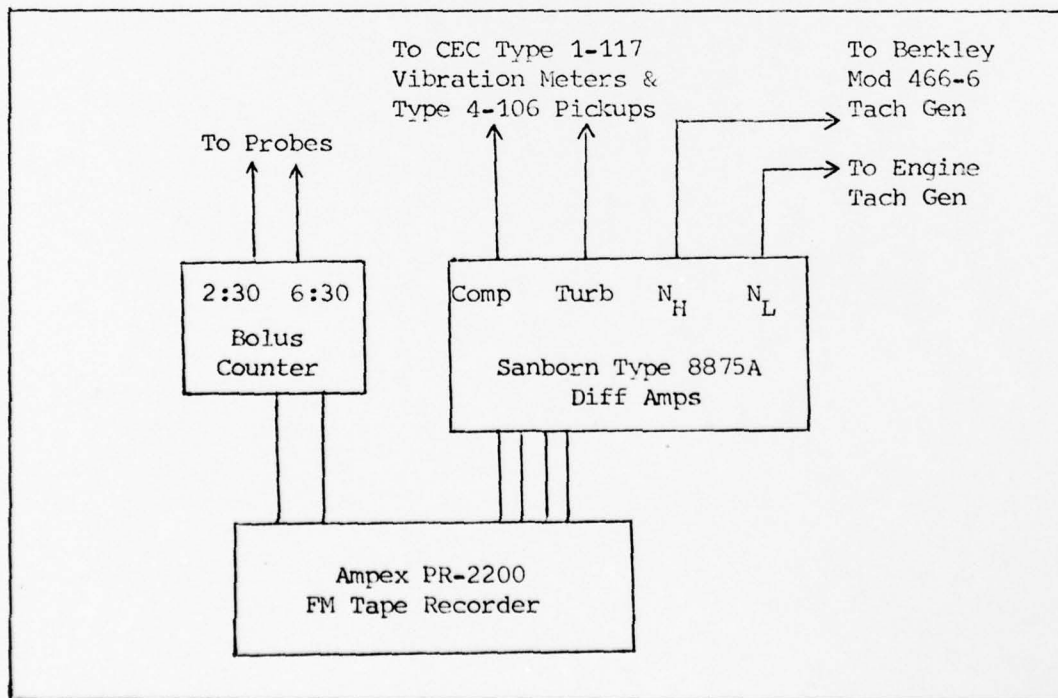
Fig. 1. Schematic of Recording Equipment Setup

The system shown in Fig. 1 was used to record data at Detroit Diesel Allison Division in Indianapolis. A TF-41 turbofan engine (S/N 908) was used as the source of the data. The TF-41 was undergoing a simulated flight endurance test.

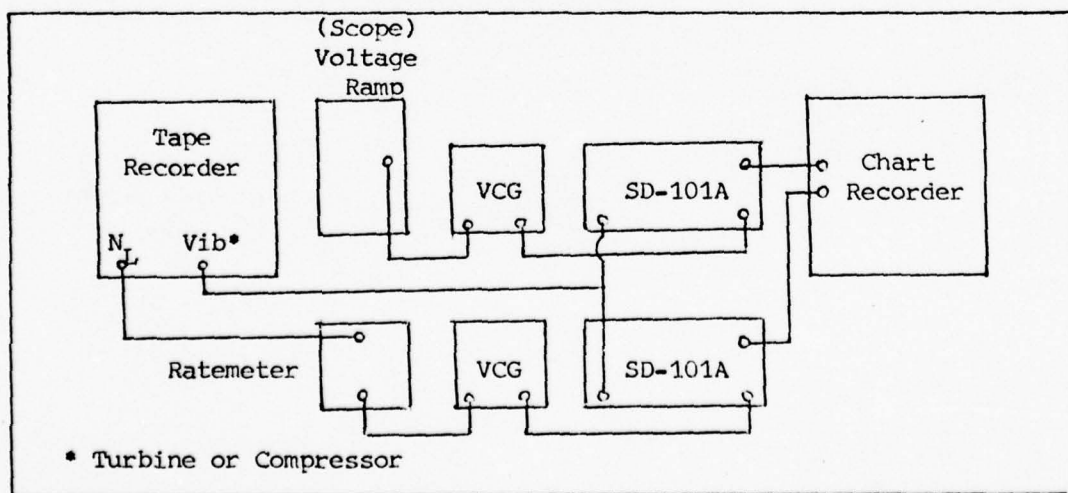
Fig. 8. Schematic of Vibration Analysis System

Engine Vibrations. Engine vibrations were studied using the system shown in Fig. 8. Only two Spectral Dynamics SD-101A frequency trackers were available. Therefore, the compressor and turbine vibrations were studied separately.

The first SD-101A was set up to examine the frequency spectrum of the vibrations. A sawtooth wave generator in the 7904 oscilloscope provided a signal which was used as a voltage ramp for the Wavetek 111 VCG voltage-to-frequency convertor. The output frequency of the VCG

served as the tuning input to the SD-101A.

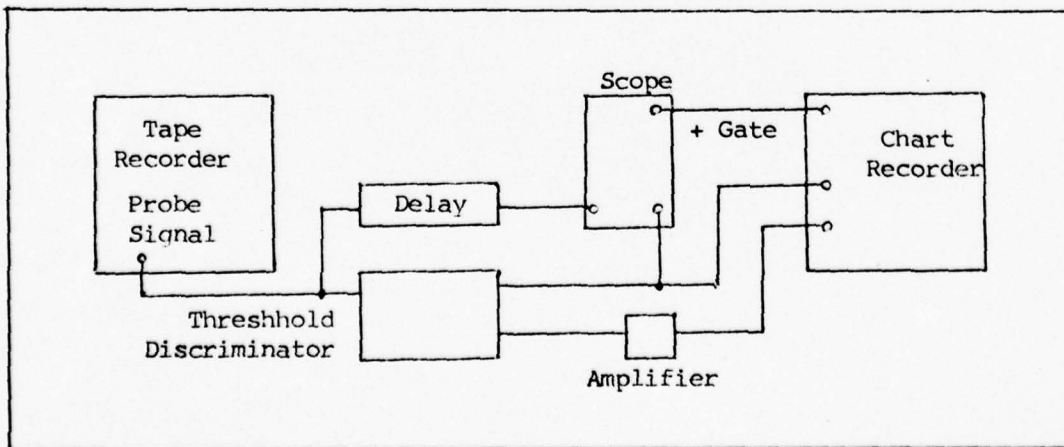
Fig. 9. Schematic of Photoanalysis System

Photoanalysis. The shape and size of the pulse waveforms was studied using the system shown in Fig. 9.

Pulse rise above a threshold is normally used to trigger the oscilloscope. The sweep, however, will only show the pulse starting from the point at which it has triggered the oscilloscope. Thus no

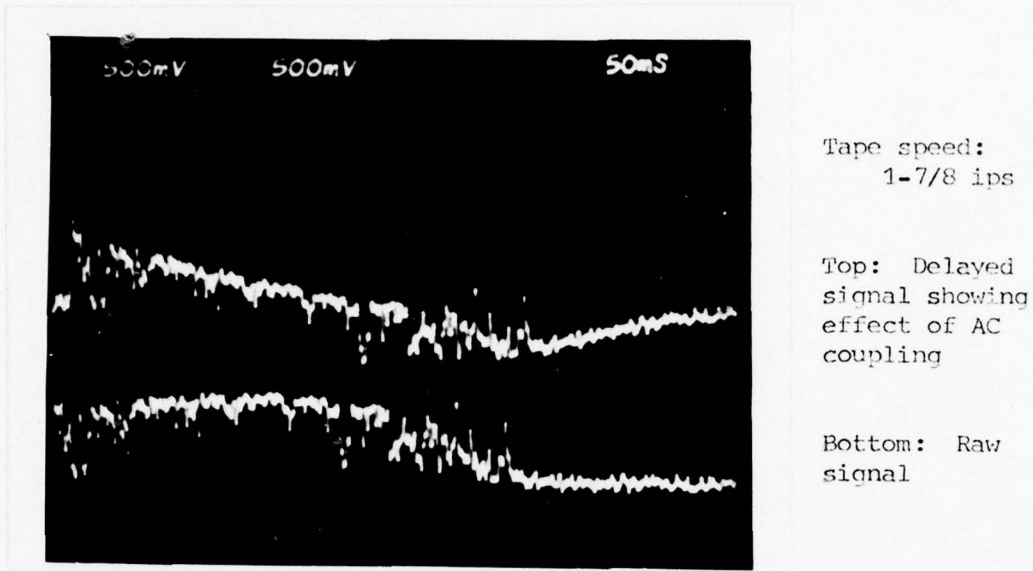
Fig. 11. Saturation Pulse Showing Effect of AC Coupling

The delay box was AC coupled for design simplification. Normally, this did not cause signal distortion. On extremely long pulses, however, the coupling effect was observed (Fig. 11).

Normally, pulses were photographed in real time. For extremely long pulses, however, the tape speed was increased to 7-1/2 ips. The pulse was squeezed together so that it could be photographed in its entirety. This also enabled the observer to see more of the current trace in front of the pulse.

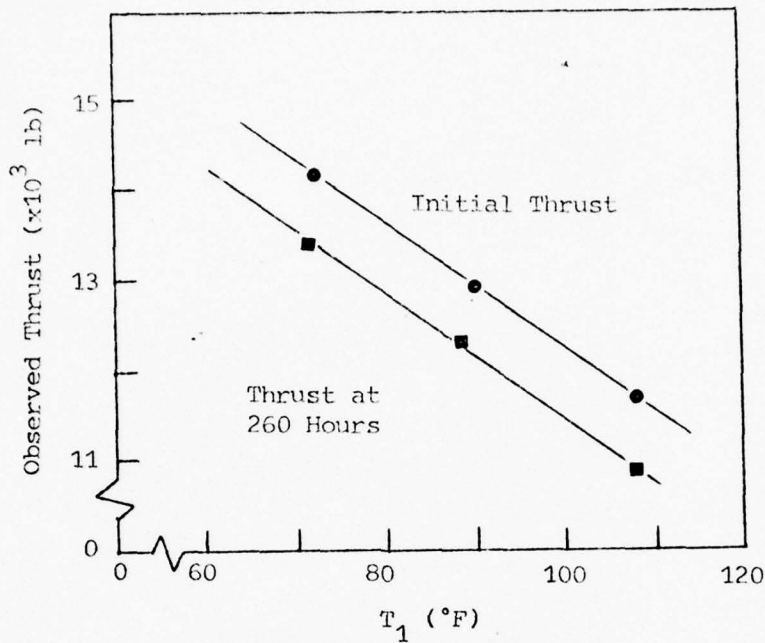
Fig. 17. Thrust vs T_1 for TF-41 S/N 908

The number of background pulses produced by the engine varied inversely with T_1 . Qualitatively, this made sense. Thrust is inversely proportional to T_1 (Fig. 17). As the temperature decreased, the engine worked harder and was more susceptible to microdistresses. During normal engine operation, then, boluses were produced at a rate that was a function of thrust. When a severe microdistress occurred, however, the boluses were produced at a rate considerably above the background rate.
