Evaluation of Basic Laser Welding Capabilities

Technical report

Contract N00014-74-C-0423

**UNITED TECHNOLOGIES
RESEARCH CENTER**

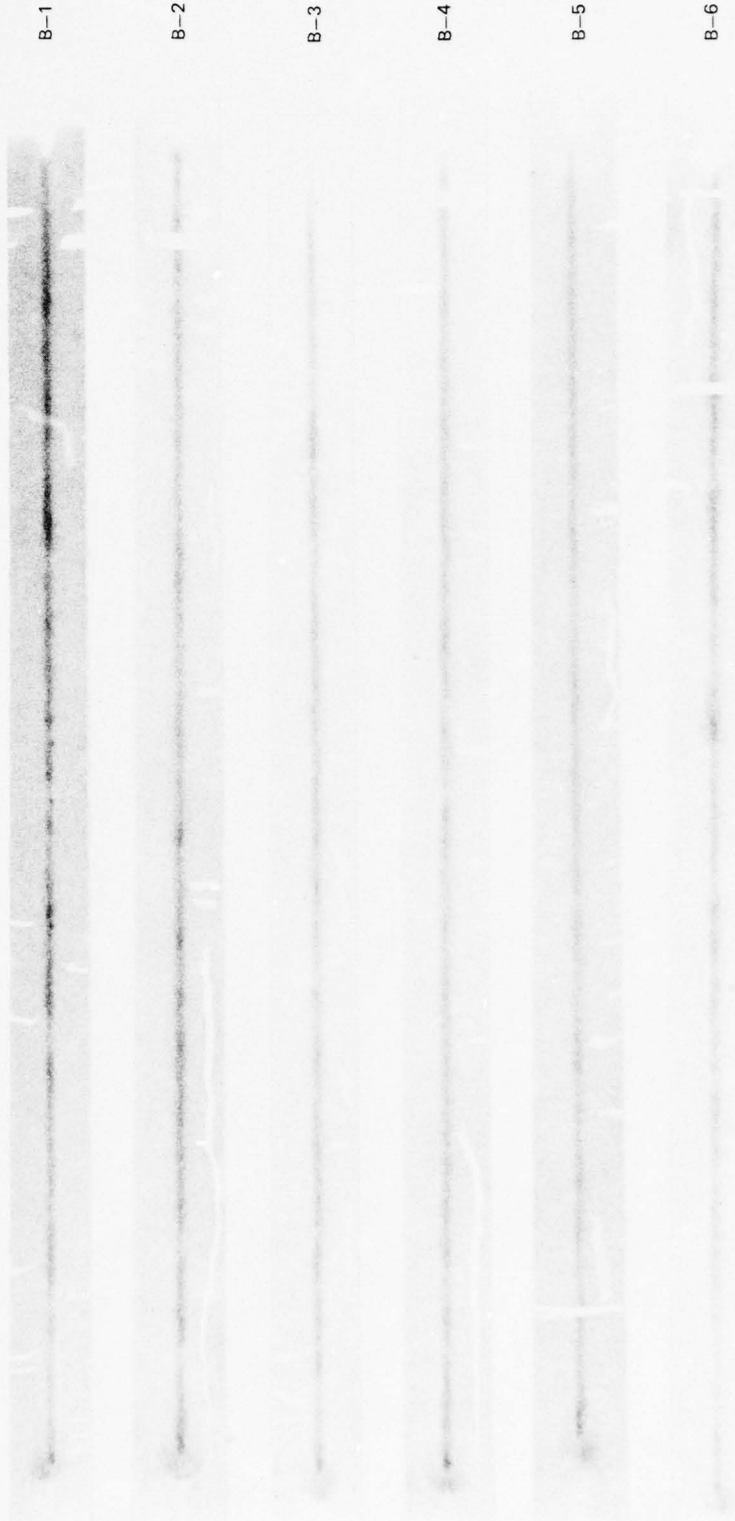
RADIOGRAPHS OF LASER WELDS IN 0.95 CM THICK HY-130 STEEL

The intermediate thickness 0.95 cm thick welds did not, on the whole, exhibit good quality. Most of these welds exhibited considerable steady porosity as evidenced by the X-rays in Fig. 5 and their interpretations in Table V. Despite this apparent difficulty in welding, other mechanical properties as measured in tensile and bend tests did not appear to be problematic. During the course of the investigation, however, no welding parameters capable of producing porosity-free, or even nearly porosity-free welds were found, and so the 0.95 cm thick welds were tested despite their known internal flaws. Surprisingly, Charpy impact strengths, as exhibited in Table VIII were almost all equivalent to or better than the base metal values. The one notable exception was specimen B-4 which registered a 17 percent decrease in impact resistance. All others were within 10 percent and several were greater with the average parent metal value being 31.7 joules, somewhat less than the weld average of 32.6 joules. Base metal values for the 0.95 cm plate were all consistent and were lower than the lower group of values in the 0.64 cm plate, indicating that the overall metallurgical quality of the 0.95 cm plate was not as high as for the thinner material. This factor, along with the greater plate thickness was felt to be responsible for the increased difficulty in welding this thickness and the fact that only porous welds were produced. If thickness were the key element, it would be expected that the 1.27 cm material would prove even more difficult to weld, however the X-rays (Fig. 6) and observations in Table IV attest to the fact that better welds were made at this thickness. The base metal impact values on all of the 1.27 cm plates were high as compared to the other thicknesses (except for the specifically high-valued 0.64 cm material), and it was ultimately confirmed by electron microprobe analysis that the 1.27 cm thick material was rare-earth earth treated. In this thicker, rare-earth treated material, a significant decrease in weld metal impact strength was observed with the base metal averaging 151.3 joules and the welds averaging 106.0 joules. This indicates that, when the base metal's metallurgical quality is sufficiently high, it is not possible to improve it enough through the localized refinement and purification which occur during laser welding (as detailed below) to compensate for the reduction in impact strength which naturally accompanies more rapid quenching in alloy steels, and which produces increased tensile and yield strengths, and higher hardness. It is, however, significant to note that the 106 joule average Charpy impact value is considerably in excess of the normally required average Charpy impact value of 74.4 joules for the -1.4°C - 21.1°C temperature range. Table VIII

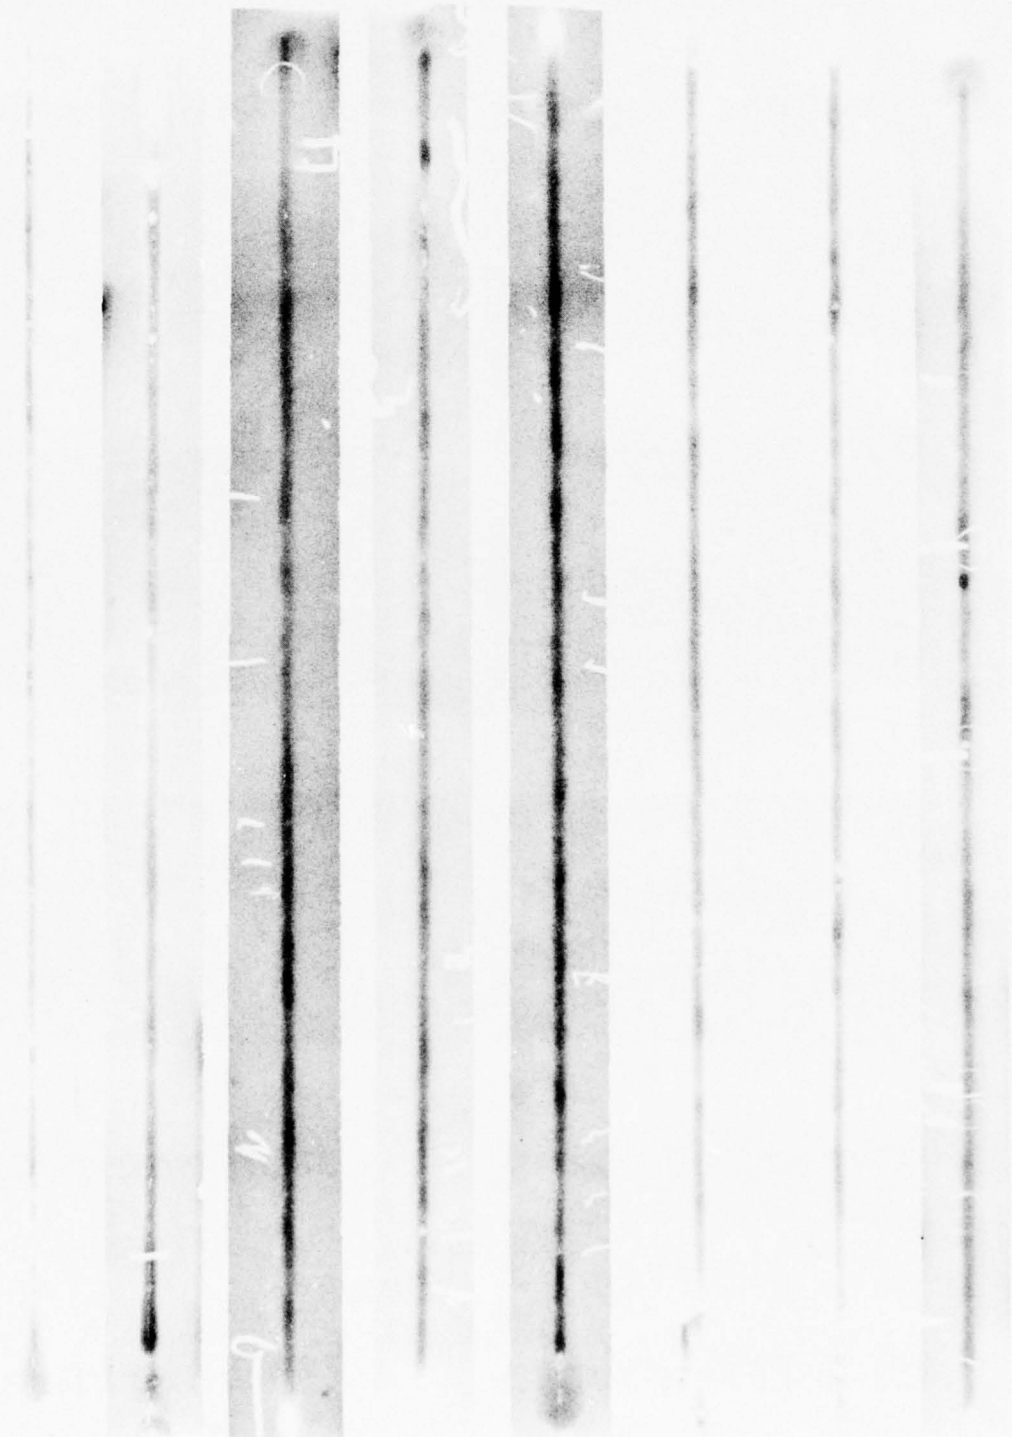
CROSS SECTIONS OF LASER WELDS IN 0.64 CM THICK HY-130 STEEL
4X MAGNIFICATION

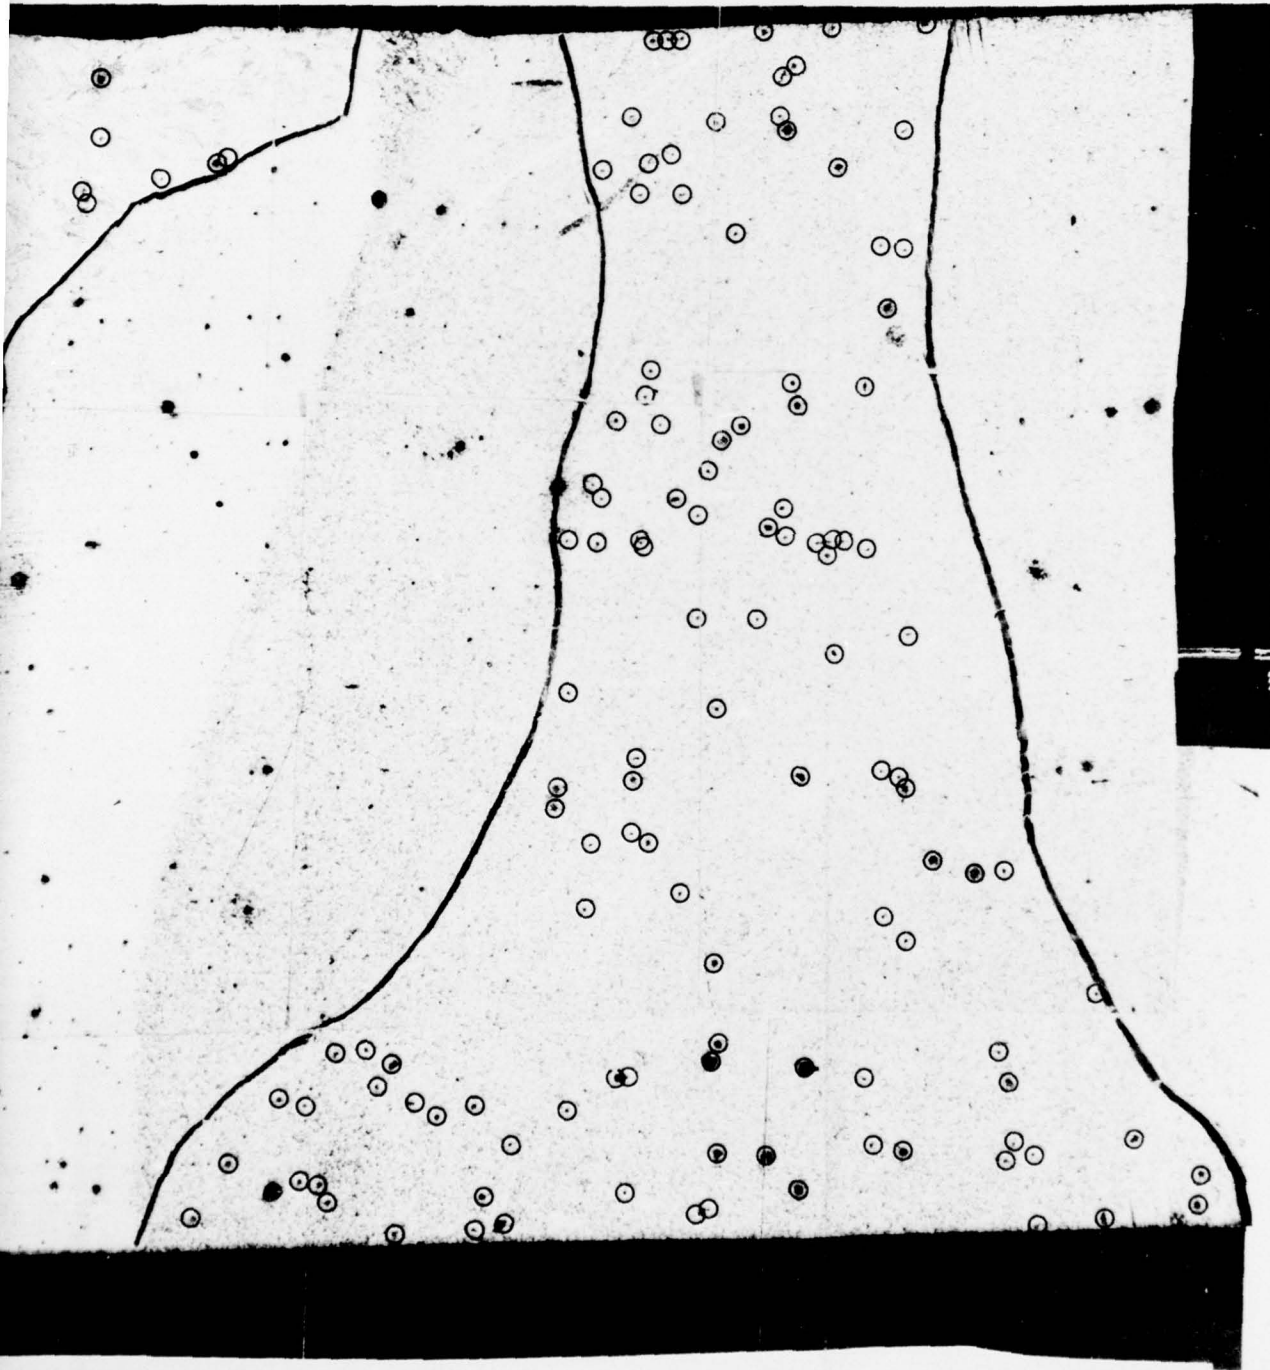
FIG. 14

DISTRIBUTION OF INCLUSIONS IN THE WELD FUSION ZONE AND EQUIVALENT ADJACENT

VALENT ADJACENT AREA OF BASE METAL IN HY-130 LASER WELD SPECIMEN A-5

IS WELD FUSION ZONE - 39 INCLUSIONS
(PHOTOGRAPHIC MAP REQUIRED ENCIRLING OF INCLUSIONS FOR CLARITY)

Inclusion count and size measurements, and electron beam microprobe analyses were performed on two samples from each of the three thickness categories of laser-welded HY-130 steel plate. All specimens were observed at 45 magnifications, and samples were selected based on the numbers of inclusions of 10 μ in diameter or above. The "best case" and the "worst case" in each thickness category were chosen for investigation with the "best case" (bc) being the weld with the fewest resolvable inclusions and the "worst case" (wc) being the weld with the greatest number of resolvable inclusions within a given thickness category. As indicated in Table X and clearly documented in Figs. 14-19, all three specimen thicknesses exhibited marked reduction in resolvable weld inclusion content (10 μ resolution limit) as compared with an immediately adjacent equal area of base metal. This was true for both "best cases" and "worst cases", as well as for all plate thicknesses. (Note: Reduction in magnification of the original photomicrographic maps which required encircling of inclusions for clarity in Figs. 14-19.) The percentage of resolvable inclusions retained in each case is also given in Table X. In the best noted example of fusion zone purification (1.27 cm or "c" plate), 82 percent of the resolvable inclusions were eliminated from the weld fusion zone during the process of deep penetration laser welding. In the worst observed example involving the "A" plate, 44 percent of the resolvable inclusions were eliminated. Investigation of the inclusion count data in Table X surprisingly indicated a trend toward greater fusion zone purification with increased specimen thickness. Although this effect was not predicted, it is most probably explained by the fact that the thicker sections require greater specific energy inputs, allowing more time for inclusions

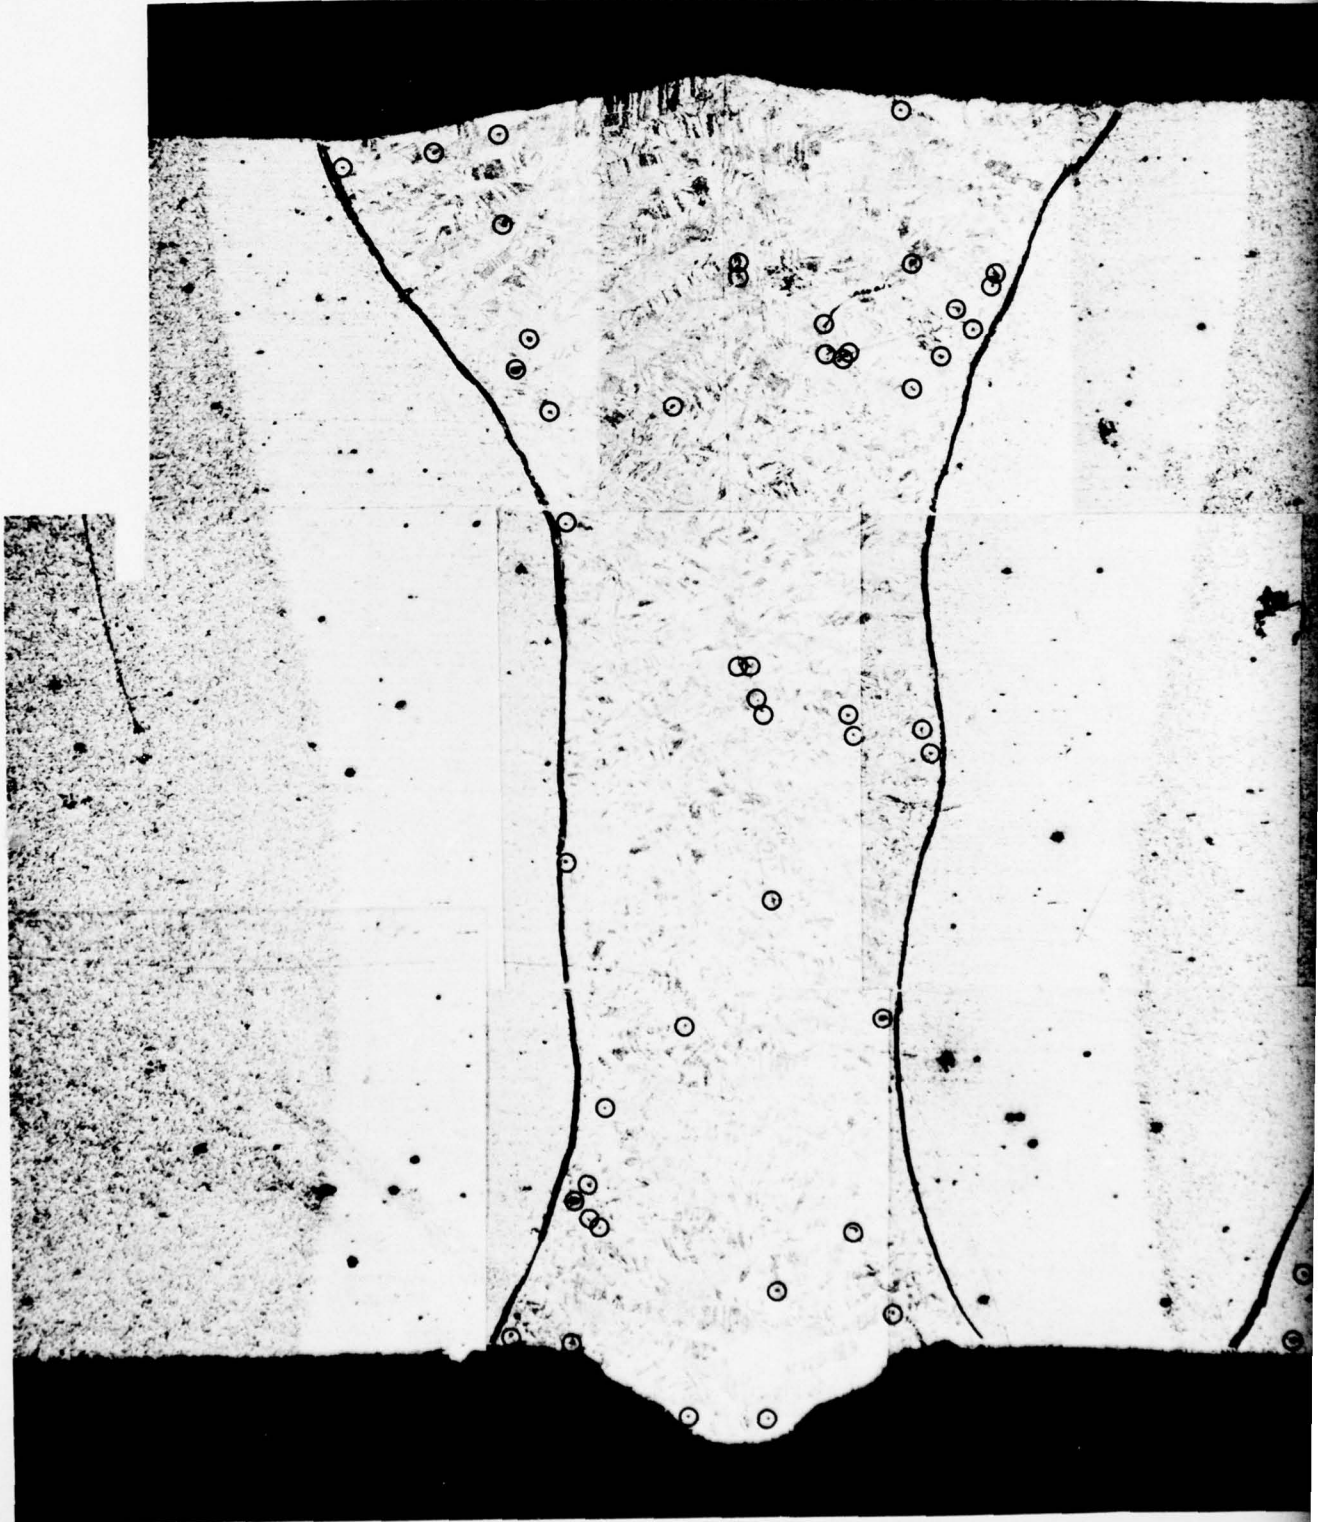
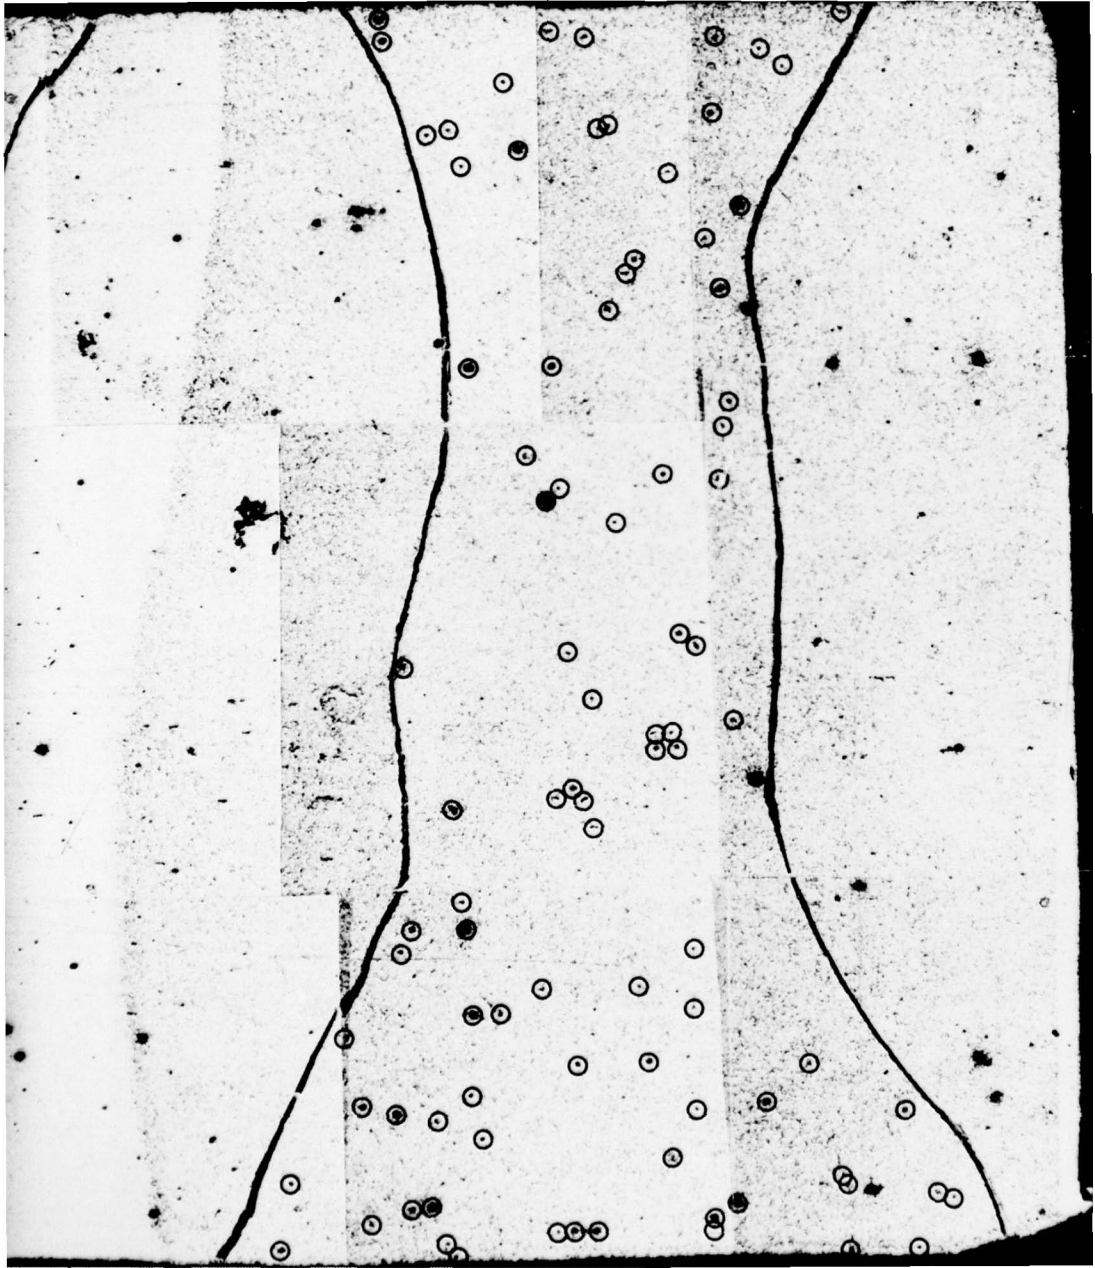
WELD FUSION ZONE

DISTRIBUTION OF INCLUSIONS IN THE WELD FUSION ZONE AND EQUIVALENT ADJACENT AREA

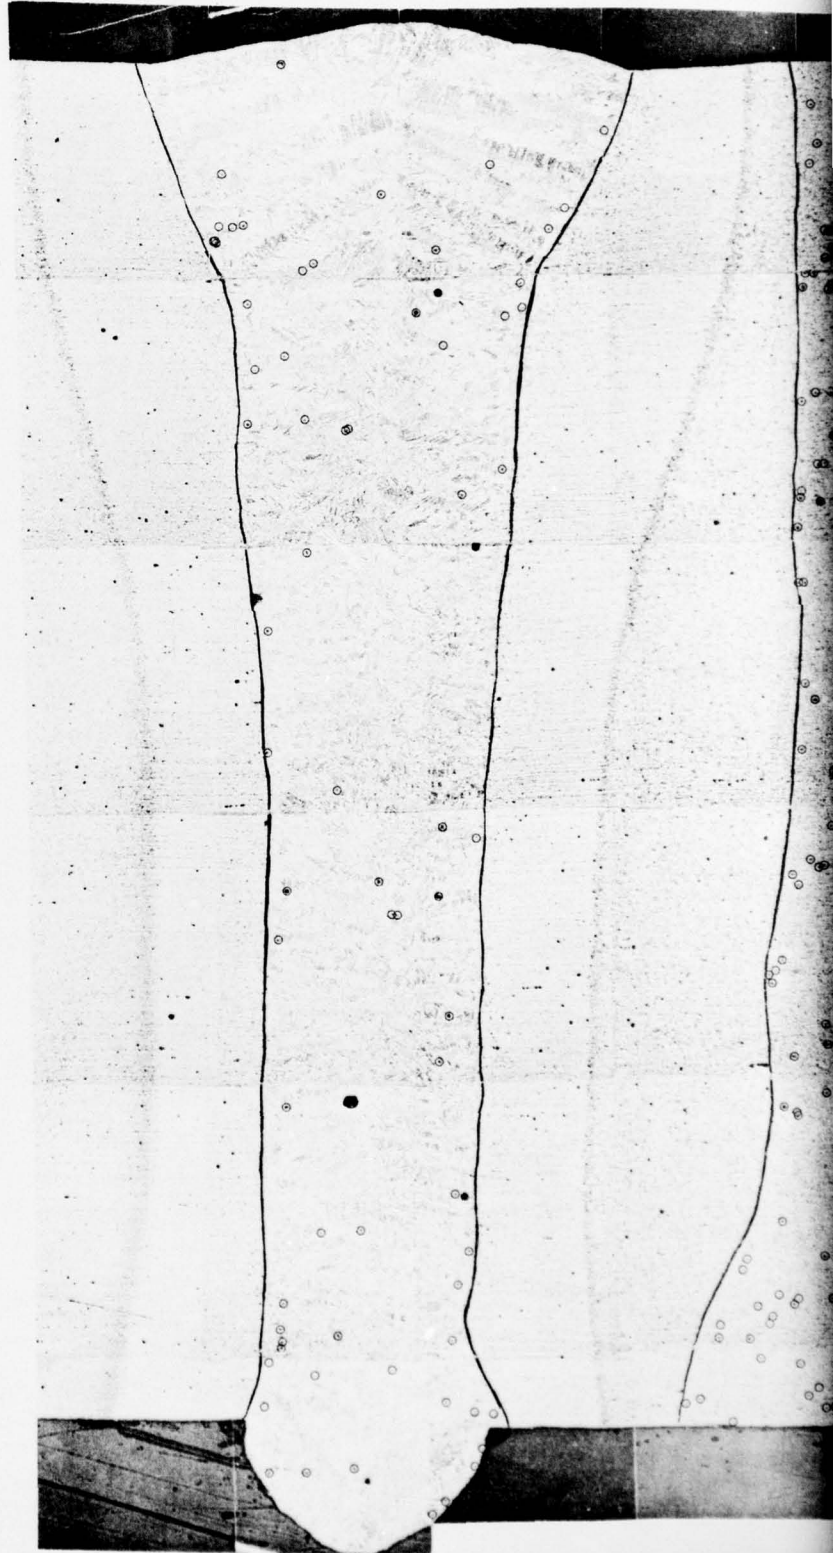
FIG. 18

ADJACENT AREA OF BASE METAL IN HY-130 LASER WELD SPECIMEN C-1

WELD FUSION ZONE - 74 INCLUSIONS

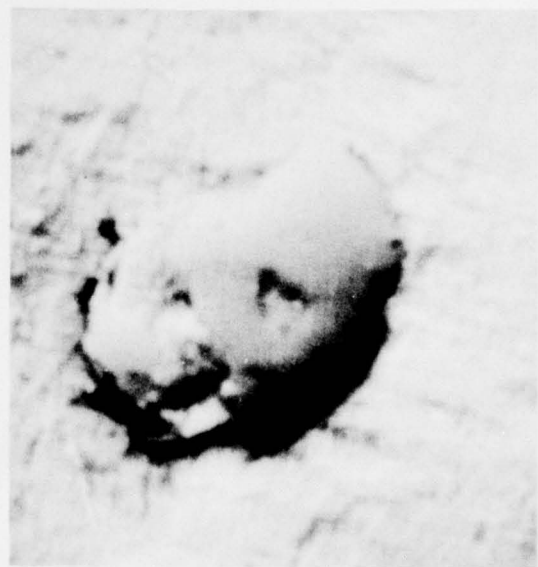
ELEMENTAL MICROPROBE ANALYSIS OF REPRESENTATIVE INCLUSION COMMON TO WELD AND BASE METAL OF 0.64 AND 0.95cm THICK HY-130 PLATE

Results of electron beam microprobe analysis of inclusion compositions are given in Table XII. X-ray patterns for representative inclusions of the two characteristic types found are shown in Figs. 20 and 21. The microprobe analysis revealed the presence of two distinct types of inclusions. The inclusions found in the samples of 0.64 and 0.95 cm plate were all aluminum oxides with small amounts of adhering free calcium (Fig. 20). All of the inclusions found in the 1.27 cm thick plate were lanthanum/cerium oxides (Fig. 21), indicating that this thicker plate was rare-earth treated. No rare-earth oxide inclusions were found in the A and B plates, and no aluminum oxides were found in the C plates. (Although impact testing subsequently revealed that some of the 0.64 cm thick plate had high impact resistance and was probably rare-earth treated, it happened that the two 0.64 cm specimens selected for microprobe analysis using the "best and worst case" criterion were both lower impact resistance specimens and so contained only inclusions of the Al₂O₃ + Ca type. The presence of rare earths in the other specimens is presently being verified.) Although numerous inclusions were sampled in each of the six selected specimens, no other types of inclusions were found in either the welds or the base metal.
