# NAVAL POSTGRADUATE SCHOOL

## THESIS

A SCANNING ELECTRON MICROSCOPE STUDY  
OF THE CORROSION OF SACRIFICIAL HULL  
ANODES UNDER SIMULATED SHIP SERVICE CONDITIONS

December 1976

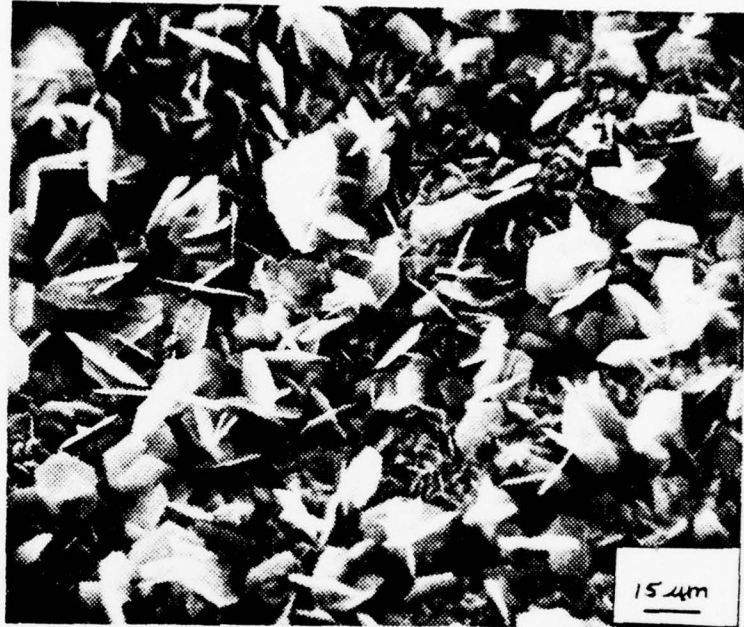
Figure 10

Zinc anode surface appearance after  
2 hour static exposure, 540X (2H23)

In order to establish a reproducible corrosion product condition prior to dynamic exposures, three specimens were subjected to identical static environmental conditions. This procedure established that the corrosion product morphology of statically exposed sets of specimens was nearly identical, as evidenced by Figures 9 and 10 which show two different specimens after 2 hours exposure each. For periods of static exposures over 12 hours, somewhat greater variations existed in corrosion product morphology. However, these variations were minor in degree and were easily characterized and compared, so that the static exposure data base remained reliable. These variations may have been due to slight differences in static exposure electrolyte pH or conductivity or slight differences in specimen surface preparation.

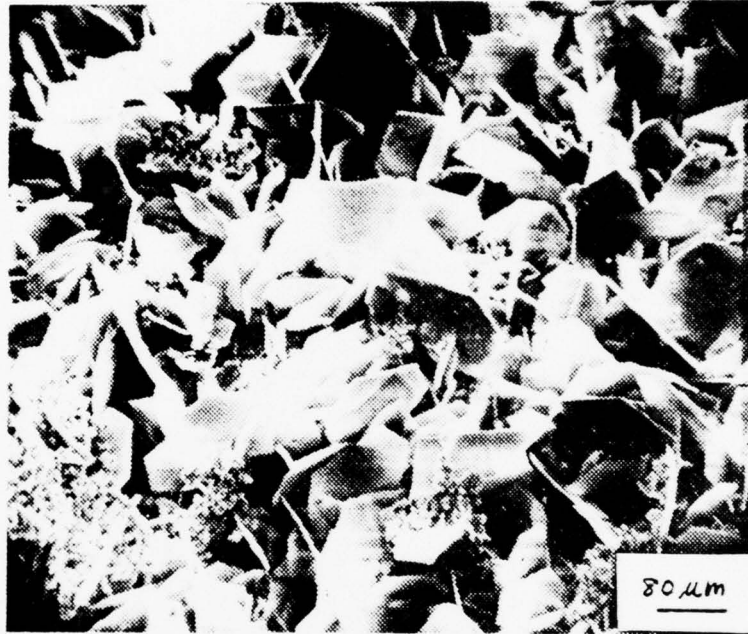
Zinc anode surface after 3 days static exposure showing surface of zinc where intermediate corrosion product layer washed away, 225X (3DZ1)

Micrographs of a 3 day static exposure sample in which corrosion products rinsed off under a gentle stream of distilled water are shown in Figures 15, 16, 17, 18 and 19. Two distinct layers and morphologies were evident here. Figure 15 exhibits a thick intermediate corrosion product layer still adherent to the zinc anode surface. Figure 16 is a close-up view of the junction of the outer layer and the intermediate layer and also exhibits a portion of the zinc anode surface. It can be seen here that the intermediate layer has a dense mossy corrosion product makeup and appears to be on the order of 50  $\mu\text{m}$  thick. Also in evidence is the appearance that an outer layer of large platelets embedded in a compact layer of smaller platelets are the only platelet layers present. Figure 17 is a view of a 3 day exposure specimen showing platelet layers typical of those that have just been described. Figure 18 shows  $\text{ZnO}$  platelets embedded in the mossy intermediate product layer. These platelets were most probably left behind as the outer platelet layers rinsed away. Figure 19 is a micrograph of the zinc anode surface exhibiting crystallographic faceting along the hexagonal close packed basal planes. This type of faceting is typical of all zinc anode metal dissolution seen to date. Also evident in this micrograph are ribbon-like corrosion products, first discovered by Luebke [22], who hypothesized that these ribbon-like products usually surround initial dissolution sites on the zinc surface and are eventually grown over as corrosion product growth increases. Figure 18 substantiates the theory that the ribbon-like products remain as corrosion product film growth increases.

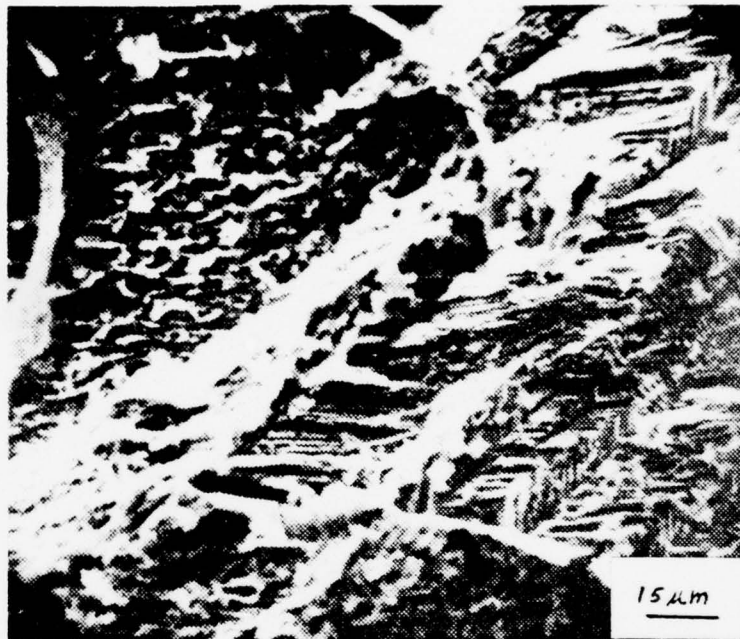
Figure 23

Zinc anode surface after 8 days static exposure  
and rinsing away of corrosion product, 720X  
(8DZ3)

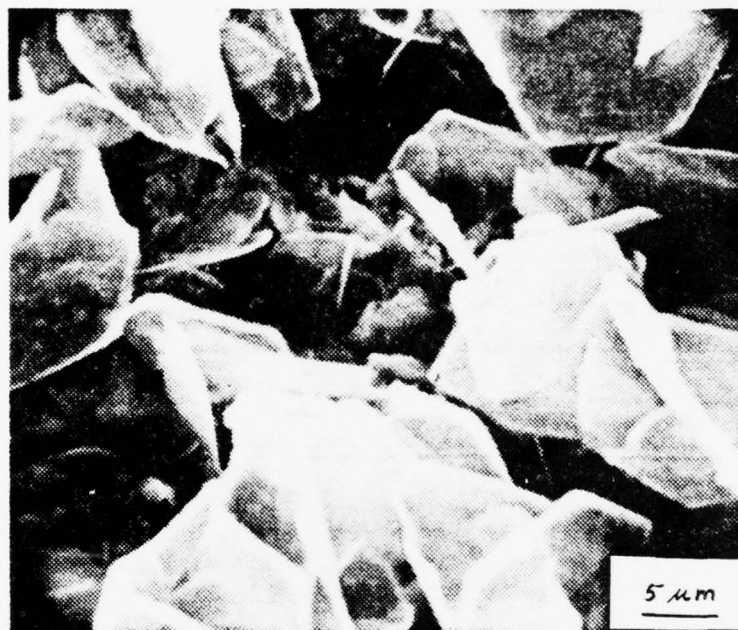
Figure 29

Zinc anode specimen 2HZ1 after 30 min  
dynamic exposure at 100 rpm and 5 mA/in<sup>2</sup>,  
showing reforming and redeposition, 2200X

Figure 25 is a micrograph of a 1 hour static exposure specimen showing typical ZnO platelet formation, and Figure 26 is a micrograph of that same specimen after 30 minute dynamic exposure at 100 rpm and the experimentally determined galvanic current density of  $5 \text{ mA/in}^2$  ( $0.775 \text{ mA/cm}^2$ ). [Unless otherwise noted, all future dynamic exposures shall be at the  $5 \text{ mA/in}^2$  ( $0.775 \text{ mA/cm}^2$ ) current density.] A marked change was noted in the platelet appearance. There seemed to be a reforming and ion redeposition action taking place. As stated previously, 100 rpm of disk velocity corresponded to the transition from laminar to turbulent flow. Figure 27 exhibits the appearance of a 2 hour static exposure specimen. Figures 28 and 29 are views of a 2 hour static exposure specimen that had been subjected to a dynamic exposure of 100 rpm for 30 minutes. Reforming and redeposition were again evident and appeared to be more marked. Figure 30 is a micrograph of another 2 hour static exposure that had been subjected to a 150 rpm dynamic exposure for 30 minutes. The effects of reforming and redeposition were even more marked at this higher velocity.

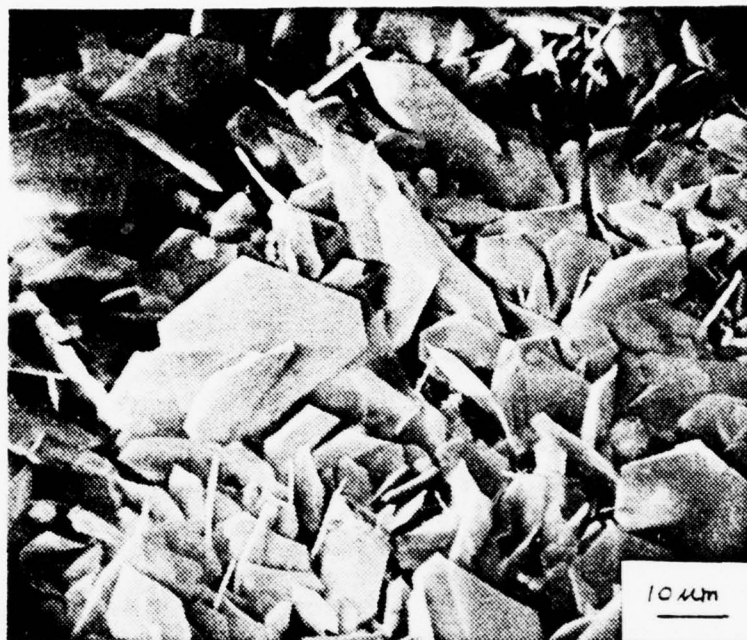
Zinc anode specimen 6HZ2 after 30 min  
dynamic exposure at 150 rpm and 0 mA/in<sup>2</sup>,  
showing lack of reforming and redeposition,  
1050X

In an attempt to further characterize the phenomena observed here, specimens with 6 hour static exposures were subjected to dynamic exposures with no impressed galvanic current density. Figure 34 exhibits a specimen that was subjected to a dynamic exposure of 30 minutes at 150 rpm with no impressed current. No evidence of redeposition was seen. This corroborates the hypothesis that a certain concentration of zinc ions is necessary for the redeposition process. The absence of evidence of erosion indicates that possibly no mechanical action of erosion was taking place. Therefore, it is hypothesized that the reforming and redeposition process is a function only of electrochemical effects of the flow conditions.

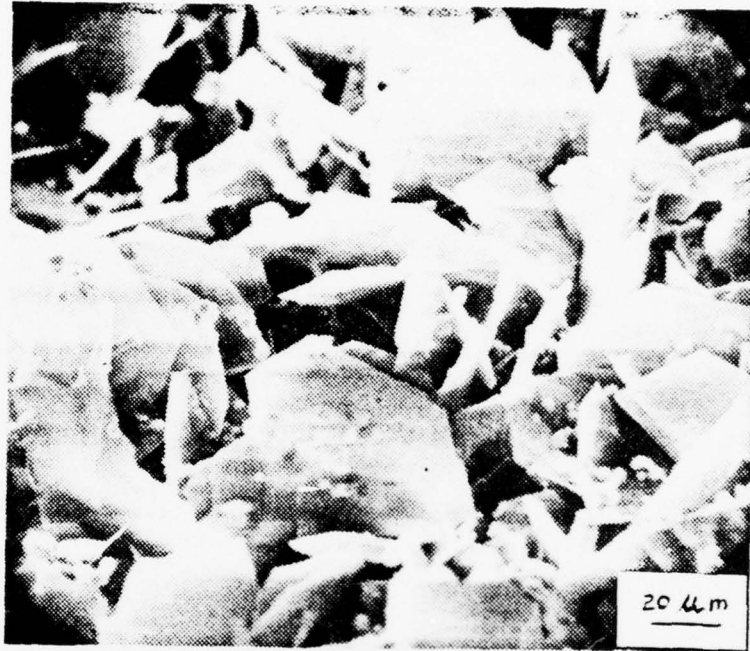
Figure 36

Zinc anode specimen 12HZ1 after 1 hour  
dynamic exposure at 150 rpm, 5 mA/in<sup>2</sup>,  
showing lack of reforming and redeposition,  
500X

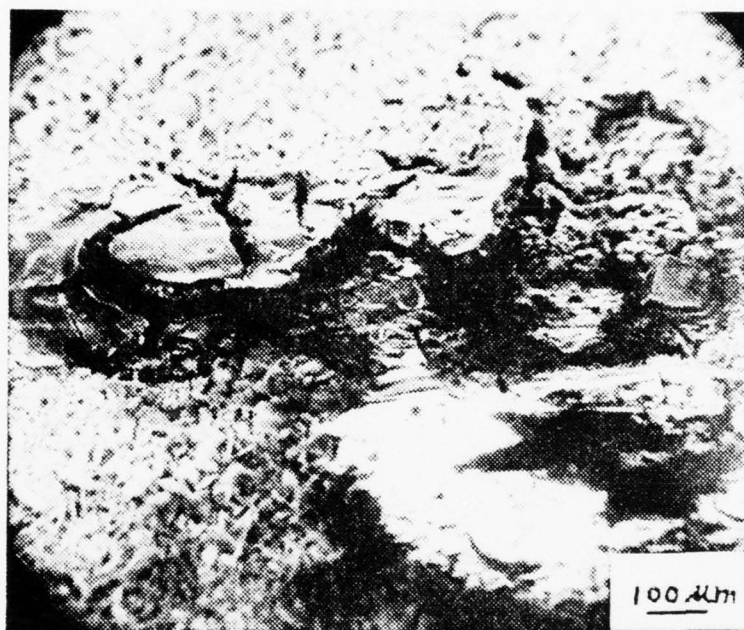
Figure 39

Zinc anode specimen 12H22 after 2 hour dynamic exposure at 150 rpm, 5 mA/in<sup>2</sup>, showing crust-like product and partial platelet layer removal, 85X

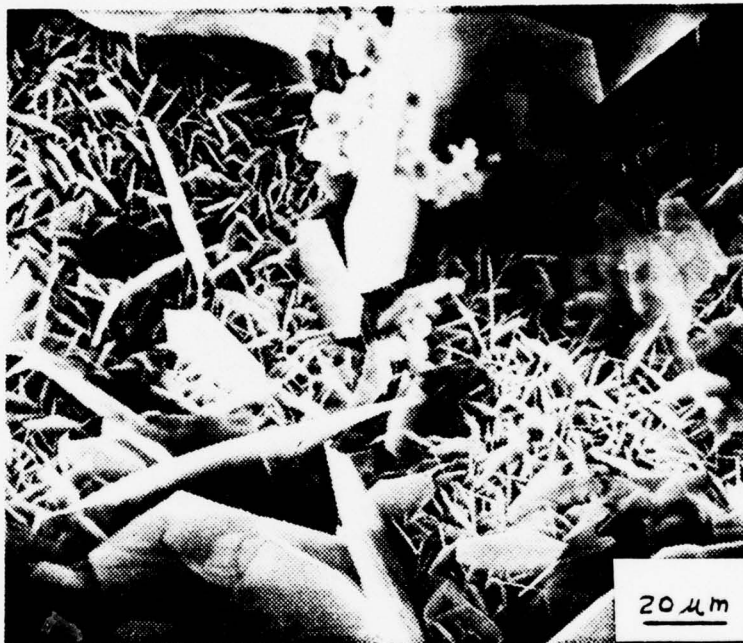
Figure 43

Zinc anode specimen after 36 hour  
static exposure, 610X (36HZ3)

Further investigation using specimens exposed statically for 36 hours reveals a similar result. Figure 42 is a micrograph of a 36 hour static exposure specimen that shows a layer of large individual and clustered ZnO platelets forming over a compact layer of smaller platelets. A closeup of this platelet network (Figure 43) reveals the denseness of the underlying fine platelet network. Also in evidence is a formation of darker platelets which seem to be oriented more parallel with the underlying zinc surface. Figure 44 is another micrograph of this same platelet growth. It is believed that the more conductive nature of these darker platelets is due to their orientation with regard to the electron beam within the SEM. Platelets more perpendicular to the SEM electron beam are better able to conduct or pass the electrons due to the platelet thinness, while platelets more parallel to the beam present a thicker path for electron transport and are thus less conductive. Less conductive platelets eject secondary electrons more readily to form a brighter image.

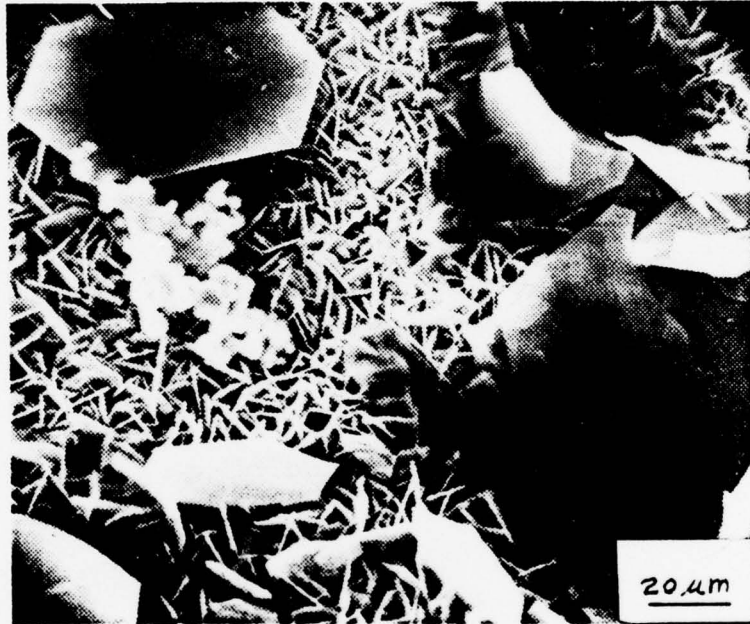
Figure 44

Zinc anode specimen after 36 hour  
static exposure, 610X (36H22)

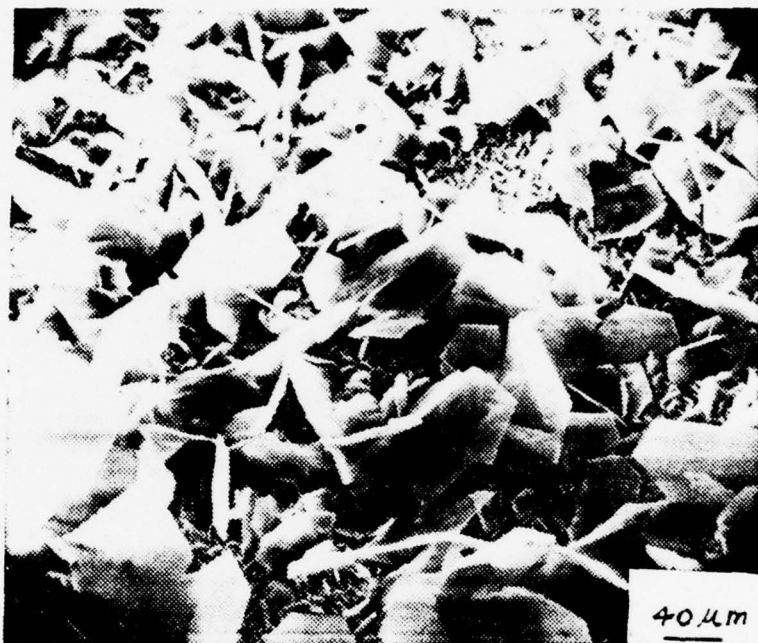
Figure 49

Zinc anode specimen 2DZ1 after 3 hour  
dynamic exposure at 100 rpm, 5 mA/in<sup>2</sup>,  
showing lack of reforming and redeposition,  
220X

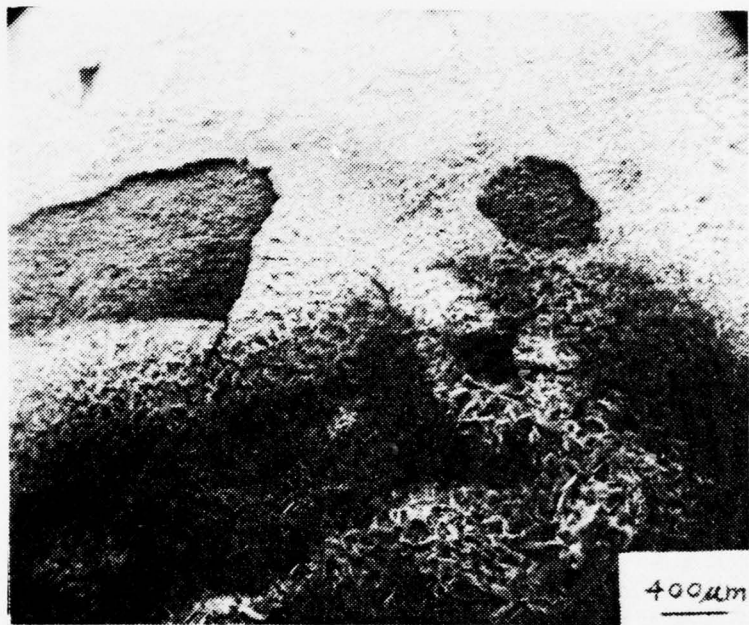
Zinc anode specimen 2DZ1 after 3 hour  
dynamic exposure at 100 rpm, 5 mA/in<sup>2</sup>,  
showing areas of platelet removal, 24X

Figure 53 is a micrograph of a 2 day static exposure specimen that has undergone the same dynamic exposure as the Figure 50 specimen, but at triple the current density ( $15 \text{ mA/in}^2$  or  $2.325 \text{ mA/cm}^2$ ). Again, spalled corrosion product areas are in evidence. However, almost the entire platelet layer had spalled off (Figure 54) revealing the nodular corrosion product found earlier. The growth rate of the  $15 \text{ mA/in}^2$  ( $2.325 \text{ mA/cm}^2$ ) nodular corrosion product was greater than that observed for the  $5 \text{ mA/in}^2$  ( $0.775 \text{ mA/cm}^2$ ), as would be expected. This increased growth rate is thought to be the cause of the increased spalling. As the intermediate corrosion product layer grew faster, the adherence of the platelet layers became even less, and greater spalling occurred. Figure 55 is a PGT-1000 X-ray spectrum for the nodular cluster corrosion product of Figure 54 and again shows a large magnesium peak in addition to the characteristic zinc peaks.

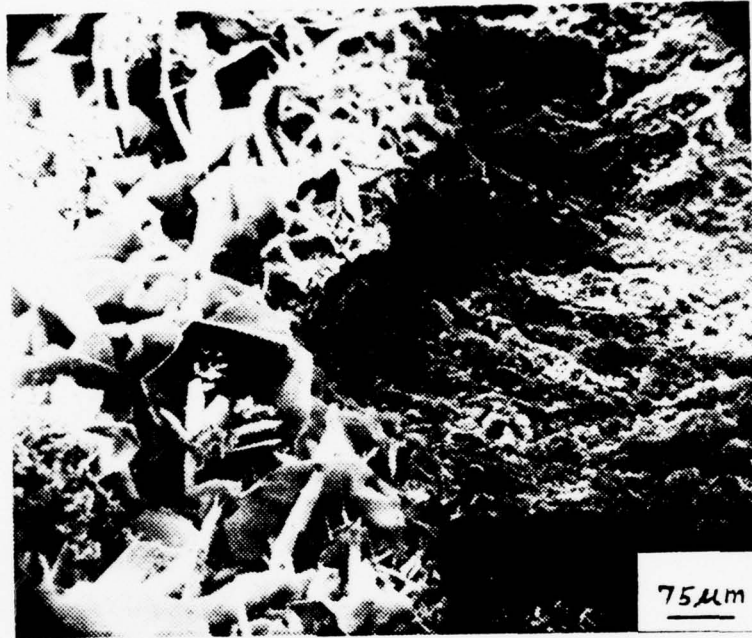
Zinc anode specimen 3DZ2 after 3 hour  
dynamic exposure at 150 rpm, 5 mA/in<sup>2</sup>,  
showing spalled off platelet area, 130X

Another example of turbulent flow effects on corrosion products may be seen in Figure 60 which shows the results of platelet layer cracking and spalling of a dynamically exposed

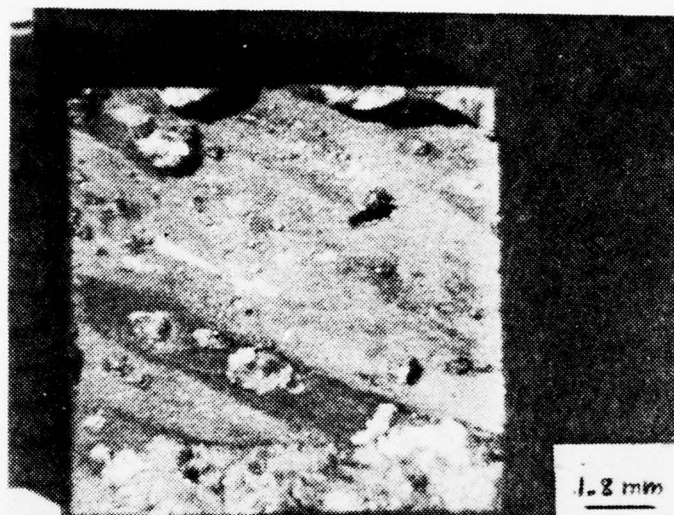
Aluminum anode specimen after 2 day static exposure, 6X (2DA1)

Investigation of aluminum sacrificial anodes in this thesis was undertaken as a corollary to the primary zinc anode work. The aluminum sacrificial anode specimens were prepared exactly as the zinc anode specimens except that the specimen sides were not painted with insulating dope. Aluminum anode specimens were only subjected to static exposures for periods of time of up to 2 days. Figure 61 is a micrograph of a specimen that was statically exposed for a period of 2 days. Striations of corrosion products and much pitting are in evidence. Pitting is particularly severe at the edges of the specimen. The striations are parallel to what was the vertical
