(6) HIGH TEMPERATURE MICROSCOPY OF PORCELAIN-PRECIOUS ALLOYS,

(10) Eugene F./Huget*
Laszlo B./de Simon**

(11) 28 Apr 77

U.S. Army Institute of Dental Research

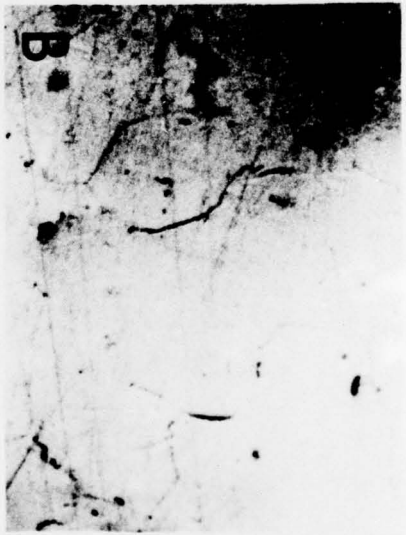
FIG. 2.

Figure 2. Microstructures of Porcelain-Precious Alloys. (A) Alloy A, 1,500F. (B) Alloy B, 1,100F. (C) Alloy C, 1,100F. (D) Alloy D, 1,100F. (E) Alloy E, 1,100F.

Microstructures of the five alloys were revealed by thermal etching. Grain boundaries, with the exception of those of alloy A, became visible at 1,100F. Alloy A specimens resisted thermal etching until the temperature of the heating chamber reached 1,500F. Grain-configurations are shown in Figure 2. Micro-grain size numbers for the test materials were: Alloy A, 6; alloy B, 7; alloy C, 5.5; alloy D, 7; and alloy E, 8. Exposure of the alloys to temperatures above those at which the grain boundaries became visible did not promote grain-growth.

The preferential etching of grain boundaries at moderately high temperatures (1,100-1,500F) suggests that vaporization of irregularly arranged atoms at grain boundaries occurs at faster rates than vaporization of the more centrally positioned atoms. Decreased specimen reflectivity at somewhat higher temperatures may be linked to oxidation of base metal components such as indium or tin. Oxides of indium and tin play prominent roles in the chemical bonding of porcelain to metallic substrates.⁶

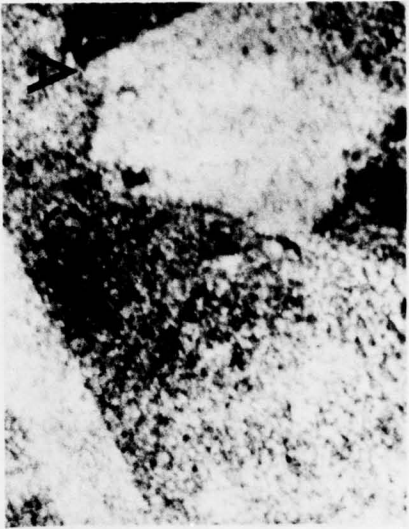
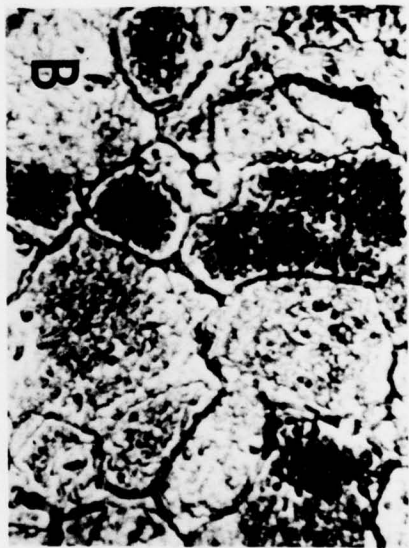
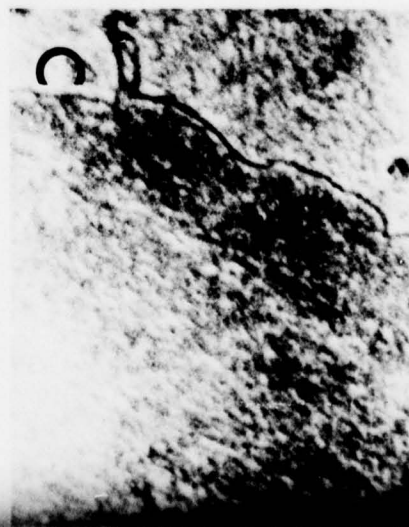
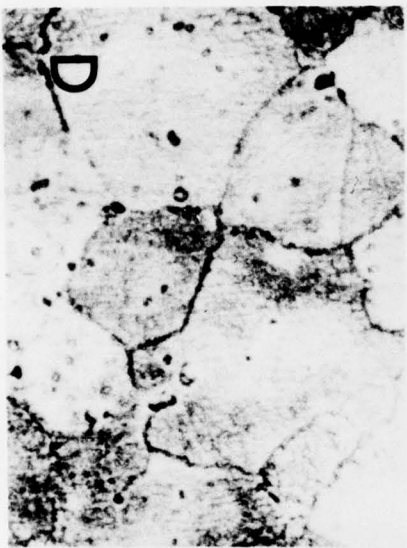
FIG.3.

Figure 3. Microstructures of Porcelain-Precious Alloys. (A) Alloy A, 1,700F. (B) Alloy B, 1,500F. (C) Alloy C, 1,700F. (D) Alloy D, 1,900F. (E) Alloy E, 1,700F.

Surface upheaval and changes in surface reflectivity accompanied further increases in treatment temperature. Alloy B was so affected at 1,500F. Changes in surface reflectivities of alloys A, C and E occurred at 1,700F. Alloy D exhibited a similar change at 1,900F (Fig 3). Additionally, alloys A, C and D showed crystallographically dependent striated contours at temperatures in excess of 1,700F (Fig 4). At 1,950F, all five alloys showed pronounced grain distortion and incipient melting.

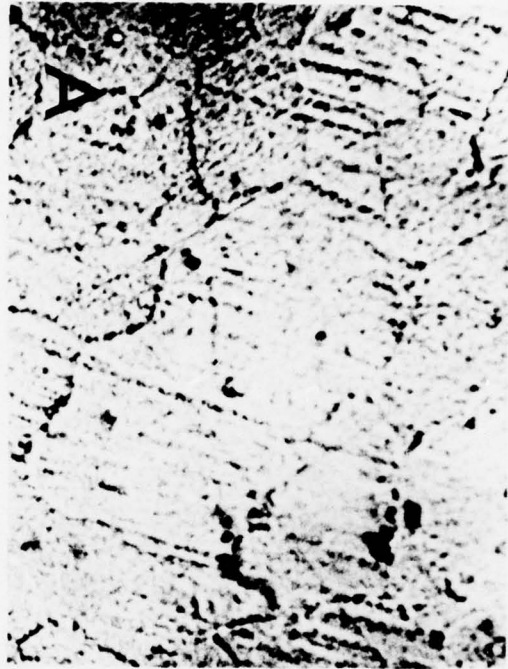
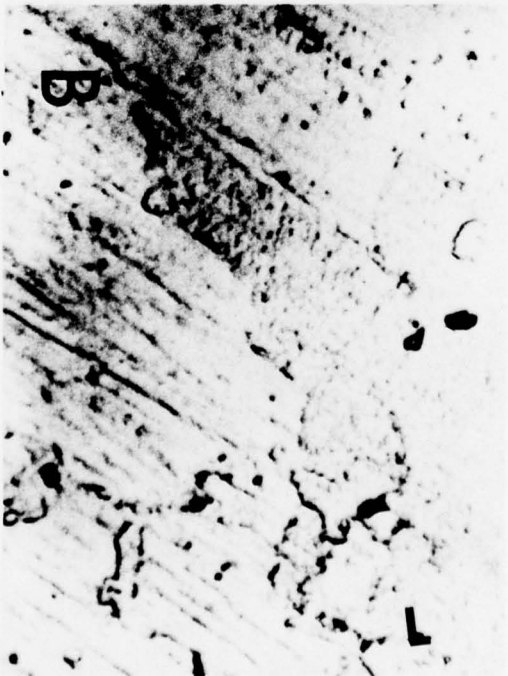
FIG. 4.

Figure 4. Microstructures of Porcelain-Precious Alloys. (A) Alloy D, 1,800F. (B) Alloy A, 1,800F.

Surface upheaval and intragranular striated markings displayed by three alloys appeared to result from nonuniform expansion of neighboring

grains and slip. These changes in surface architecture may improve the micromechanical attachment of a ceramic veneer to a cast sub-structure. On the other hand, such changes would appear to be detrimental to the fit of precision cast restorations.
