Technical Report  
**R 852-1**

CIVIL ENGINEERING LABORATORY  
Naval Construction Battalion Center  
Port Hueneme, California 93043

**CONTAINER OFF-LOADING AND TRANSFER SYSTEM (COTS)  
Advanced Development Tests of Elevated Causeway System**

VOLUME I - SUMMARY

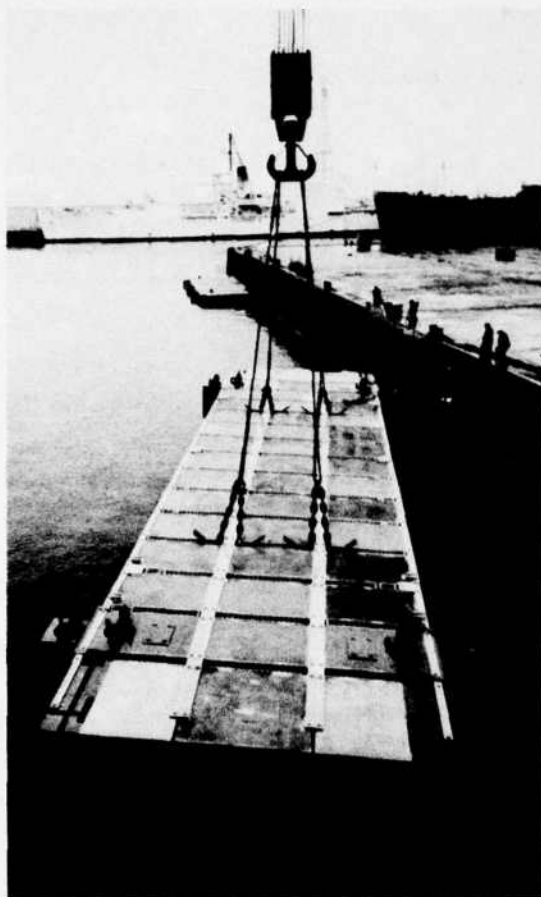
Figure 1. Causeway test section with internal and external spudwells.

The two types of spudwells, internal and external (Figure 1), developed by CEL to provide the NL P-Series pontoon system with an elevating capability, performed satisfactorily. The internal spudwells allowed the pierhead sections to be joined side by side, and the piles could be cut off close to the deck [within 10 inches (25.40 cm) or flush] for truck traffic clearance. In the causeway-to-pile connection, the steel gussets restricted cutting the piles to about 10 inches (25.4 cm) above the deck or flush with the deck if the gussets were welded under the pontoon deck.

The external spudwells allowed two-way traffic on the roadway sections from the beach to the pierhead without having to cut off the piling. The external spudwells also performed very well in positioning and holding the piling for the fender system at the pierhead. Pile guides were tested when installing and driving the fender piling. These steel plate guides were slipped into the external spudwell hole before the fender piles were inserted. With the guides installed, the piles were held in a more vertical alignment during and after driving. The guides were removed after the piles were driven. This vertical alignment of the pile was considered desirable for the fender system operation.

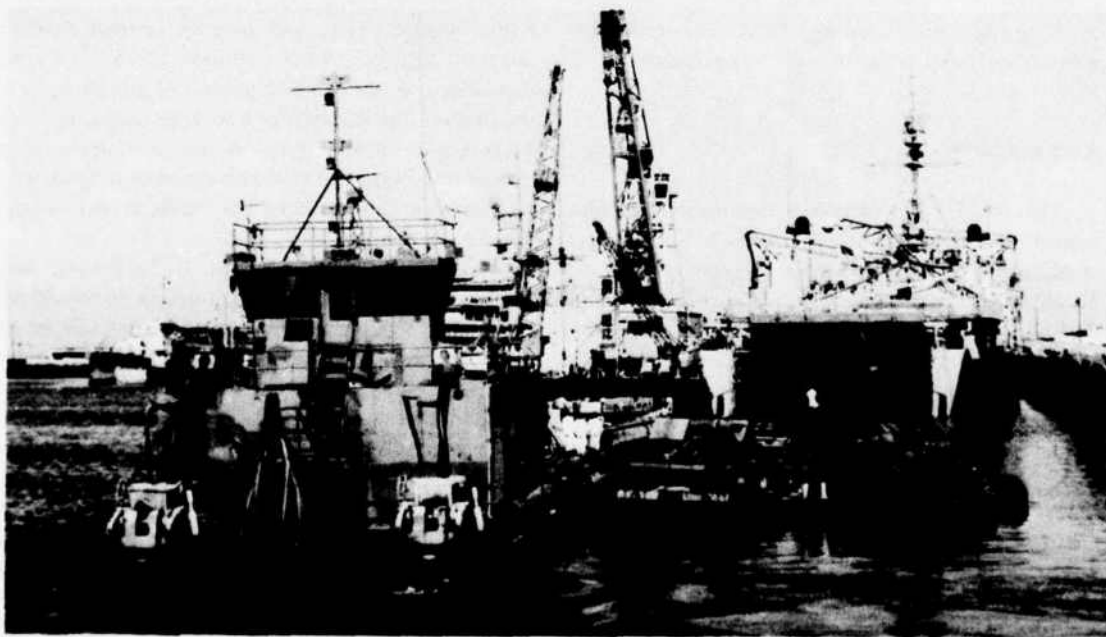
Figure 8. Loading elevated causeway components into LSD.

container-handling crane. Two additional internal spudwells were added to each of these sections. Also, the exterior pontoon angles adjacent to the crane/container operation were reinforced to resist the greater moments and shears introduced into the structure by the crane lifting 20-ton (18-Mg) containers from the lighters. The four sections, along with the crane, the pile hammer, and accessory gear, were shipped to Coronado by LSD-31 *Point Defiance* on 29 October 1975 (Figure 8).

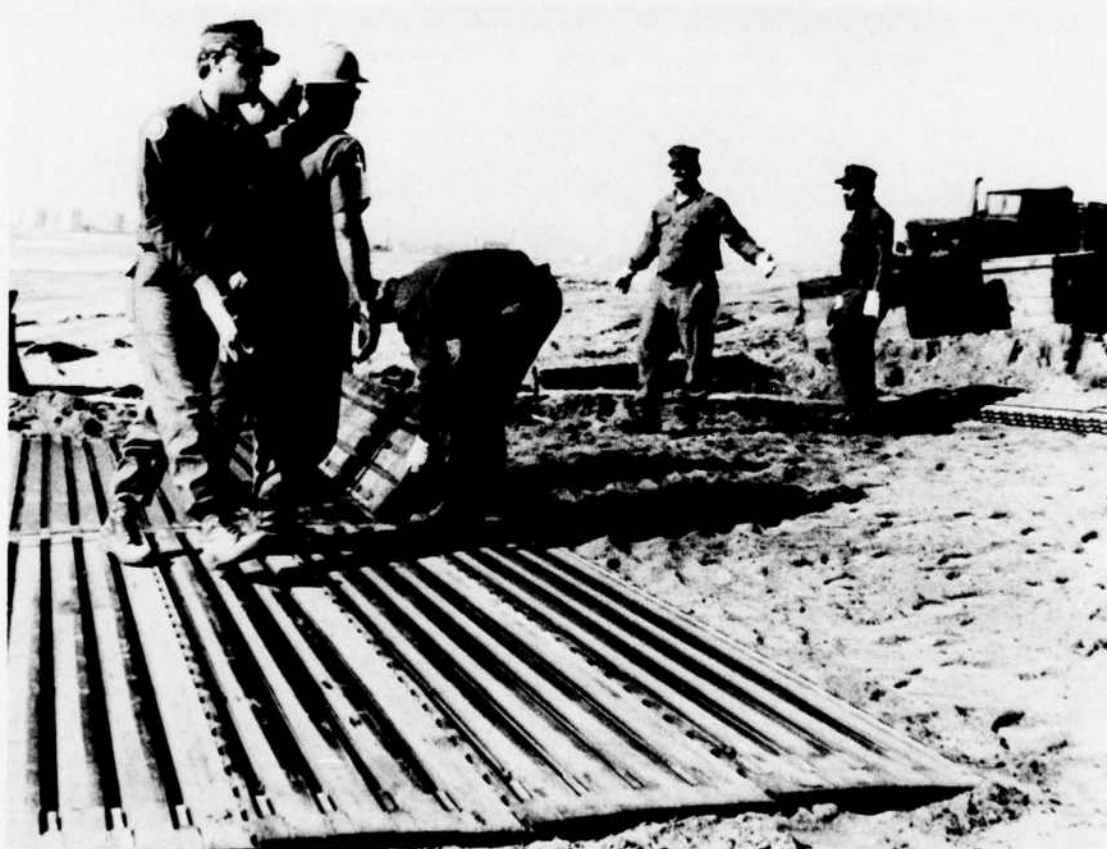
Figure 10. Steel mat, M8A1, used to support container crane and container transporters across beach.

A 30-foot (9-m) long, two-piece steel ramp provides a roadway from the elevated shore section to the beach (Figure 9). Each ramp piece weighs 9 tons (8 Mg) and attaches to the open padeyes of the NL pontoon end connection. The ramp is capable of supporting the 148,000-pound (67-Mg) container-handling crane. Steel matting (M8A1) was provided as a beach surfacing at the end of the causeway (Figure 10).

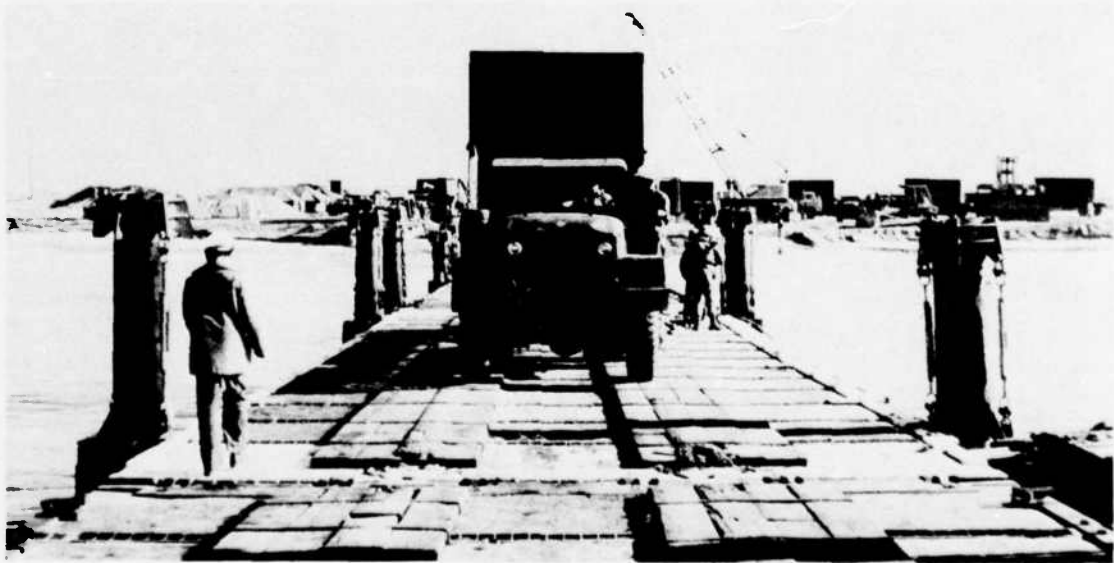
Figure 16. Pontoon deck reinforcement of 3x12 timbers provides roadway for vehicles.

Container handlers, mobile truck cranes, and truck/trailers create tire print pressures up to 130 psi (896 kPa). This pressure exceeds the allowable stress of about 75 psi (517 kPa) of the pontoon deck plate; thus, a suitable reinforcement is required. The pontoon causeway deck was reinforced with 3 x 12 timbers to distribute the vehicles' weights while transiting the causeway and on the pierhead. These timbers were secured to the deck with 3/16 x 2-inch (95 x 50-mm) steel straps placed across the timbers and welded to the deck. The AP1 pontoon assembly plates were not level with the timber roadway; therefore, they were covered by plywood sections. The plywood was held by steel straps welded across the A6 bolt heads (Figure 16).

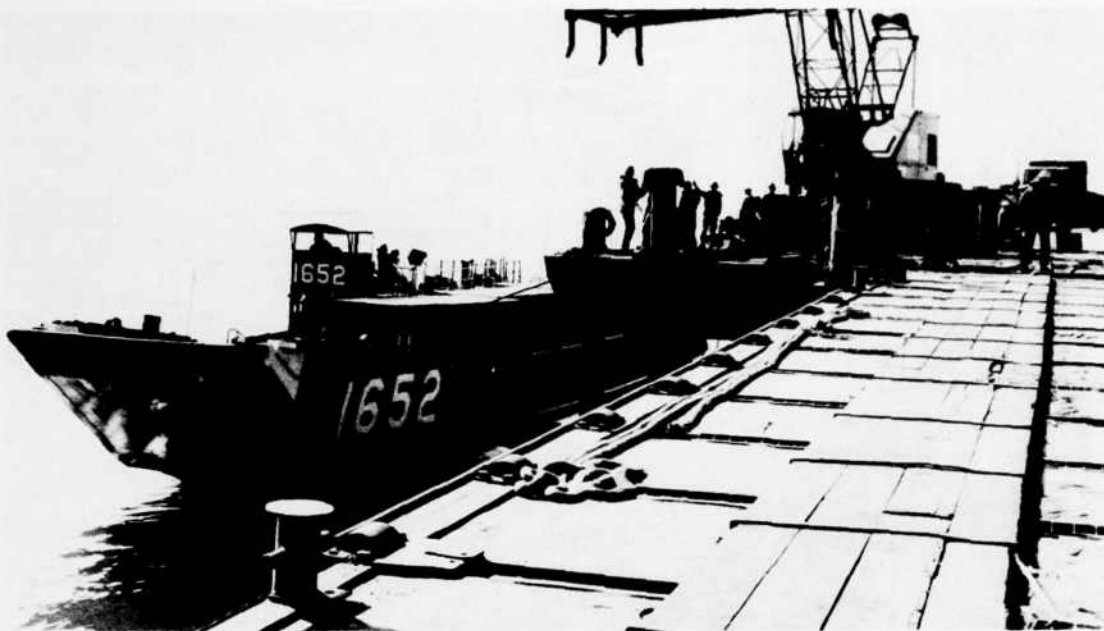
Figure 18. Class 1610 LCU, moored to elevated pier.

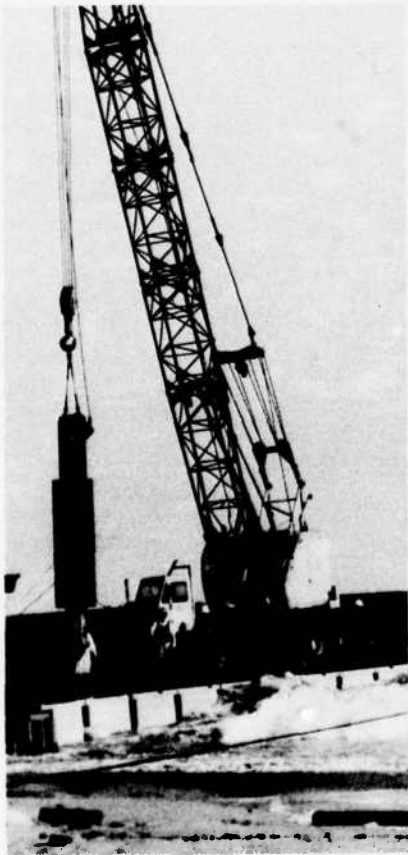
Figure 21. Model DE-30 diesel-operated pile hammer.

hardware. The two types of spudwells, internal and external, which were developed by CEL, provide alternative methods for raising the NL pontoon sections in conjunction with the jack system. A DE-30 diesel-driven pile hammer was used to drive the steel piles. A P&H Model 935 rubber-tired truck crane was used to handle the pile hammer and piling. A 5-ton (4.5-Mg) capacity hydraulic crane was used in conjunction with the 35-ton (32-Mg) capacity crane to move jacks and accessory gear on the causeway.

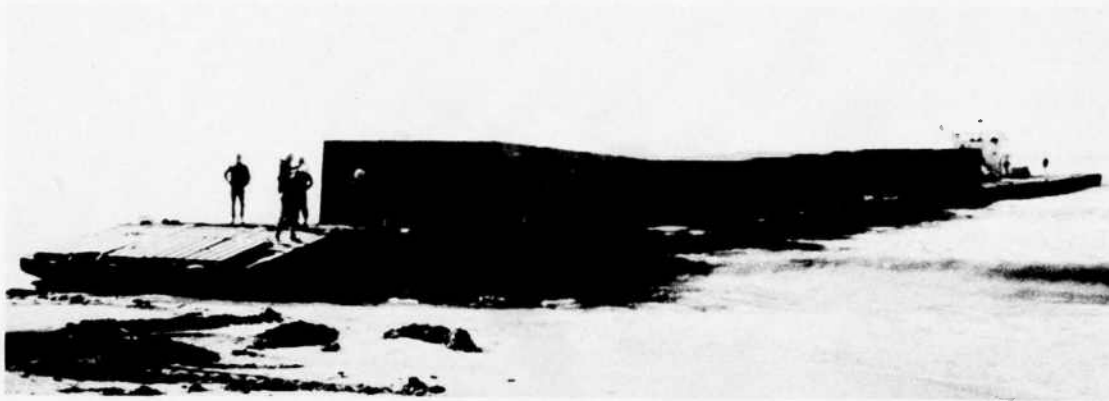
Figure 22. Causeway ferry beached for Lo/Ro operation.

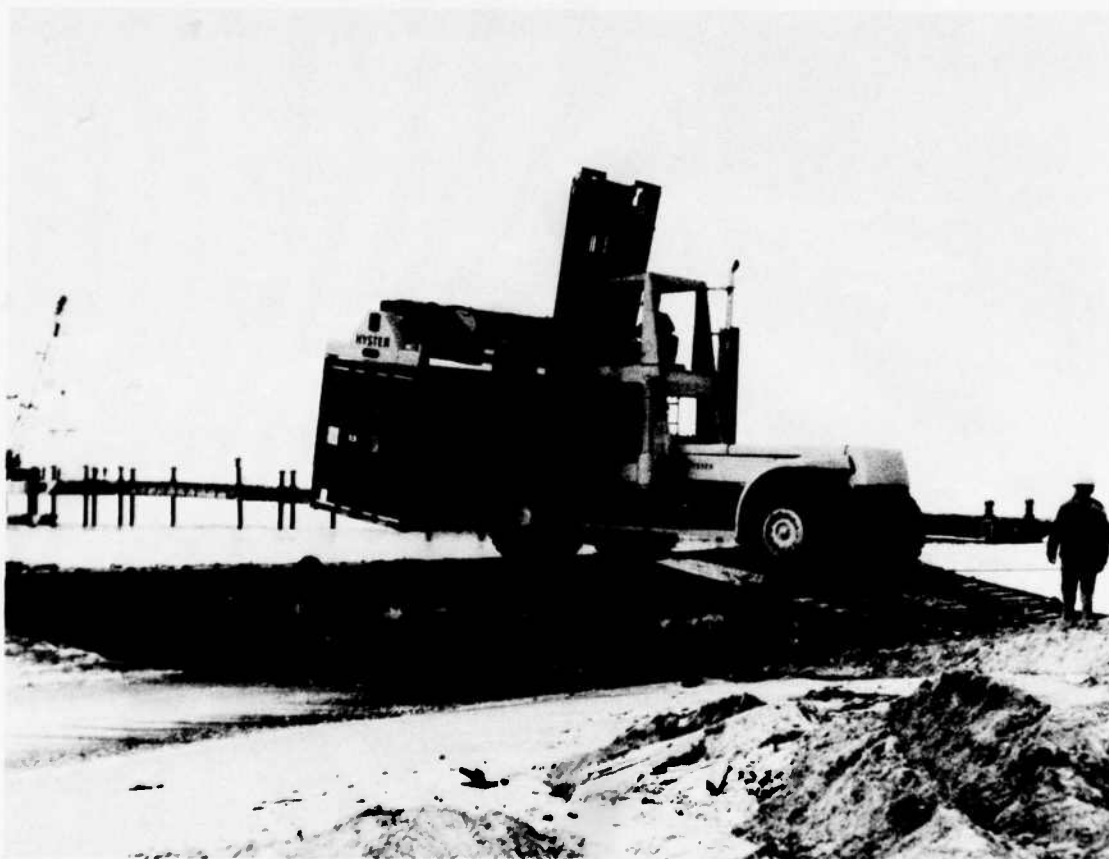
Figure 23. Top-lift loader removing 20-foot container from beached causeway during Lo/Ro test.

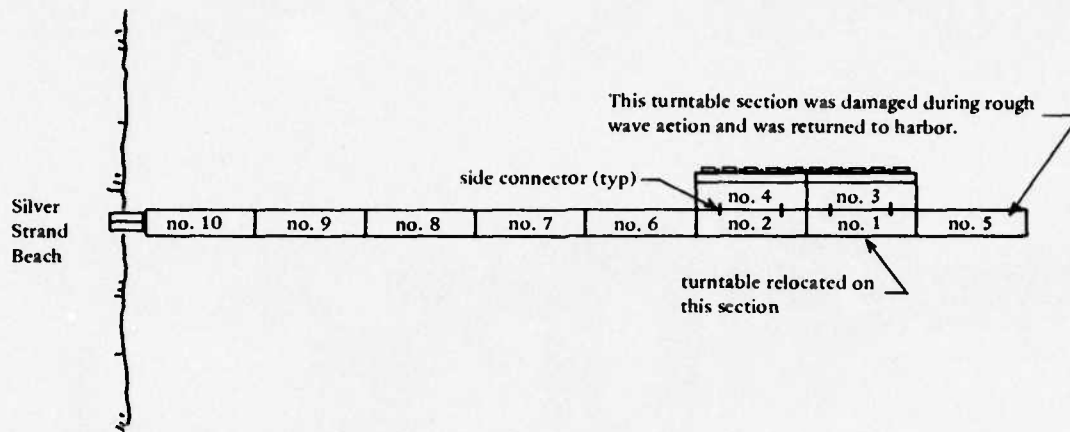
Figure 25. Location of sections of elevated causeway for Phase II operations.

The advanced development tests at Coronado, California, were conducted with the following structure: four pierhead sections (No. 1 through 4), five approach sections (No. 6 through 10), and the turntable section (No. 5) located seaward of the pierhead. Before the turntable section could be elevated, it was damaged during severe seas and could not be used. Consequently, the turntable was relocated to pierhead Section No. 1.
