RECREATIONAL BOAT SAFE LOADING - OPERATOR STUDY.(U)

Report No. CG-D-15-77

# RECREATIONAL BOAT SAFE LOADING - OPERATOR STUDY

FINAL REPORT

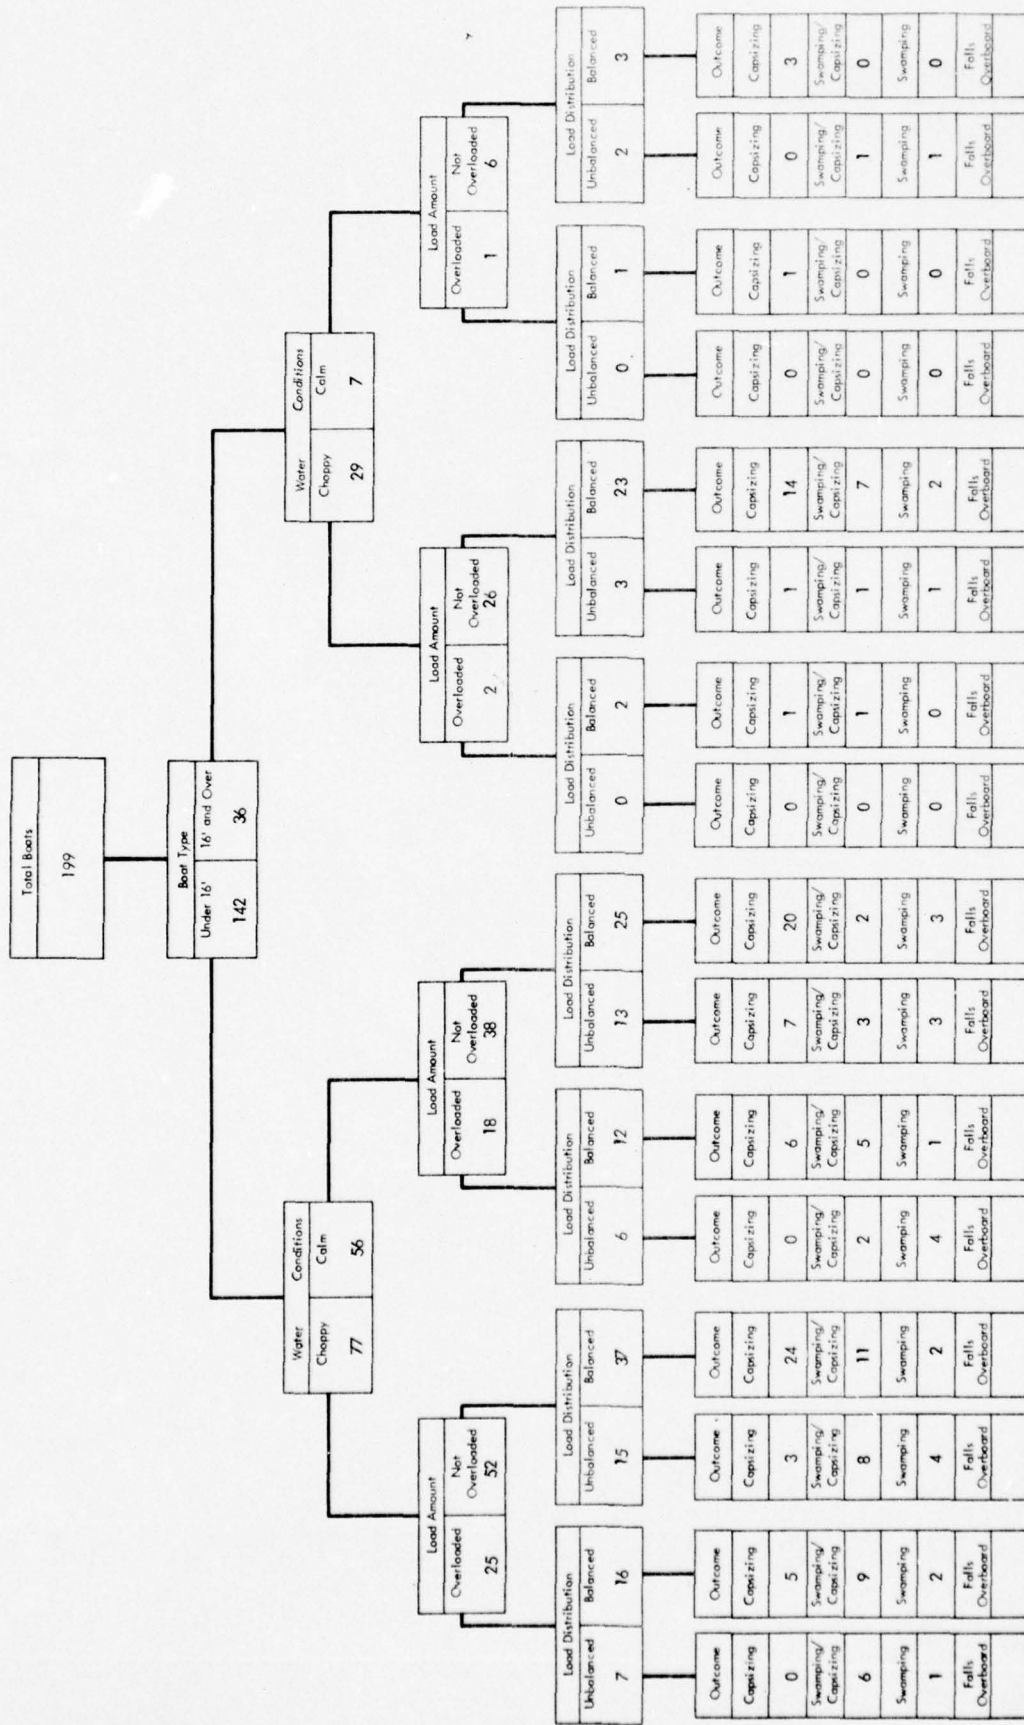
FIGURE II-1(a). CAPSIZING/SWAMPING ACCIDENTS — FREQUENCY OF COMBINATIONS OF PRE-ACCIDENT PARAMETERS

The subsequent analyses were based upon combinations of boat type, water conditions, load amount, load distribution and accident type (capsizing, swamping leading to capsizing, swamping and falls overboard). Figures II-1, II-1(a) and II-1(b) show the frequencies by all loading-related accidents, capsizing/swamping accidents (capsizing, swamping, and swamping leading to capsizing), and falls overboard accidents, respectively.

The most frequent pre-accident conditions in loading-related accidents regardless of boat size were choppy water conditions, not overloaded, and balanced load distribution. The results were the same for capsizing/swamping accidents, but were slightly different for falls overboard. Here, the results were the same for the 16 ft (4.9 m) and over group, but for the under 16 ft (4.9 m) group the most frequent combination was calm, not overloaded, and balanced. In all these accident types, there were many accidents for the under 16 ft (4.9 m) group in calm water.

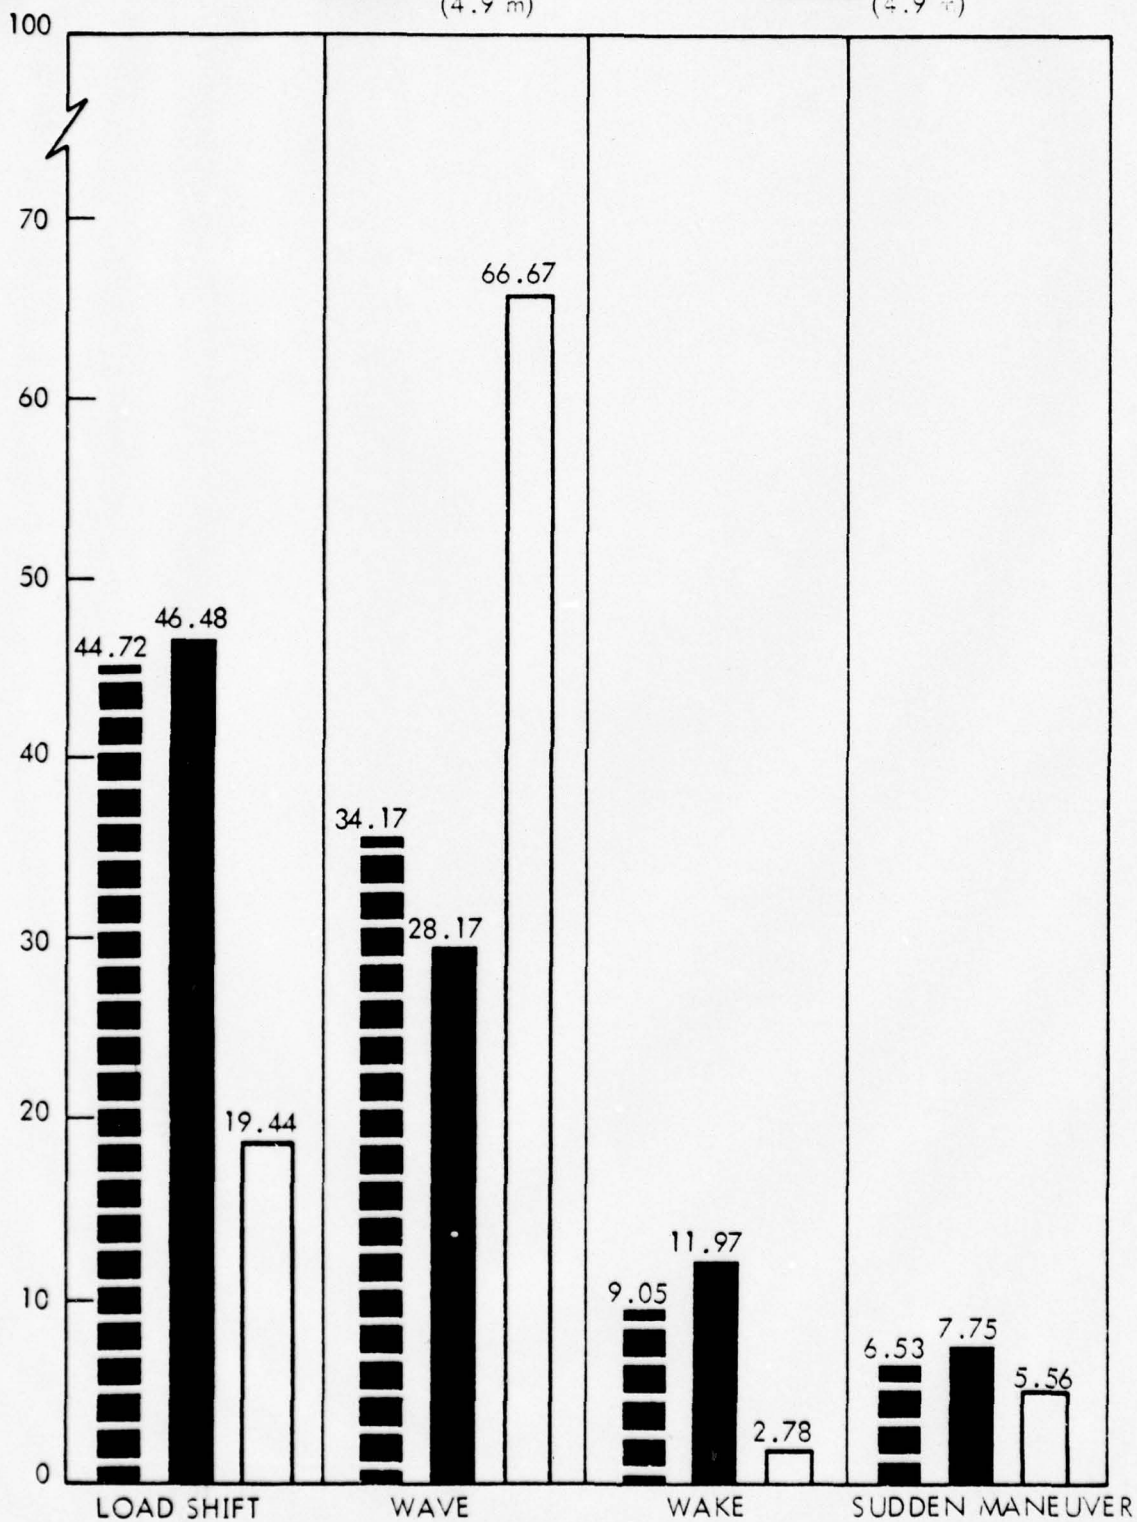
FIGURE II-2. PERCENTAGES OF OCCURRENCES OF ACCIDENT INITIATORS GROUPED BY MAJOR INITIATOR FOR CAPSIZING/SWAMPINGS

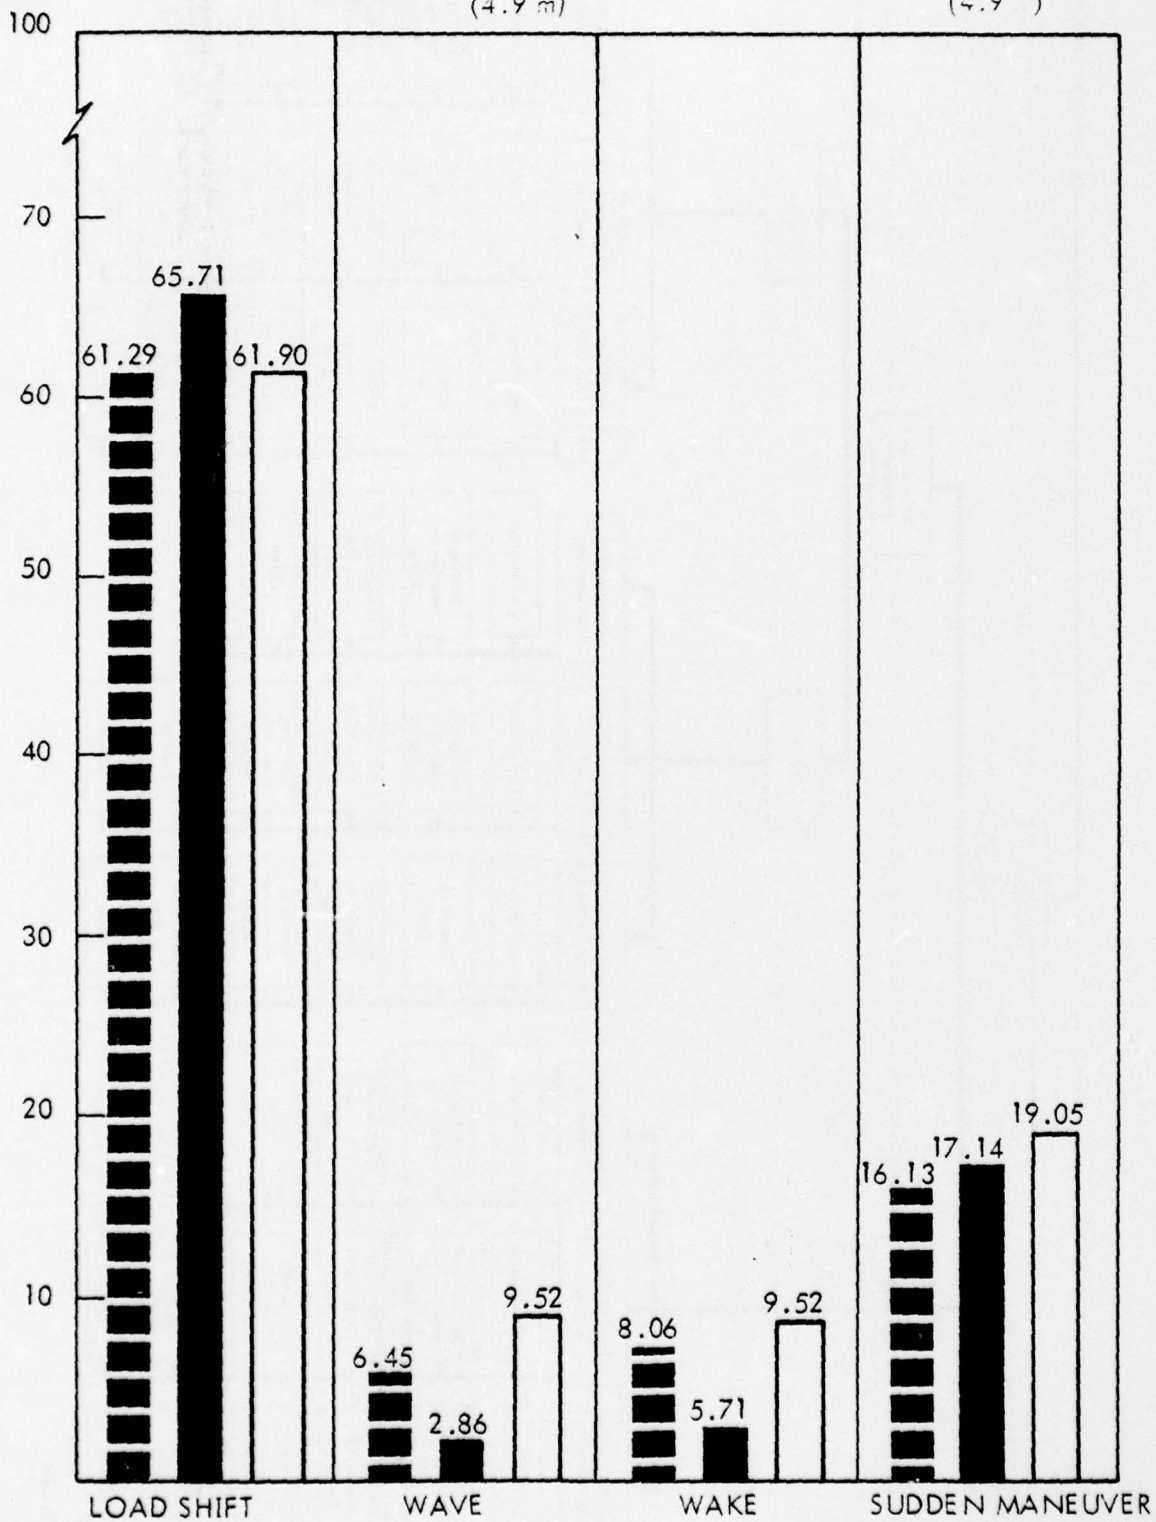
FIGURE II-4. PERCENTAGES OF OCCURRENCES OF ACCIDENT INITIATORS GROUPED BY MAJOR INITIATORS FOR FALLS OVERBOARD ACCIDENTS

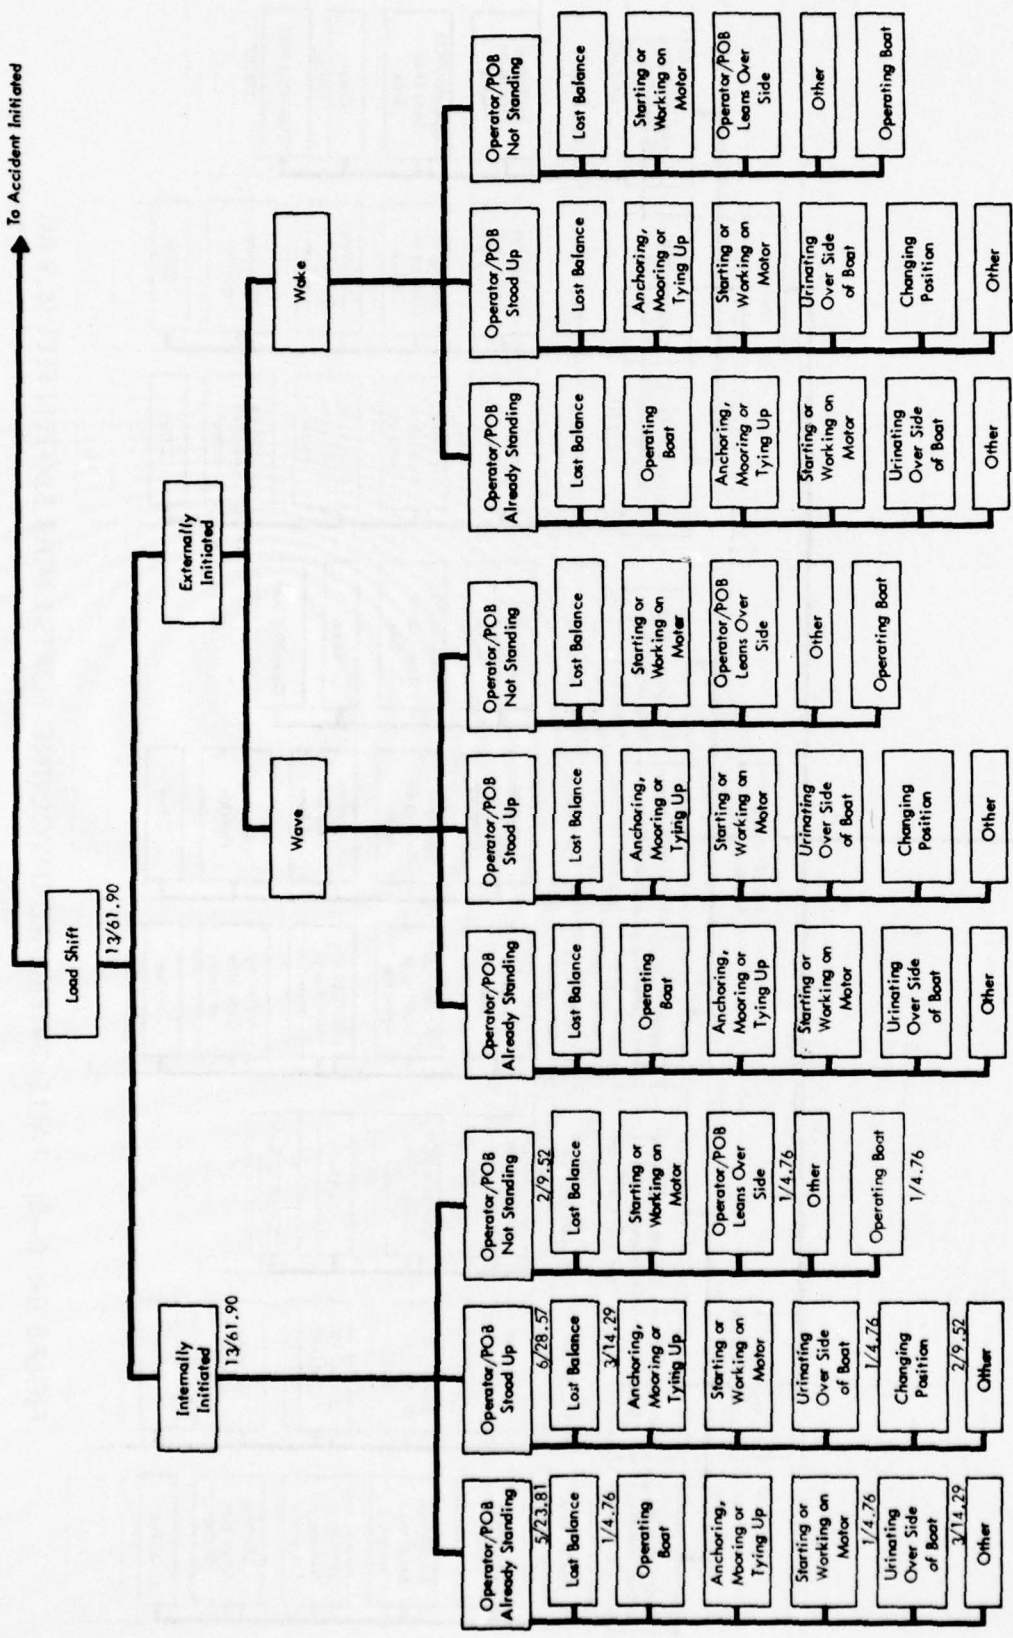
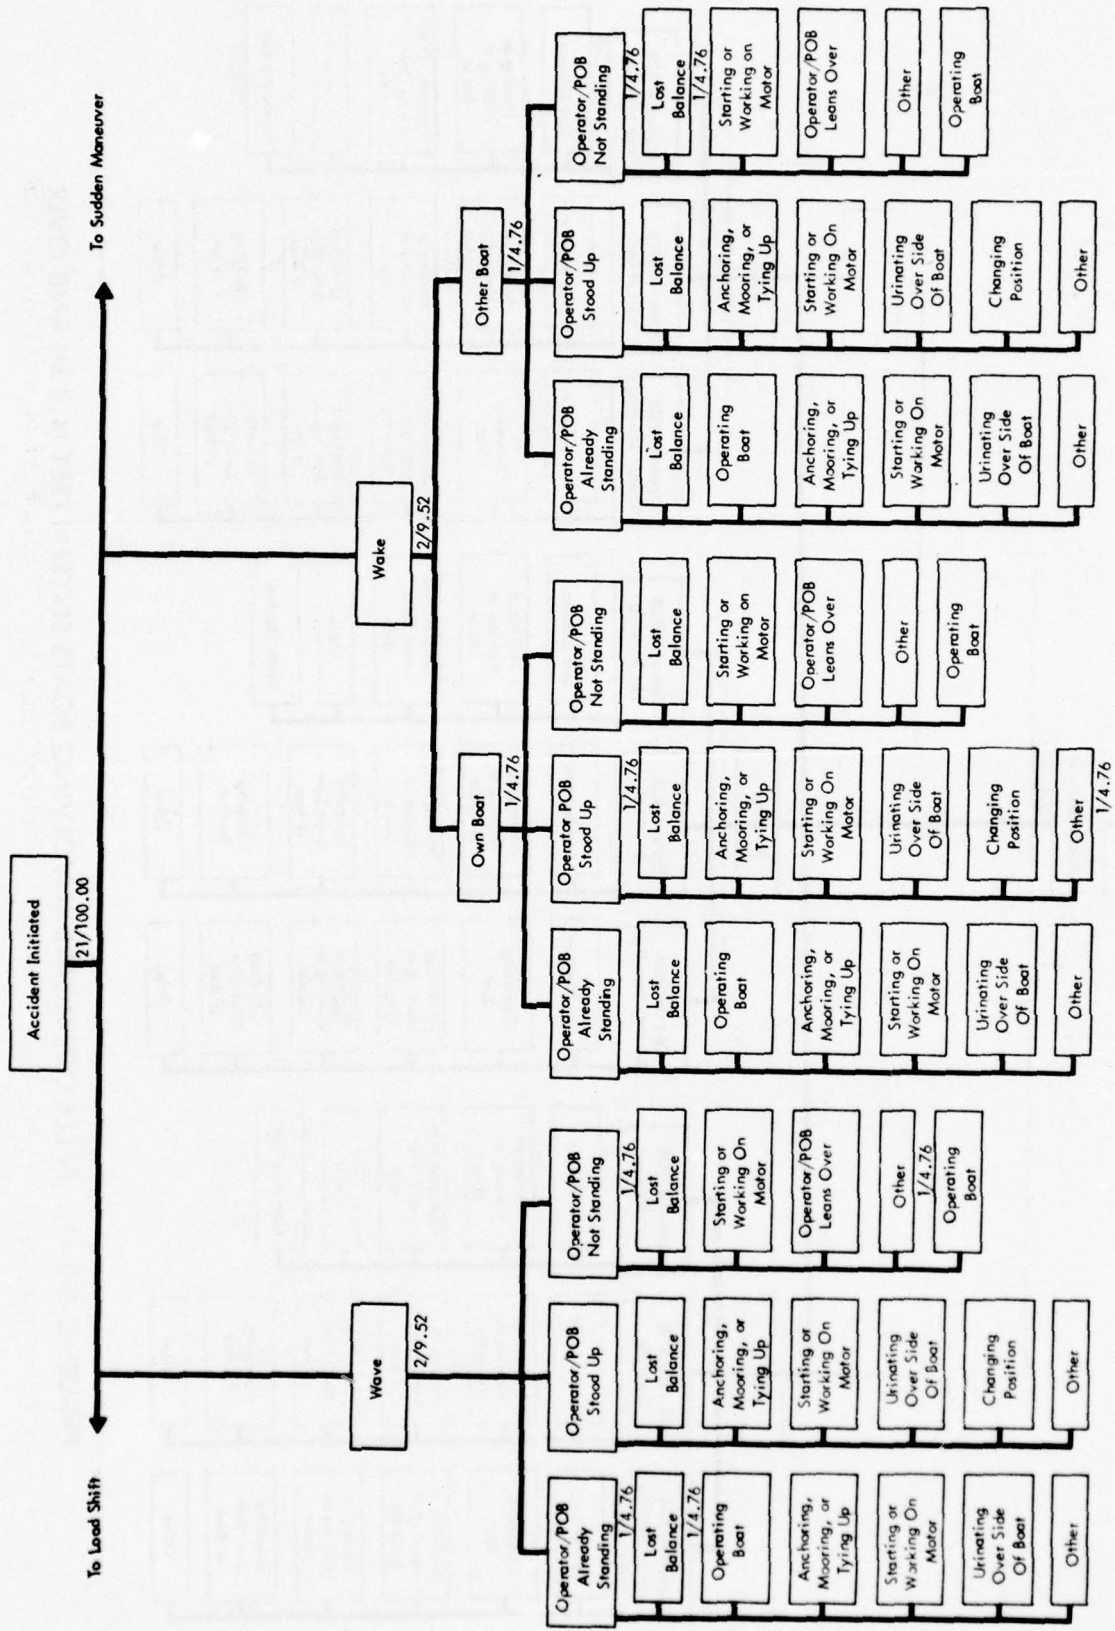
FIGURE II-5 (c-1). FALLS OVERBOARD INVOLVING BOATS SIXTEEN FEET (4.9 M) AND OVER

FIGURE II-5 (c-2). FALLS OVERBOARD INVOLVING BOATS SIXTEEN FEET (4.9 M) AND OVER

FIGURE II-5 (c-3). FALLS OVERBOARD INVOLVING BOATS SIXTEEN FEET (4.9 M) AND OVER

All of the figures in the II-5 series show the fault trees for falls overboard. Overall, load shifts accounted for 61.29% of the falls overboard, with sudden maneuvers accounting for an additional 16.13%. The load shift accidents often involved people standing or changing positions on the boat. These activities were undertaken usually in order to work on or start the motor, urinate, or lean over the side for some reason. The only sudden maneuver leading to a fall overboard was turning the boat. Often, the operator was not standing when operating the boat and yet he fell overboard.

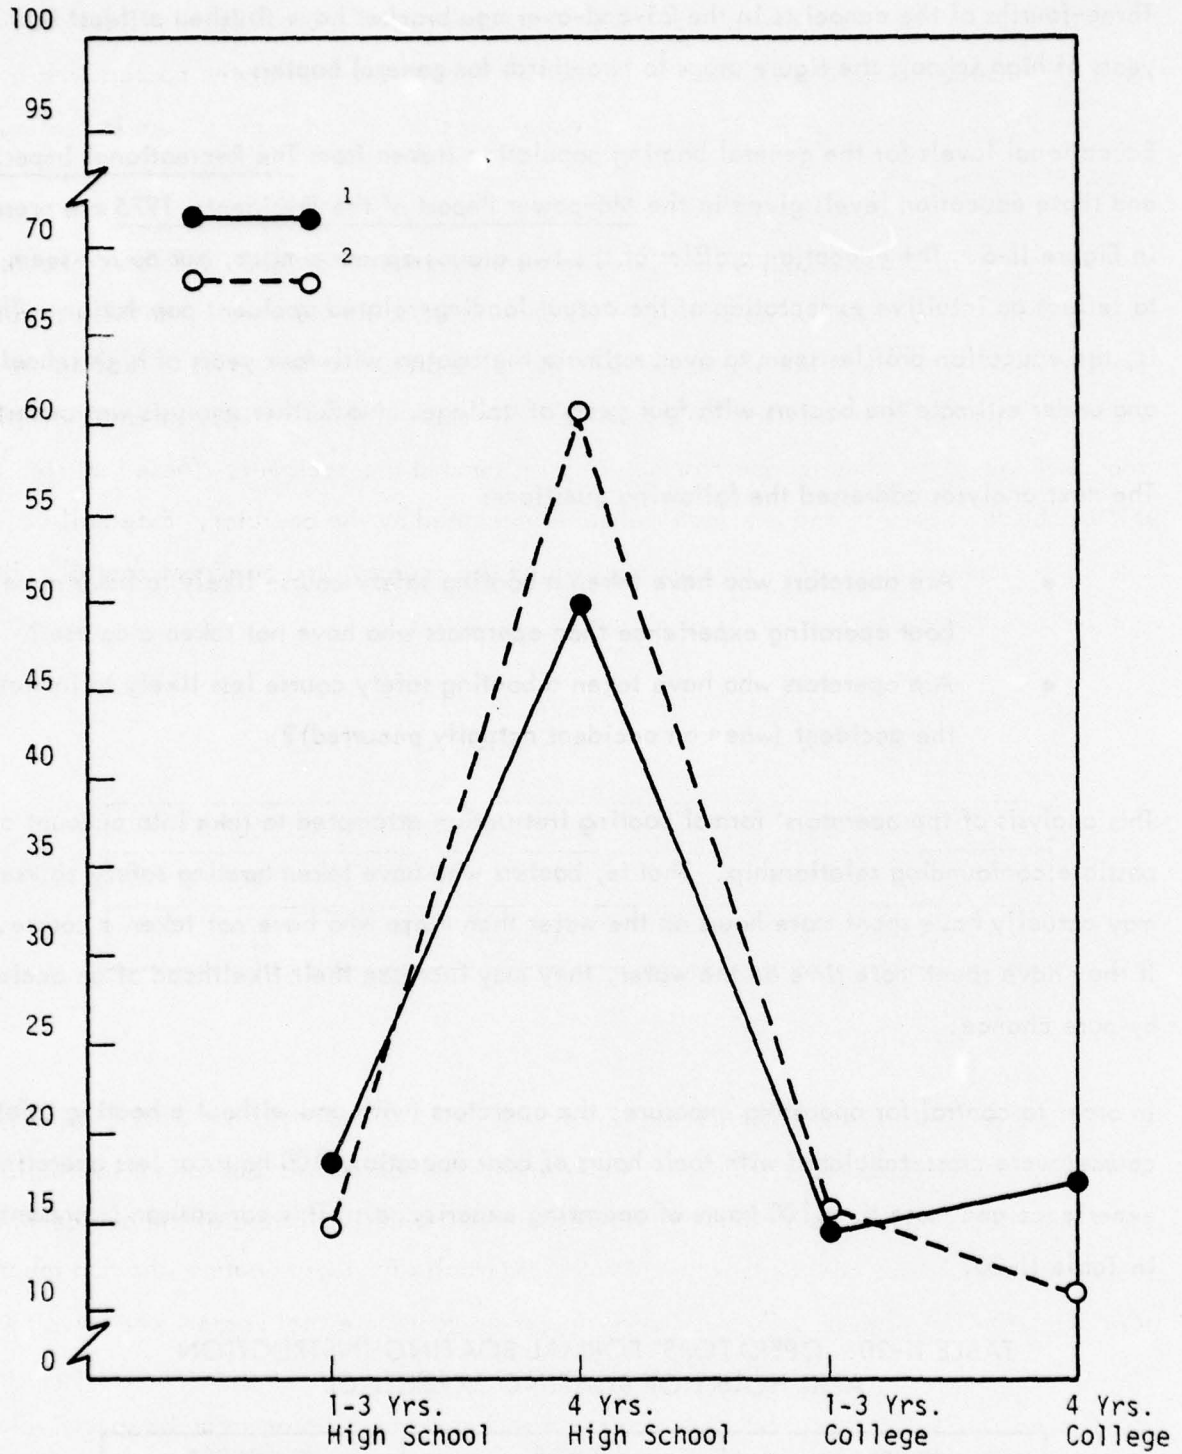
FIGURE II-6. GENERAL BOATING POPULATION AND ACCIDENT POPULATION EDUCATION USING THE RECREATIONAL IMPERITIVE AND MANPOWER REPORT SOURCES

- 1 General boating population (from The Recreational Imperitive)
- 2 Manpower Report extrapolations (using median years of education shown in Table II-19)

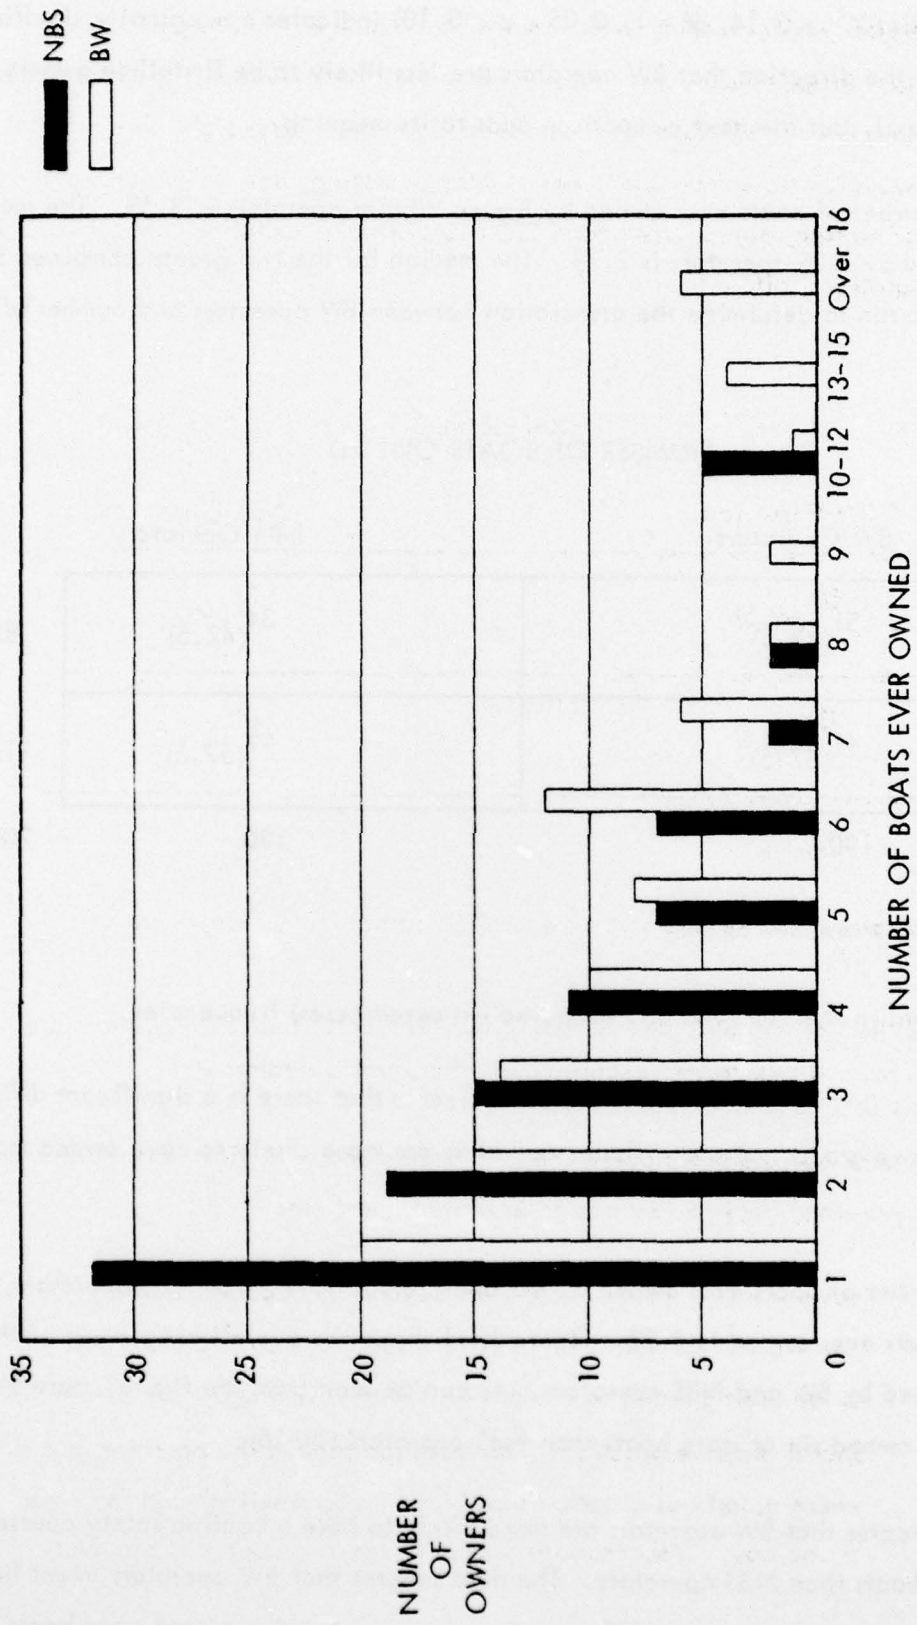
Figure III-1. Comparison of Boats Owned

The mean number of boats ever owned by BW operators is 4.99. For NBS operators, the mean number of boats ever owned is 3.22. Figure III-1 shows the overall breakdown of the number of all boats owned by BW and NBS operators. As can be seen from the figure, more BW operators (N=33) have owned six or more boats than NBS operators (N=16).
