# FIBER-OPTIC UNDERSEA TOW CABLE OPTICAL AND ENVIRONMENTAL TESTS

WH PUTNAM

20 December 1976

NAVAL ELECTRONICS LABORATORY CENTER  
SAN DIEGO, CALIFORNIA 92152

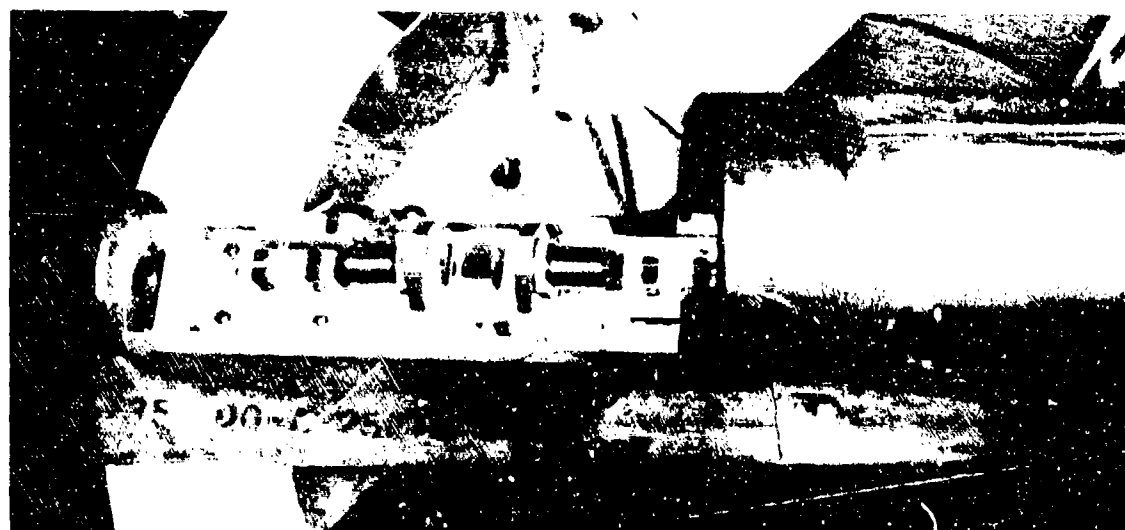
Figure 28. Original configuration of optical monitoring device.

A. Optical monitoring device.

B. Pressure housing and cable.
