CONTRACTOR REPORT ARLCD-CR-77006

**BLAST CAPACITY EVALUATION OF
BELOWGROUND STRUCTURES**

RAM ARYA ALBERT AMMAR
NORVAL DOBBS SAMUEL WEISSMAN
 AMMANN & WHITNEY
 PAUL PRICE
 ARRADCOM COORDINATOR

MAY 1977

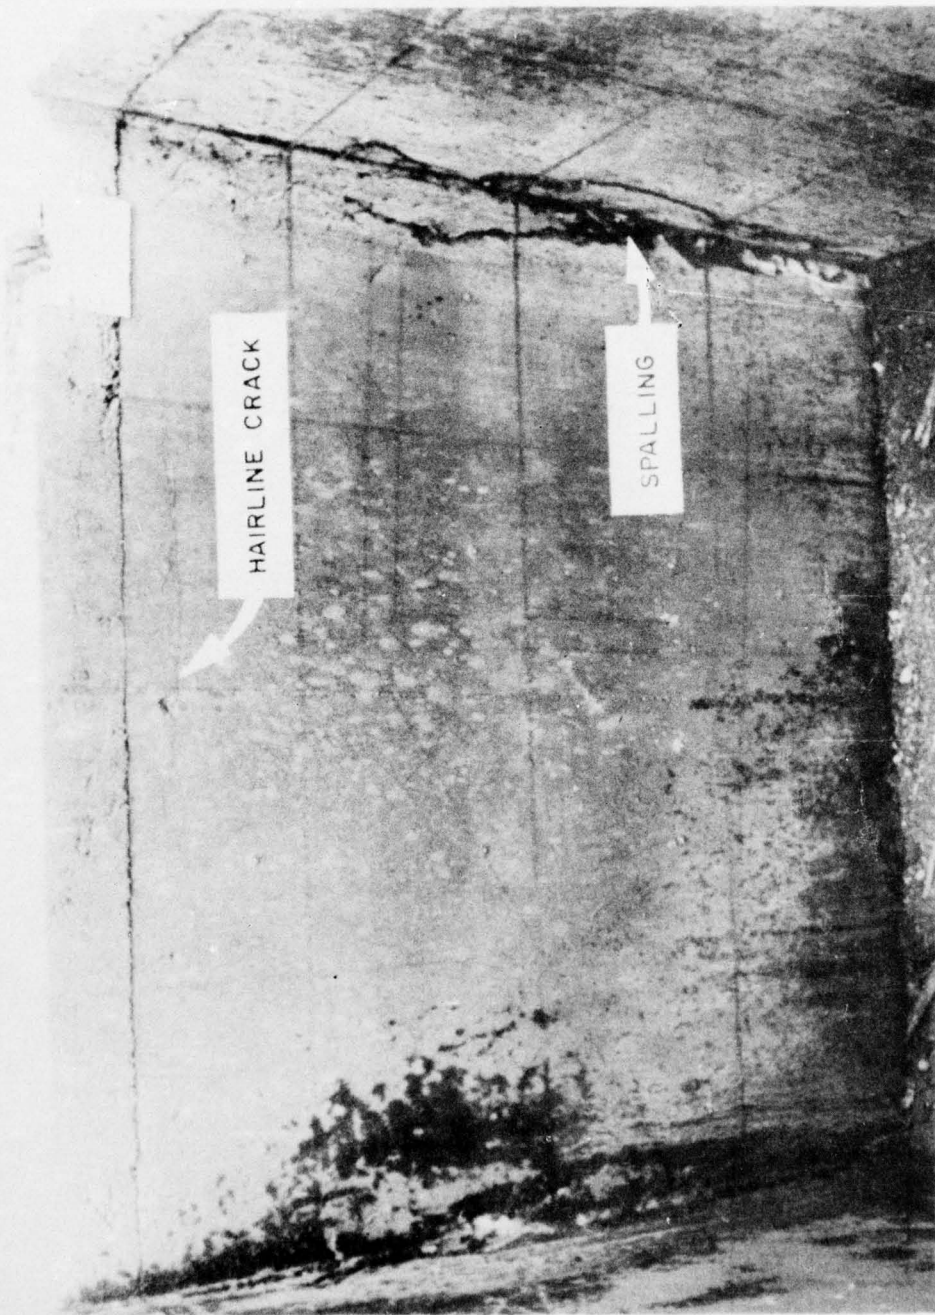
Fig 13 Post-test damage to Cell No. 1 east wall (Test No. 4)

Spalling of concrete in corners of the cell observed in Test No. 3 was appreciably increased and extended over the lower three-fourths of the cell height. Depth of spall was as large as 19 mm (3/4 in.) with some reinforcing bars in the corners visible. Cracks appeared along the intersection of floor slab and all four walls. Approximately 0.3 m (1 ft) below the top of the walls, horizontal hairline cracks were formed. These cracks were formed by the yielding of vertical reinforcement at the interface of the walls which, in turn, was produced by the blast loads acting on the top of the aprons. Hairline cracks were formed in the floor slab which radiated from its center. All this damage is illustrated in Figure 13.

The above described damage indicated that walls were being pushed into the soil by the blast loads and were acting as plates supported on four sides; the top support being furnished by the apron acting as a series of interconnected deep beams. The apron crack pattern, as shown in Figure 12, illustrates the above-mentioned beam action of the apron. It may also be noted from Figure 12 that cracks were formed in the soil at the location of the poles indicating the soil movement has occurred. These cracks were situated at the poles because of the soil weakness produced at these locations by insertion of the poles. The significance of the cracks is the extent away from the structure to which the soil is effective in resisting the movement of the structure, i.e., the angle of friction (θ) between the structure and the supporting soil is equal to or greater than 65 degrees (Fig 14). This relatively large friction angle is in part attributed to the vertical compression forces produced by the downward motion of the concrete apron and to a lesser extent by the blast loads acting on the surface of the backfill surrounding the structure.

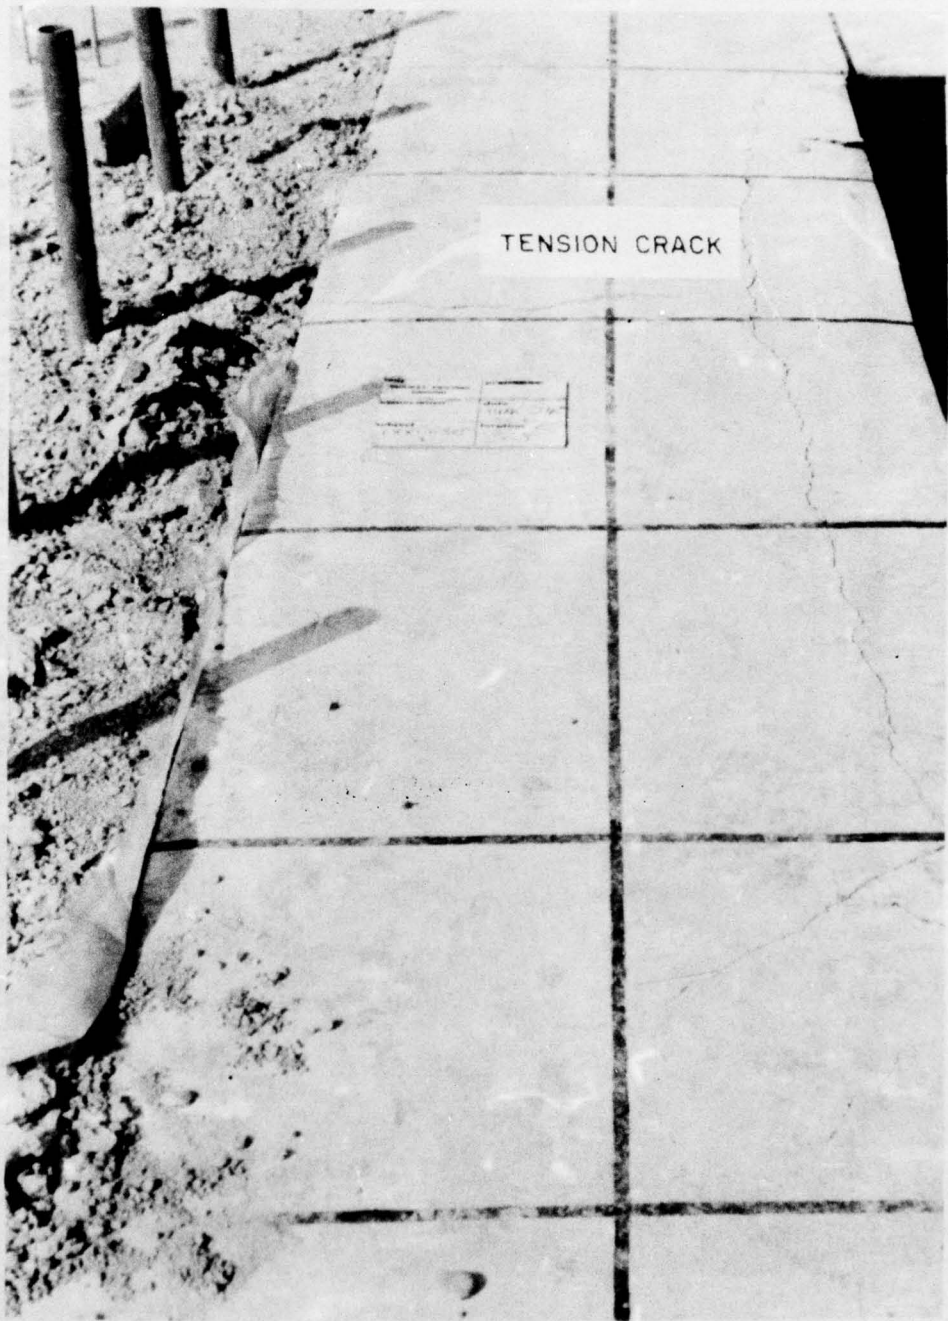
Fig 17 Post-test damage to Cell No. 1 apron (Test No. 5)

The general crack pattern of the apron in this test remained the same as that of Test No. 4. However, the cracks did widen a bit and a few new cracks around the outside corners of the apron were formed (Fig 17).

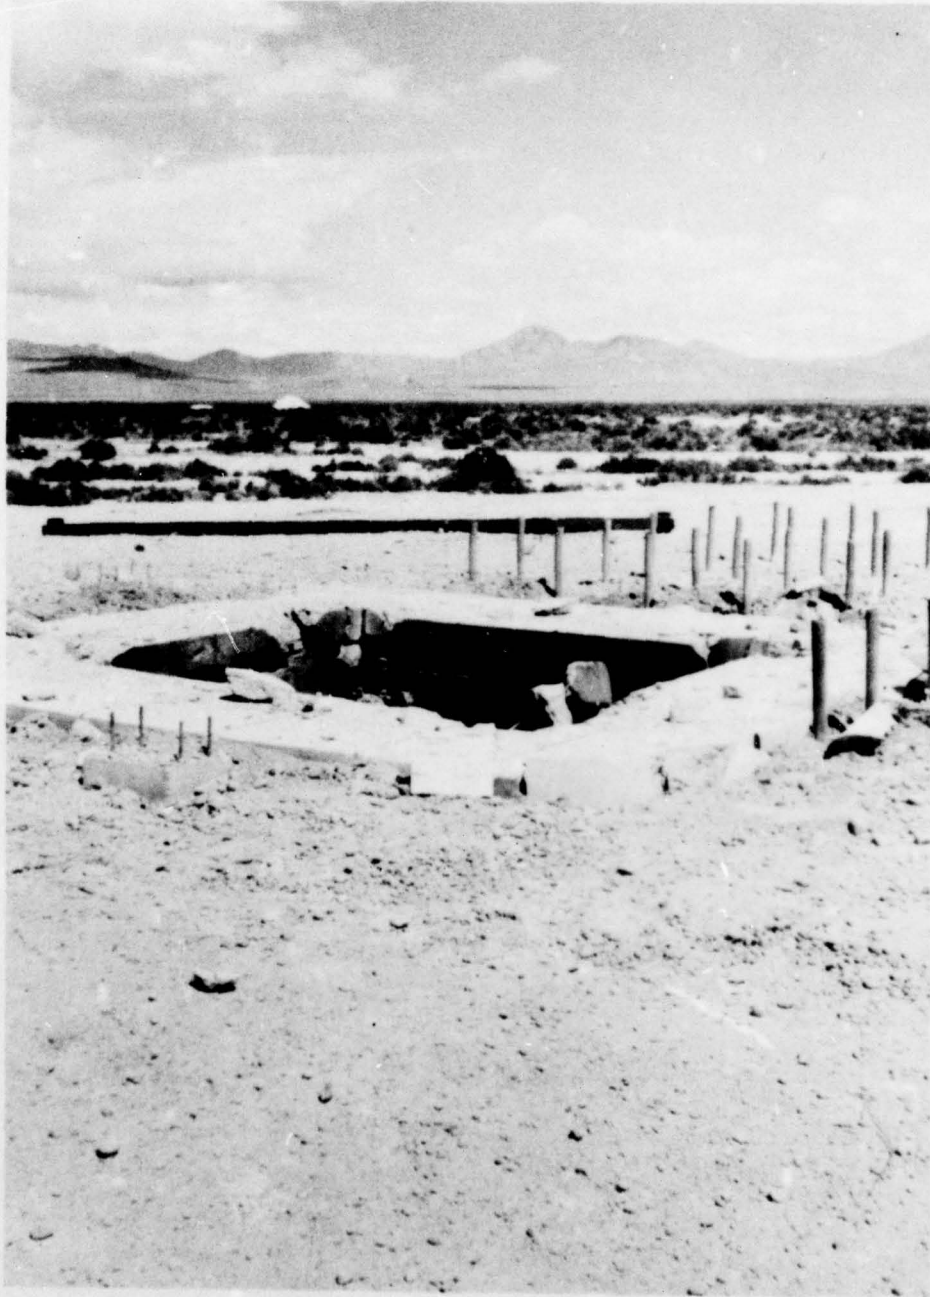
Fig 21 Post-test exterior view of Cell No. 1 (Test No. 7)

Figure 21 illustrates the overall view of the damage to the cell including debris from the breakup of the wall and apron after Test No. 7. Damage to the walls and apron is illustrated in Figure 22. Most of the debris was formed from the breakup of the wall corners. All reinforcing bars at the corners were exposed for a wall length of 0.2 m (8 in.). Some of the earth-fill fell into the cell from behind the corners (Fig 23). Permanent deflections of walls into the soil were as large as 0.2 m (8 in.) and with uniform curvatures of the walls clearly visible. This uniform curvature is attributed to the support provided by the soil over the full length and height of the walls and again is evidence of the increased resistance of the walls provided by the earth-fill.

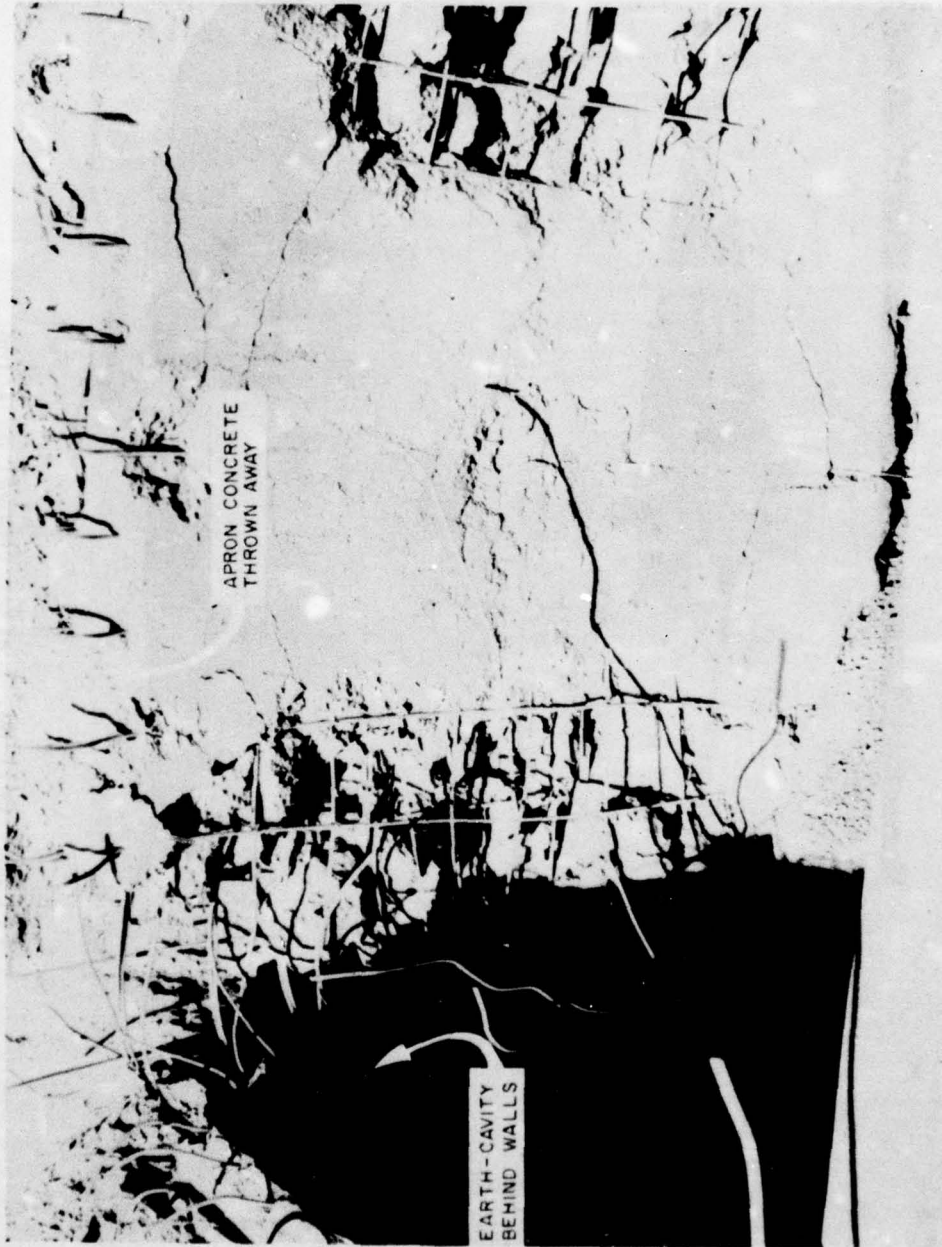
Fig 31 Post-test damage to Cell No. 1 north wall
(Test No. 9)

The added damage to the structure consisted of an increase in the removal of the concrete located at the four corners of the walls and near the intersection of the walls and floor slab, increase in the displacement of each wall panel into the earth-fill, additional cracking of the walls and the disengagement of the top of the wall which originally was part of the apron which was not removed prior to the test (Fig 31).
