TECHNICAL REPORT ARLCD-TR-77014

A PRELIMINARY THERMOGRAPHIC HEAT SURVEY
OF ARRADCOM FACILITIES (DOVER, NJ)

US ARMY ARMAMENT RESEARCH AND DEVELOPMENT COMMAND
LARGE CALIBER
WEAPON SYSTEMS LABORATORY ✓
DOVER, NEW JERSEY

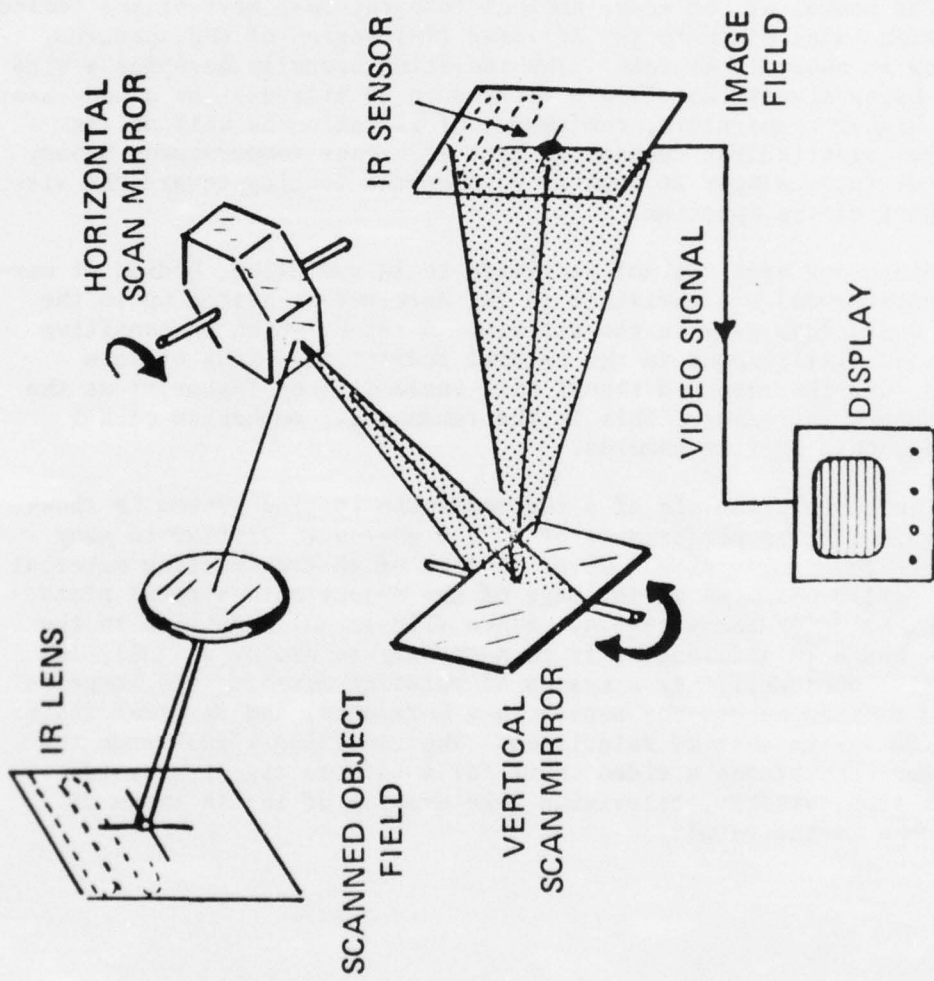
Fig 1 Basic infrared camera

The basic principle of a thermographic imaging system is shown in Figure 1. The performance of such a device is similar in many respects to a television camera. A lens of IR transmitting material (i.e., silicon) forms an IR image of the object onto a focal plate, not unlike an ordinary camera. Since film is not sensitive to the middle and a IR wavelength, it is necessary to employ a small, IR sensitive photocell. By a system of rotating mirrors, the image is caused to scan across the sensor in a horizontal and vertical raster scan similar to that of television. The resulting signal from the detector constitutes a video input for a cathode ray display tube. A real time, visible, television like display of the IR image of the scene is the result.

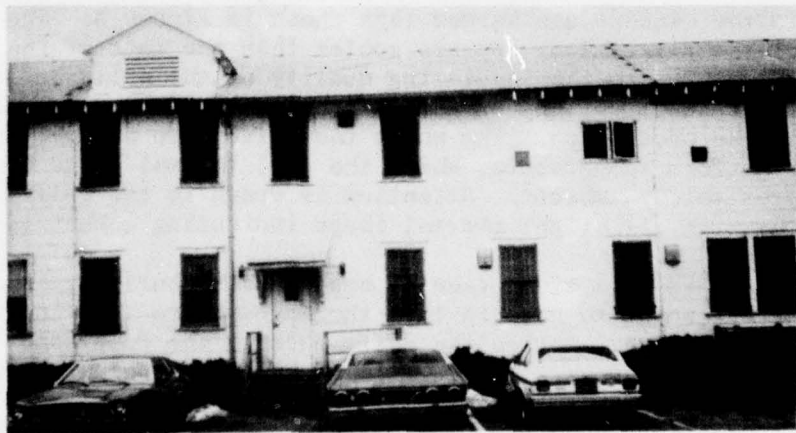
Fig 2a Thermogram of BOQ located on Navy Hill

Figure 2a is a thermographic display of the main entrance to the BOQ located on Navy Hill. The obvious places of heat loss such as windows and air vents, are indicated by their bright thermographic image. The areas of the building which the thermograph indicates as regions of heat loss which would not be otherwise obvious are the wall sections showing bright areas. These bright regions are warmer on the exterior of the building than the darker regions. The reason for this variation in outside wall temperature can be either poor insulations in these bright regions, or warmer temperature at the corresponding inside regions, such as the location of a radiator in the near proximity of the wall. In either case the addition of insulation or a reflecting material behind a radiator would decrease the amount of heat leaking through the outside wall surface.

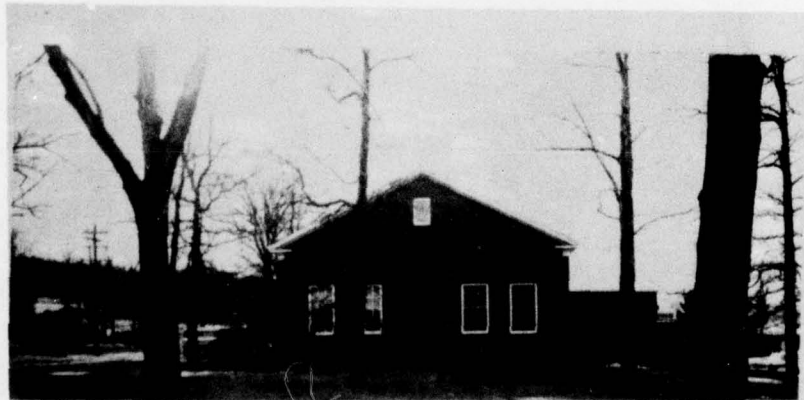
Fig 3a Thermogram of north end of building 183

Figure 3a shows the north end of building 183. As can be seen from this thermogram, the outside wall temperature appears quite uniform. The four windows appear to be quite well insulated since they do not appear to be radiating much more than the center window, which was bricked over. The area of major heat loss in this photo is the attic vent located near the peak. Although it may not be desirable to seal it off completely because of moisture buildup in the attic, it may be possible to reduce its area without affecting its function as a vent. This photo displays the ease with which inadvertent draft type of heat losses can be recognized with the proper thermographic instrumentation.

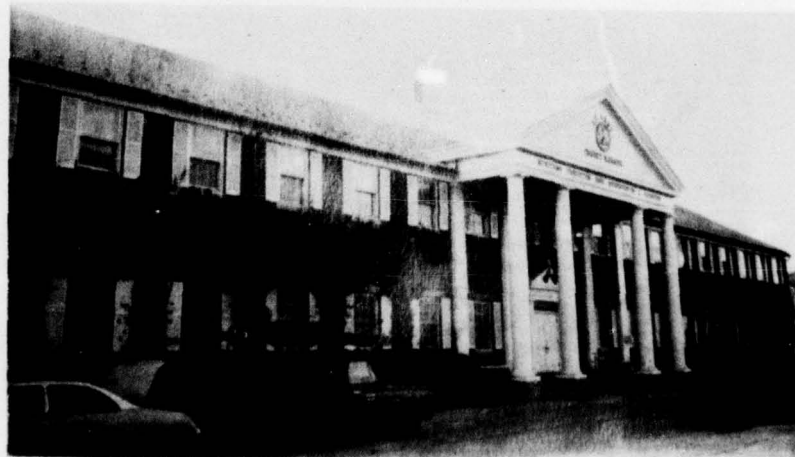
Fig 4a Thermogram of front view of building 171

Figure 4a is a front view of building 171. Note that in this picture the windows are warmer than those in Figure 3. The right side of the first floor appears cooler than the rest of the building. This is not due to the insulating quality of the walls but rather a result of those sections of the wall being ivy covered--as can be seen in the photograph. The walls themselves are probably at a relatively uniform temperature, while the cool thermal image of the ivy is approximately ambient. Attention is drawn to the belfry atop the building with its bright thermal image indicating a heat loss.

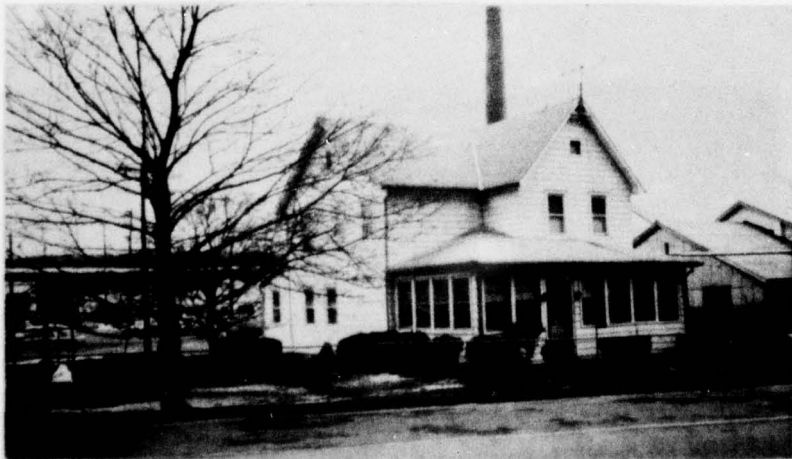
Fig 6a Thermogram of home next to building 59

Figure 6a is a thermogram of the home next to building 59 showing heat leaks under the overhang along the roofline. It is interesting to note the high radiometric temperature along the inside corner above the porch roof. This increased temperature is probably a combination of heat loss and low wind velocity in the region of the inside corner causing a warm region of relatively stagnant air. Great care must be exercised in the interpretation of this type of thermograph in terms of heat loss because of the complicated interplay of air temperature, wall temperature, and convective and radiative exchange which occurs at inside corners of structures.

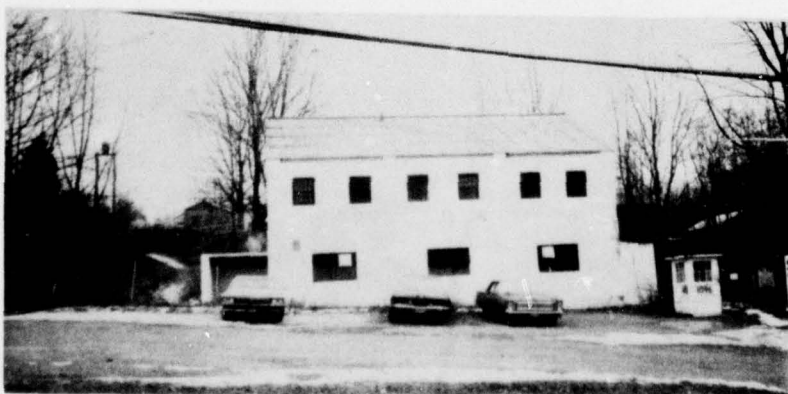
Fig 7a Thermogram of changehouse on Navy Hill Road

Figure 7a, a thermogram of the change house on the Navy Hill Road, is a good example of differences in outside wall temperature due to differences in thermal transmission through the wall. Notice the difference in radiometric temperature between the upper and lower half of the building. Either the insulating value of the wall is different, or the inside temperature of the building is different between upper and lower floors.

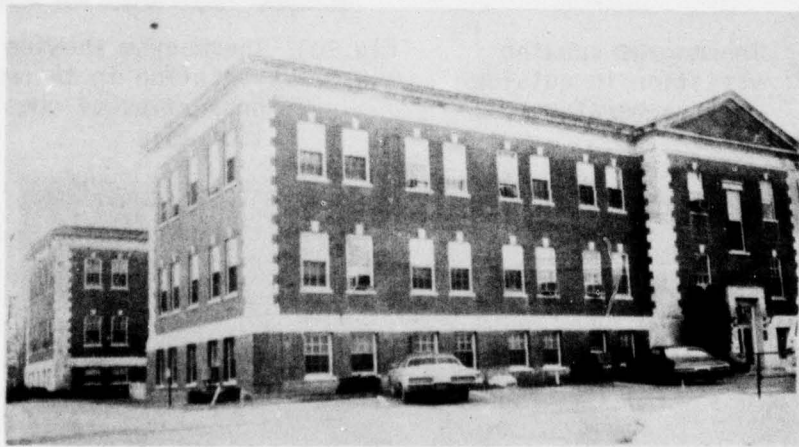
Fig 8a Thermogram of backside of building 151

Figure 8a shows the rear side of Headquarters, building 151 thermographically. Notice the warmer horizontal and vertical areas where the floors and walls butt to the outside wall indicating a high thermal coupling to those regions. Again, notice the effect of double storm windows wherever there is an air conditioner requiring the partial opening of a window.

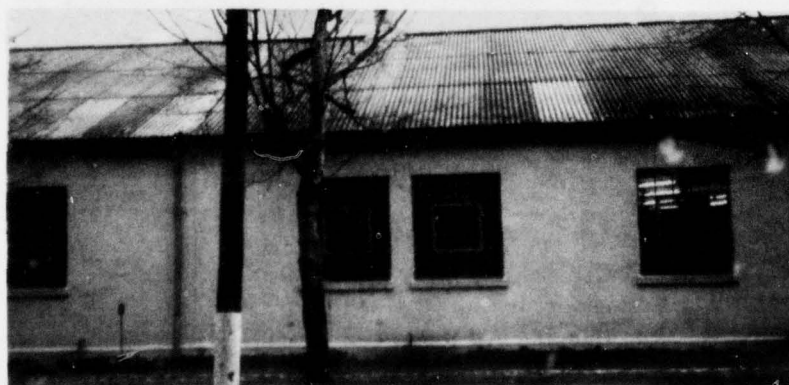
Fig 9a Thermogram of building 10

Figure 9 gives several thermographic views of building 10. Figure 9a shows unevenness in the outside wall temperature of the building. Of particular interest is the very warm region running along the base of the thicker wall section, perhaps indicating a steam pipe imbedded within the wall. This warm region is visible in all three thermograms. In Figure 9b we can see a large difference in outside wall temperature. We feel this is due to a wall mounted radiator located on the inside. The straight line on the left of the window is the outline of a tree and just to the left of it is a section of the wall which is much cooler than the warm region around the windows. Figure 9c is shown to illustrate the difference in the thermal properties of the tile building block and the cement mortar joints. The outside radiometric temperature of the blocks is cooler than the mortar joints since the air holes within the blocks act as an insulating layer. Using the isothermal scale built within the instrument, it was estimated that the center of the tile blocks outside surface are about 3°C above ambient while the mortar joints are about 4.5°C above ambient.

Fig 9b Thermogram showing variation in outside wall temperature

Fig 9c Thermogram showing a variation in thermal properties of construction tile

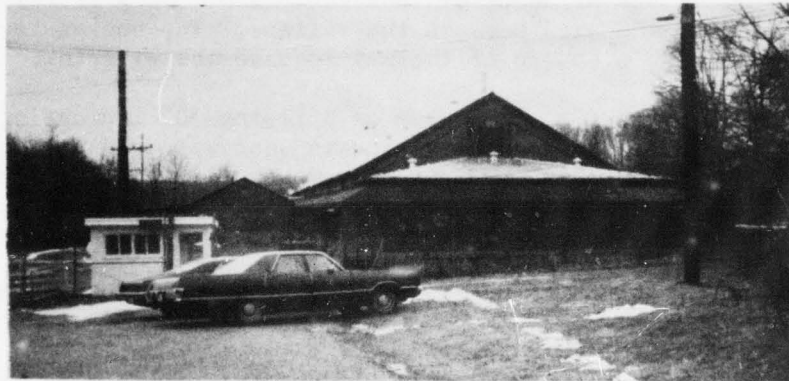
Fig 10a Thermogram of building 329 taken from Picatinny Peak

Figure 10a is a thermogram of building 329 taken with an 8° field of view lens from the vantage point of Picatinny Peak. This illustrates what sort of information is possible from an aerial survey. Detailed resolution is obviously missing, however, this is a good way for spotting gross effects over a large area in a relatively short time. It is obvious, for instance, that the small annex is much warmer on the exterior than the main building. Also of interest are the two very warm windows on the near side of the main building which would warrant a physical inspection.

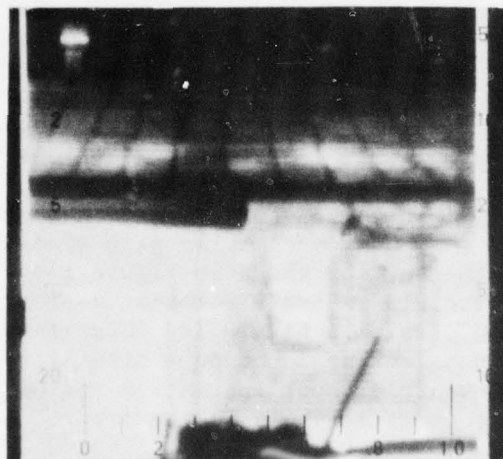
Fig 11 Thermogram of close-up view of building showing heat loss through roof

Figure 11a is a closeup view of a building illustrating detailed localized information in contrast to the information obtained in the aerial view of Figure 10. Notice the heat loss differences in the roof due to variations in the insulation. The parallel lines on the roof are due to the presence of roof rafters offering better thermal insulation than the area between the rafters. The noninsulated overhead door is also a source of thermal loss to the exterior.

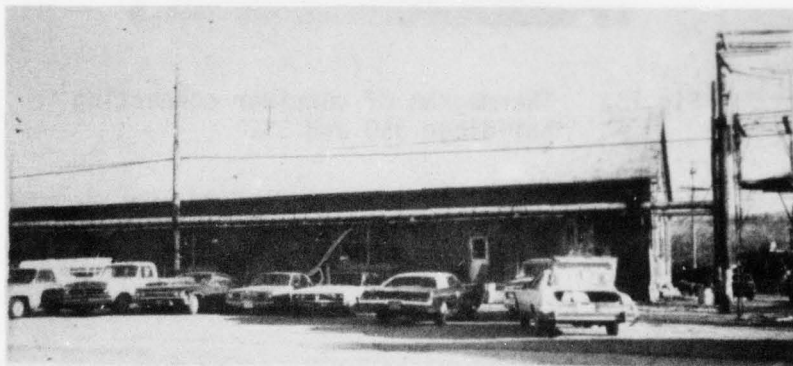
Fig 12a Thermogram of building 307

Figure 12a shows a thermogram of building 307 indicating heat losses through the rectangular region in what was probably a skylight in the roof. This skylight is made of corrugated fiberglass and has since been painted over serving no useful purpose. It has no insulation whatsoever and can very well be the largest single heat loss in the building. Several of these regions are present on 307 and again the same situation exists on building 302 shown in Figure 12c.

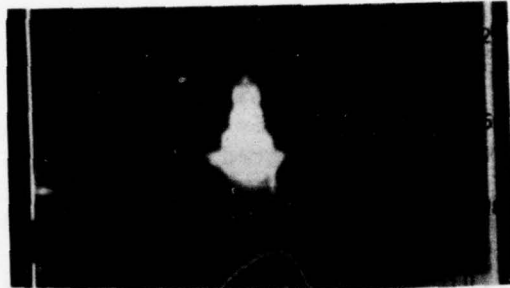
Fig 14a Thermogram of steam pipe and valve (Navy Hill)

Figure 14a is a thermographic recording of a section of steam line running up to Navy Hill. Notice that although the uninsulated valve is about 150°C above ambient, the outside temperature of the insulated pipe section is quite cool. It was noted during the course of this survey that different steam pipe sections had large variation in the insulation quality of the pipe wrapping. For example, in Figure 14c the valve in the 350 area is again about 150°C above ambient but in this case notice that the pipe wrapping has a higher temperature than the section shown in Figure 14a. Neglecting emissivity, variations could indicate somewhat poorer insulation in this particular section of pipe. Figure 14d shows the ease with which poor insulation spots can be found on a steam line. By scanning the steam line from a vehicle, poor insulation regions show up as bright easily discernible areas as shown in the figure.

Fig 14c Thermogram of steam pipe and valve (350 area)

Fig 14d Thermogram showing poor circulation spot in steam line

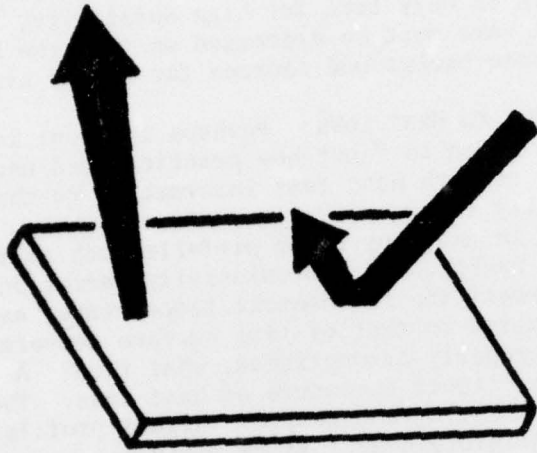
Fig 22 Emissivity

- GOOD EMITTER
- POOR REFLECTOR
- APPEARS "BRIGHT"

- POOR EMITTER
- GOOD REFLECTOR
- APPEARS "DIM"

As indicated earlier, the true temperature of a surface can be correctly inferred from the measured radiometric temperature only if emissivity and reflectance is properly accounted for. This relationship is symbolically illustrated in Figure 22. For example, special care must be taken when working with unpainted, metal surfaces. Since such surfaces have poor emissivity and high reflectivity, it is not unusual for the inexperienced thermographer to measure the thermal reflection from his own body and attribute this to the "temperature" of the metal. Conversely, slight emissivity variations over the surface due to dirt stains, uneven oxidation, etc can be
