GE Document No. 77SDR2181

AN EXPERIMENT TO CORRELATE STRUMMING AND FISHBITE EVENTS ON DEEP OCEAN MOORINGS

May, 1977

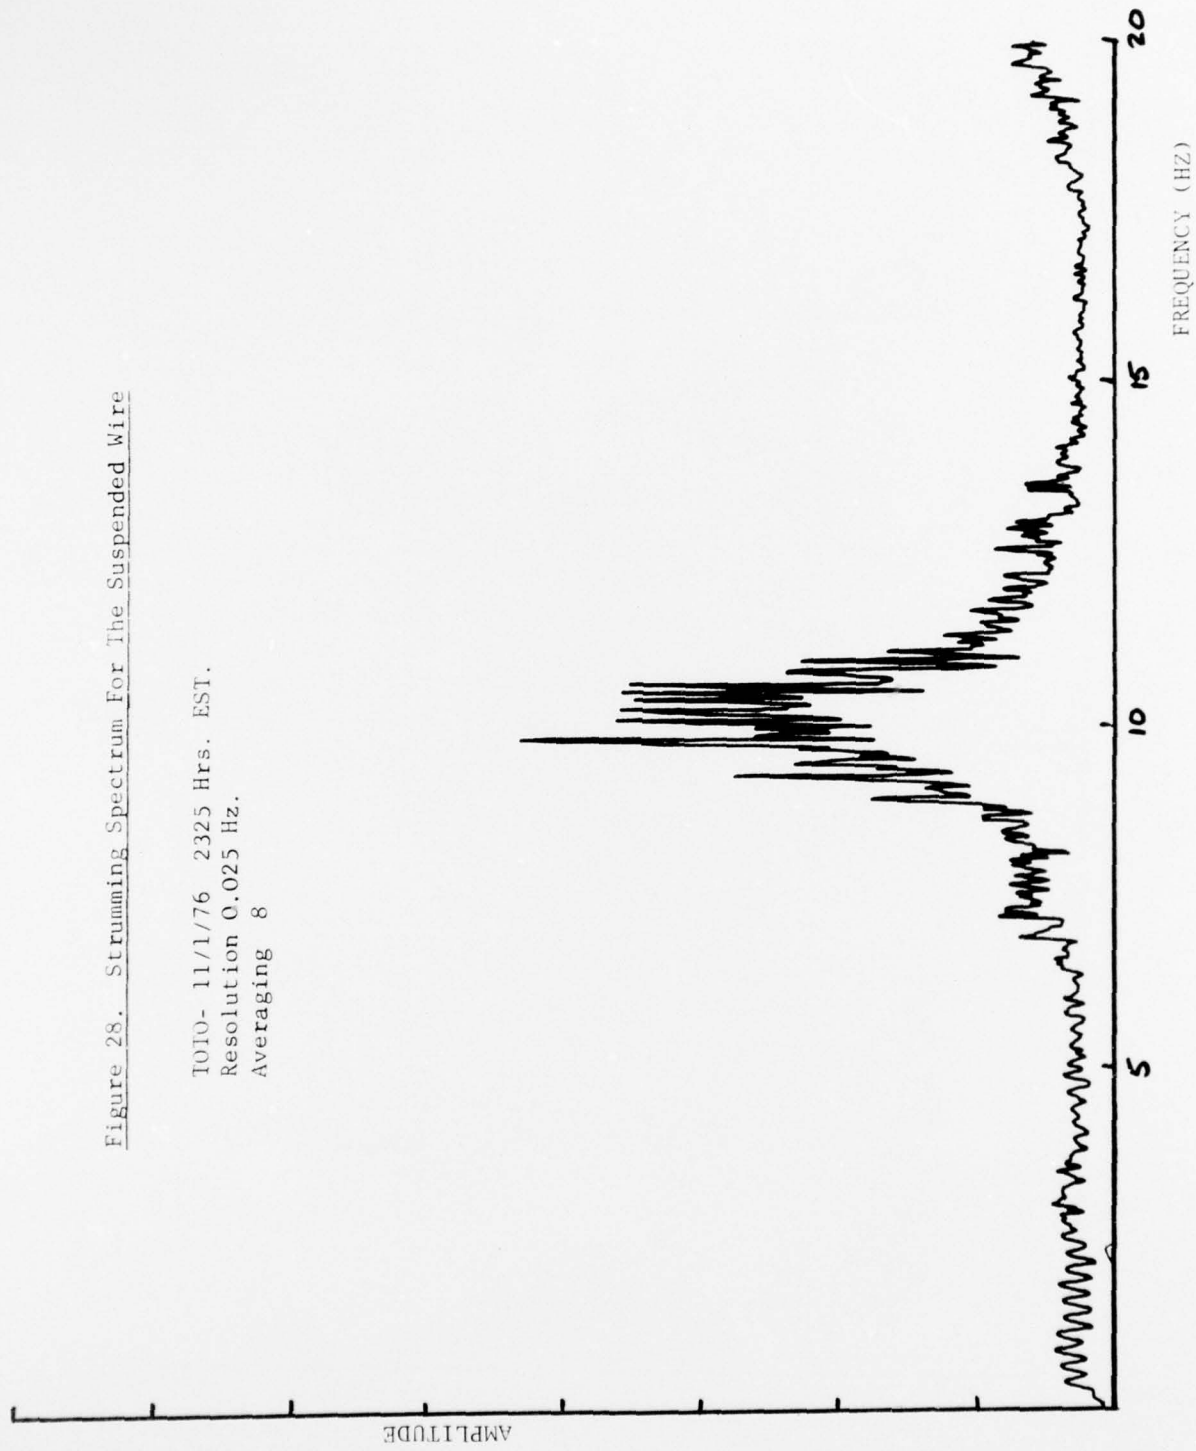
Figure 28. Strumming Spectrum For The Suspended Wire

The wire was suspended from the vessel and, for an 18 hour period, the strumming was recorded on magnetic tape. The location was identical to that of the southern "fishbite" mooring. The currents observed followed a generally tidal pattern as expected. Maximum currents were about 0.7 knots. The vessel remained remarkably still during the recording and motion over the bottom never exceeded 0.05 knots. Figure 27 shows part of a LOFAR grain where the spectral history of the strumming is shown for a 20 minute period. The strumming recorded is rarely steady and a 5 minute period of reasonably steady strumming is rare. One period of approximately 25 minutes where the strumming was sufficiently steady was located and the strumming signature is shown in Figure 28. A typical wide band signature centered around 10 Hz is seen. This was expanded as shown in Figure 29. No fine line structure, corresponding to multimodes of the natural frequency (.025 Hz) were seen. This really should be expected since the attenuation length is estimated to be about 25 meters (at 10 Hz) for the wire.

1010- 11/1/76 2325 Hrs. EST.
Resolution 0.025 Hz.
Averaging 8

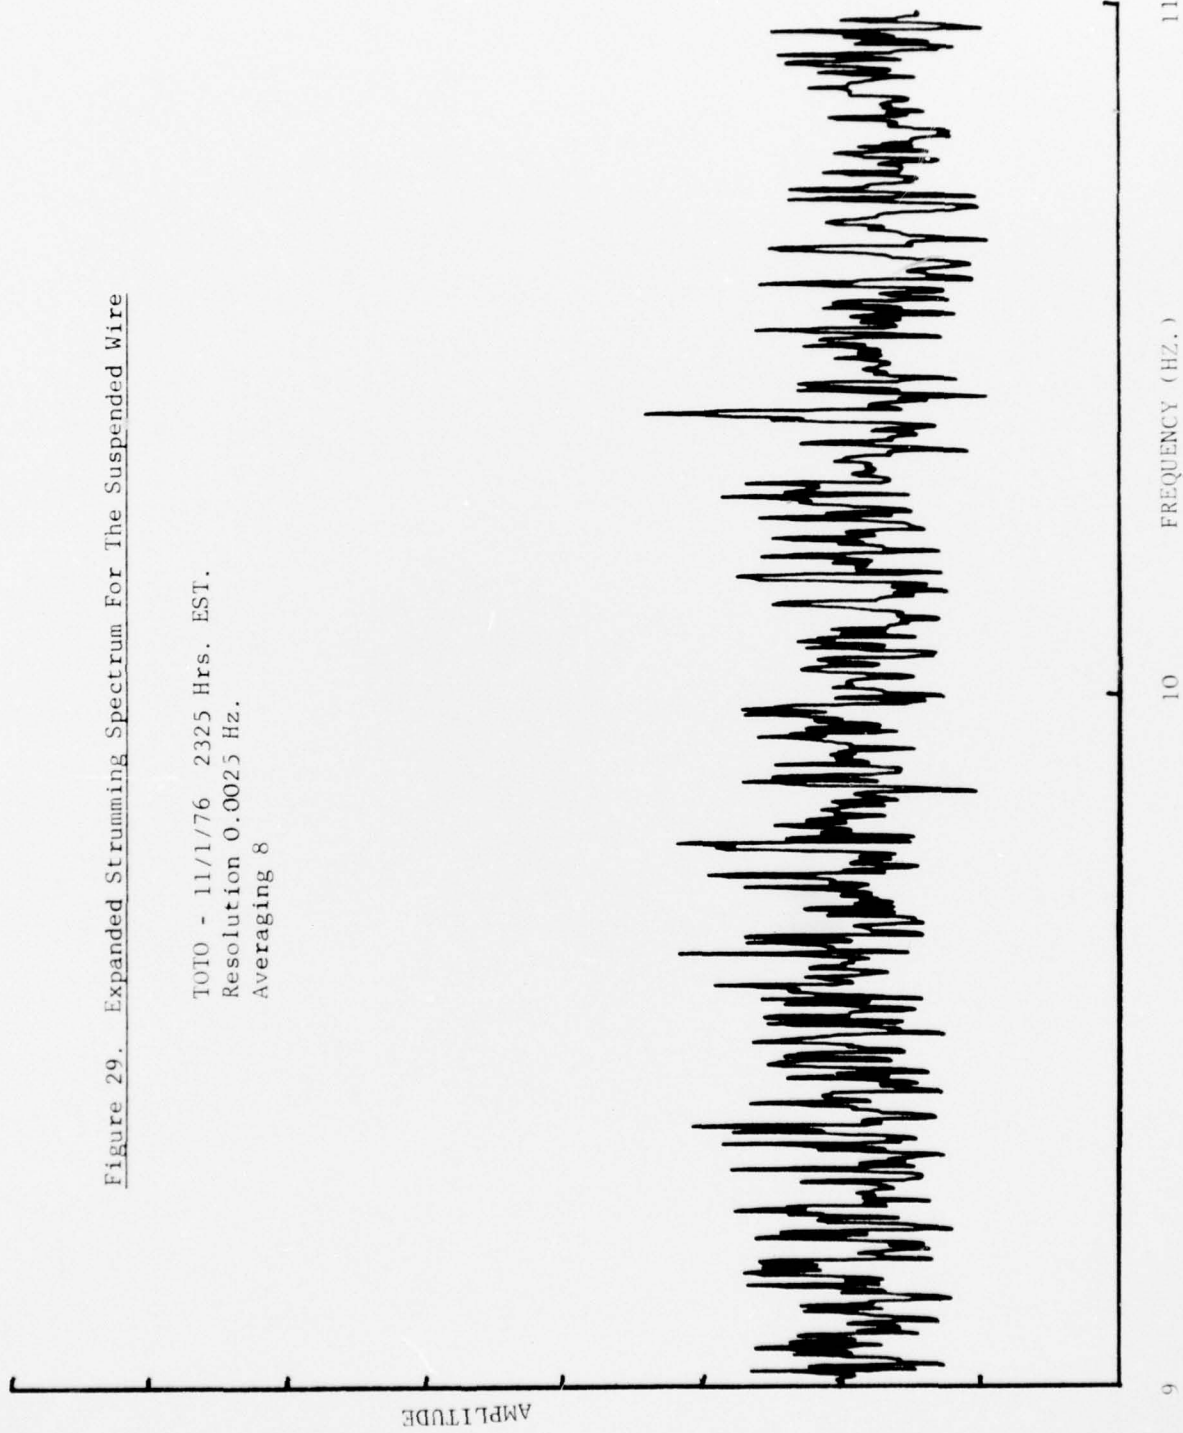
Figure 29. Expanded Strumming Spectrum For The Suspended Wire

TOTO - 11/1/76 2325 Hrs. EST.
Resolution 0.0025 Hz.
Averaging 8
