Research and Development Technical Report

ECOM -4500

DATA LINK VALIDATION PROGRAM

Combat Surveillance & Target Acquisition Laboratory

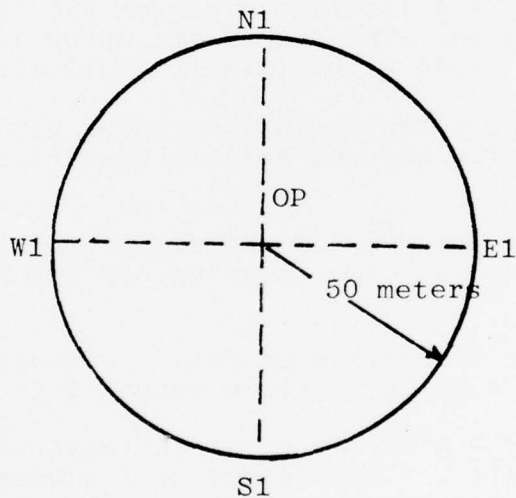
(3) To simulate the effects on the data link's performance associated with emplacement errors. This was accomplished by placing an expendable relay (EXRAY) at five locations for each test configuration. The five locations included an optimum point (OP) representing the desired relay site, and four relay offset points (N1, E1, S1, W1) representing the maximum allowable deployment error. Each offset point was located 150 feet (50 meters) from the OP. (See diagram below):

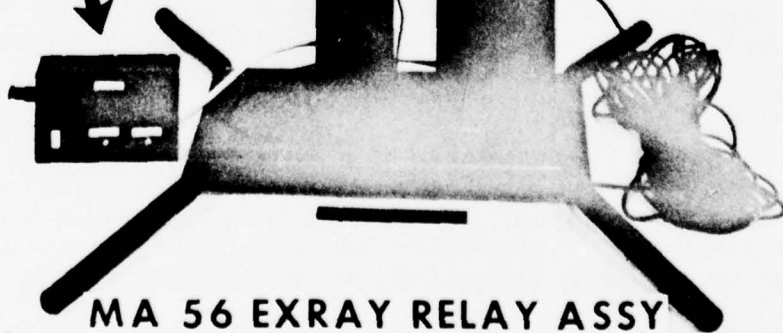
Figure 1

**MA 56 EXRAY RELAY ASSY
& AN/GRQ-21 SPIKE ANTENNA**

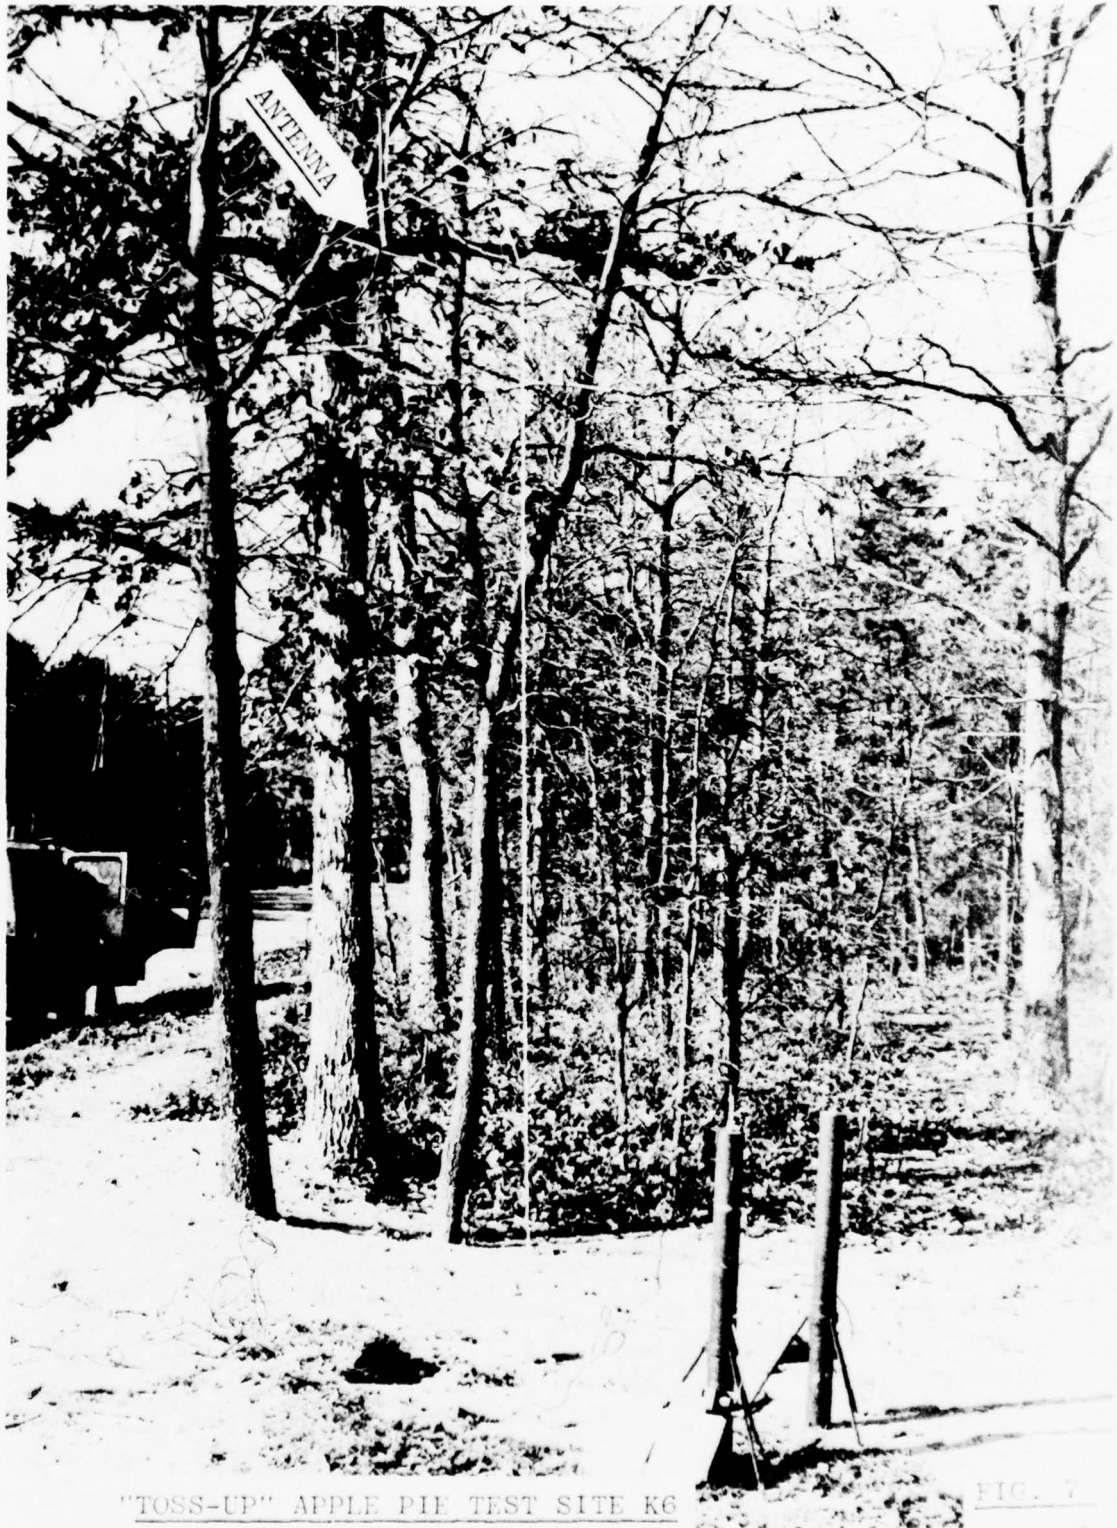
FIG. 7

"TOSS-UP" APPLE PIE TEST SITE K6

- (a) Run 11, a vertical SIRR antenna was used;
- (b) Run 12 and 13, Keyer 1 was replaced with Keyer 2, using the MINISID antenna;
- (c) Run 17, Keyer 1, was replaced with Keyer 2;
- (d) Run 18, the Toss Up antenna was used with Keyer 2;
- (e) Run 19, Keyer 1 used the Toss Up antenna;
- (f) Runs 20 and 22 through 29, a vertical SIRR antenna was used. Notice the improved performance by using a better (low VSWR) antenna.

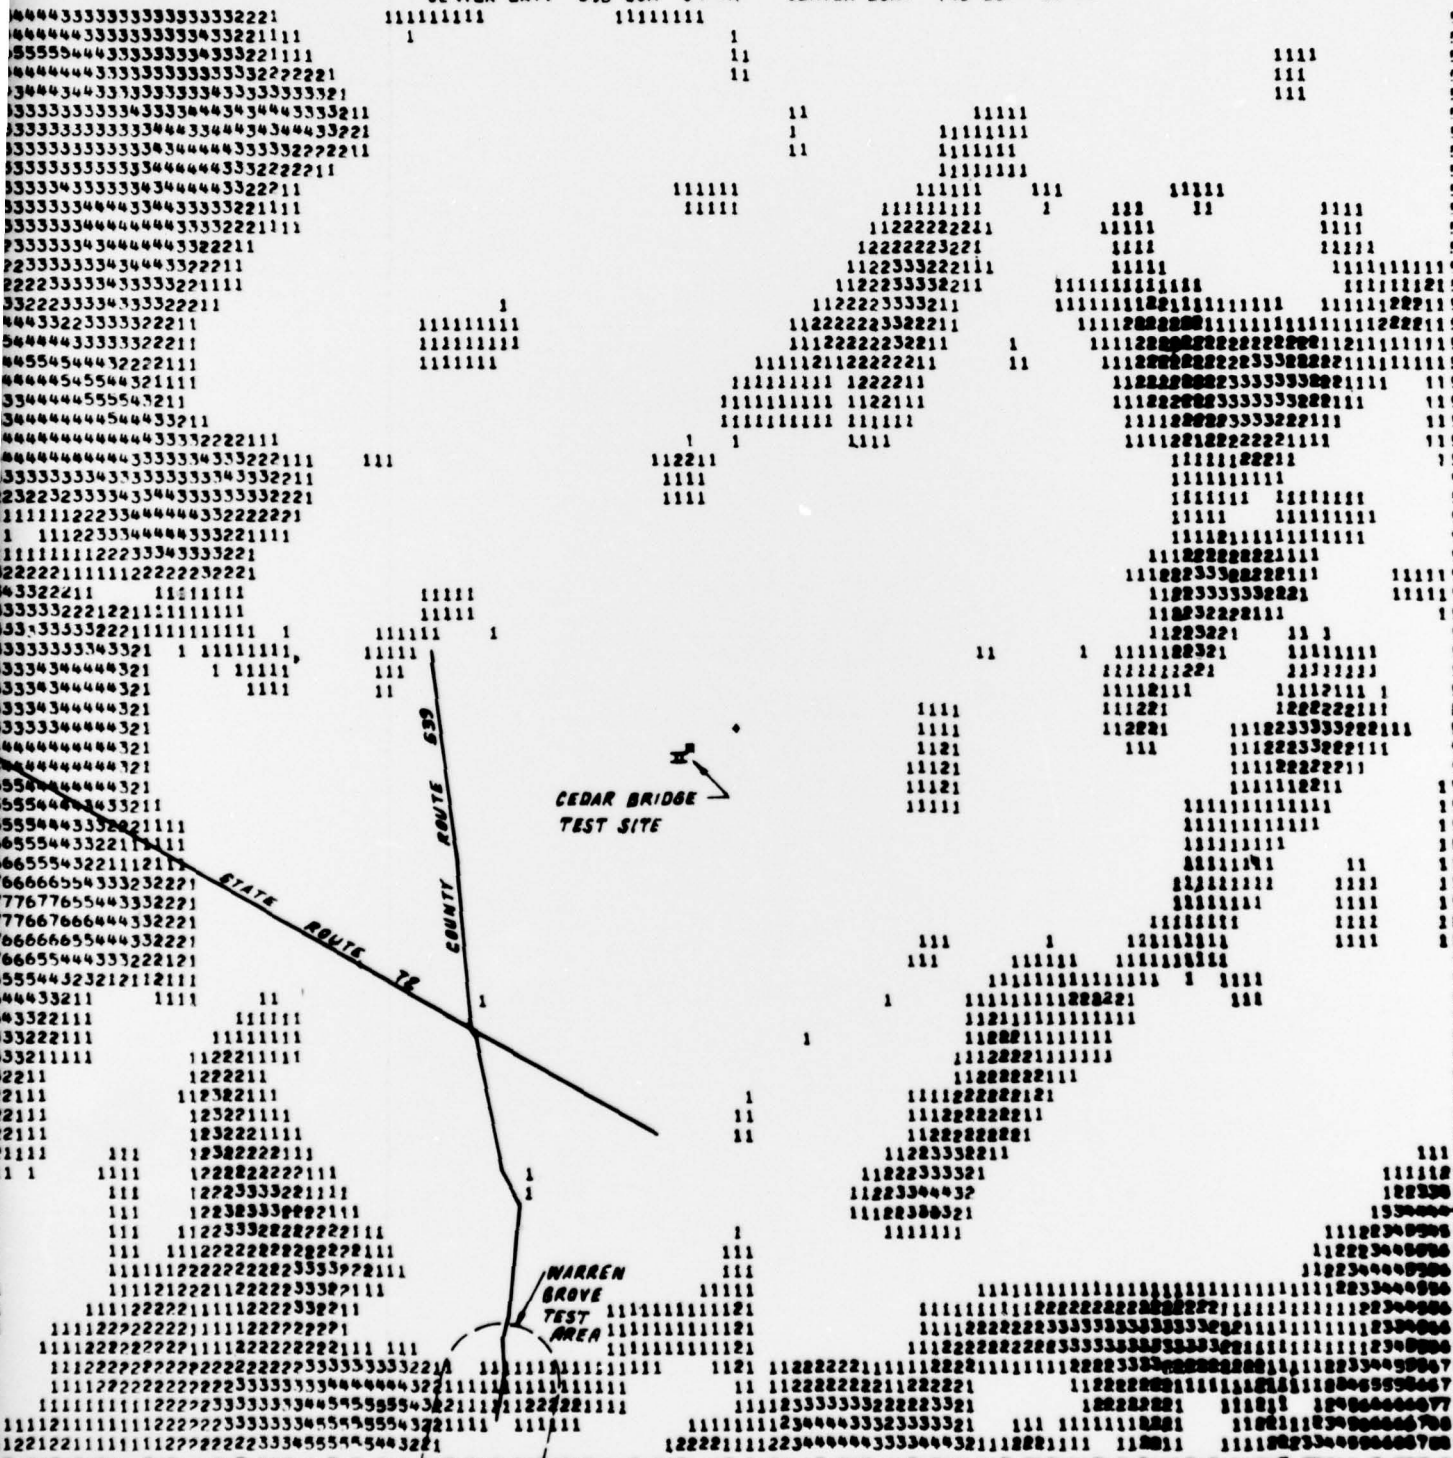
EFFACTIVITY INDEY: 311.00
INCH: .99 ST. MI. (62500:1)
TYPE ANGLE: .00 DEG.

CENTER LAT: 39D 50M 05 0N CENTER LONG: 74D 20M 05 0W

R.F. DEGREE OF SHIELDING CHART
CEDAR BRIDGE TO APPLE PIE AND WARREN
GROVE AREAS
NO SCALE
