TECHNICAL REPORT M-217  
May 1977

Corrosion Behavior of Cracked Fibrous Concrete

## CORROSION BEHAVIOR OF STEEL FIBROUS CONCRETE

by  
D. C. Morse  
G. R. Williamson

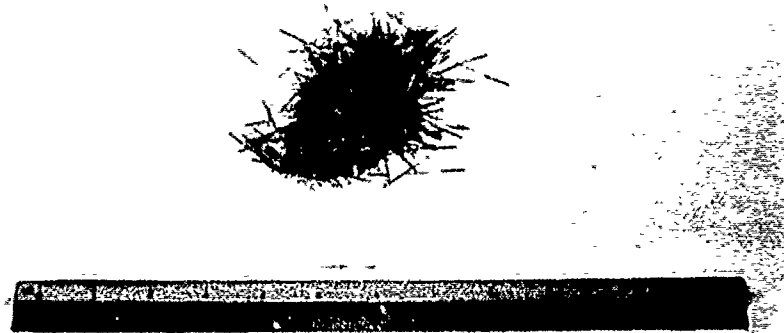
Figure 1. U.S. Steel fibers.

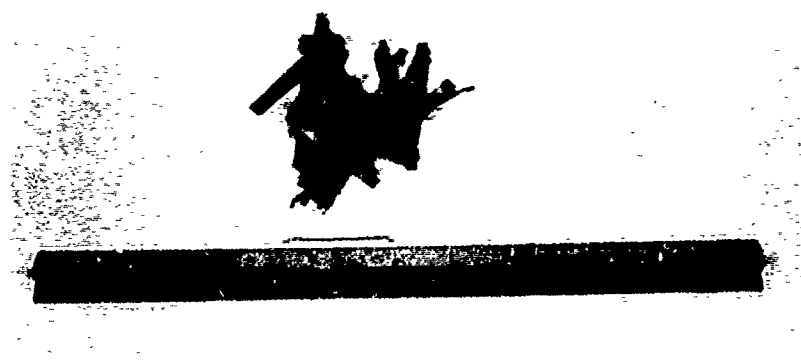
Figure 2. Bekert fibers.

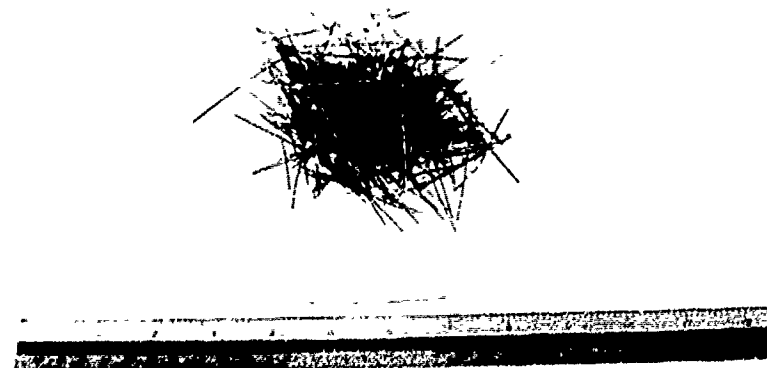
Figure 3. Atlantic fibers.

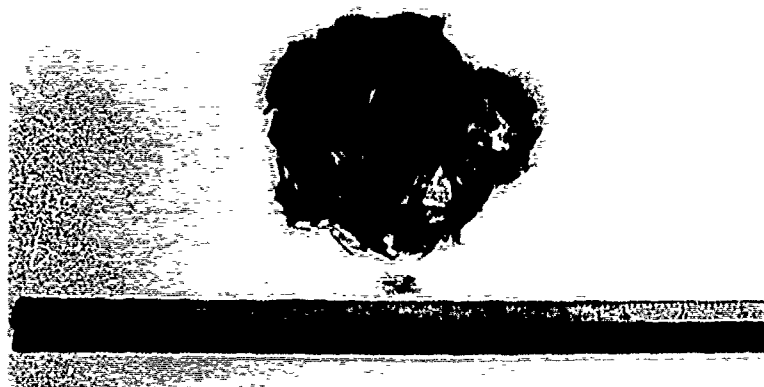
Figure 4. Kevlar fibers.

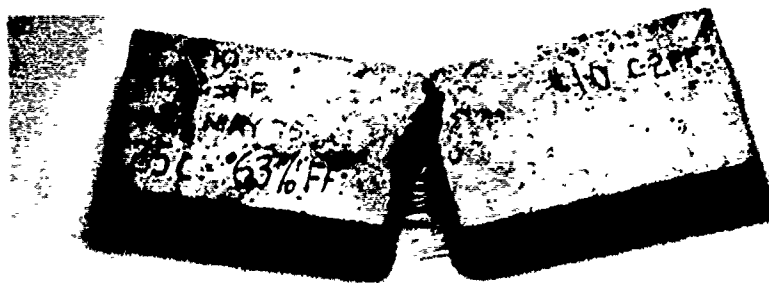
Figure 26. Tested preflawed specimen at 25 wet-dry cycles.

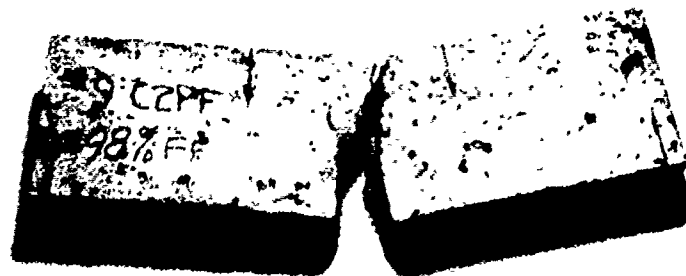
Figure 27. Tested preflawed specimen at 55 wet-dry cycles.
