A CRITICAL SURVEY AND ANALYSIS OF AIRCRAFT SPLINE FAILURES

In Support of
NAVAL ANALYTICAL REWORK PROGRAM

FINAL REPORT
Contract N00156-70-C-2156

August 18, 1971

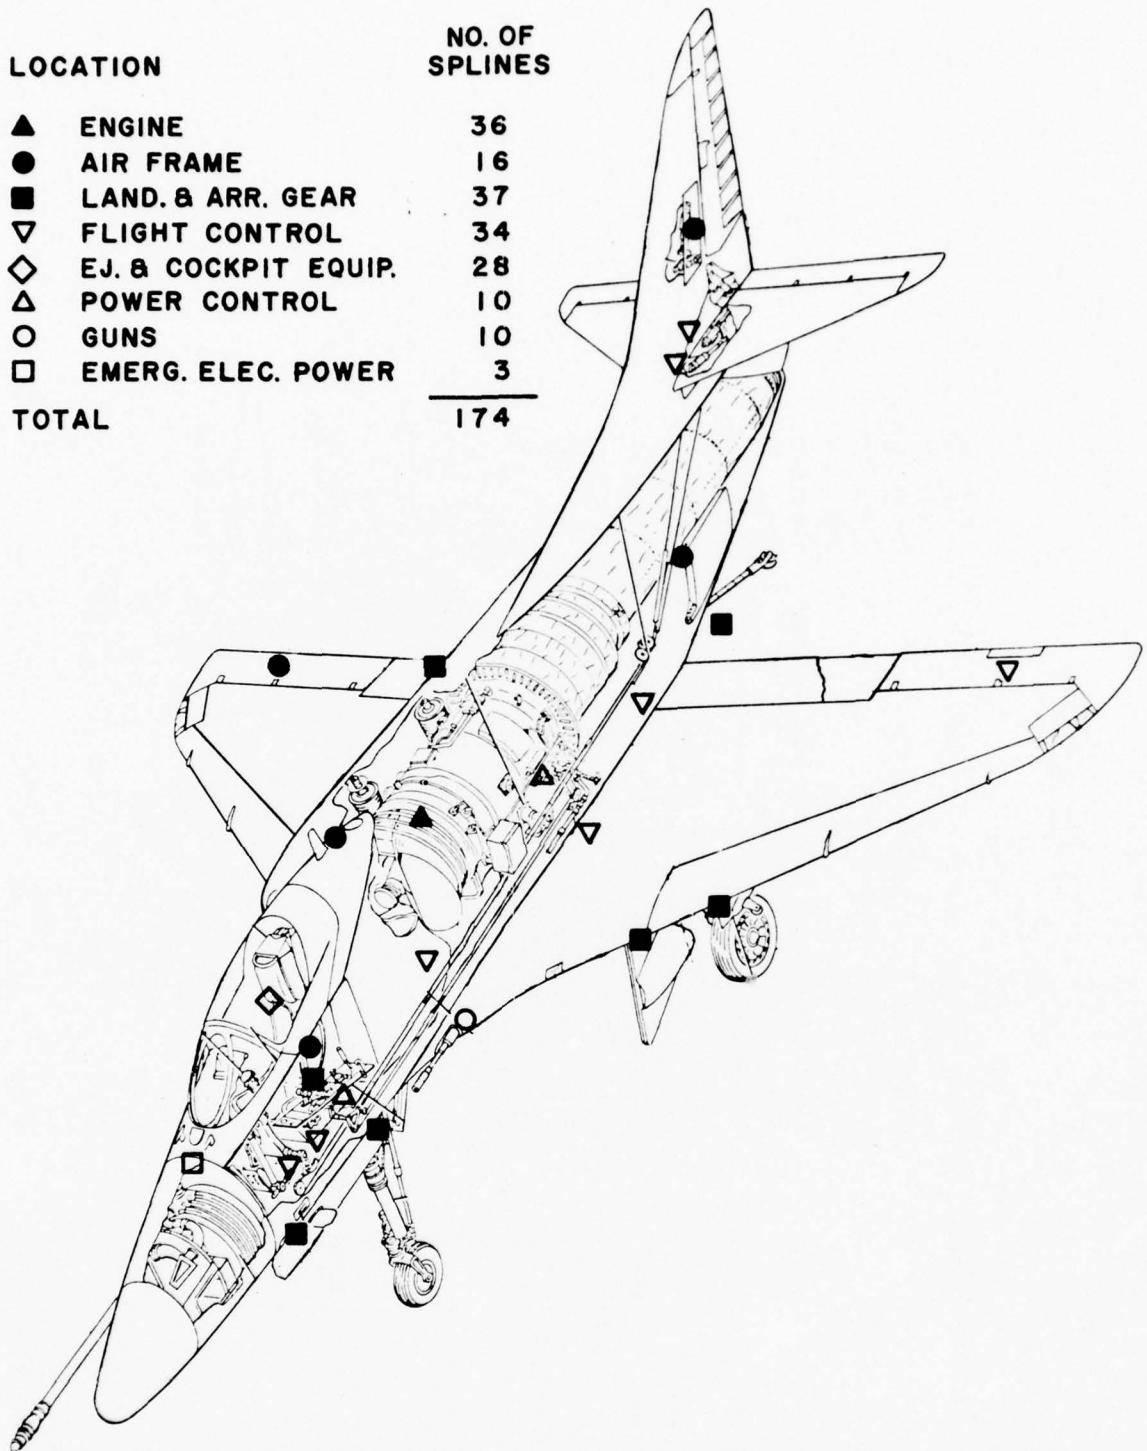
LOCATION	NO. OF SPLINES
▲ ENGINE	36
● AIR FRAME	16
■ LAND. & ARR. GEAR	37
▽ FLIGHT CONTROL	34
◇ EJ. & COCKPIT EQUIP.	28
△ POWER CONTROL	10
○ GUNS	10
□ EMERG. ELEC. POWER	3
TOTAL	174

FIGURE 1. LOCATION OF SPLINE CONNECTIONS ON THE A-4 AIRCRAFT

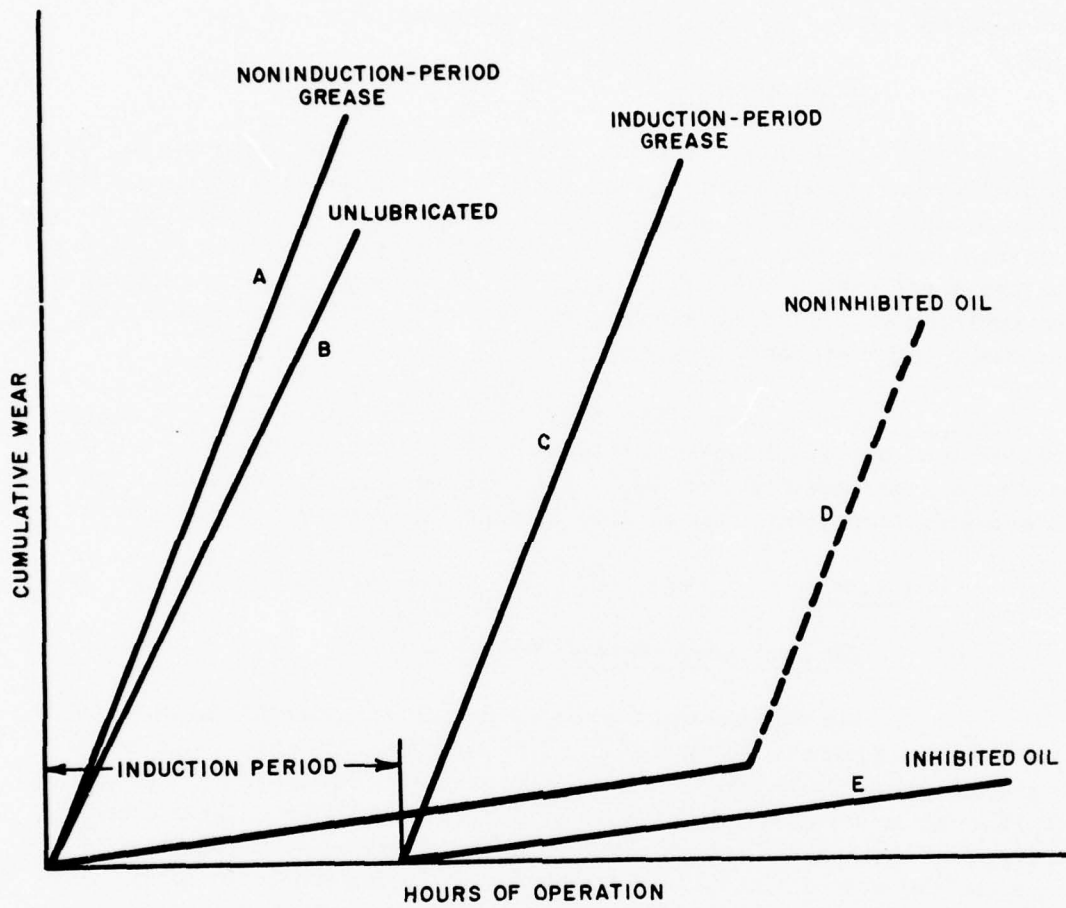
Figure 2 portrays the behavior described. Case B in this figure shows the wear behavior in dry air without any lubricant present. In this case, wear commences immediately upon the start of oscillatory motion, and proceeds at a linear rate. Case A illustrates the behavior with a noninduction-period grease, which also gives immediate and a linear rate of wear, but the rate of wear is noticeably, though

FIGURE 2. GENERAL BEHAVIOR OF SPLINE WEAR IN DRY AIR

only slightly, higher than the unlubricated case. This is because the grease tends to retain the wear debris in the contact zone, which oxidizes or partially oxidizes to form hard oxides and cause abrasive wear.

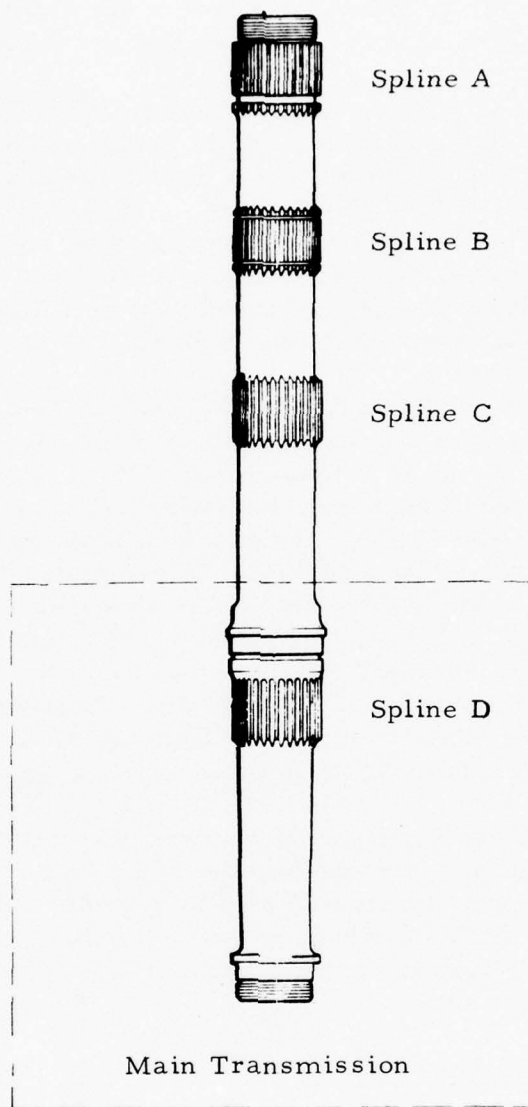
The main rotor mast (Bell P/N 204-011-450) used on UH-1B, C, D, E, F, and H helicopters is reported by ARADMAC to require 50 percent replacement due to pitting damage experienced on the three upper spline connections, i. e., splines A, B, and C shown in Figure 3 (Survey Form Nos. 135, 146, 147). Each main rotor mast costs approximately \$590, exclusive of labor cost. This main rotor mast is used on a vast majority of the helicopters overhauled at ARADMAC; in addition, similar pitting problems have been experienced

FIGURE 3. LOCATION OF SPLINES ON MAIN ROTOR MAST OF UH-1 SERIES HELICOPTERS

on Bell P/Ns 204-010-410 and 209-010-450 which are used on other UH-1 and AH-1 series helicopters. Spline D located in the transmission is oil-lubricated and has not been a serious maintenance problem.

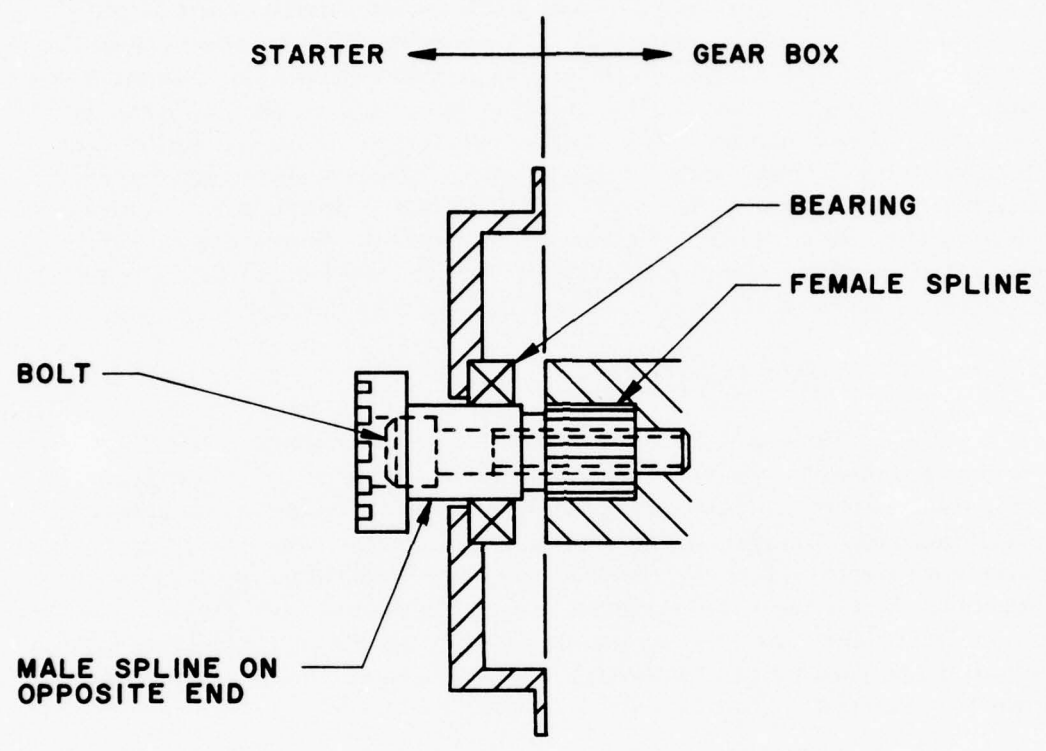
The automatic-disengaging gear-type is illustrated in Figure 4. In this design, the male spline on the starter is bolted directly into the female spline of the gearbox, thereby ensuring that no relative motion is obtained between the male and female splines, thus minimizing or eliminating the possibility of spline wear at the gearbox. Bendix starters utilizing this design are used on the following aircraft:

FIGURE 4. AUTOMATIC DISENGAGING GEAR-TYPE STARTER DRIVE

The principal advantage of this design is that after the engine has started, there is complete disengagement from the engine of nearly all of the rotational mass of the starter. Thus, during engine operation, only a very light load is transmitted through the bolt-on splines.

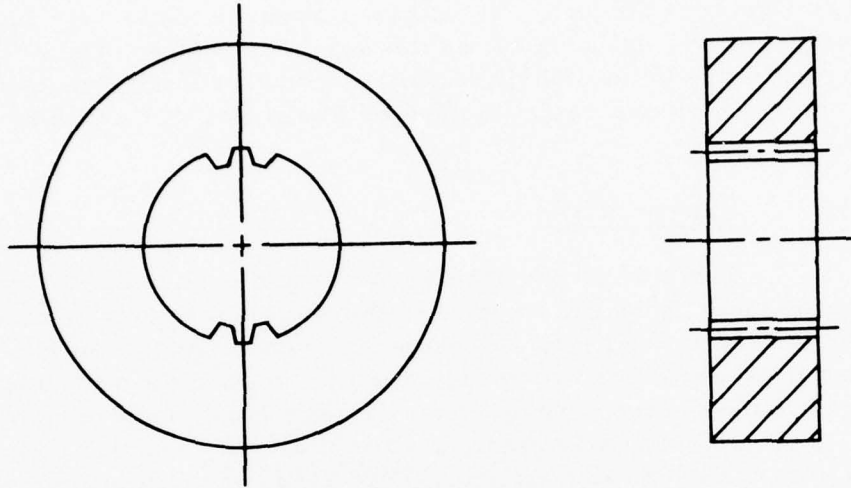
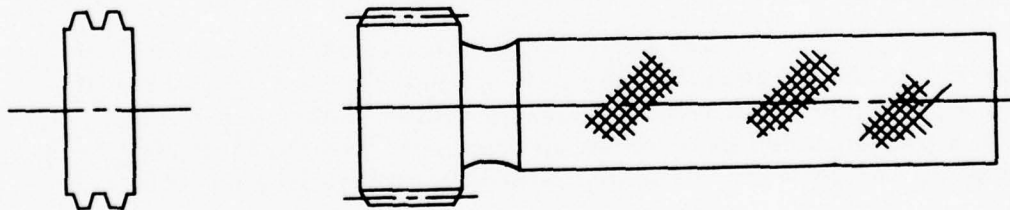
d. United Airlines also utilizes another type of go-no-go gage on the female spline at the gearbox. This tee-handle gage has the male spline having a 20 percent greater tooth width. Once 20 percent of the female spline has worn off, the gage will slide into the female spline rejecting the female spline. The end of the female spline must be worn for effective use of the gage.

e. United Airlines utilizes a similar device for the male spline. A thin plate is made having a cut-out of a female spline. The cut-out is made so as to represent a female spline having oversize (wider) teeth. Once the male spline wears so that it can pass into the female go-no-go gage the spline is rejected.

A. MALE SPLINE GAGE

B. FEMALE SPLINE GAGE

FIGURE 6. GO-NO-GO GAGES USED BY SQUADRONS

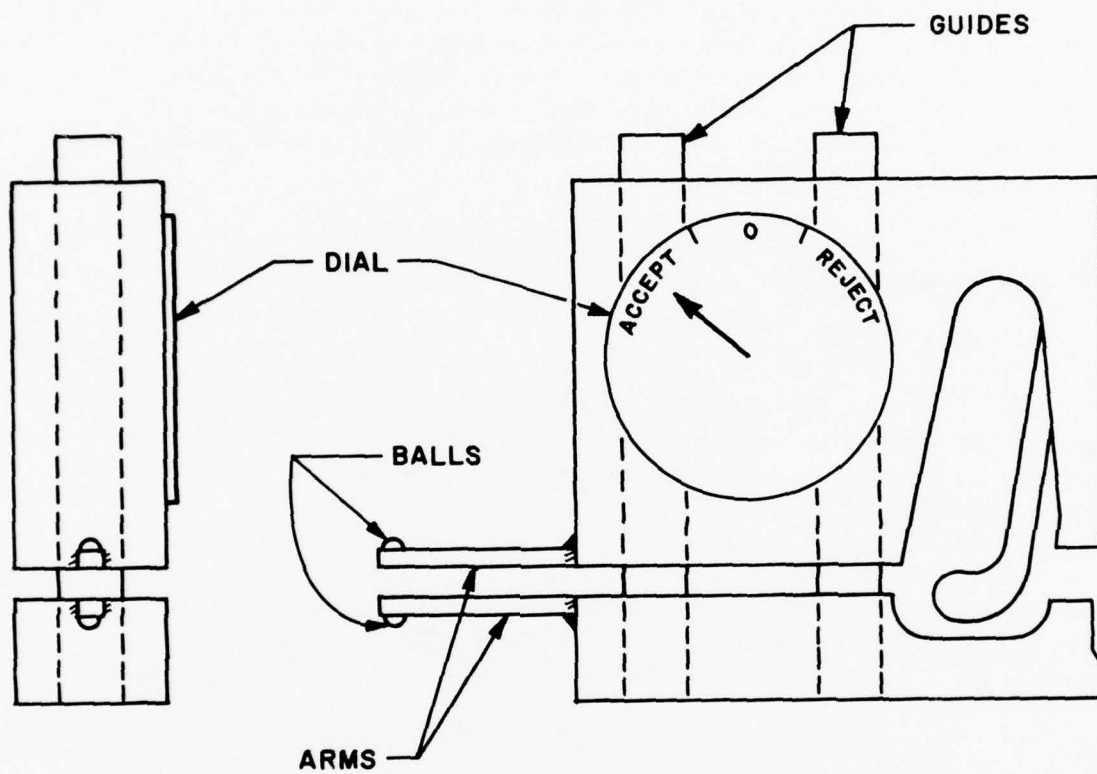
Quonset Point engineers have incorporated square tips (Q. P. Drawing 42330-C) in place of the balls on the two arms of a Versa-Dial gage (manufactured by Standard Gage Company, Poughkeepsie, New York). A standard gage block is used to set the gage for a specific size spline. The trigger is depressed allowing the arms to move closer together so that the tips can be installed in a female spline. The trigger is then released and the needle will indicate "accept" or "reject". This device cost approximately \$1,200. It can be reset for other size splines; however, this is not normally accomplished in the course of routine spline measurement, therefore requiring a large number of gages for a variety of male and female splines.

FIGURE 7. VERSA-DIAL TYPE GAGE

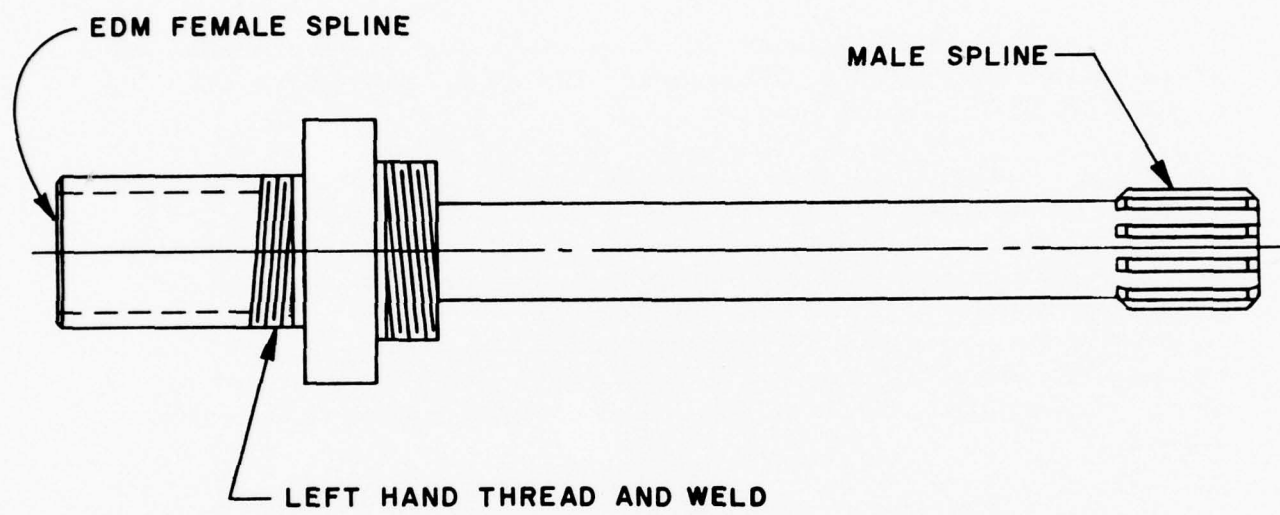
FIGURE 8. REPAIR OF SPLINE SHAFT USED ON HYDRAULIC-OIL PUMP

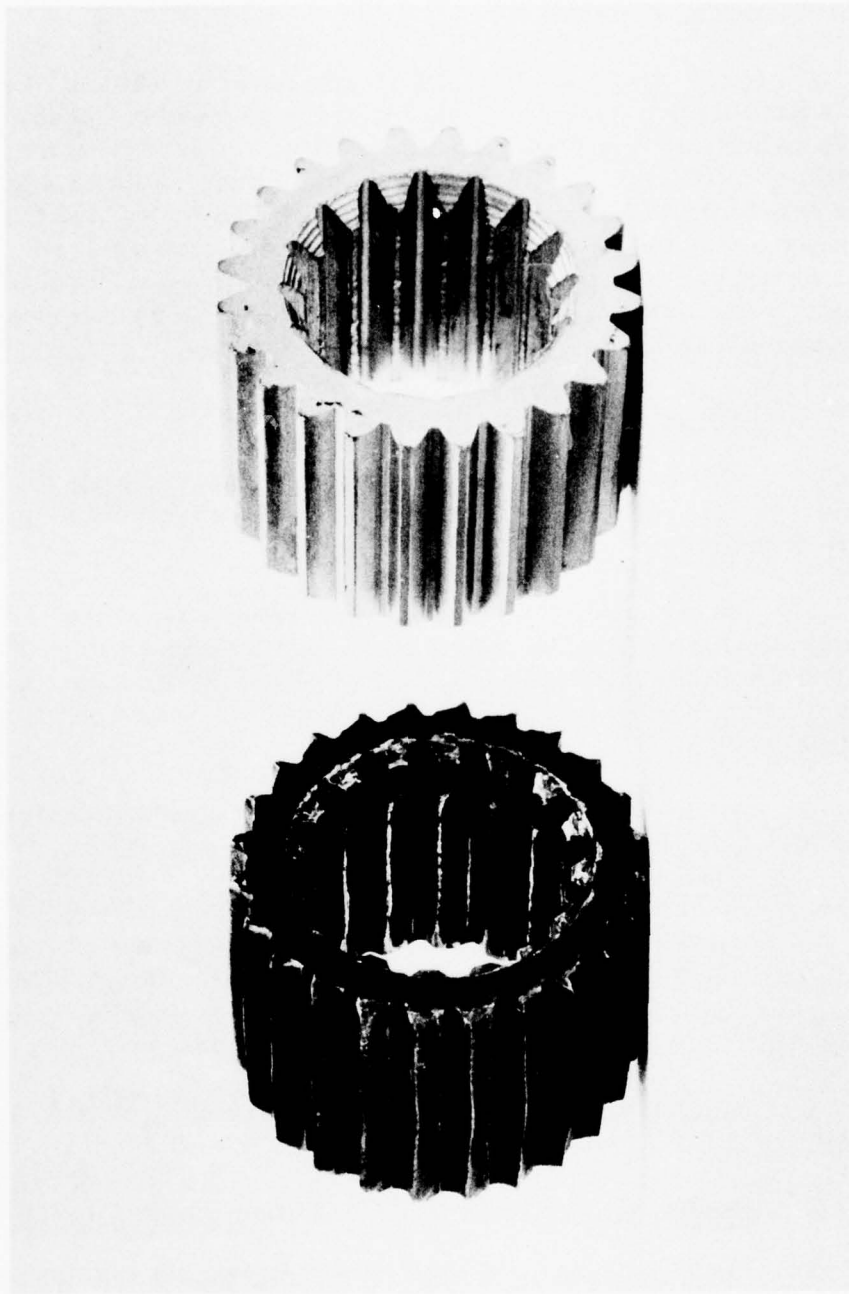
The photograph in Figure 9 illustrates a typical spline muff used on a current problem area (Survey Form No. 199, Tinker) before and after excessive spline wear. The muff may be described as a cylinder having female splines within the cylinder and male splines on the outside. The muff is generally used between the male accessory spline and the female spline on the accessory gearbox. The muff is held in place over the small male accessory spline by means of a snap ring or pin. Its primary function is to allow the spline connection to accept more

FIGURE 9. TYPICAL SPLINE MUFF BEFORE AND AFTER EXCESSIVE WEAR
(Survey Form No. 199, Tinker)

misalignment. The muff is being used by many accessory manufacturers for use at the interface spline connection to the gearbox and in some cases within the accessory itself. Since the muff is considered a part of the accessory, the accessory manufacturers have control of its design. This will be particularly true for new splines made under the MS standards which do not specify spline materials and provide that the case hardness should be greater than Rockwell C 56. In the AND standards, the material selection is left up to the discretion of the designer.

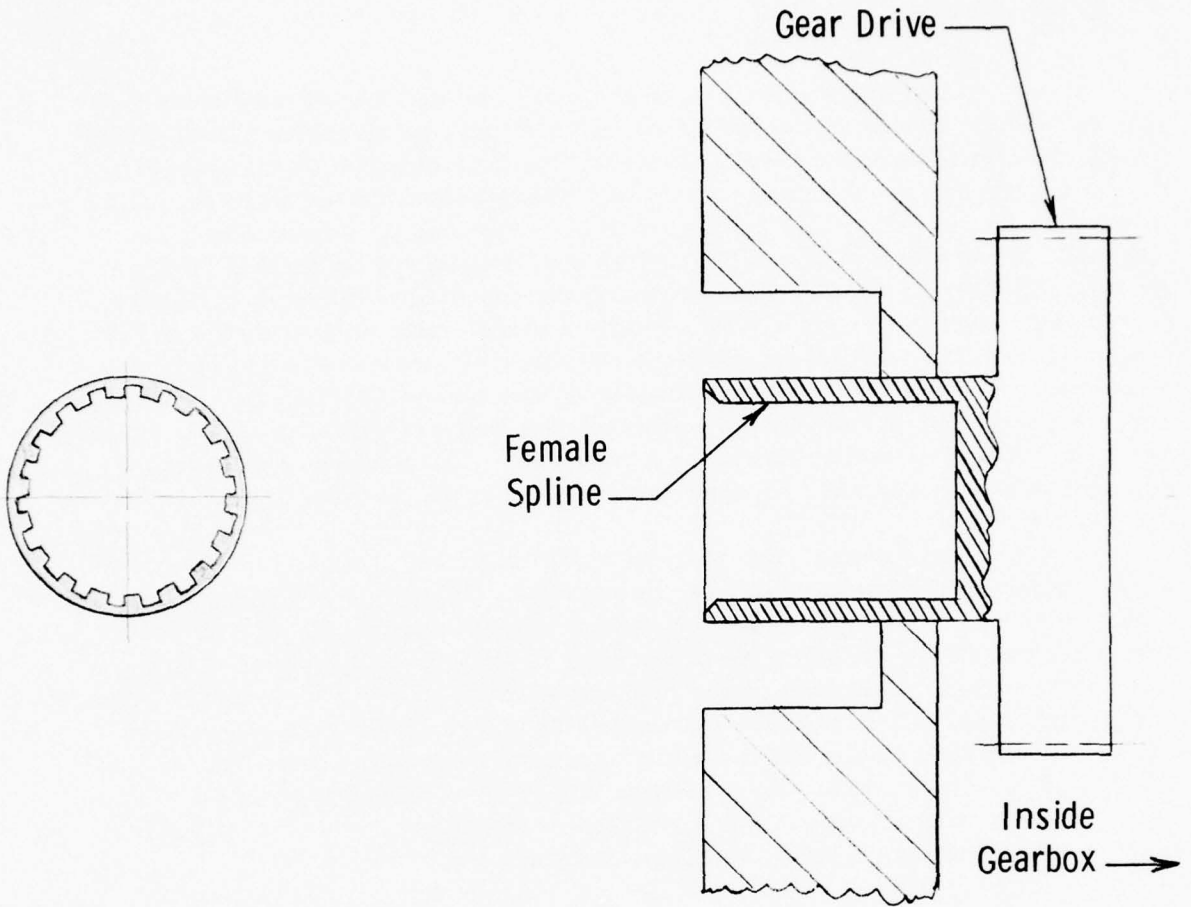
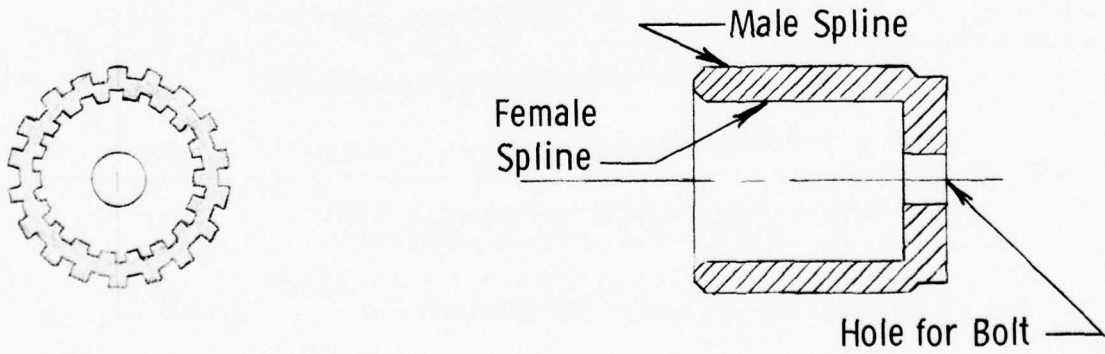
The expendable bolt-on spline is one of several techniques, all of which may be considered as an extension of the spline muff concept discussed in the preceding chapter. It is believed to be worthy of exploitation from the economic standpoint.

Figure 10A illustrates a conventional engine accessory gearbox pad spline connection. In this design, several female splines are provided on the gearbox to drive various engine accessories. An accessory, such as a generator, fuel pump, hydraulic pump, or starter, will have a male spline which mates with a corresponding female spline on the gearbox. In this arrangement, once the female spline is worn, it must be replaced; but that would entail disassembly of the gearbox.

A. TYPICAL GEARBOX

B. EXPENDABLE BOLT-ON SPLINE

FIGURE 10. TYPICAL ENGINE ACCESSORY GEARBOX AND BOLT-ON SPLINE

- a. Development of expendable bolt-on splines of optimum design for use in critical interface spline connections.

b. Modification of existing gearboxes to accept expendable bolt-on splines in critical applications.

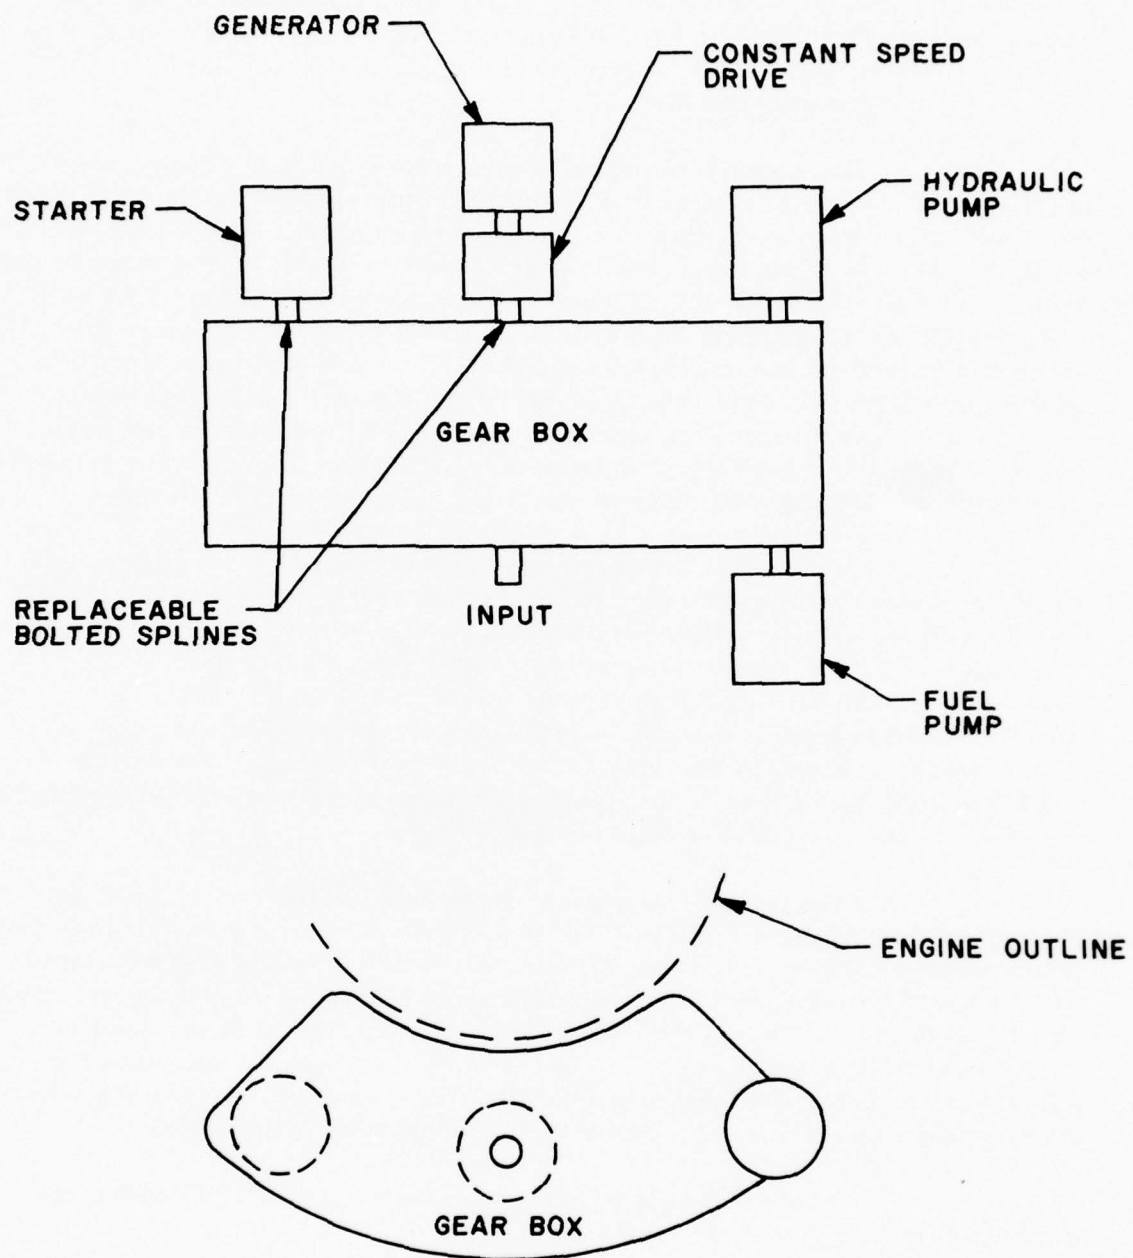
FIGURE 11. SPLINE CONNECTIONS ON GEARBOX OF JT-8D COMMERCIAL AIRCRAFT ENGINE

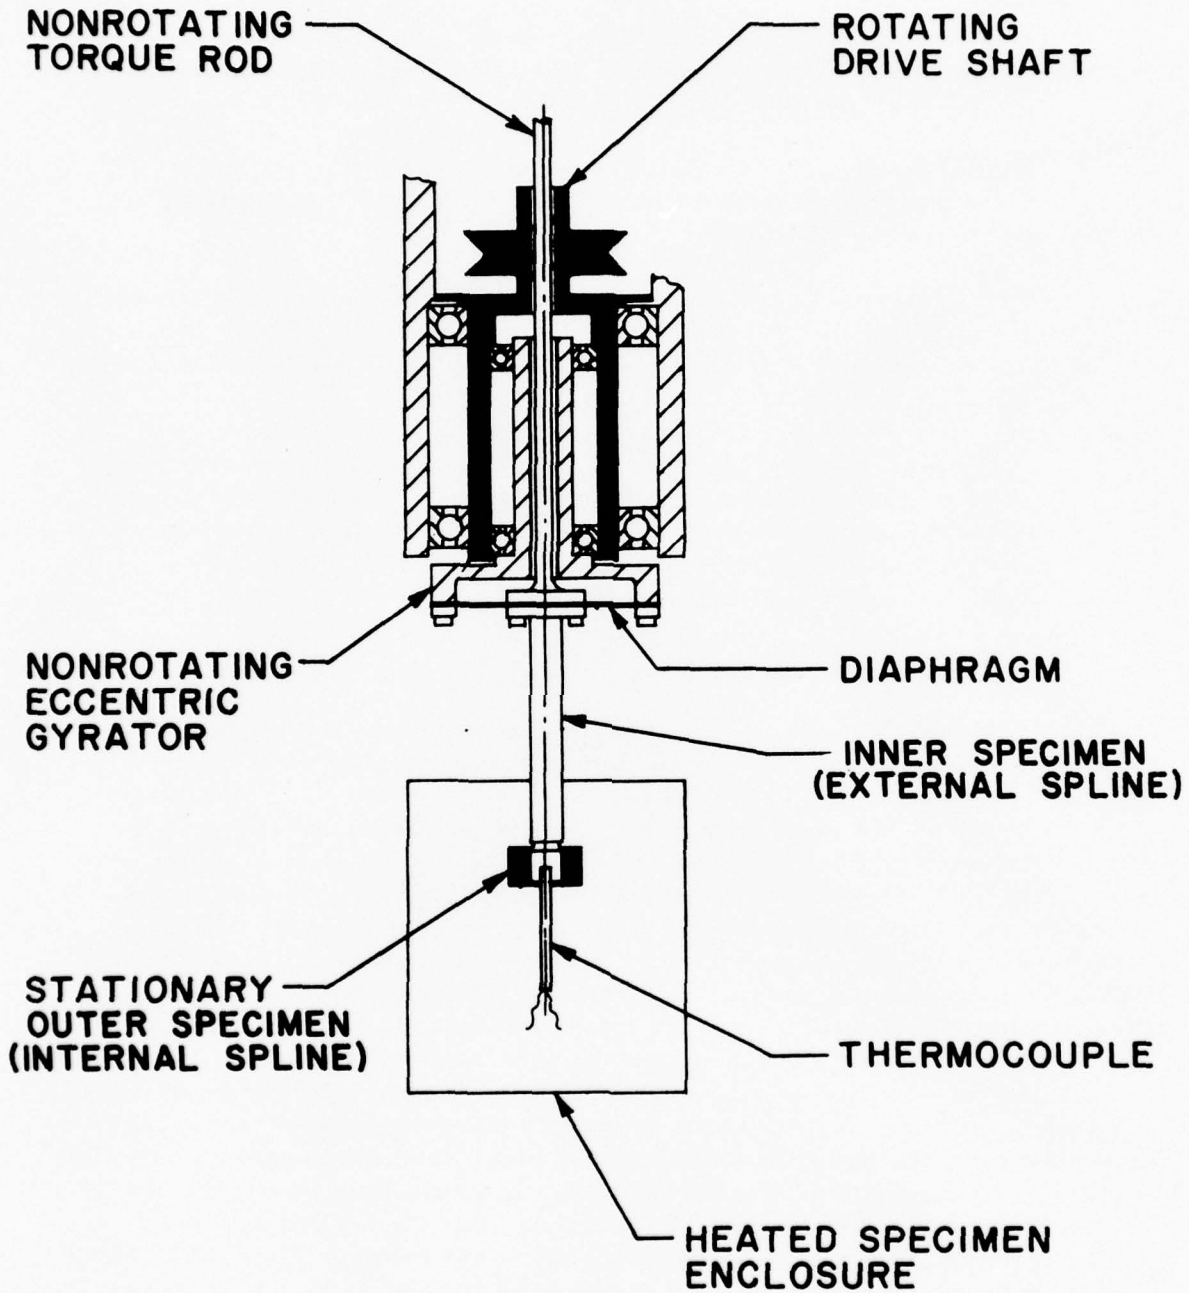
The design of the spline wear tester is shown in Figure A-1 with the details of the spline specimens illustrated in Figure A-2.

In the spline wear apparatus, the splined outer specimen is clamped in a fixed position, and the flanged end of the splined inner specimen is caused to gyrate without rotating, thereby simulating the relative oscillatory motion of a pair of angularly misaligned splines. The gyratory motion is produced by placing a nonrotating gyrotor shaft eccentrically within a cylindrical drive shaft which rotates at 4400 rpm. The amount of eccentricity can be controlled and varied. For most of the work reported herein, the eccentricity was such that it resulted in a spline misalignment of 0.006 inch per inch of spline length. To accommodate this misalignment, a diaphragm is used to provide the necessary flexibility between the gyrating shaft and the inner specimen shank. A flexible torque-transmitting rod is attached directly to the flanged end of this shank through the diaphragm. This torque rod is extended upward through the hollow gyrotor shaft to a convenient location where the torque is applied. Since the torque rod is mounted vertically, a lever system is provided to allow the application of torsional load with a deadweight. As the spline teeth wear during an experiment, the deadweight gradually moves downward, and the changing position is detected and recorded with a linear variable differential transformer instrumentation system.

FIGURE A-1. SCHEMATIC REPRESENTATION OF SwRI SPLINE WEAR TESTER

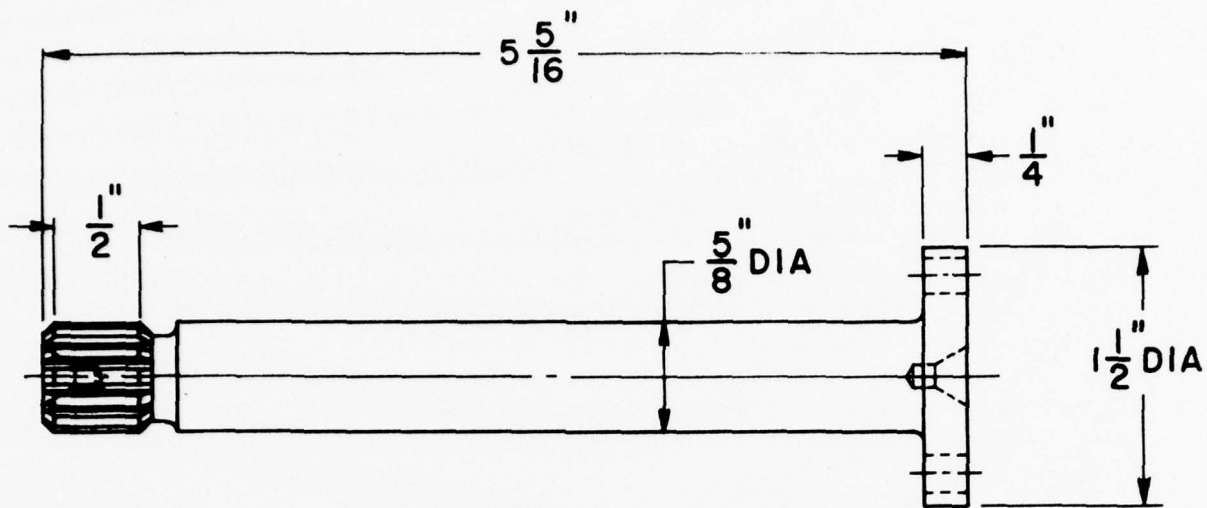
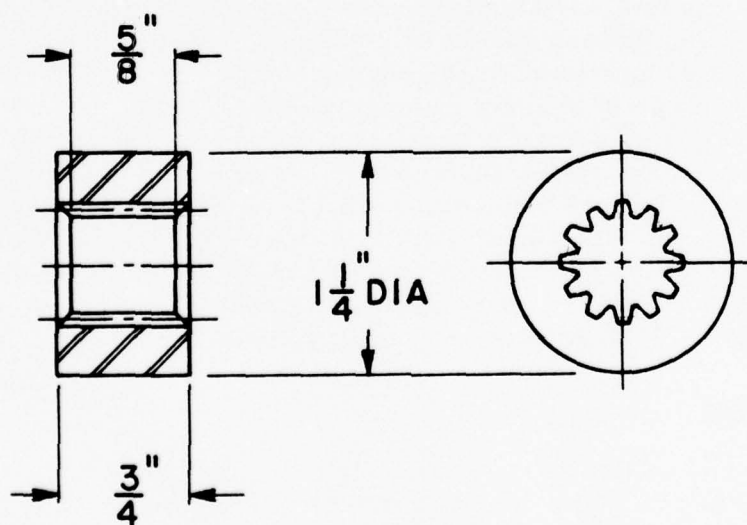
INNER SPECIMEN (EXTERNAL SPLINE)

OUTER SPECIMEN (INTERNAL SPLINE)

FIGURE A-2. DETAILS OF SPLINE SPECIMENS

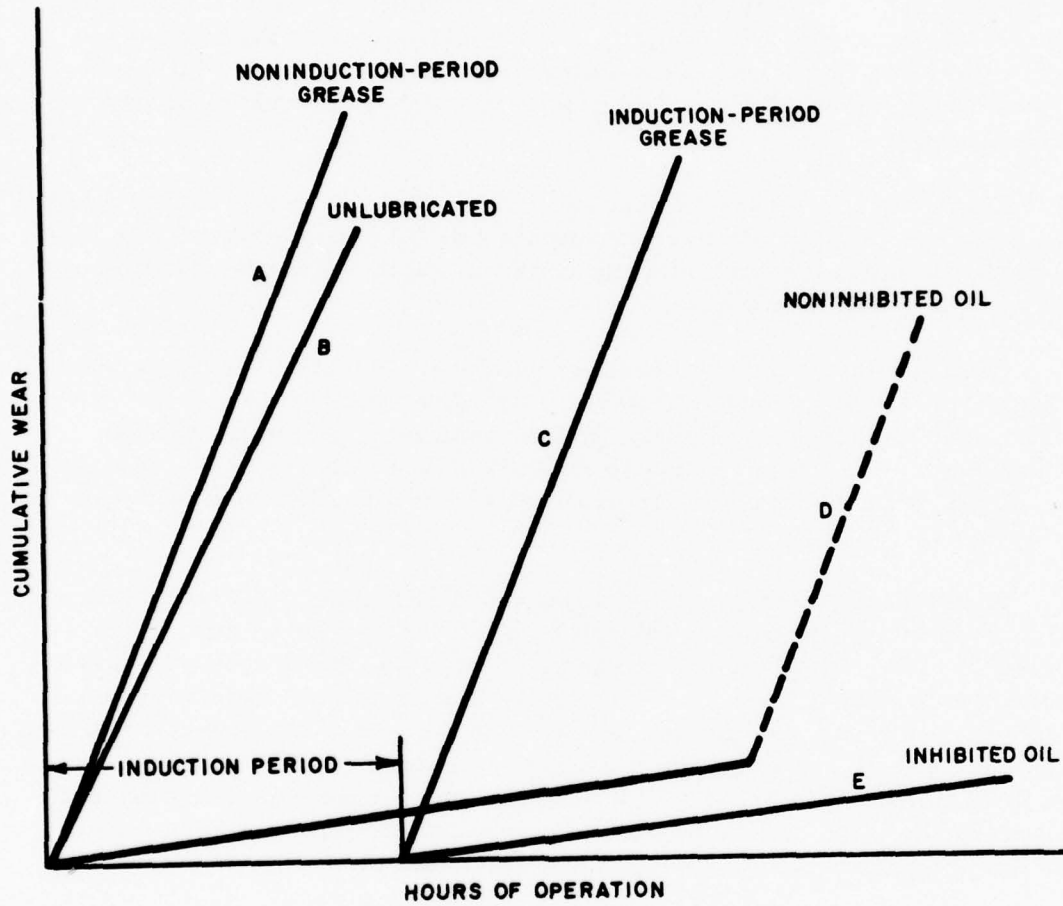
If the splines are lubricated with a fixed and limited amount of a noninhibited oil (no induction period), the wear behavior would be as illustrated by Case D. Without an induction period, wear commences immediately upon the start of relative motion. However, in this case, the wear rate, while also linear, is very low because the

FIGURE A-3. GENERAL BEHAVIOR OF SPLINE WEAR IN DRY AIR

presence of the liquid tends to help carry the wear debris away from the contact zone. Further, presence of oil tends to minimize the oxidation of the wear debris. However, after the liquid has been "pushed away" from the contact zone by the repeated oscillatory motion, there is no more lubricant present and hence a period of rapid wear ensues, much as in the unlubricated case.

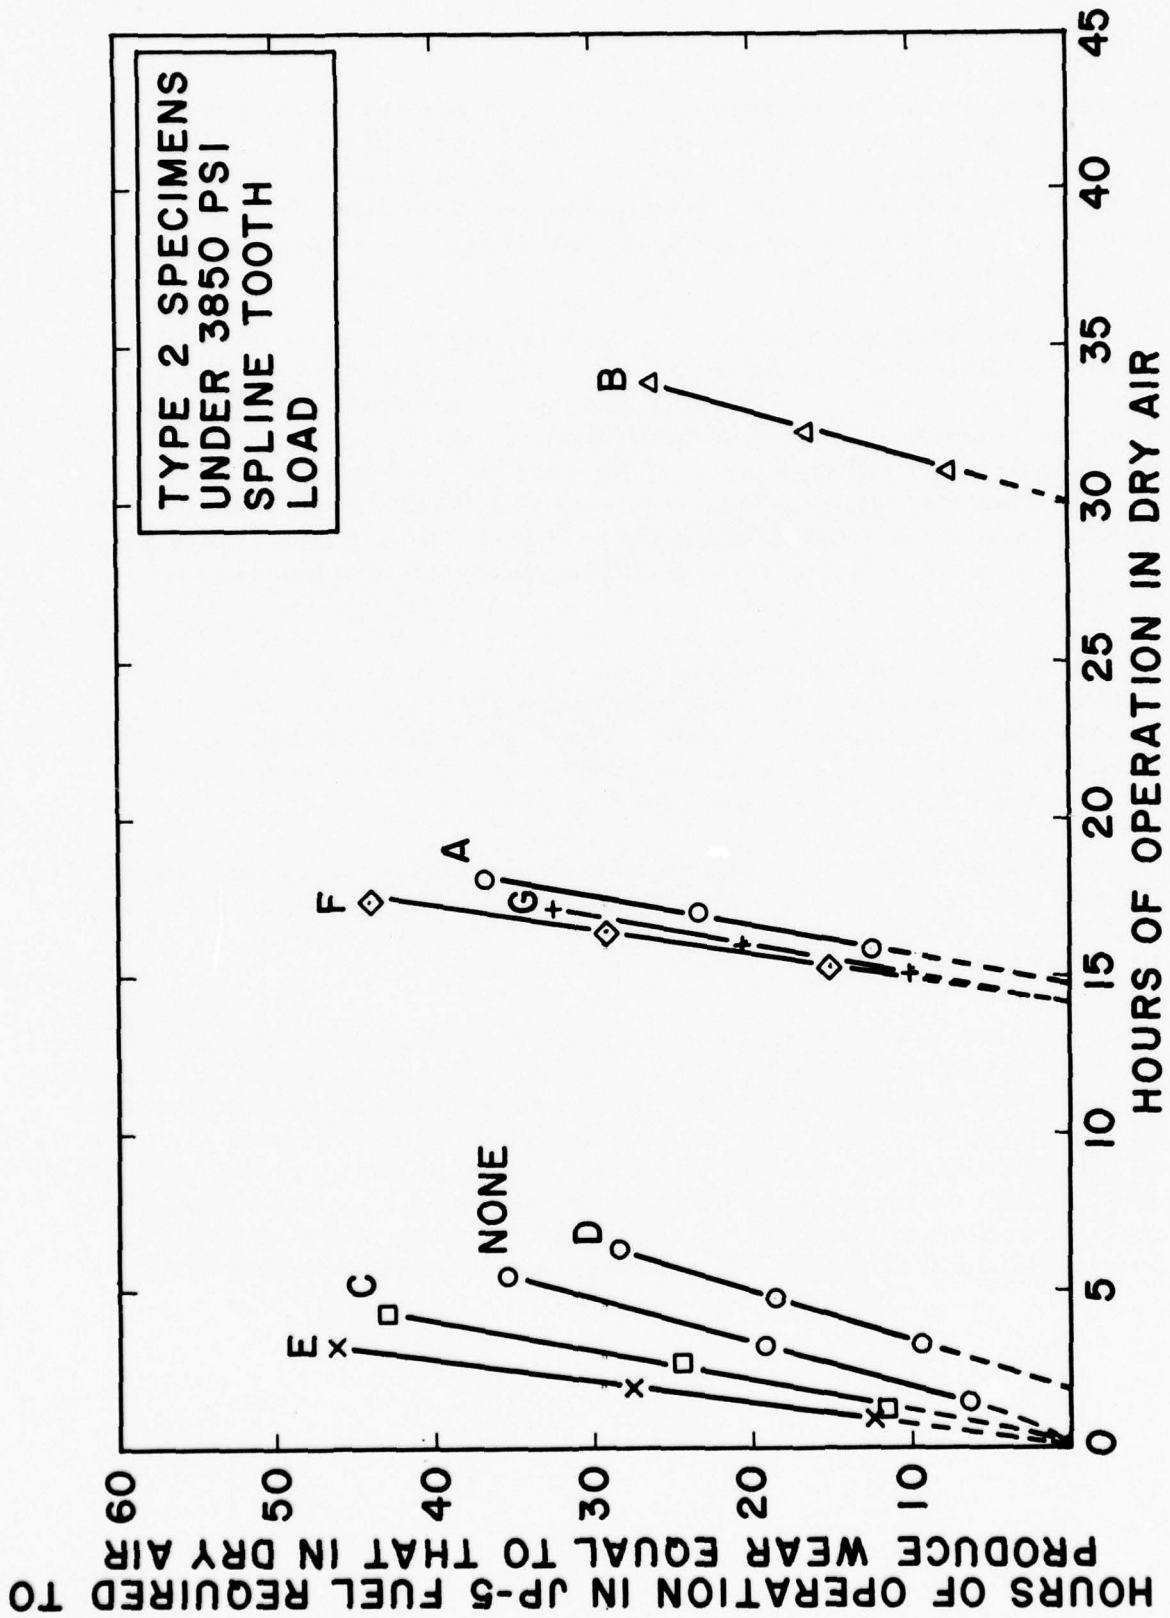
Figure A-4 presents the comparative performance of Type 2 splines, unlubricated and lubricated with several greases in dry air and JP-5 environments. The abscissa denotes the time required to reach a certain amount of total spline wear in dry air environment; the ordinate denotes the time required to reach the same amount of total wear in JP-5 environment. The various lines portray the performance of splines with no lubrication (none) and with various greases (A, B, C, etc.). For each of the lines shown, three data points are given that correspond to different amounts of total

FIGURE A-4. PERFORMANCE OF GREASES IN DRY AIR AND JP-5 ENVIRONMENTS
(TYPE 2 SPLINES)

spline wear. For each line, the first point reckoned from the abscissa represents a total wear of 0.003 inch. Similarly, the second and third points represent a total wear of 0.006 inch and 0.009 inch, respectively. Thus, for unlubricated splines, the total wear reaches 0.009 inch after 6 hours of operation in dry air, while in JP-5 fuel it takes 36 hours of operation to reach the same amount of wear. Likewise, with splines lubricated with Grease B, this same amount of wear is reached after 34 hours of operation in dry air, but 26 hours of operation in JP-5.

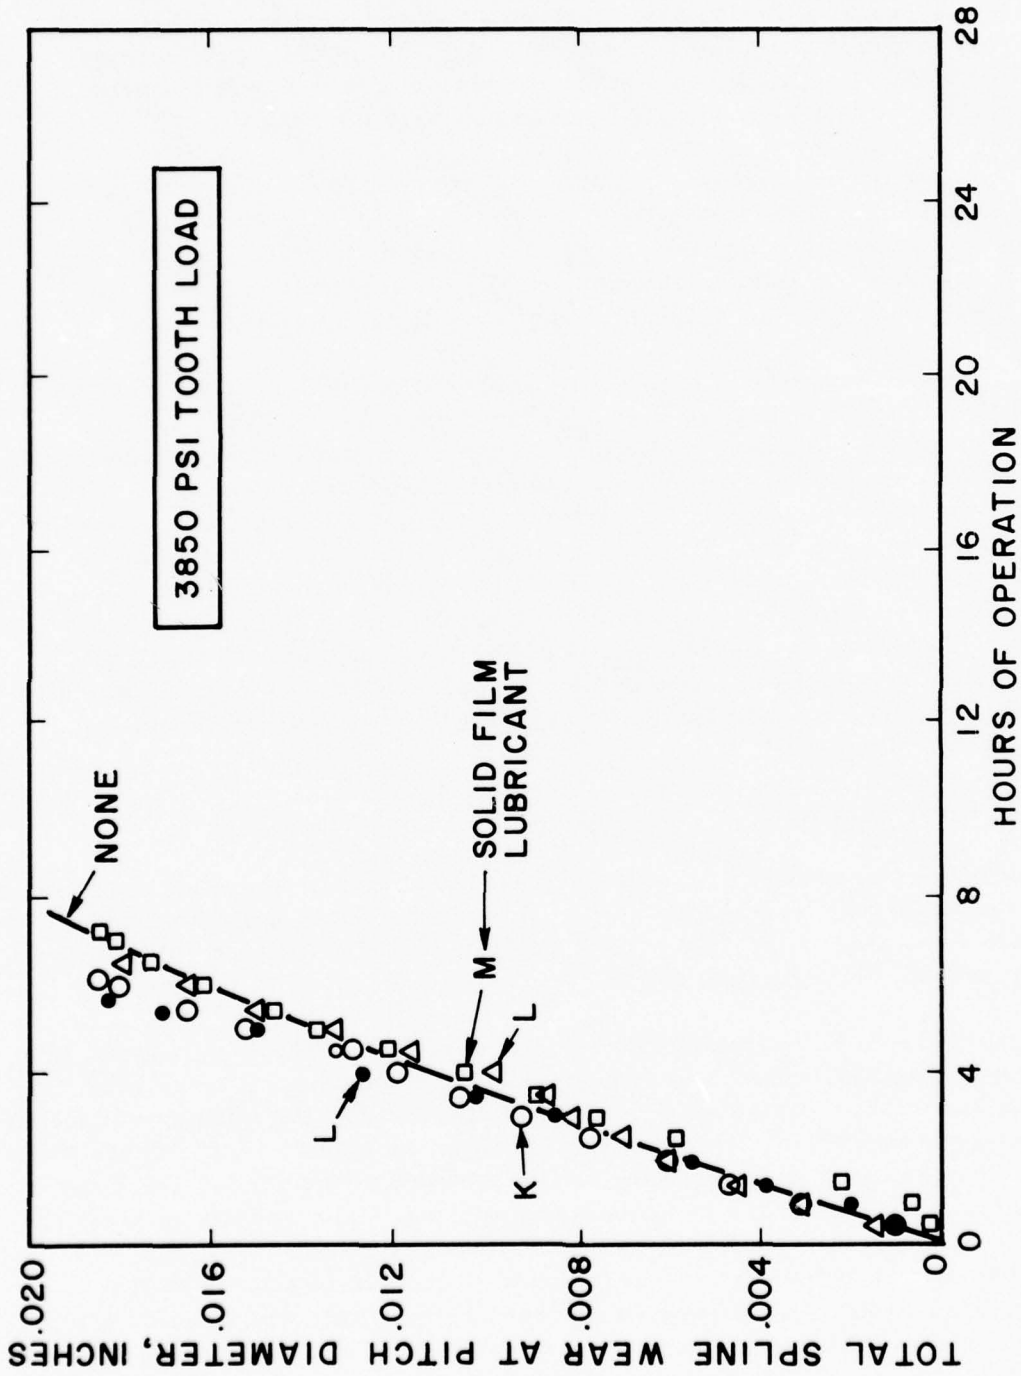
Figure A-5 illustrates the results obtained with the K, L, and M solid-film lubricants operated in a dry air environment. It is evident that the solid films did not provide any protection for the spline connection and were essentially the same as the uncoated reference test. Tests were also performed (not included here in the interest of space) for the Type 1 specimens with K, L, and M solid films applied. The results of these tests were also essentially the same as those presented in Figure A-5; the solid-film lubricants have been found to behave similarly to the unlubricated case. Solid-films are generally very thin and provide almost no protection against wear under these conditions. The loose wear debris will work away from the contact zone, since there is no grease to retain them there.

FIGURE A-5. PERFORMANCE OF SOLID-FILM LUBRICANTS IN DRY AIR (TYPE 2 SPLINES)

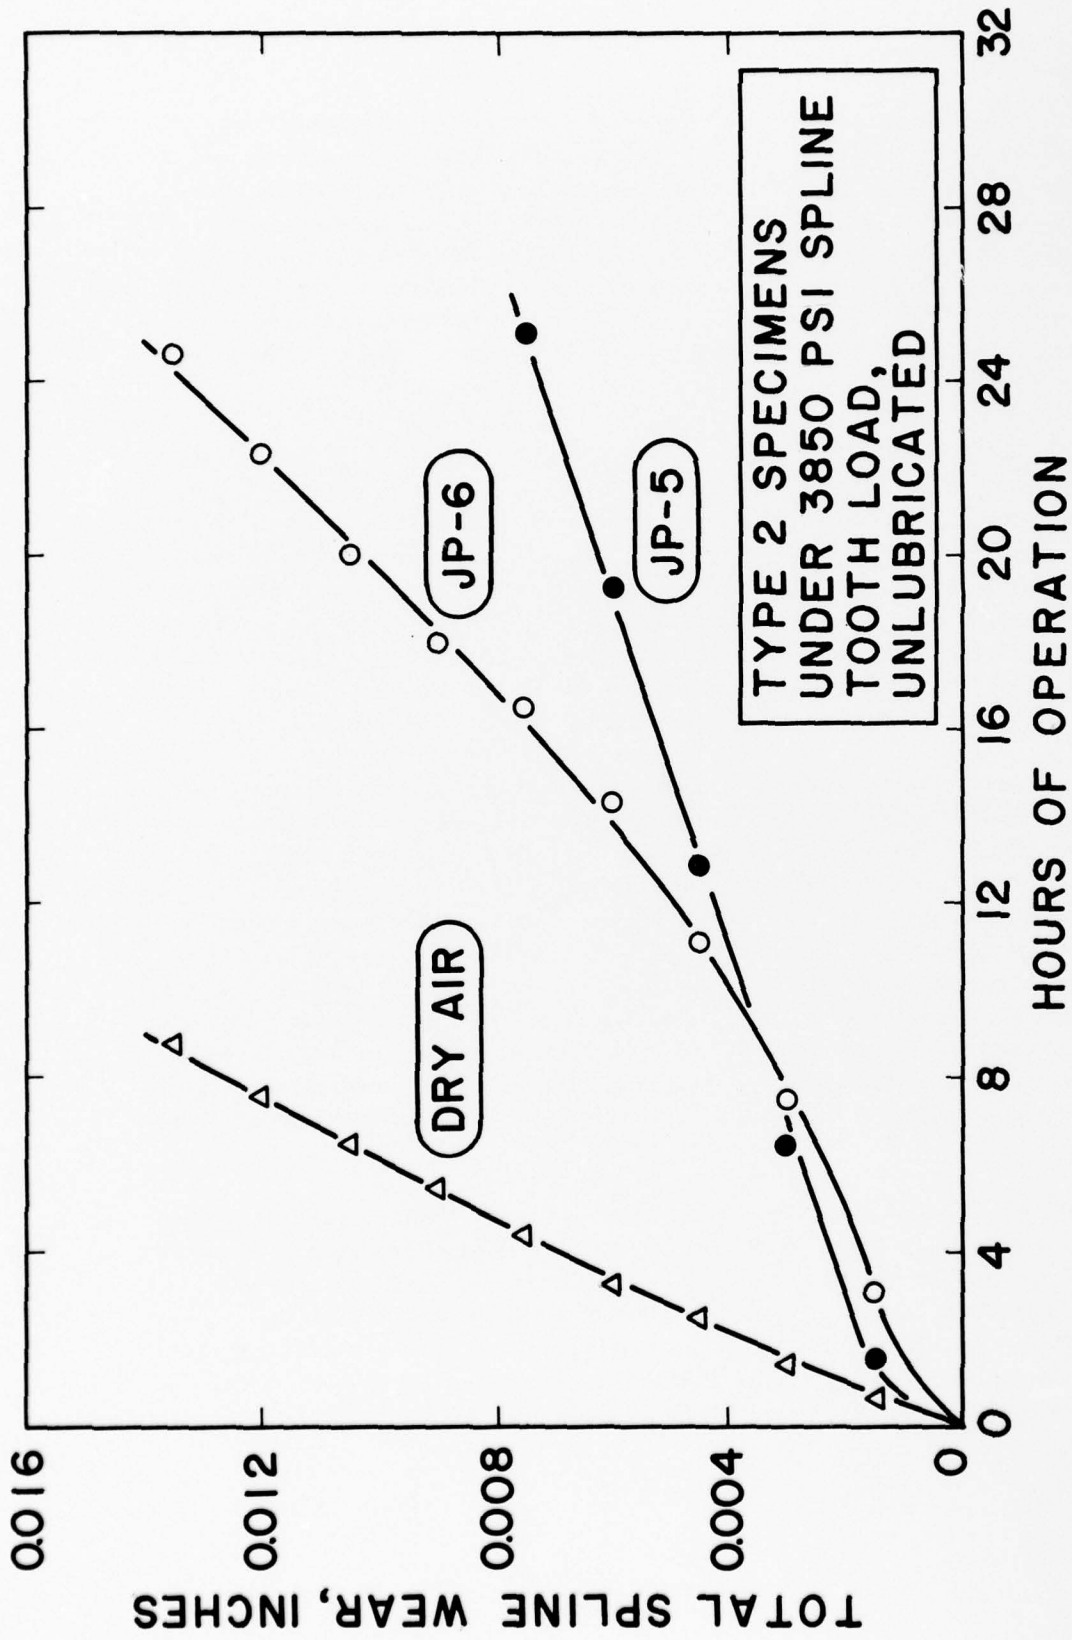
FIGURE A-6. INFLUENCE OF SPLINE ENVIRONMENT FLUID ON WEAR RATES FOR UNLUBRICATED SPLINES (TYPE 2 SPLINES)
