A CRITICAL SURVEY AND ANALYSIS OF AIRCRAFT SPLINE FAILURES

In Support of
NAVAL ANALYTICAL REWORK PROGRAM

FINAL REPORT
Contract N00156-70-C-2156

August 18, 1971

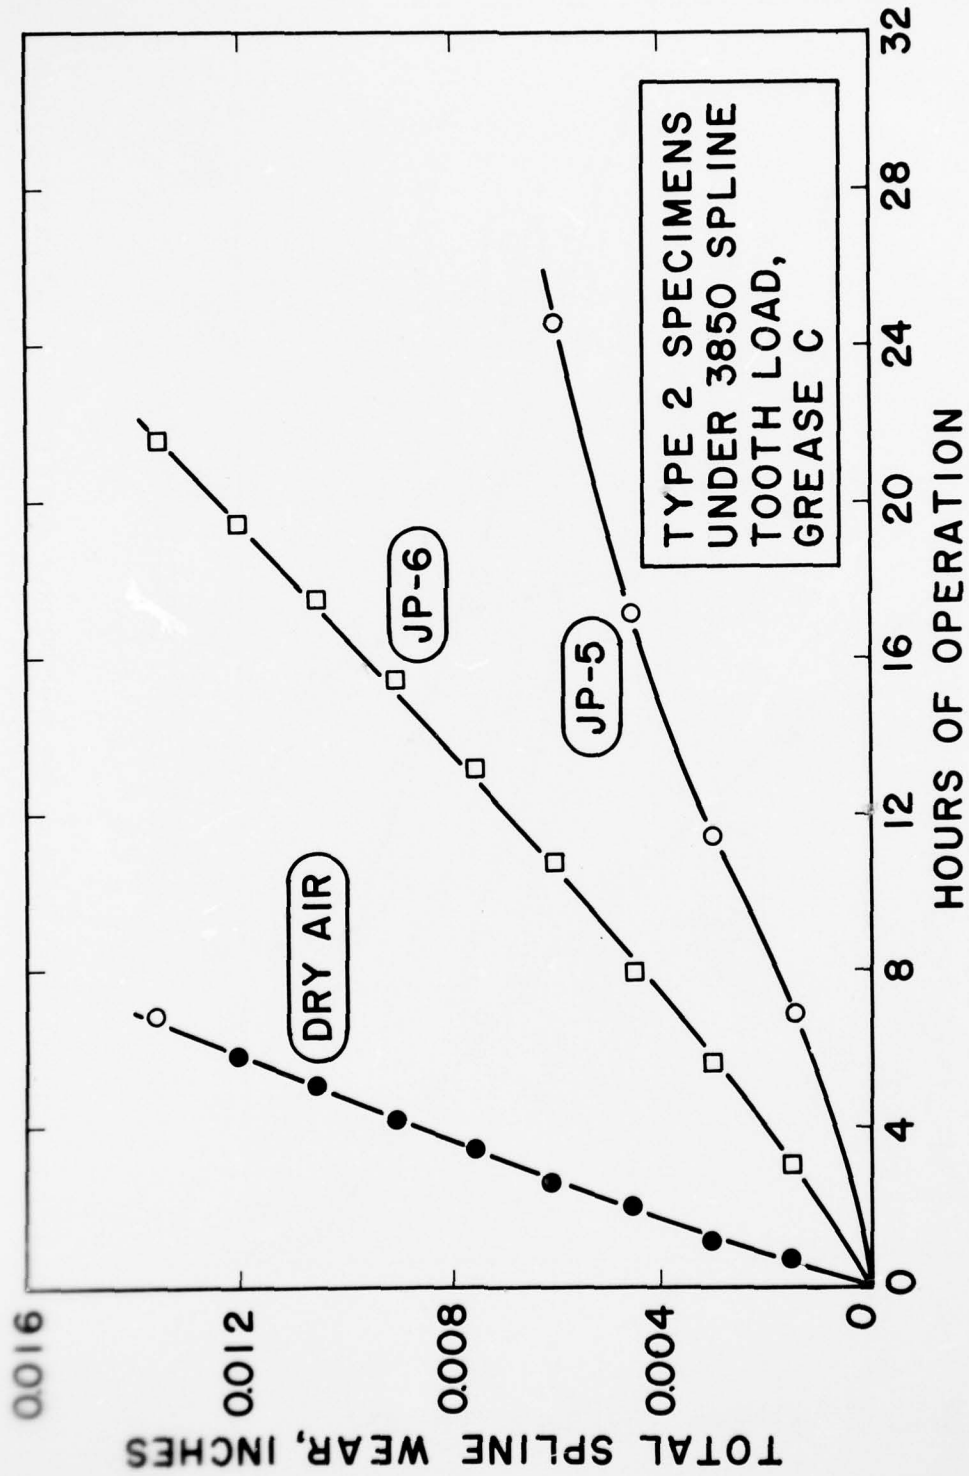
FIGURE A-7. INFLUENCE OF SPLINE ENVIRONMENT FLUID ON WEAR RATES FOR SPLINES LUBRICATED WITH GREASE C (TYPE 2 SPLINES)

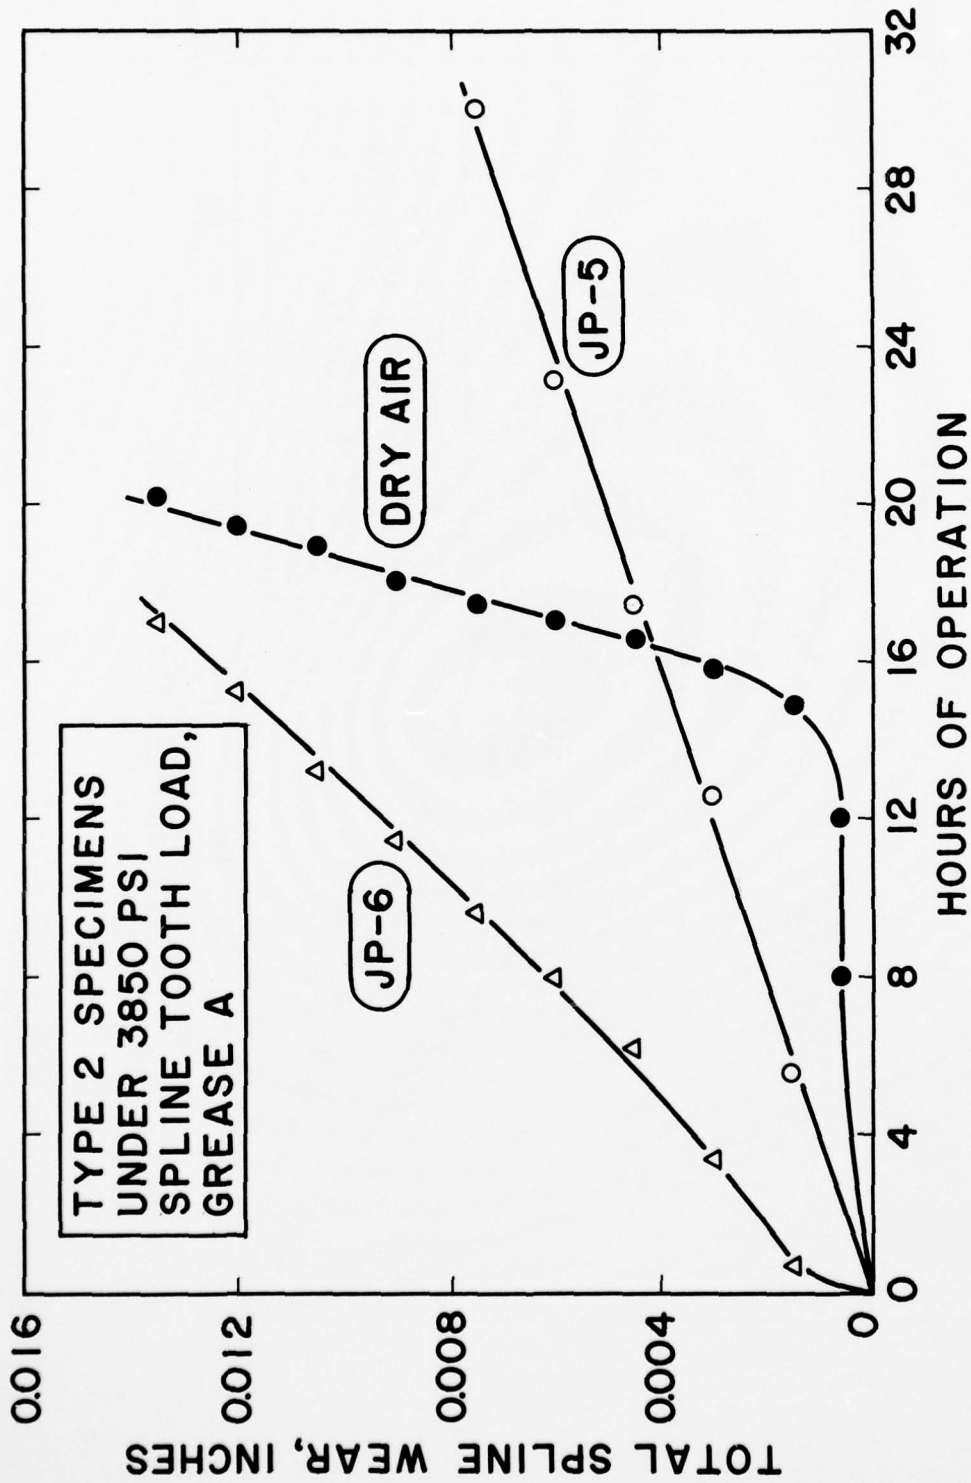
The performance of greases that show induction periods in dry air is illustrated in Figure A-8 for Grease A. The disappearance of an induction period in the presence of fuel is believed to be due to the solubility effect of the fuel, as Grease A is highly soluble in fuel (see Table A-4). The relative performance in dry air and in fuel is dependent upon the magnitude of the induction period in air. However, the relative effects of JP-5 and JP-6 are preserved as explained previously.

FIGURE A-8. INFLUENCE OF SPLINE ENVIRONMENT FLUID ON WEAR RATES FOR SPLINES LUBRICATED WITH GREASE A (TYPE 2 SPLINES)

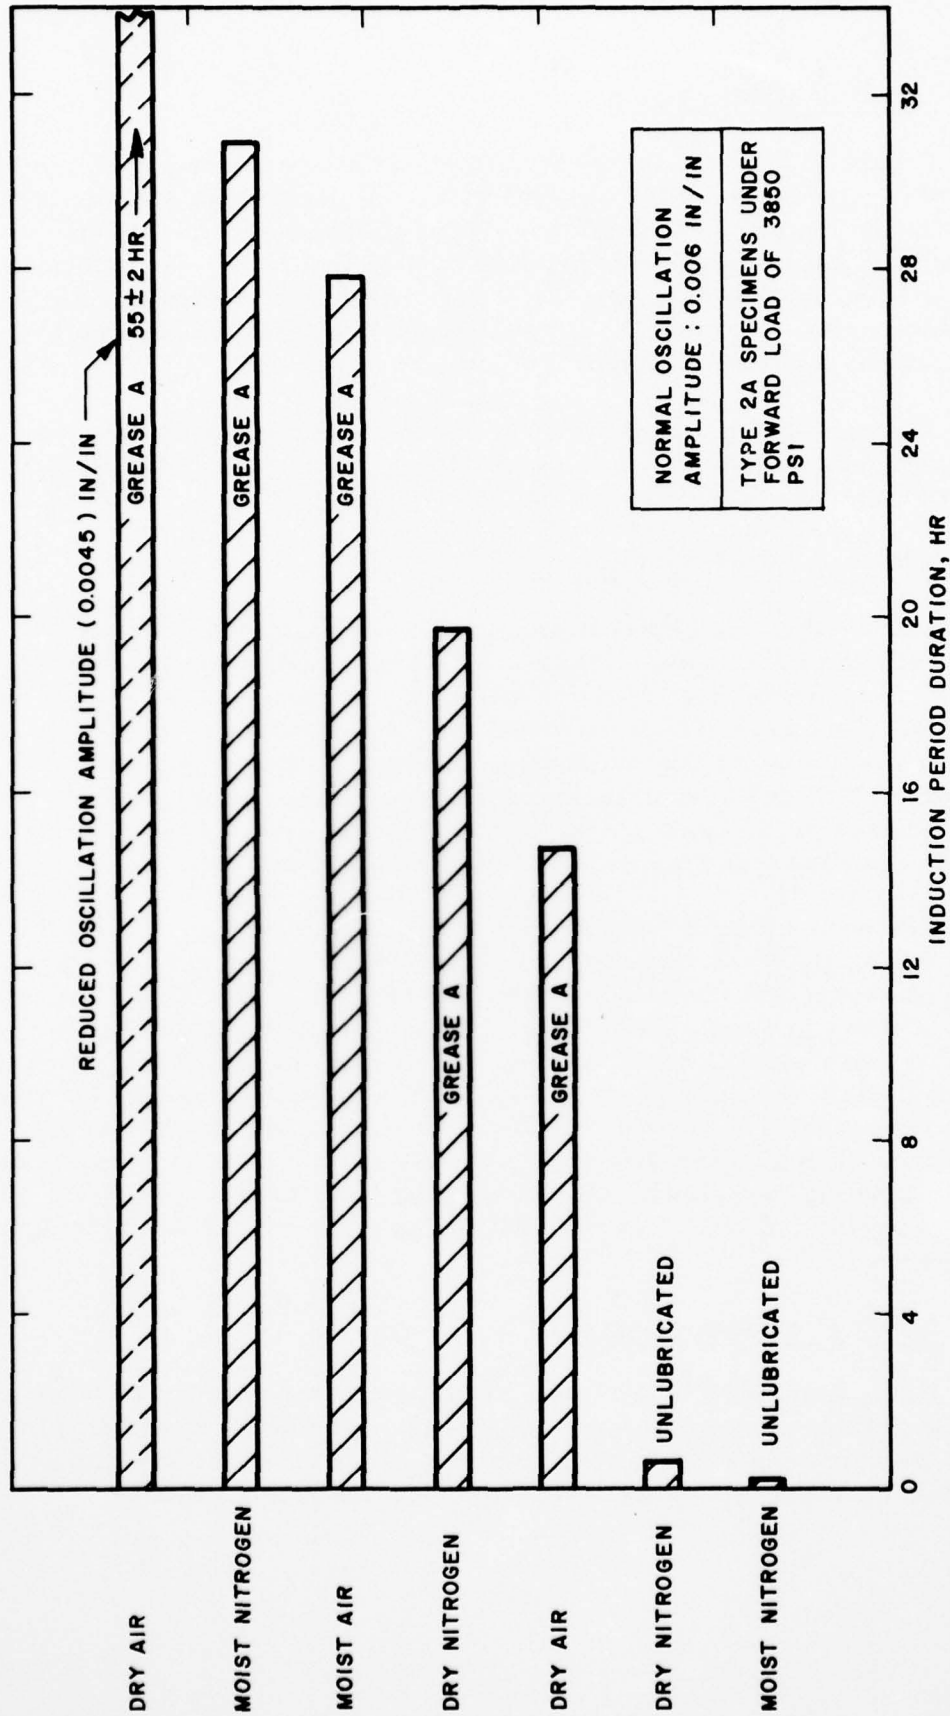
FIGURE A-9. EFFECT OF SPLINE MISALIGNMENT AND GASEOUS ENVIRONMENT (TYPE 2A SPLINES)

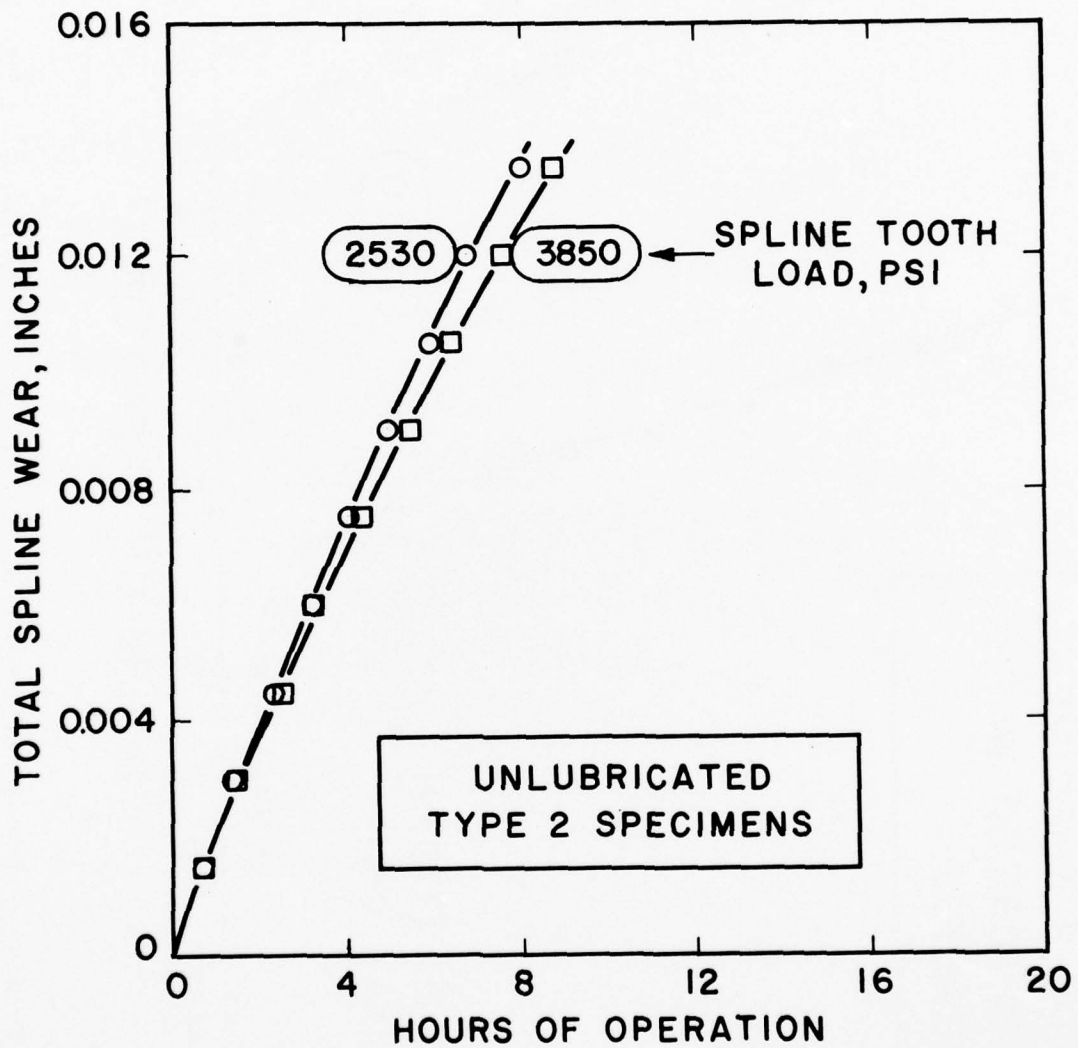
FIGURE A-10. INFLUENCE OF LOAD ON SPLINE WEAR RATES IN DRY AIR FOR UNLUBRICATED SPLINES (TYPE 2 SPLINES)

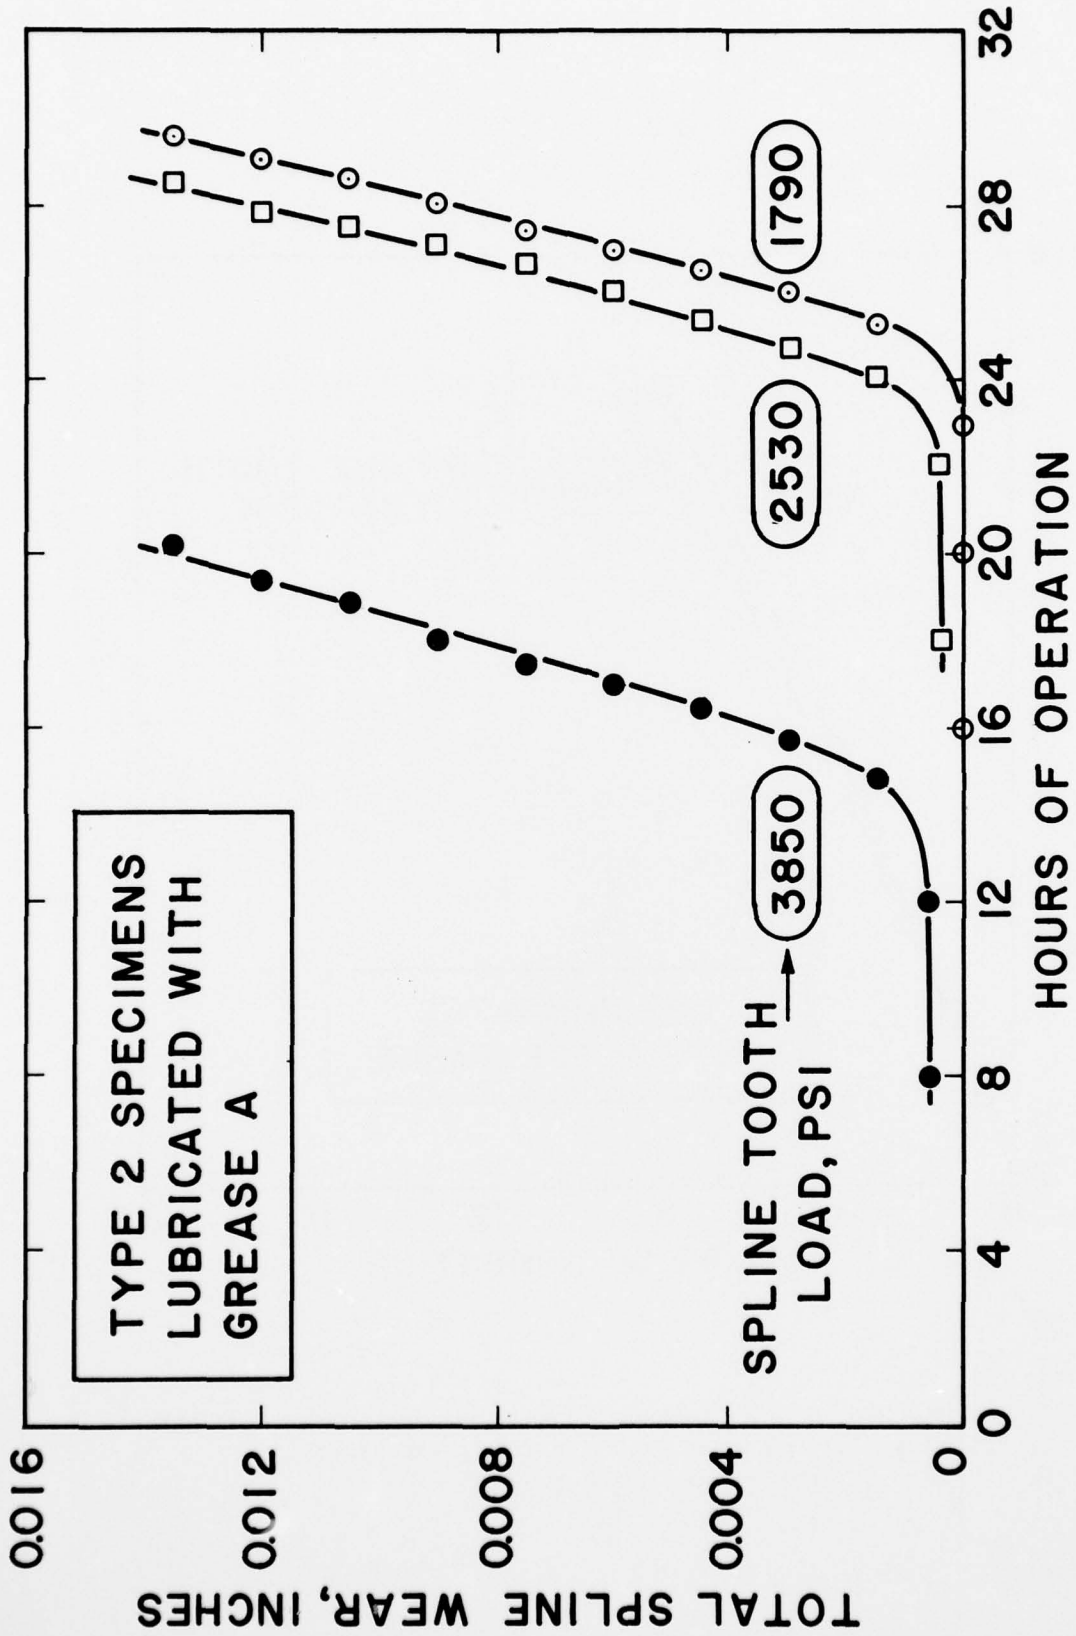
FIGURE A-11. INFLUENCE OF LOAD ON SPLINE WEAR RATES IN DRY AIR FOR SPLINES LUBRICATED WITH GREASE A (TYPE 2 SPLINES)

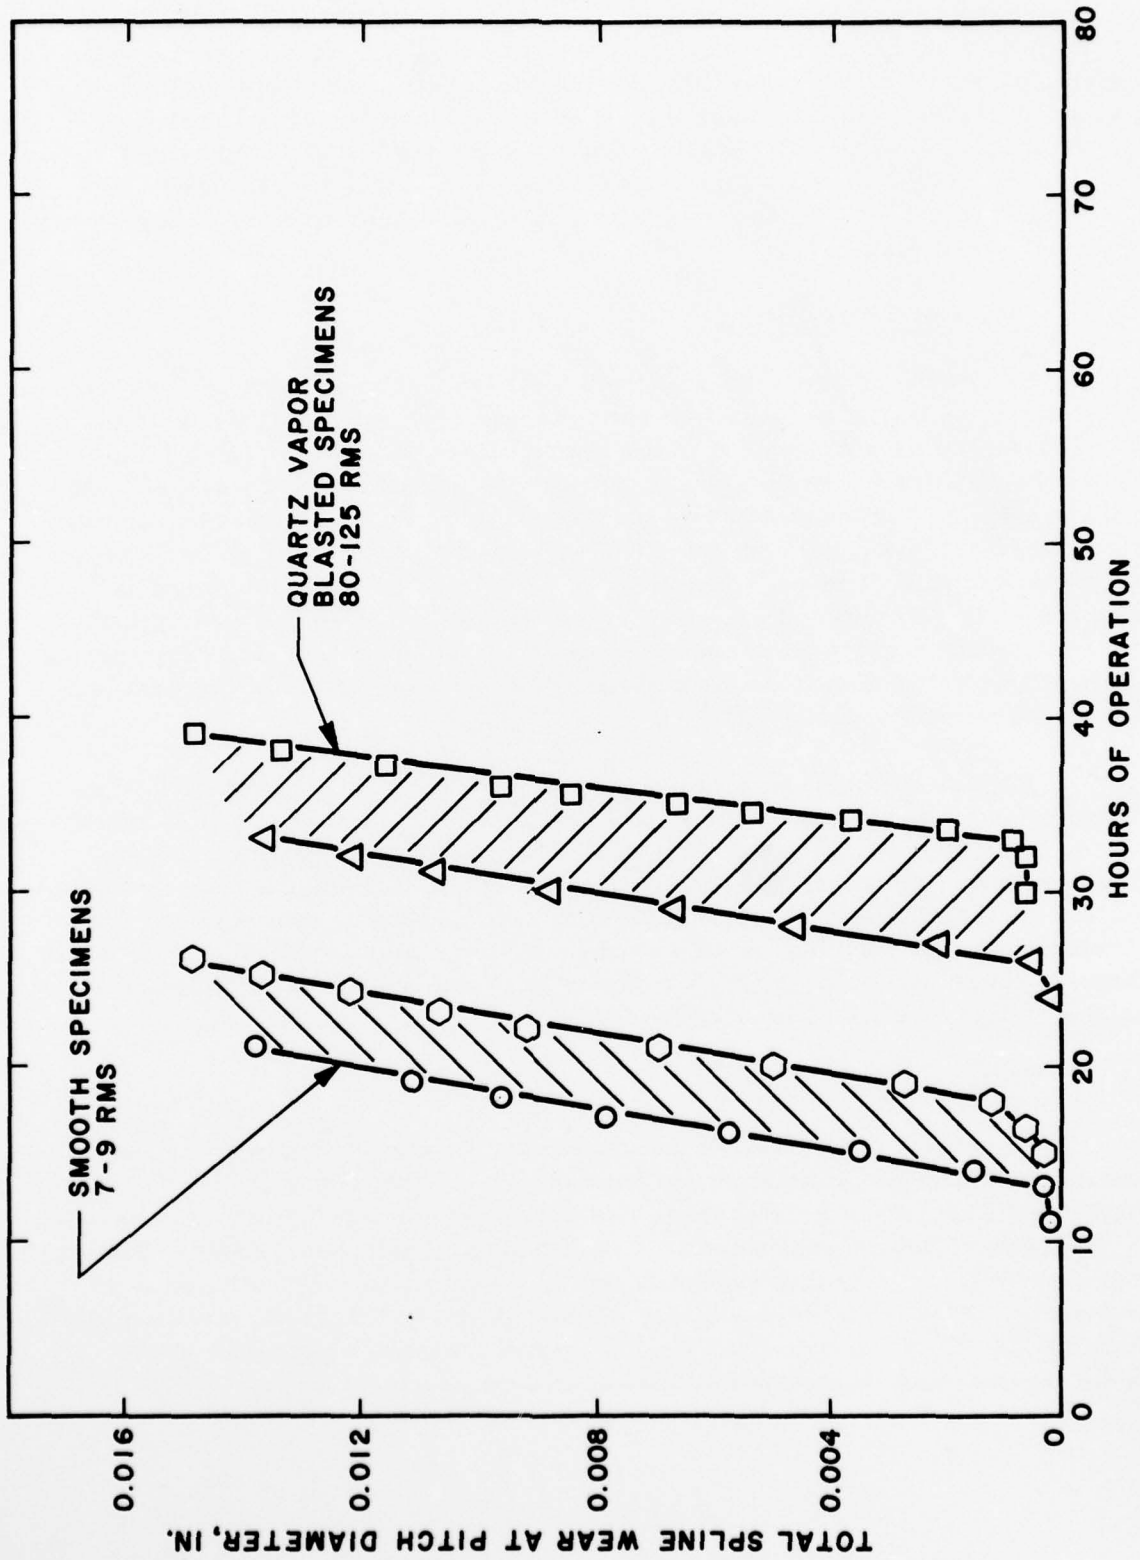
Using Grease A, a series of experiments was conducted to investigate the influence of spline-tooth surface roughness on wear behavior. This study employed smooth new specimens (7-9 rms) and specimens roughened by vapor blasting (80-125 rms) with a quartz grit.

FIGURE A-12. INFLUENCE OF SURFACE ROUGHNESS FOR SPLINES IN DRY AIR LUBRICATED WITH GREASE A (TYPE 2 SPLINES)

The results presented in Figure A-12 indicate that roughening of the spline-tooth surfaces increased the induction period. This is attributed to the greater grease holding capacity with rougher surfaces, which also facilitates grease flow to provide lubrication. Although the induction period with the roughened specimens was almost twice that of the smooth specimens, the wear rates after the induction period were essentially the same. Analogous results were observed when used specimens (i. e., specimens roughened by wear rather than by vapor blasting) were employed.

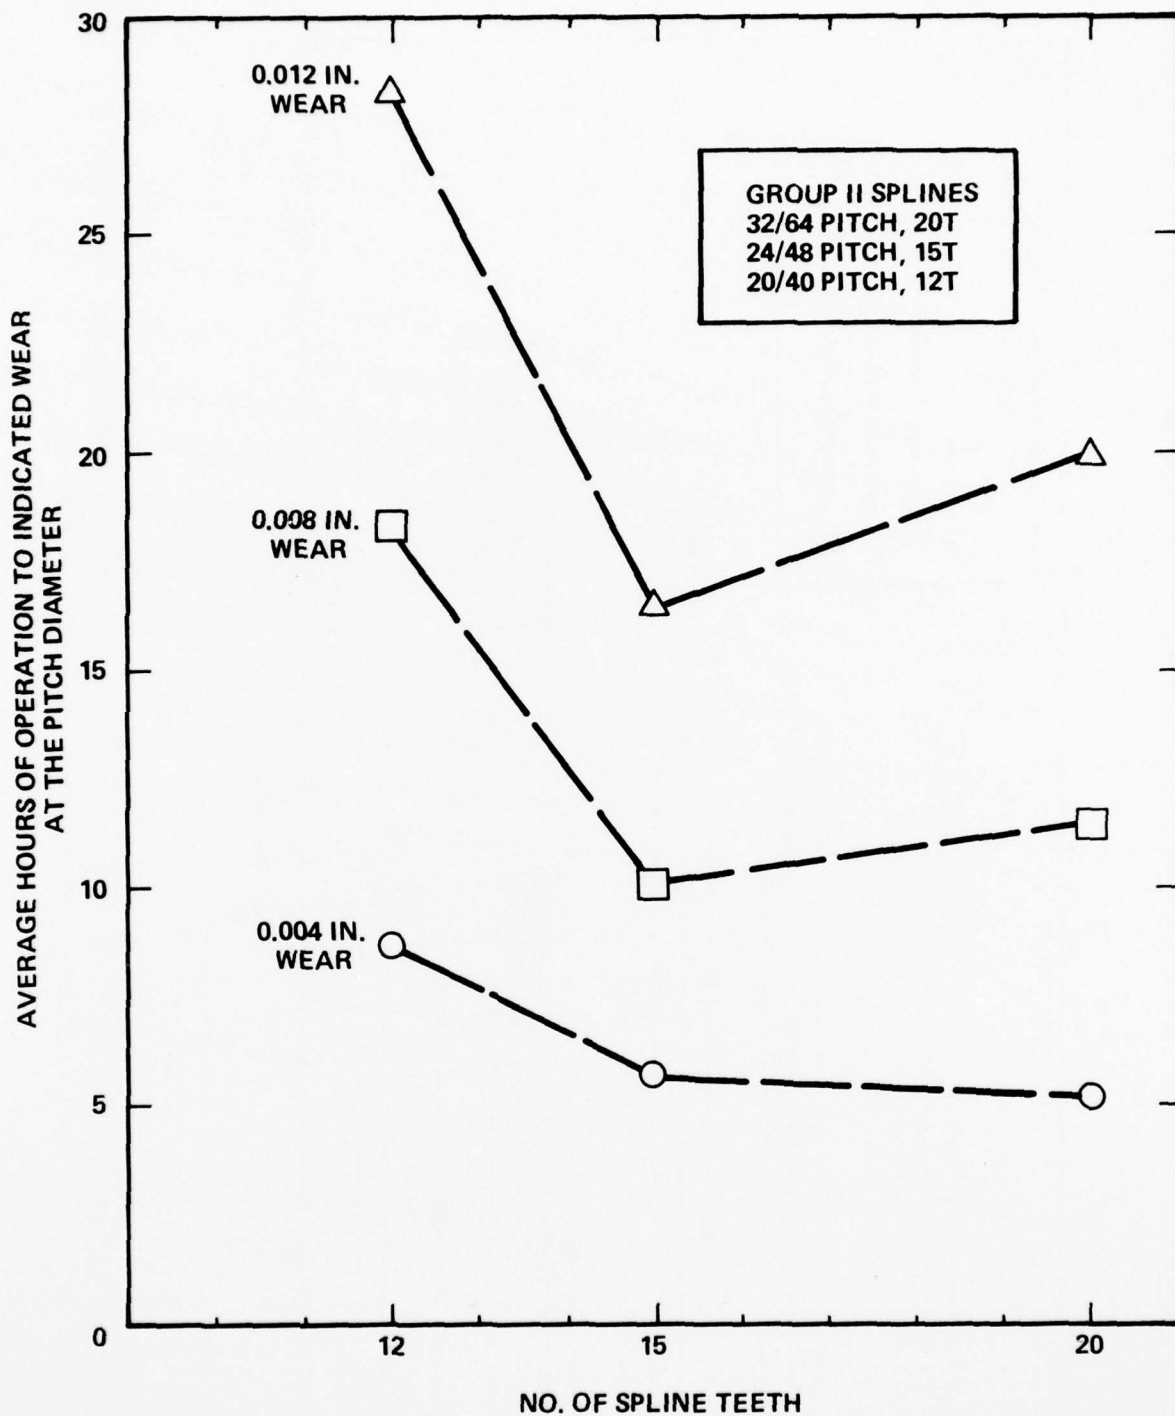
FIGURE A-13. INFLUENCE OF TOOTH PITCH FOR SPLINES IN JP-5 FUEL (GROUP II SPLINES)

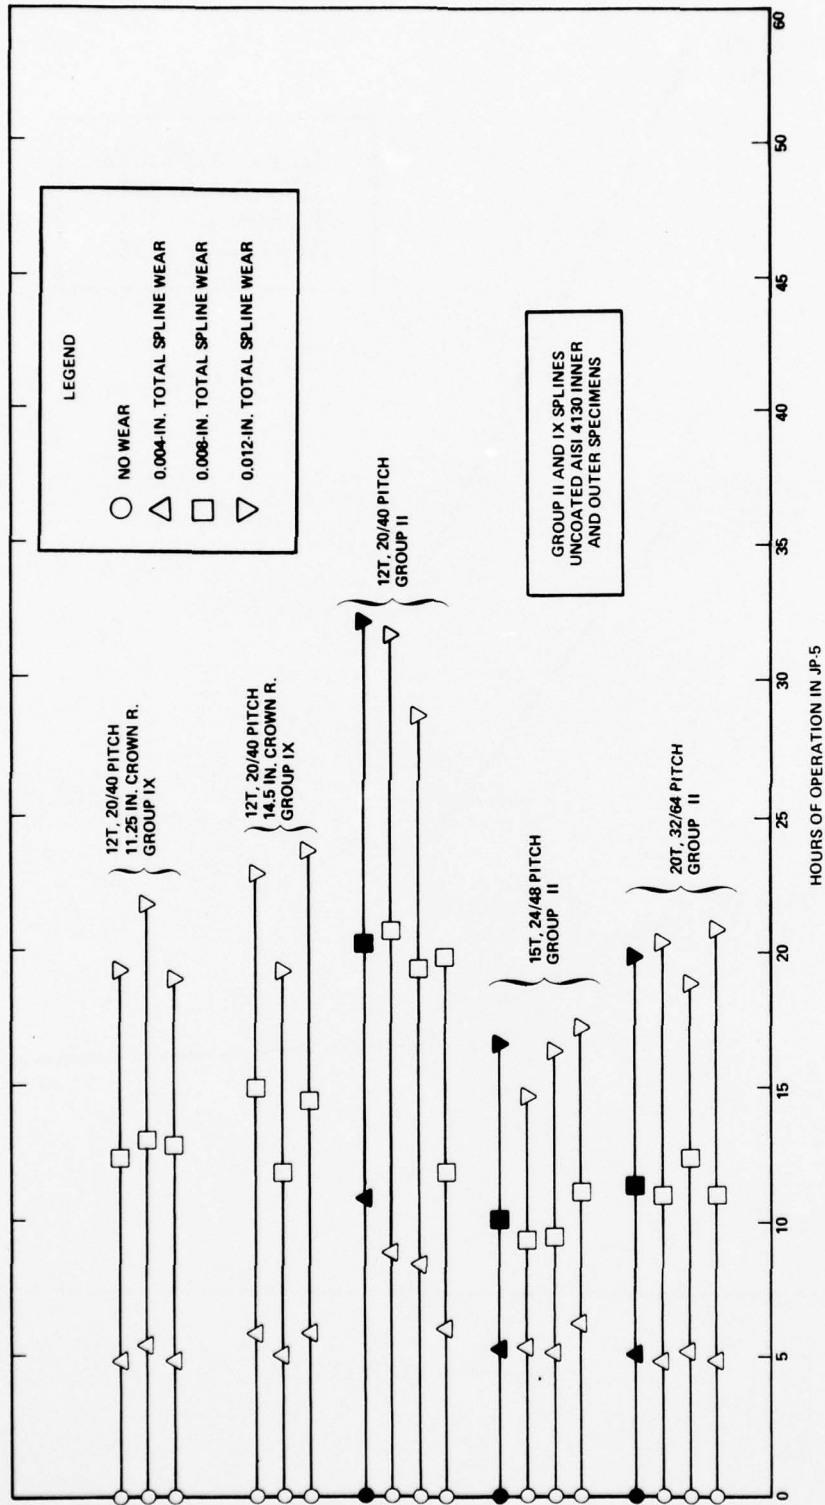
The upper three sets of bargraphs in Figure A-14 illustrate the results of the tests performed on three different crown radii: 11.25, 14.50 and ∞ in, also in JP-5 fuel. As can be seen, a moderate increase in the wear rate was present with a reduction in the crown radius. The increase in wear rate was probably due to the increase in tooth contact pressure. There was only a slight advantage of the 14.50 in. crown radius over the 11.25 in. crown radius. The added clearance provided by crowning the inner specimen produced an unequal depth of engagement

FIGURE A-14. INFLUENCE OF TOOTH PITCH (GROUP II SPLINES) AND CROWNED SPLINES (GROUP IX SPLINES) IN JP-5 FUEL

within the spline connection. Apparently, the inner specimen moved radically within the outer specimen producing a greater amount of tooth contact on about half of the spline teeth. This was observed on all of the 11.25 and 14.50 in. crown radii spline specimens and not on the uncrowned Group II spline specimens.

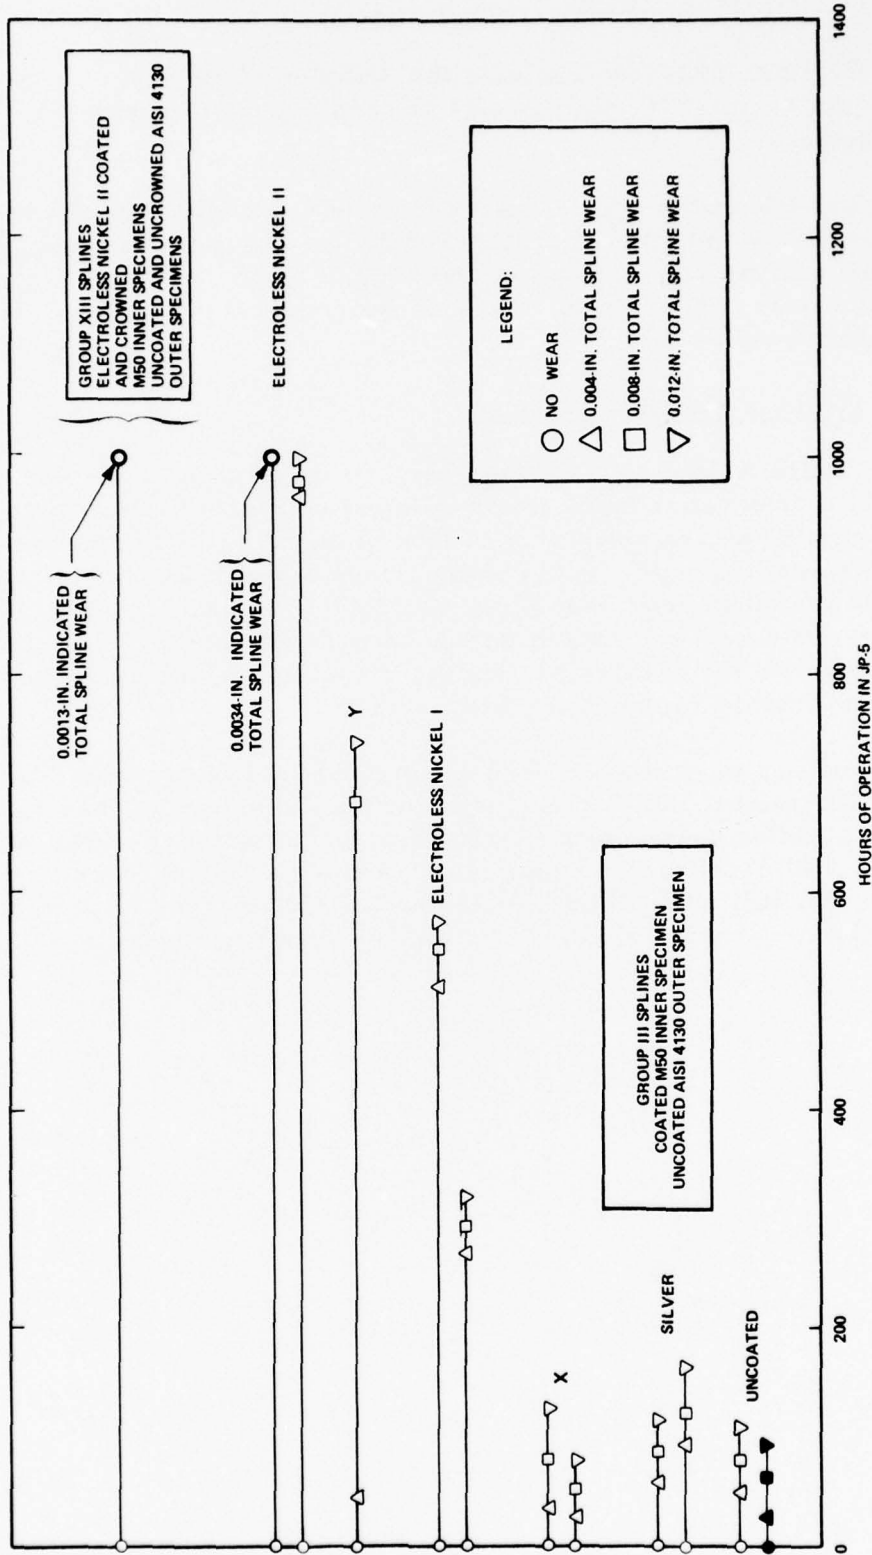
Further work was carried out in JP-5 fuel environment with the Group XIII splines, which comprised M50 male specimens having a 14.5-in. crown radius coated with Electroless Nickel II and uncrowned and uncoated AISI 4130 female specimens. Although four such sets were made, only one test was performed. At the end of 1000 hours of operation, the total spline wear was only 0.0013 inch, as shown in Figure A-16.

FIGURE A-16. EFFECT OF VARIOUS METALLIC COATINGS AND CROWNED SPLINES IN JP-5 FUEL (GROUPS III AND XIII SPLINES)

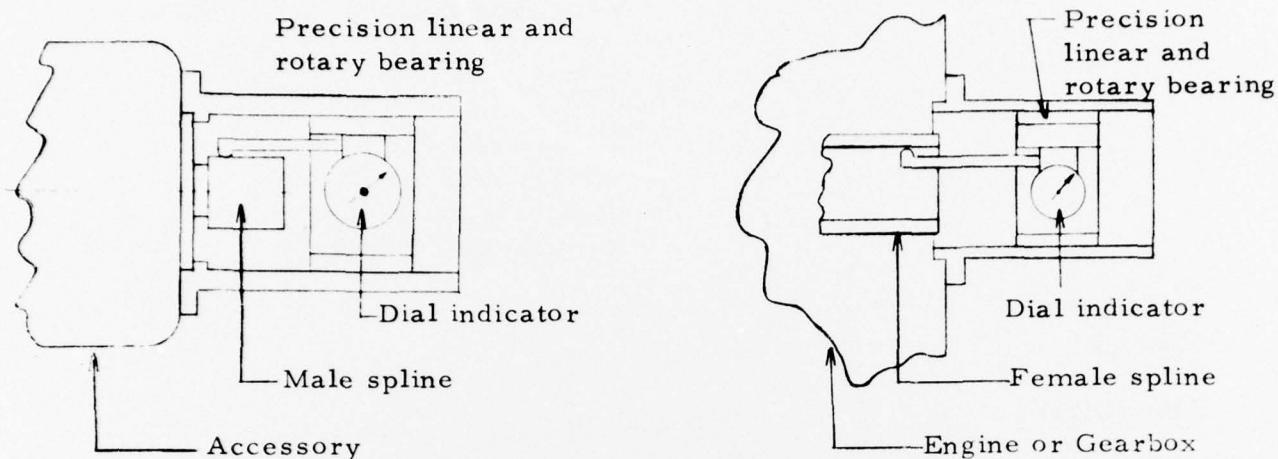
A ball-tipped stylus is employed to ride in contact with the sides of adjacent teeth. Misalignment is measured by axially traversing the stylus along the length of three or more equally spaced grooves. Differences in readings can be converted to give lateral and angular misalignments. Traversing in both the axial and circumferential direction is made possible by affixing the dial indicator to a precision linear and rotary bearing.

In the event that misalignment of a worn spline is to be measured, it would be necessary to slip a splined cylindrical sleeve over the spline for male splines and a splined plug into the female splines. Gaging measurements are made on the sleeve or plug. The splined sleeve or plug must fit closely with the spline being checked.

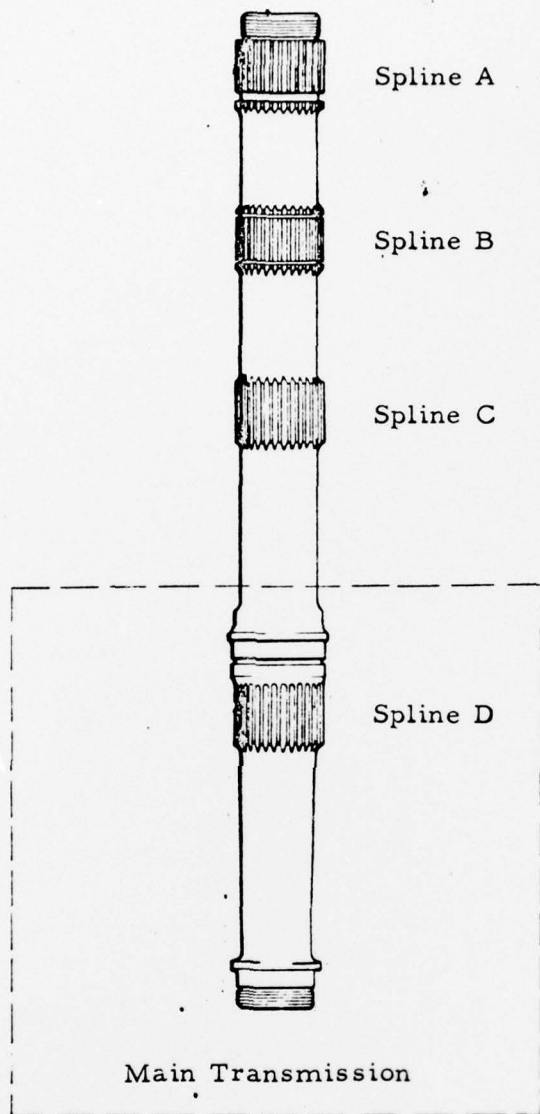
LOCATION OF SPLINES ON MAIN ROTOR MAST
OF UH-1 SERIES HELICOPTERS
